### **N789LH Inspector Kachinski Statement**

On April 22, 2023 at 1225 CDT it was reported that N789LH, a 2008 Schweizer 269C, Serial Number S1911, certificated in the Normal Category, crashed in a field near 3802 Black Rd. (Springfield TN) due to a loss of rotor RPM. Helicopter sustained tail boom damage. No injuries to occupants.

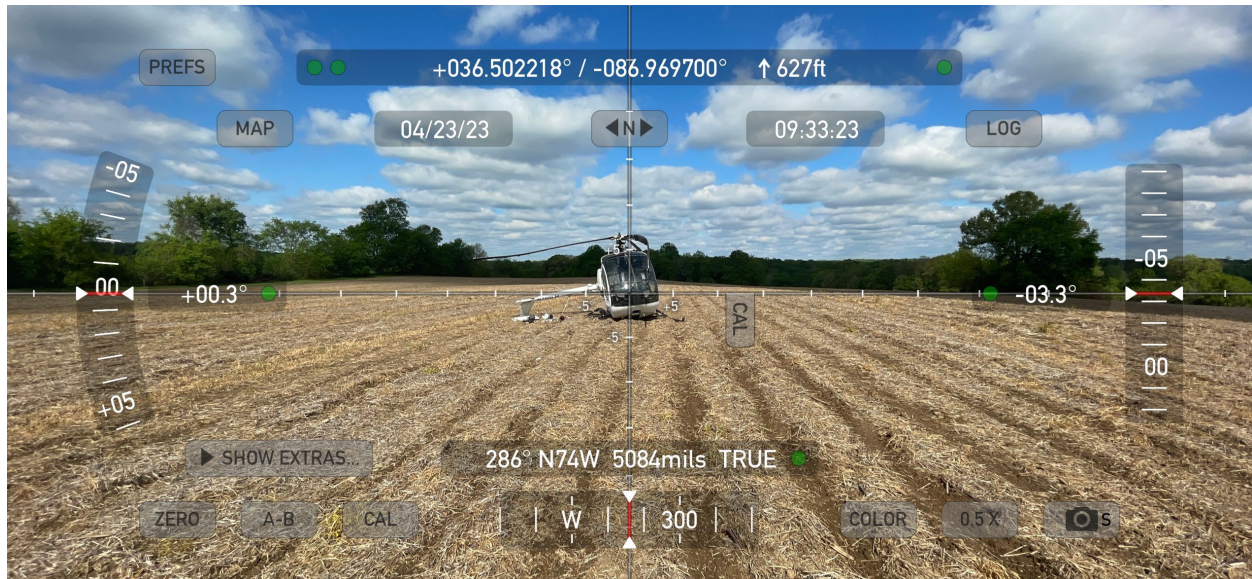
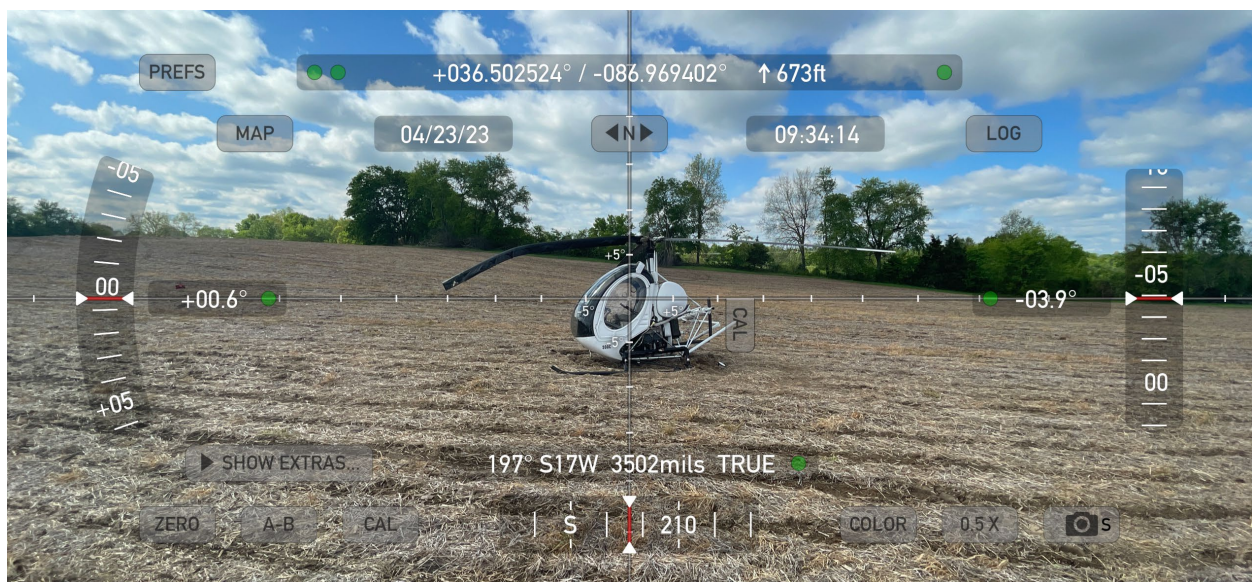
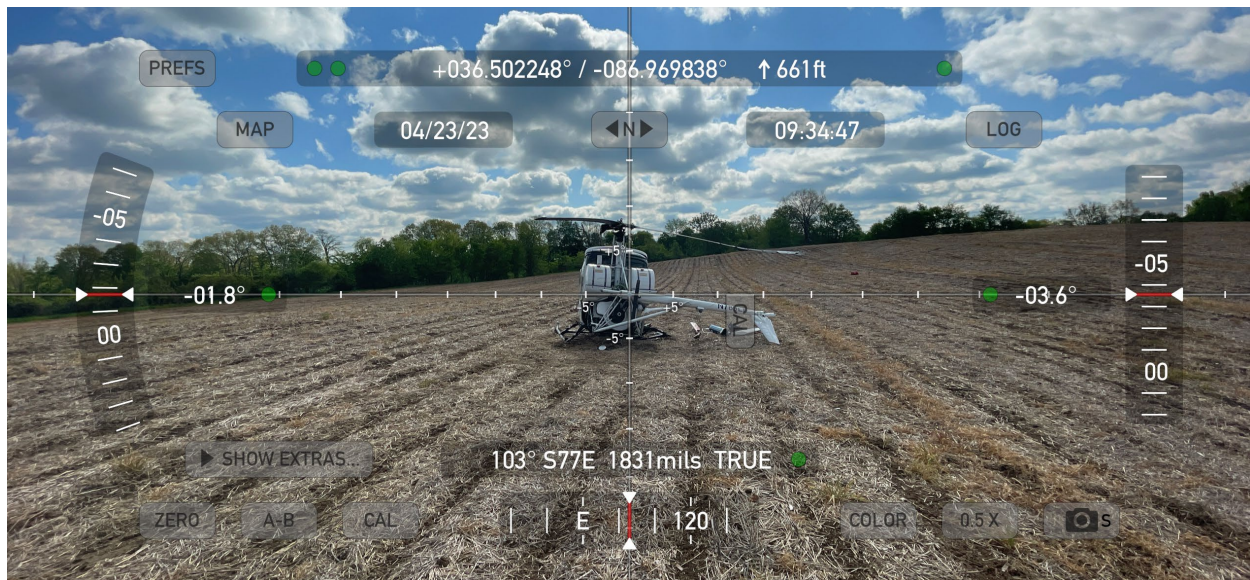
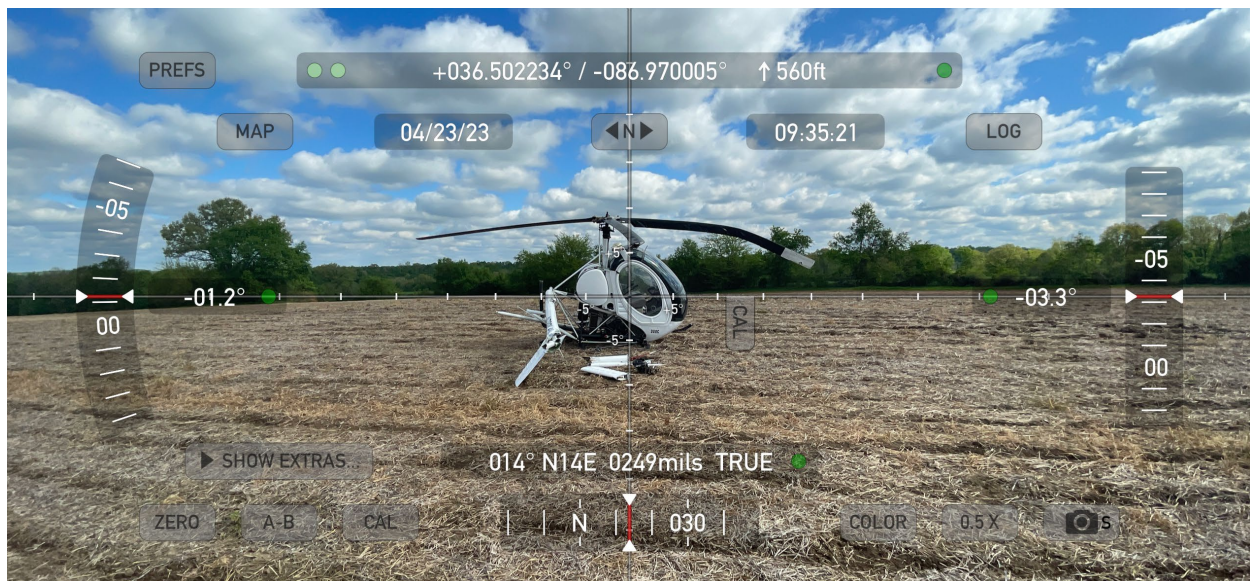
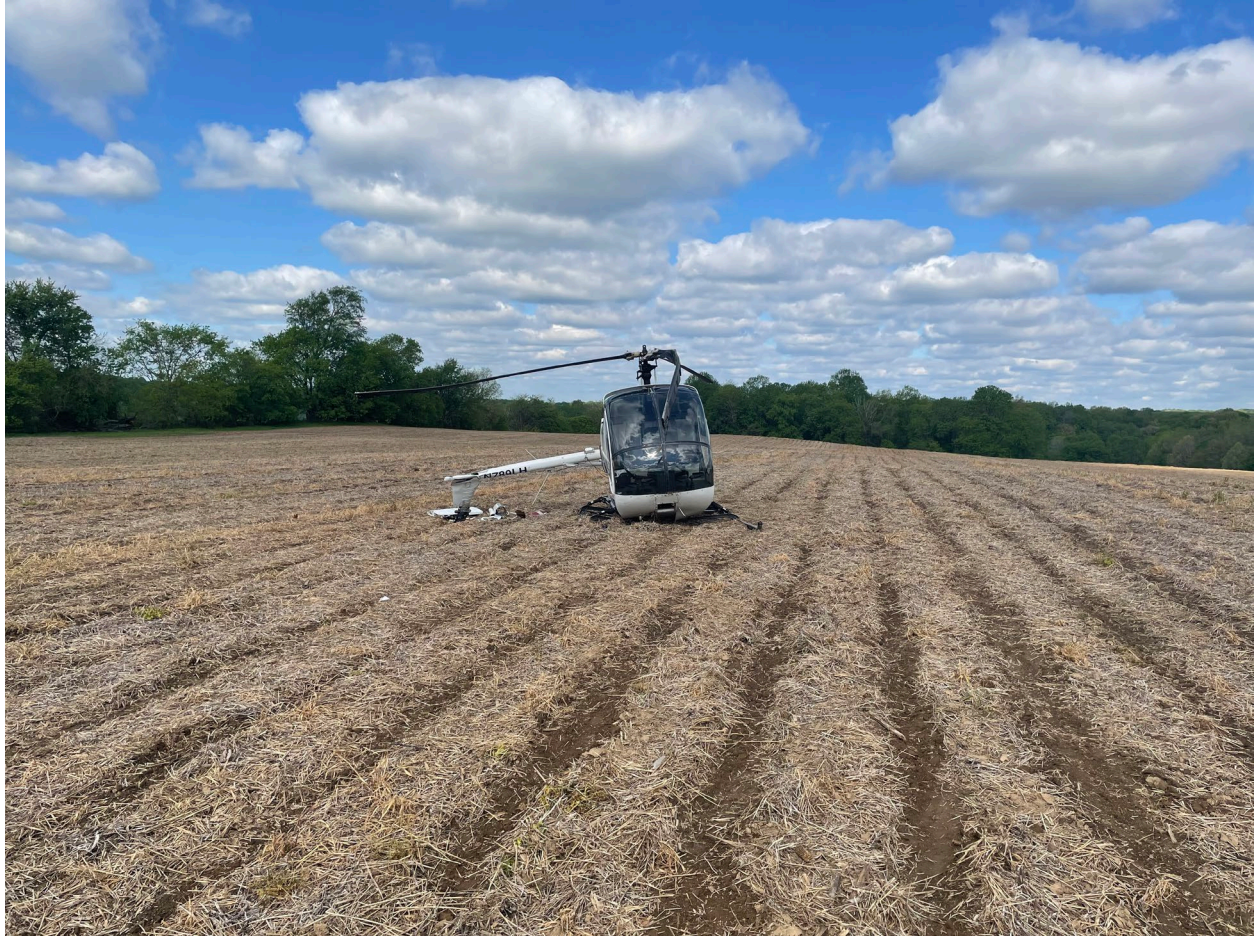
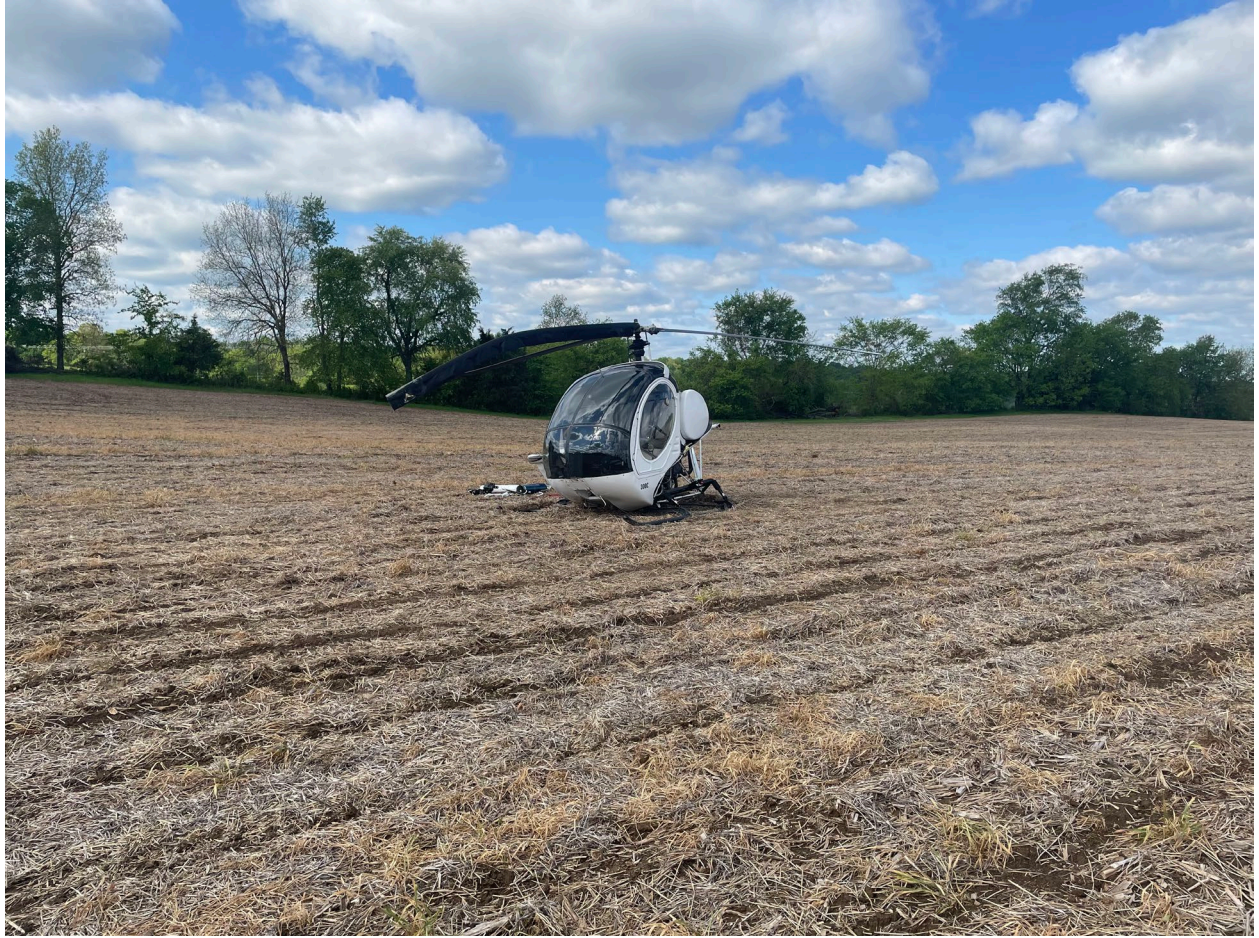
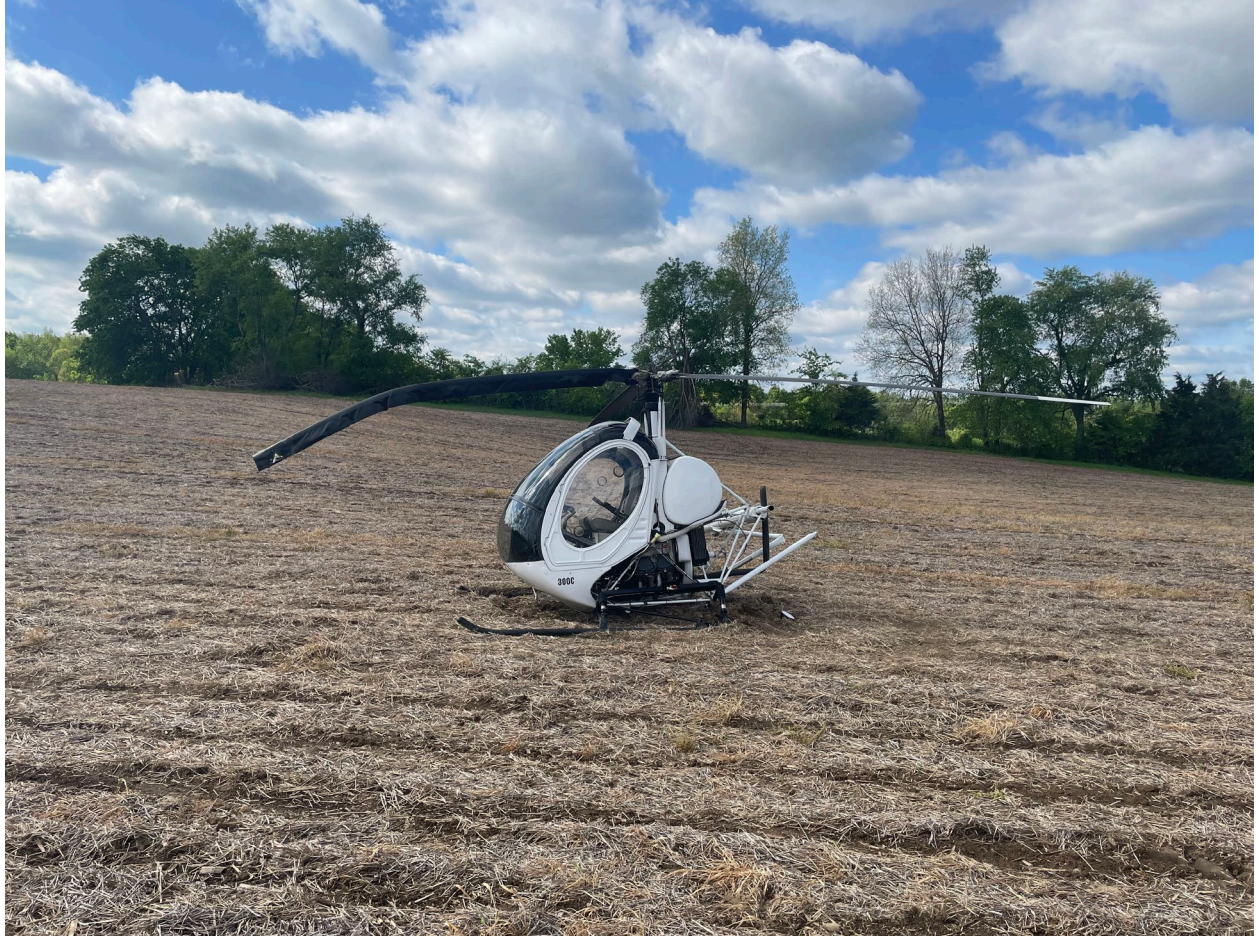
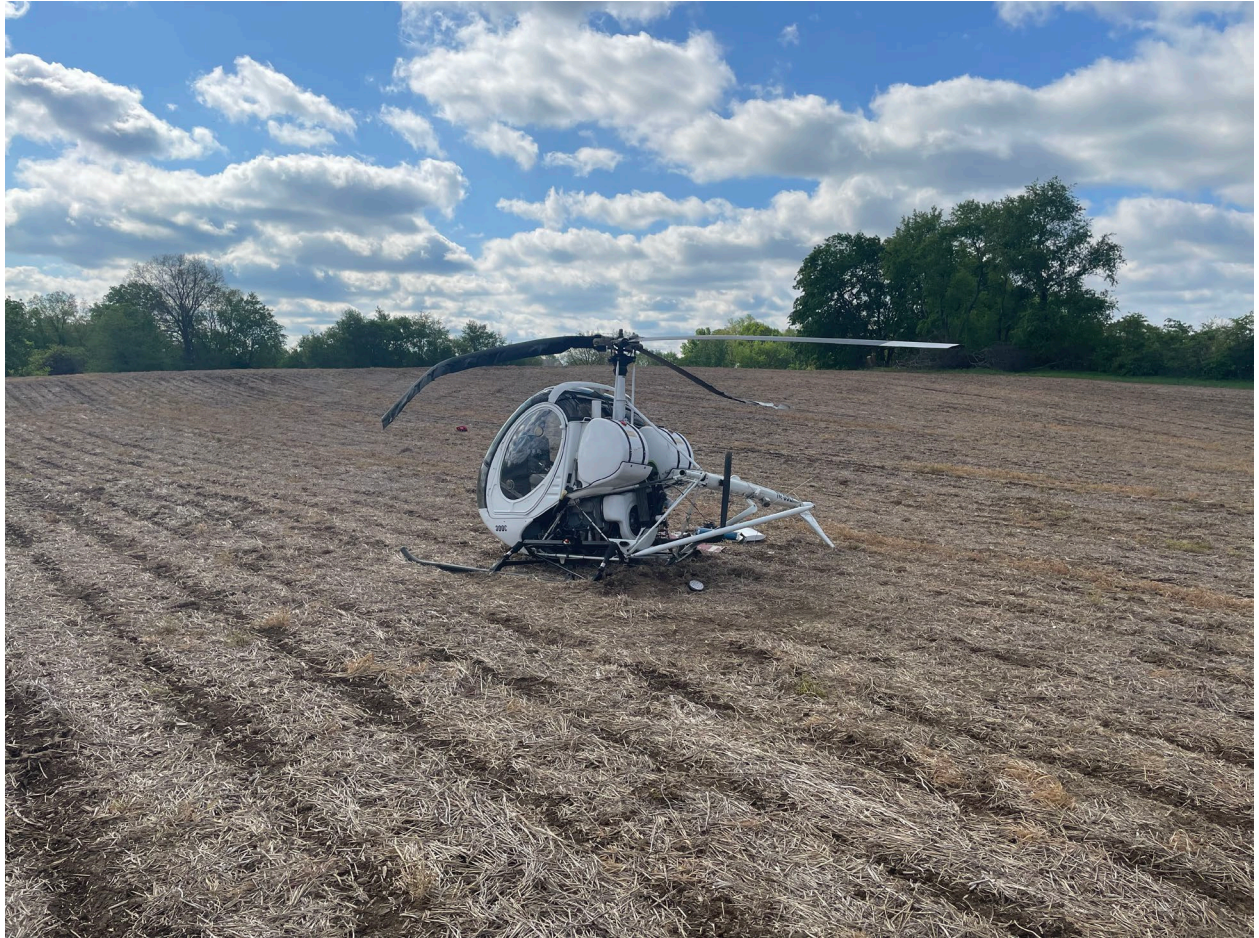
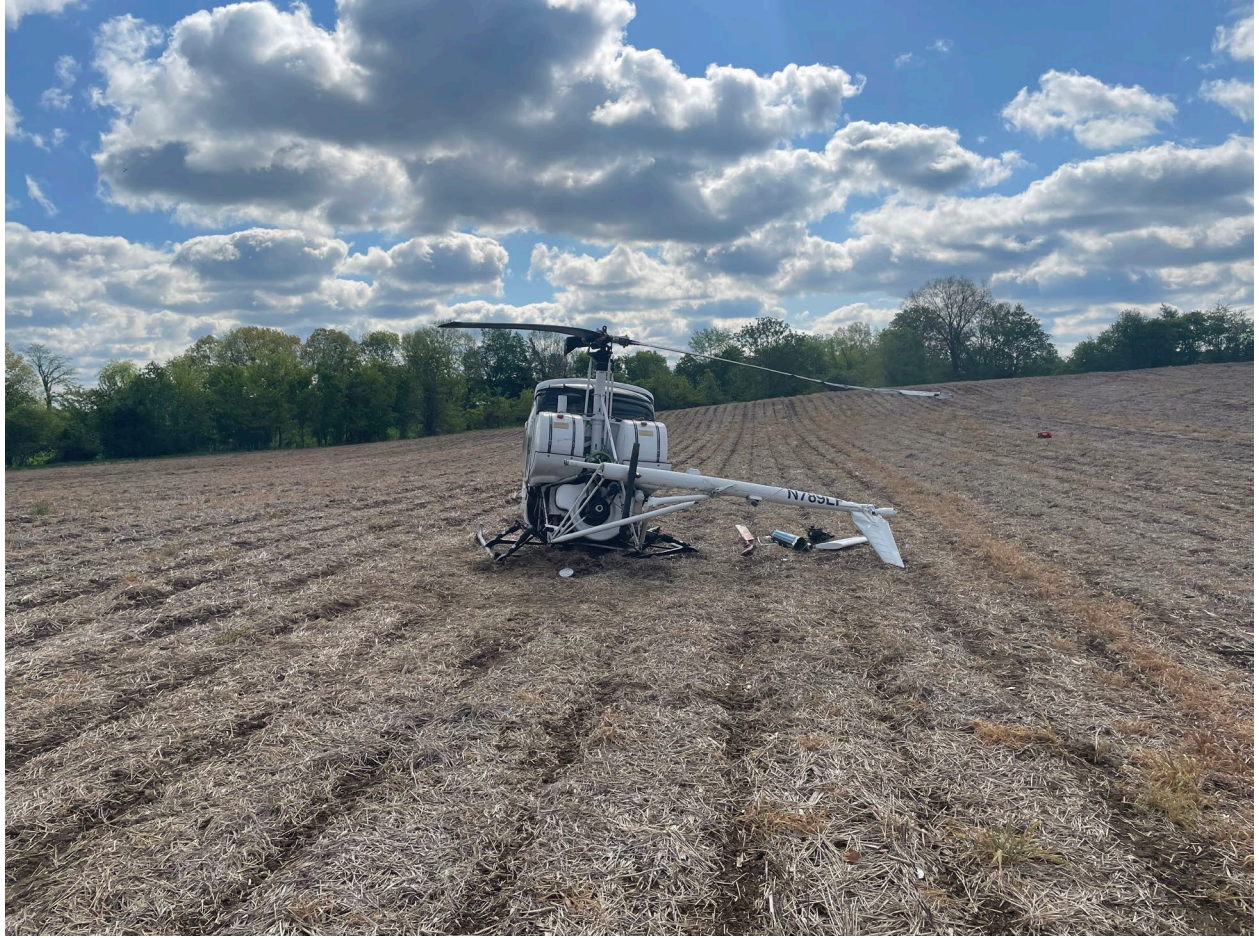
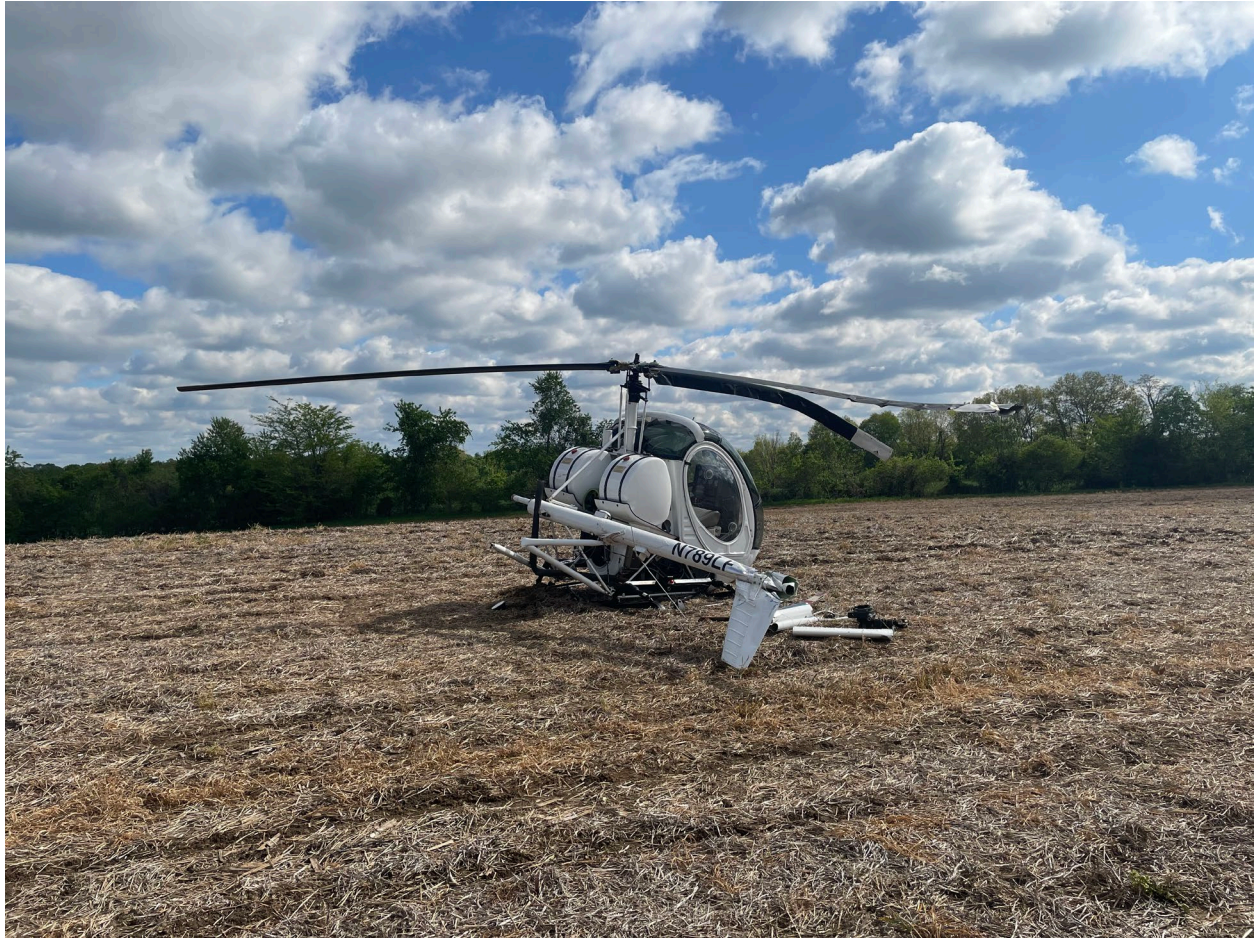
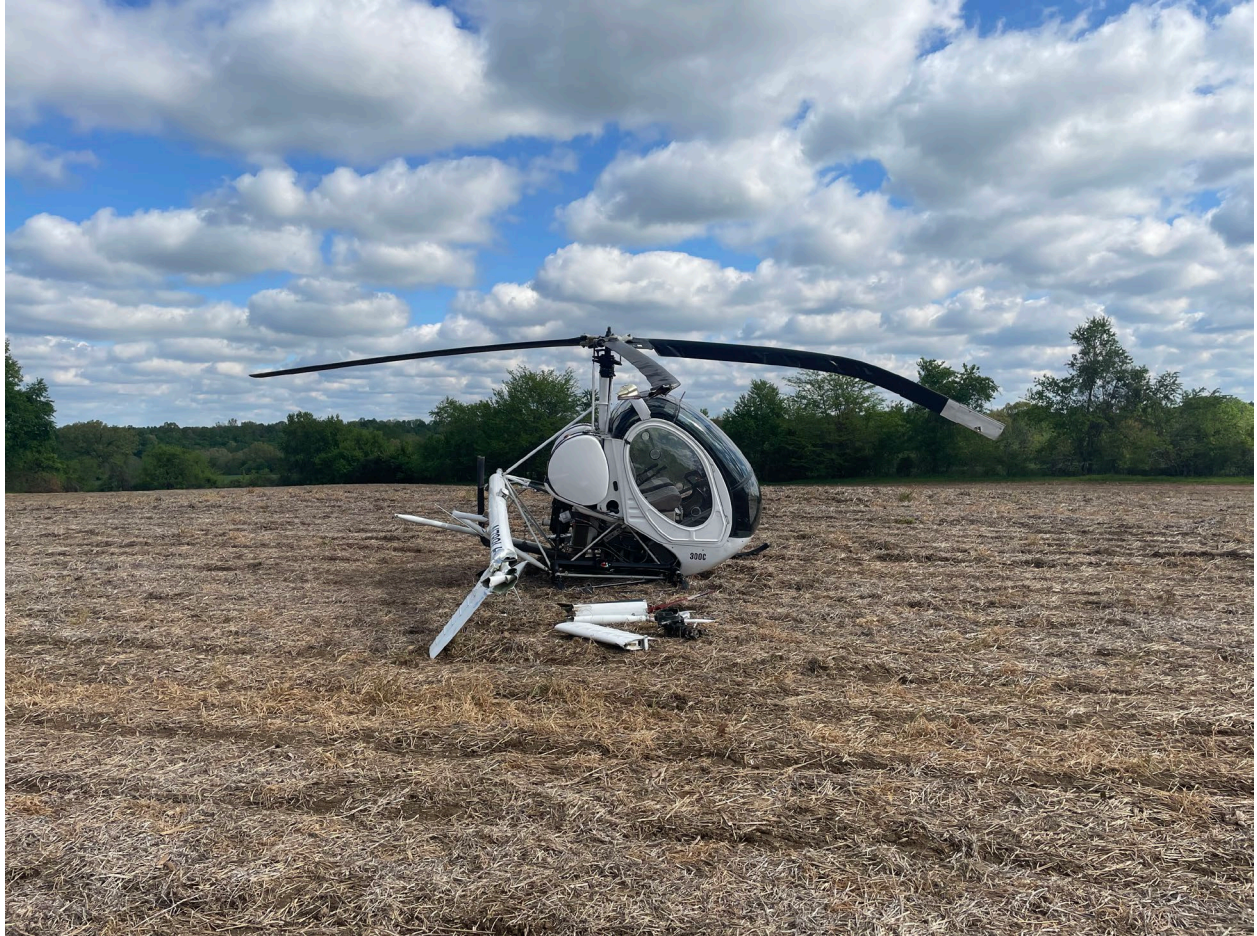
I walked to the impact area and started my photographic documentation of the scene:

The pieces of the tail rotor, gearbox and rotor blade were not in their original location. Mr. Jones stated the night prior he was at the scene with Emergency Management and those piece were recovered from approximately 100 feet away. It was stated that Emergency Management moved them closer to the aircraft.

I observed that the aircraft had impacted a field that appeared to be recently tilled, with soft dirt that crops could be planted in. There was a layer of hay over the field. The aircraft skids were spread out showing evidence of the ground impact. The LH skid was partially buried in the soft dirt while the RH skid was buried approximately 2-3 inches.

The tail rotor, rotor blade, and gearbox were placed neatly near the aircraft. They had separated from the aircraft during the accident and reported to have been located approximately 100 feet away from the aircraft.

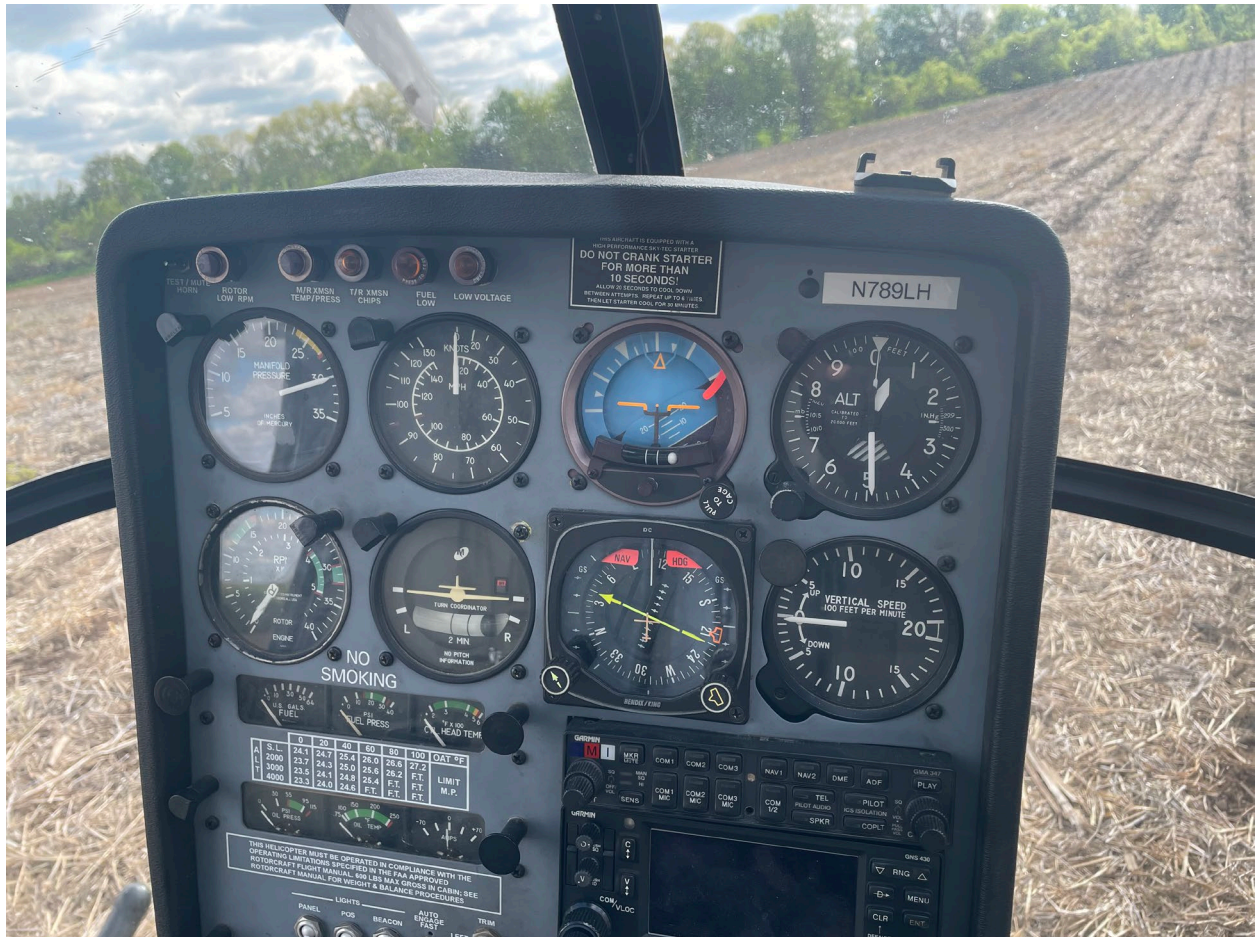
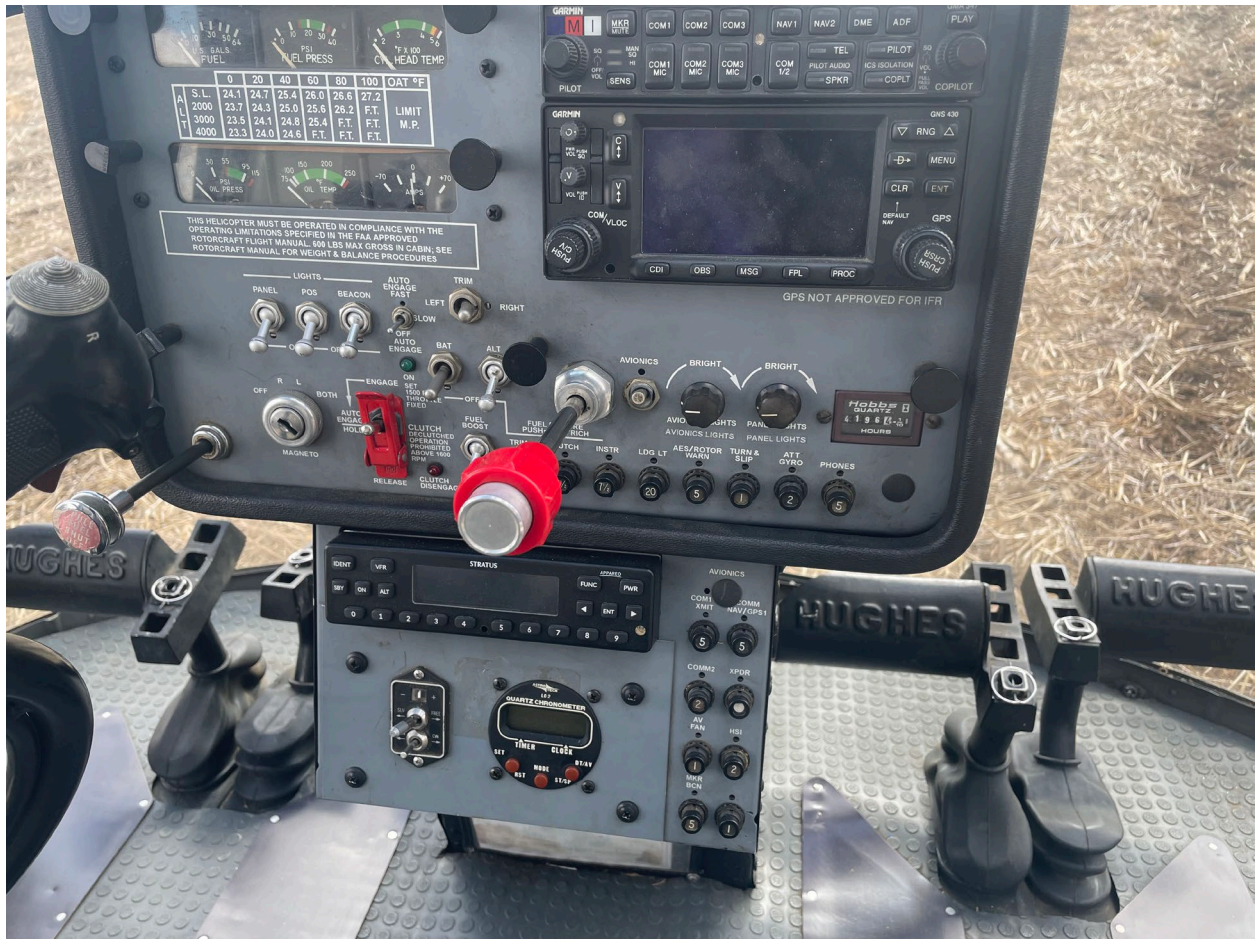
I photographed the cockpit and control layout:

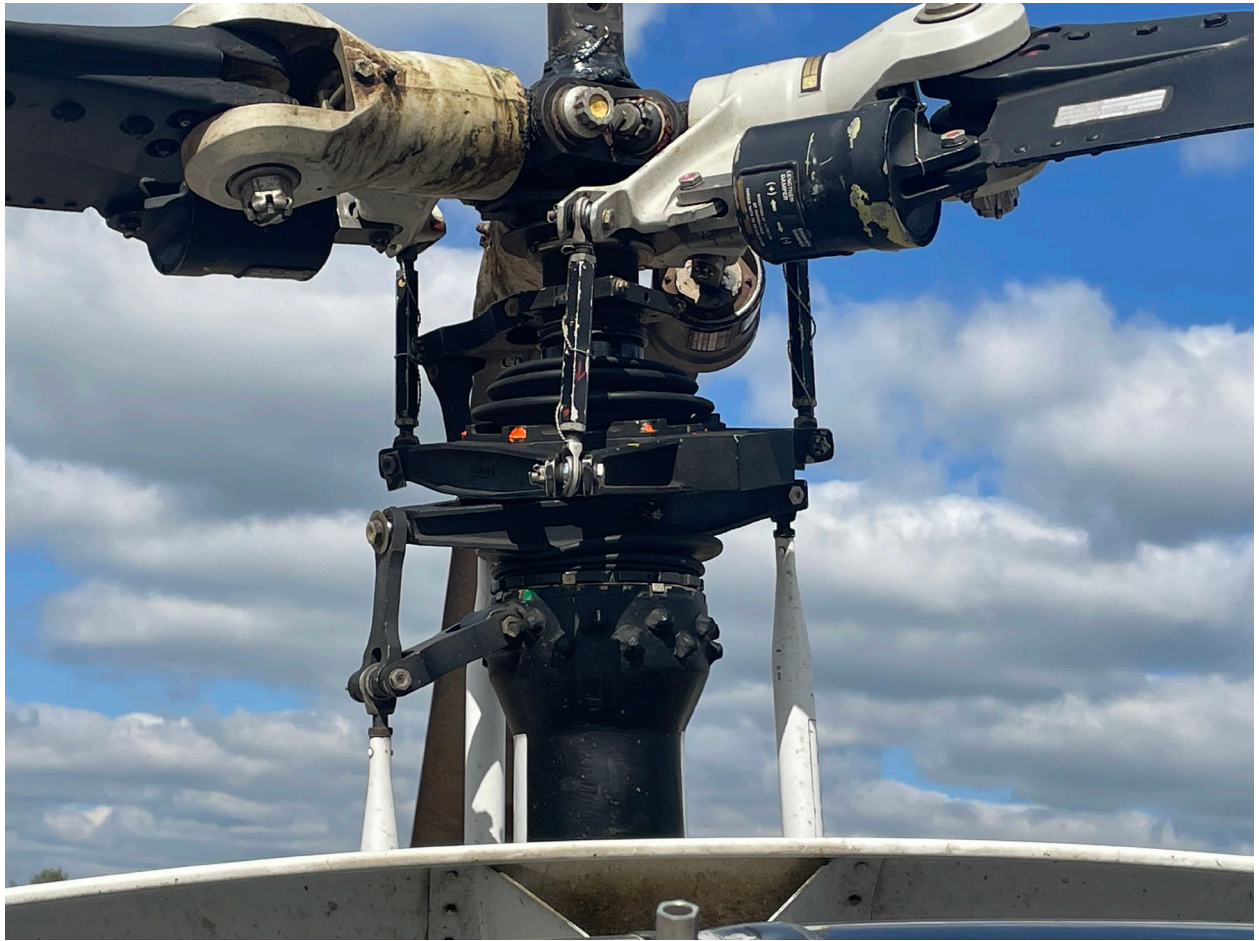
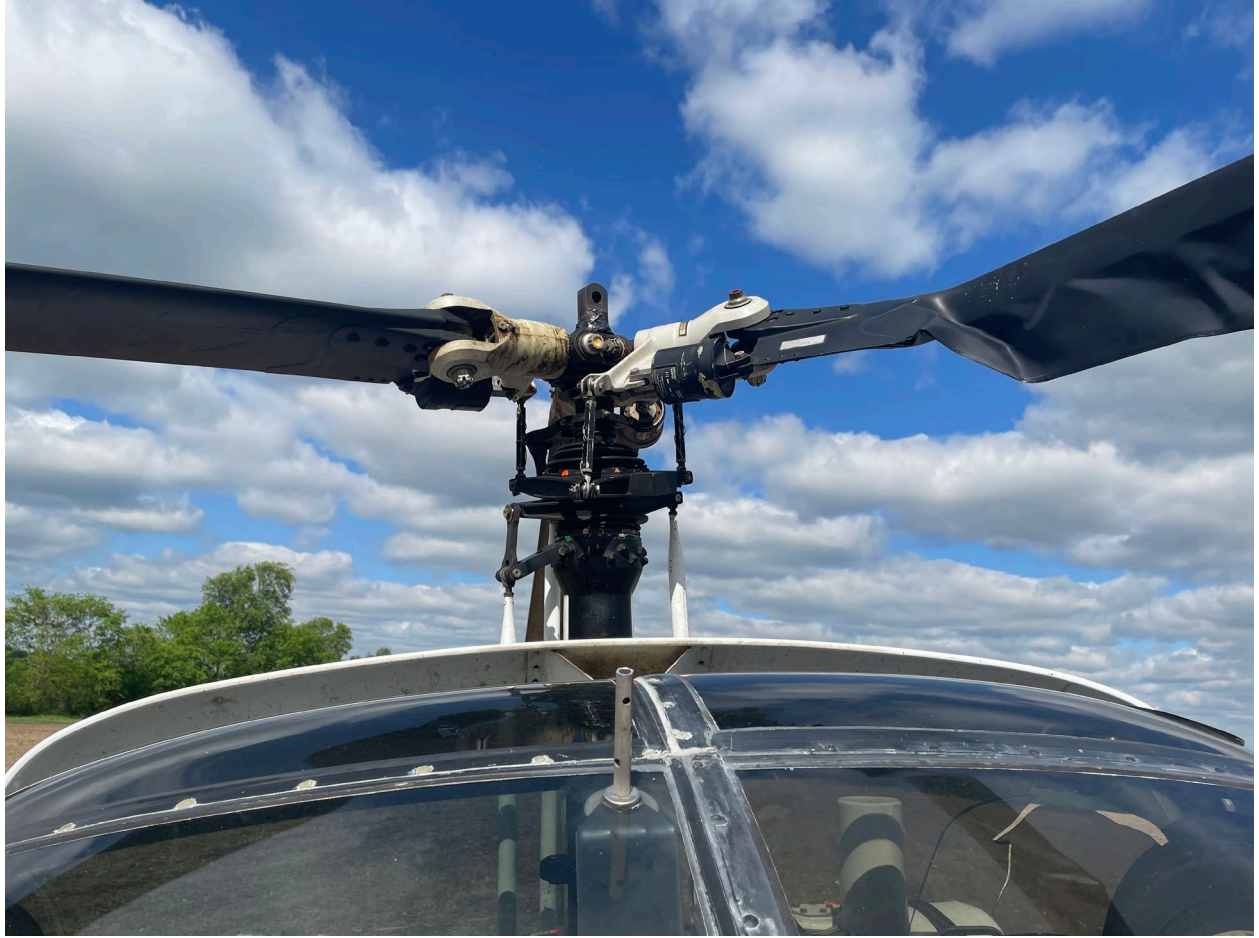
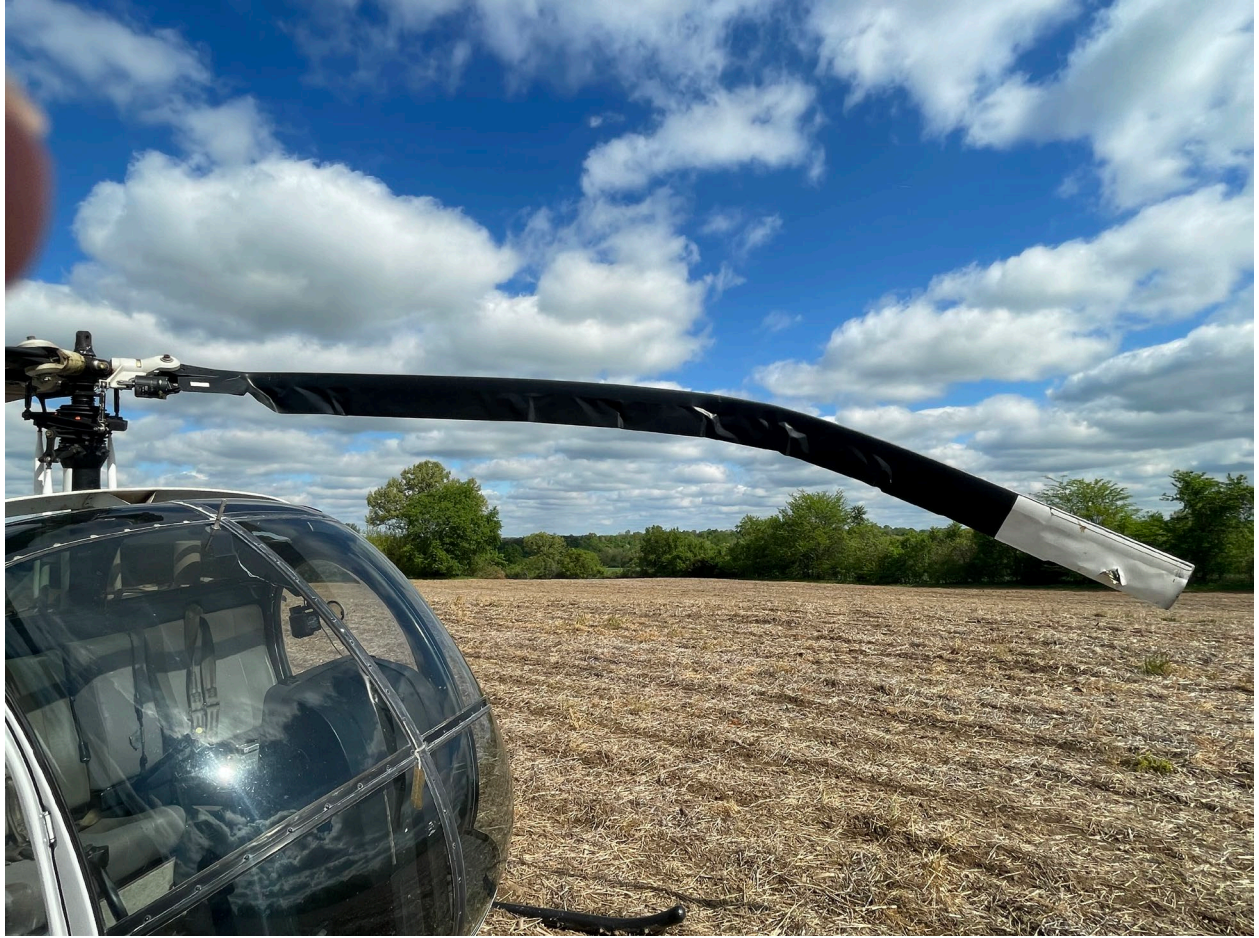
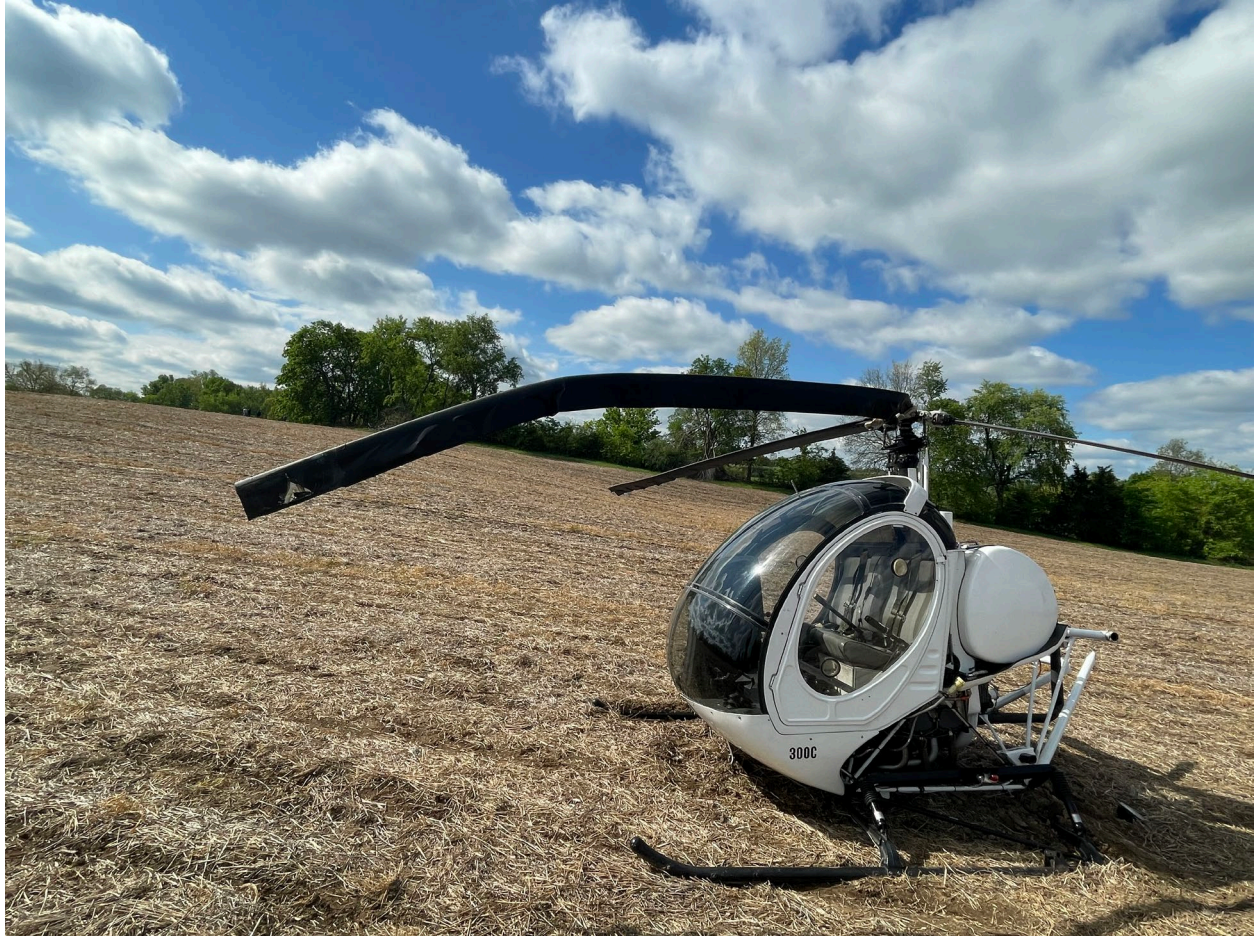
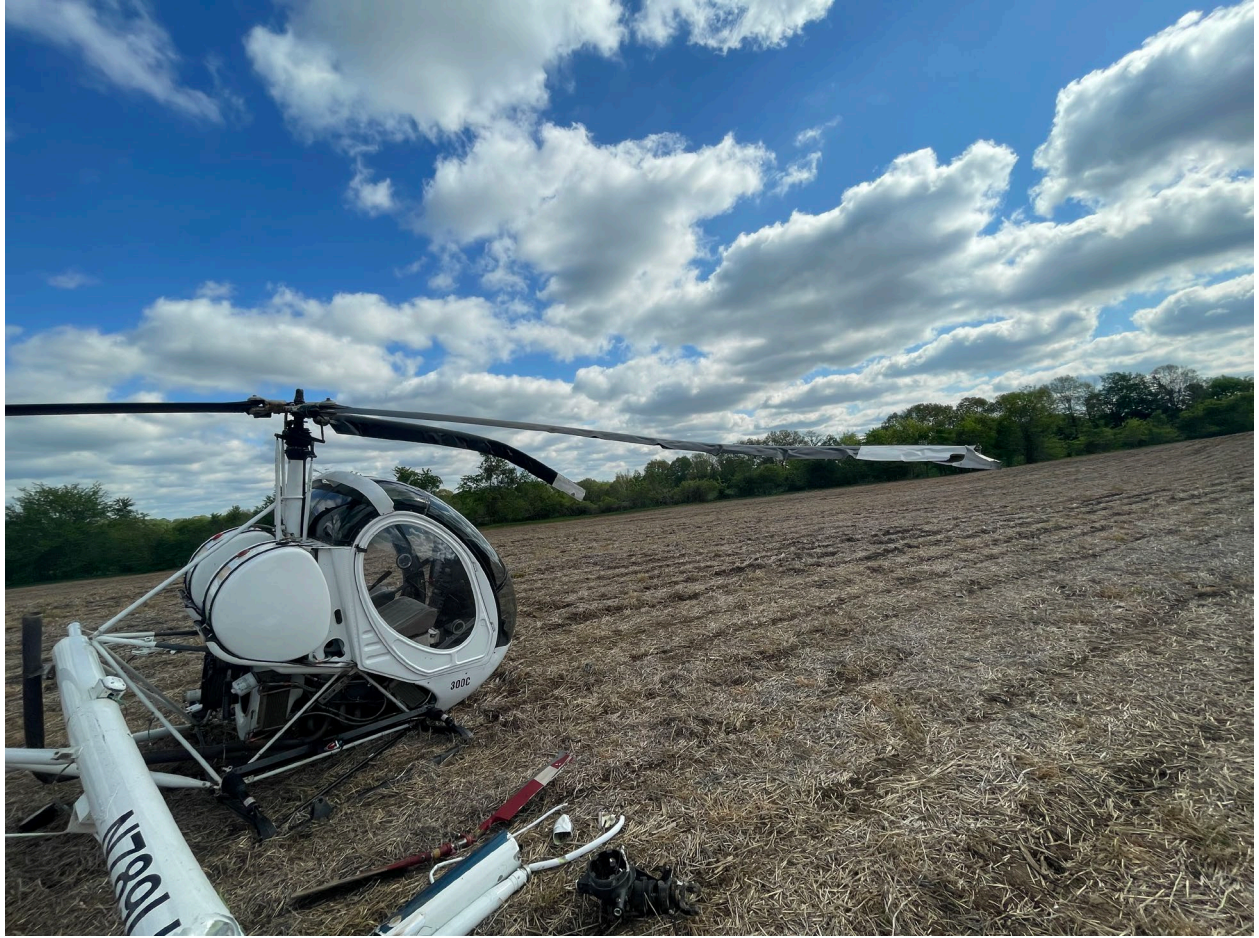
I photographed the main rotor head and rotors:

There was evidence of damage to all three main rotor blades. The tail boom was partially separated from the aircraft and bent at an approximate 90 degree angle to the right side of the aircraft.
