### **N789LH Inspector Kachinski Statement**

On April 22, 2023 at 1225 CDT it was reported that N789LH, a 2008 Schweizer 269C, Serial Number S1911, certificated in the Normal Category, crashed in a field near 3802 Black Rd. (Springfield TN) due to a loss of rotor RPM. Helicopter sustained tail boom damage. No injuries to occupants.

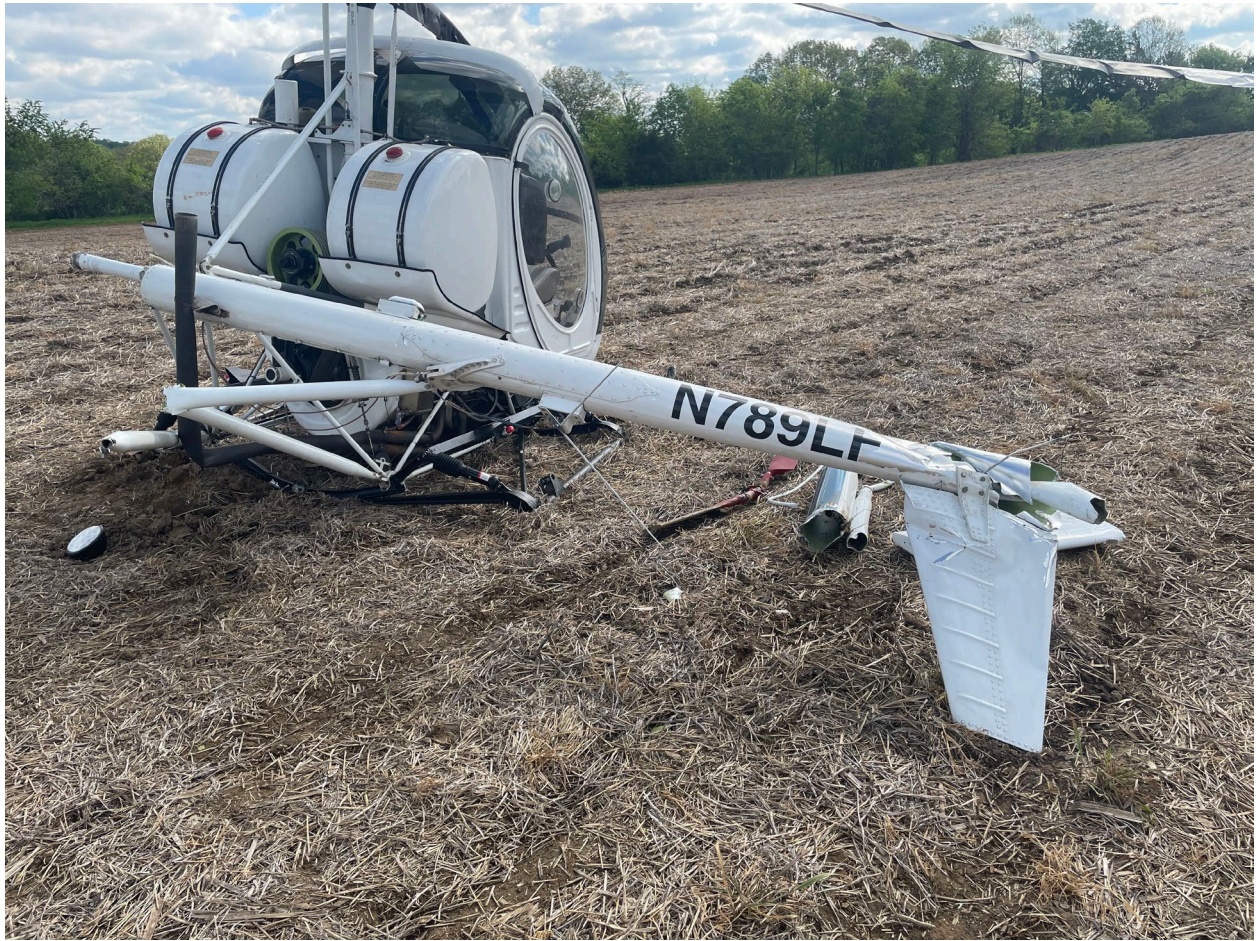
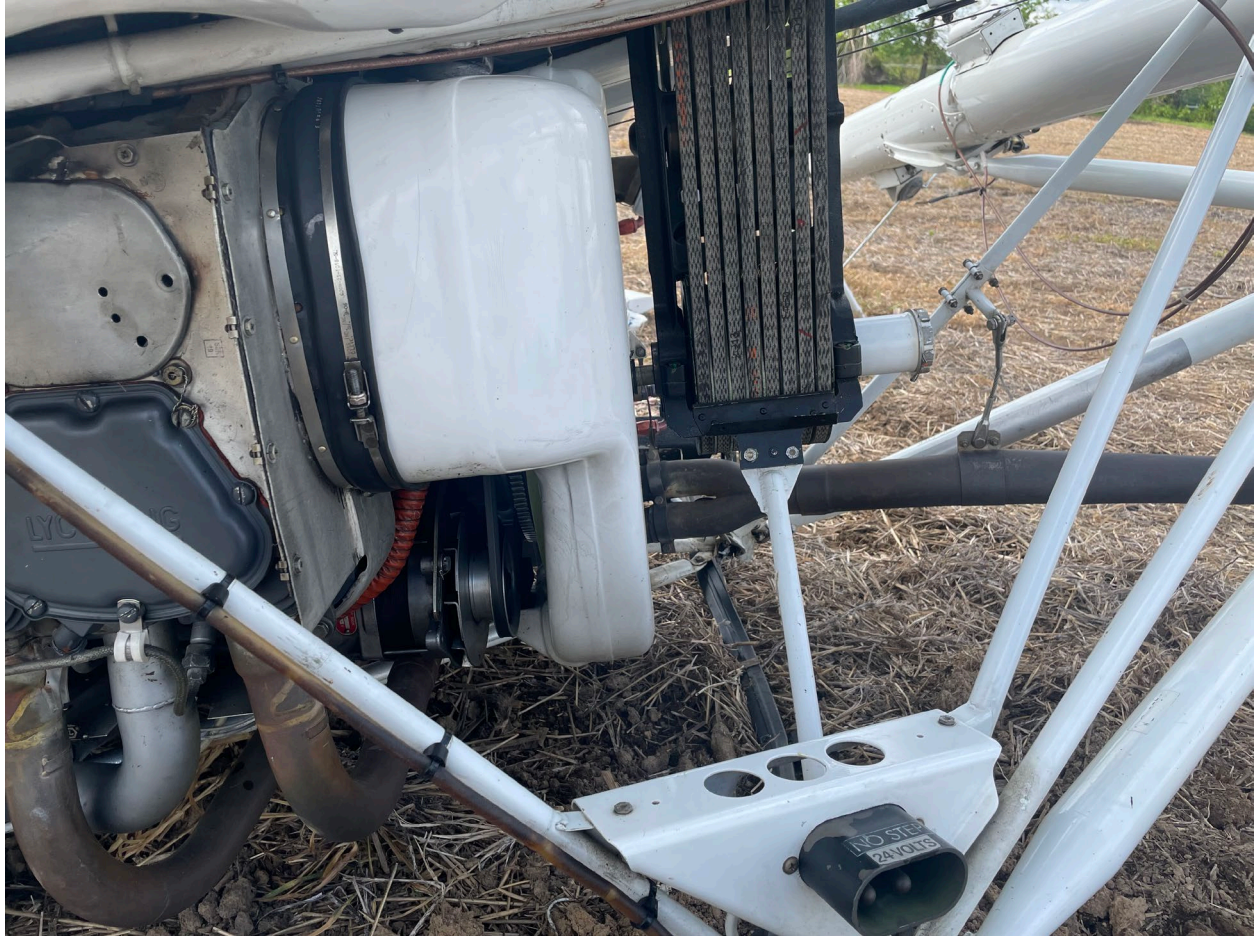
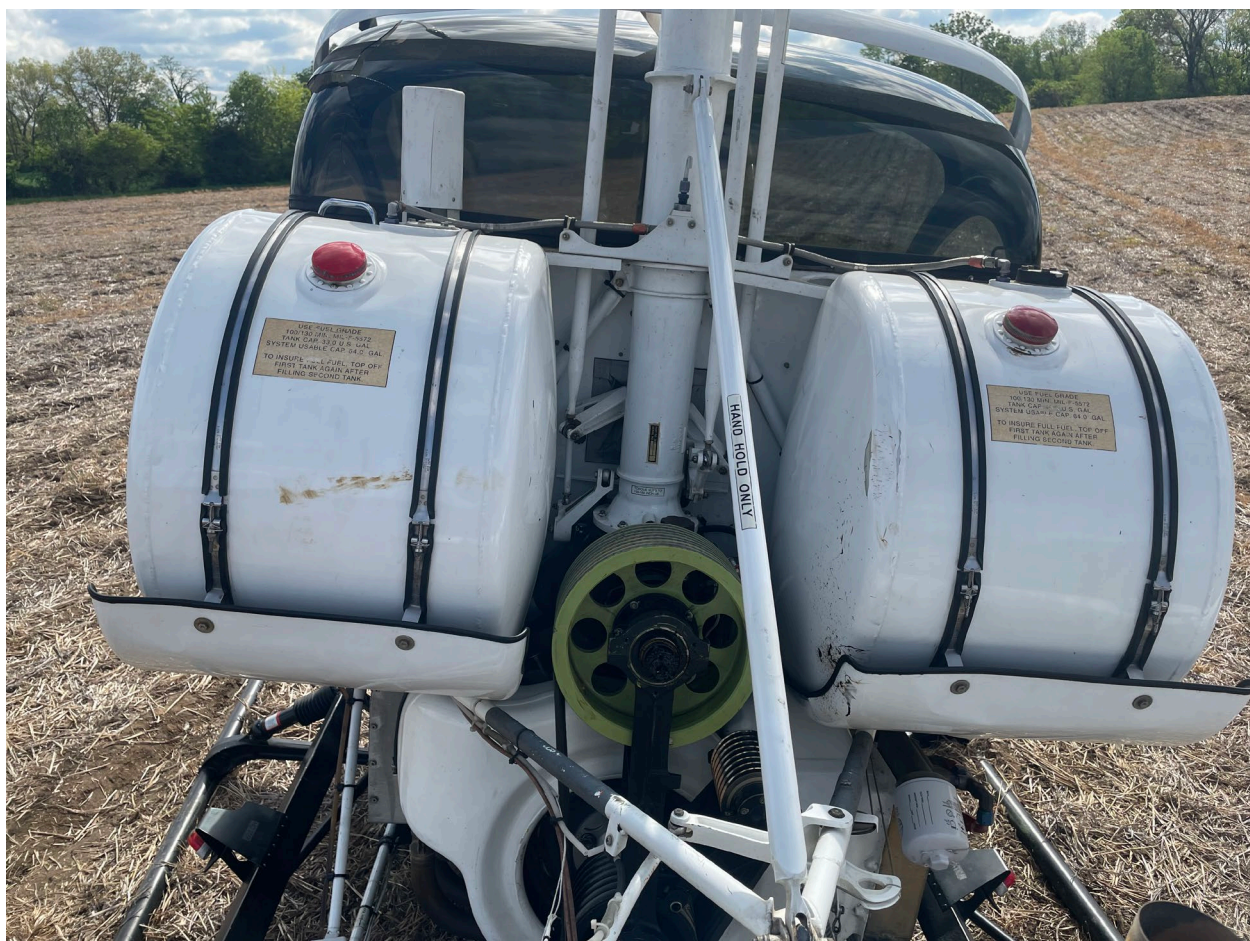
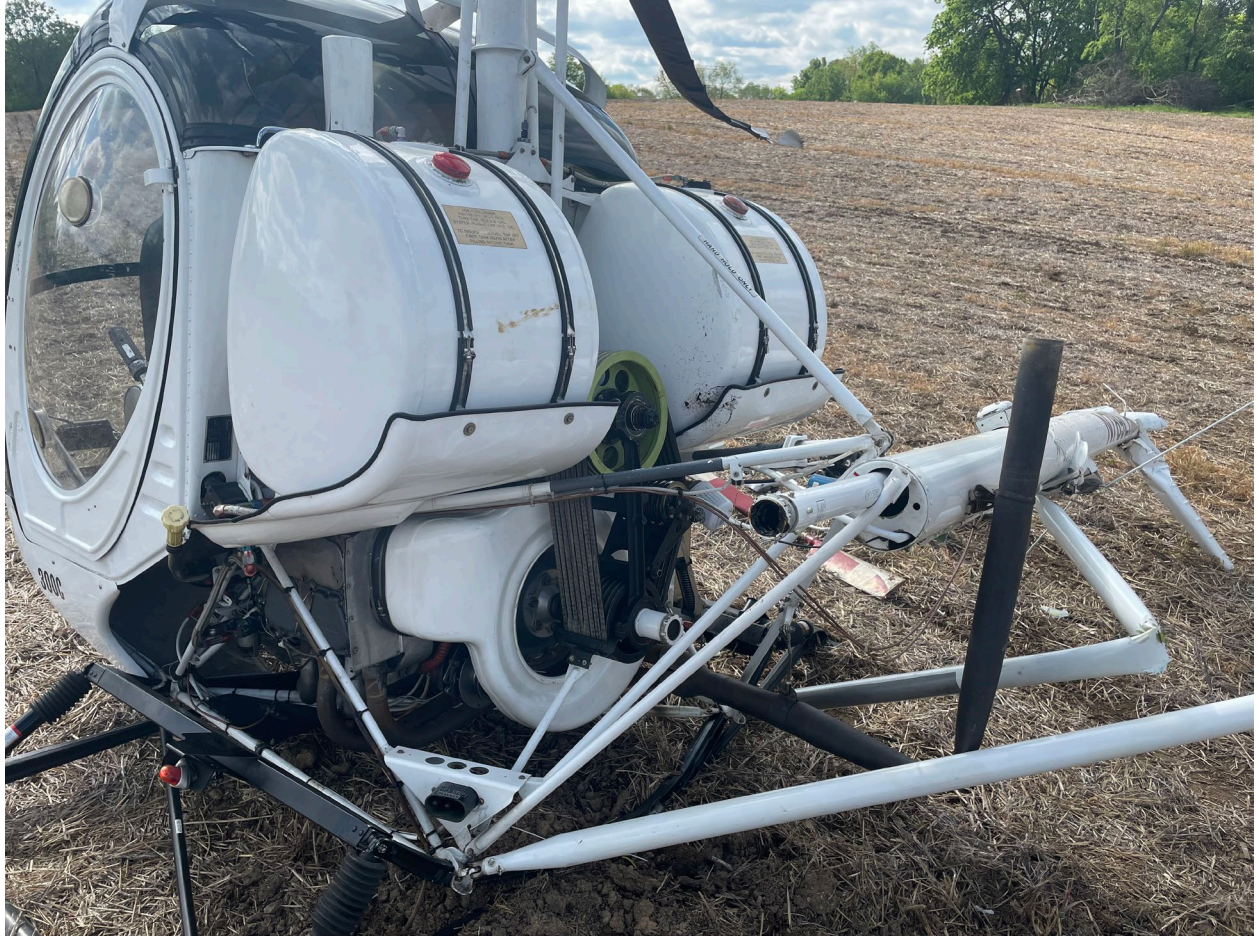
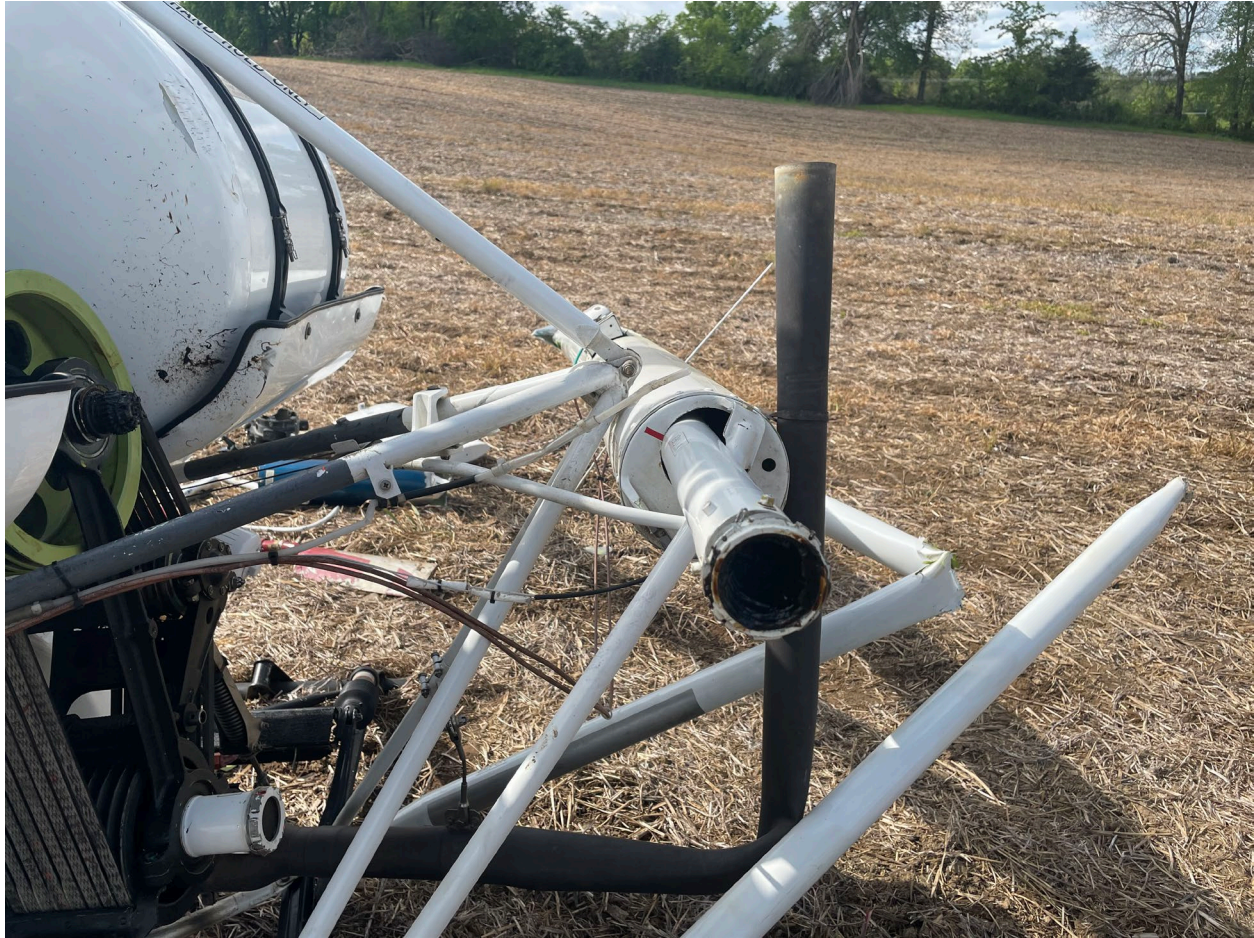
I photographed the tail boom section.

There was evidence of damage to all three main rotor blades. The tail boom was partially separated from the aircraft and bent at an approximate 90 degree angle to the right side of the aircraft.

I received a pilot's statement and it was stated that due to unknown issues with the rotor RPM, the pilot decided to start autorotation procedures at approximately 40kts and 100'-200'AGL. The aircraft proceeded to experience a hard landing with the ground. Upon impact, it was stated that the rotors dipped and contacted the tail boom and damaged both.
