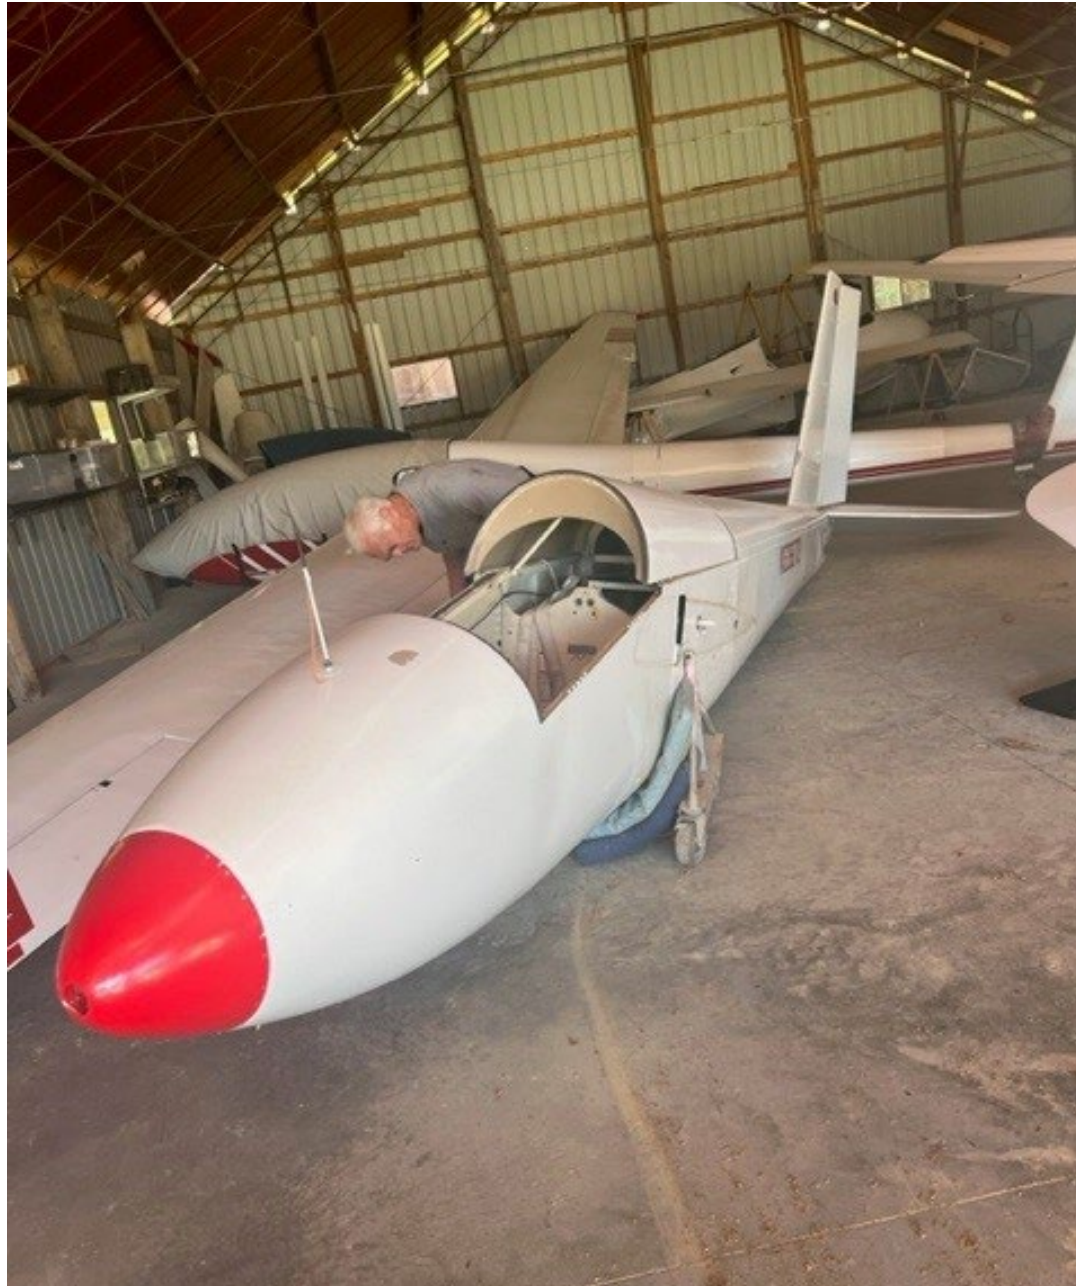
**Photo 1 – Main wreckage, front view (FAA)**

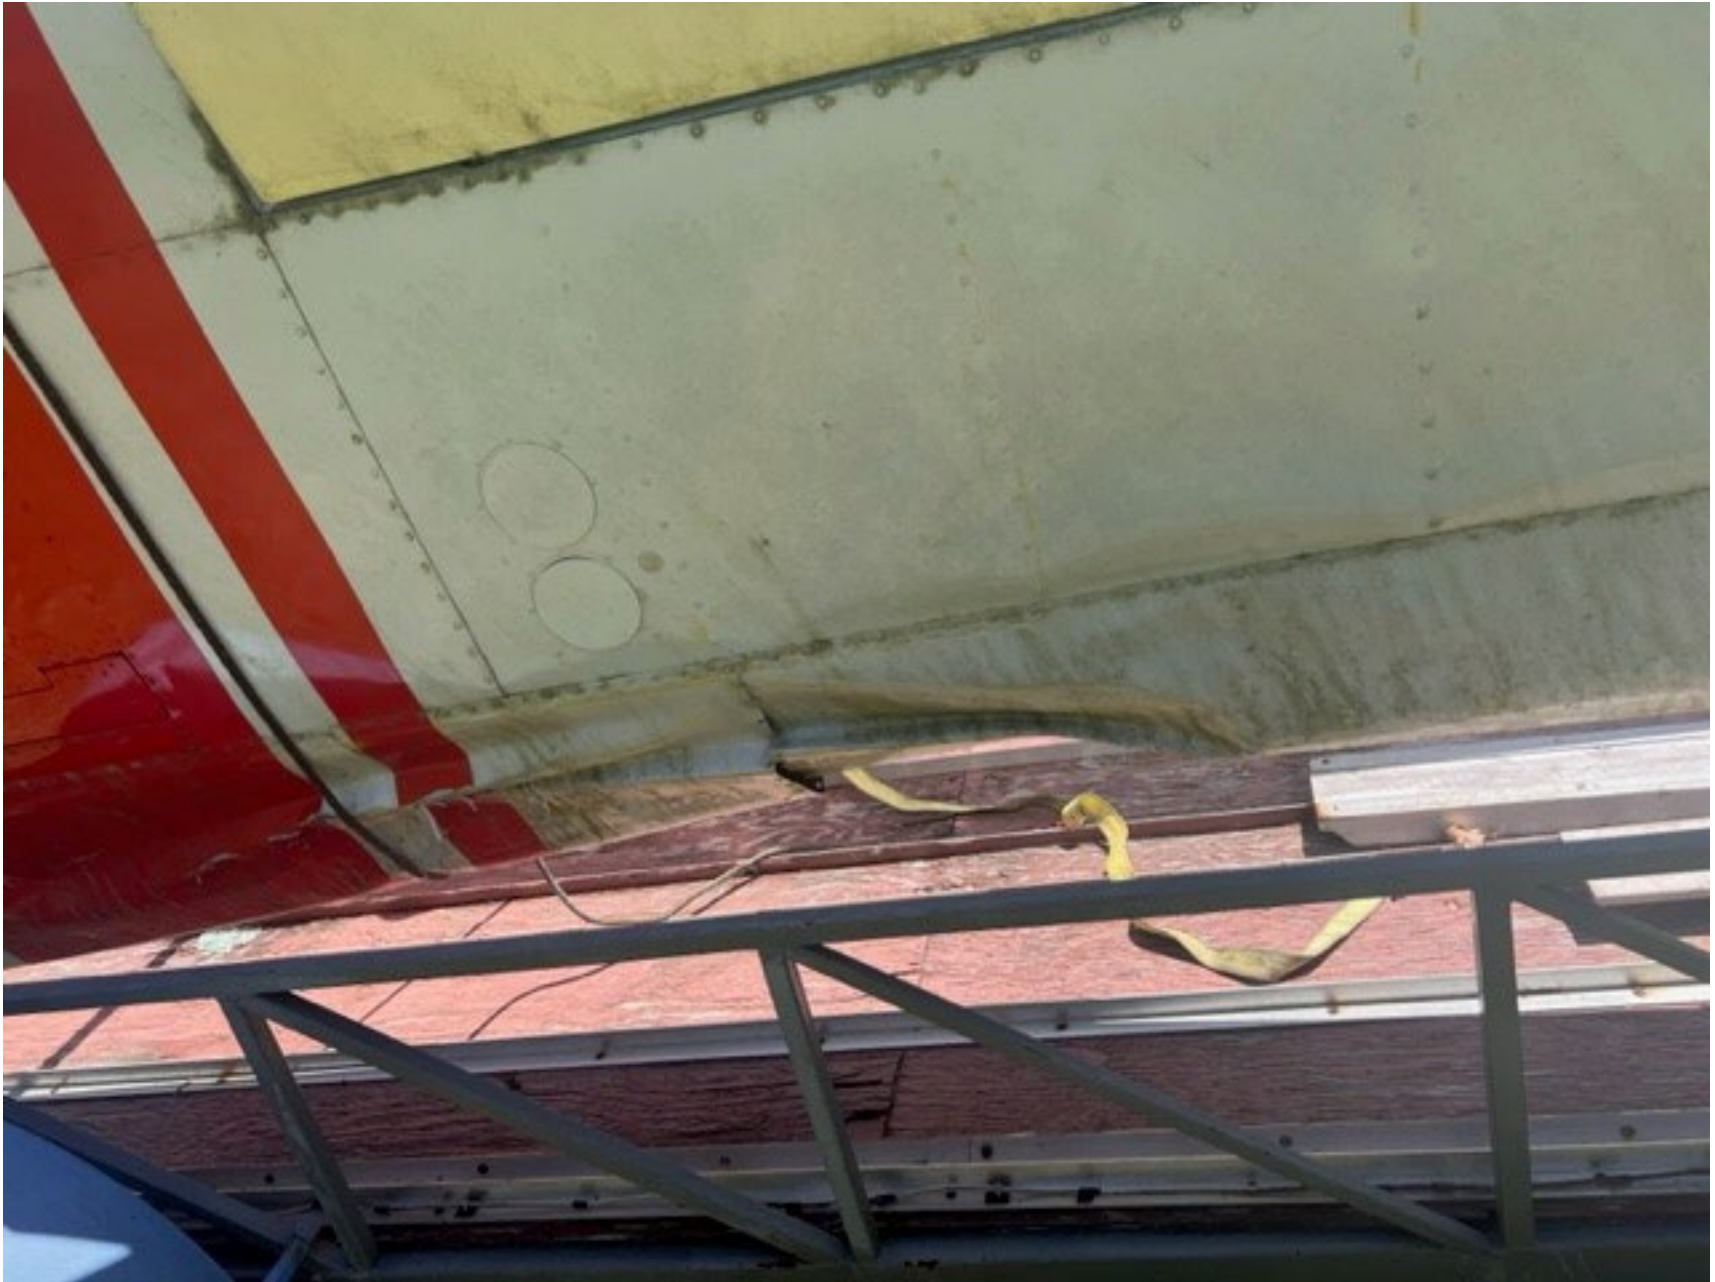
**Photo 2 – wing, leading edge damage (FAA)**

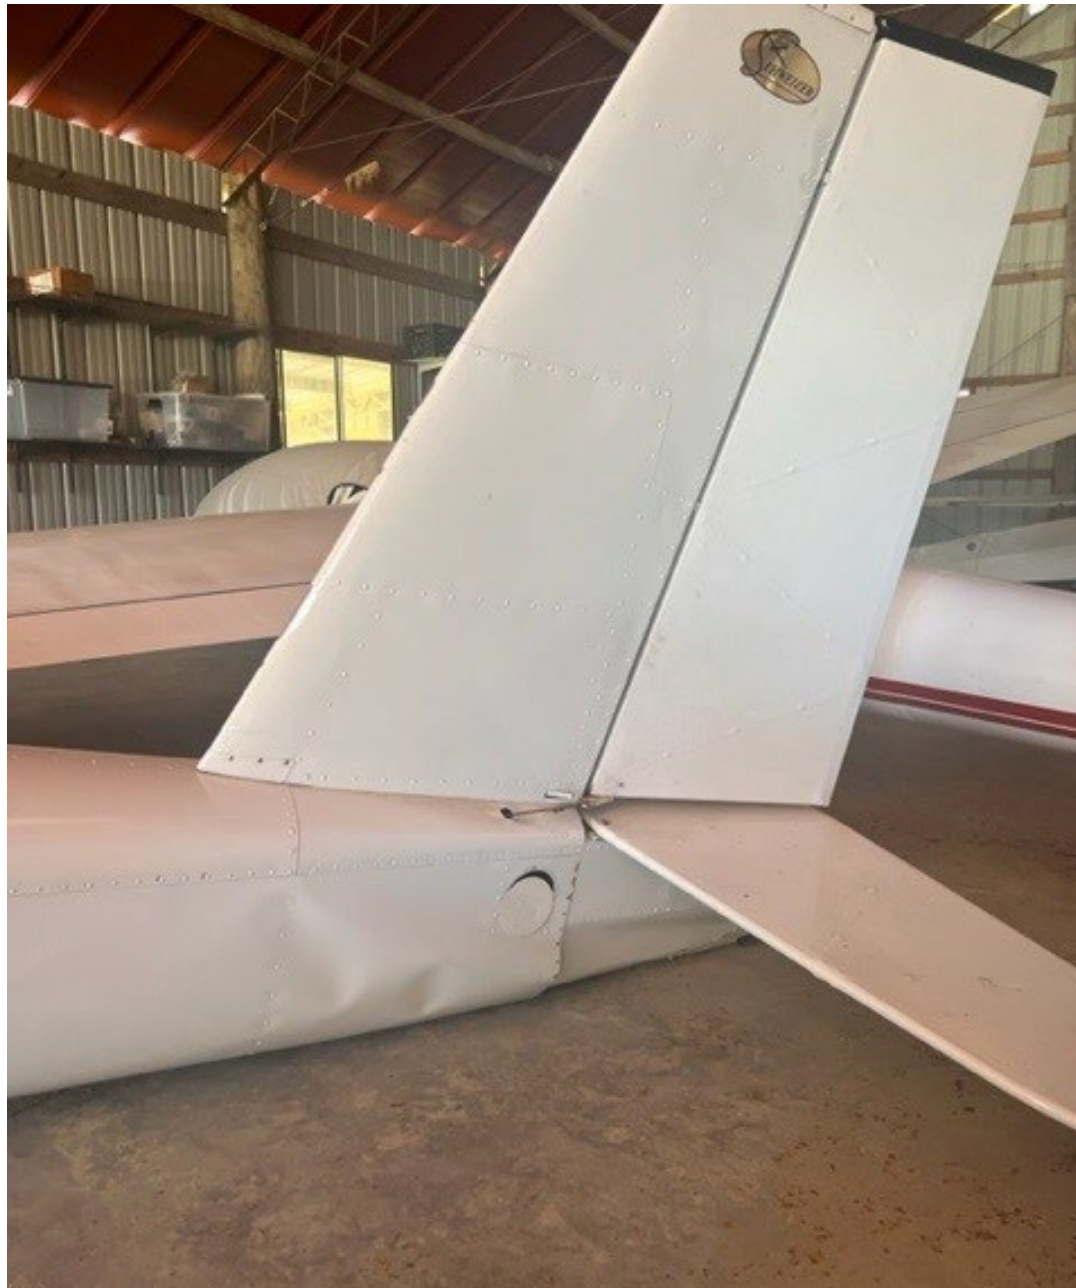
**Photo 3 – Tail section, (FAA)**
