# NTSB ERA23LA210 Piper PA30 | N751WW

Investigative Photographs

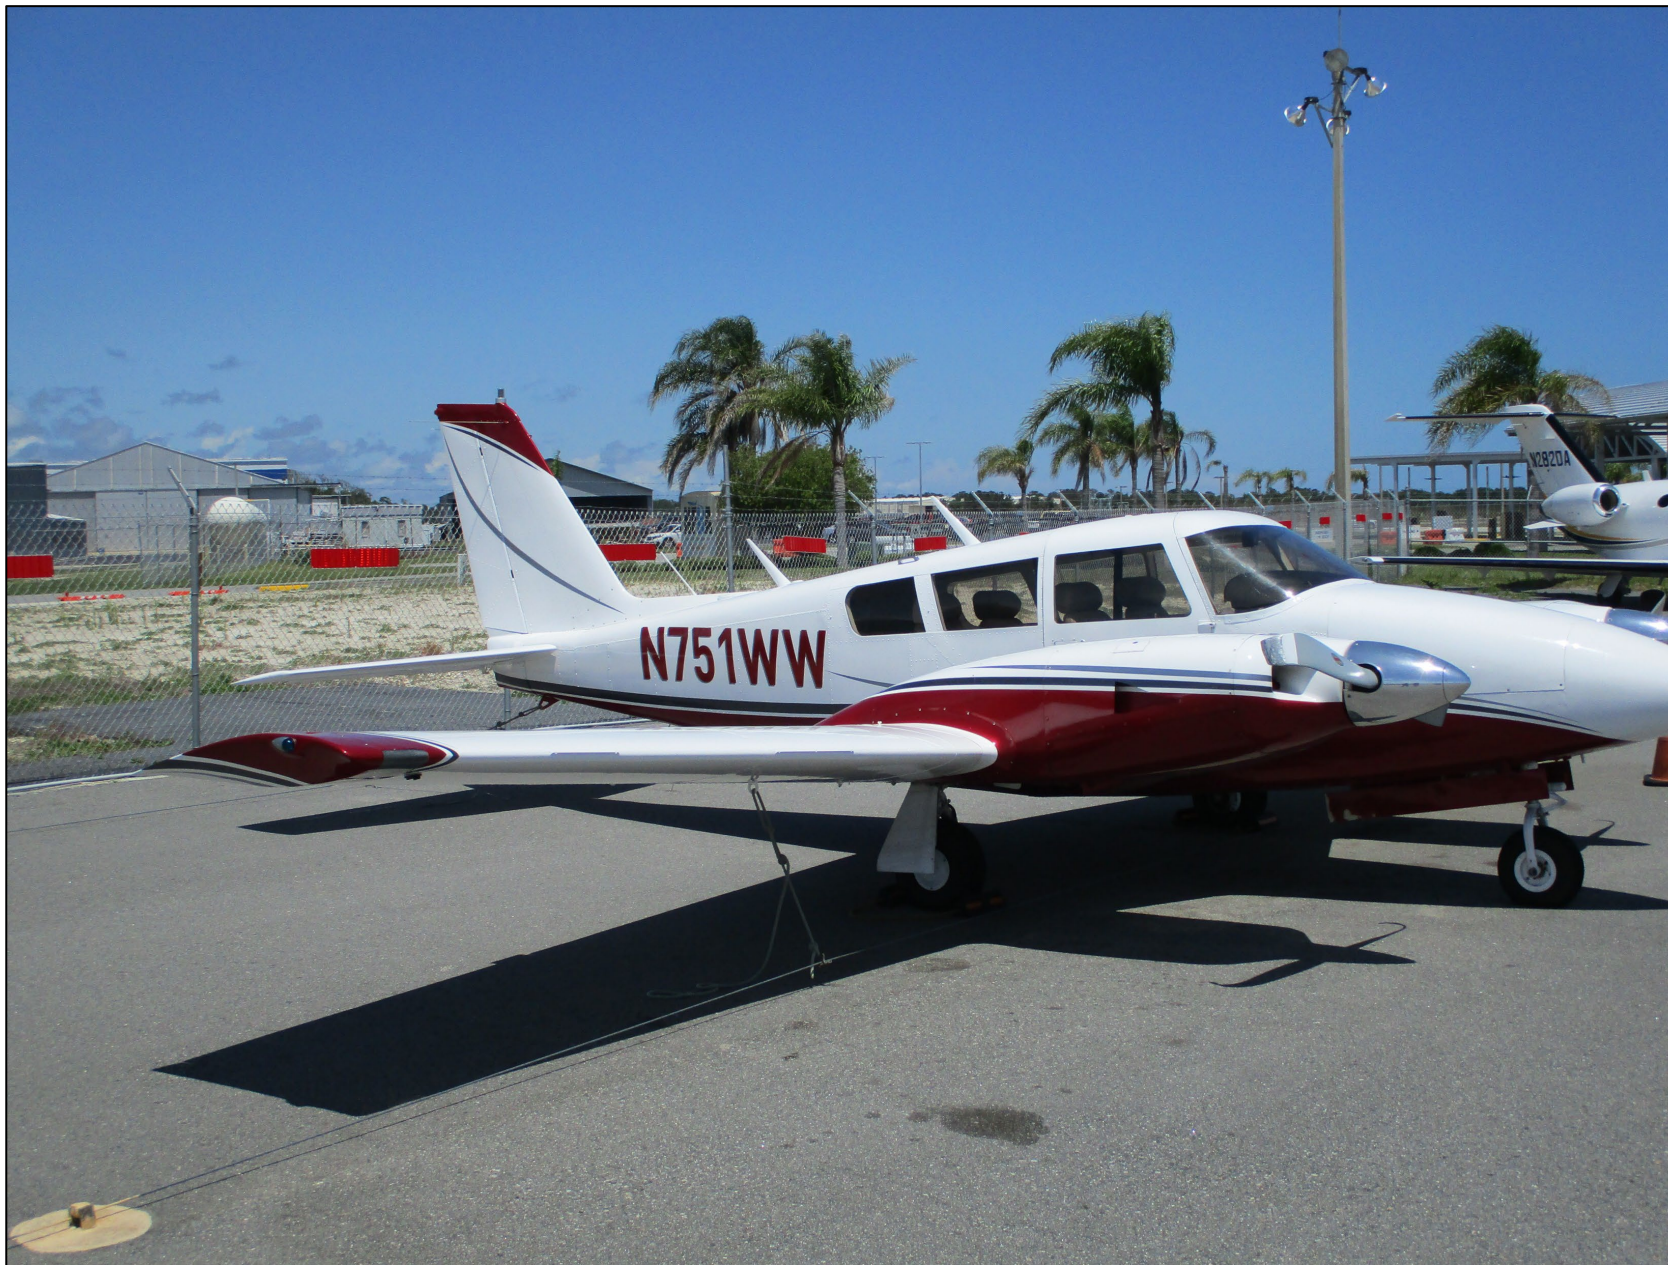
Photo 1: Overview of the airplane after recovery from the runway (Photo Courtesy of FAA)

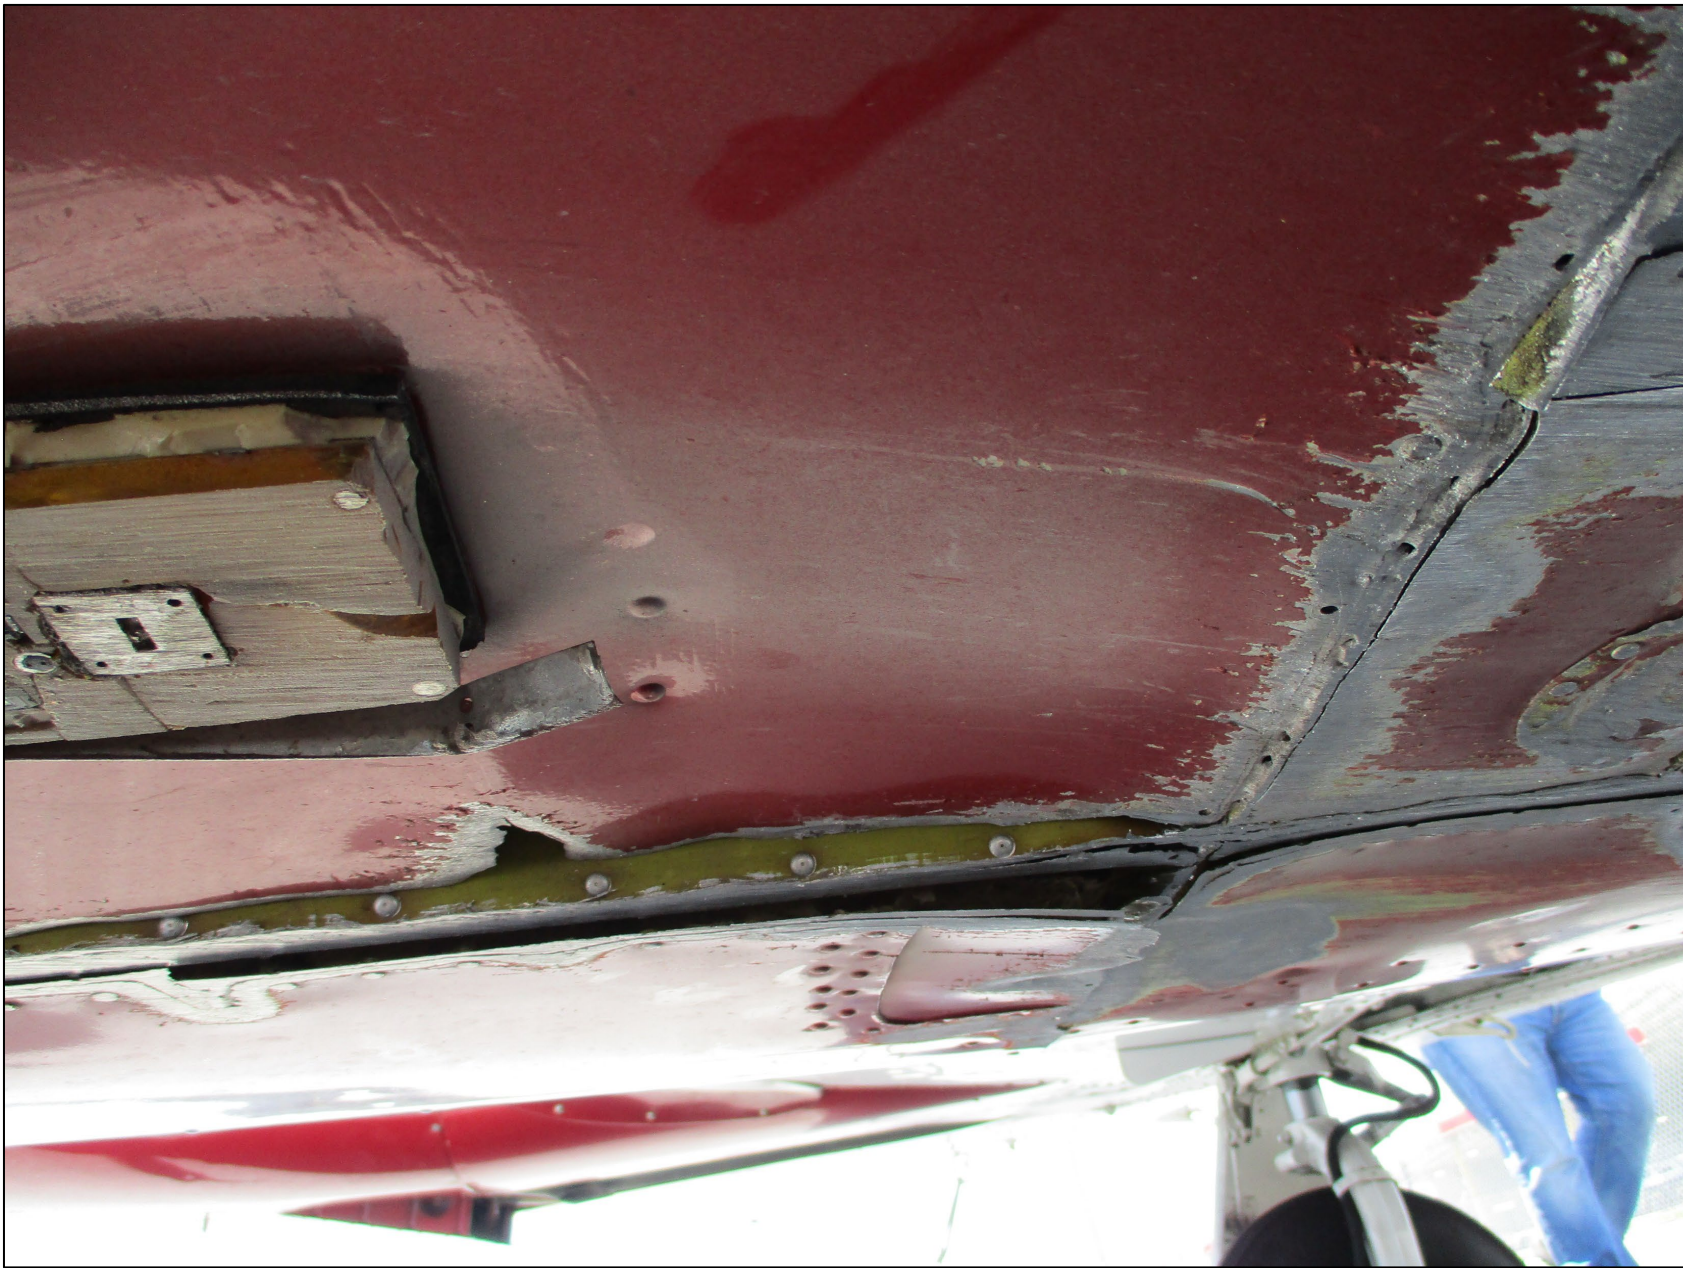
Photos 2: Overview of the substantial damage sustained to the fuselage (Photo Courtesy of FAA)

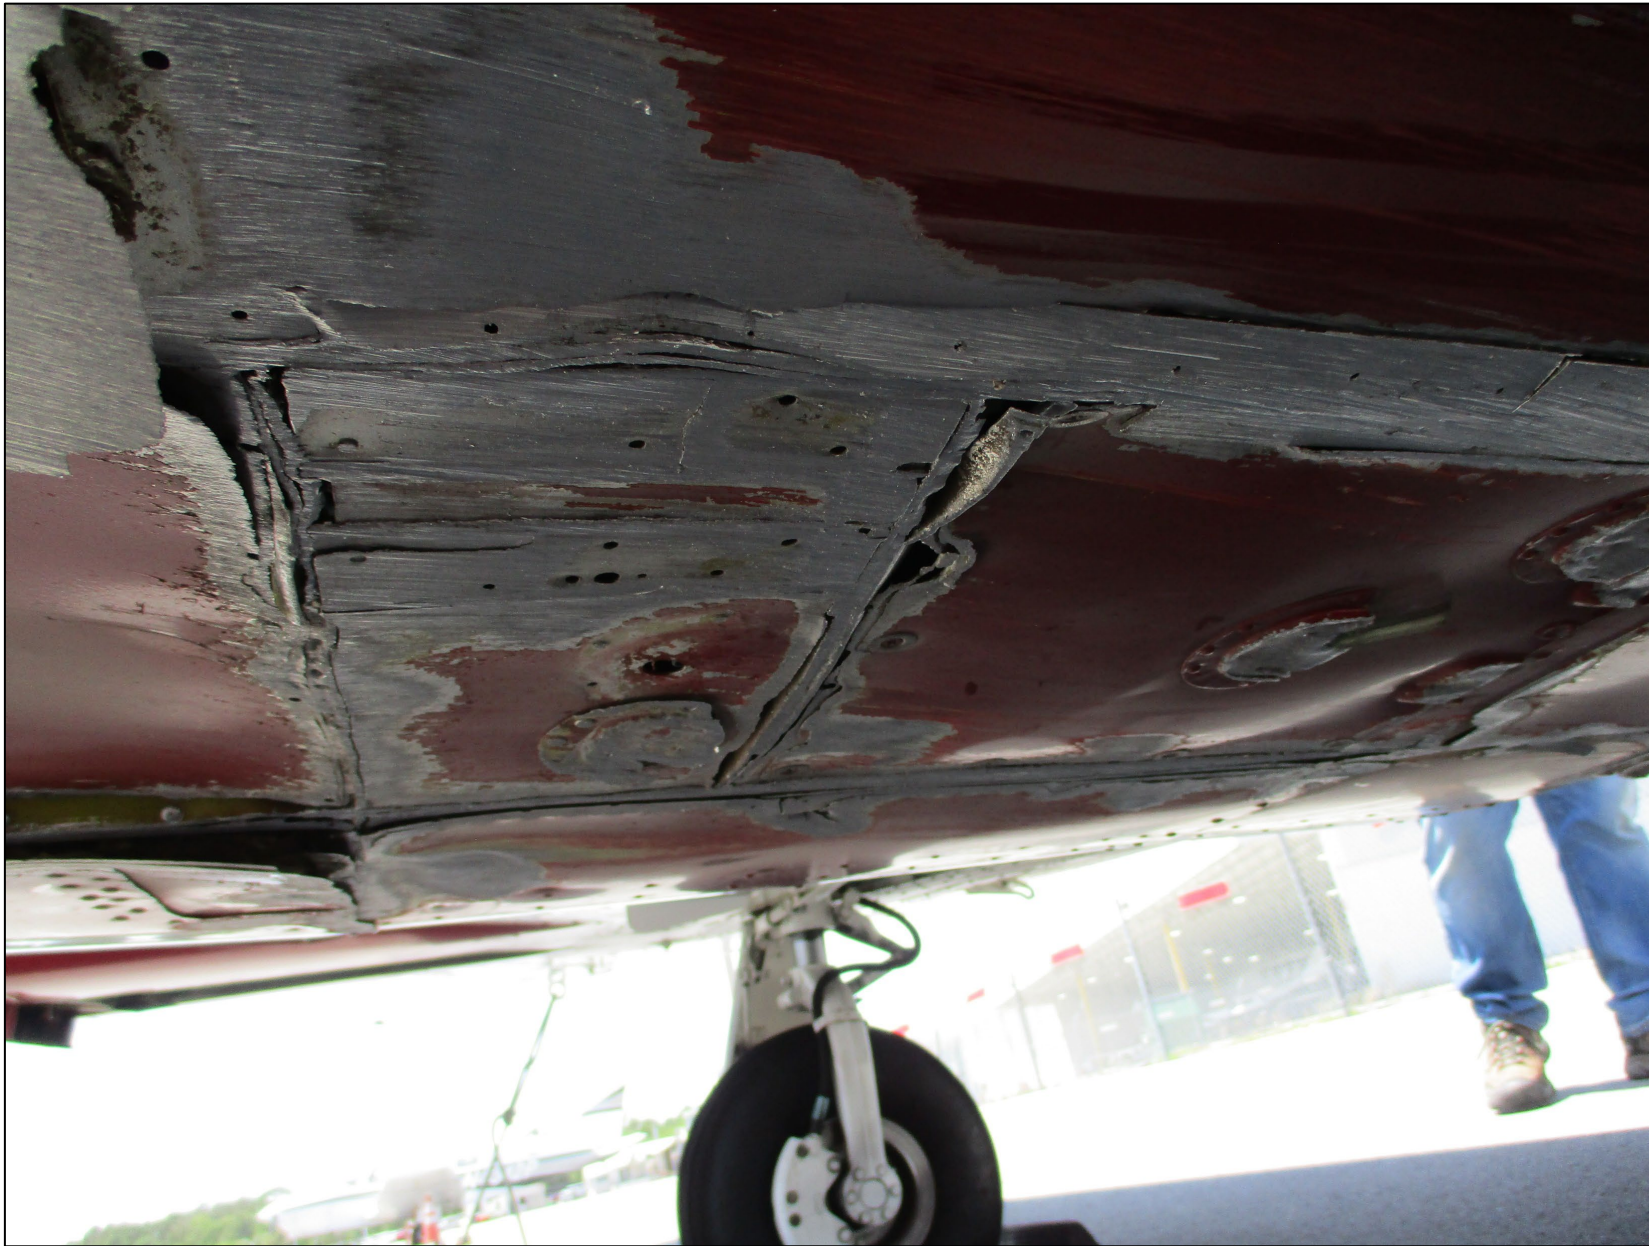
Photos 3: Additional overview of the substantial damage sustained to the fuselage (Photo Courtesy of FAA)
