NTSB  
Attention: Mr. Dennis Diaz  
Supervisory Air Safety Investigator  
NTSB - Eastern Region

I am responding to your invitation to submit additional information regarding the gear collapse of C-GPEX at Bridgeport, CT Tuesday April 26 2023.

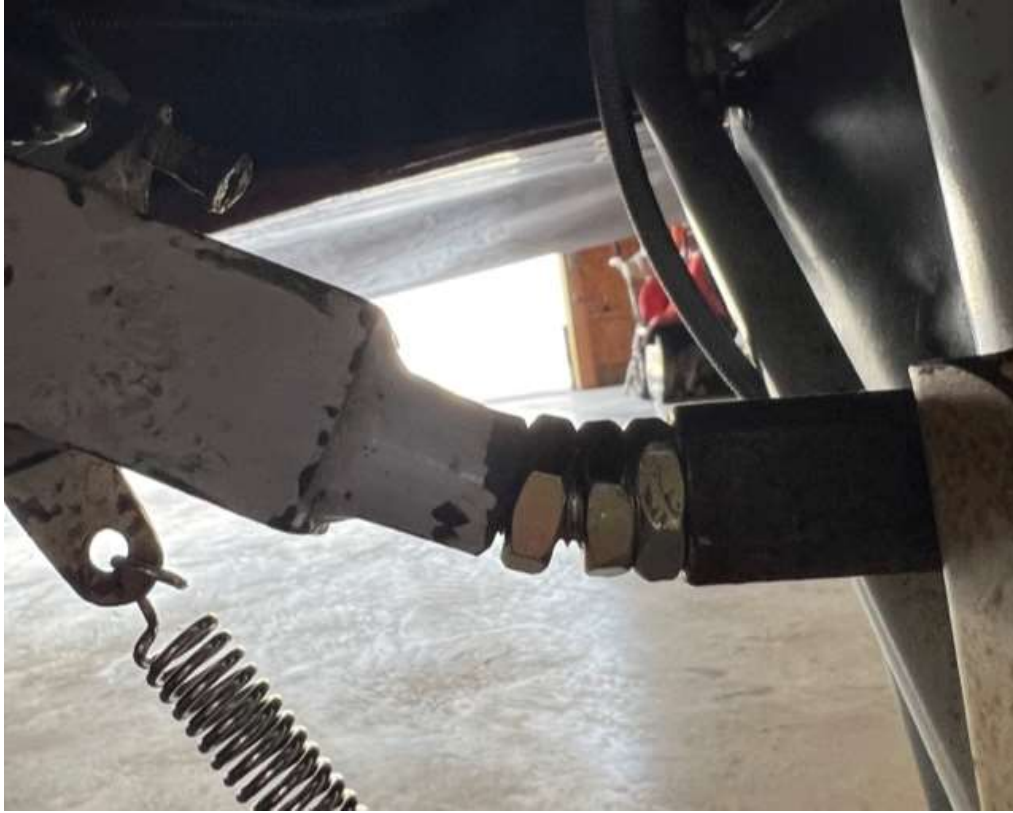
Photograph 1a & 1b

The owner invited me to see his new acquisition and I discovered that the threaded rod on the LHS of the aircraft had bent. (Photograph 1a & 1b) The owner had a spare threaded rod, and I did a non-destructive of the piece and found it to be 136,000 psi. (Photograph 4) I/A/W Engineering series manual "Aerospace metals, general data and usage factors" T.O. 1-1A-9 dated 11-17-2016. I feel that the tensile strength is lower than the industry standard of 180,000 psi that is used by Boeing, North American, Waco and Fairchild aircraft, to name a few.

I reviewed the drawings by the designer and discovered that the builder had deviated from the plans. The design plans call for an AN6-14 bolt to be welded to the over center lock. The builder had tapped and threaded the over center lock and used a threaded rod. I inspected the righthand strut and discovered that the builder had stacked lock nuts on the thread which was likely preventing it from bending. (Photograph 3)

My opinion is that the design is inherently weak and the builder's deviation from the plans contributed to the part failure. Another item that we are reviewing is if the main landing gear has "toe in" on the wheel alignment. It visually appears to have "toe in" and aircraft that I have worked on in the past, the wheel alignment is set to zero with no toe in or toe out. If the main gear is "toe in" this will cause excess pressure on the over center link, contributing to the failure.

The owner is treating the aircraft as unairworthy until an appropriate redesign of the over-center lock is implemented.
