## **NATIONAL TRANSPORTATION SAFETY BOARD**

Office of Aviation Safety  
Eastern Region

**Photo Array**

**ERA23LA216**

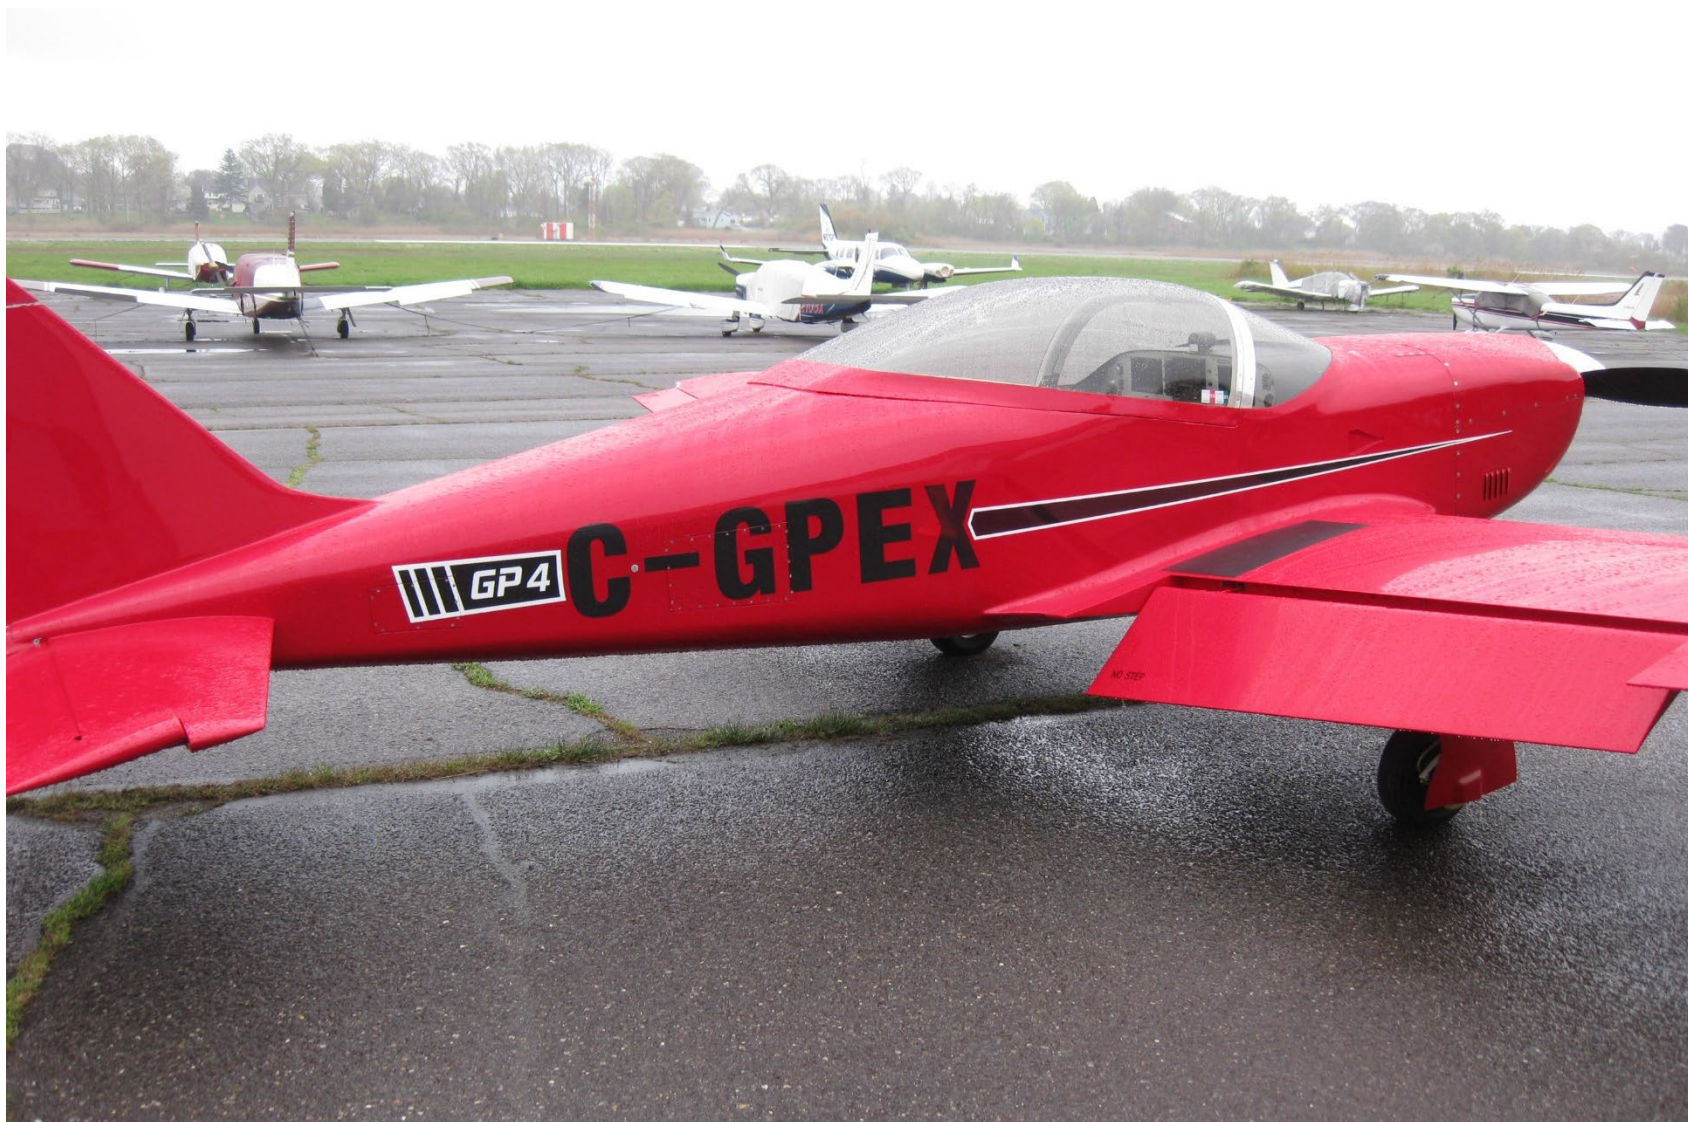
**Photo 1 – Right Rear View of Accident Airplane (Courtesy of FAA)**

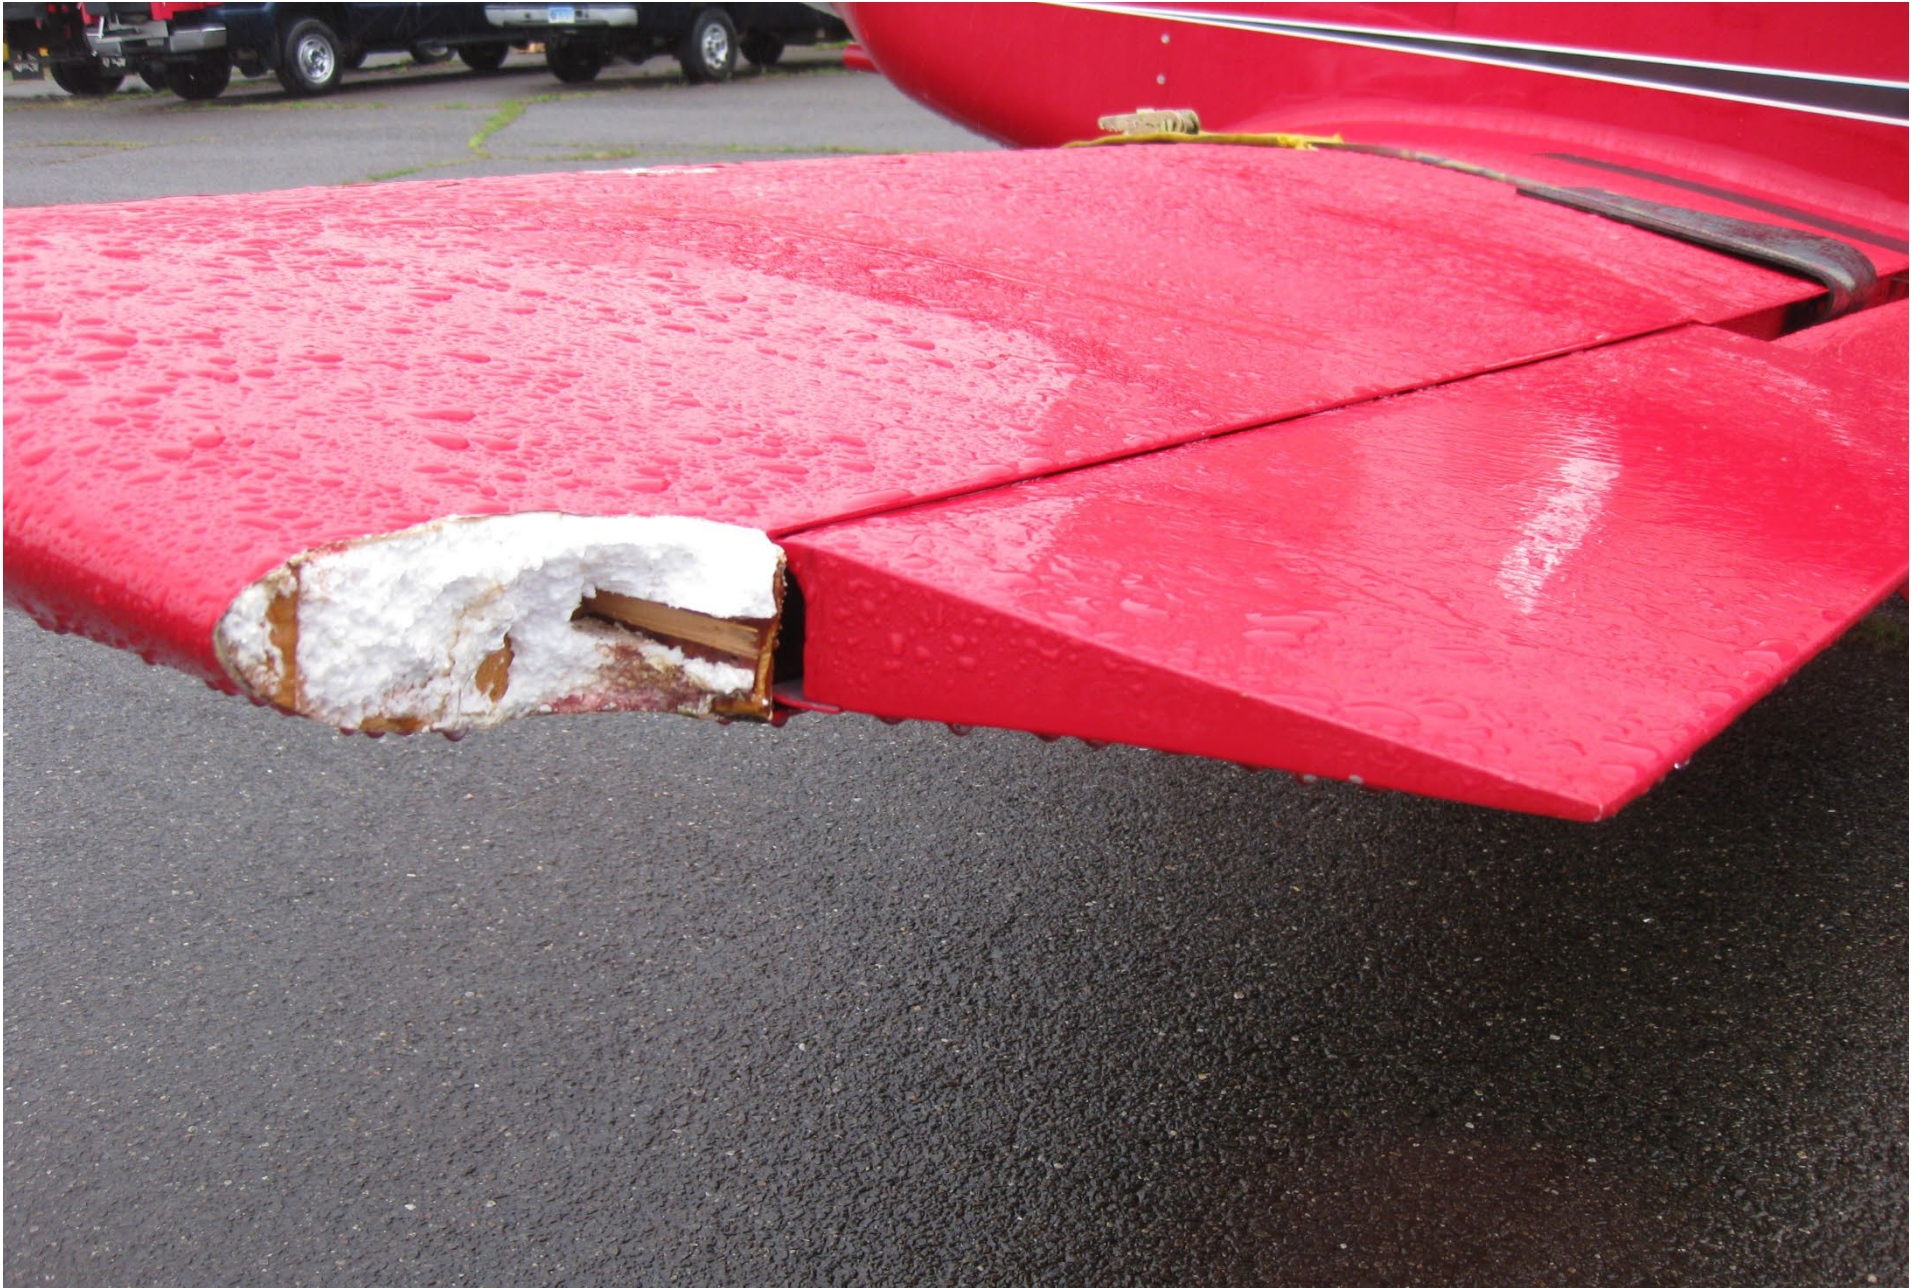
**Photo 2 – Closeup View of Damaged Left Wingtip (Courtesy of FAA)**

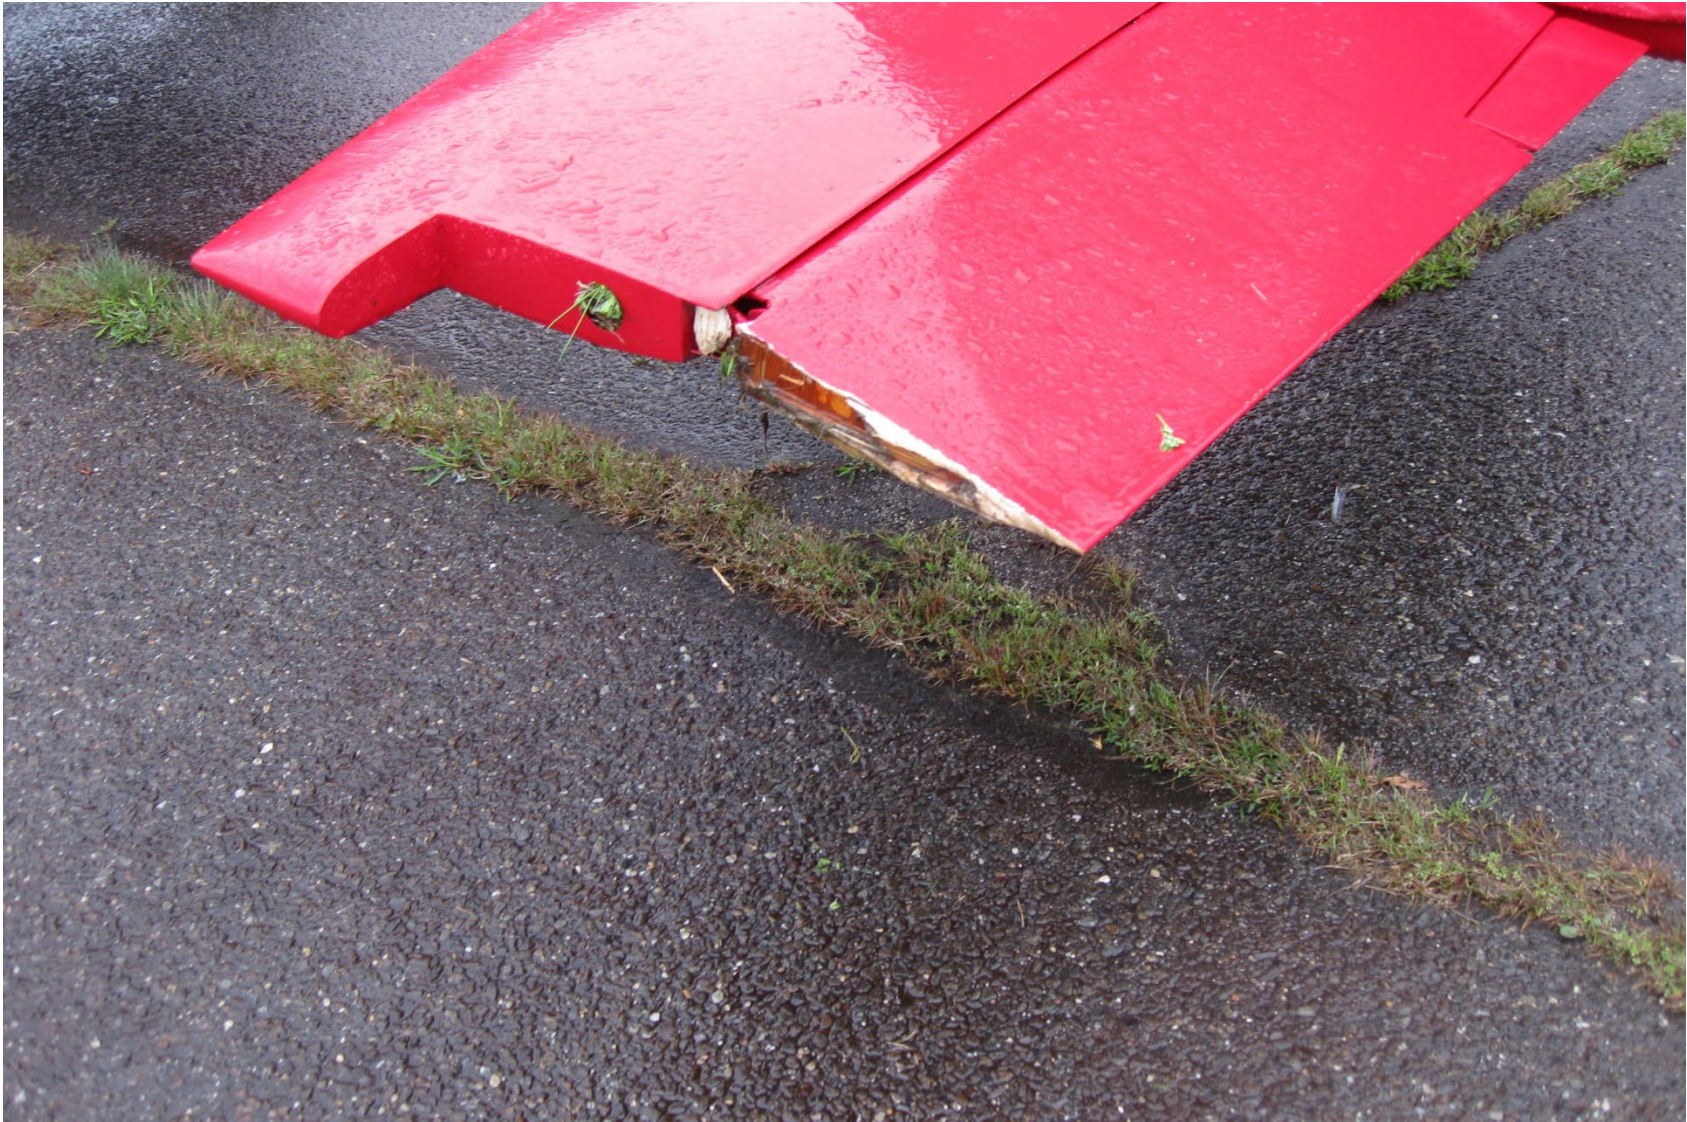
**Photo 3 – View of Damaged Elevator – Left Side. Note Missing Counterweight (Courtesy of FAA)**

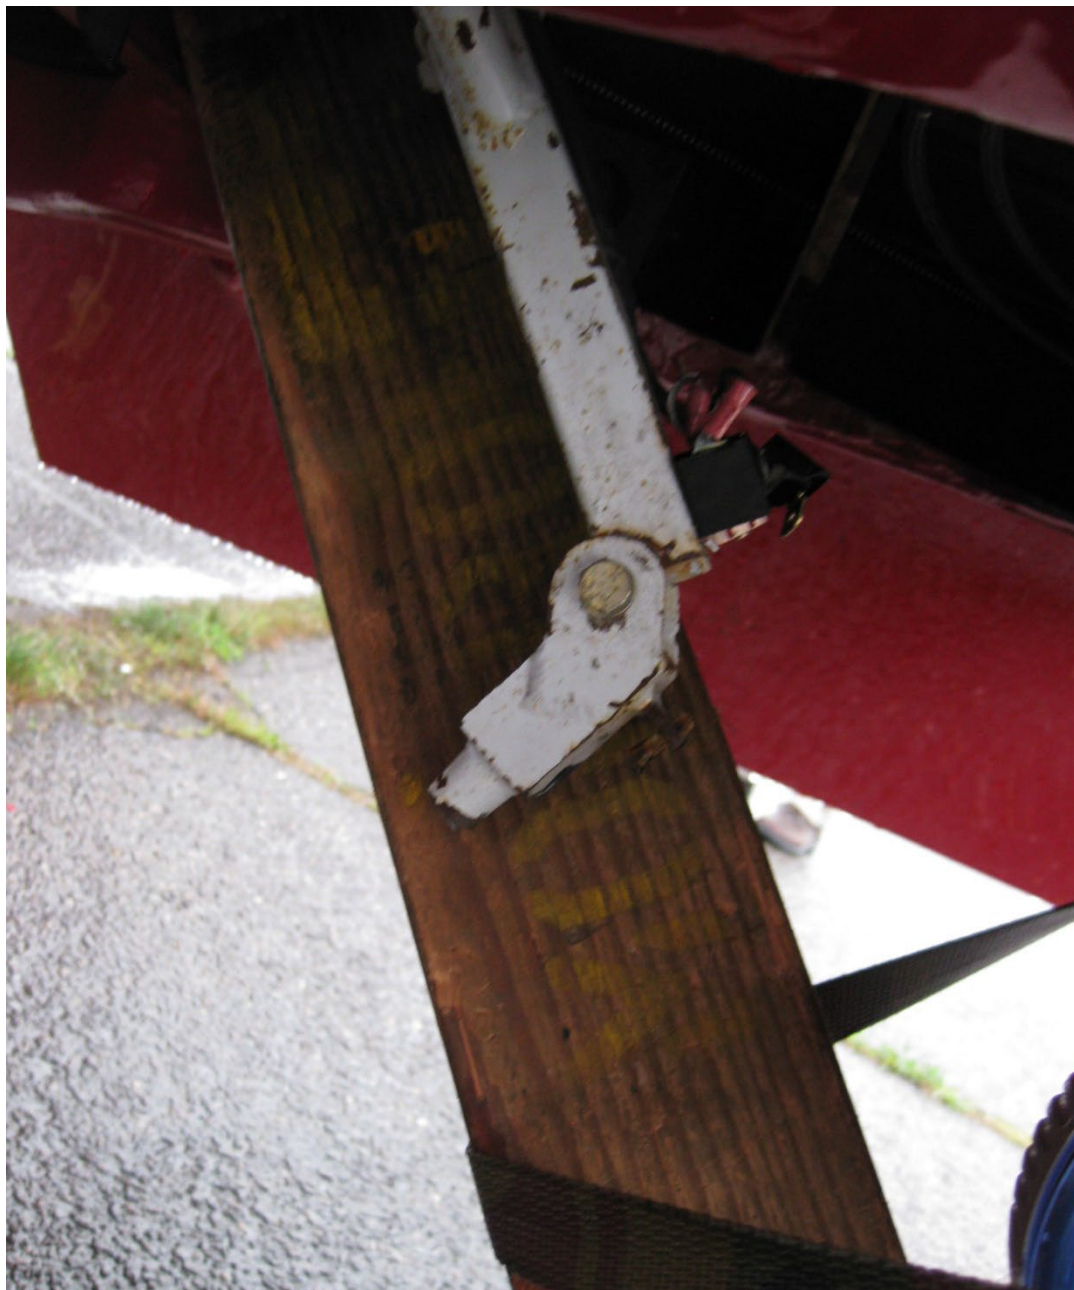
**Photo 4 – View of Broken Left Landing Gear Lock. Wood For Support Post-Accident (Courtesy of FAA)**

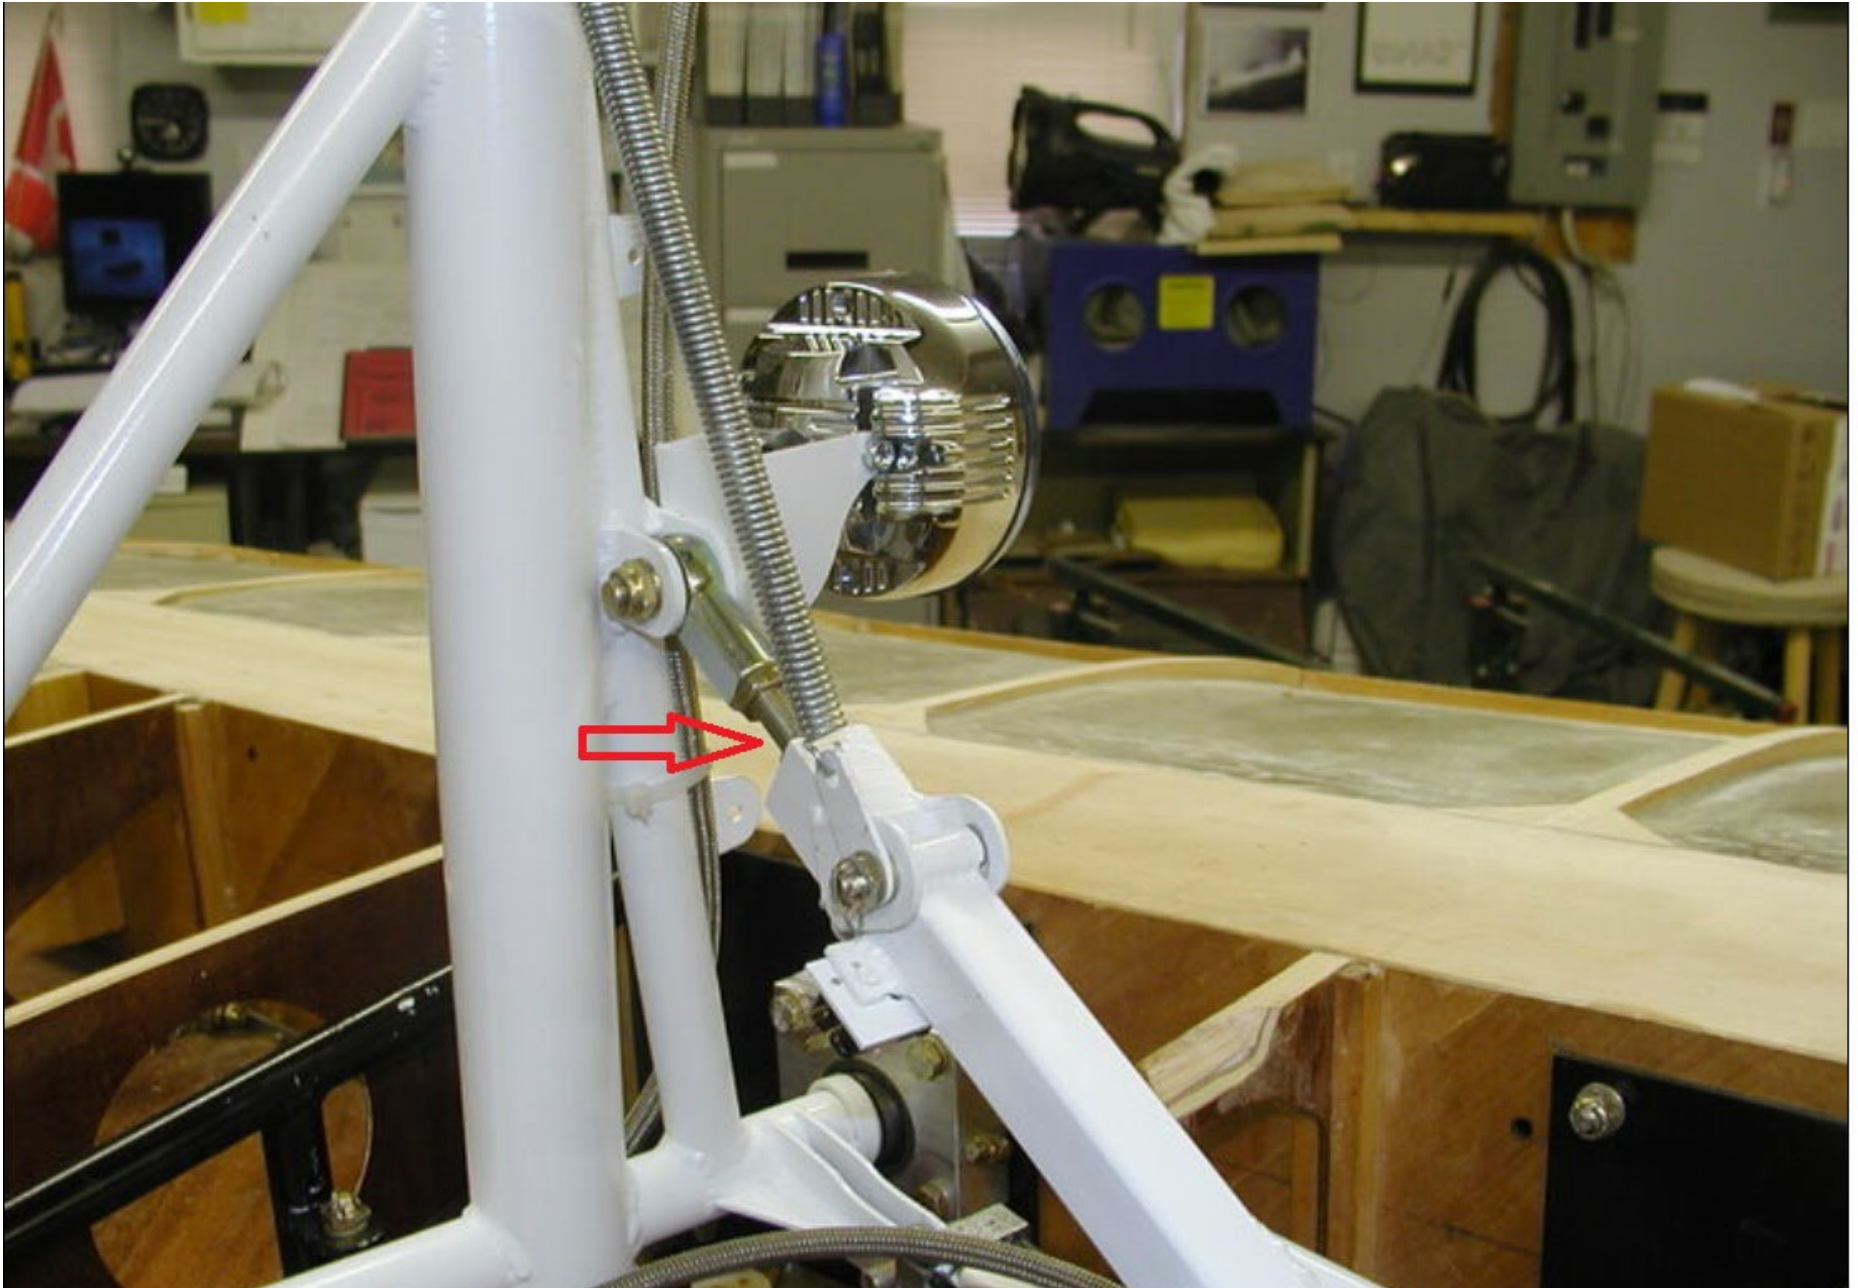
**Photo 5 – View of Landing Gear Assembly, After Repairs. Arrow Points to Replaced Lock (Courtesy of Pilot)**
