# National Transportation Safety Board

ERA23LA218

## **MATERIALS LABORATORY**

Factual Report 24-060

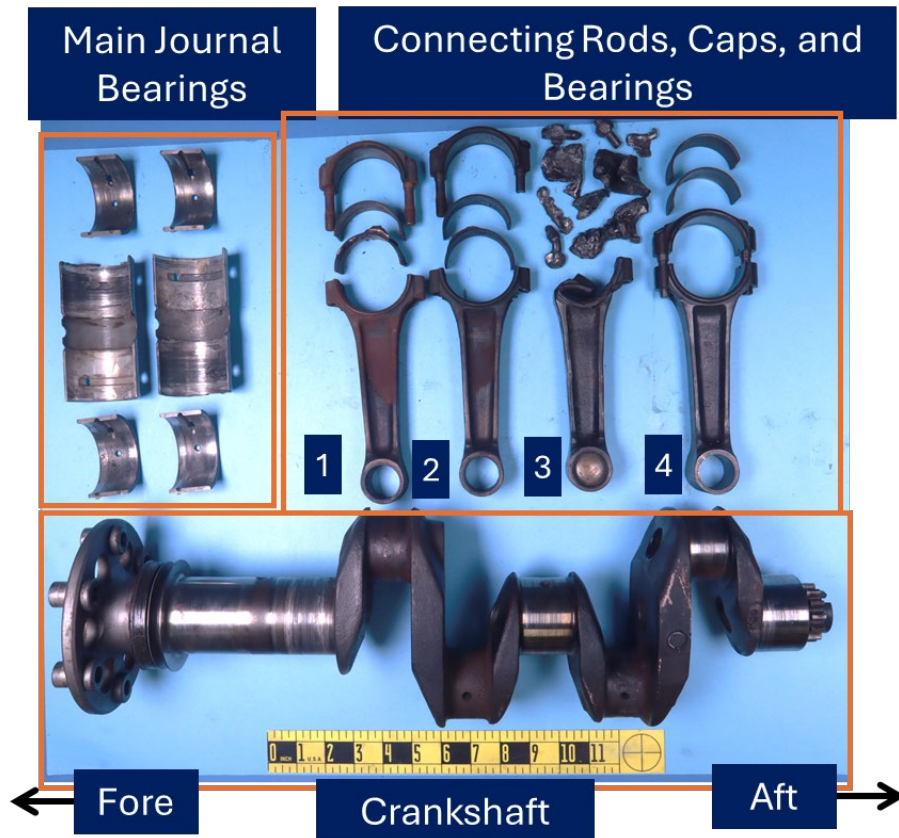
Figure 1 shows the parts as received at the materials laboratory. Most parts were intact, but the connecting rod for piston 3 showed significant damage at the connection to the crankshaft journal and the cap was broken into multiple pieces. One bolt from connecting rod 2 showed cutting marks consistent with a metal saw; it was confirmed that the cutting occurred during the engine examination. The oil filter, shown in Figure 2, contained flakes of silver-colored metal.

**Figure 1.** Crankshaft, bearings, and connecting rods as received. Connecting rod journals are numbered starting at 1 at the fore and increasing as one moves aft.

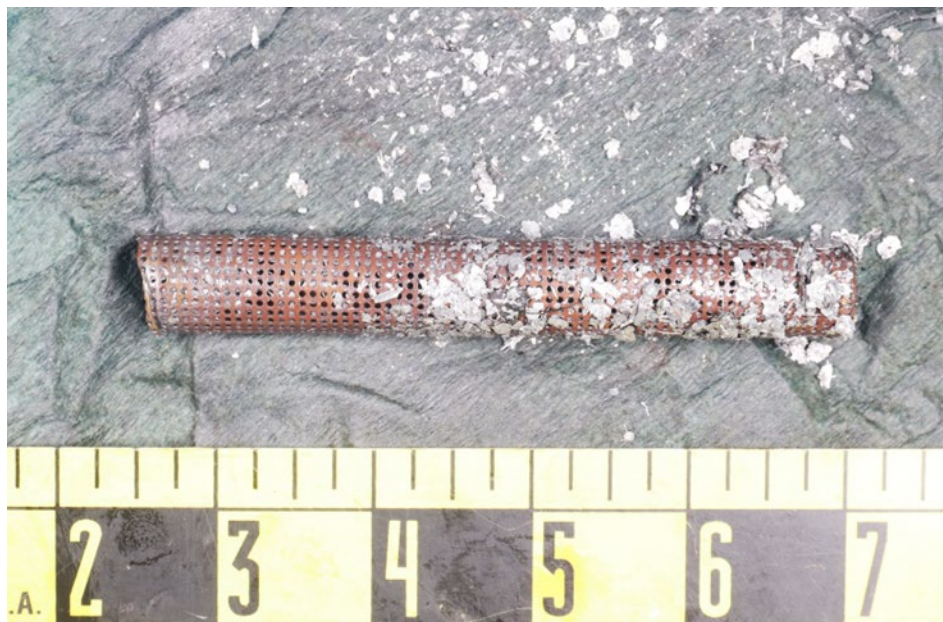
**Figure 2.** Oil screen as received. Silver-colored metal particles were seen inside and outside of the screen.

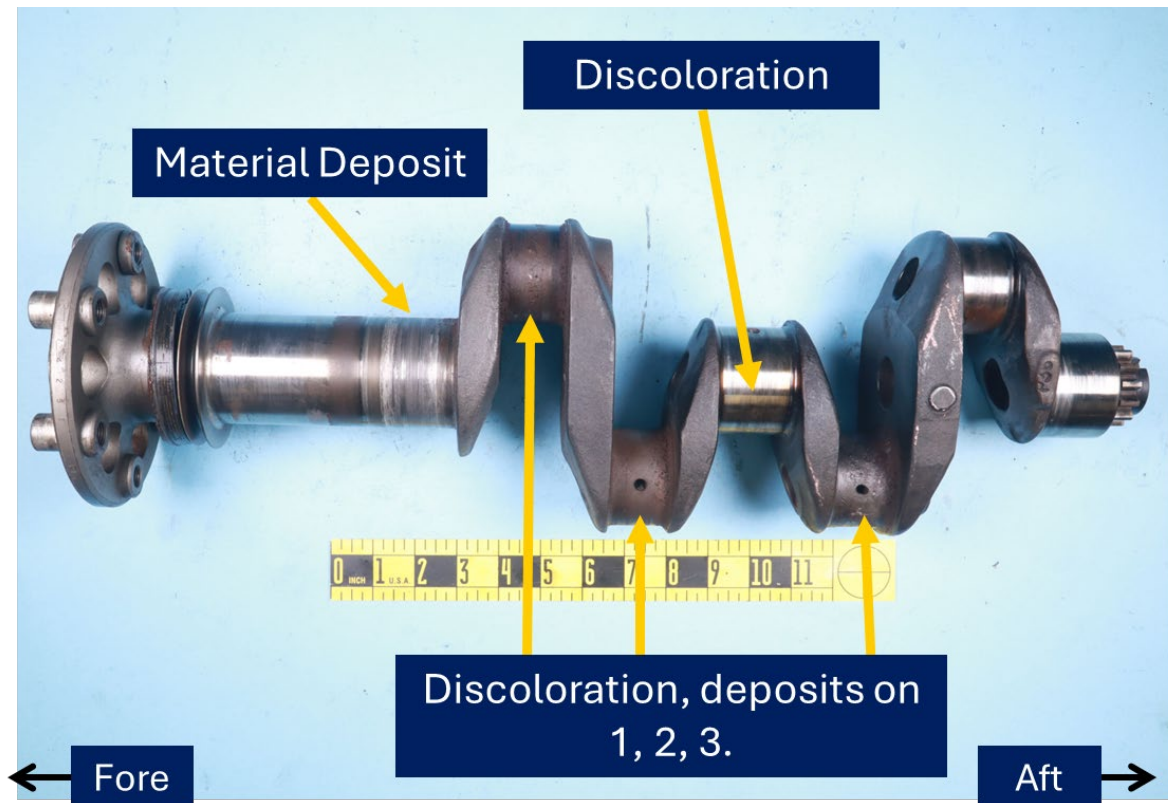
The crankshaft (Figure 3) showed damage to most bearing surfaces. The forward main bearing journal showed gray and white streaks around its circumference, consistent with material transfer. The middle main bearing journal (between the second and third connecting rod journals) was discolored with a yellow/brown patina, consistent with exposure to elevated temperature. The aft main bearing journal was silver in color with no discoloration or evidence of damage. Crankpin journals 1, 2, and 3 (numbered from fore to aft) were discolored and the surfaces were rough. Brown and black metal and corrosion deposits were visible around the outer wall of the three journals. X-Ray Fluorescence (XRF) was used to determine the composition of the metal deposits. Measurements taken on journals 1, 2, and 3 showed a higher concentration of copper (3-5 wt%) than a measurement taken on a clean (silver-colored) part of the main crankshaft (<0.05 wt%).<sup>1</sup> Journal 3 also showed surface damage consistent with gouging or hard contact with other surfaces. Journal 4 showed some brown discoloration and deposits, but to a lesser

extent than the other three journals. A micrometer was used to measure the diameter of journal 4 as received, which was found to be 2.1243 inch.

**Figure 3.** Parts of the crankshaft showed damage consistent with contact and exposure to high temperatures. Crankpin journals are designated 1 to 4 moving fore to aft.

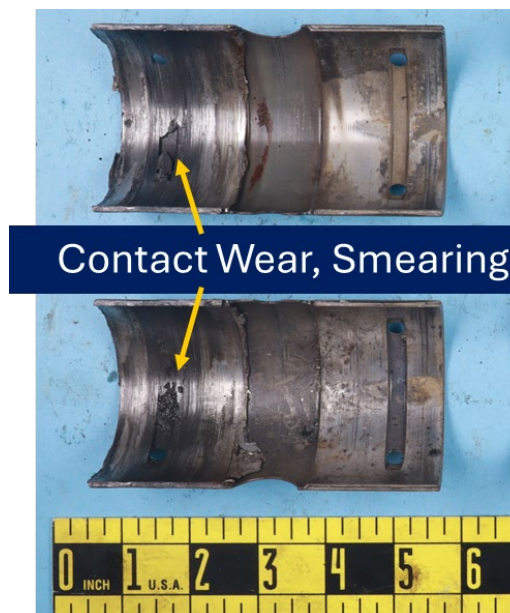
Bearings submitted with the parts also showed damage consistent with contact and wear. The bearings were washed in ethanol in an ultrasound bath to remove dirt and residue. The forward main journal bearing (Part No. SL-13884) showed smearing in and around one oil channel, to the degree that much of the channel had been filled in and one inlet hole had been covered completely (Figure 4). XRF measurements of the bearing surface showed a high amount of aluminum (>60 wt%). The outer surface showed high amounts of iron (>90 wt%) and low amounts of aluminum (<1 wt%).

**Figure 4.** Wear on the forward main journal bearing.

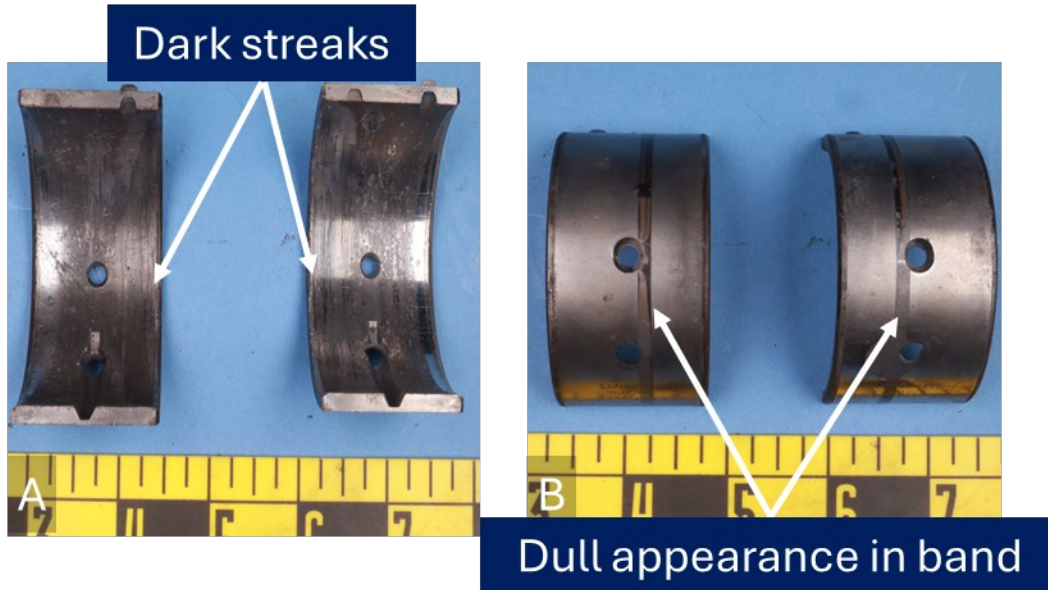
The second pair of main journal bearings (Part No. SL-11020) did not show the level of wear seen in the forward bearings, though the inner surface was shiny and silver in color with some areas showing dark circumferential streaks (Figure 5). The outer surface showed a dark, dull band approximately 0.11 inch wide going around the outer circumference of the bearing. XRF measurements on the inner bearing surface showed a high amount of copper (>80 wt%) and lead (approx. 12 wt%).

**Figure 5.** Second set of main journal bearings. A) Inner bearing surface. B) Outer bearing surface.

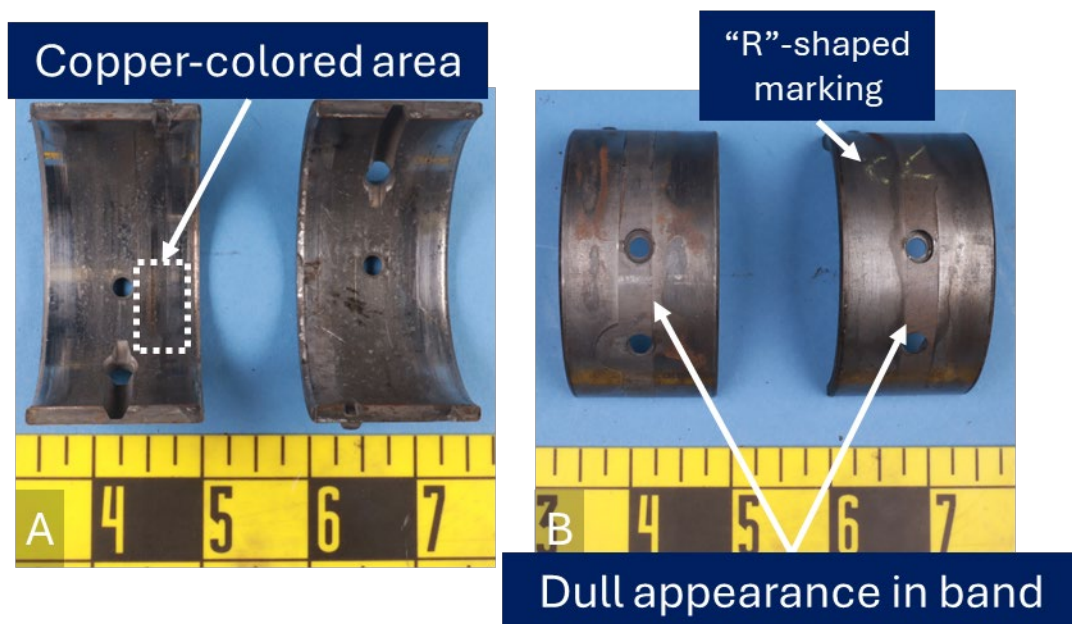
One half of the final pair of main journal bearings was marked in yellow with a symbol resembling an "R". The inner surface did not show smearing, though a section of the shiny silver layer was worn away on the inner part of one half, revealing a copper-colored layer (Figure 6). The outer surface showed a dark, dull band approximately 0.26 inch wide running around the circumference of the two bearings. The band intersected the holes in the bearing. XRF measurements on the inner bearing surface showed a high amount of lead (>70 wt%) and copper (>10 wt%).

**Figure 6.** Final set of main journal bearings. A) Inner bearing surface. B) Outer bearing surface.

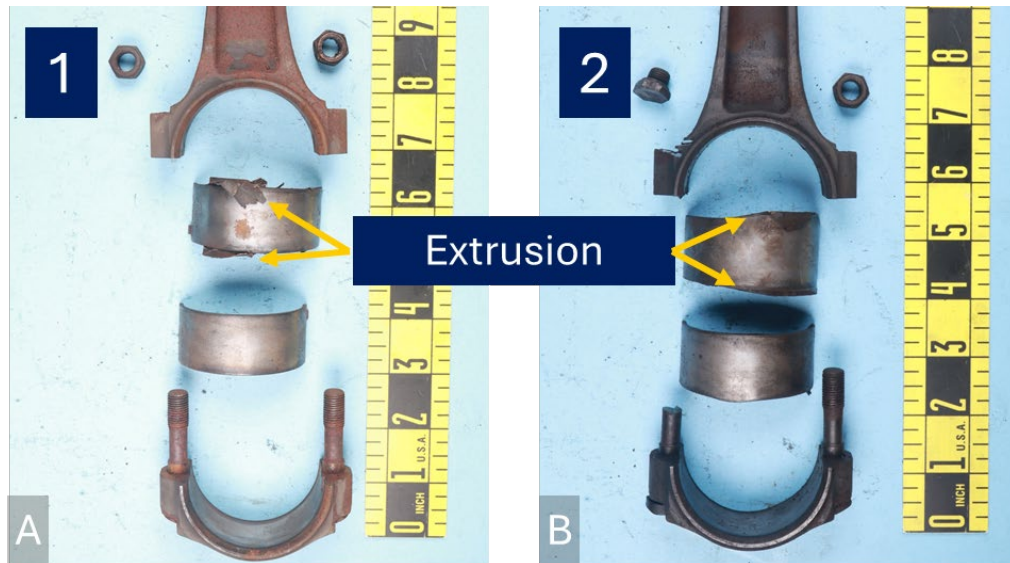
The bearings from the rods (Part No SL-13521) had a copper-colored appearance on the inner wall of the bearing. The copper-colored material on the inner surface of the bearings from rods 1 and 2 was extruded out the sides of the bearings, causing the bearings to be misshapen (Figure 7). XRF readings of this layer showed a high concentration of copper (>60 wt%). Comparatively, the bearings from rod 4 showed little damage.

**Figure 7.** Bearings from A) connecting rod 1 and B) connecting rod 2. The inner layer of the bearing was extruded out the sides for both rods.

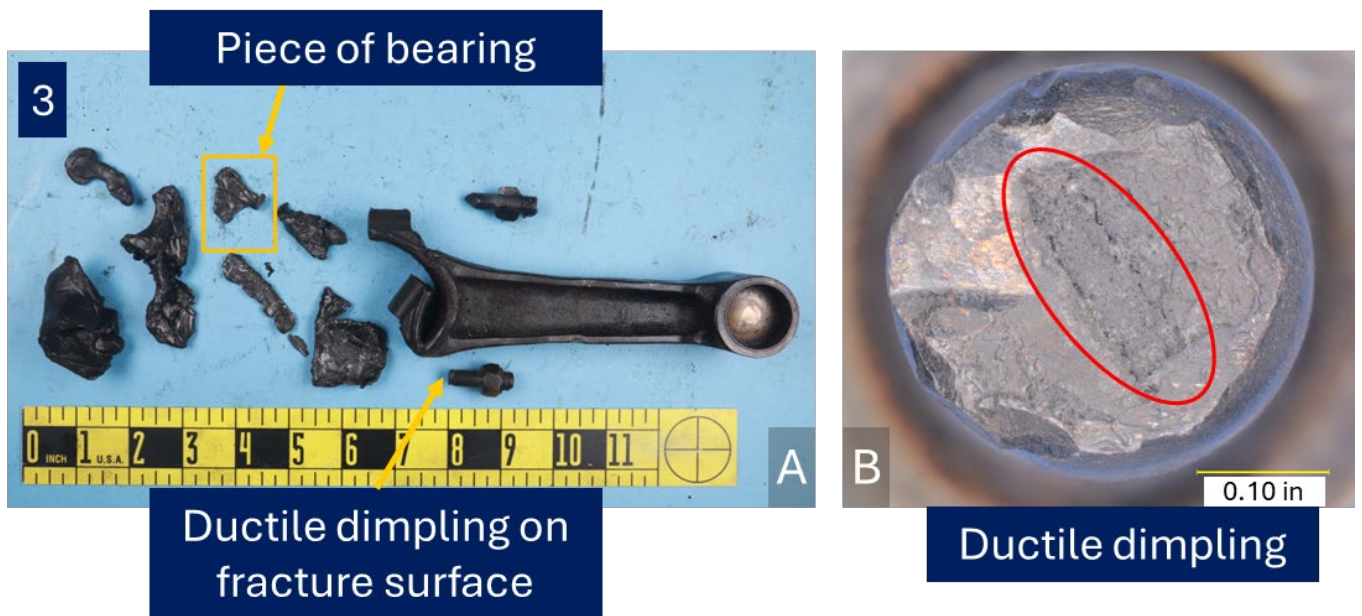
The remains of connecting rod 3 were examined for evidence of pre-existing damage (Figure 8). Most surfaces showed signs of smearing and deformation consistent with post-fracture hard contact damage. A portion of the fracture surface for one bolt showed a rough, matte gray finish consistent with overload failure. A thin, flattened fragment was identified as a piece of the bearing and was subjected to XRF examination. This piece showed an elevated amount of copper (>5 wt%) on one side. No evidence of pre-existing damage was seen.

**Figure 8.** A) Connecting rod 3. The highlighted piece of bearing was subjected to XRF analysis. B) The fracture surface on the bolt highlighted in A.

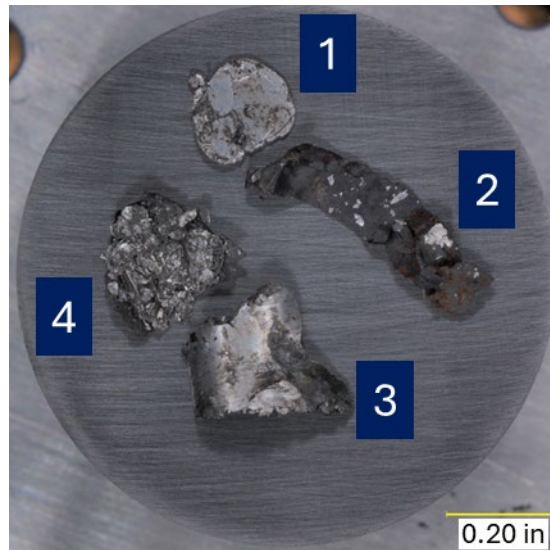
A selection of large metal flakes from the oil filter (Figure 9) were cleaned with acetone in an ultrasound bath and examined with a field-emission scanning electron

microscope. Energy Dispersive Spectroscopy (EDS) was used to determine their composition (Figures 10-13). The flakes were arbitrarily numbered 1-4 for tracking purposes. Flakes 1,3 and 4 showed high amounts of aluminum. Flake 2 showed high amounts of iron and aluminum.

**Figure 9.** Particles from the oil filter subjected to EDS analysis. EDS Spectra for each particle can be seen in the following figures.

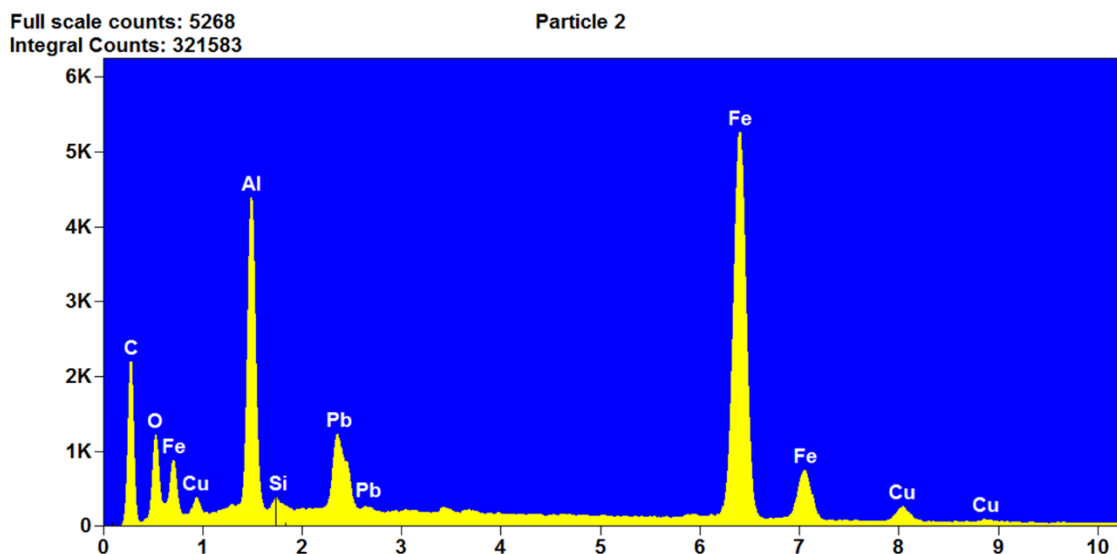
**Figure 11.** EDS Spectrum for particle 2 showing strong peaks for aluminum and iron.
