ERA23LA218

## INVESTIGATION PHOTOGRAPHS

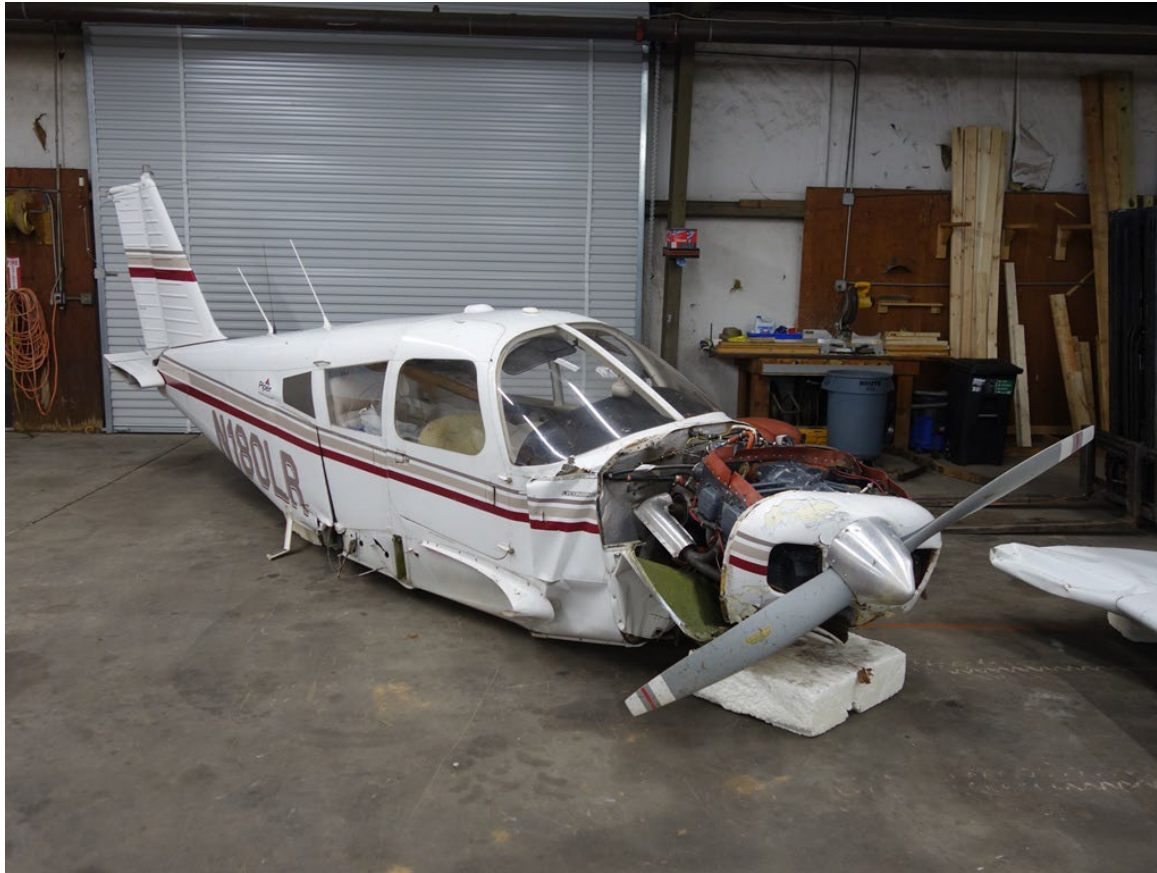
**Photograph 1 - Right Side View of Airplane (Courtesy of Piper Aircraft Company)**

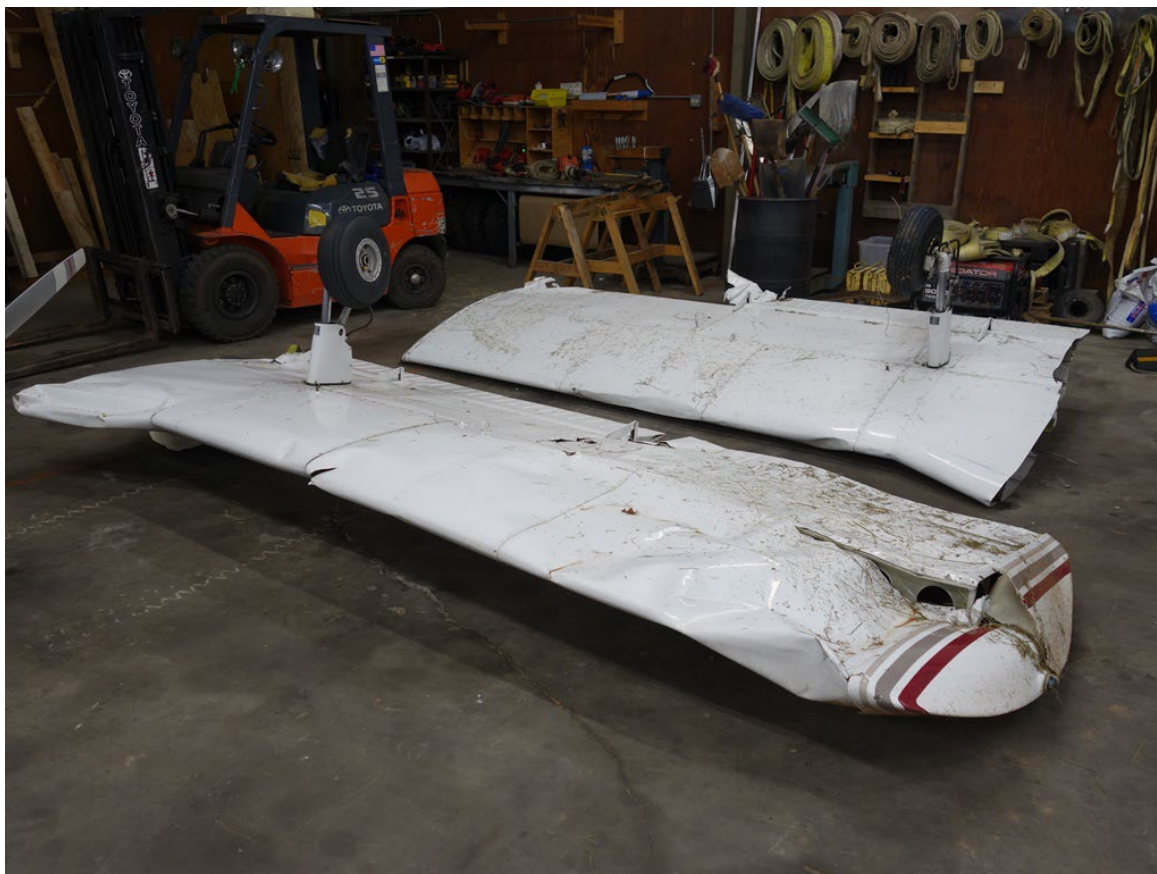
**Photograph 2 - Left and Right Wings (Courtesy of Piper Aircraft Company)**

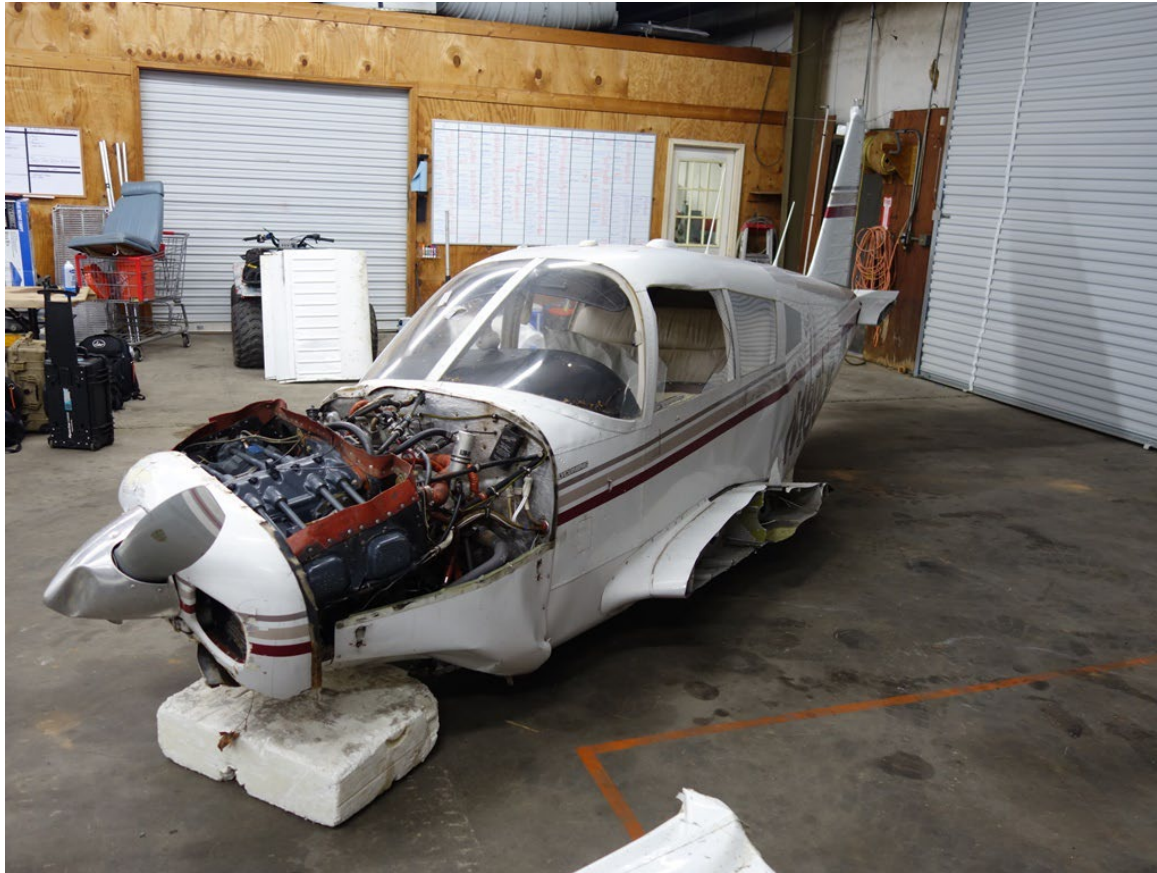
**Photograph 3 - Left Side View of Airplane (Courtesy of Piper Aircraft Company)**

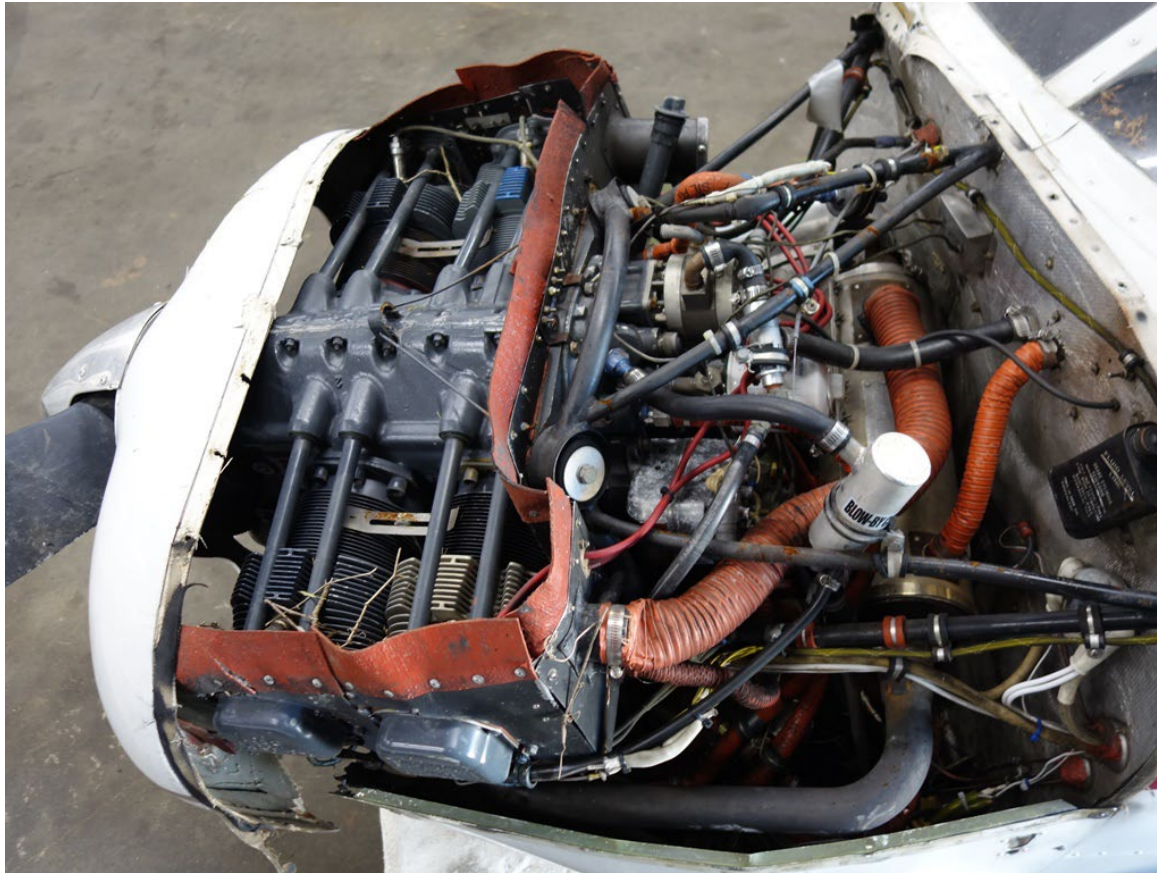
**Photograph 4 - Engine (Courtesy of Piper Aircraft Company)**

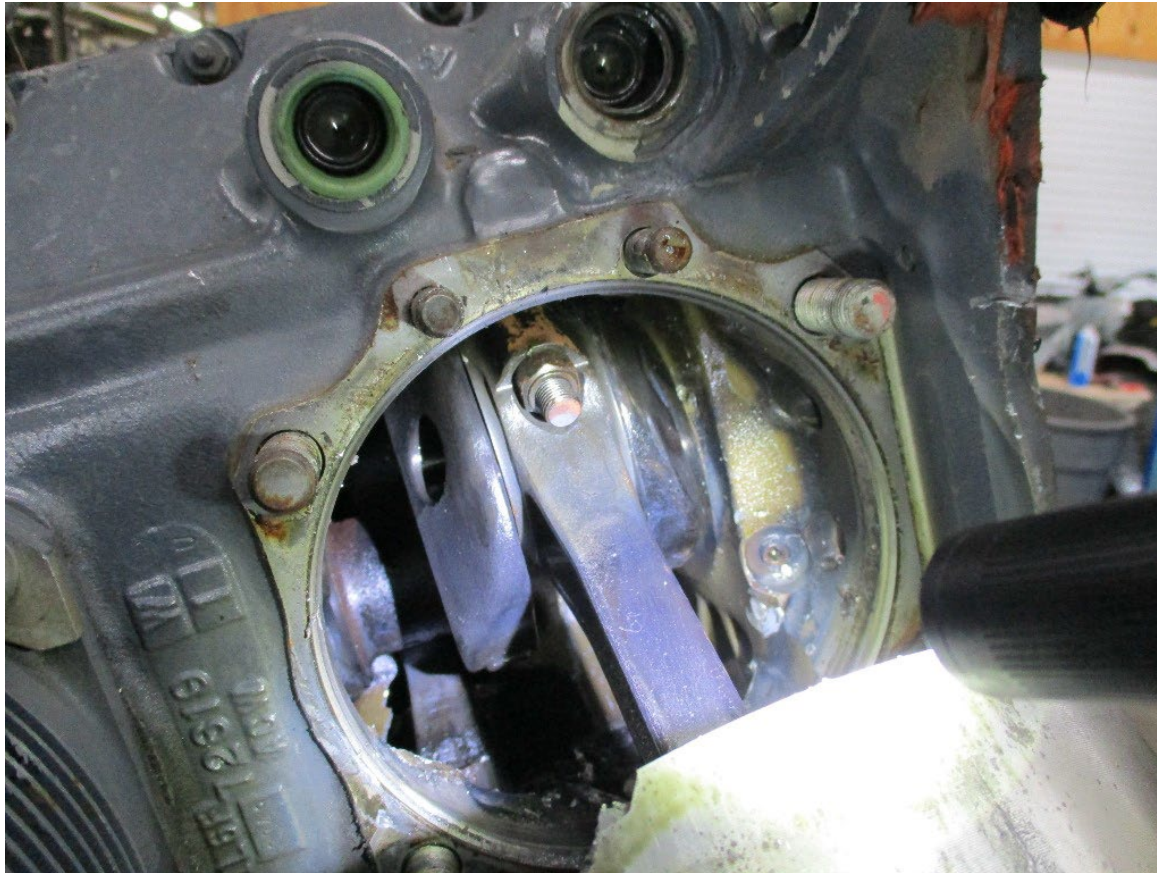
**Photograph 5 - Damage to the No. 4 cylinder/piston (Courtesy of FAA)**

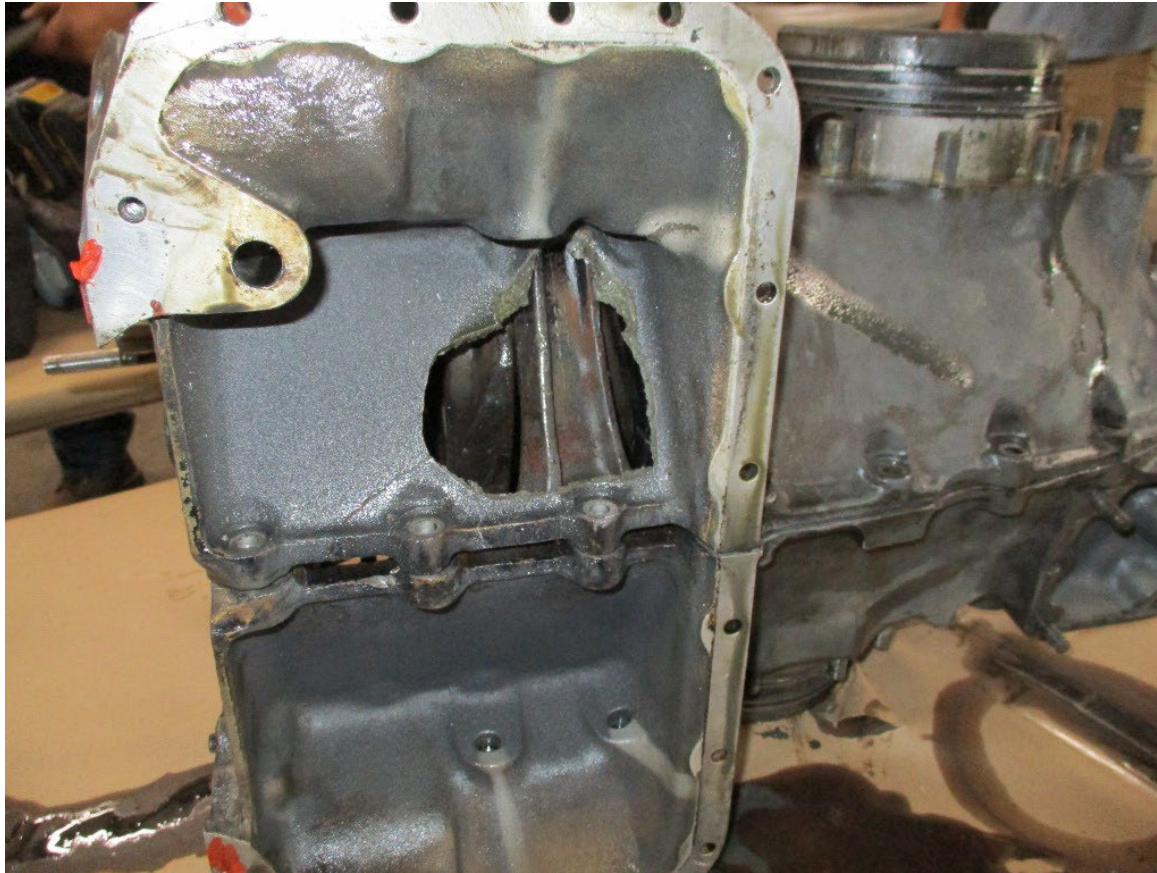
**Photograph 6 - Large Hole in the Engine Case (Courtesy of FAA)**

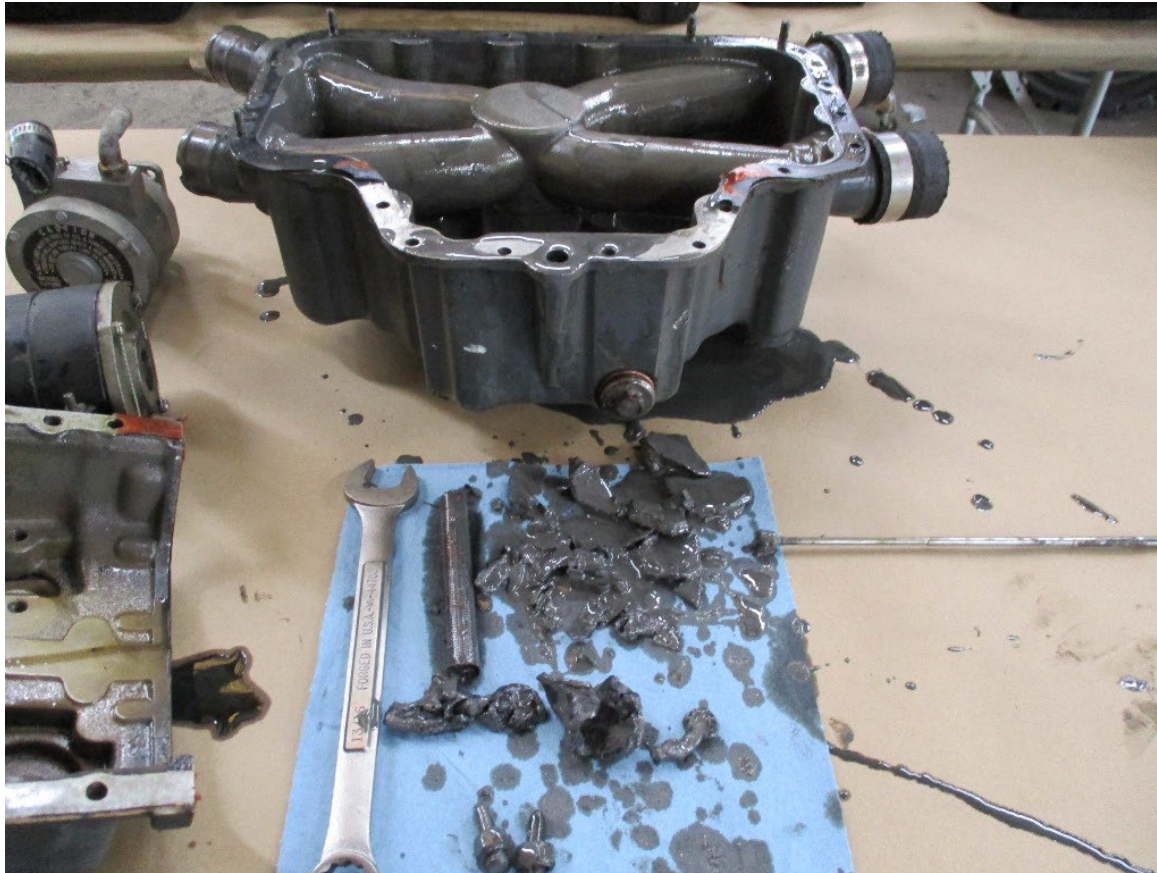
**Photograph 7 - Oil Sump Screen and Metallic Debris Found in the Oil Sump (Courtesy of FAA)**
