ERA23LA218

## ENGINE PHOTOGRAPHS

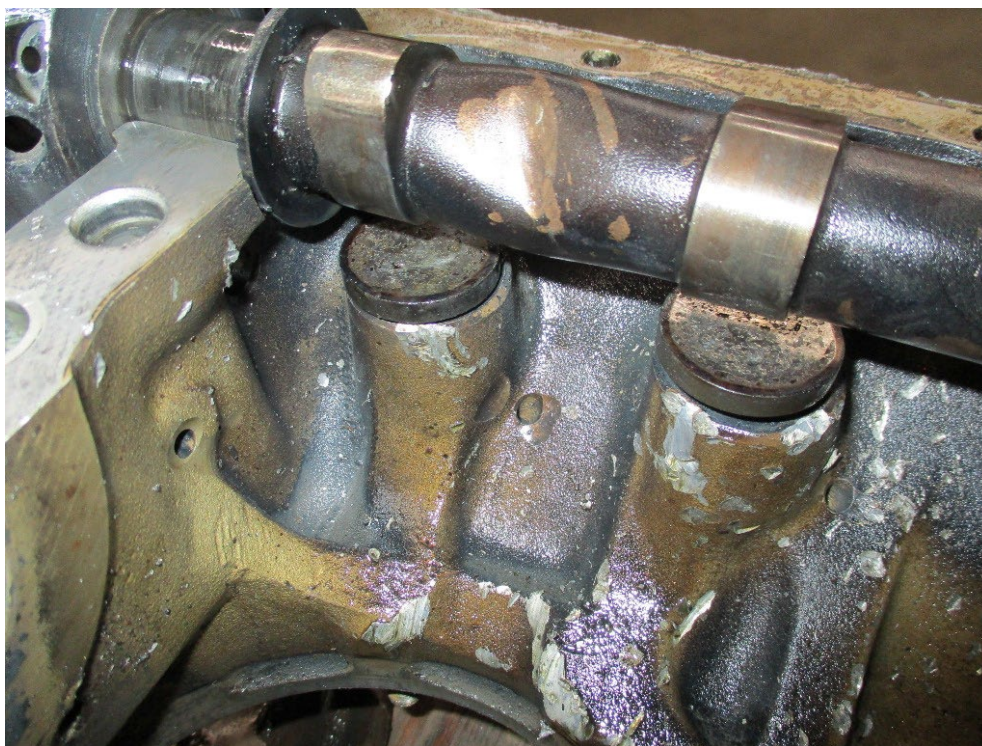
**Photograph 1 -Wear to Camshaft Lobes and Lifters (FAA)**

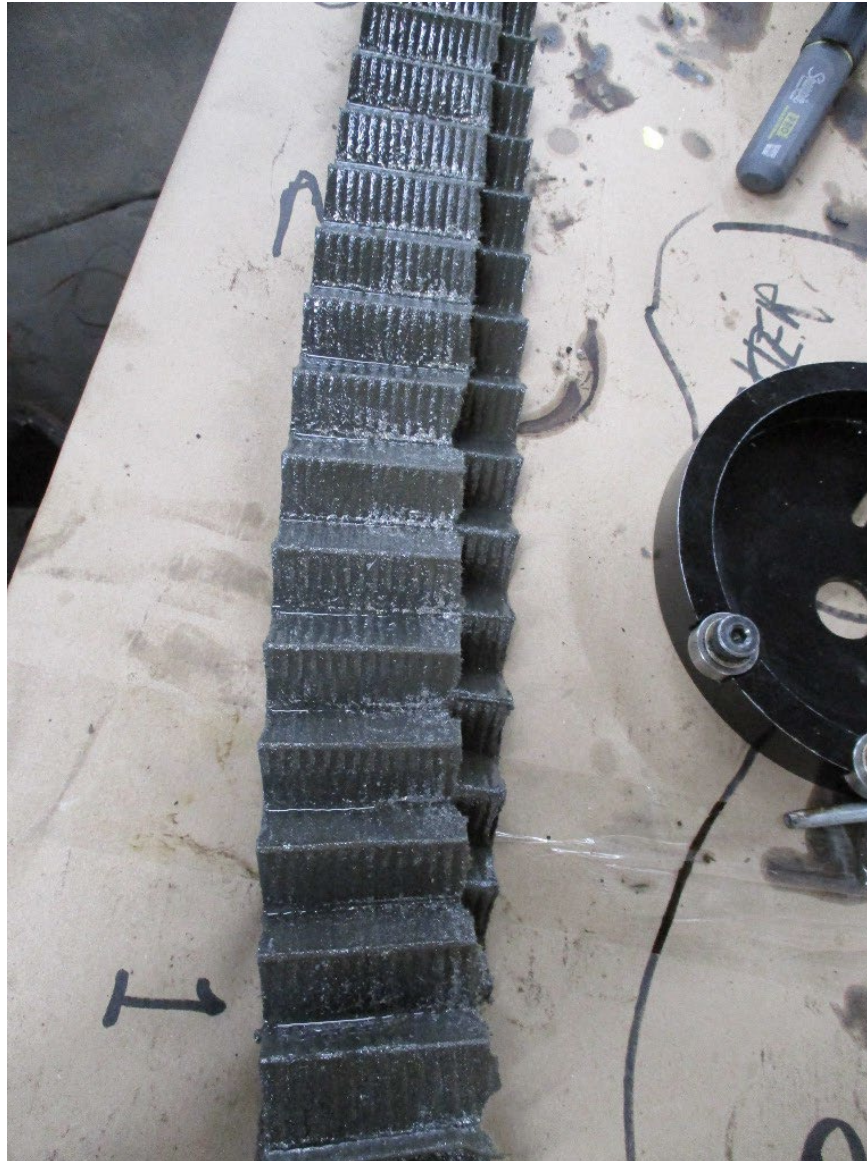
**Photograph 2 - Oil Filter Screen with Metallic Debris (FAA)**

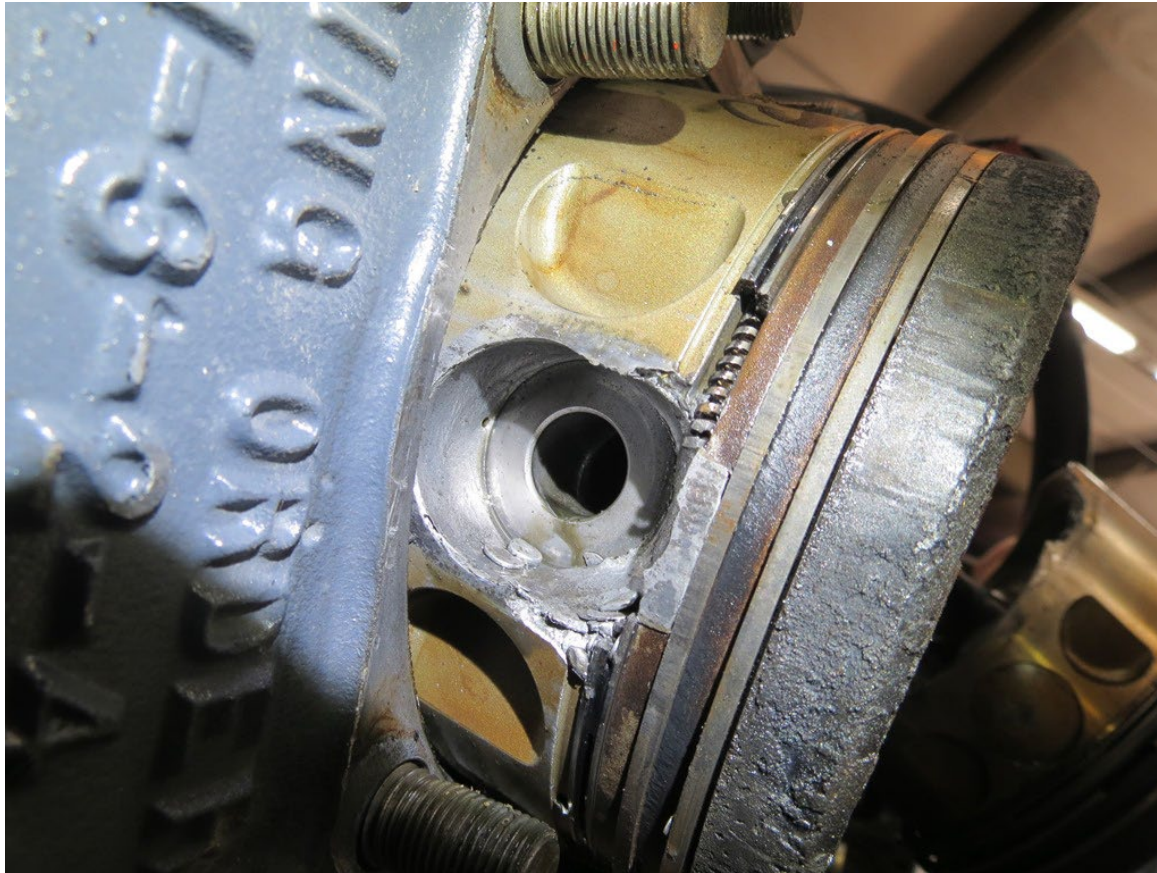
**Photograph 3 - No. 2 Cylinder Piston Pin Plug Damage (Lycoming)**

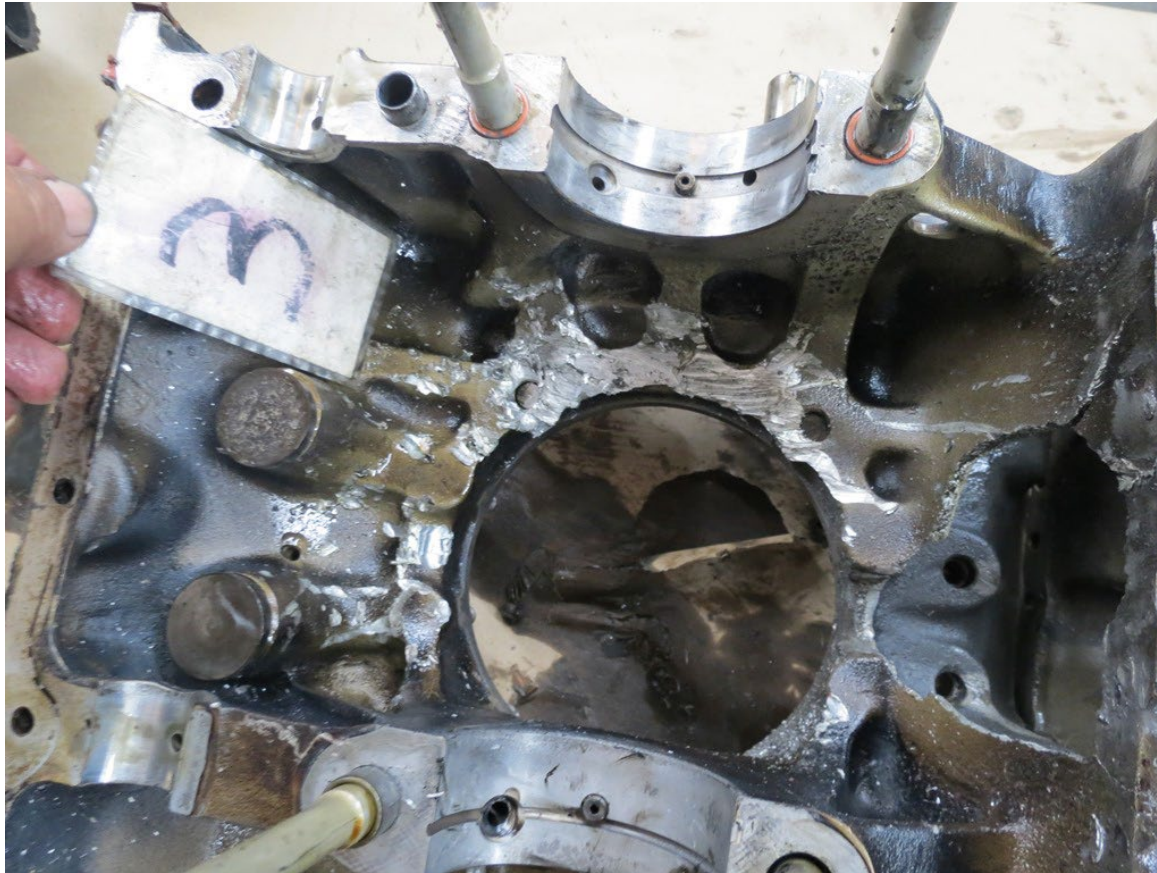
**Photograph 4 - Internal Damage to Crankcase (Lycoming)**
