# National Transportation Safety Board

ERA23LA225

## **AIRWORTHINESS FACTUAL REPORT**

Location: Manville, New Jersey  
Date: May 6, 2023  
Time: 1400 local  
1800 UTC  
Airplane: Mooney M20K, N262MK

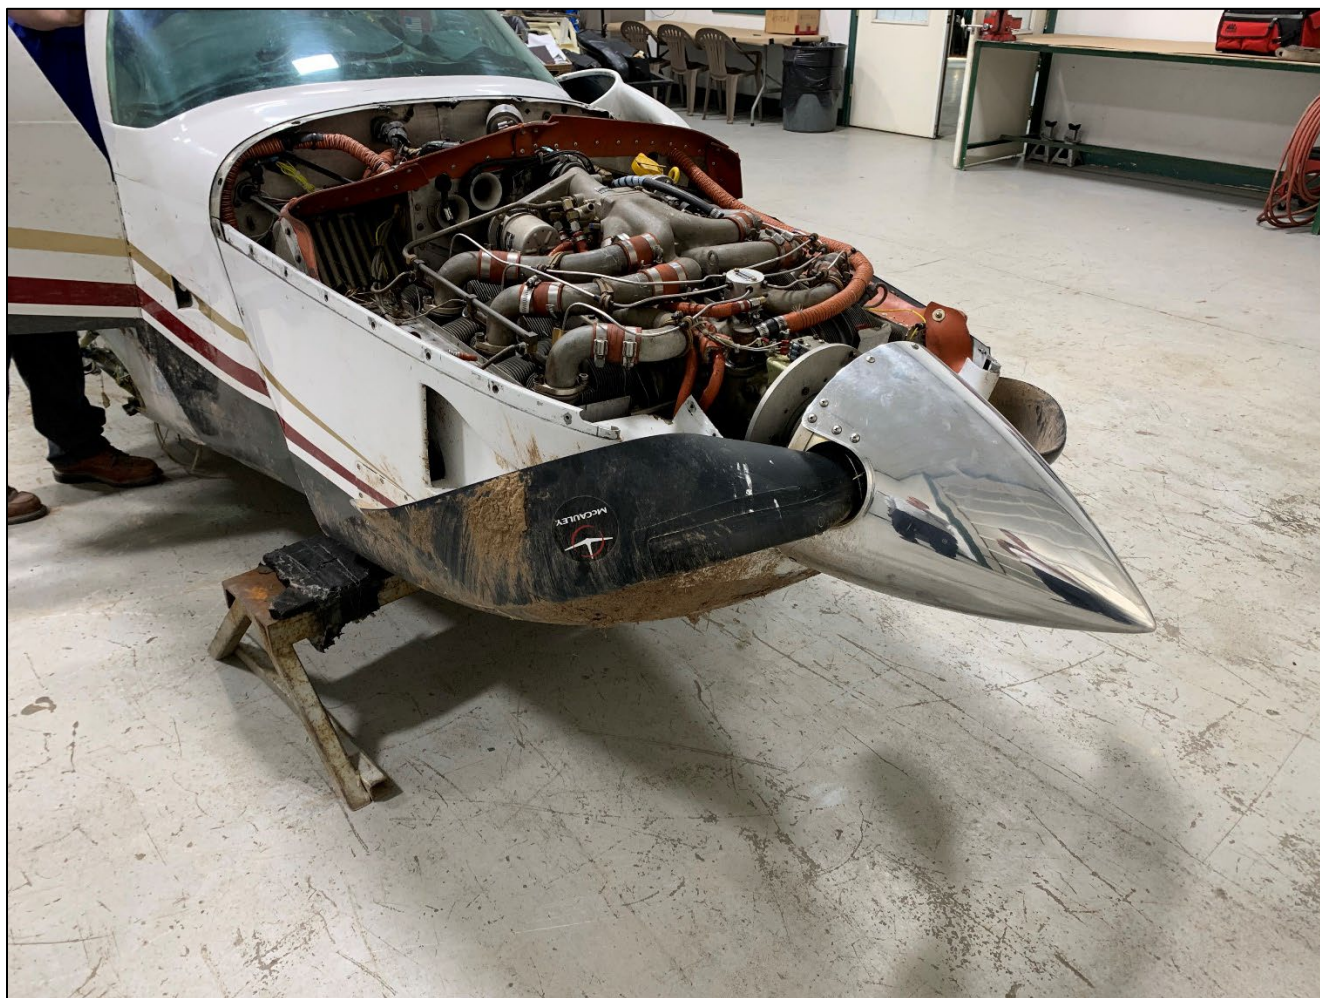
The engine remained attached to the firewall. Significant accumulation of dirt and sand was present on the bottom of the engine as a result of the impact with terrain, but the engine was largely free of any substantial impact damage.

**Figure 1: View of the engine compartment as viewed at the recovery facility.**

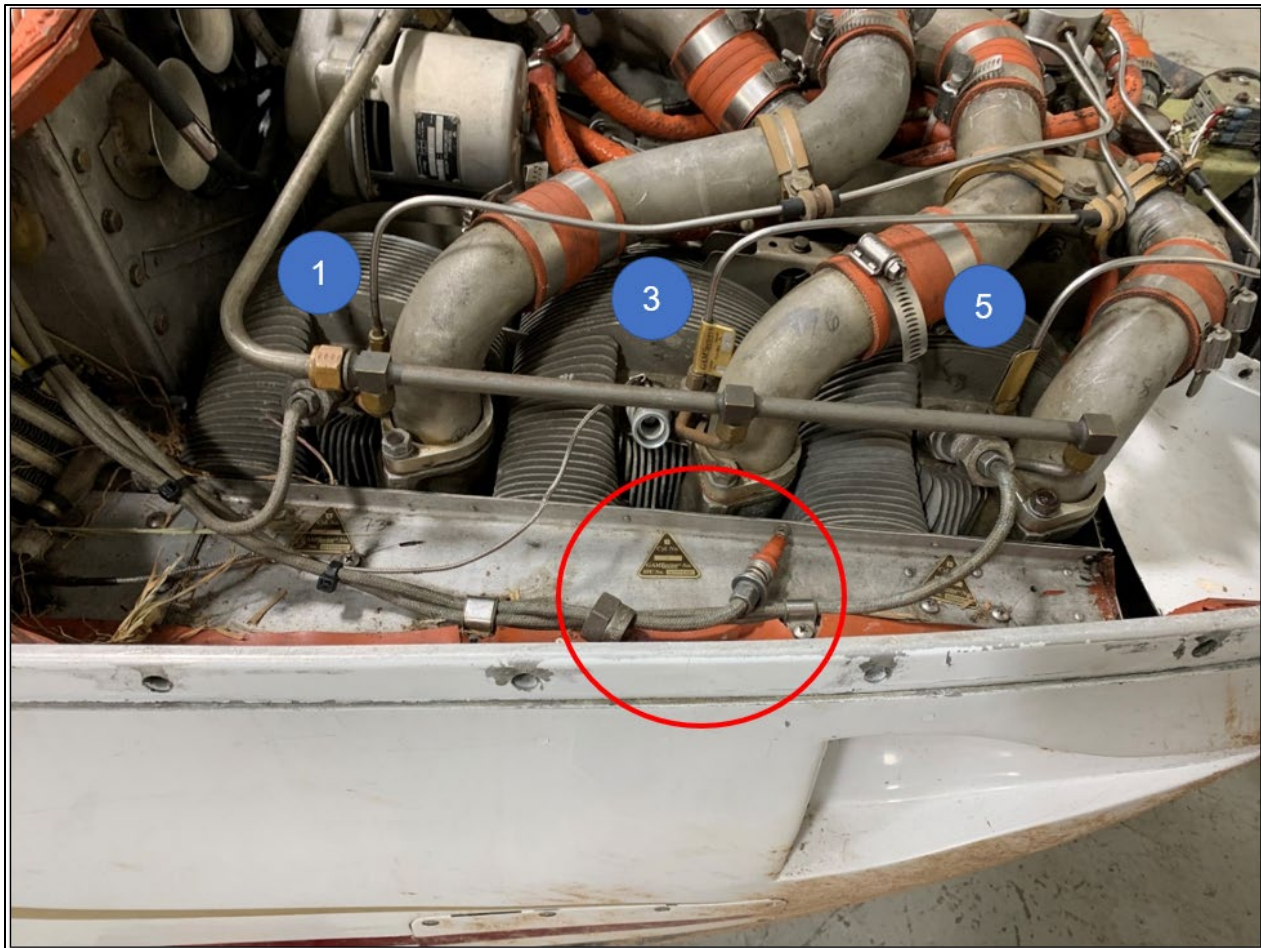
The Nos. 1 and 5 spark plug ignition harnesses were found loose to their attachment area to their respective sparkplugs when touched by hand. The No. 3 spark plug ignition harness was found completely unscrewed, detached, and lying next to the spark plug on top of the cylinder shroud. There was a black composite material mark observed next to the No. 3 shroud area.

**Figure 2: View of the Nos. 1, 3, and 5 cylinders and ignition harnesses as found at the recovery facility. The No. 3 ignition harness was found lying next to its installation area. The No. 1 and 5 ignition harnesses were loose to the touch.**

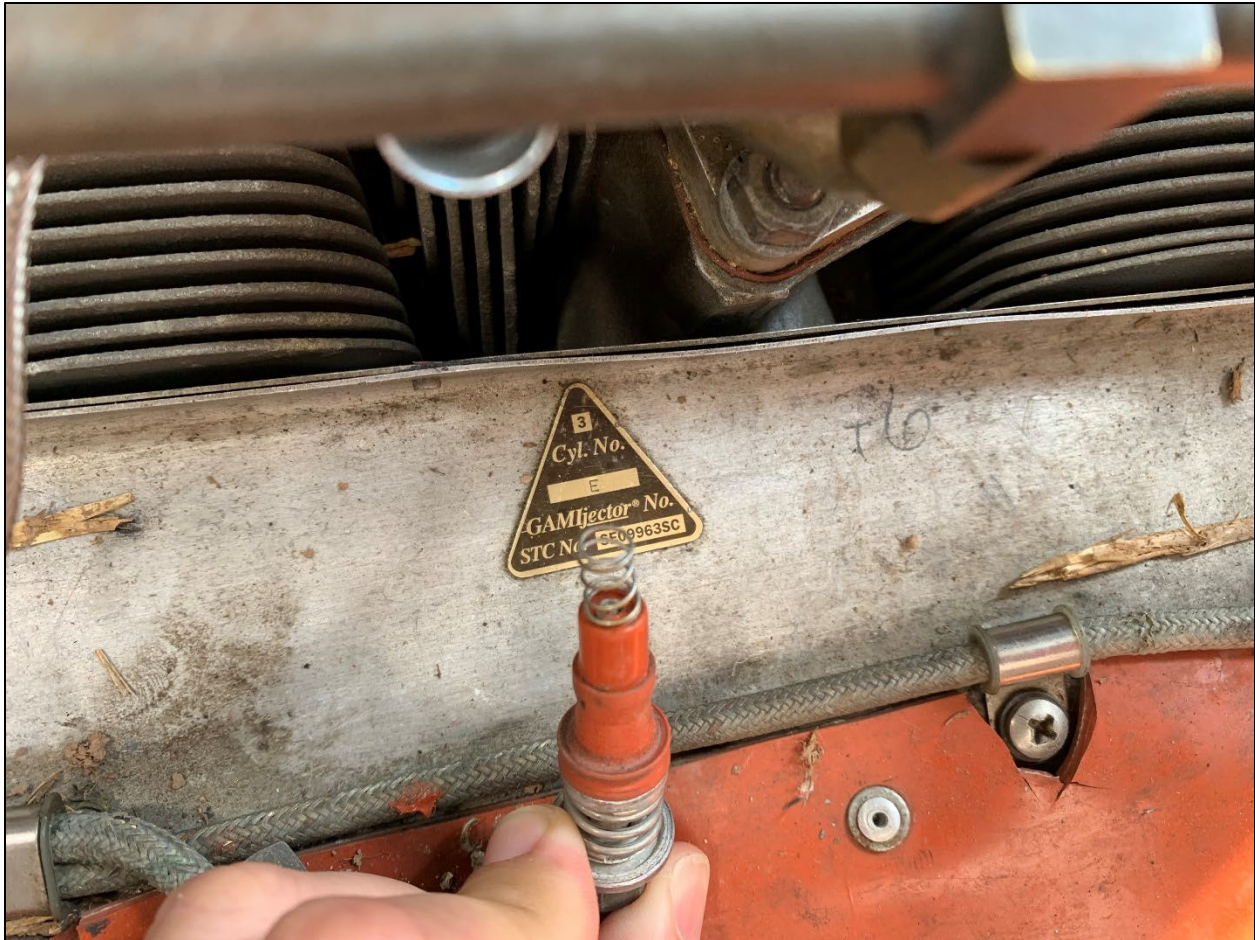
**Figure 3: View of the No. 3 cylinder ignition harness.**

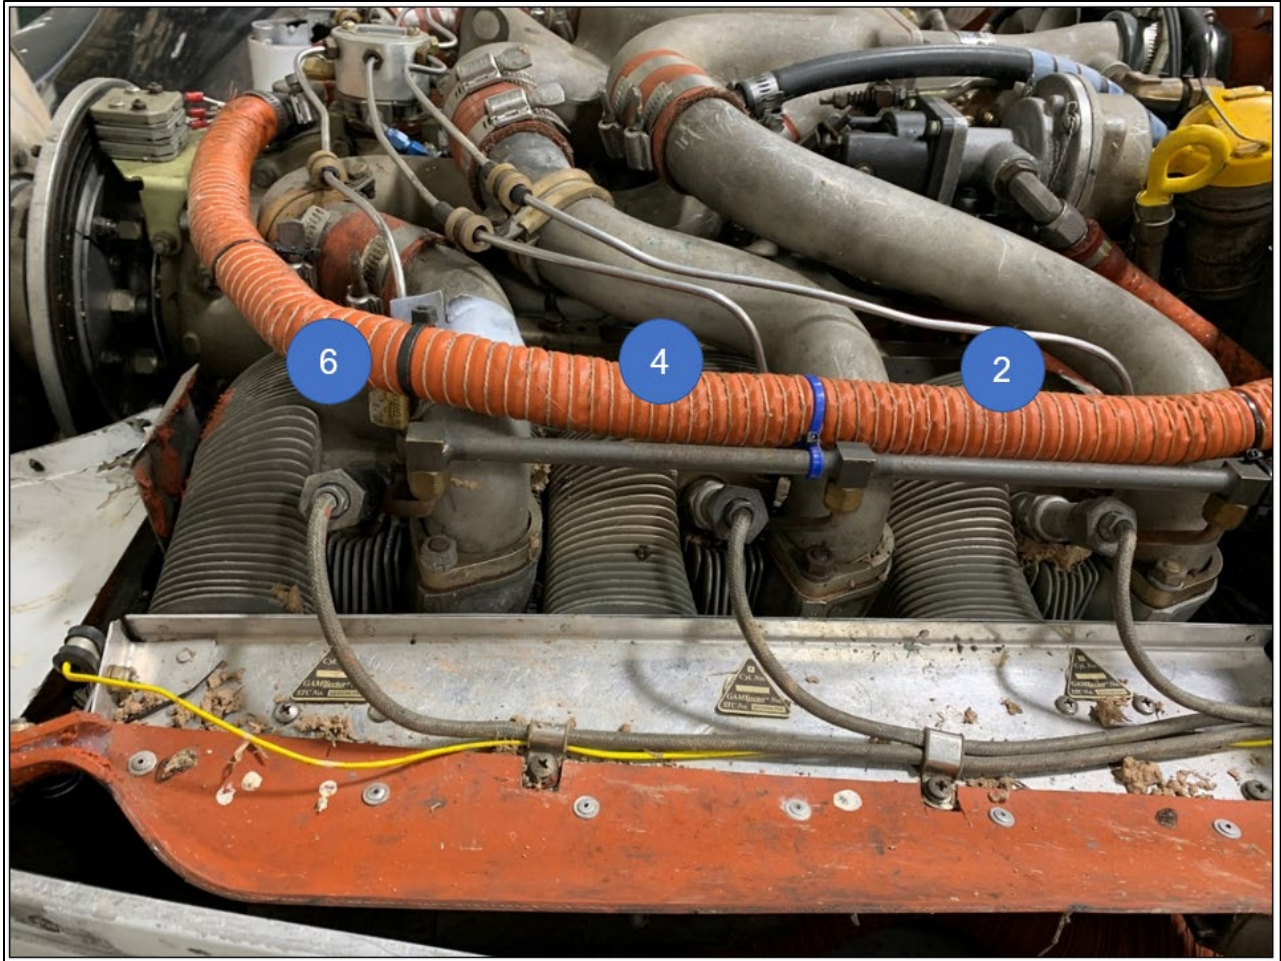
The Nos. 2, 4, 6 ignition harnesses were all found secured and tight to their spark plugs. The top and bottom spark plugs were removed. Each were tight within the cylinders. Each spark plug displayed normal combustion signatures.

**Figure 4: View of the Nos. 2, 4, and 6 cylinders and ignition harnesses. Each harness was found installed and tight.**

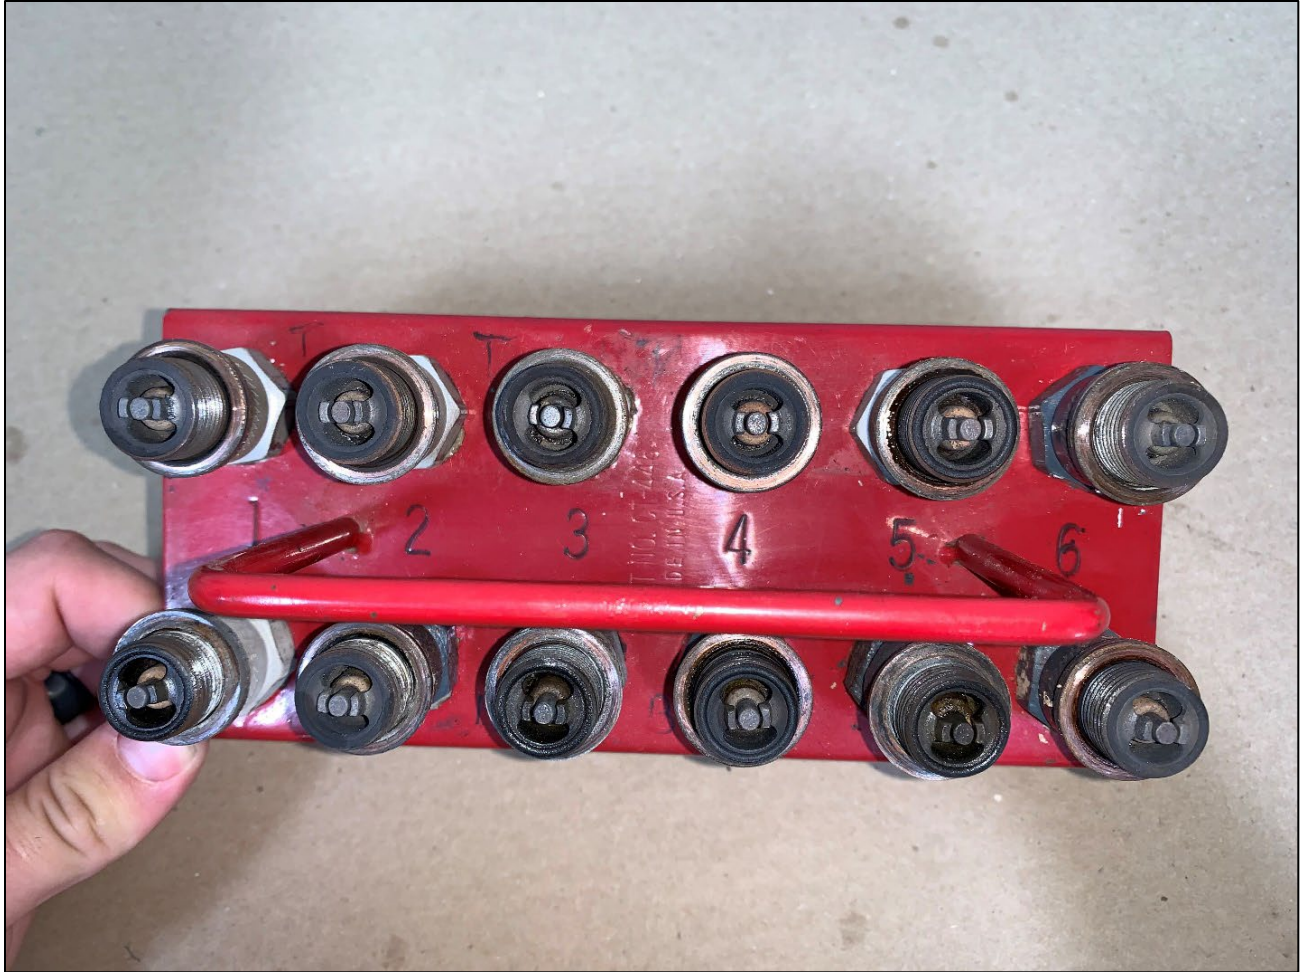
**Figure 5: View of the top and bottom spark plugs.**

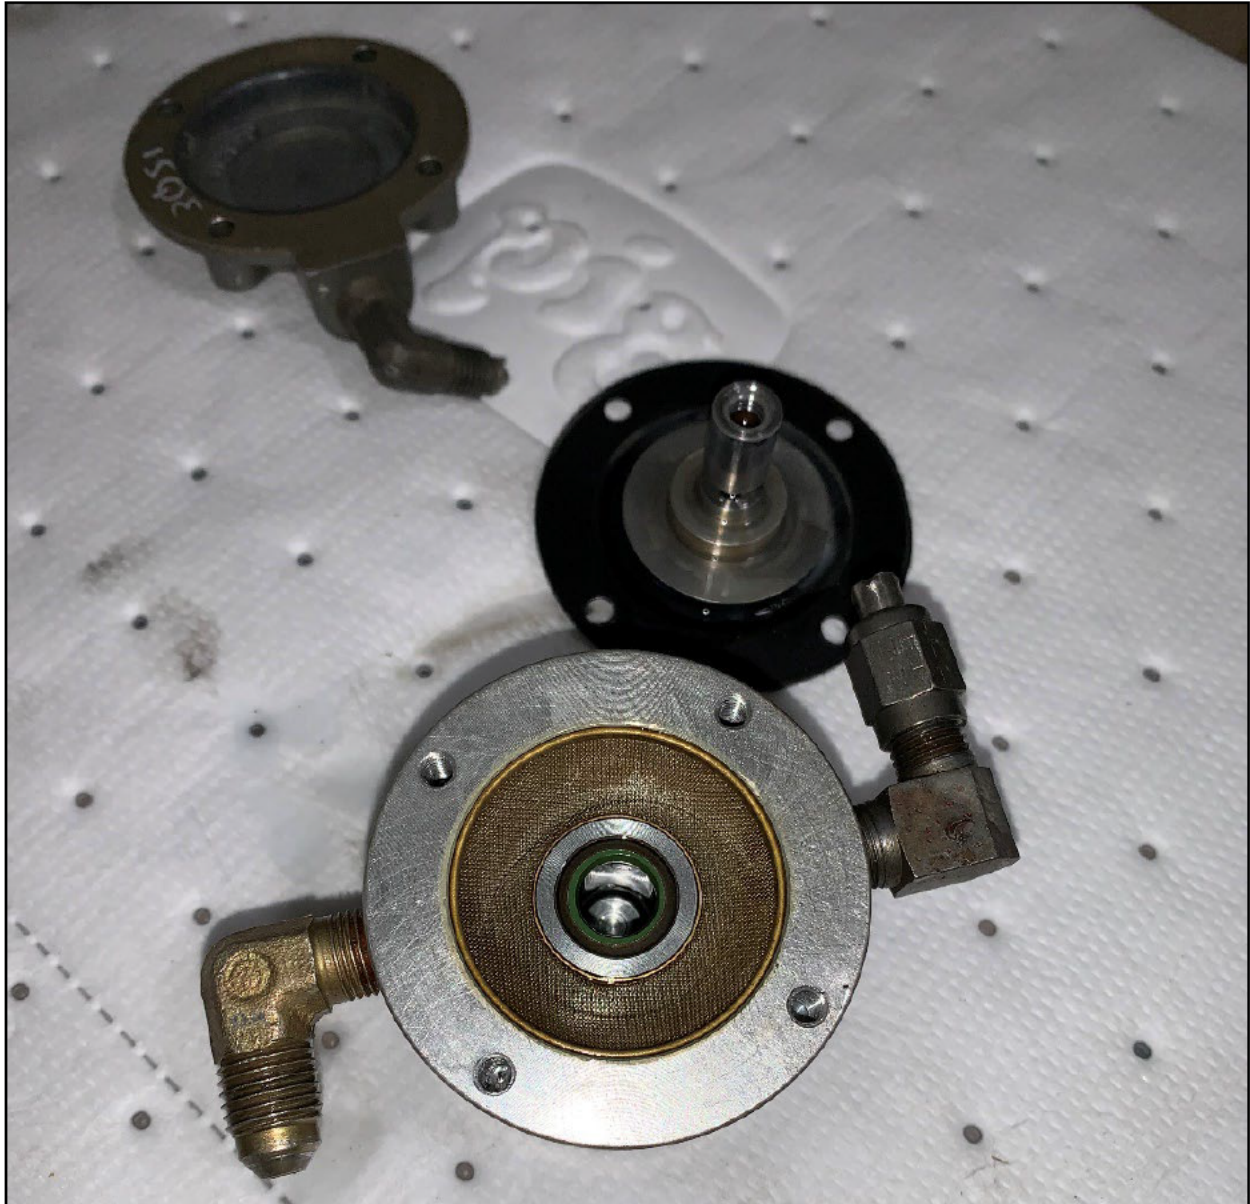
The fuel manifold was intact and installed to its installation area. It was removed and disassembled. The manifold contained fuel and the fuel filter screen was free of debris. The throttle, propeller, and mixture levers operated normally.

**Figure 6: View of the fuel manifold partially disassembled and without contamination.**

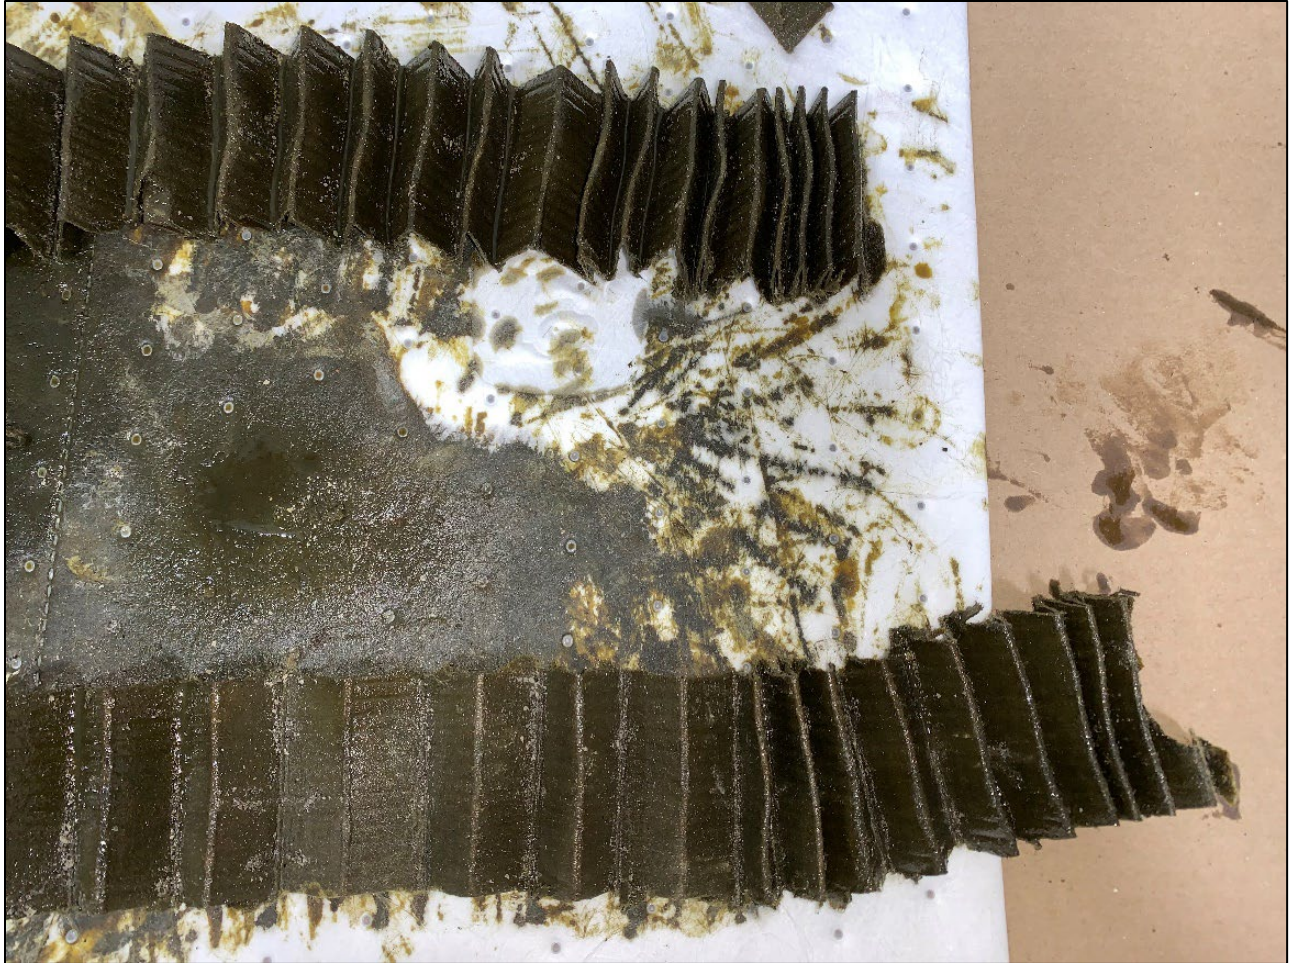
The oil filter was removed and disassembled. It displayed a grainy contaminant consistent with dirt or sand. A magnet was used on the contaminants, and the material did not stick to the magnet.

**Figure 7: View of the oil filter removed and disassembled.**

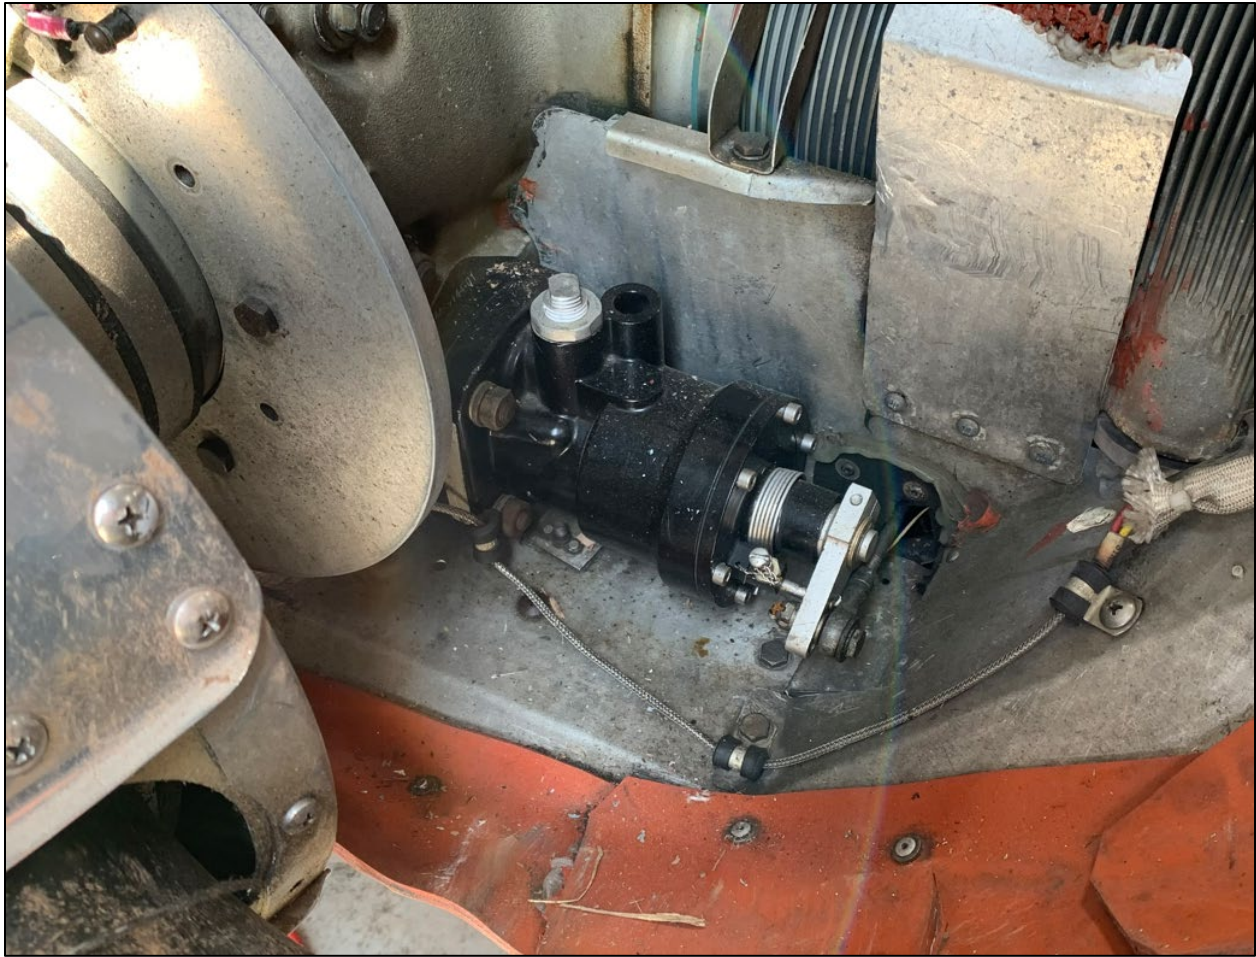
**Figure 8: View of the propeller governor.**
