## Memorandum For Record

**Date: 12/13/2023**  
**NTSB Accident Number: ERA23LA231**

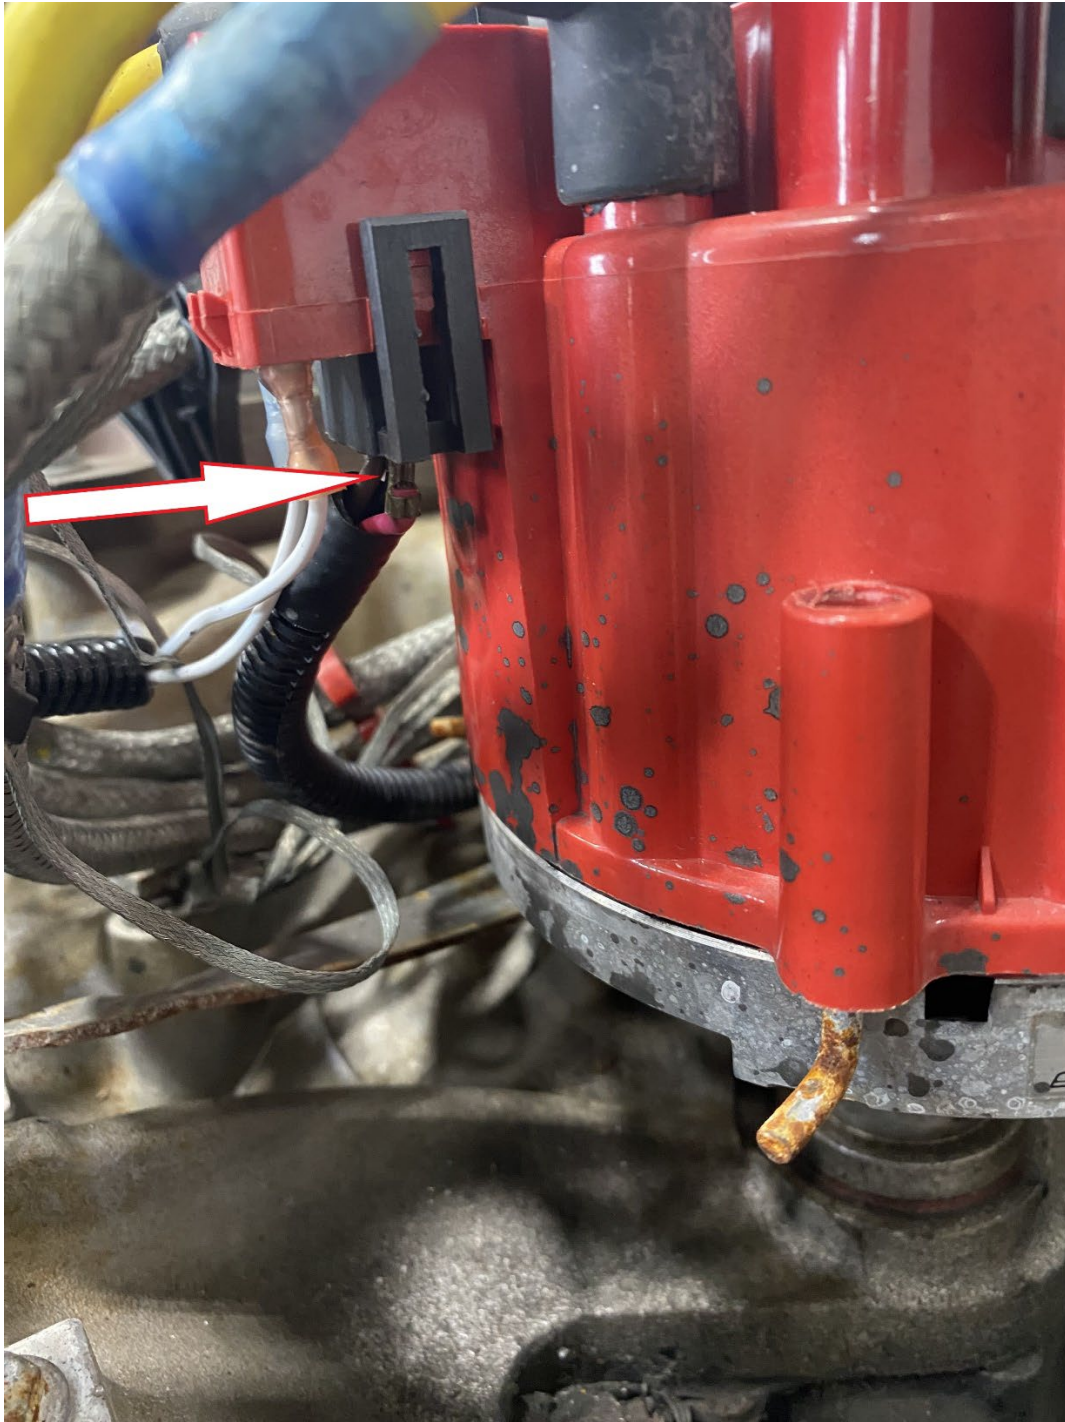
Inspection of the ignition system revealed all spark plugs had the same color with no lead noted. Testing of the spark plugs was not possible. The distributor cap was removed from the distributor and no carbon tracking was noted inside the cap. The rotor of the distributor was tightly secured. Battery power was turned on and electrical power to the distributor was confirmed but there was no electrical power to the ignition module. Inspection of the electrical connector at the distributor revealed the female spade electrical terminal connector of the red colored (power) electrical wire was separated from the plastic connector and also from its mating male connector at the distributor (Figure 1). The red colored electrical wire (power) goes from the distributor to the ignition module providing power to it. Closer inspection of the female spade electrical connector and plastic connector revealed there was no positive locking resistance of the female spade terminal electrical connector inside the plastic connector. The female spade electrical connector of the separated wire was placed on its mating male connector at the distributor and the connection was tight. Inspection of the length of wire from the ignition module revealed there was no clamp along its approximate 3-inch length.

Figure 1: Annotated AMF Aviation, LLC Digital Photograph. Arrow Points to Separated Red Colored Electrical Wire at Distributor. The Wire Provides Power to the Ignition Module.
