# National Transportation Safety Board

ERA23LA232

## **AIRFRAME AND ENGINE EXAMINATION**

N1347T, PA-28-180

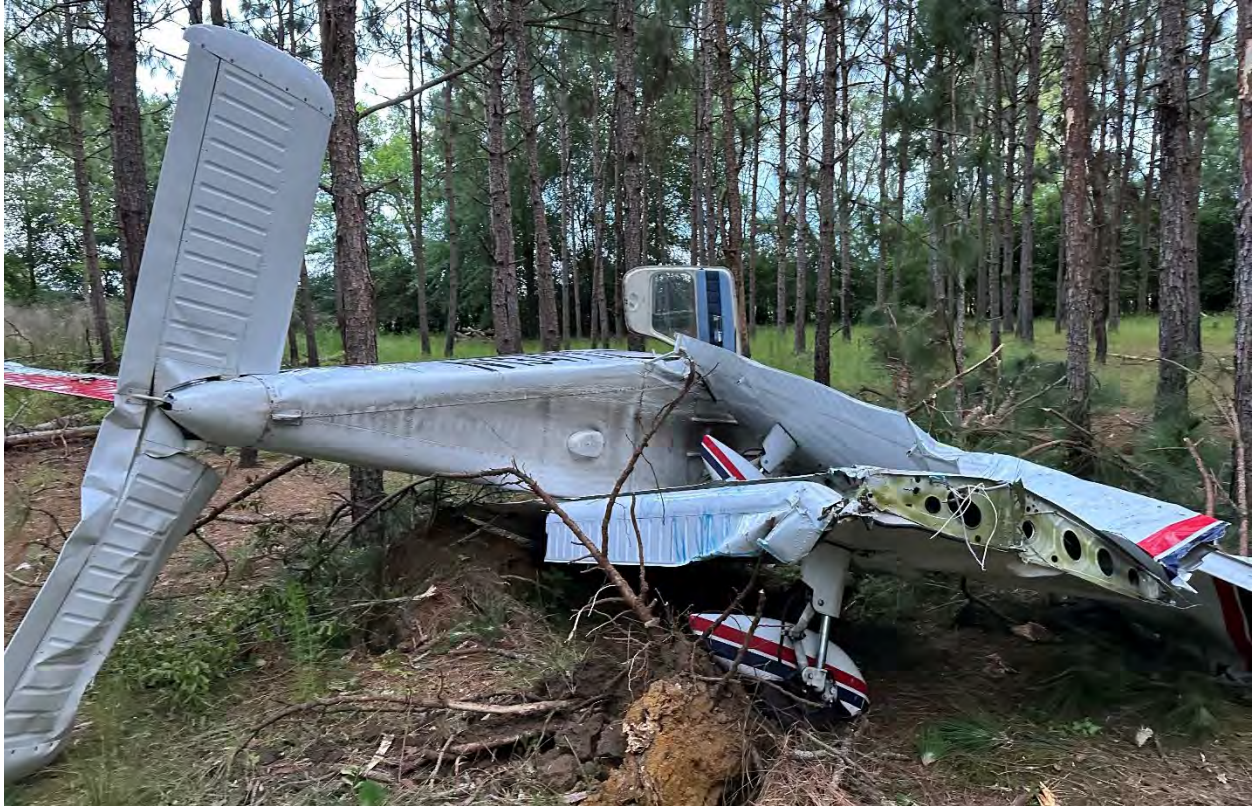
Examination of the airframe revealed that the left wing fuel sump drain was in the up and locked open position, which would have allowed fuel to drain during the flight. Photos of the airplane “minutes after” the accident were e-mailed on the day of the examination showing fuel staining on the left flap aft of the fuel drain, consistent with fuel leakage during the flight.

Photo 1 - Photo of airplane after impact with fuel stains on left flap. (Photo courtesy of owner)

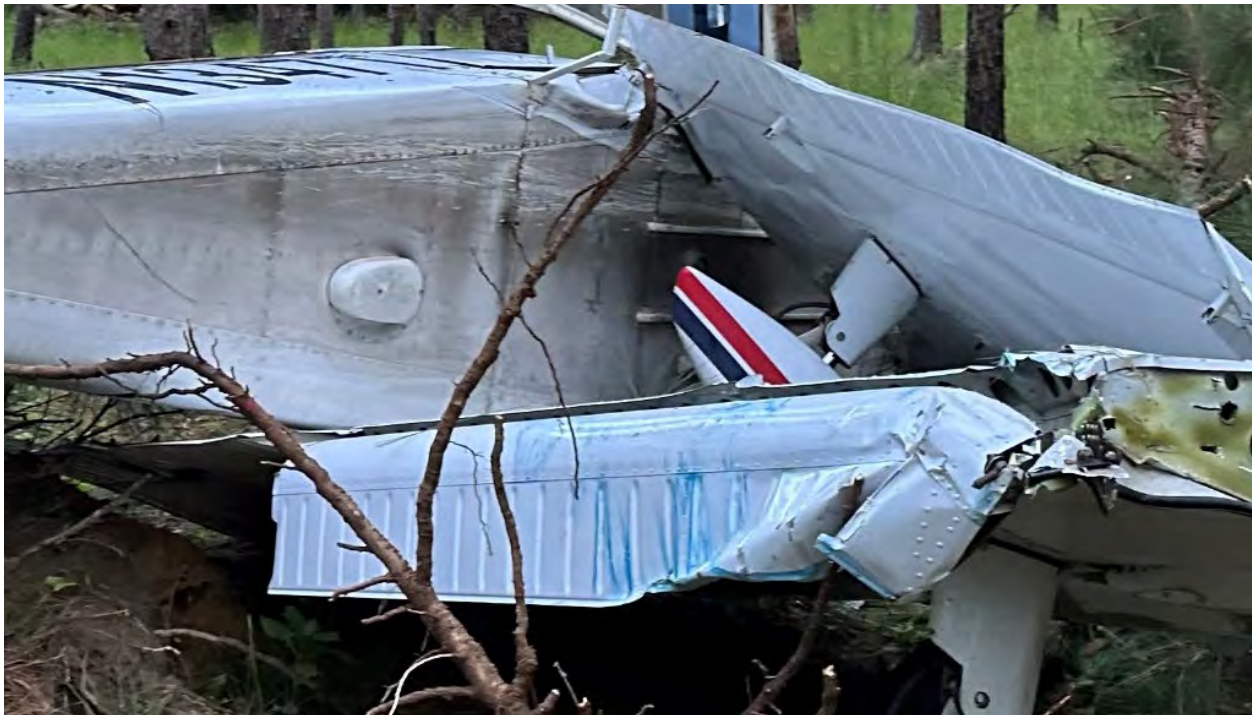
Photo 2 - Enlarged close-up view of fuel staining on left flap. (Photo courtesy of owner)

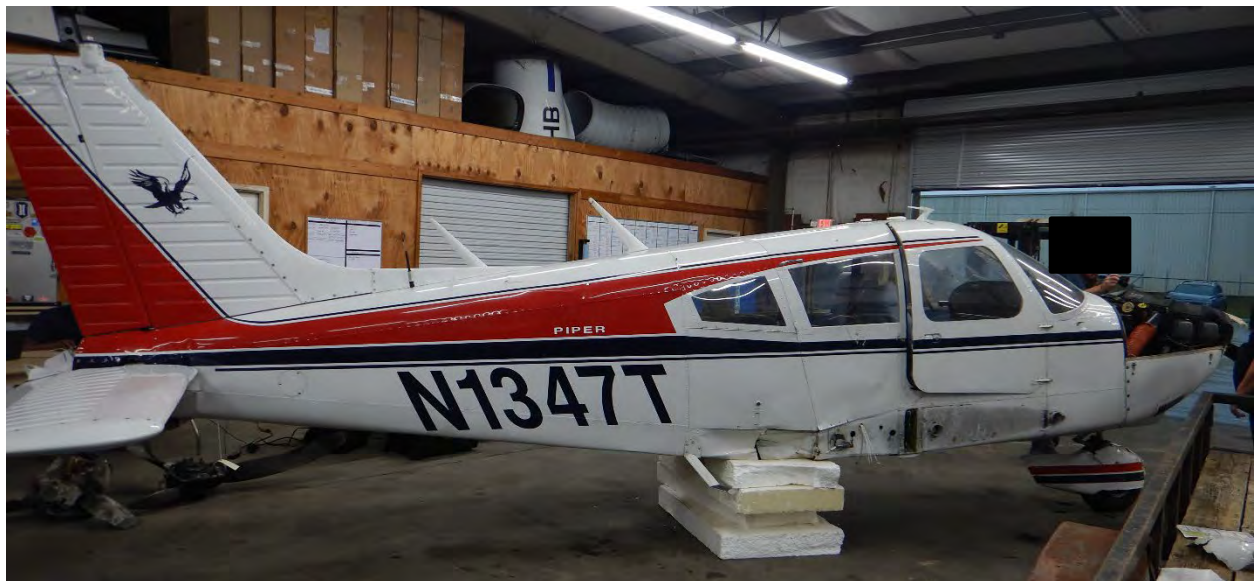
Photo 3 - View of airplane from right before examination.

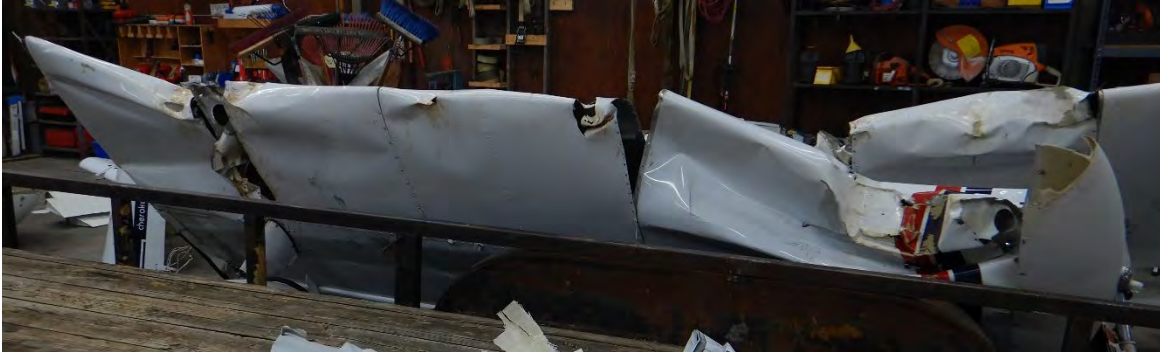
As first viewed, the fuselage and empennage remained intact, the engine remained attached at its mounts the fuselage, and the wings and left portion of the stabilator were detached. The airplane was still loaded on the trailer that had been used to transport it to the recovery facility. The airplane and wings were removed from the trailer. The fuselage was impact damaged above the cockpit and by both wing roots. The empennage was intact except for the left portion of the stabilator which had been cut. The rudder was attached to the vertical stabilizer and was deformed left about 5 inches from the top. The right stabilator with elevator attached was damaged at the leading edge. The removed left portion of the stabilator was substantially damaged on all surfaces and the elevator was partially detached. Both wings were impact separated at their roots and substantially damaged with impact signatures spanning the leading edges consistent with tree impact.

Photo 4 - View of underside of left wing showing leading edge impact damage before examination.

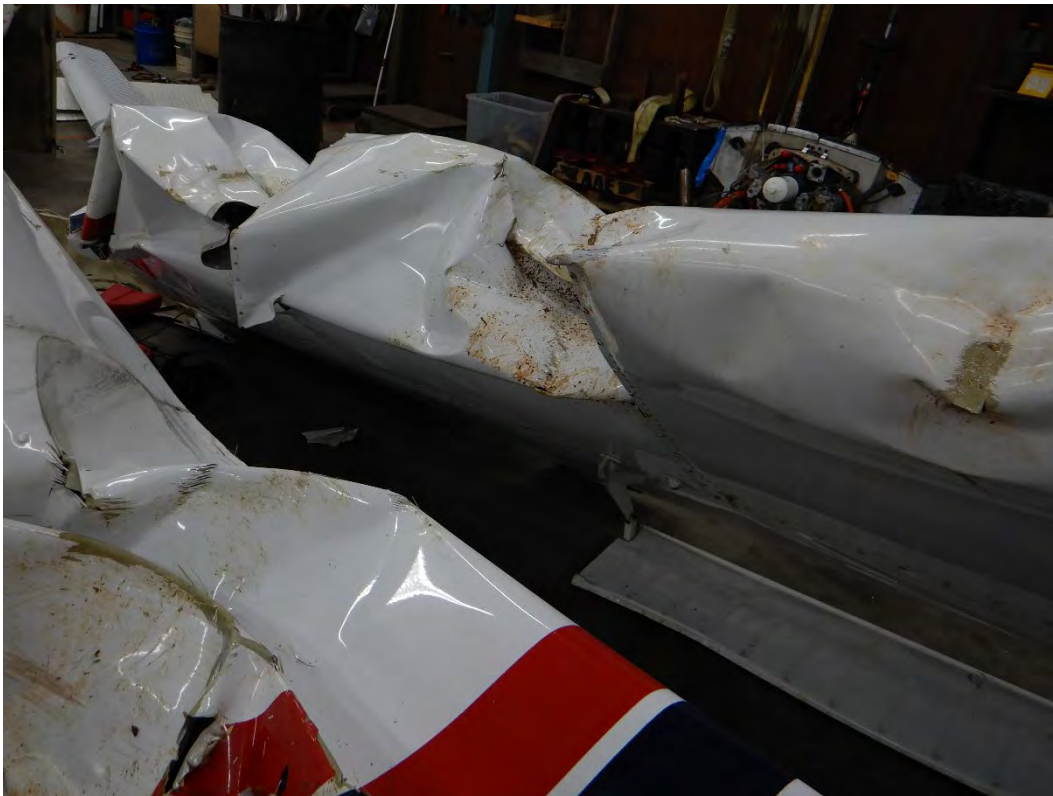
Photo 5 - View of right wing leading edge with impact damage prior to examination.

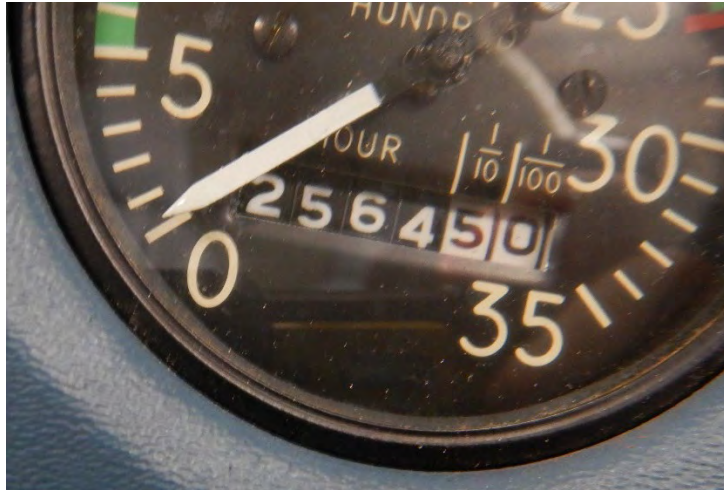
Photo 6 - View of tachometer showing 2,564.5 hrs

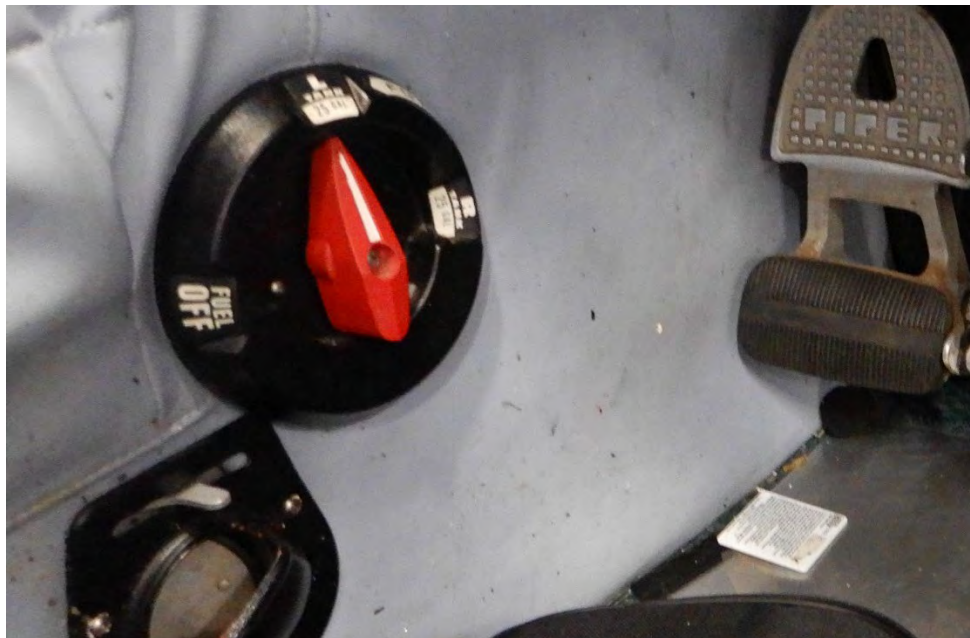
Photo 7 - View of fuel selector selected to left wing tank.

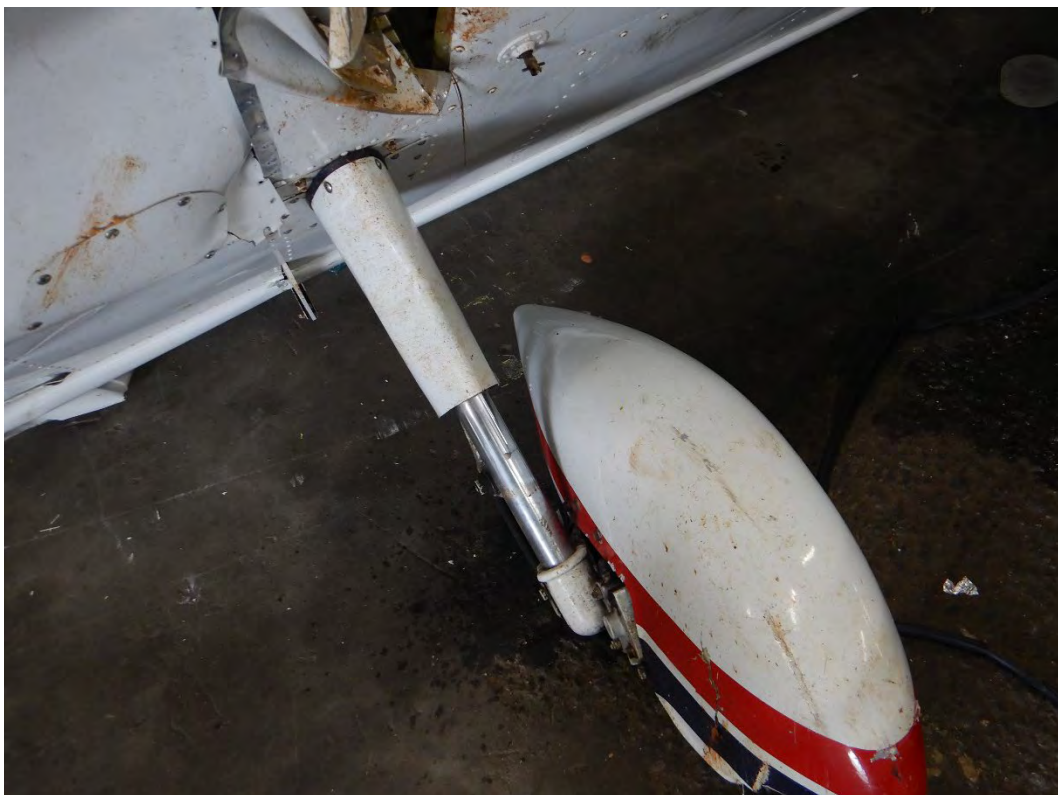
The left wing fuel tank was mostly intact and contained a small amount of fluid. The wing's fuel sump drain was found in the open and locked position, and fluid drained from the sump as soon as the wing was up righted. The fluid was tested with water-finding paste and tested positive for water. No fluid consistent with fuel was evident in this sample. The sump drain was closed, the wing was again up righted, and about a cup of fluid was drained from the tank. It tested positive for water when tested with water-finding paste. No bluish fluid consistent with fuel was observed. The right wing fuel tank was breached and devoid of fuel. The right wing's fuel sump drain was in the closed position. Both fuel caps remained seated in place.

Photo 8 - View of fuel drain sump in open and locked position on left wing.

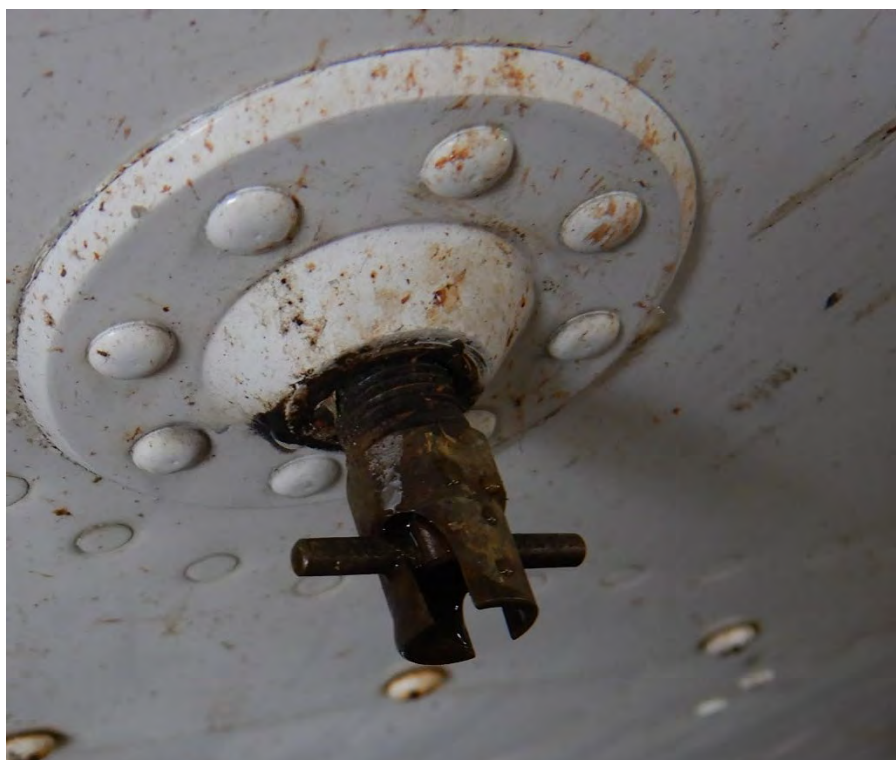
Photo 9 - Close-up view of left wing fuel sump in open and locked position.

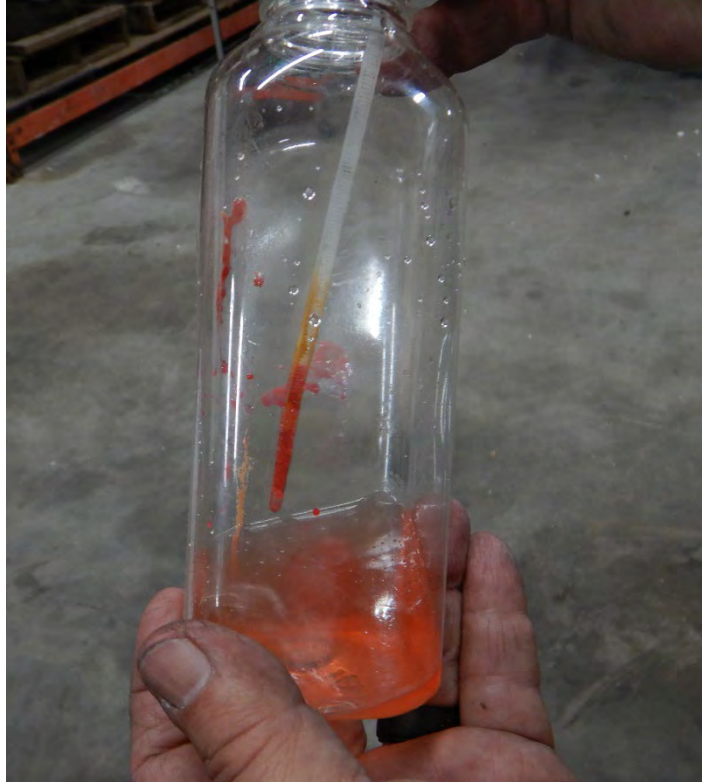
Photo 10 - Liquid drained from left wing fuel sump testing positive for water.

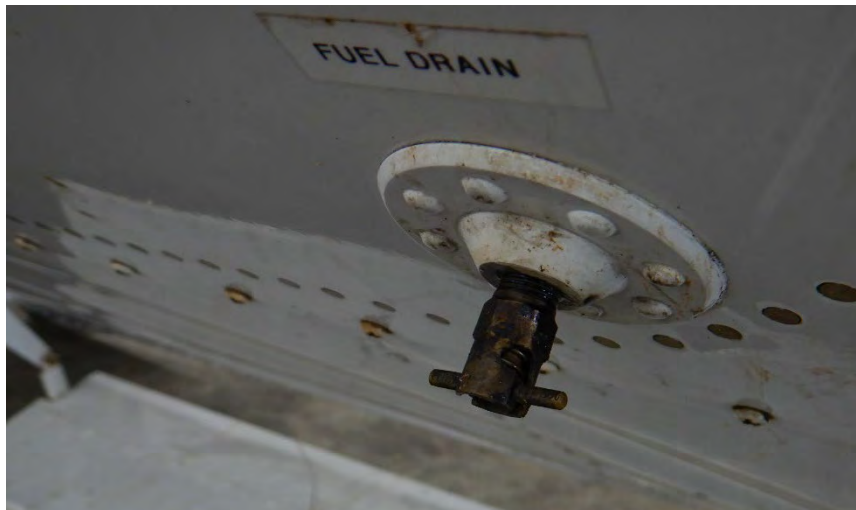
Photo 11 - Close-up view of right wing fuel sump in closed position.

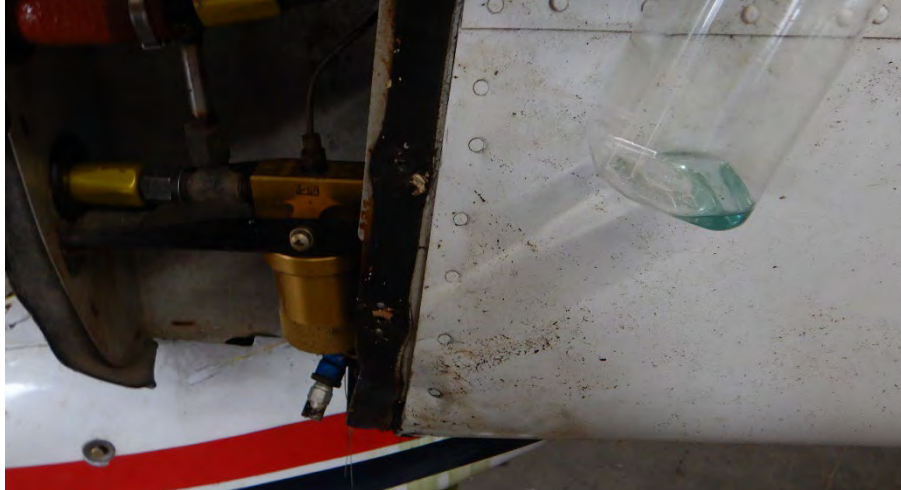
A small amount of liquid was drained from the fuel strainer sump drain. The liquid was blue in color and had an odor consistent with 100LL avgas. The liquid was tested with water finding paste and tested negative. The fuel strainer bowl was intact and secured

Photo 12 - View of fuel strainer bowl and sump drain with drained fluid.

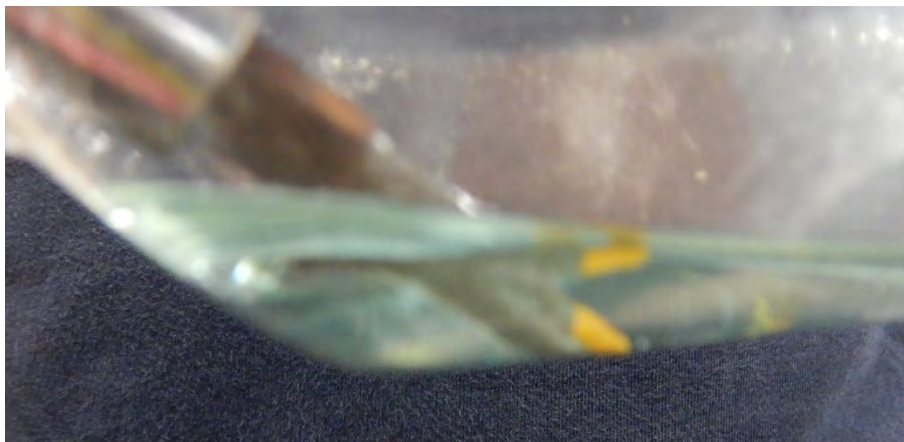
Photo 13 - Test of fluid from fuel strainer sump showing no water contamination.

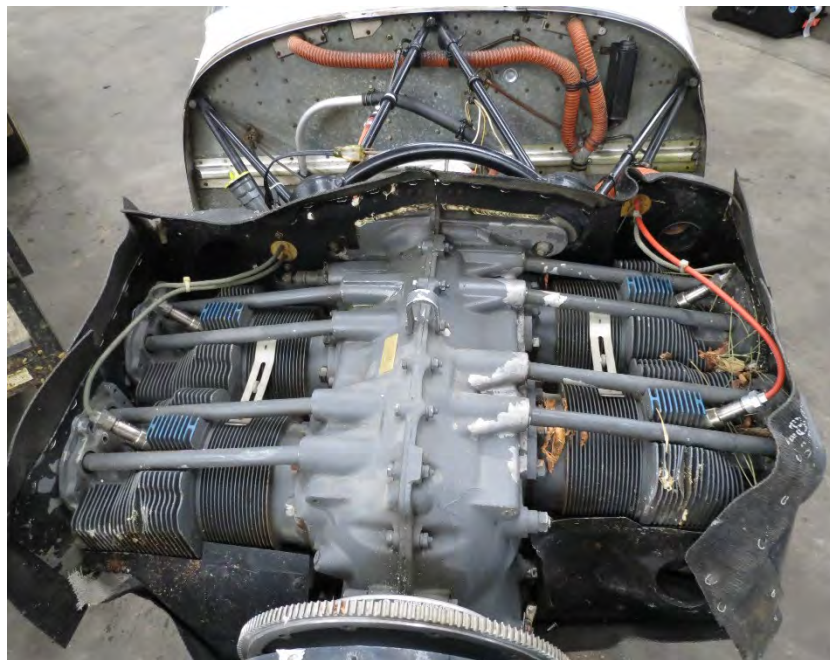
Photo 14 - Engine before examination.

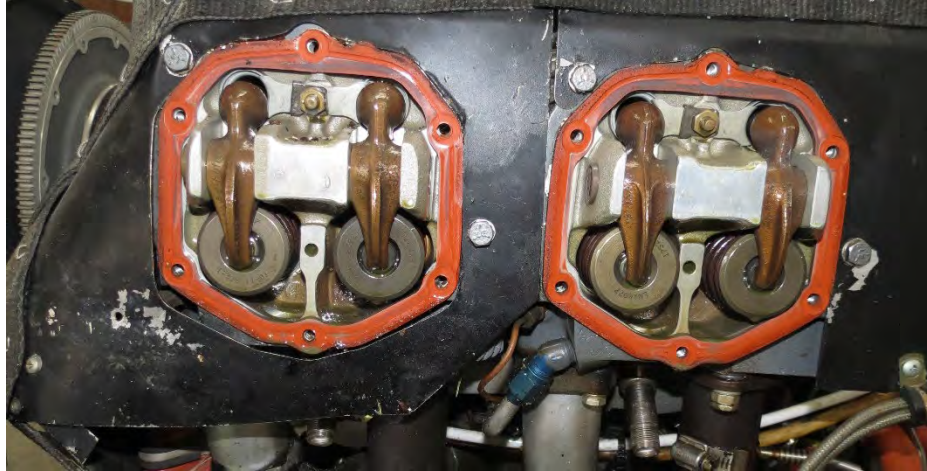
The engine remained attached to the engine mount and the engine mount remained attached to the fuselage. The upper cowling had been removed and the lower cowling remained installed. The lower cowling was removed to facilitate examination of the engine. The magnetos appeared intact and secure to their mounts. The magneto timing was found to be 25° BTC (left) and 23° BTC (right). The top spark plugs and rocker covers were removed and the crankshaft was rotated manually. The engine was rotated by turning the propeller and continuity of the crankshaft to the rear gears and to the valvetrain confirmed. Compression and suction were observed from all four cylinders. The interiors of the cylinders were viewed using a lighted borescope and no anomalies noted other than oil in the Nos. 2 and 4 cylinders.

Photo 15 - Cylinder Nos. 2 and 4 after rocker cover removal.

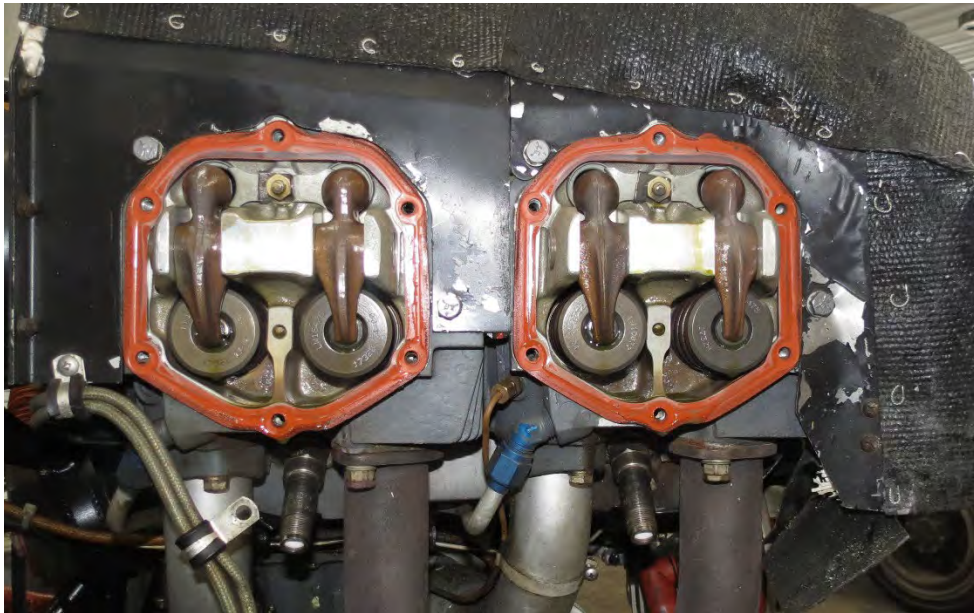
Photo 16 - Cylinder Nos. 1 and 3 after rocker cover removal.

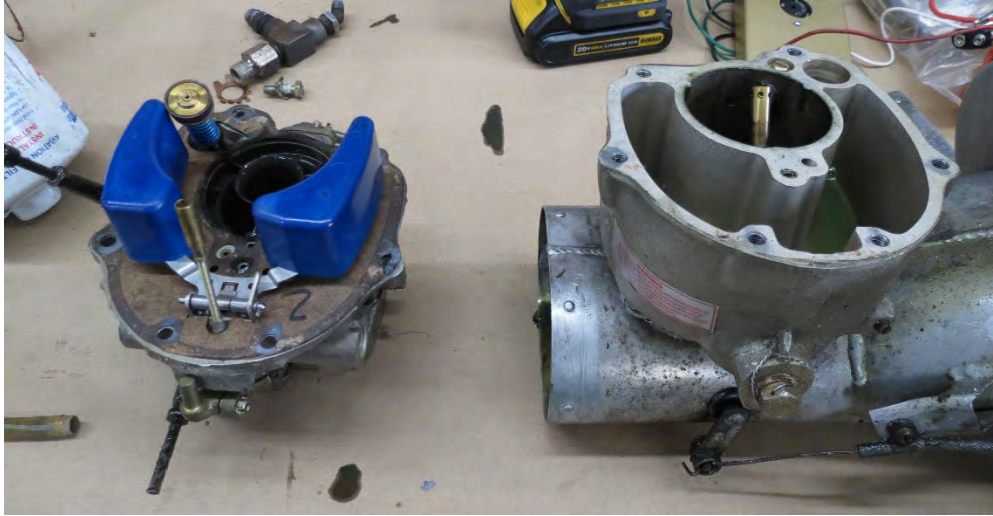
Photo 17 - Disassembled carburetor and floats (note no hydraulic deformation).

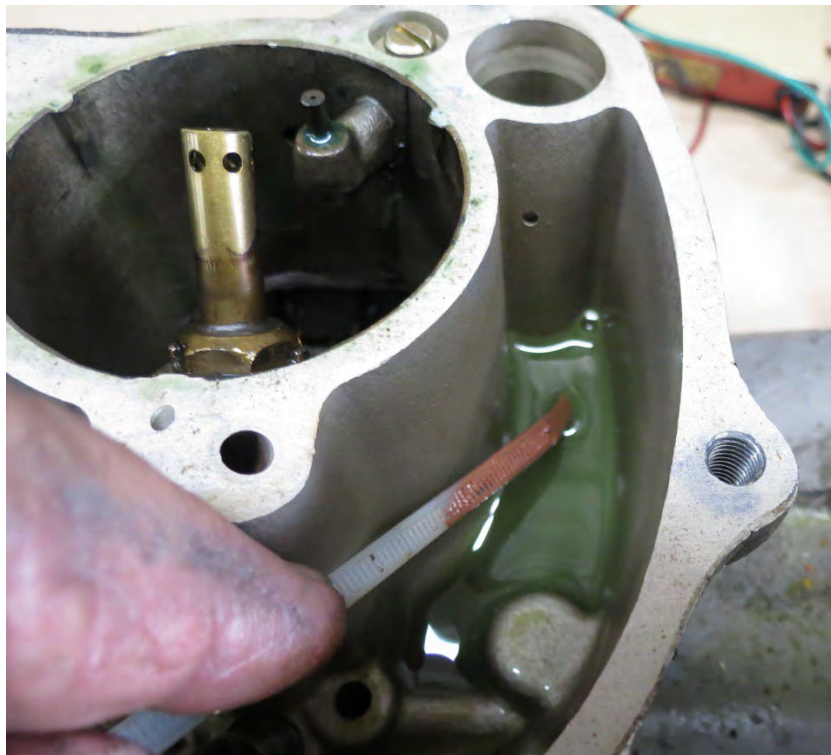
Photo 18 - Fuel in the carburetor bowl tested negative for water.

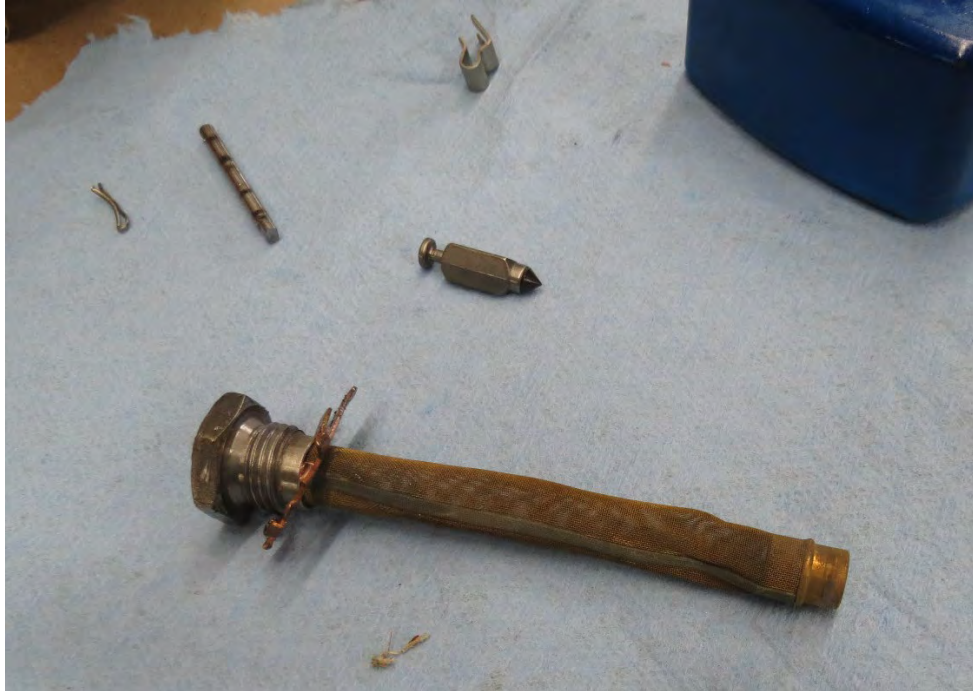
Photo 19 - Disassembled carburetor parts including fuel inlet screen (free from debris).

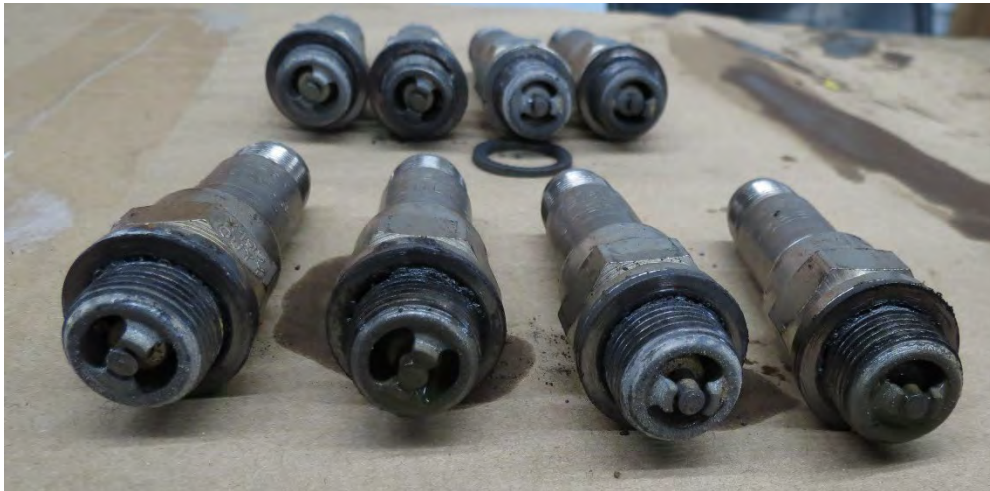
Photo 20 - Spark plugs after removal.

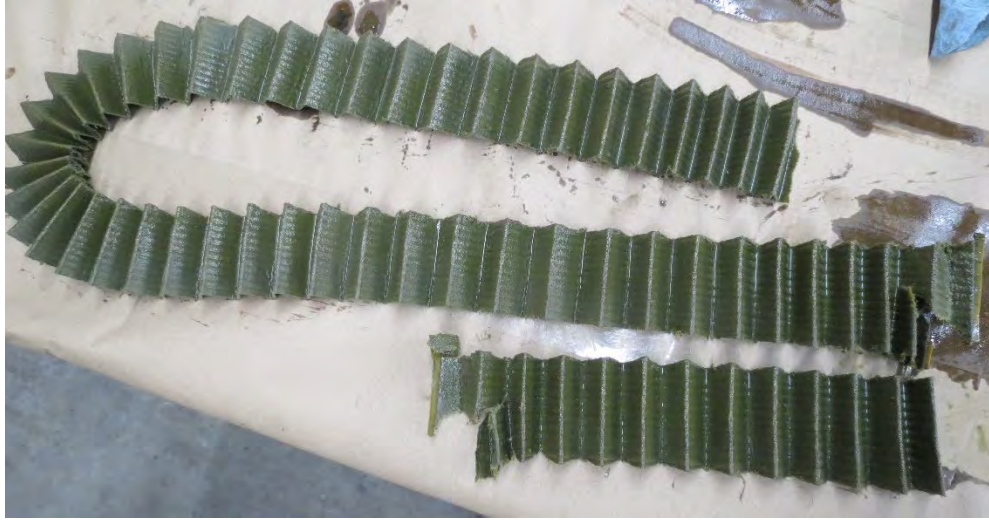
Photo 21 - Oil filter element after removal with no metallic debris.

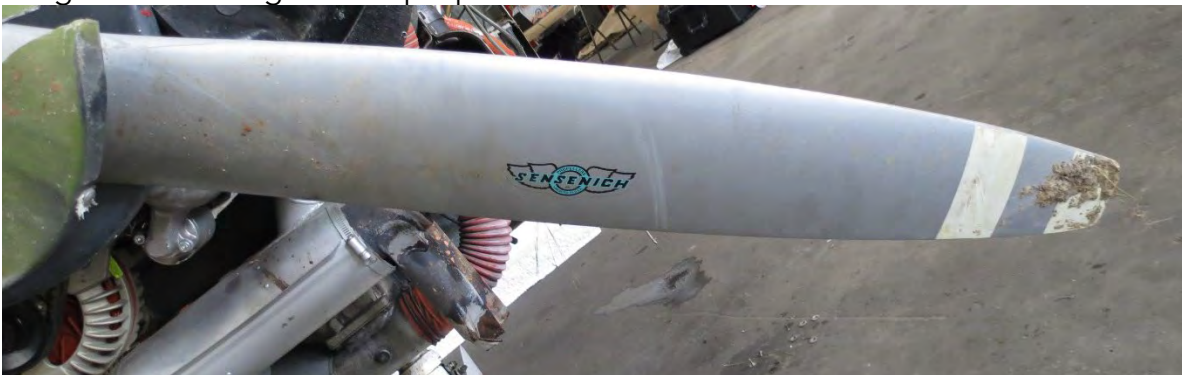
The fixed pitch propeller remained attached to the crankshaft propeller flange and the two blades remained attached to the hub. The propeller spinner was impact damaged. No damage to the propeller blades was noted.

Photo 22 - View on propeller blade.

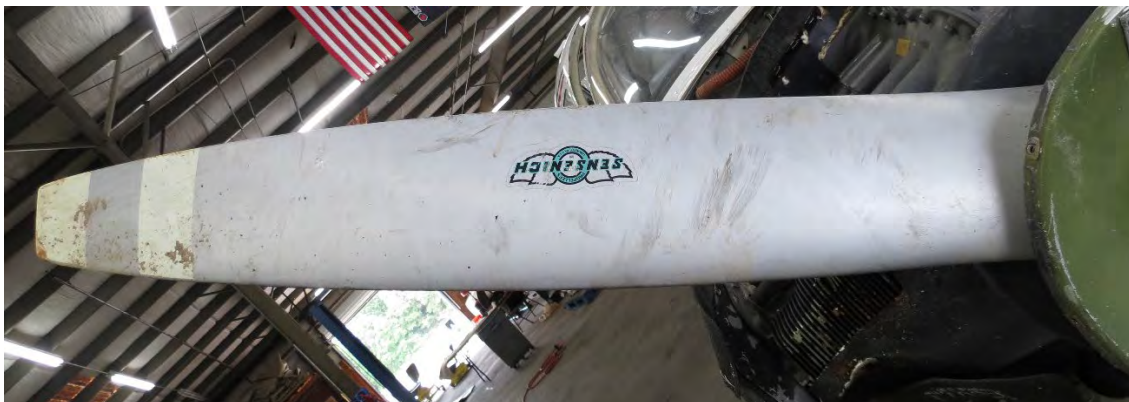
Photo 23 - View of propeller blade.
