**ERA23LA240**  
**Macon, NC**  
**May 21, 2023**  
**Cessna R182**  
**N182LG**

**Wreckage Examination**  
**Anglin Aircraft Recovery**  
**Clayton, DE**  
**June 1, 2023**

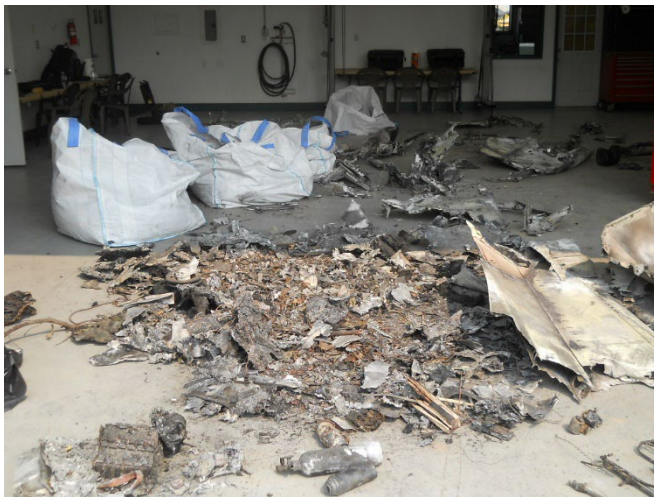
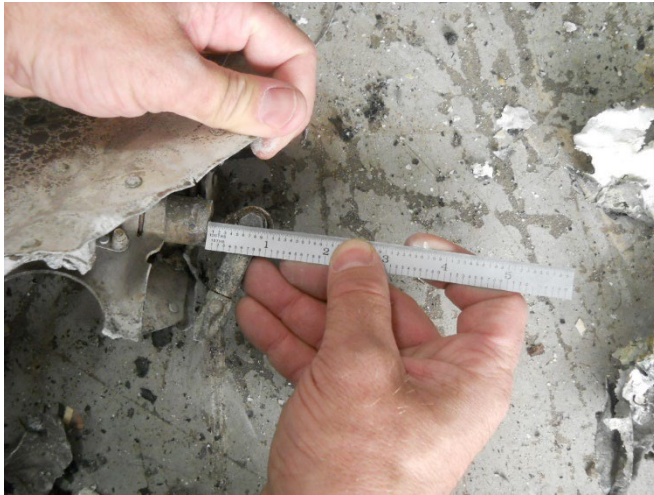
The wreckage was subsequently examined at a recovery facility. Elevator control cable continuity was confirmed from the cockpit, through recovery cuts, to the elevator bell cranks. Rudder cable continuity was confirmed from the cockpit pedals to recovery cuts at the rear empennage. Aileron cable remained attached to the left and right aileron bellcranks and in the cockpit; however, aileron cable from the cockpit to the wing was not identified. Measurement of the flap jackscrew corresponded to a flaps near retracted position (between 0° and 2° extension). Measurement of the elevator trim actuator corresponded to a full tab down (nose-up) elevator trim position. The pilot's seat tracks were not identified.

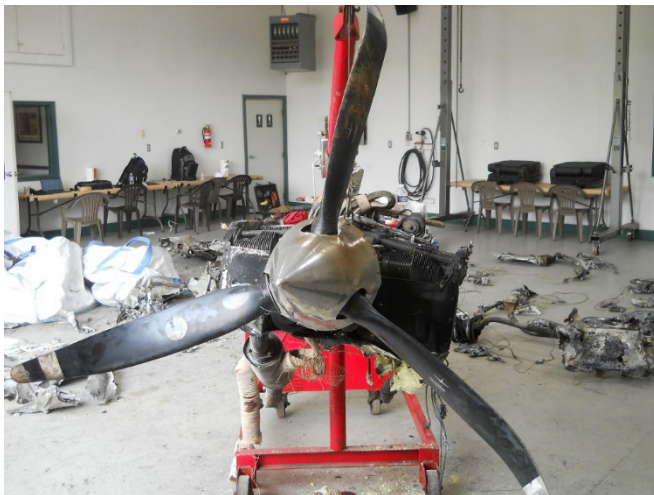
The engine remained attached to the airframe and was separated and lifted with a hoist for examination. The three-bladed propeller remained attached to the crankshaft flange. One blade exhibited s-bending, one blade was bent forward, and the third blade was bent aft. All three blades exhibited chordwise scrapes. Borescope examination of the cylinders did not reveal any anomalies. The top spark plugs were removed, and their electrodes were intact and sooty. When the propeller was rotated by hand, crankshaft, camshaft, and valve train continuity was confirmed to the rear accessory section of the engine. Thumb compression was attained on all cylinders. Due to fire damage, the ignition system and fuel system could not be tested.
