Timothy W. Monville  
Sr. Air Safety Investigator  
OAS-Eastern Region Aviation

**Date:** May 21, 2023

**Subject:** ERA23LA240, Record of Conversation/Interview

**Contact:** Nicholas Thornsburg

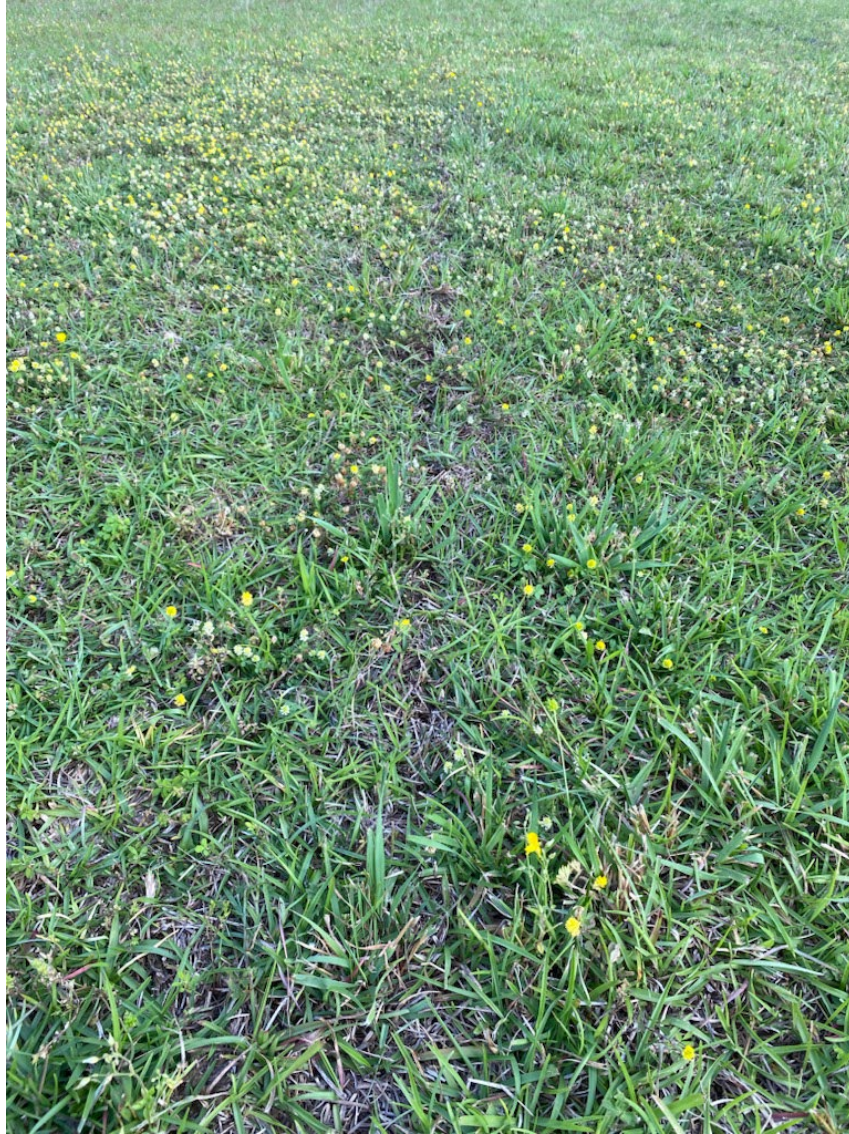
He can get measurements and will provide to me. By text messages the same day at 1916 EDT, 1918 EDT, and 1920 EDT he provided 3 pictures and the following details. The 1<sup>st</sup> identified tail strike gouge was located about 50 ft south of Wellington and the gouge was 10 ft in length (figure 1). He indicated that 50 ft from the starting point of the 1<sup>st</sup> strike, or 40 ft from the ending point of the 1<sup>st</sup> strike, another tail strike 12 ft in length was noted (Figure 2). Moving south 50 ft from the starting point of the 2<sup>nd</sup> strike, or 38 ft from the end of the 2<sup>nd</sup> strike, the third tail strike 16 ft in length was noted (Figure 3).

Figure 1: Digital Photograph From Witness Thornsbury. View Of the 1<sup>st</sup> skid mark on the Runway from the Tail of N182LG.

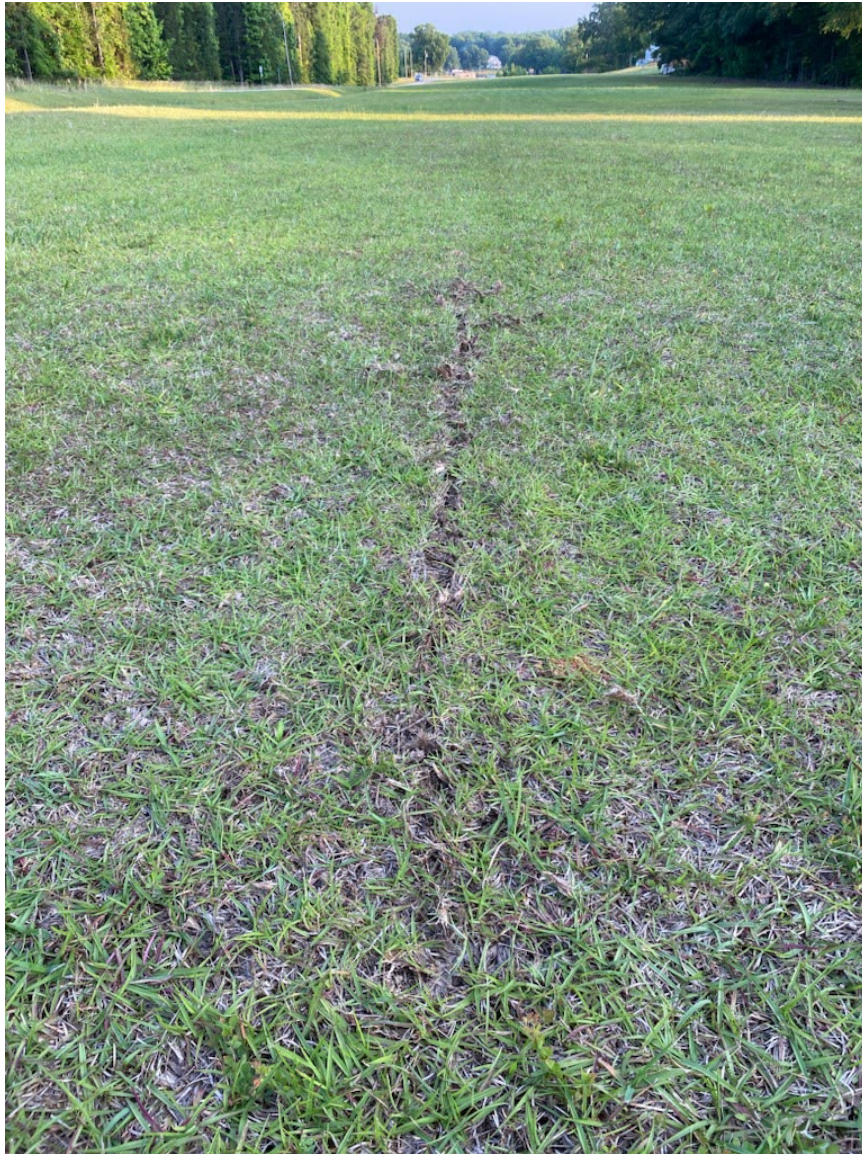
Figure 2: Digital Photograph From Witness Thornsberry. View Of the 2nd skid mark on the Runway from the Tail of N182LG.

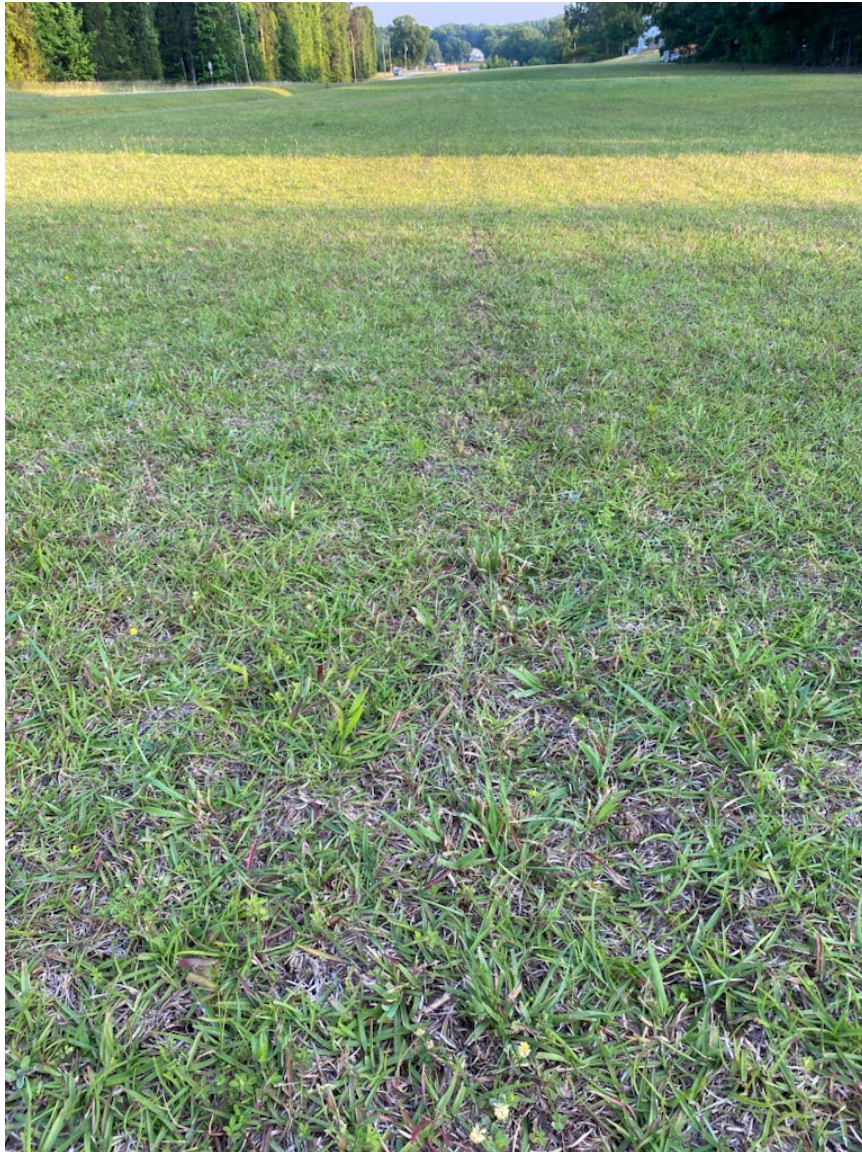
Figure 3: Digital Photograph From Witness Thornsbury. View Of the 3rd skid mark on the Runway from the Tail of N182LG.
