ERA23LA245

## INVESTIGATION PHOTOGRAPHS

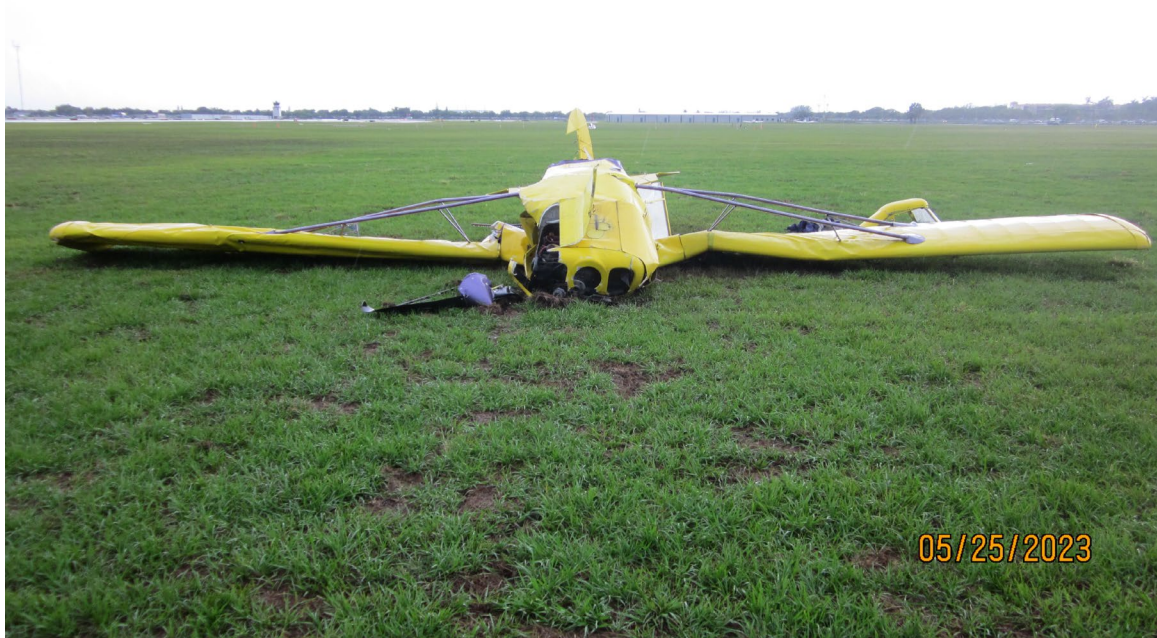
**Photograph 1 - Main Wreckage (Courtesy of FAA)**

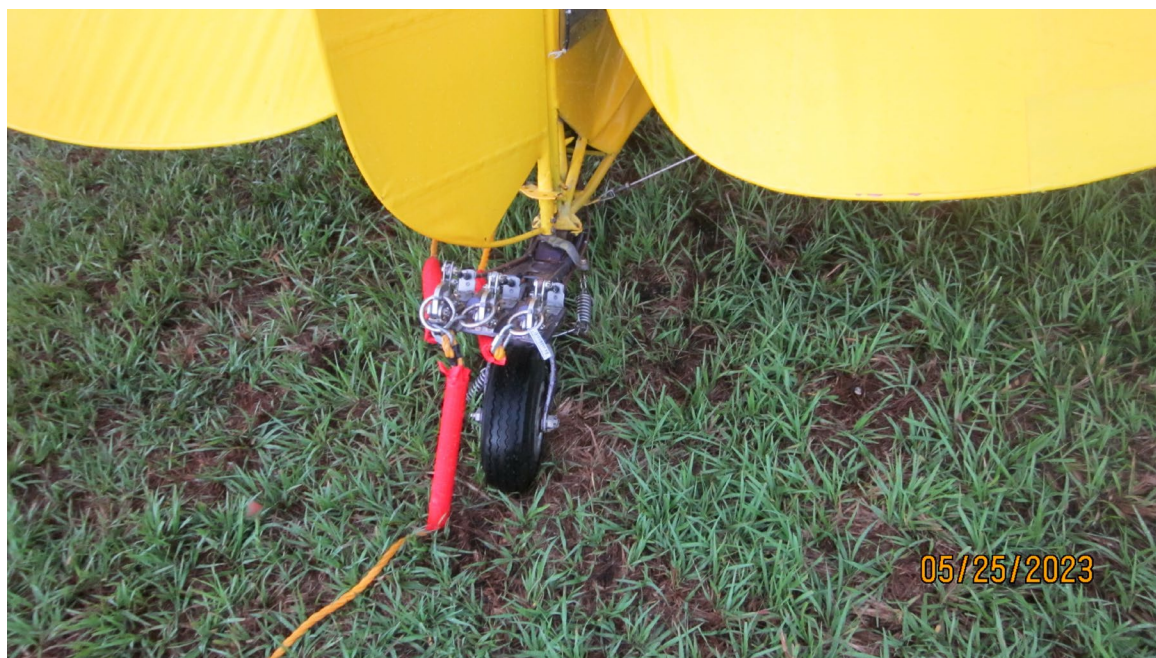
**Photograph 2 - Tailwheel and Lower Rudder (Courtesy of FAA)**

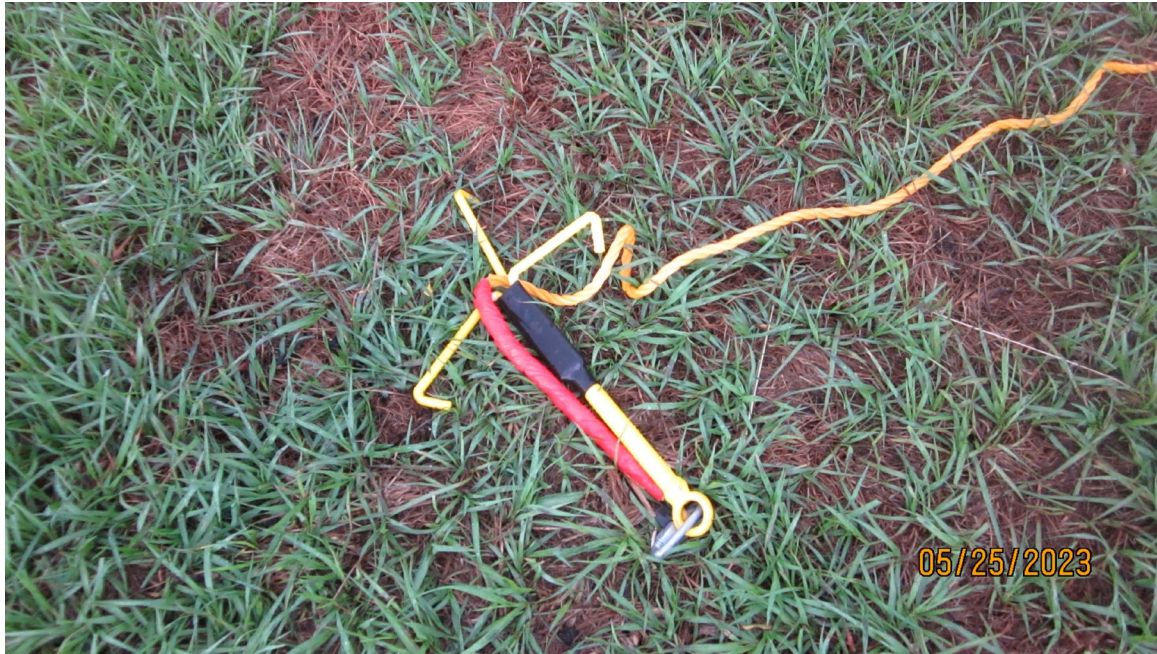
**Photograph 3 - Tow Hook (Courtesy of FAA)**

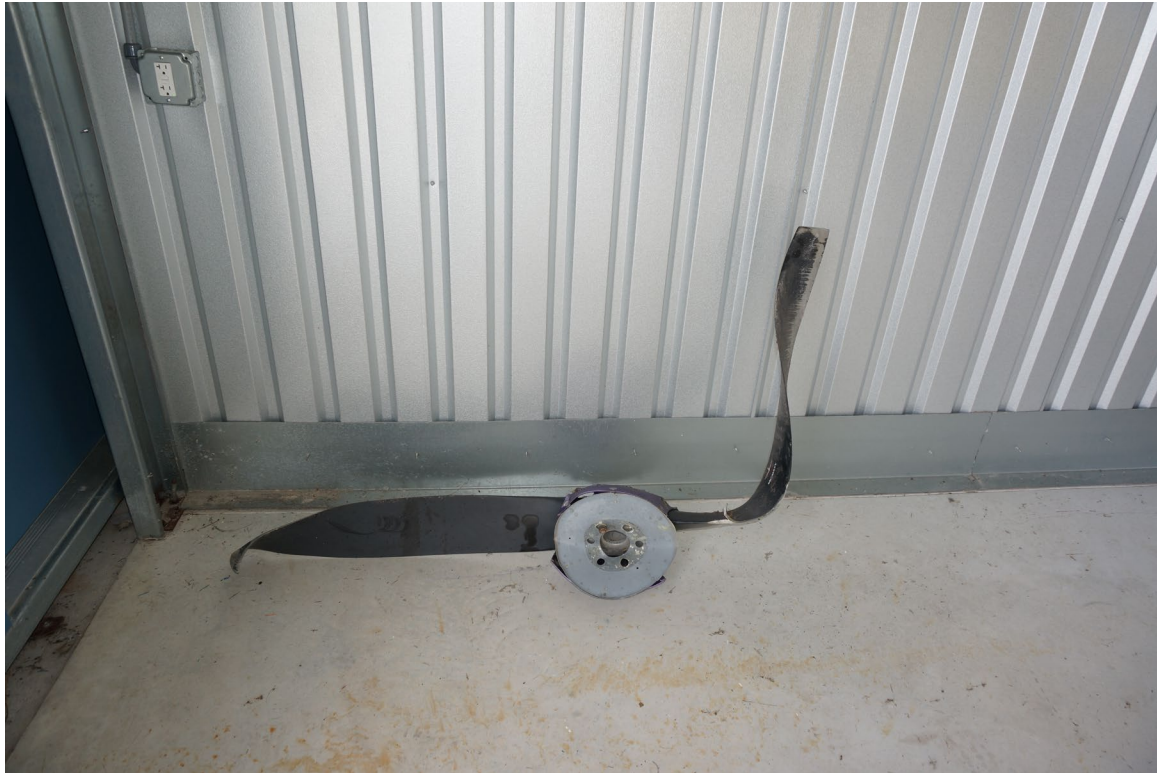
**Photograph 4 - Propeller**

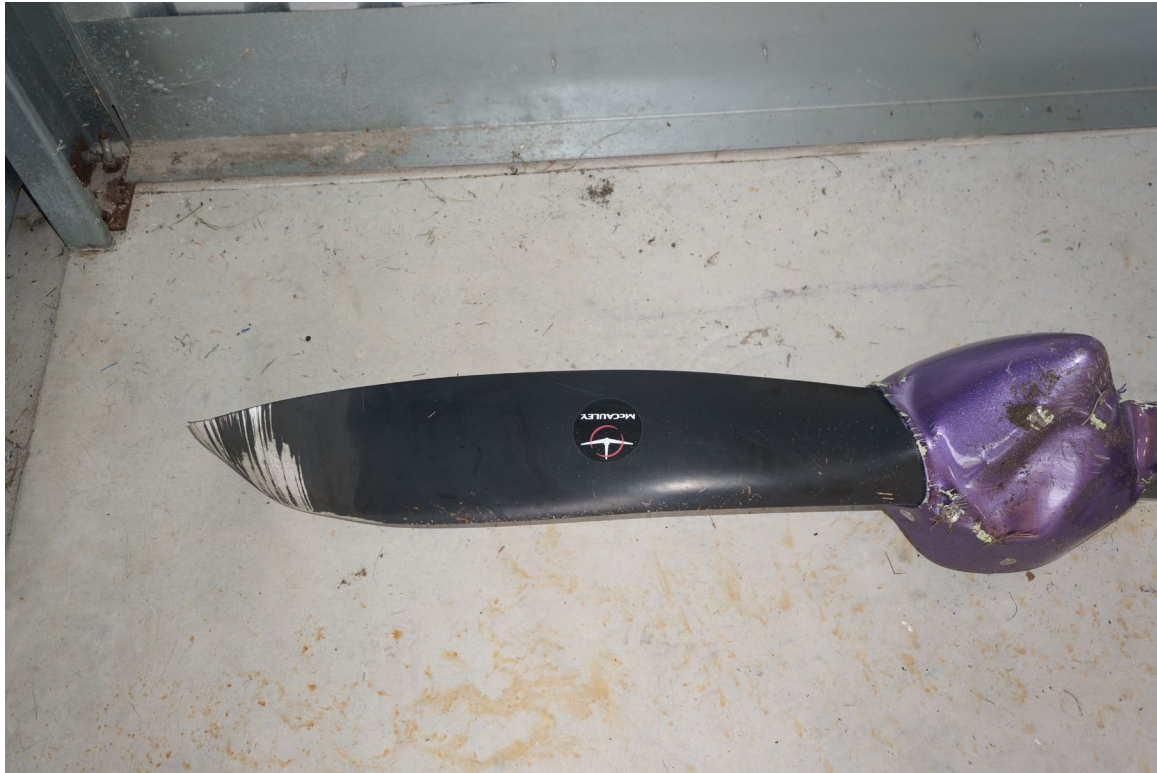
**Photograph 5 - Propeller Blade**

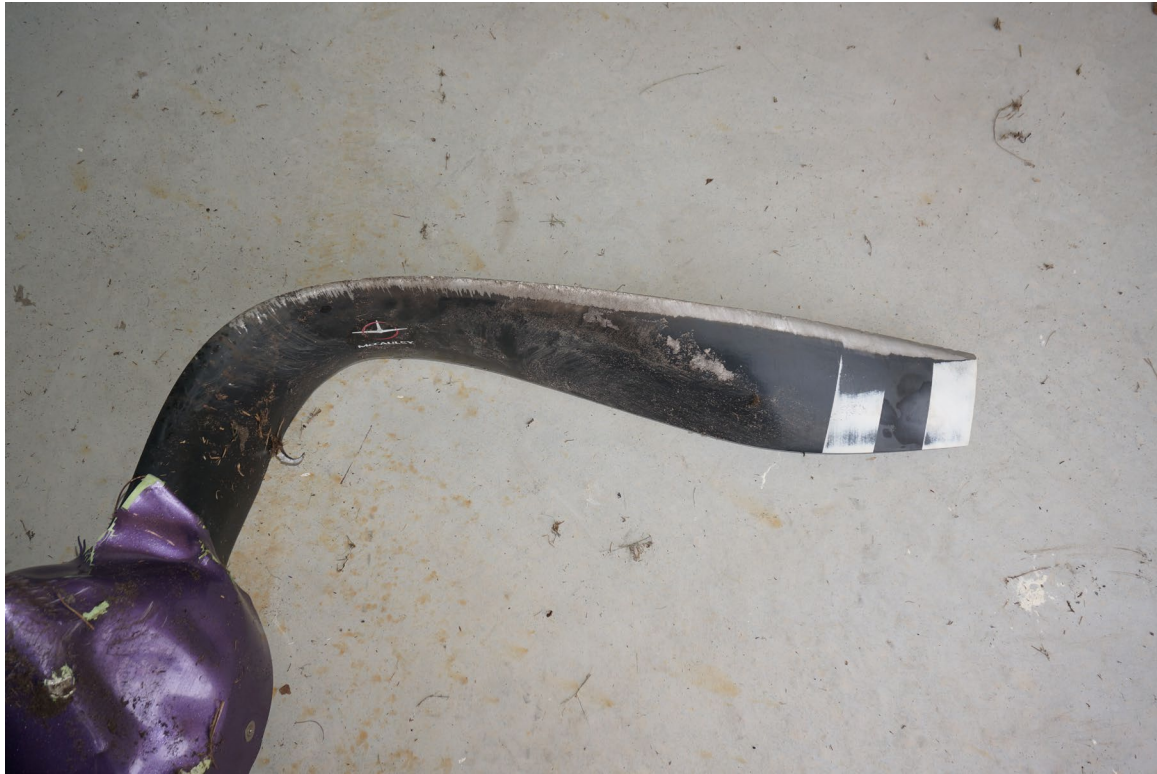
**Photograph 6 - Other Propeller Blade**

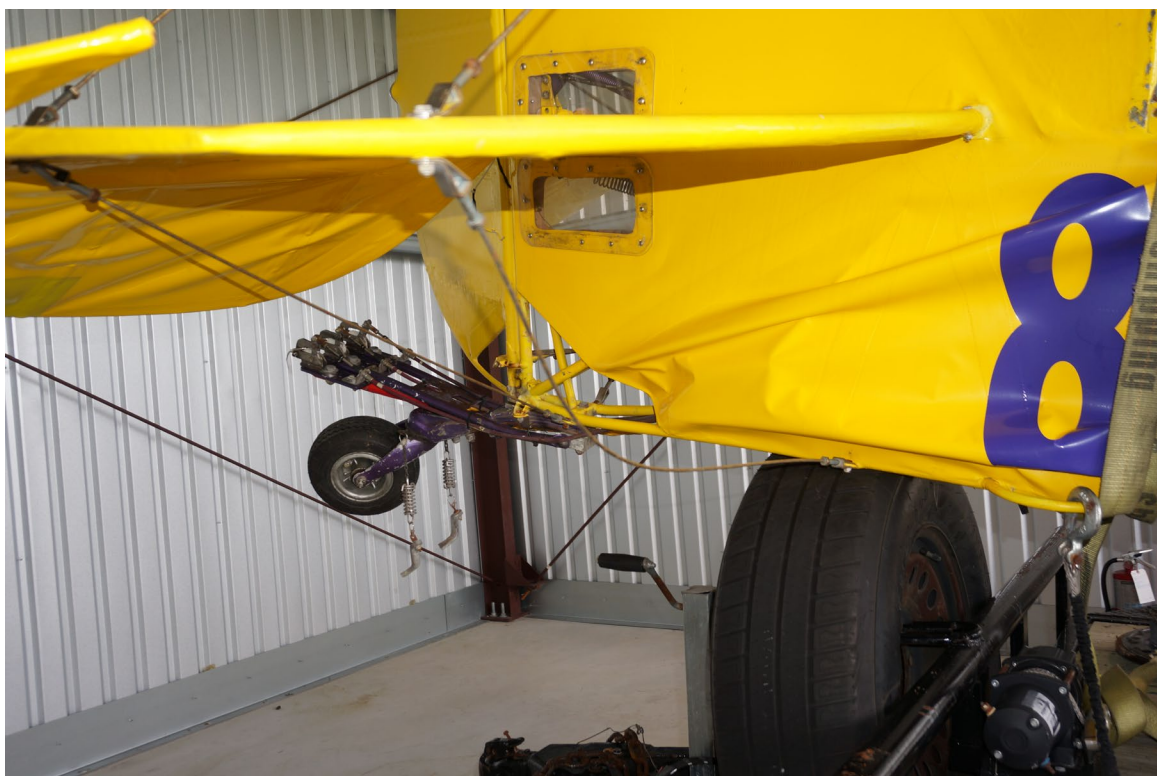
**Photograph 7 - Right Side of Lower Rudder and Tailwheel**

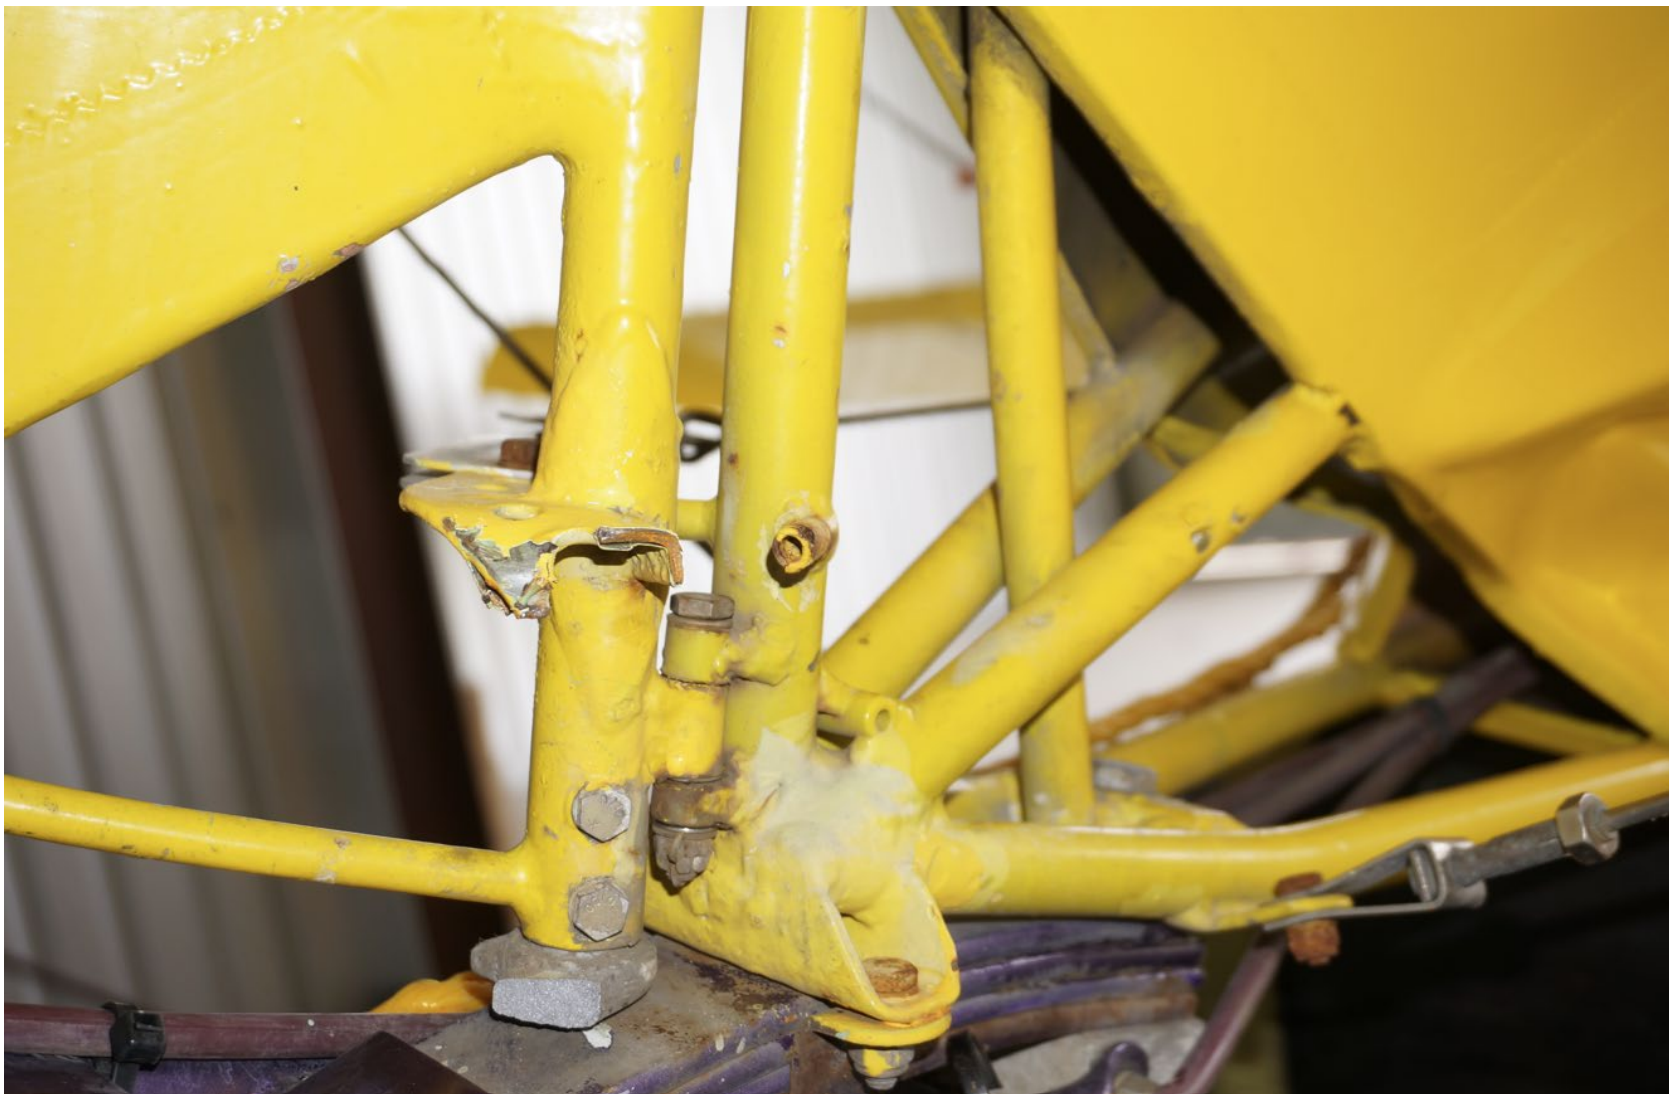
**Photograph 8 - Close Up of Right Side of Lower Rudder Showing Fractured Rudder Horn**

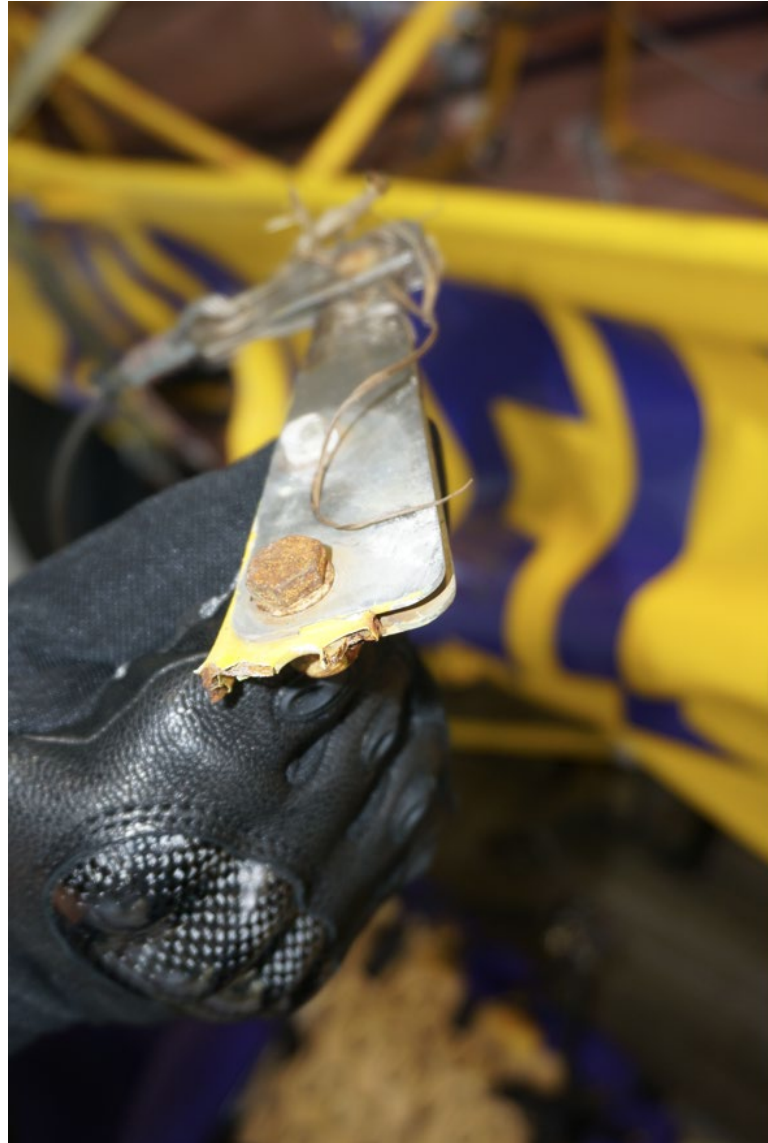
**Photograph 9 - Broken Right Rudder Horn and Extension**

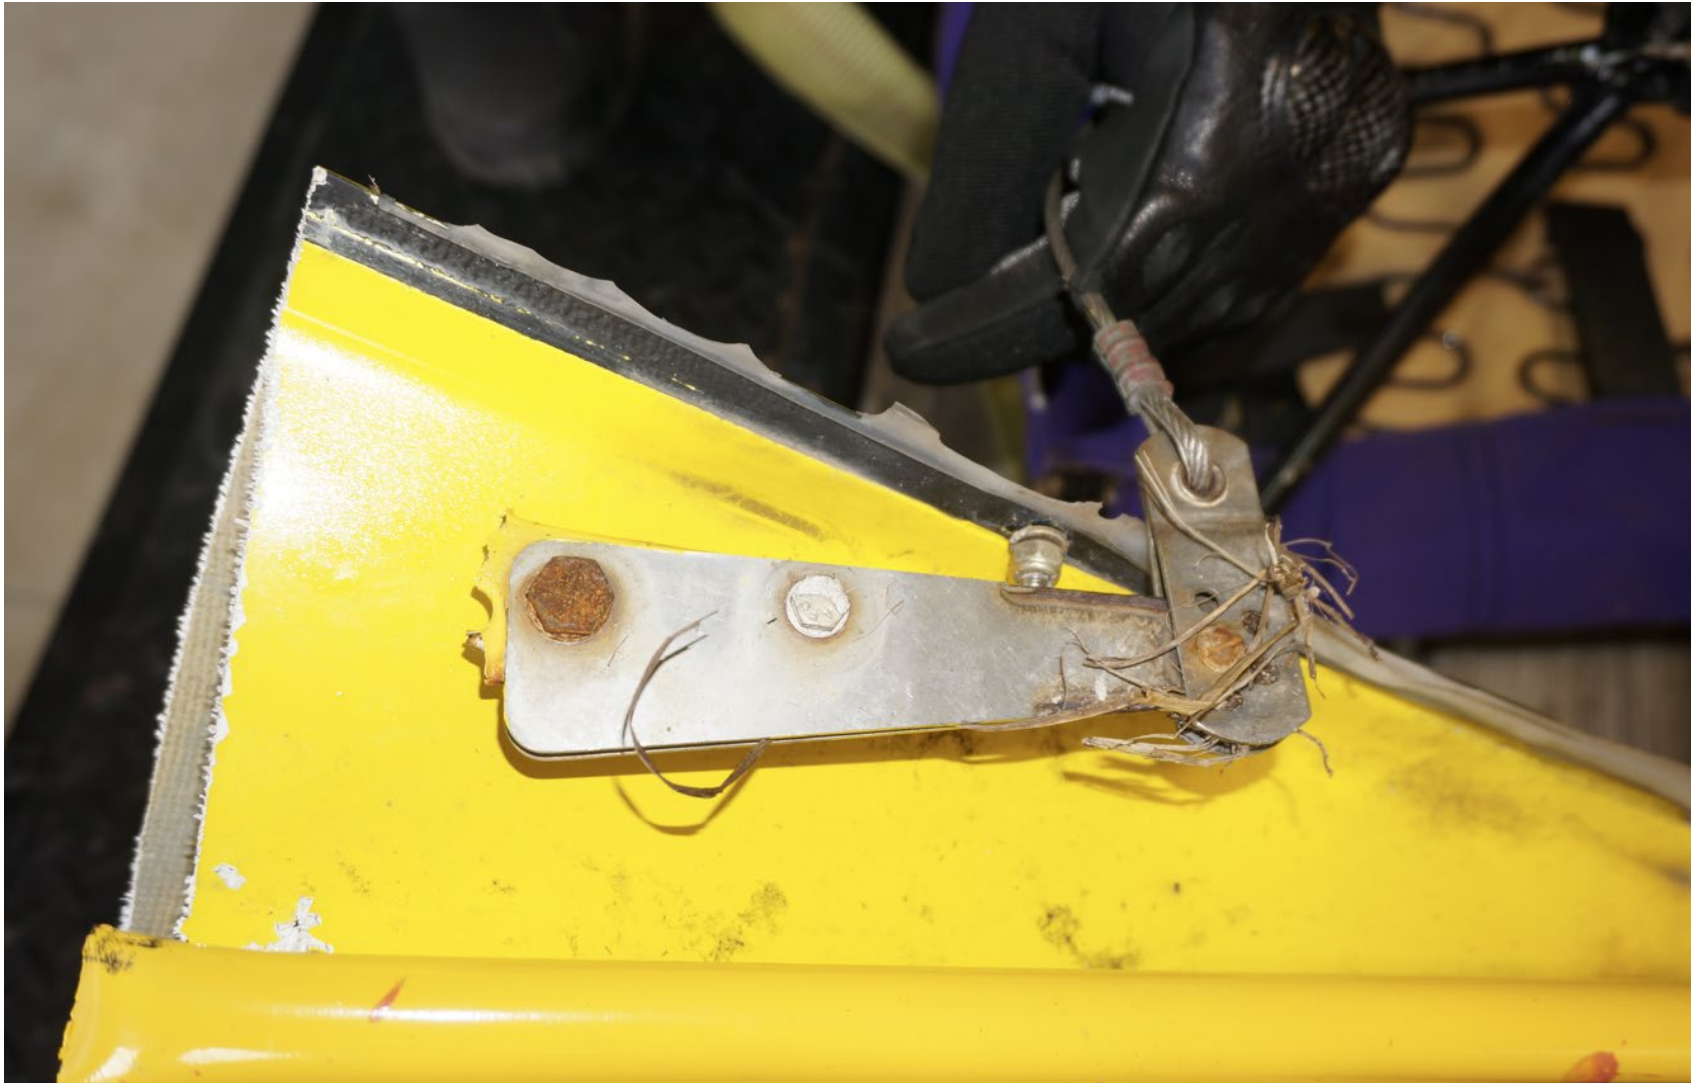
**Photograph 10 - Top View of Broken Right Rudder Horn and Extension**

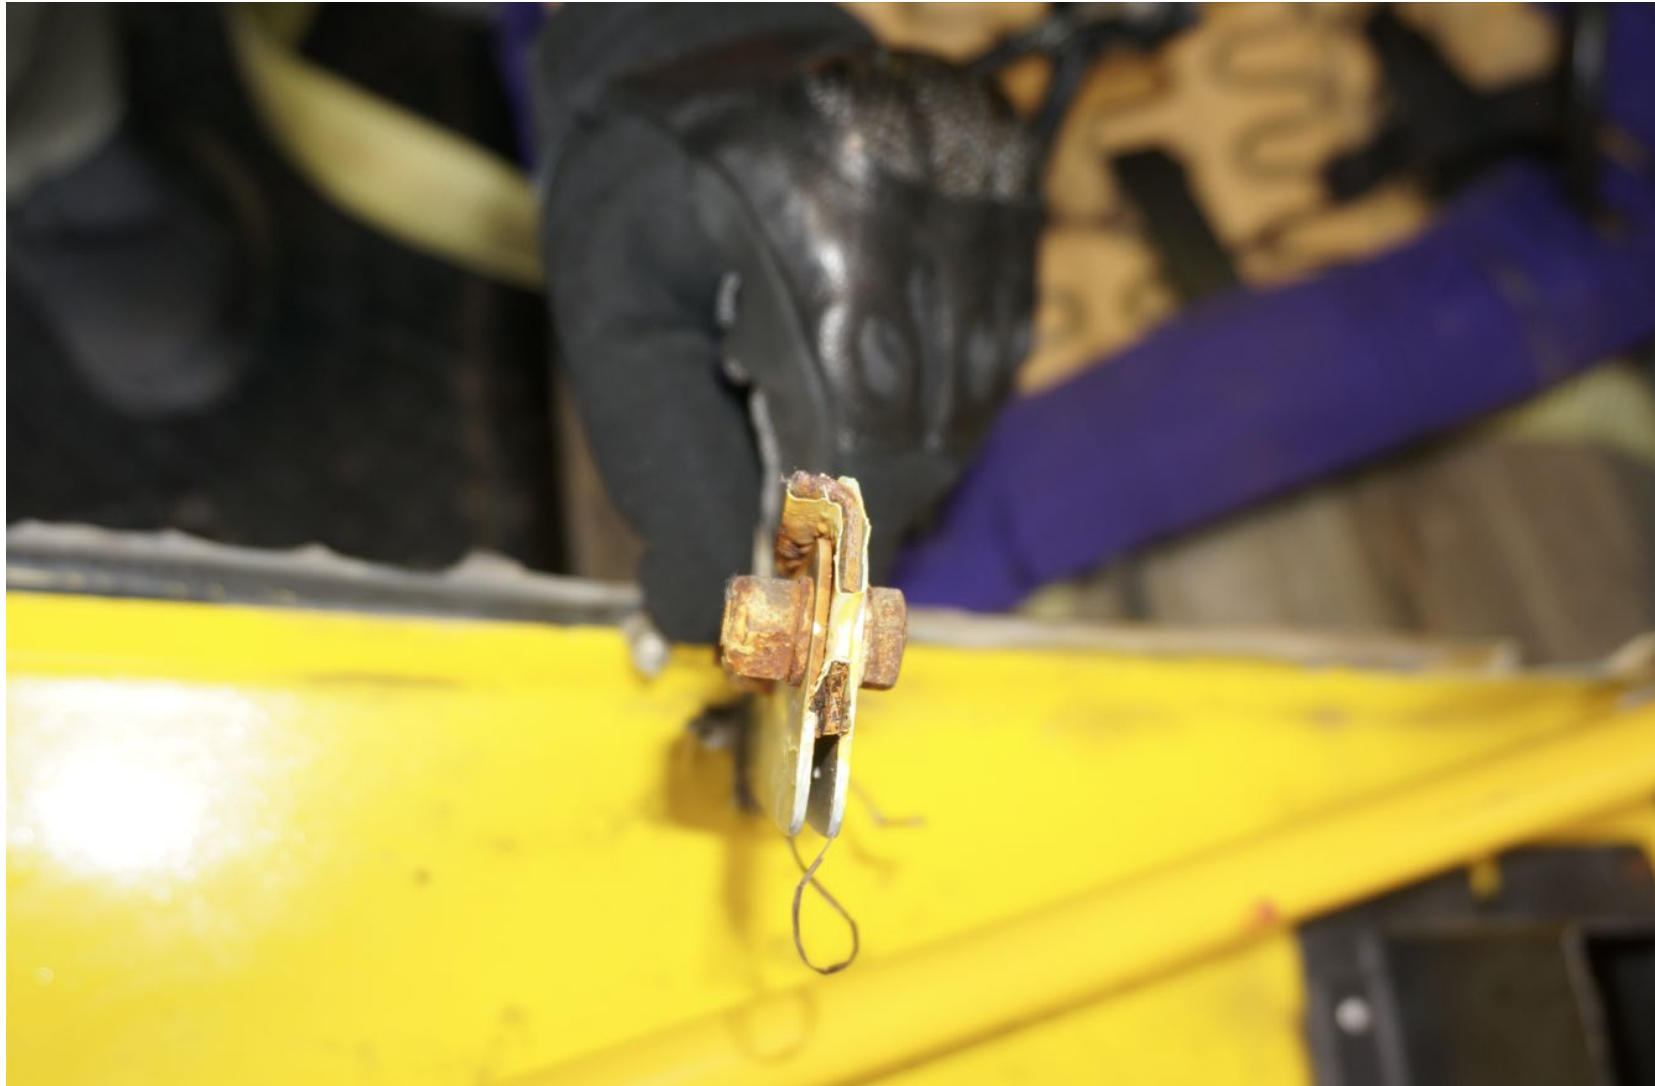
**Photograph 11 - Fracture Face on Right Rudder Horn and Extension**

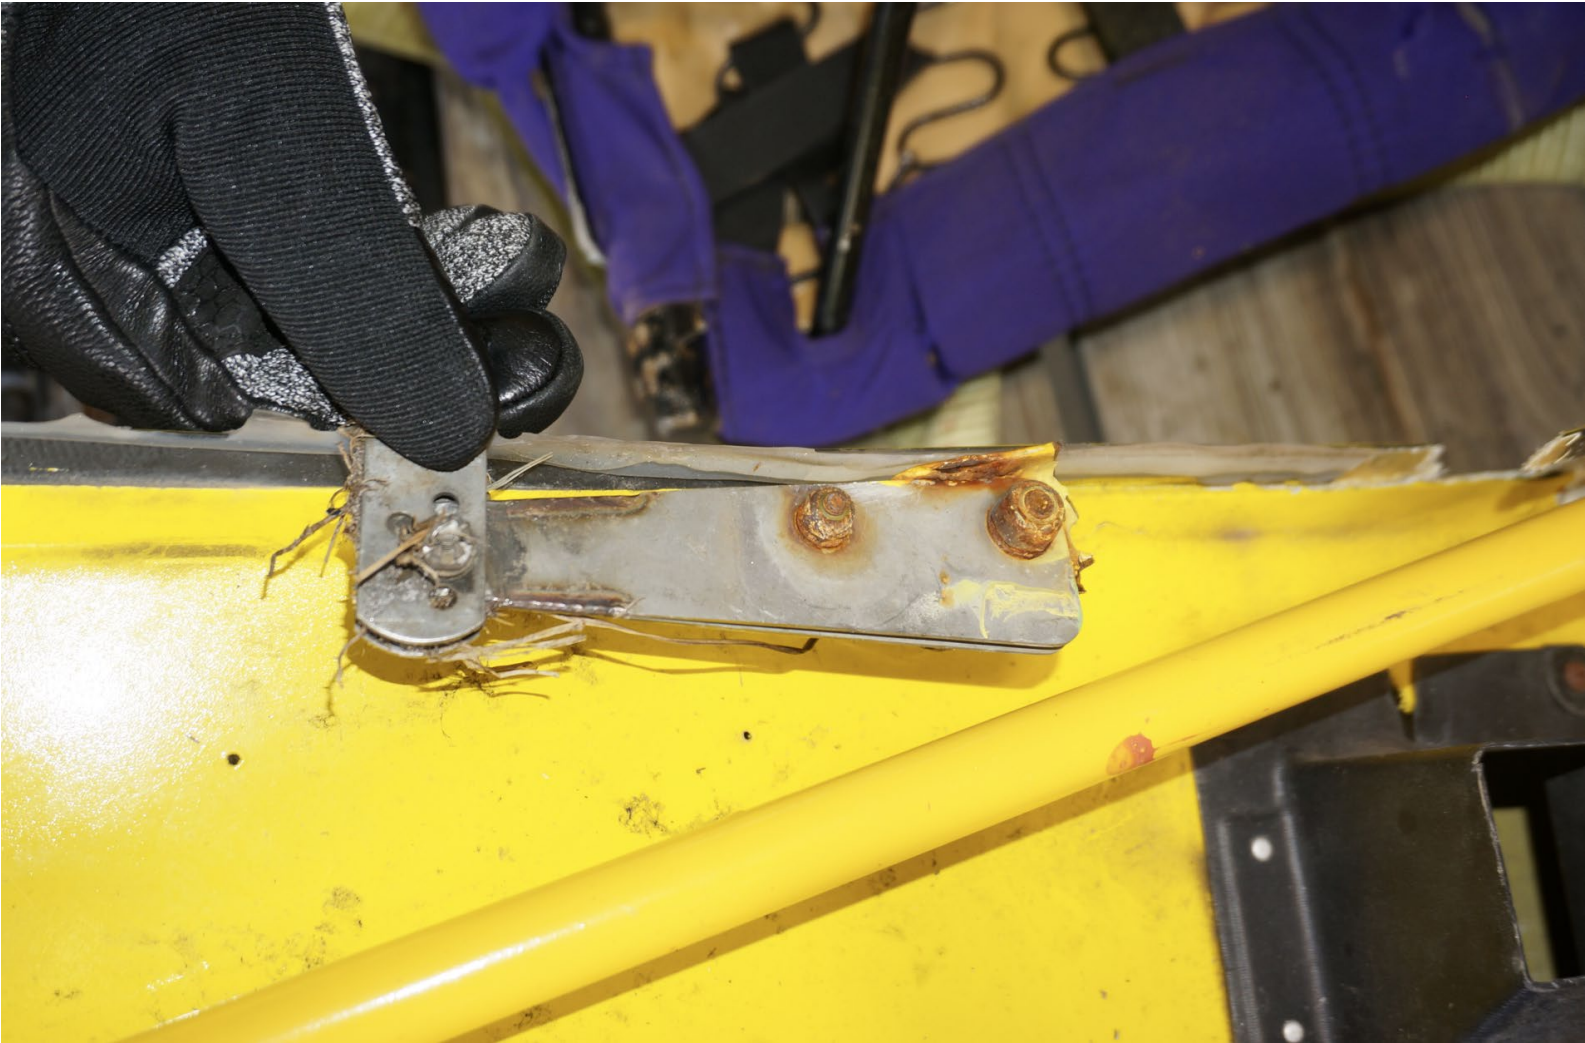
**Photograph 12 - Bottom View of Broken Right Rudder Horn and Extension**

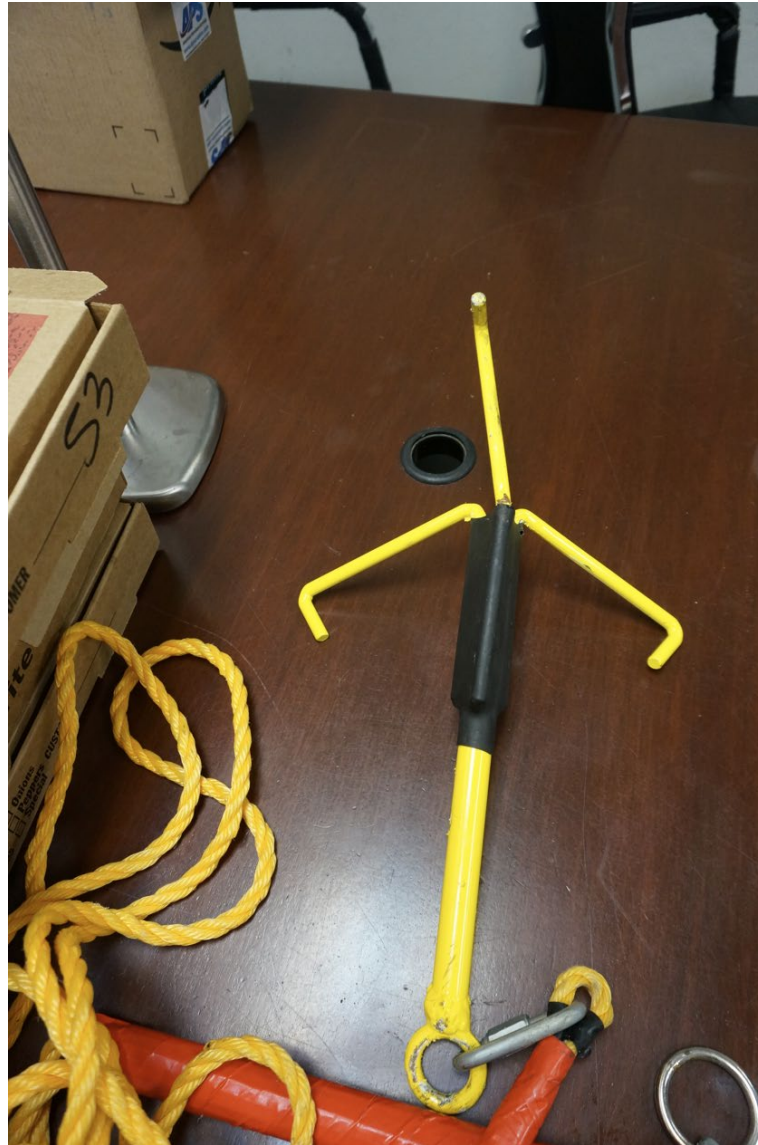
**Photograph 13 - Tow Hook Displaying Bent Prong**

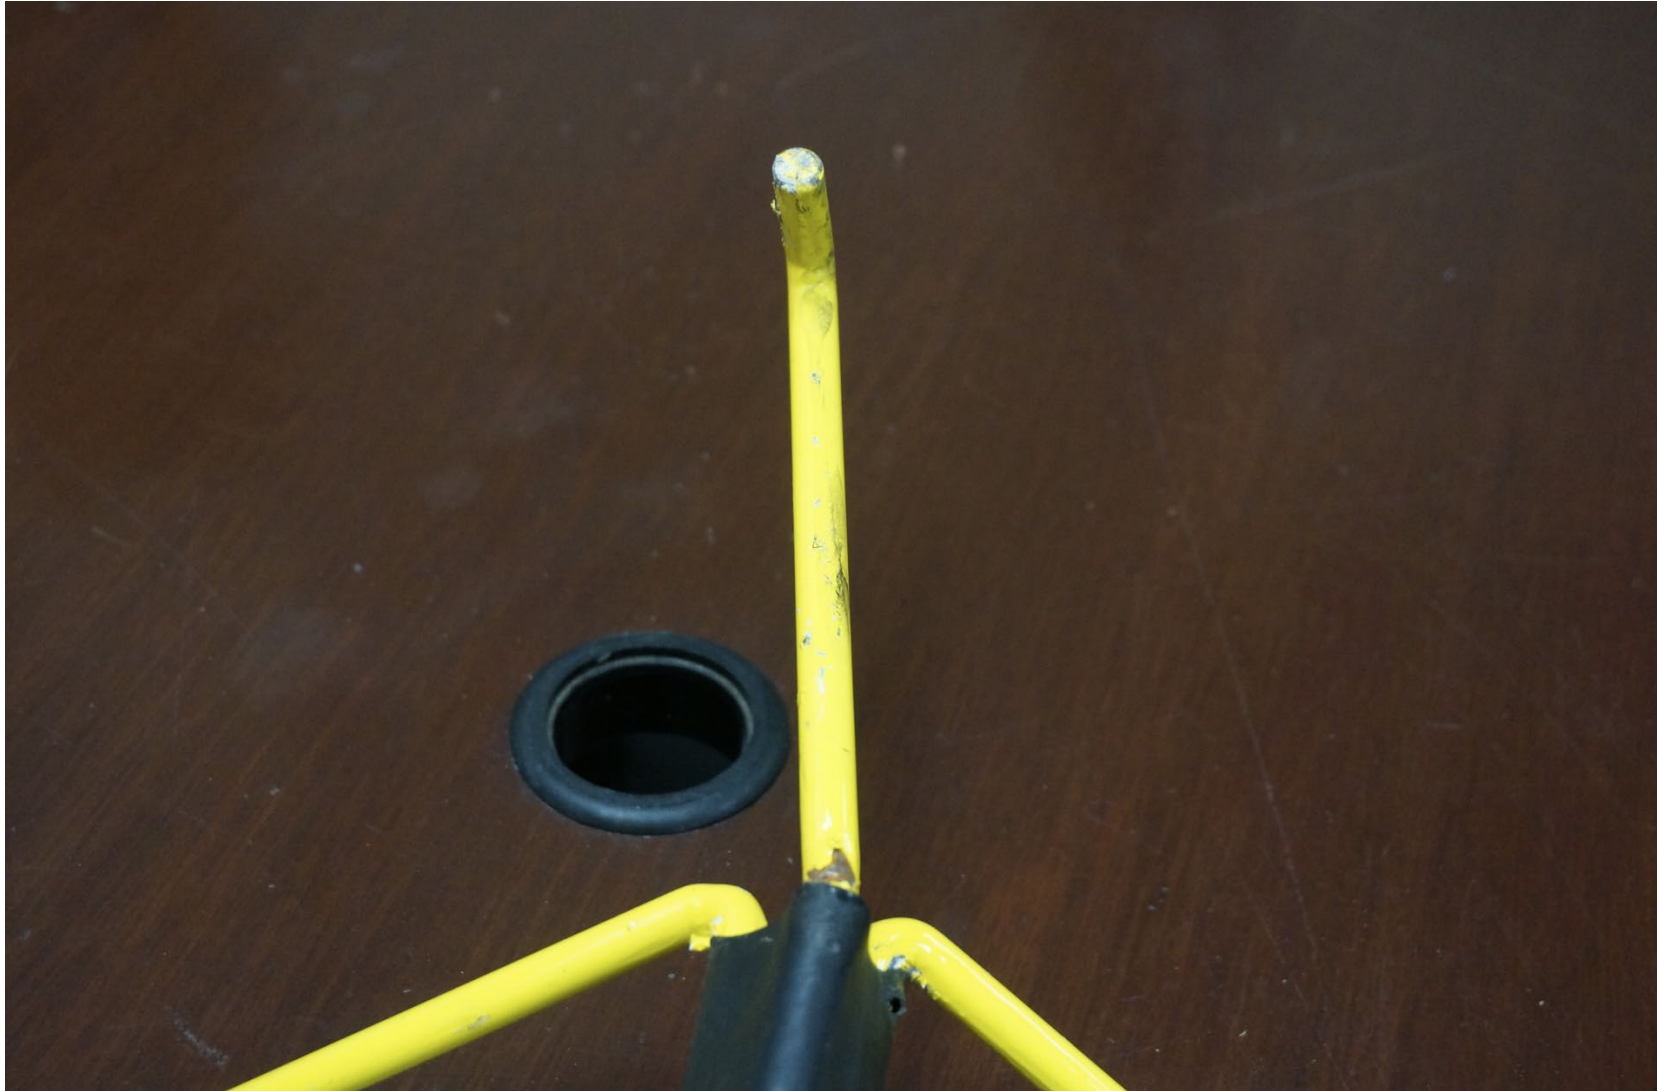
**Photograph 14 - Close Up of Bent Prong**

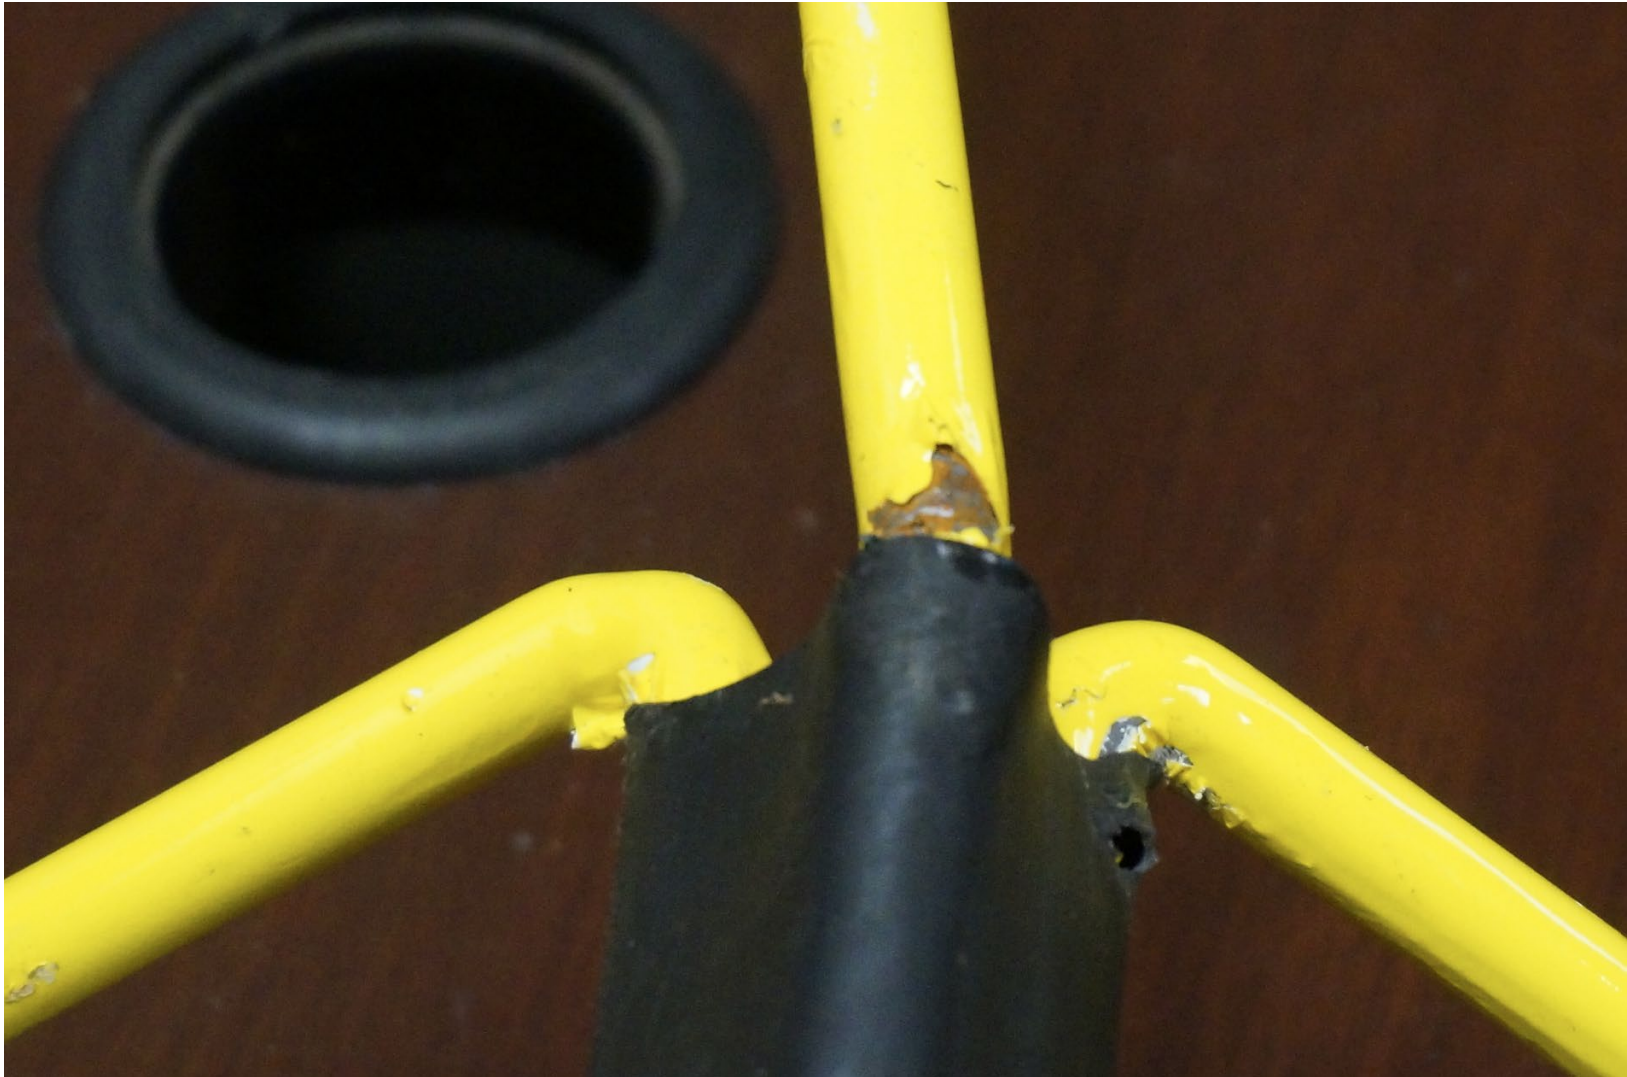
**Photograph 15 - Close Up of Bend in Prong**
