**RE: Aerial Banners Party Submission to the NTSB**  
Date of Accident: May 25, 2023  
NTSB Investigation Number: ERA23LA245

The purpose of this letter is to provide recommendations on behalf of Aerial Banners regarding the National Transportation Safety Board (NTSB) Report and NTSB Materials Laboratory Report, for Investigation Number ERA23LA245.

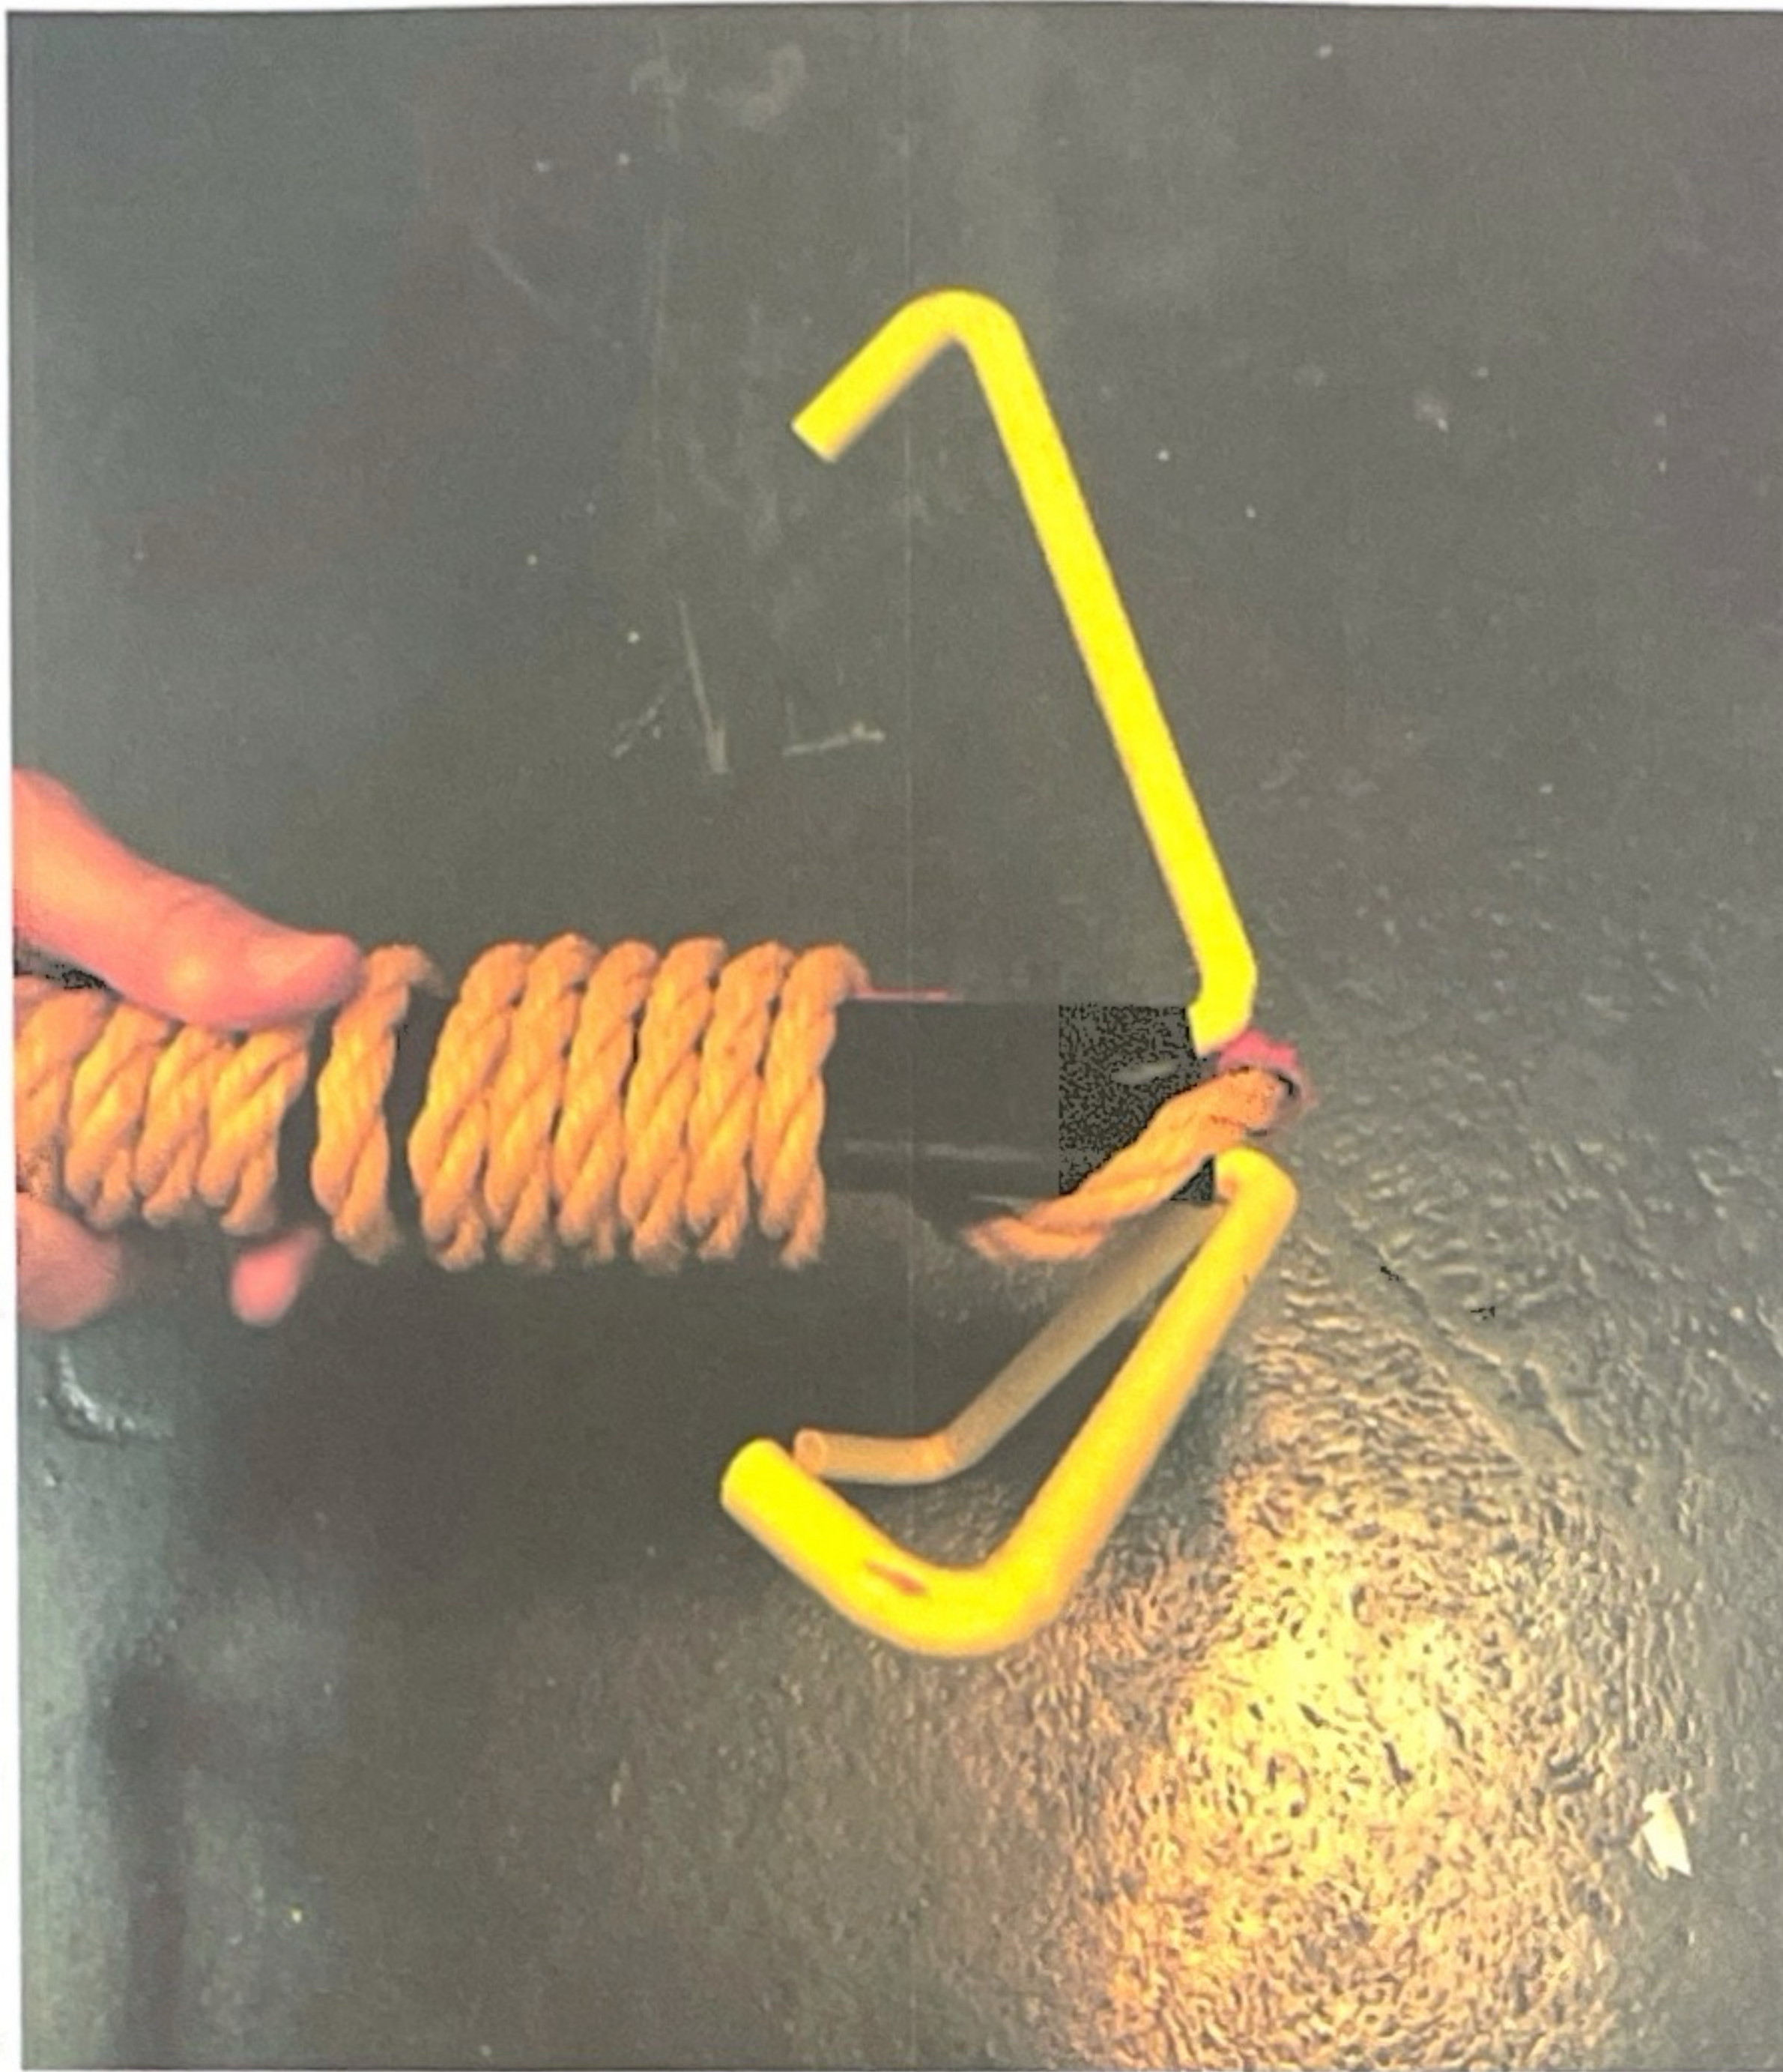
Image 1 – demonstrative photo of undamaged tow hook

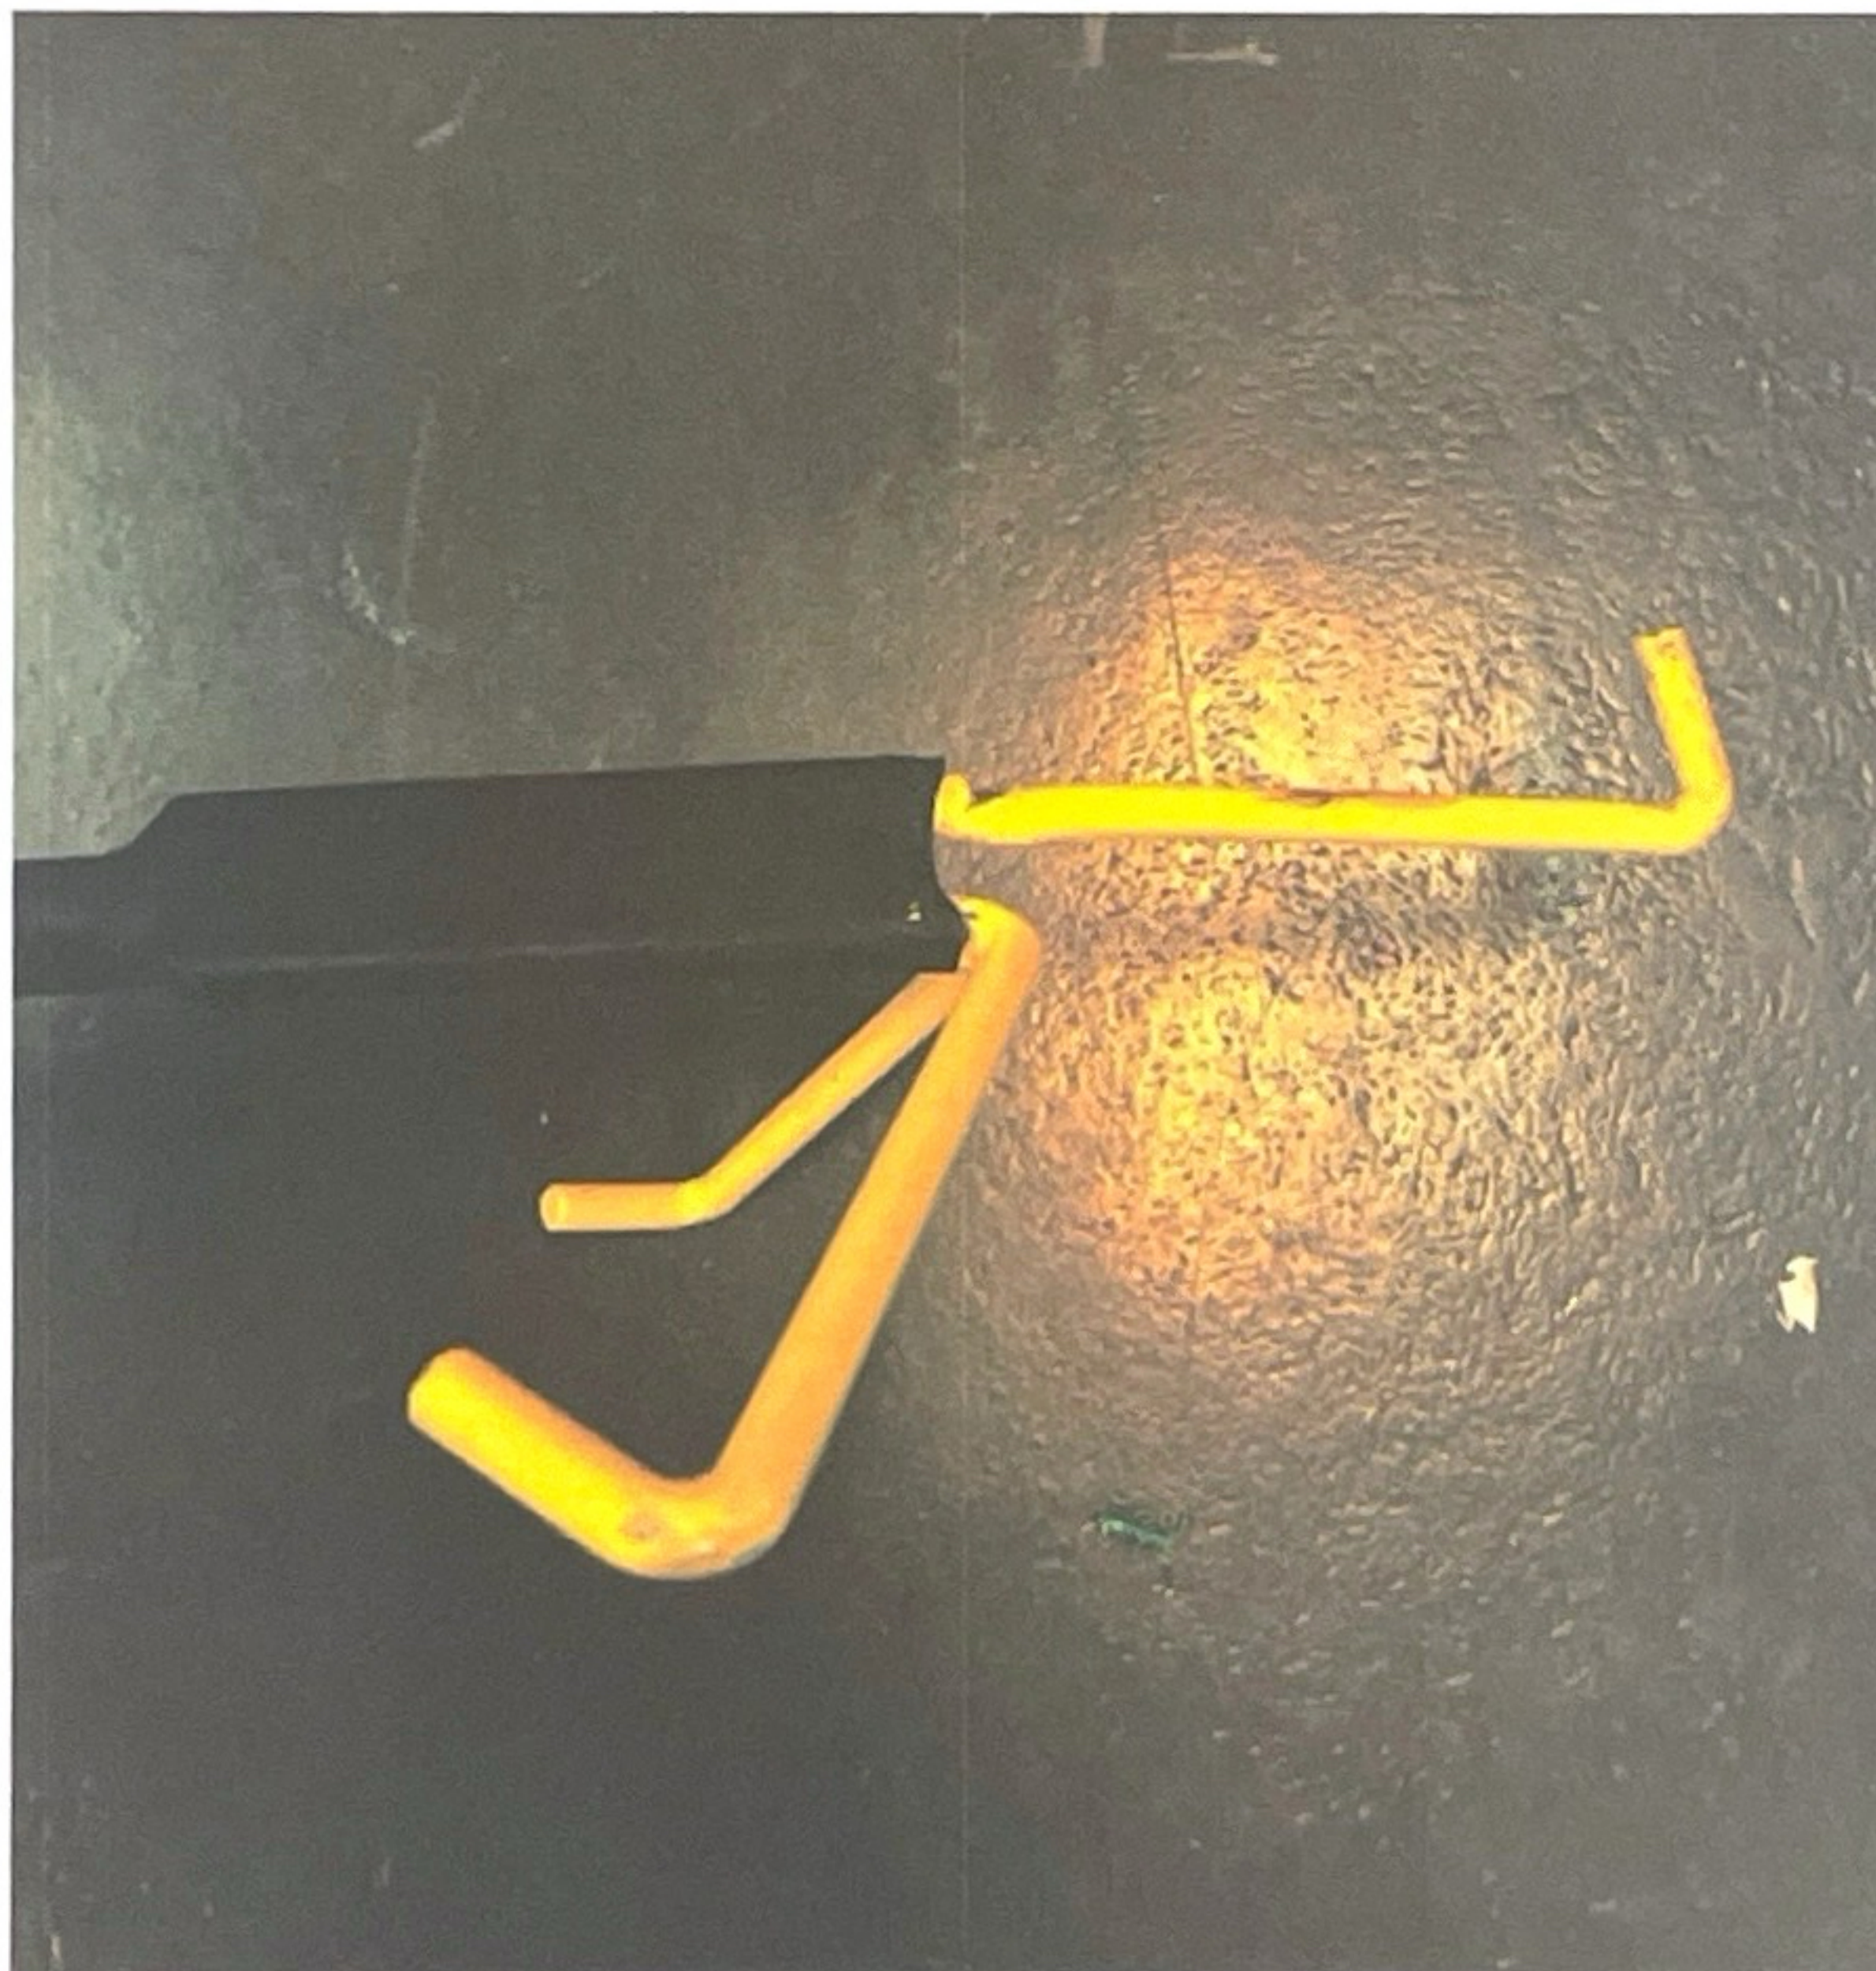
- d. Inspection of the tow hook after this accident identified that one of the tow prongs was severely bent outward into almost a flat position. The Aerial Banner director of ground operations reported that, in his nearly 20 years of experience, he had never seen a tow hook prong bent so far out of position. The tow hook was manufactured from ¼ inch thick steel rebar. The severity of damage to the tow hook is evidence it experienced a significant impact and significant energy passed through the tow hook during the accident sequence.

- e. Aerial Banners concludes that inadvertent recoil of the tow rope, and subsequent impact between the tow hook and right rudder horn, most likely caused the overload fracture of the right rudder horn.

Image 2 – Photo of damaged tow hook after accident. Note that damaged prong is bent nearly straight.
