# National Transportation Safety Board

ERA23LA245

## **MATERIALS LABORATORY**

Factual Report 23-093

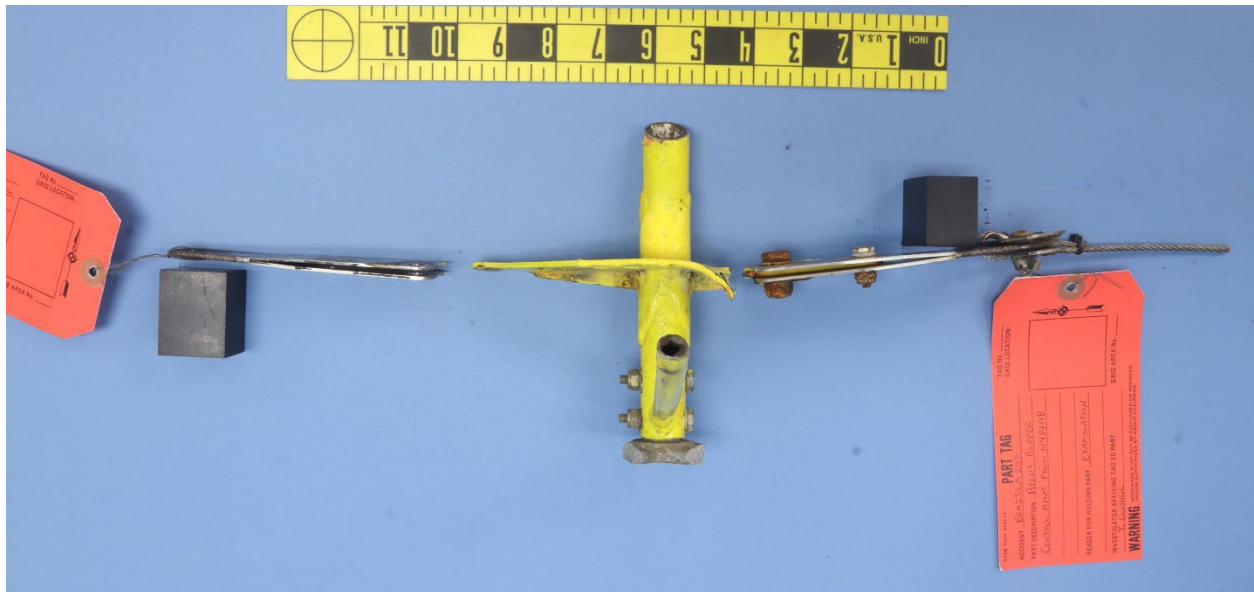
Figure 1 shows the rudder arm assembly, with the two extensions, as received. The right side of the rudder horn had fractured approximately 1.25 inches from the vertical arm assembly body. While the right extension was still affixed to the broken right rudder horn remnants, the left extension had been disassembled from the still intact left rudder horn. The cast link had also fractured in two locations. The rest of the

rudder arm assembly had been sectioned in two places, facing downward and toward the reader in Figure 1.

**Figure 1.** View rudder arm assembly, with the two extensions on either side. The right rudder horn had fractured attached to the extension.

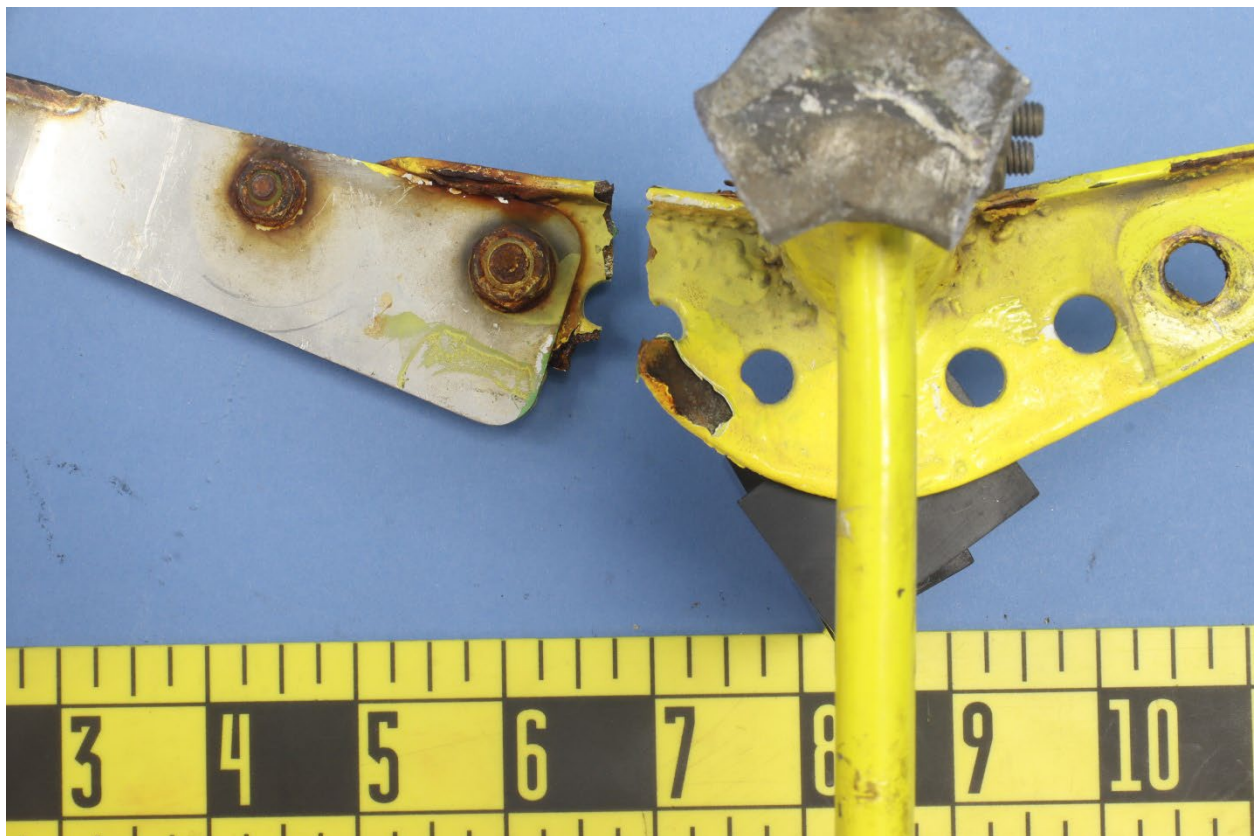
Figure 2 shows the mating sides of the fractured rudder horn, positioned in their locations at the time of fracture. Figures 3 and 4 show the mating fracture surfaces of the outer horn remnant and inboard horn flange, respectively. The lower filament towards the arm assembly exhibited an upward out-of-plane deflection (lower right in Figure 2 and upper right in Figure 4). The mating side showed a primarily straight orientation, but with a slight downward bending deformation (left in Figure 3). All fracture surfaces exhibited enough surface oxidation (rust) to conceal the underlying metal surfaces, including the fracture surfaces. Much of the yellow paint in these areas had also begun to spall.

**Figure 2.** Fractures of the link casting (upper right) and the right rudder horn (center) from Figure 1, showing the mating fracture surfaces.

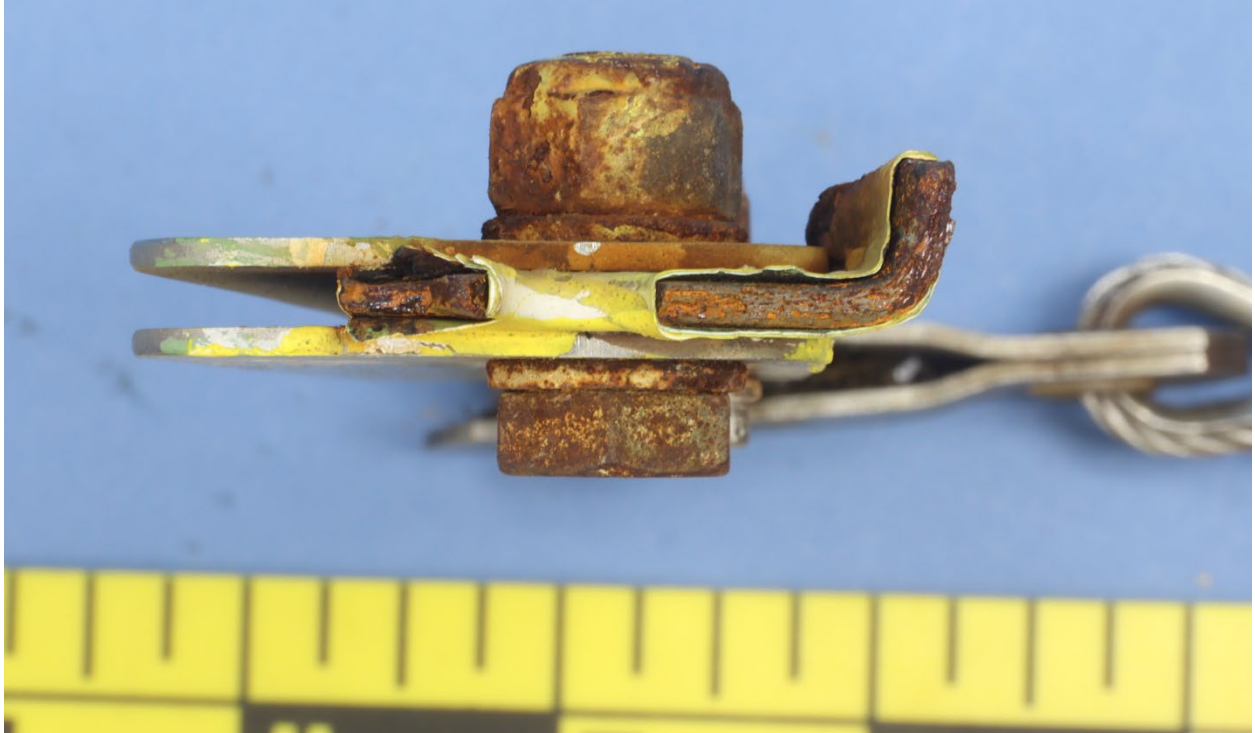
**Figure 3.** View of the outboard horn fracture still attached to the respective extension.

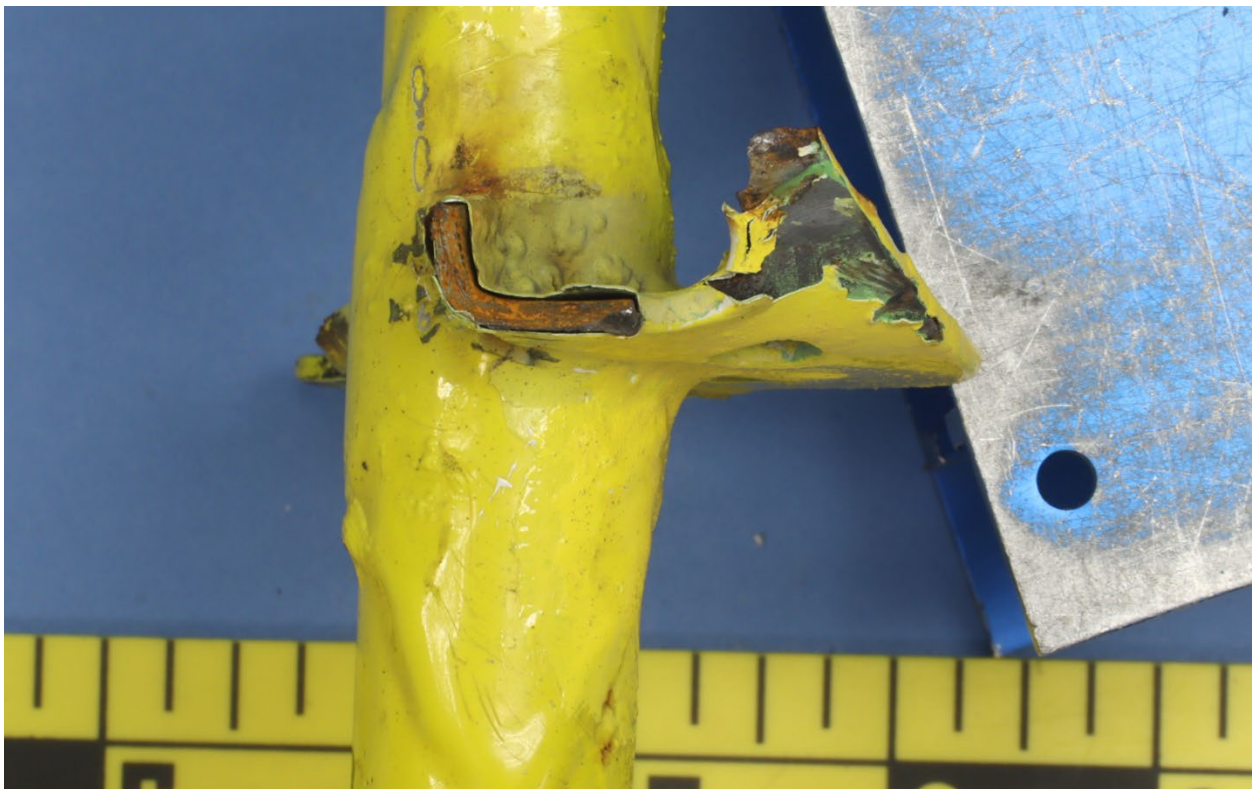
**Figure 4.** View of the inboard fracture surface of the rudder horn that mates to the one shown in Figure 3.

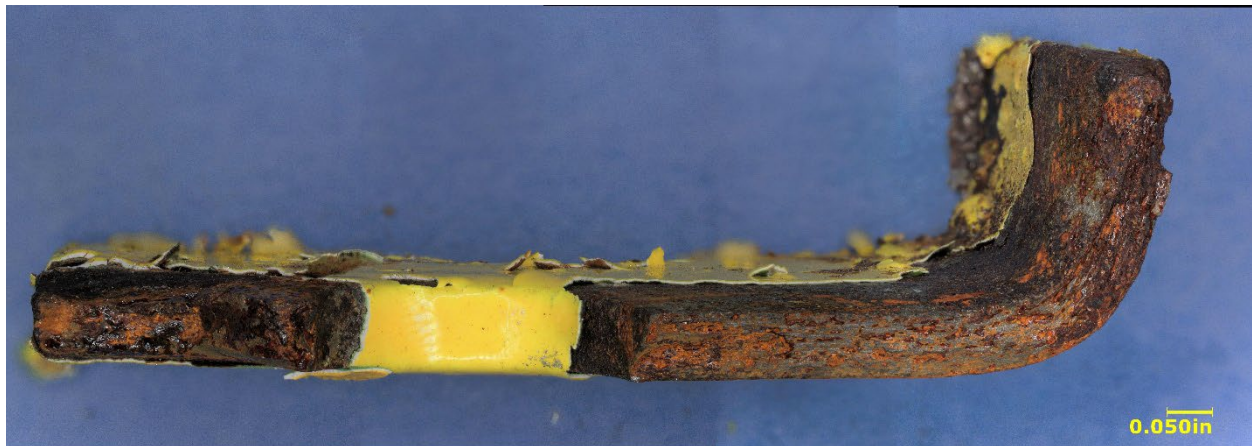
The outboard rudder horn fragment was sectioned, and the fracture surface is shown in Figure 5 after cutting. To examine the underlying fracture features, the sectioned horn piece was cleaned in an ultrasonic bath using an aqueous solution of a commercial chelating agent (Evapo-Rust).<sup>1</sup> Figure 6 shows the fracture surface after the removal of the surface rust.

**Figure 5.** Section of the outboard rudder horn fracture surface, with surface corrosion.

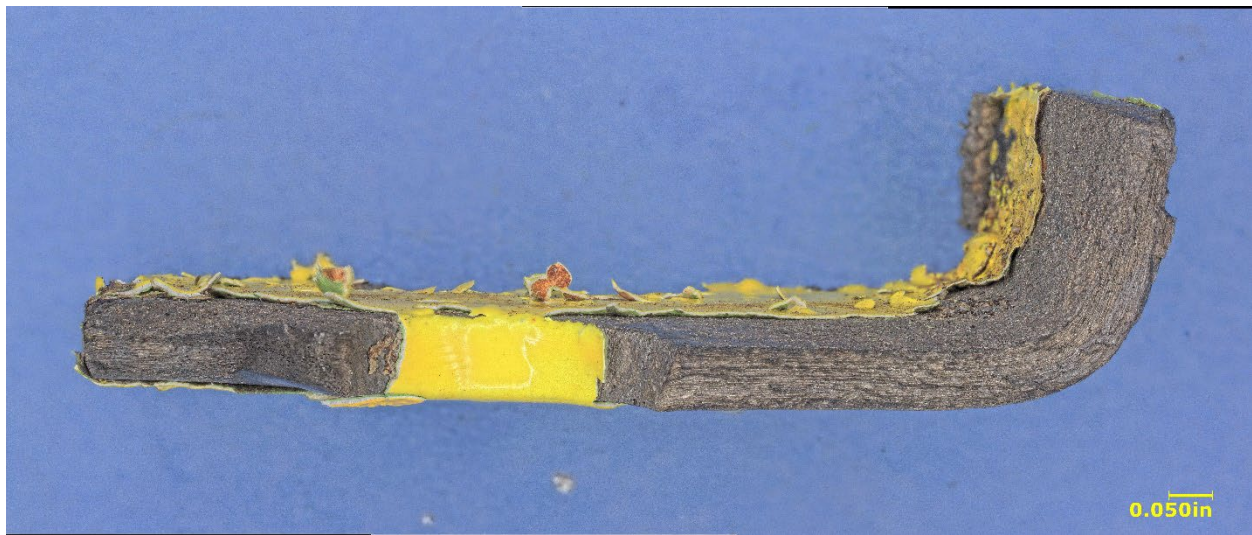
Along with closer views of the fracture morphology shown in Figures 7 through 9, Figure 6 shows the fracture surfaces of the outer horn fragment exhibited a rough, tortuous surface texture with a dull, fibrous luster. The smaller filament on the left side of Figure 6 exhibited thinning and necking near the fracture surface. In addition, as shown in Figure 7, the upward deformation and smearing of the necked area near the hole bore to the right. Examination of this surface using a field emission scanning electron microscope (SEM) revealed dimpled rupture, as typified in Figures 8 and 9. These features were consistent with overstress fracture of ductile material in tension and localized bending.

**Figure 6.** View of the rudder horn fracture surface section shown in Figure 5, after cleaning with acetone and chelating rust removal.

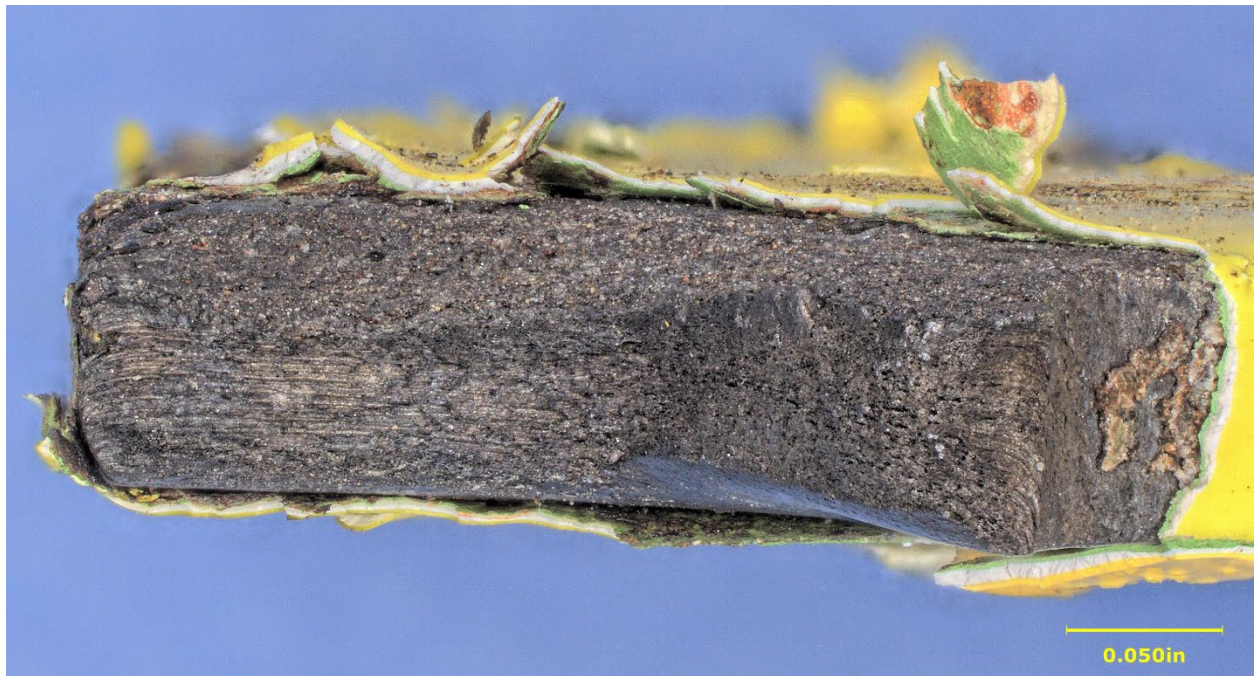
**Figure 7.** Closer view of the fractured segment of the horn to the left in Figure 6.

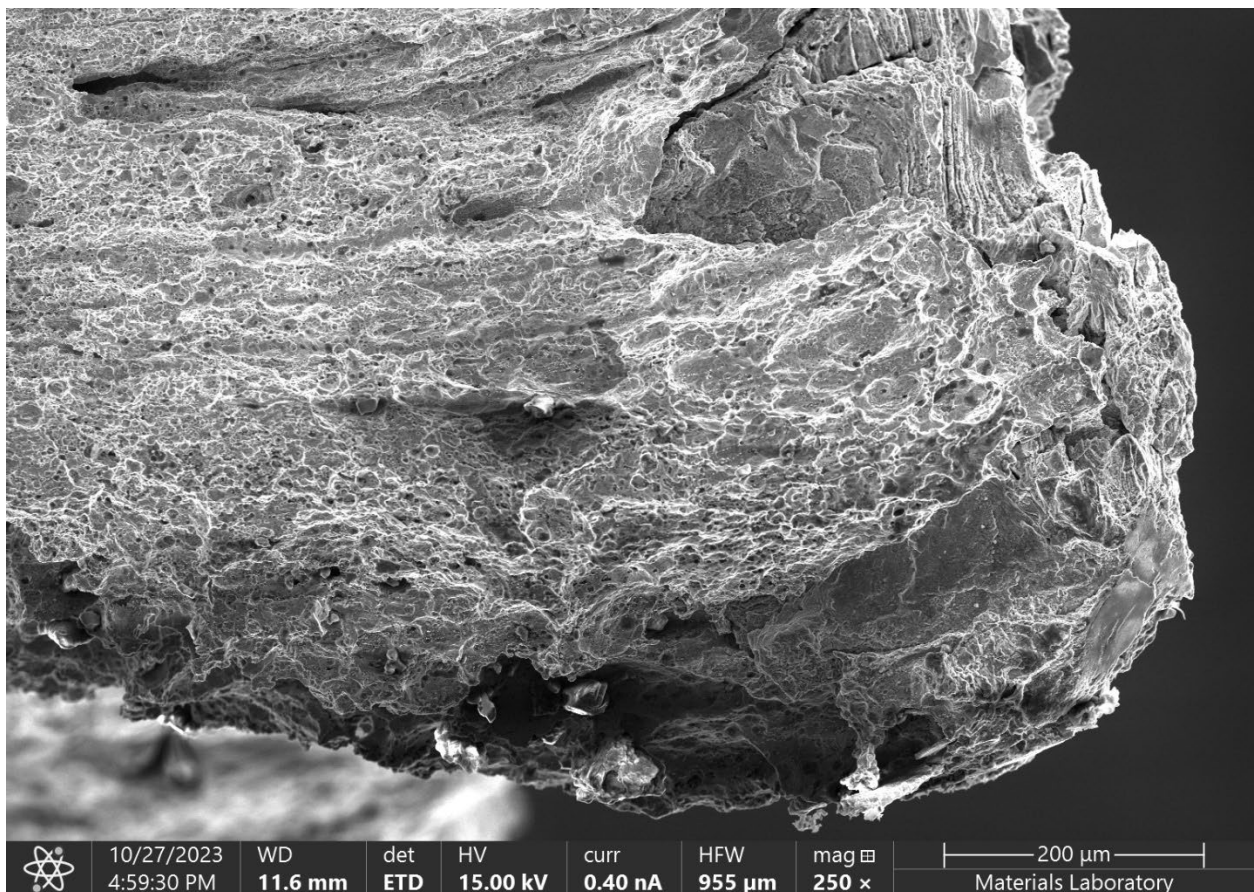
**Figure 8.** Secondary electron (SE) micrograph of the bore corner of the fracture surface in Figure 7, showing plastic deformation.

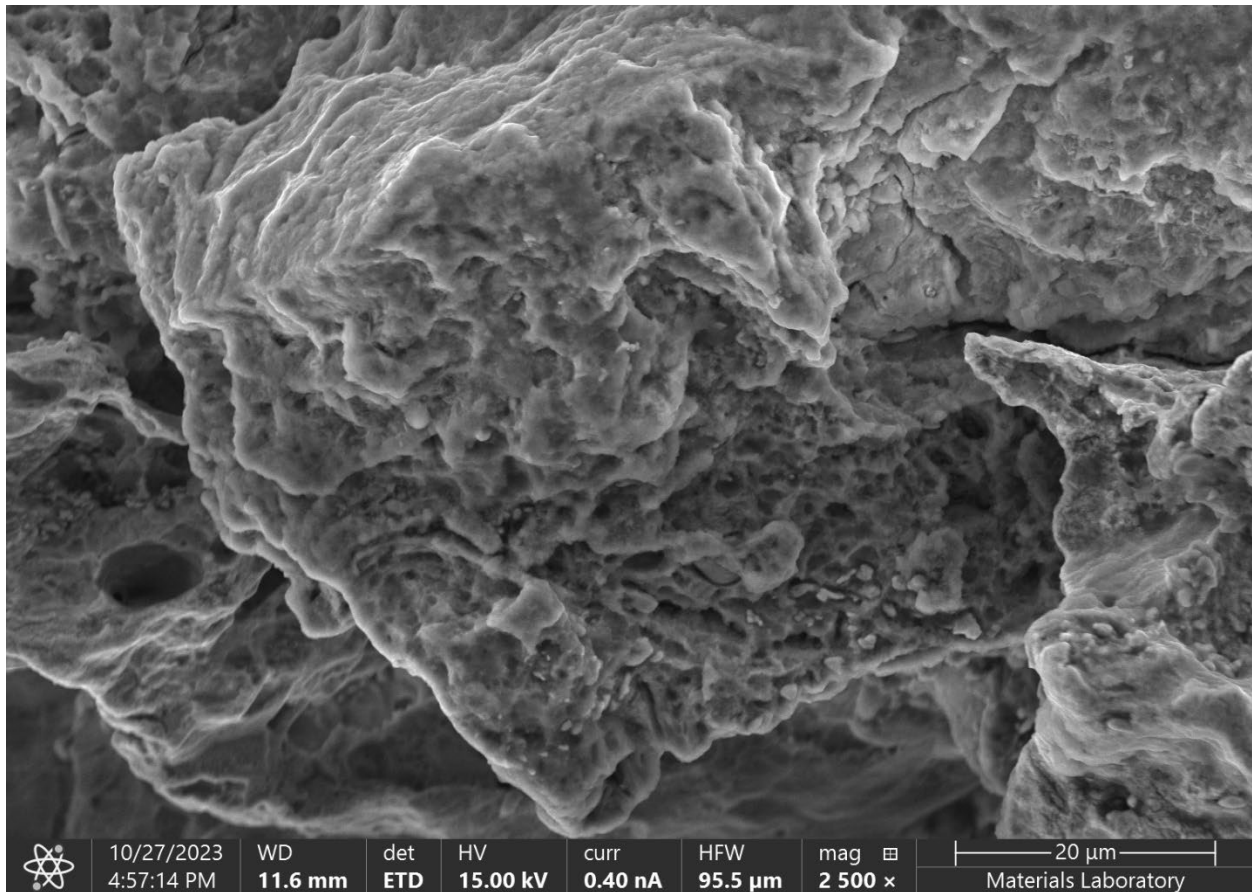
**Figure 9.** SE micrograph of dimpled rupture and corroded material in Figure 8.

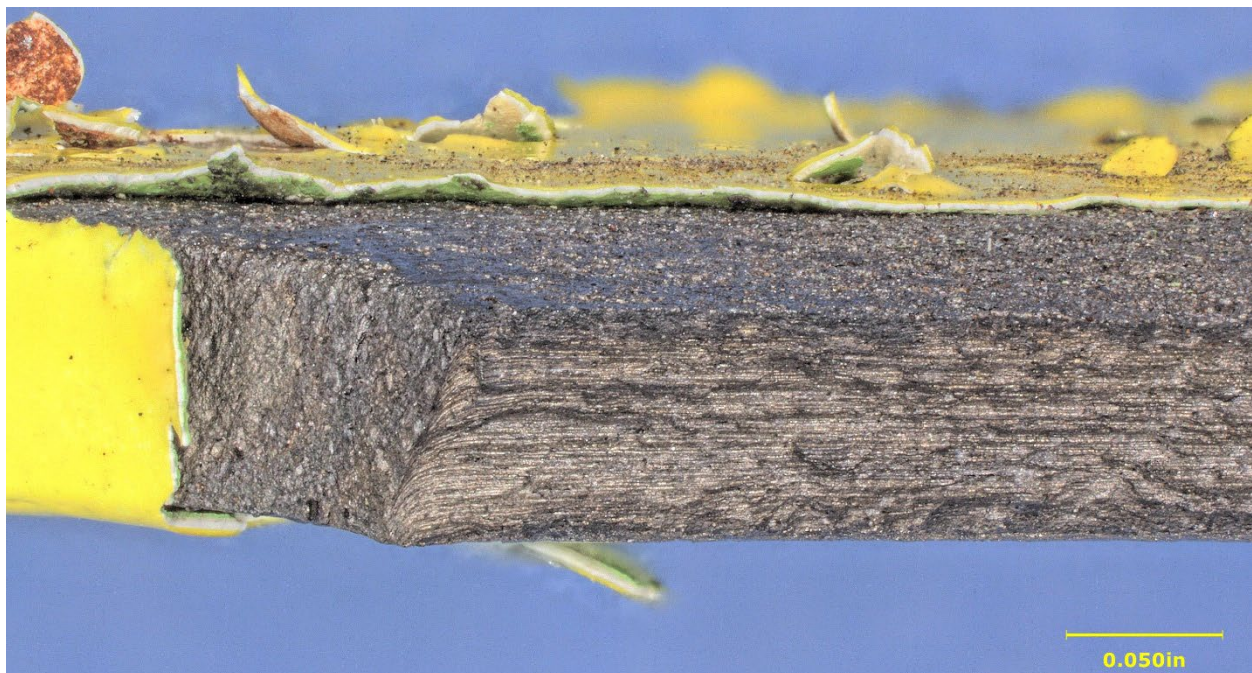
The larger filament on the right side of the rudder horn fragment is shown in Figure 10. This figure demonstrates the fracture surface at a 45° slant angle relative to the part. There was a localized downward deformation of the highly textured grain flow near the hole bore. Examination of this part of the surface using an SEM revealed the localized flow deformation (Figure 11, inverted relative to Figure 10). The fracture surface exhibited dimpled rupture, consistent with overstress fracture (Figure 12). Examination of the rightmost (L-shaped) side of the horn fracture showed localized necking near the fracture surface (Figure 13). These features were consistent with tensile and bending overstress fracture of the horn.

**Figure 10.** Fracture surface edge with the bore of the horn section in Figure 6.

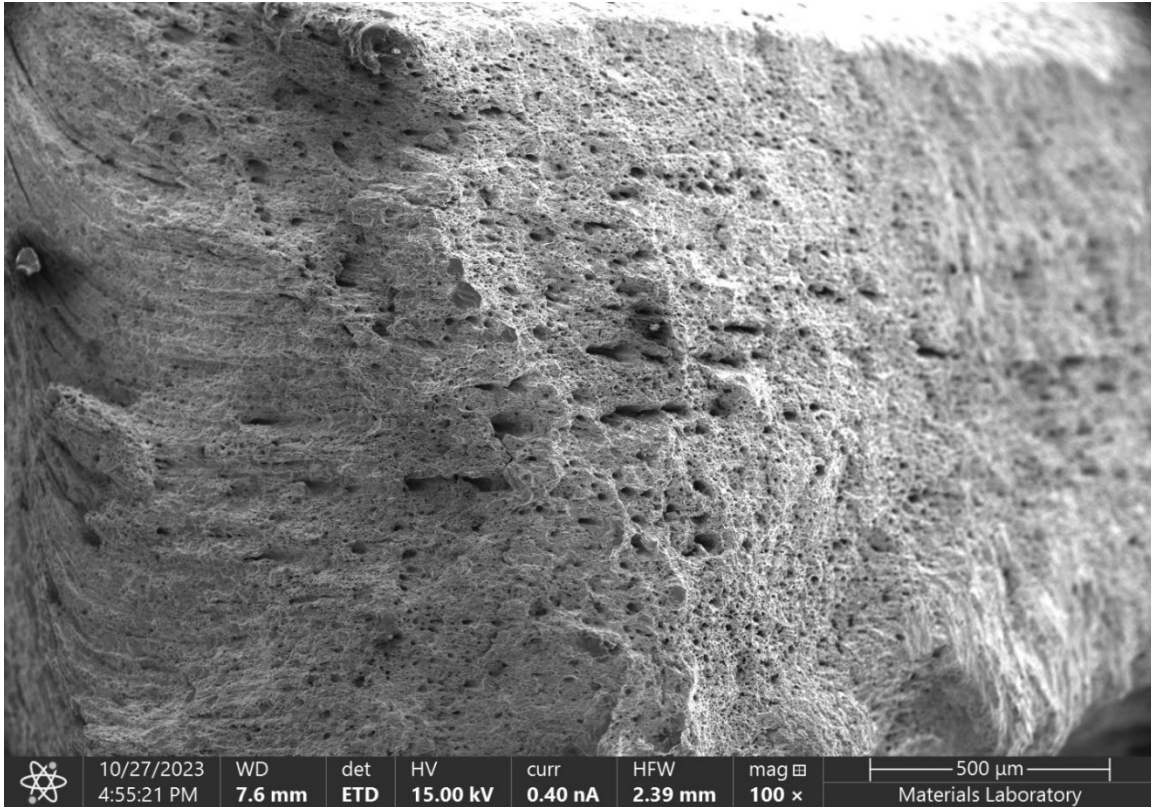
**Figure 11.** SE micrograph of a closer view of the corner in Figure 10.

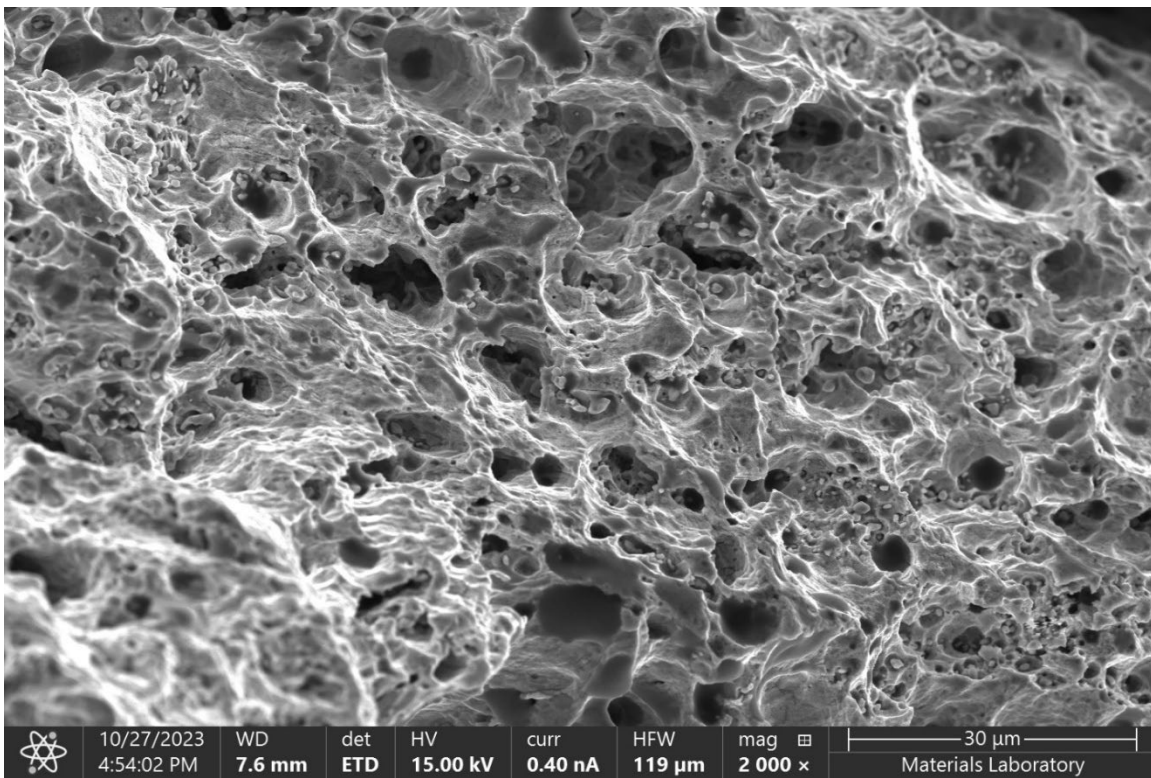
**Figure 12.** SE micrograph of dimpled rupture in the area in Figure 11.

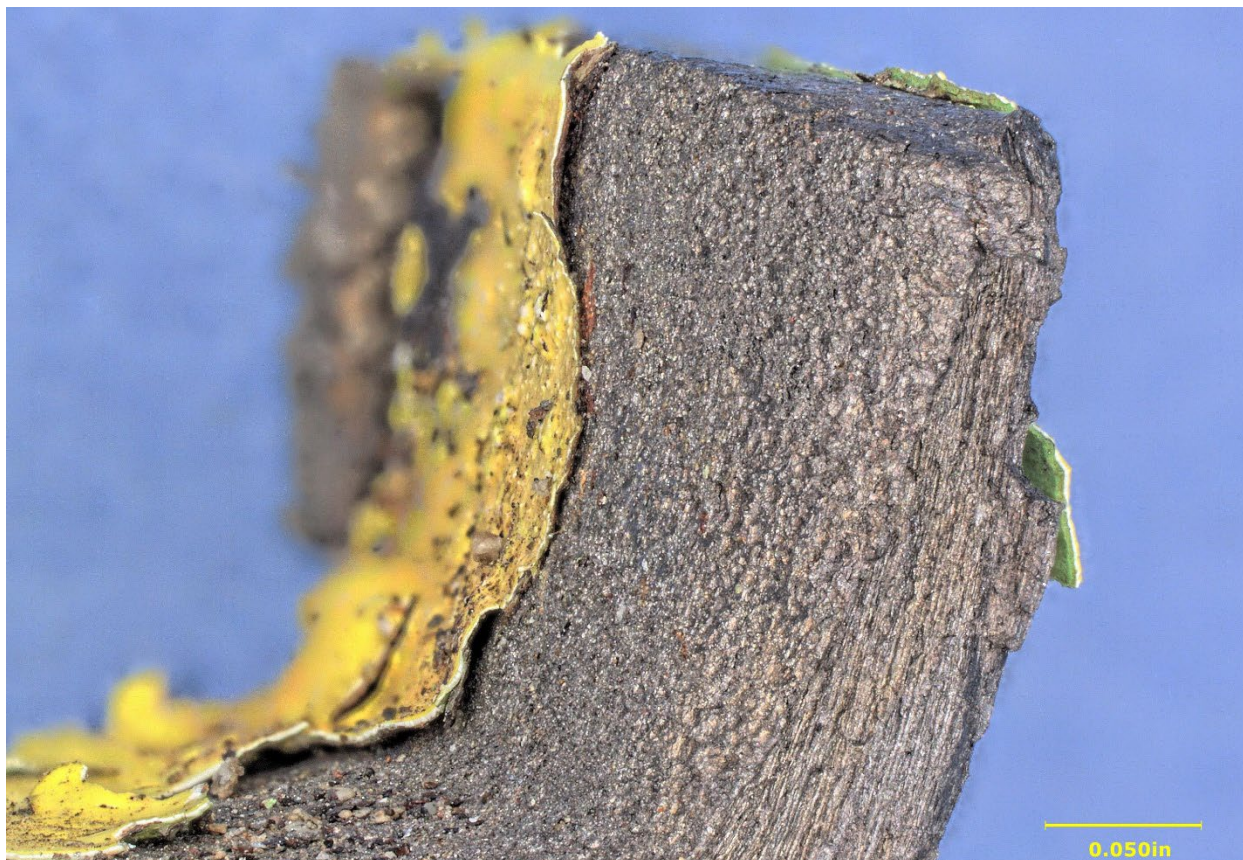
**Figure 13.** Opposite edge of the right fractured segment in Figure 6, showing thinning.

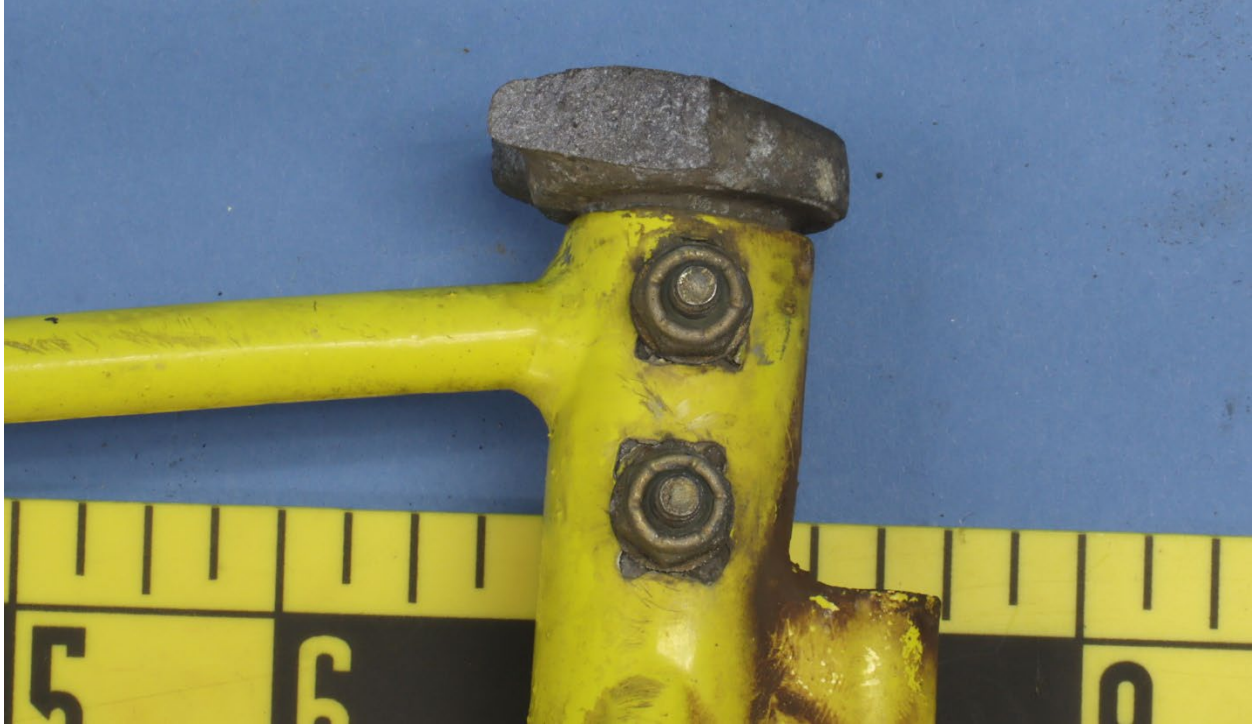
The fractured link casting was also examined, as shown in Figures 14 and 15. These fractures had occurred adjacent to the rudder arm assembly body. The broken surfaces were sectioned from the rudder arm assembly and cleaned in an ultrasonic bath of acetone to remove much of the post-fracture surface contamination on the component.

**Figure 14.** View of one of the fracture surfaces of the link casting.

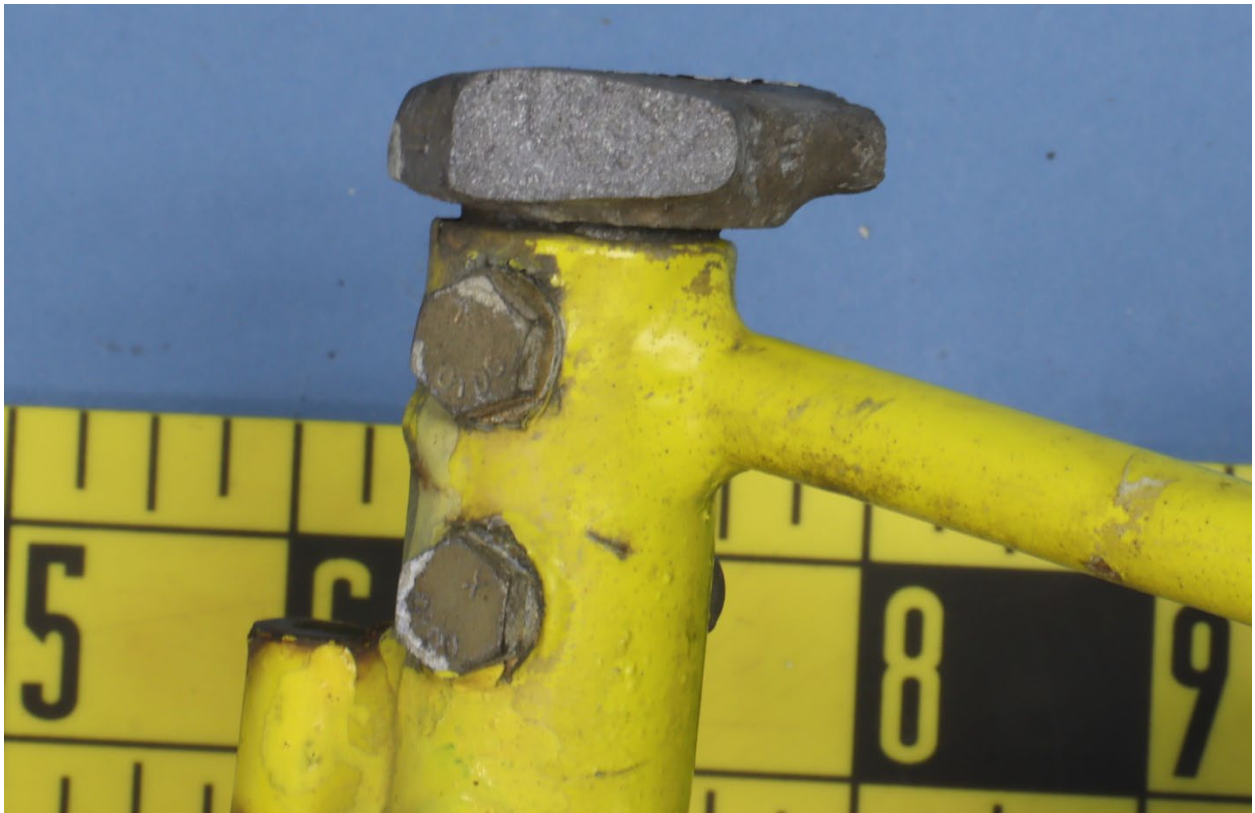
**Figure 15.** The opposite fracture surface from that shown in Figure 14.

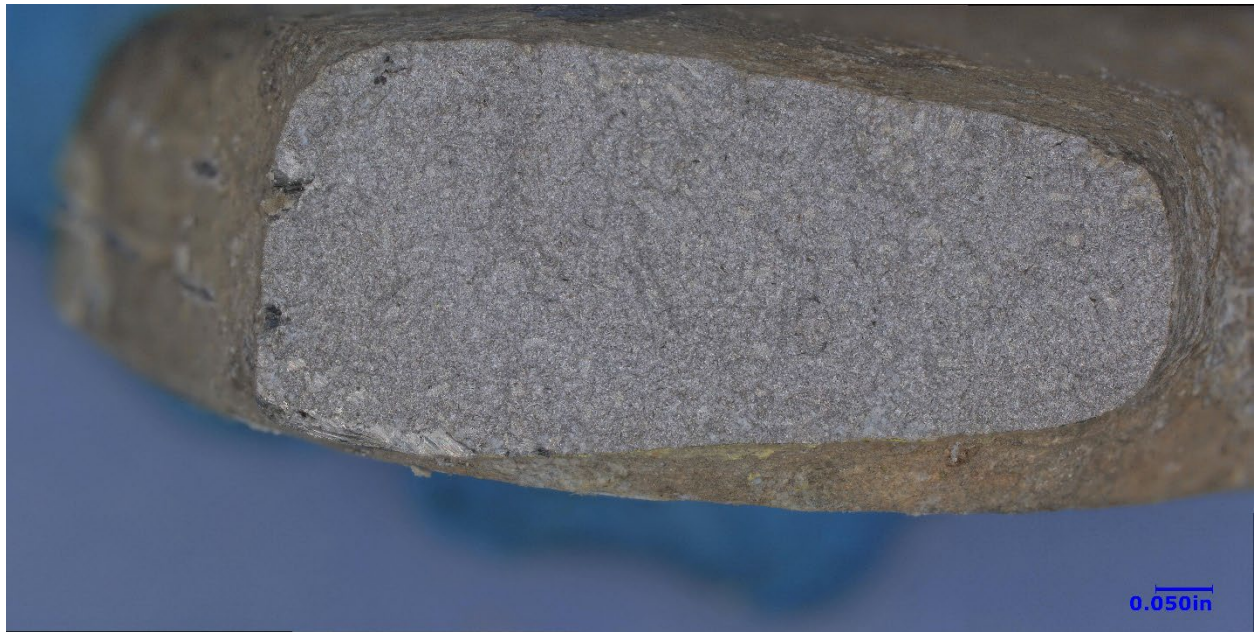
As illustrated in Figure 16, much of the fracture surfaces were flat and 90° in orientation relative to the fractured arms, though parallel to the rudder arm cylinder. Figure 17 shows the dull luster and rough texture of the fracture surface. The surfaces were examined using SEM, and the composition was examined using EDS. The composition of the link was consistent with 319 aluminum-silicon casting alloy.

**Figure 16.** Closer view of the fracture surface in Figure 15.

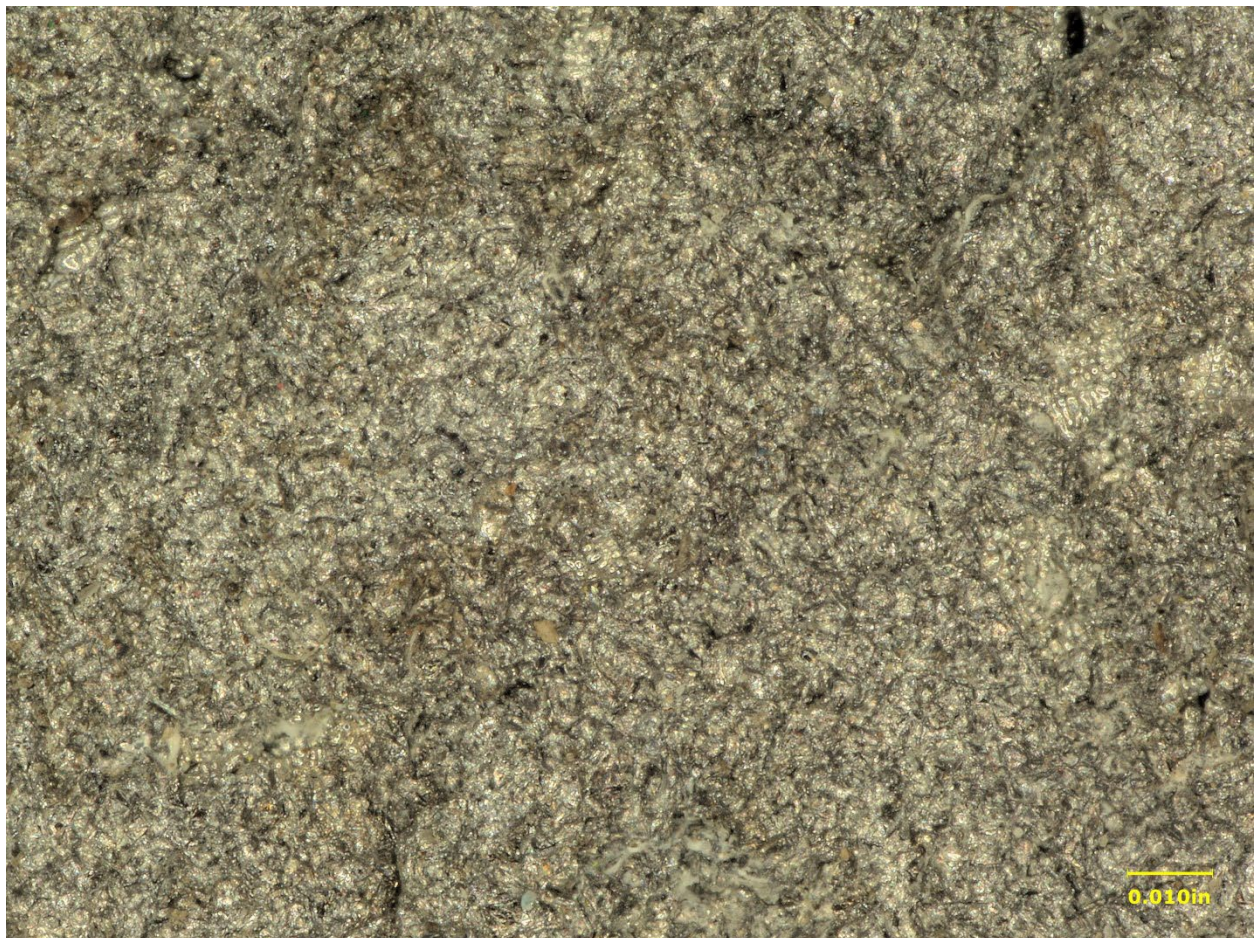
**Figure 17.** Typical area of the fracture surface in Figure 16.

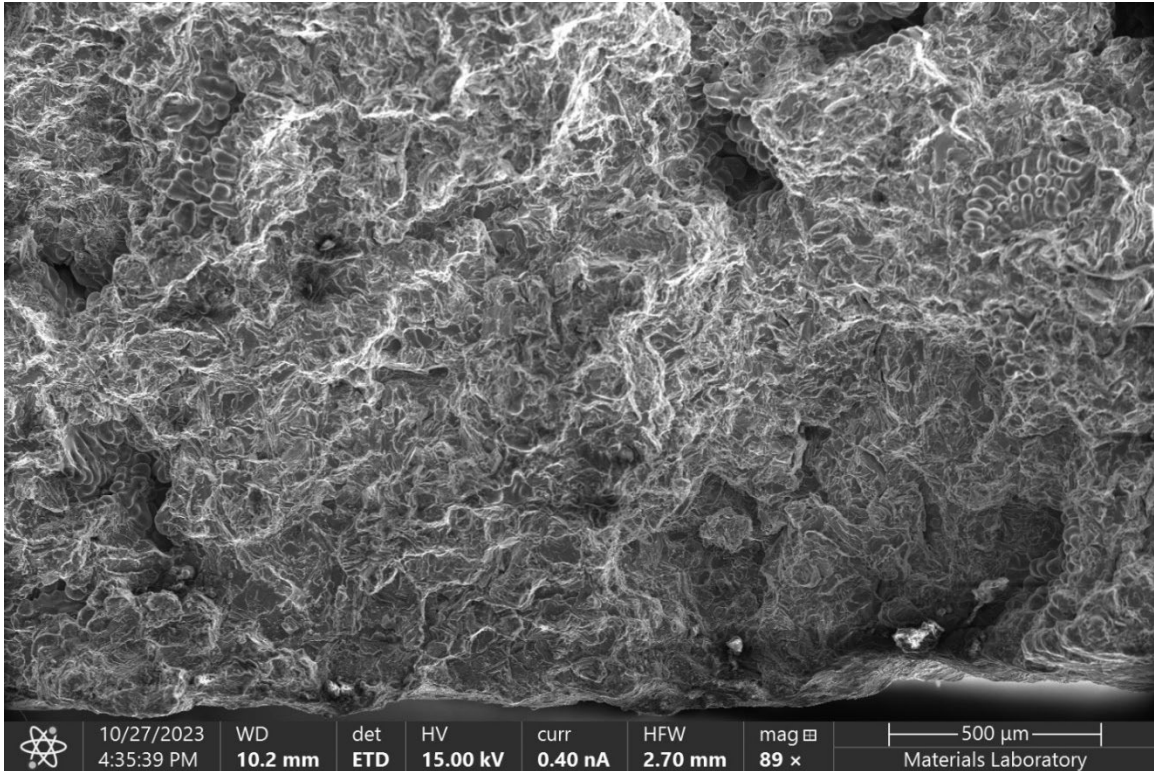
As shown in Figures 18 and 19, the surface exhibited roughness and faceted regions, consistent with the constituents of the casting. The lighter areas shown in the backscattered view of Figure 19 were consistent with silicon-rich phases present in the microstructure.<sup>4</sup> Figure 20 shows a closer view of one of the silicon-rich phases on the fracture surface, revealing a star-shaped radial pattern, typical of fracture of these phases. The surrounding aluminum-rich matrix exhibited fine dimpled rupture, as typified in Figure 21. These features were consistent with overstress fracture of the link.

**Figure 18.** SE micrograph of the lower right edge of the casting fracture surface.

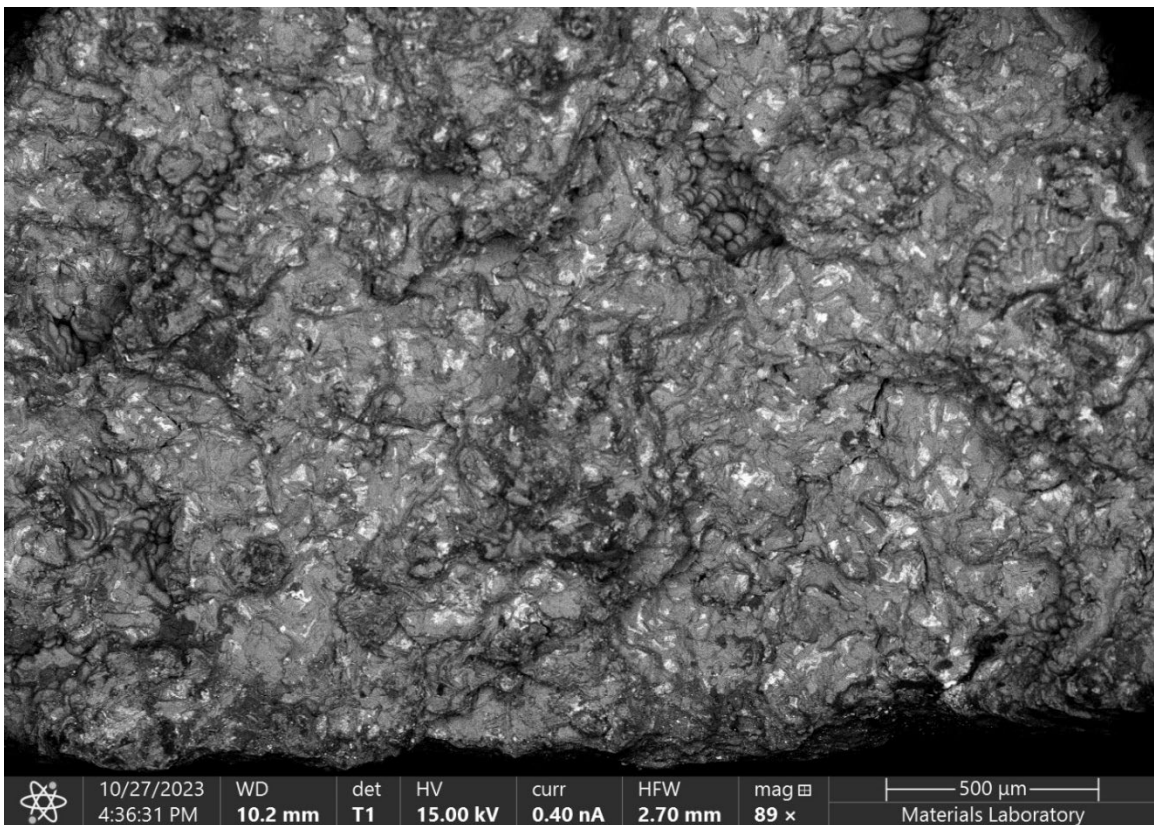
**Figure 19.** BE micrograph of Figure 18, showing the Si-rich regions (white).

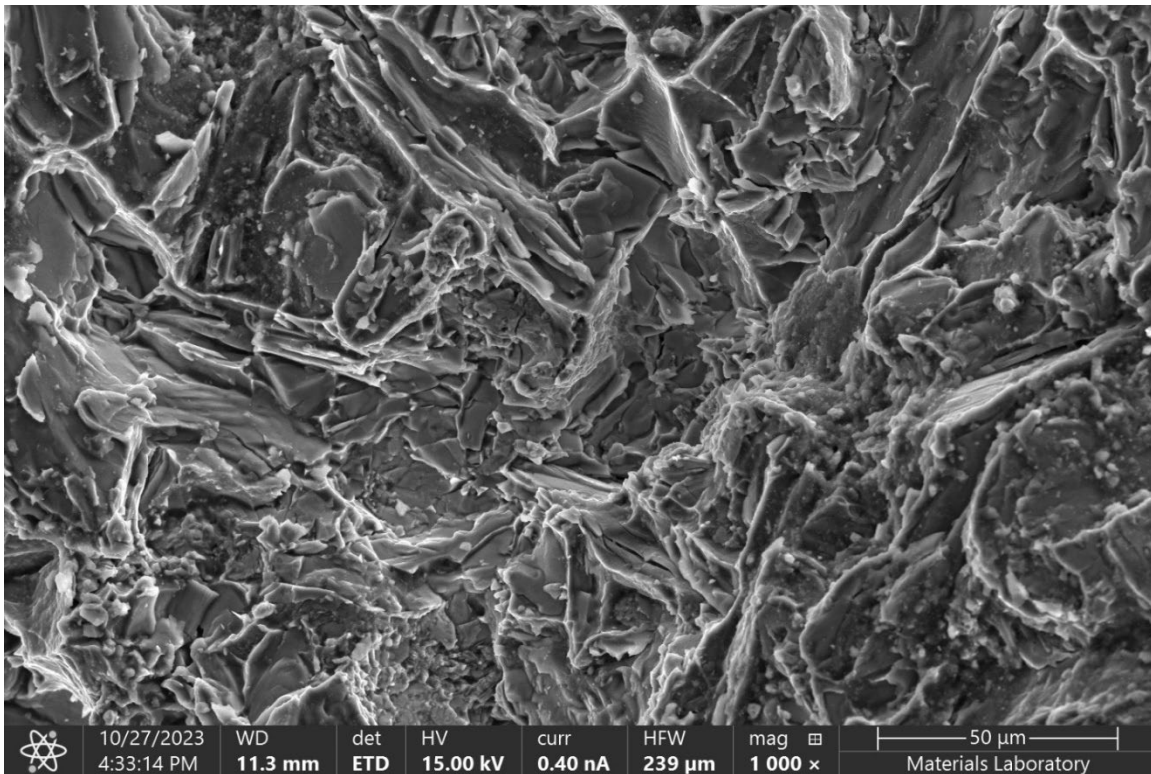
**Figure 20.** SE micrograph of a Si-rich region, showing dimpled rupture.

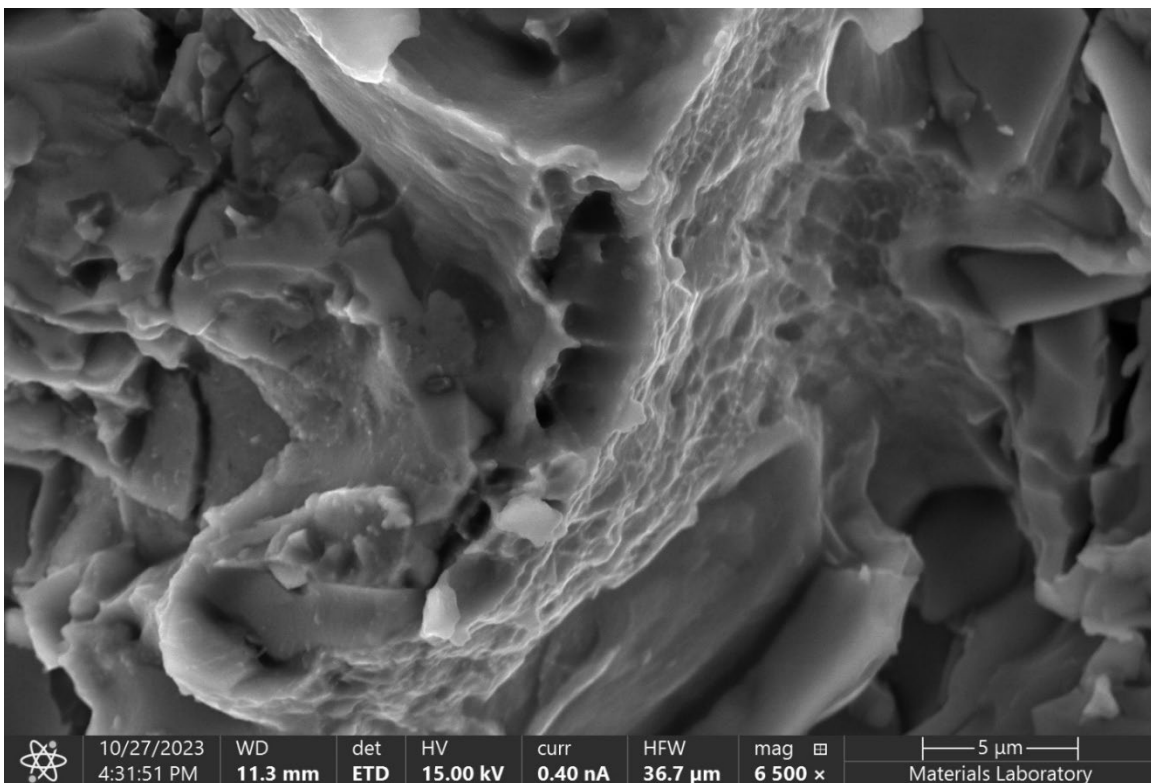
**Figure 21.** SE micrograph of dimpled rupture from Figure 20.
