Office of Aviation Safety  
Eastern Region

**Photo Array**

**ERA23LA259**

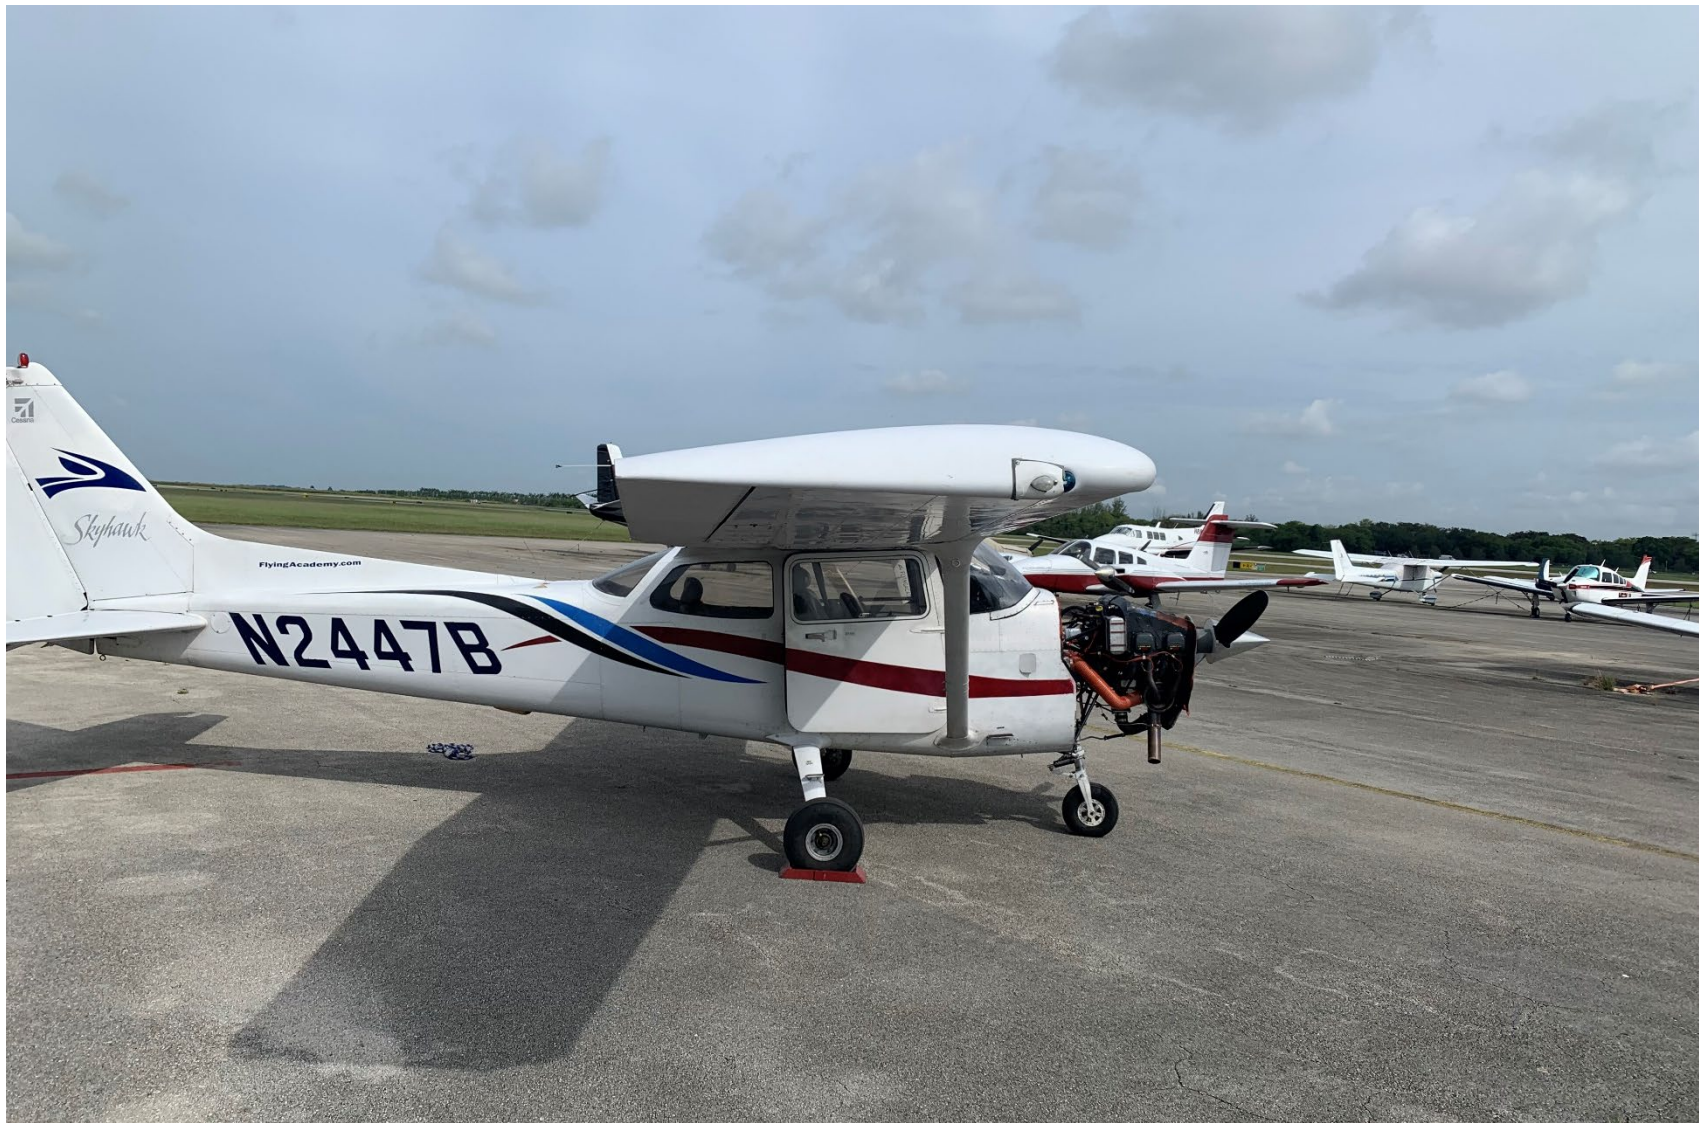
**Photo 1 – View of airplane from right wing (photo courtesy of FAA)**

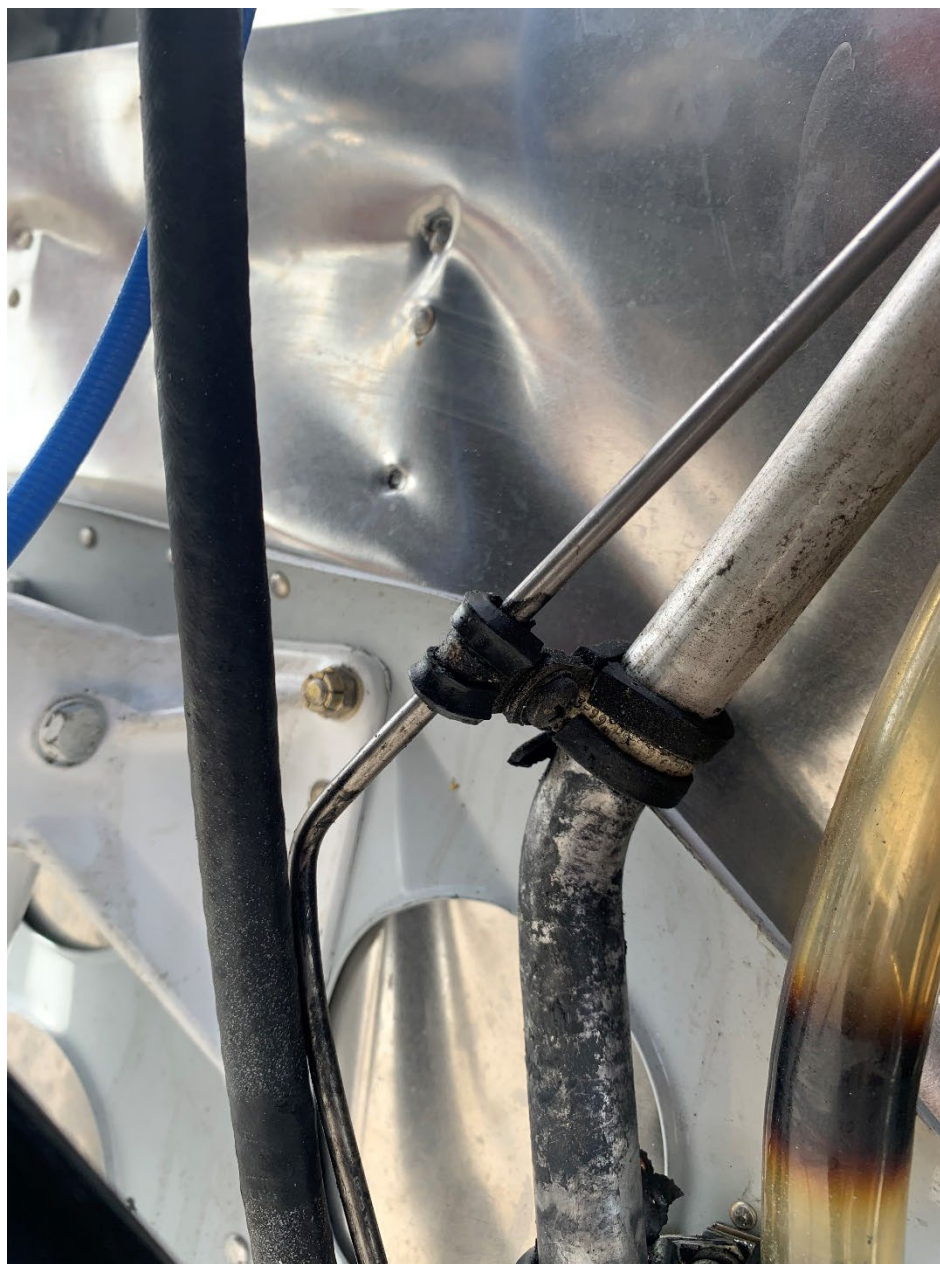
**Photo 2 – View of firewall damage (photo courtesy of FAA)**

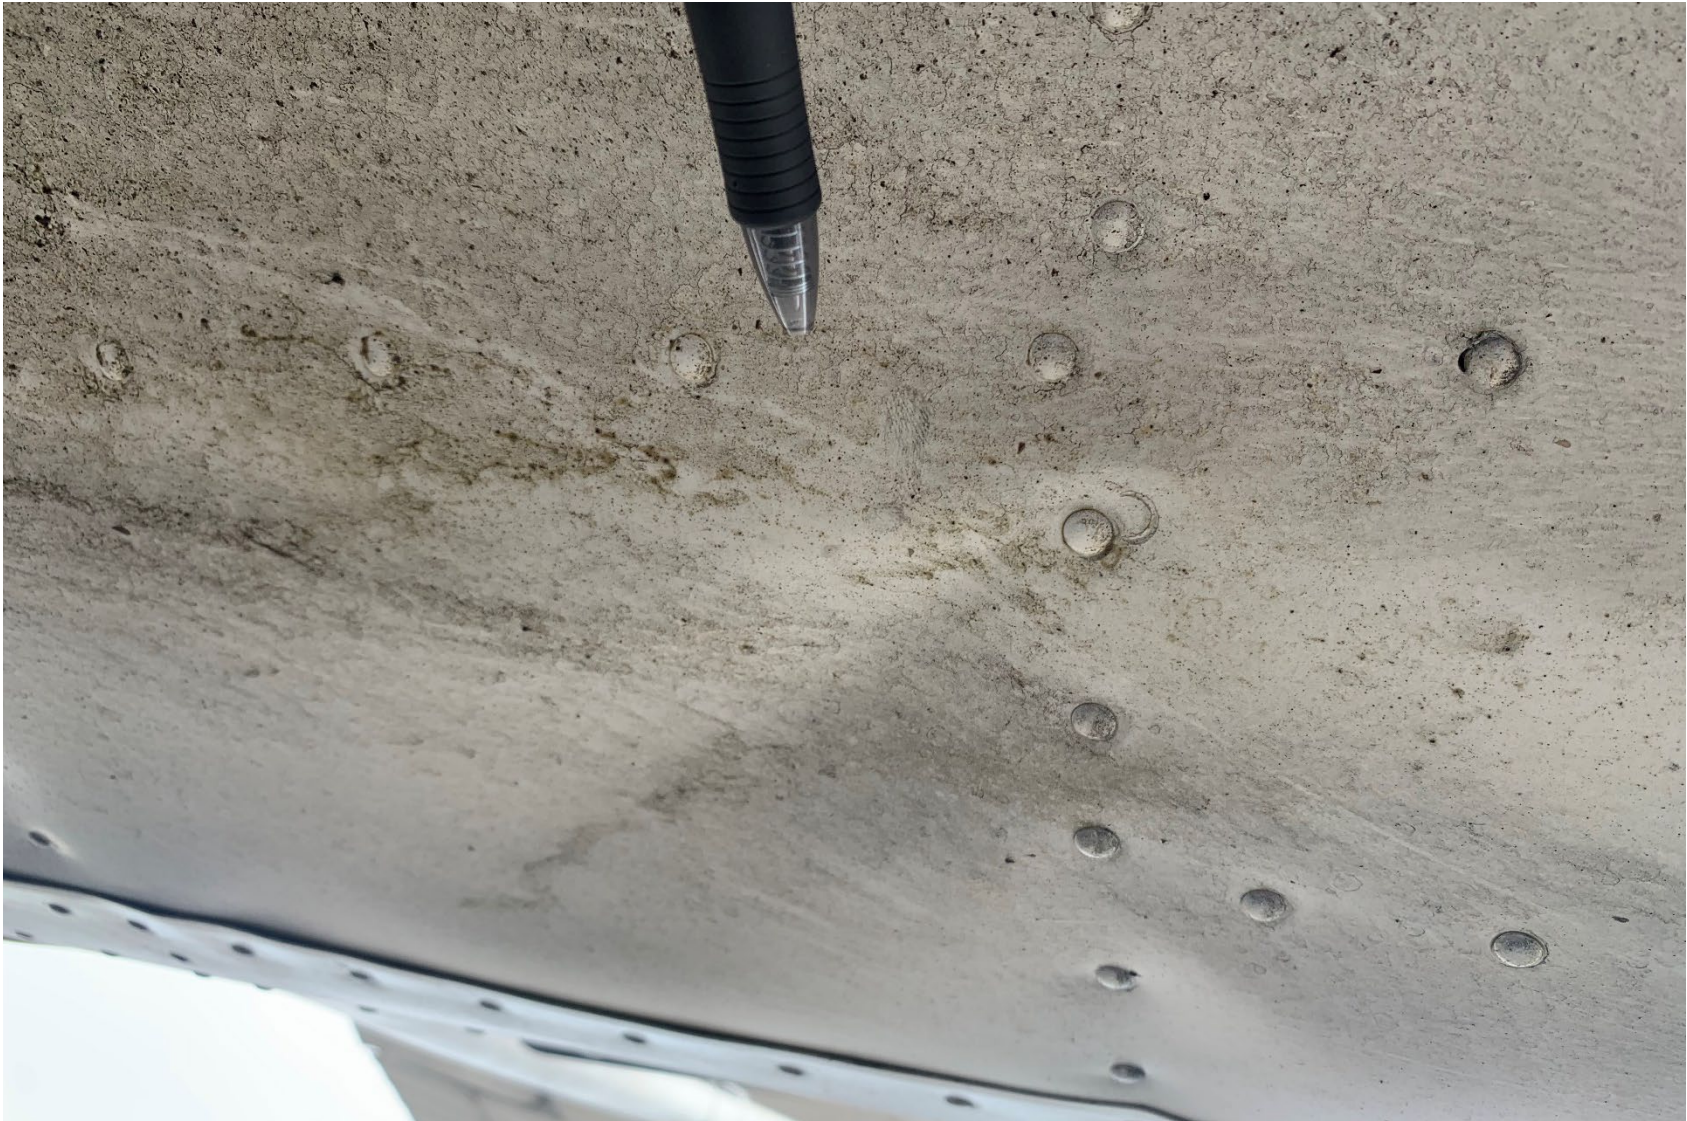
**Photo 3 – Close-up view of wrinkle in lower fuselage (photo courtesy of FAA)**
