# National Transportation Safety Board

ERA23LA261

## **COCKPIT VOICE RECORDER**

Location: Panama City, Florida  
Date: June 6, 2023  
Time: 20:17 eastern daylight time (EDT)  
Airplane: Dassault-Breguet Falcon 10, PREMIER LJ40 INC, N87RT

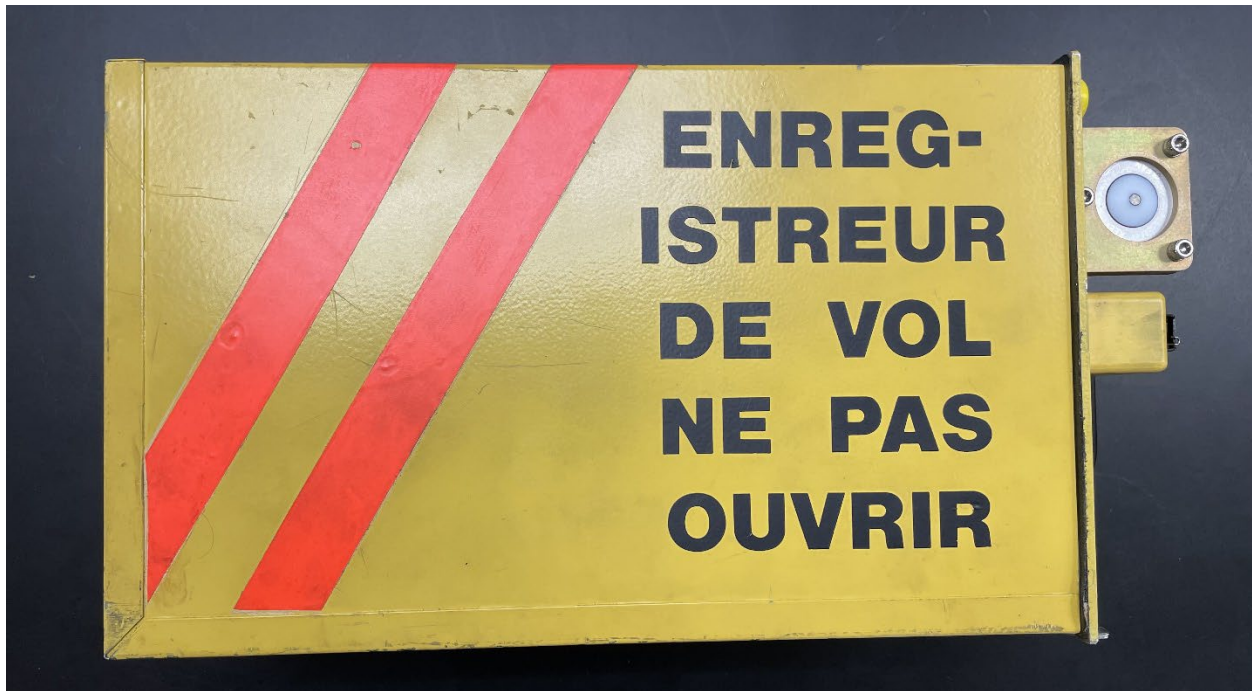
The CVR arrived at the laboratory with no visible external damage, as shown in Figure 1.

**Figure 1.** B&D Instruments CVR, as received.

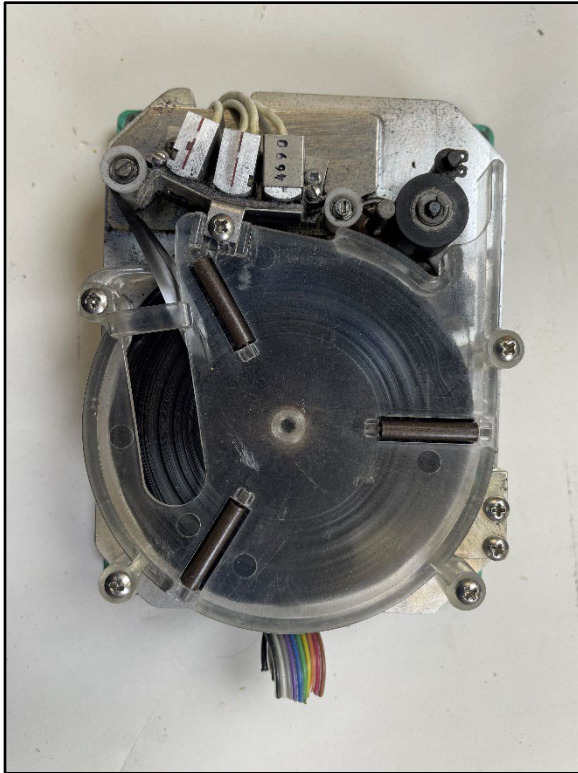
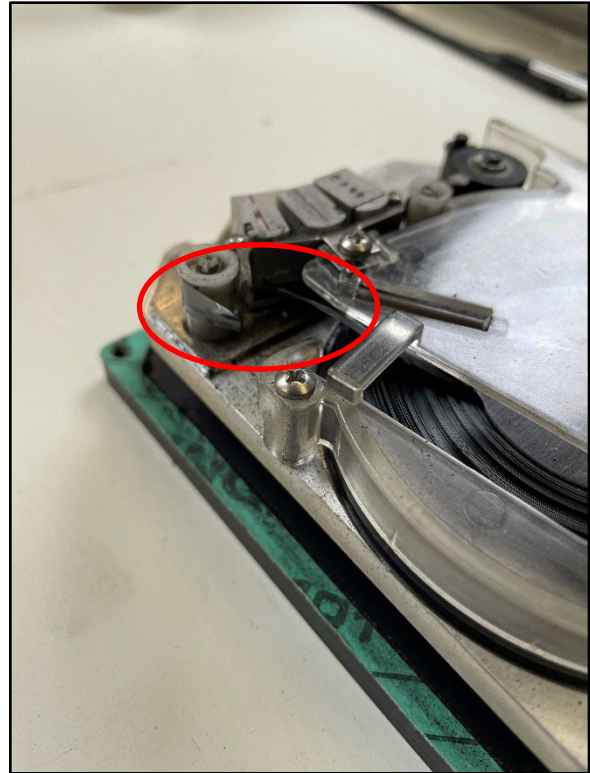
The tape was severed near the erase head and portions of the tape showed other signs of physical distortion. The tape was repaired, flattened, and loaded onto a new reel. Audio data from the tape was then successfully digitized using established lab procedures.

**Figure 2.** Magnetic tape surrounded by crash-protected casing (left) and severed magnetic tape (right, circled in red).

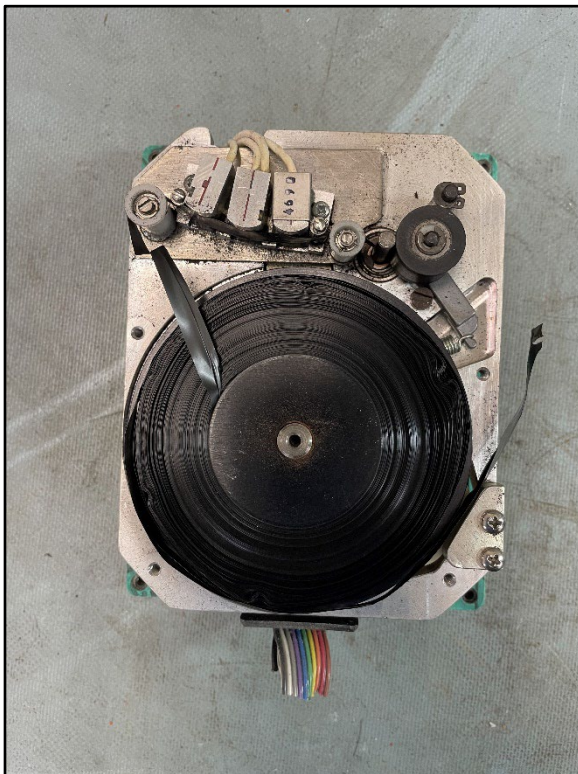
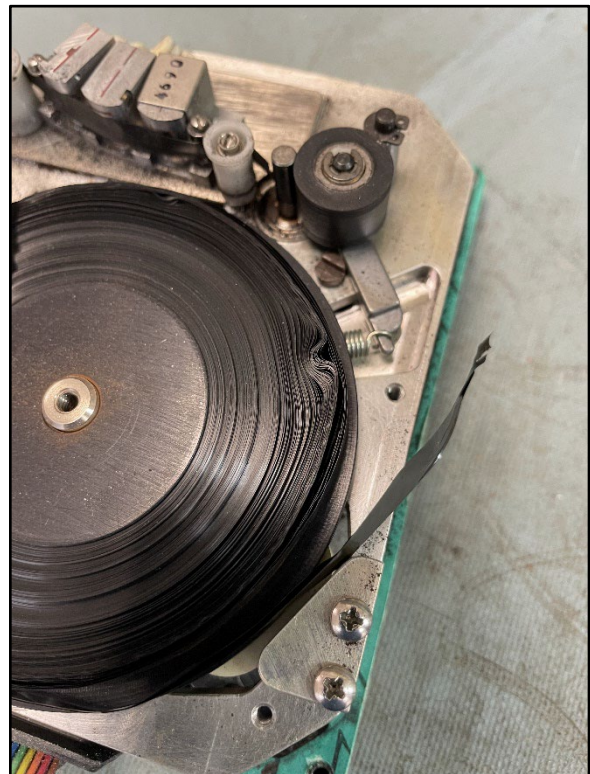
**Figure 3.** Magnetic tape with cover removed (left) and magnetic tape damage (right).
