ERA23LA261

## INVESTIGATION PHOTOGRAPHS

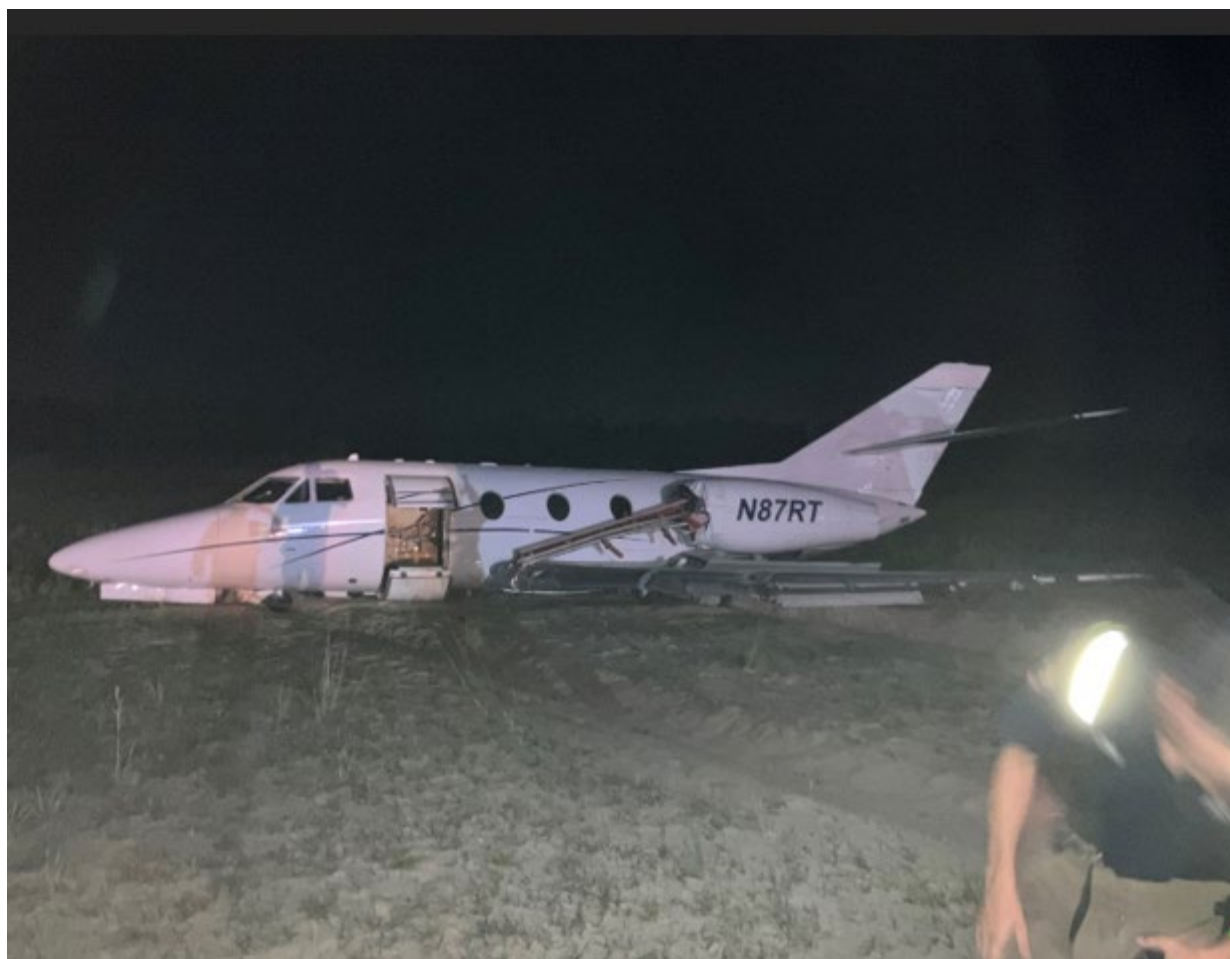
**Photograph 1 - Main Wreckage (Courtesy of KEPC ARFF)**

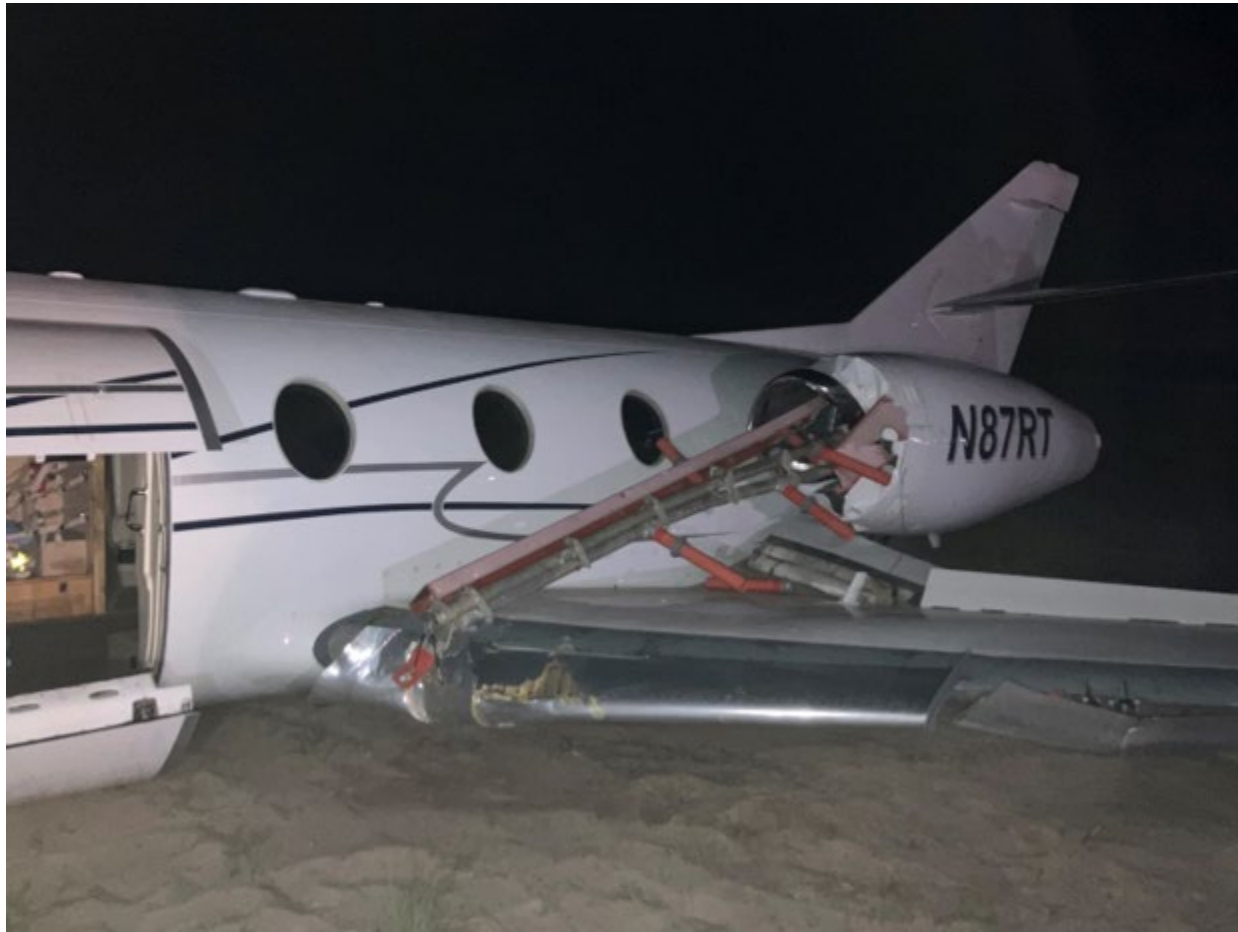
**Photograph 2 - Left Wing and Engine (Courtesy of KEPC ARFF)**

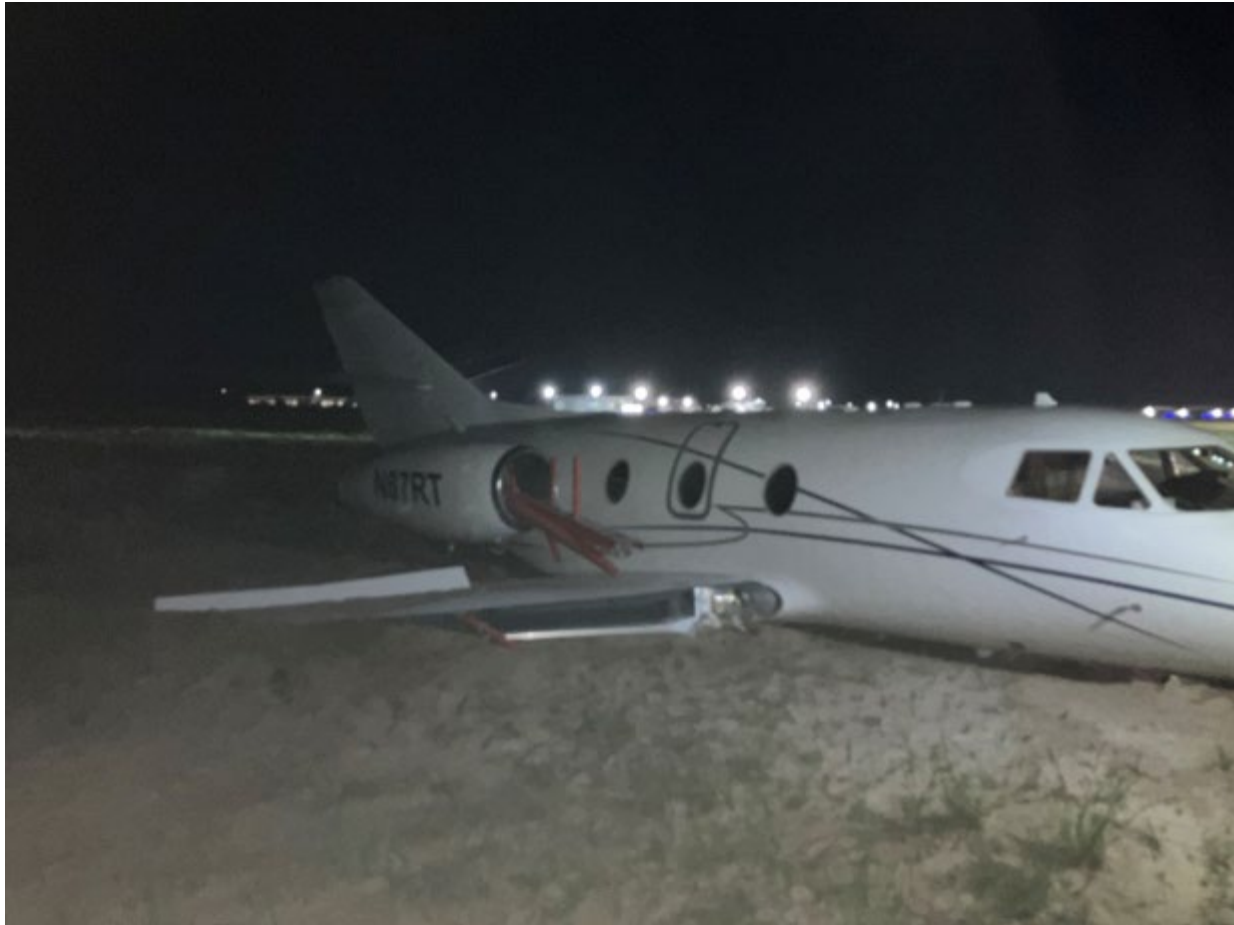
**Photograph 3 - Right Wing and Engine (Courtesy of KEPC ARFF)**

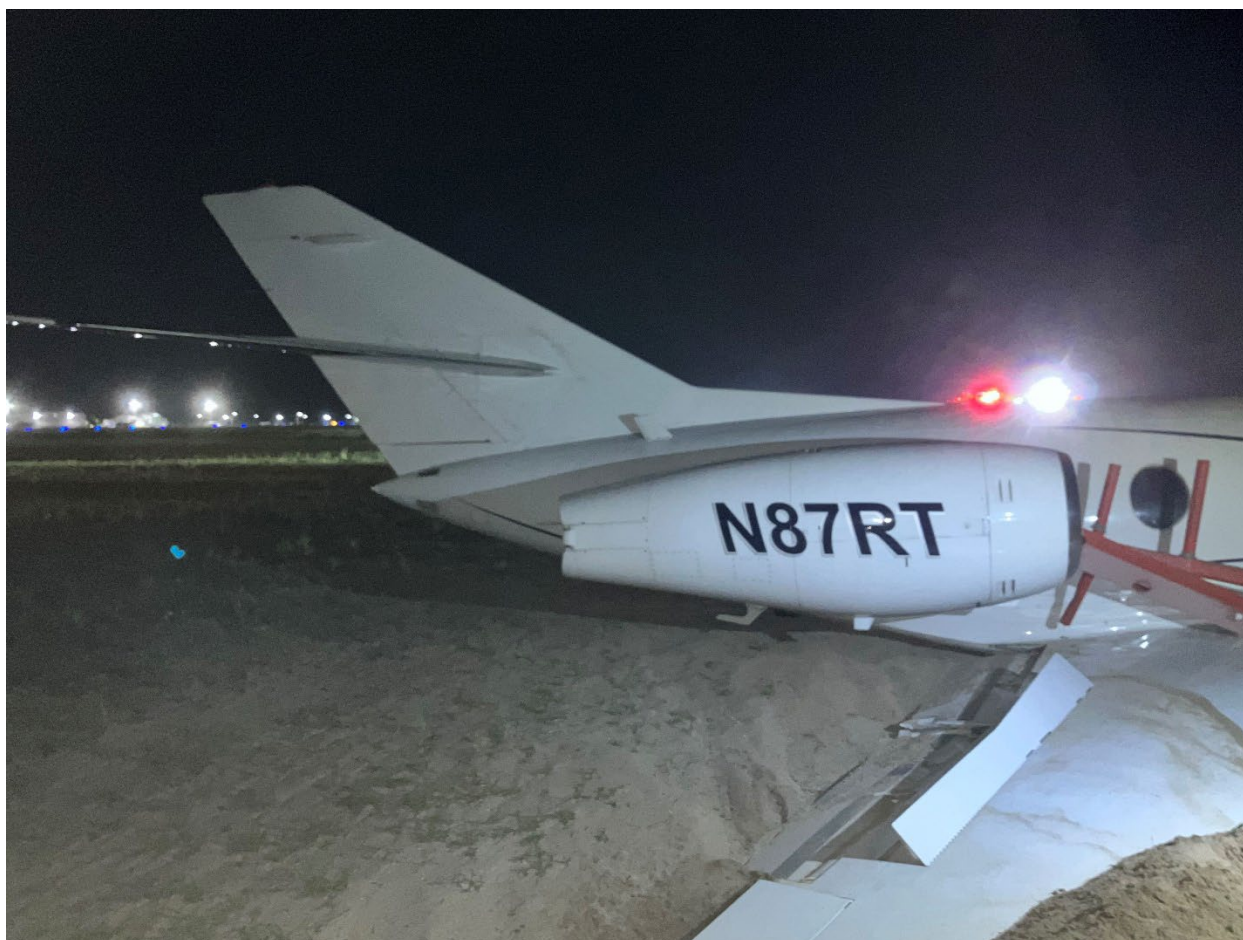
**Photograph 4 - Right Wing and Empennage (Courtesy of KEPC ARFF)**

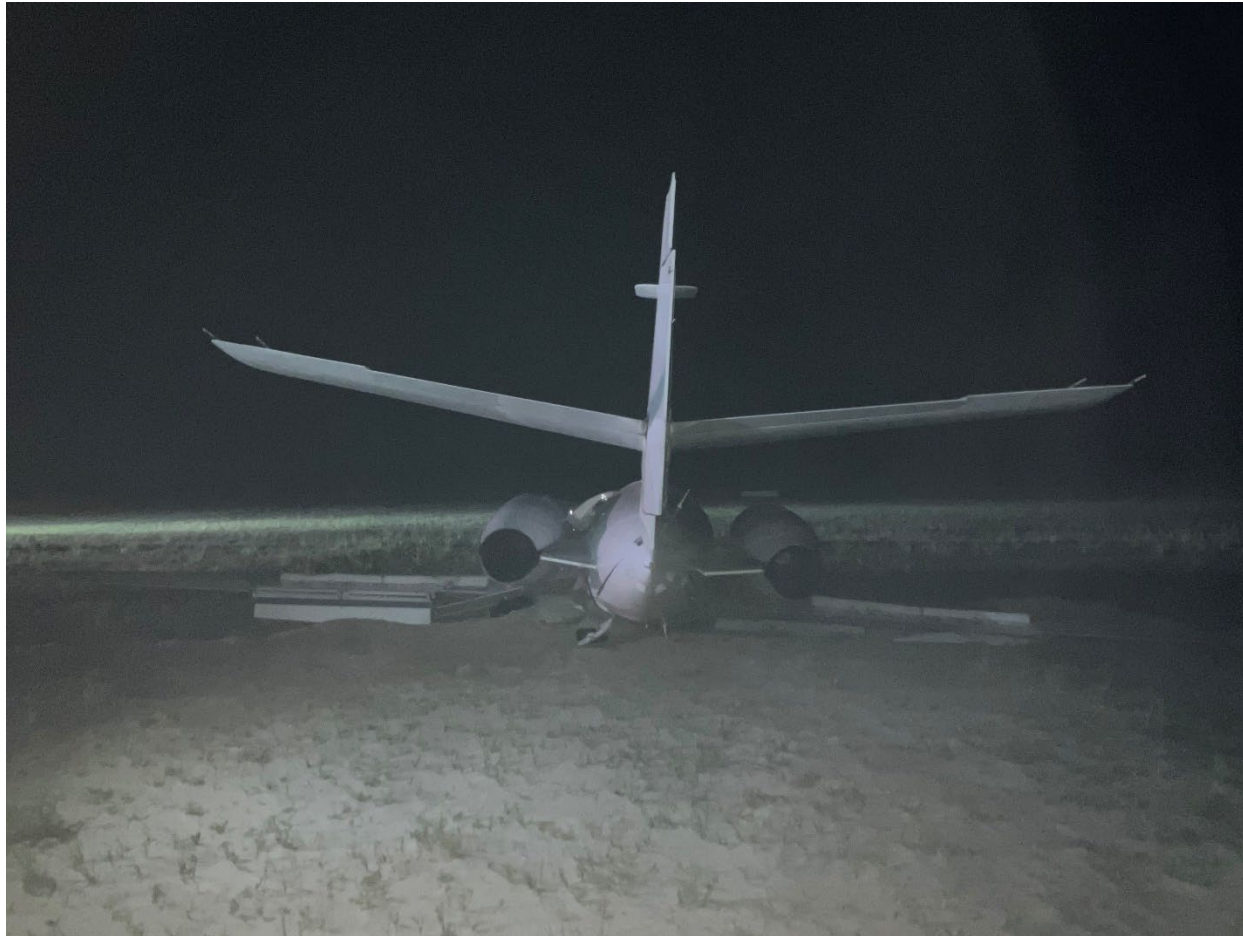
**Photograph 5 - Rear View (Courtesy of KEPC ARFF)**

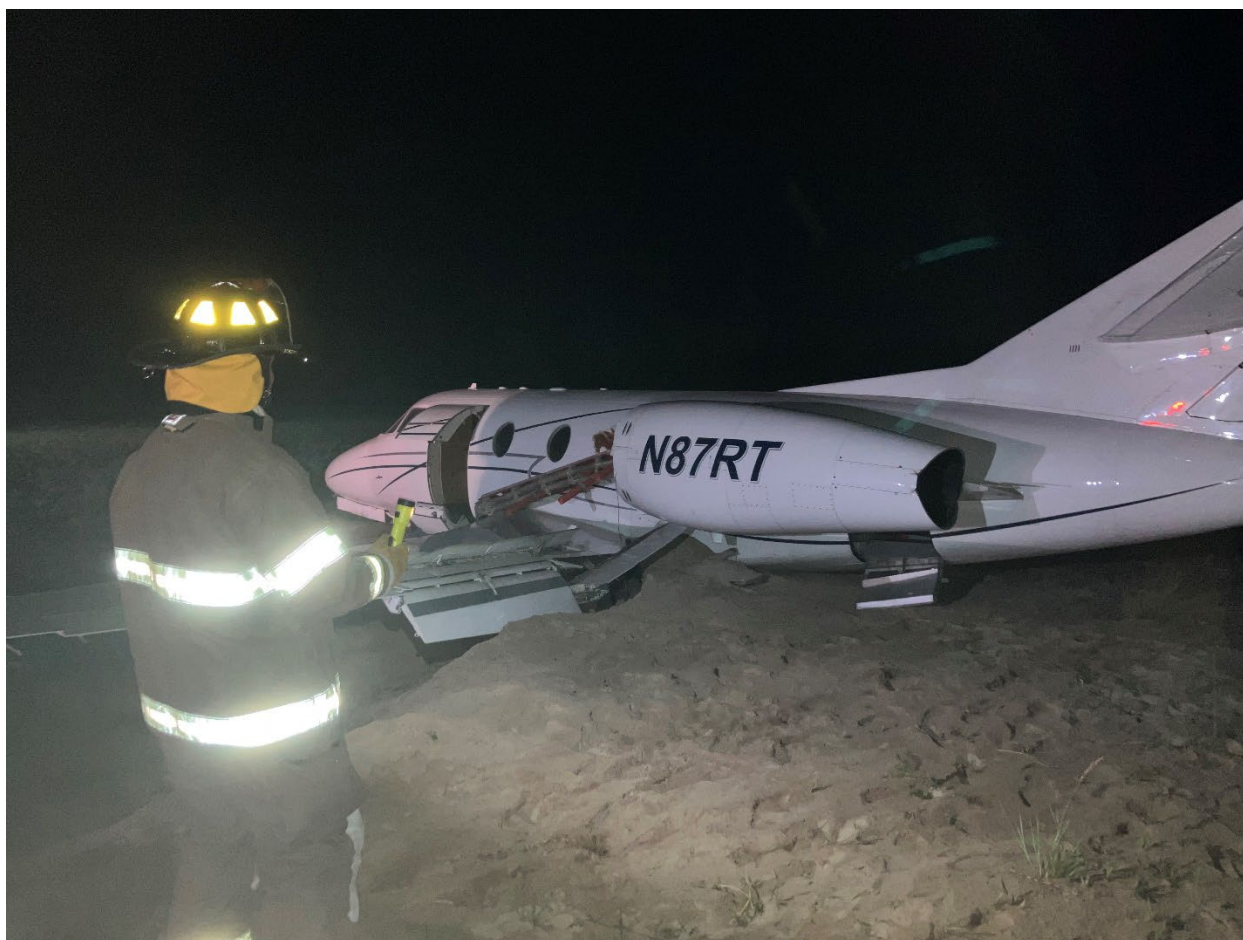
**Photograph 6 - Left Rear View (Courtesy of KEPC ARFF)**

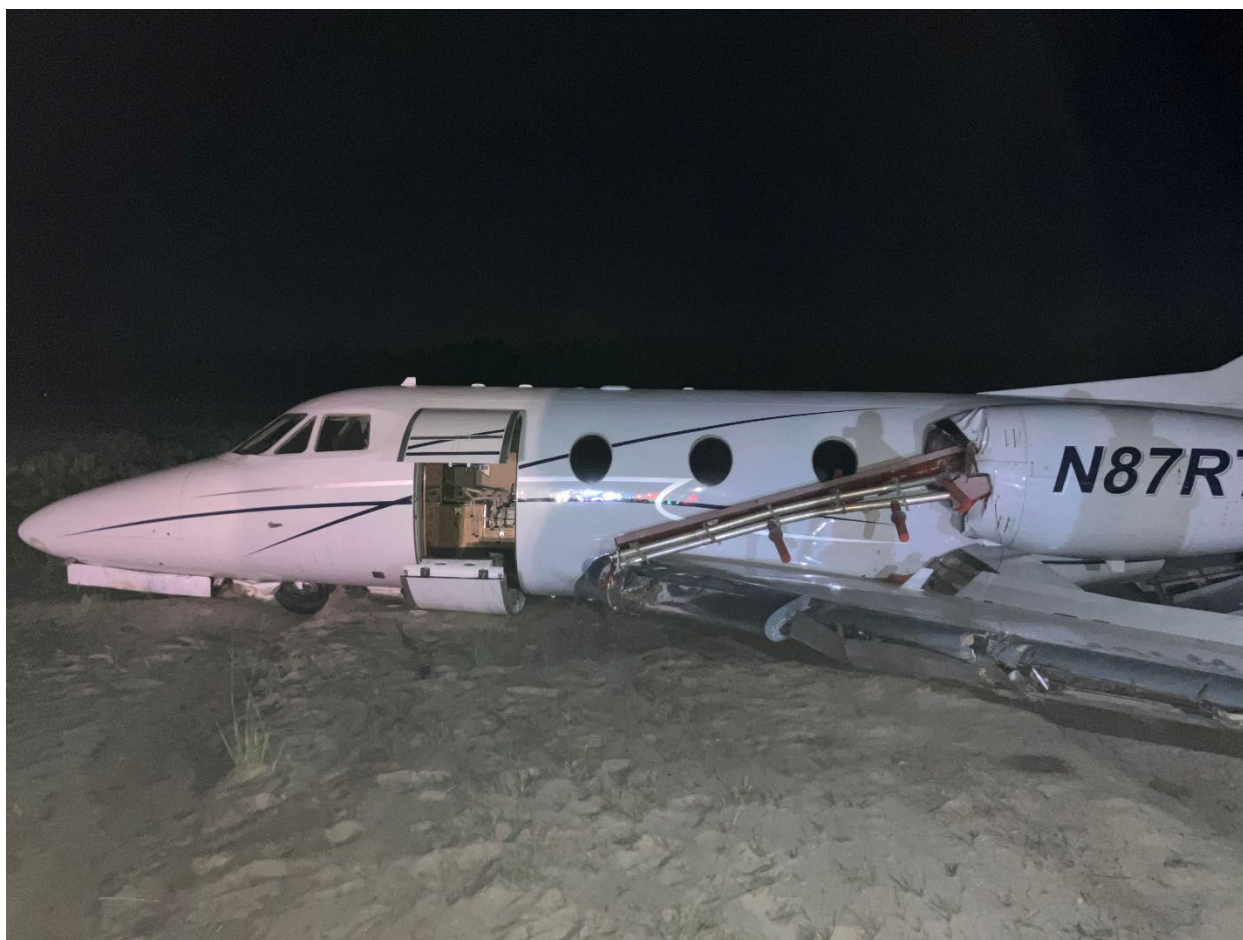
**Photograph 7 - Left Wing (Courtesy of KEPC ARFF)**

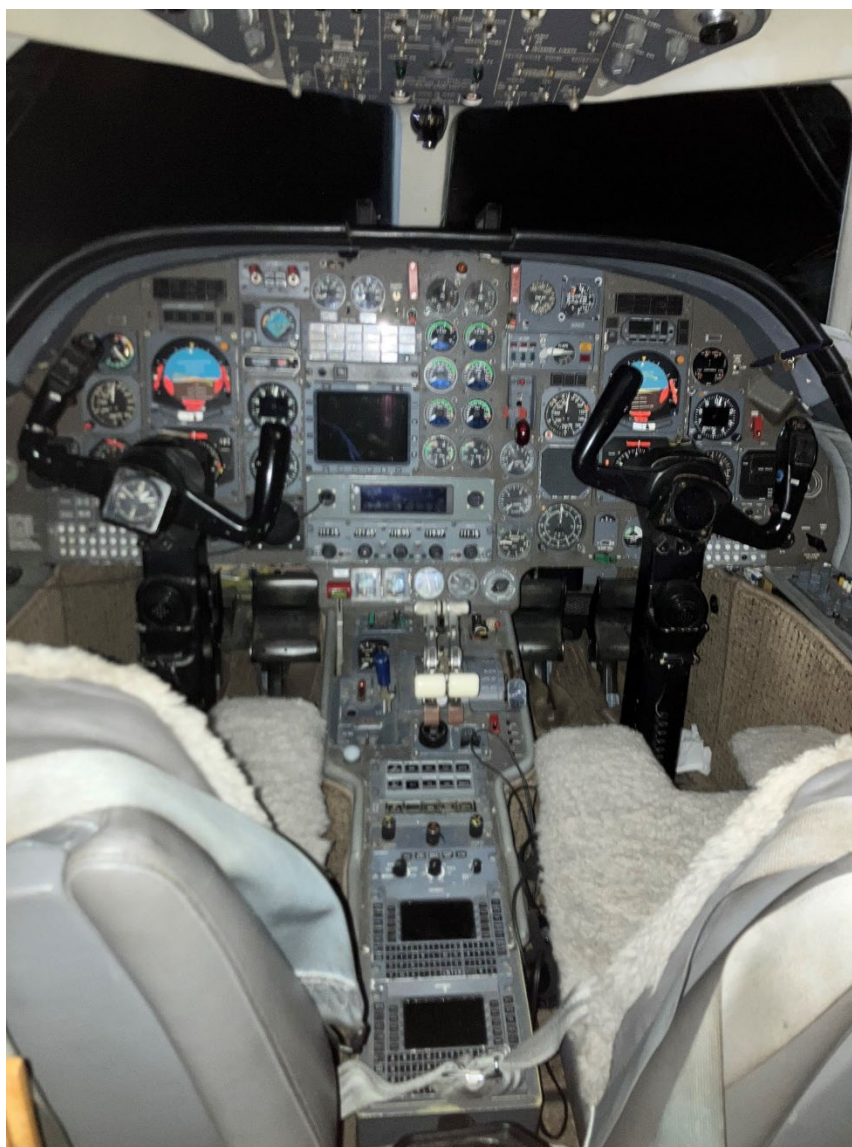
**Photograph 8 - Cockpit (Courtesy of KEPC ARFF)**

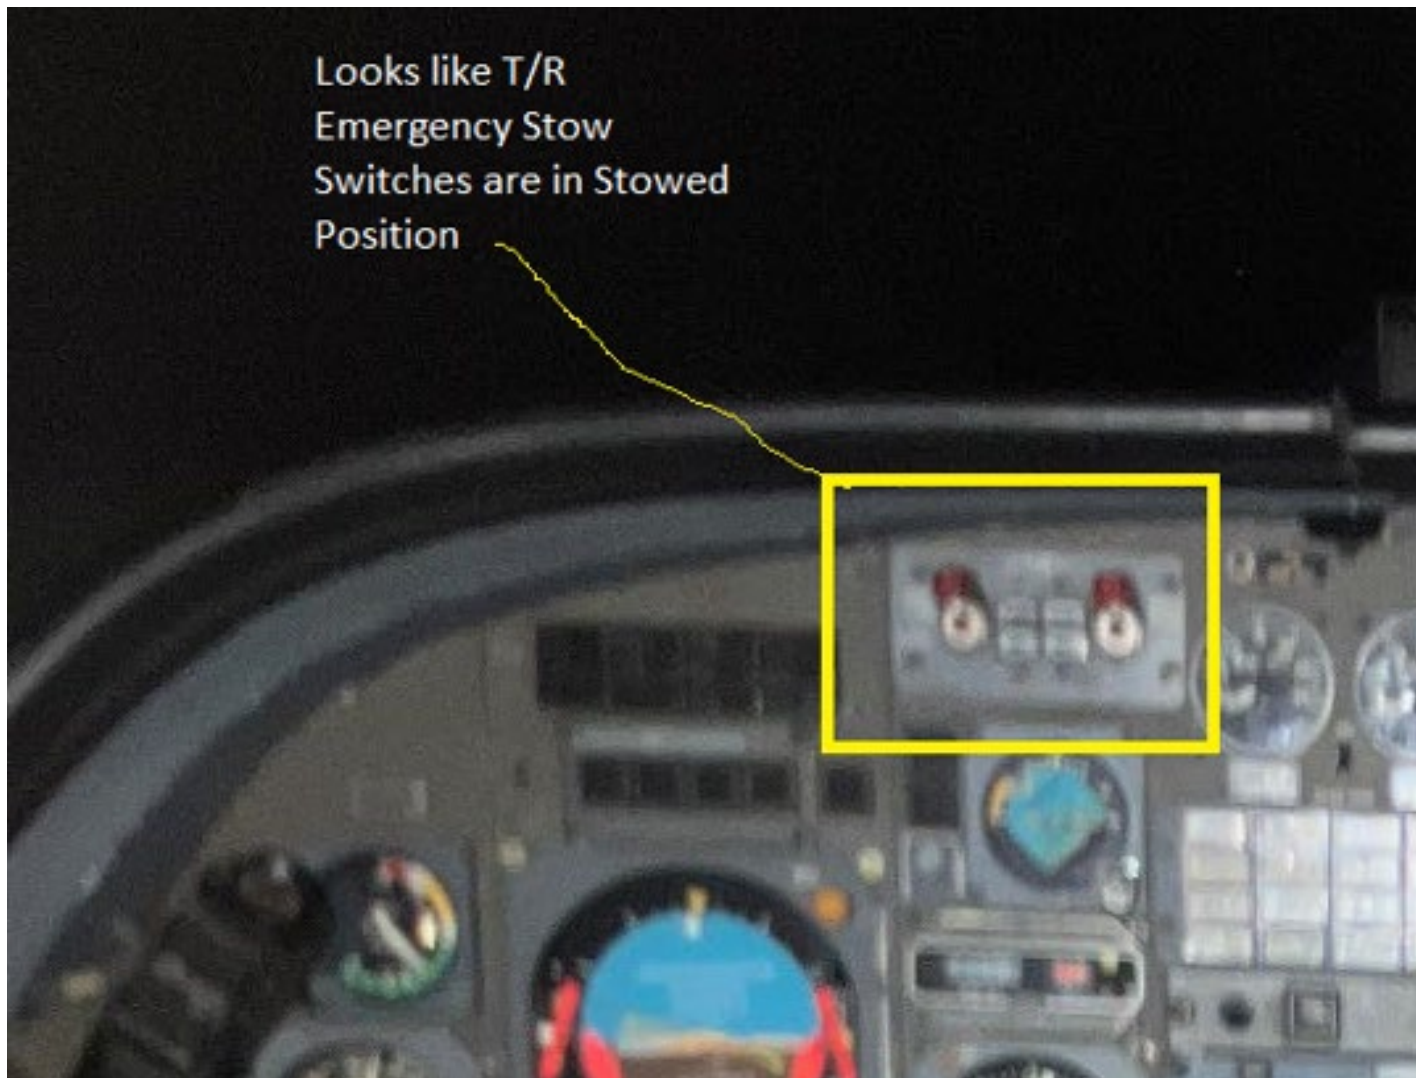
**Photograph 8 - Enhanced Cockpit Photo**

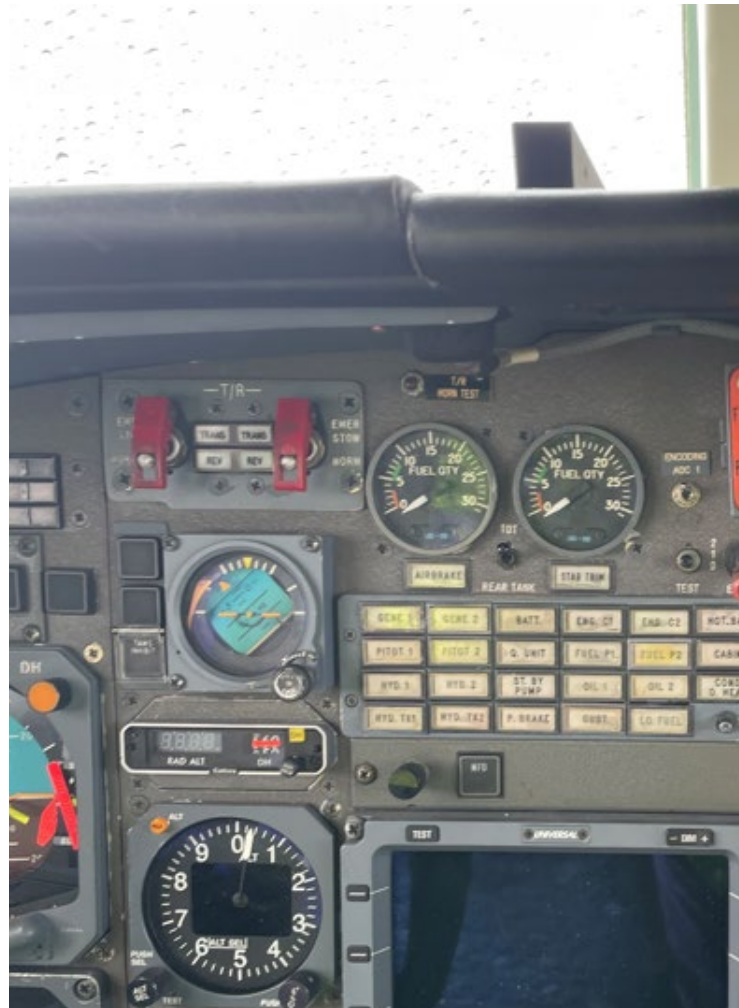
**Photograph 10 - T/R Emergency Stow Switches as Found Prior to Aircraft Recovery**

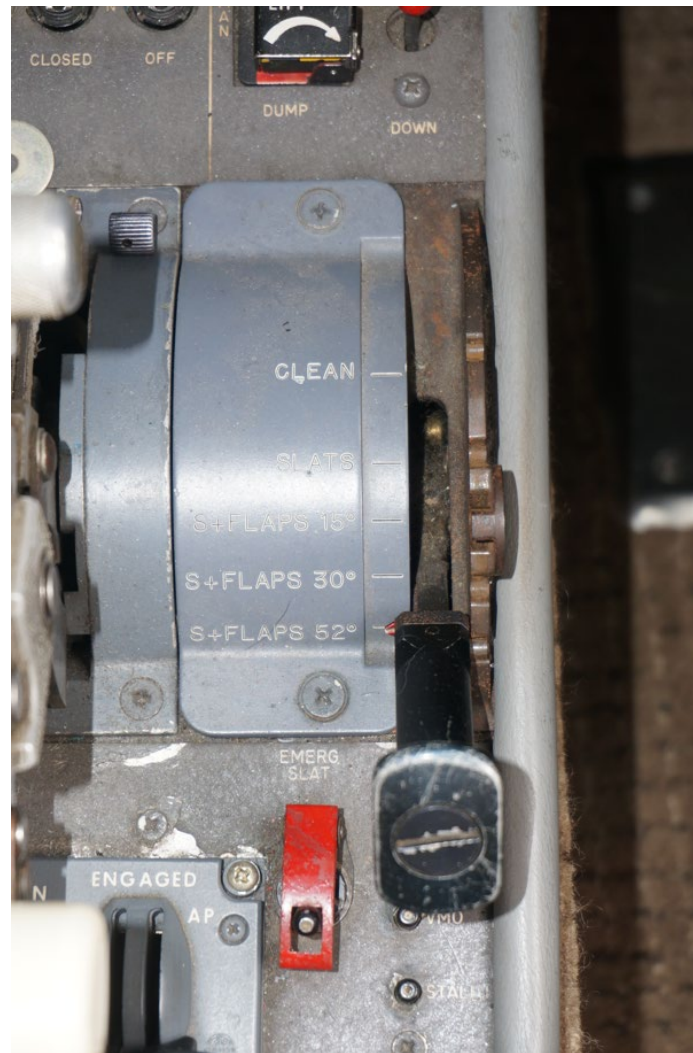
**Photograph 11 - Flap Handle**

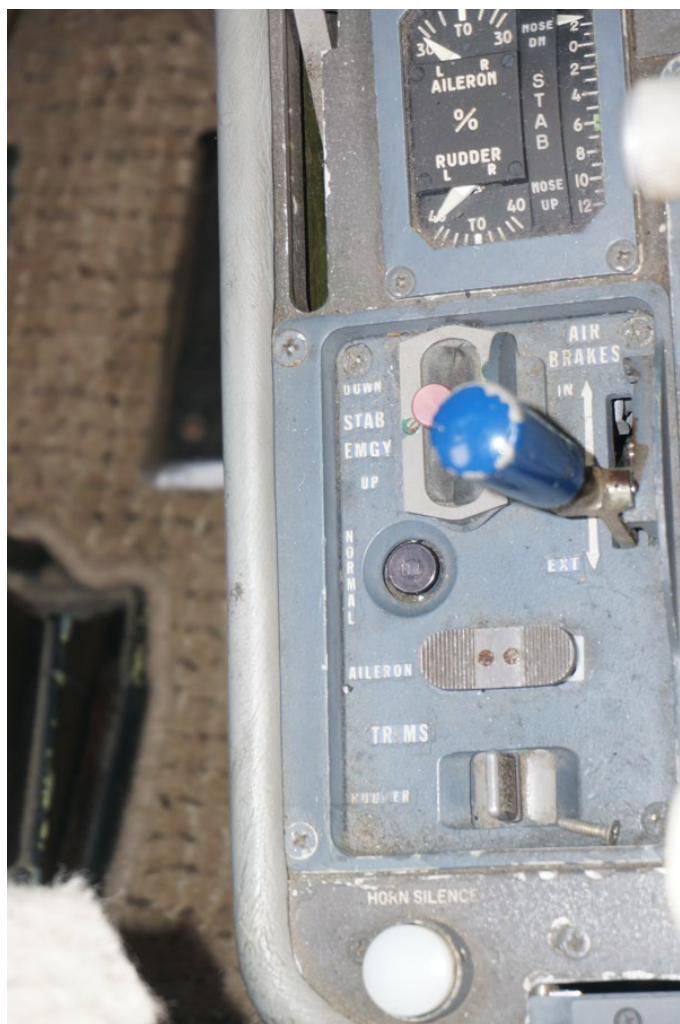
**Photograph 12 - Air Brakes (Spoilers)**

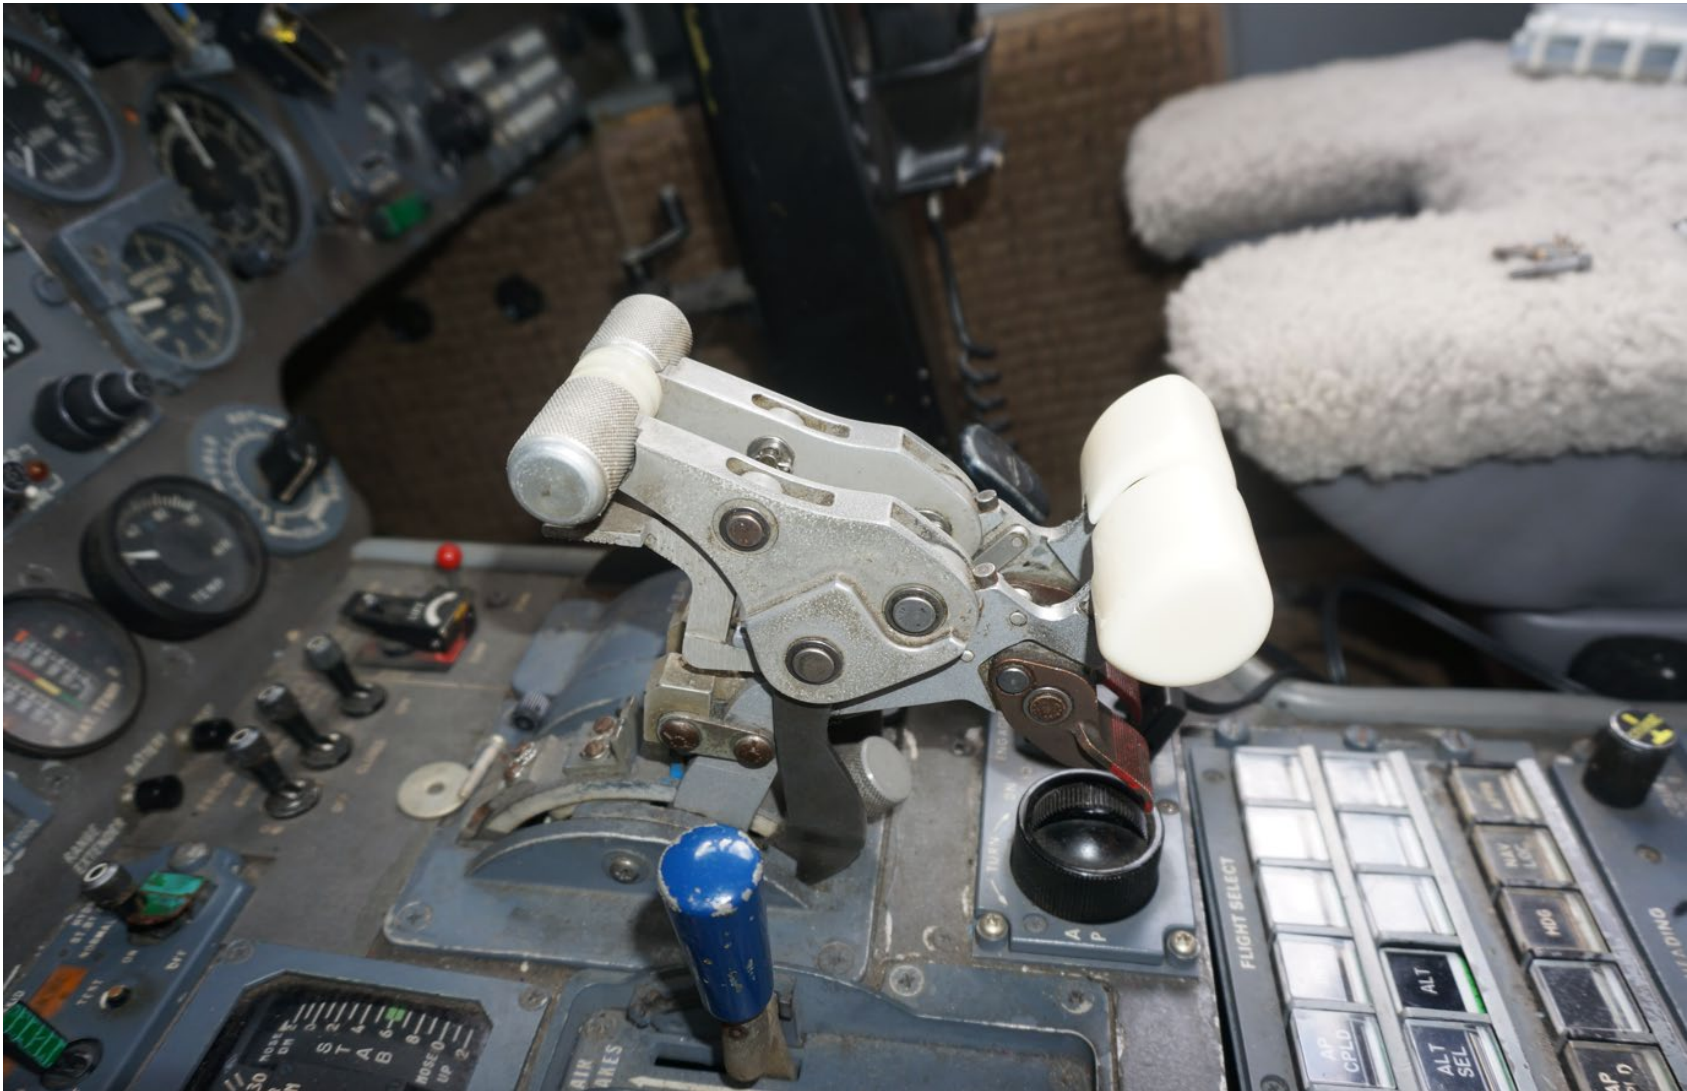
**Photograph 13 - Thrust Levers**

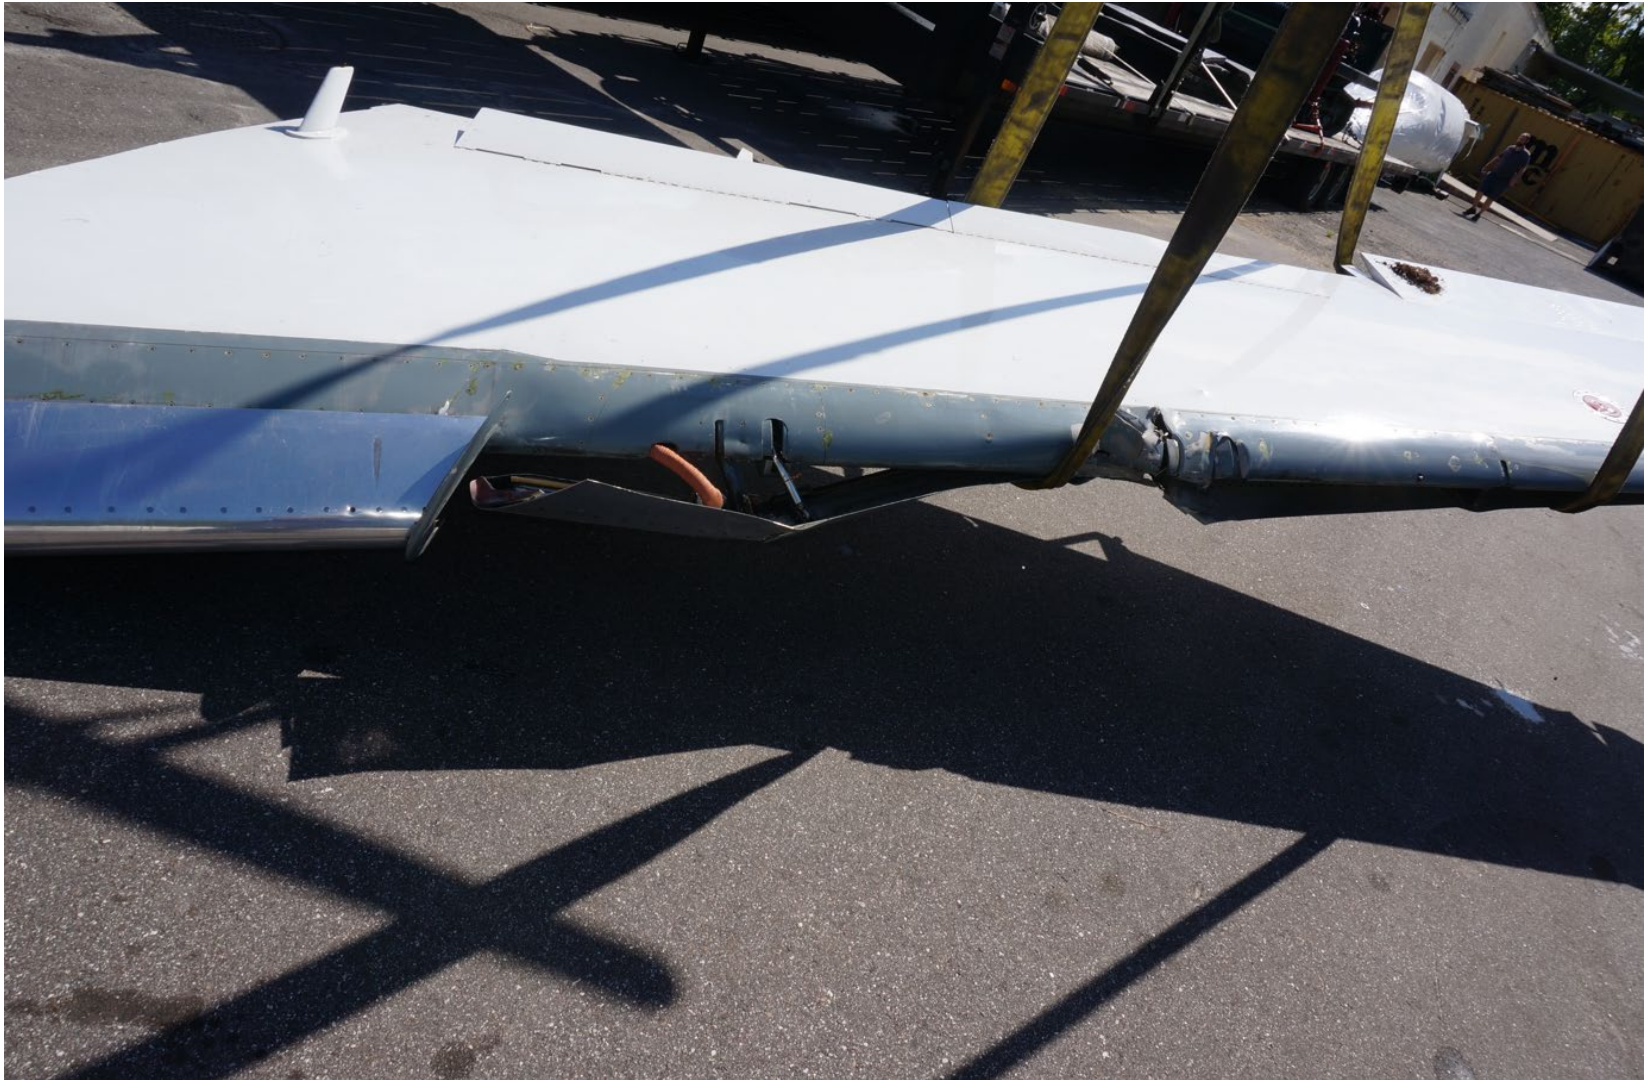
**Photograph 14 - Top of Left Wing**

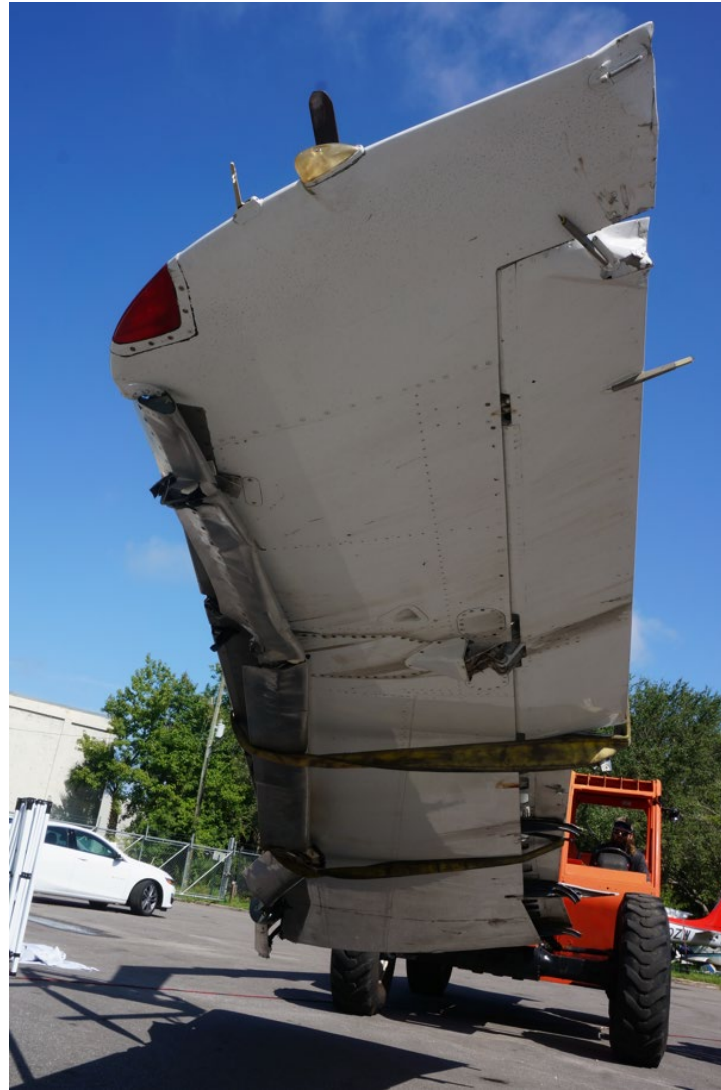
**Photograph 15 - Bottom of Left Wing**

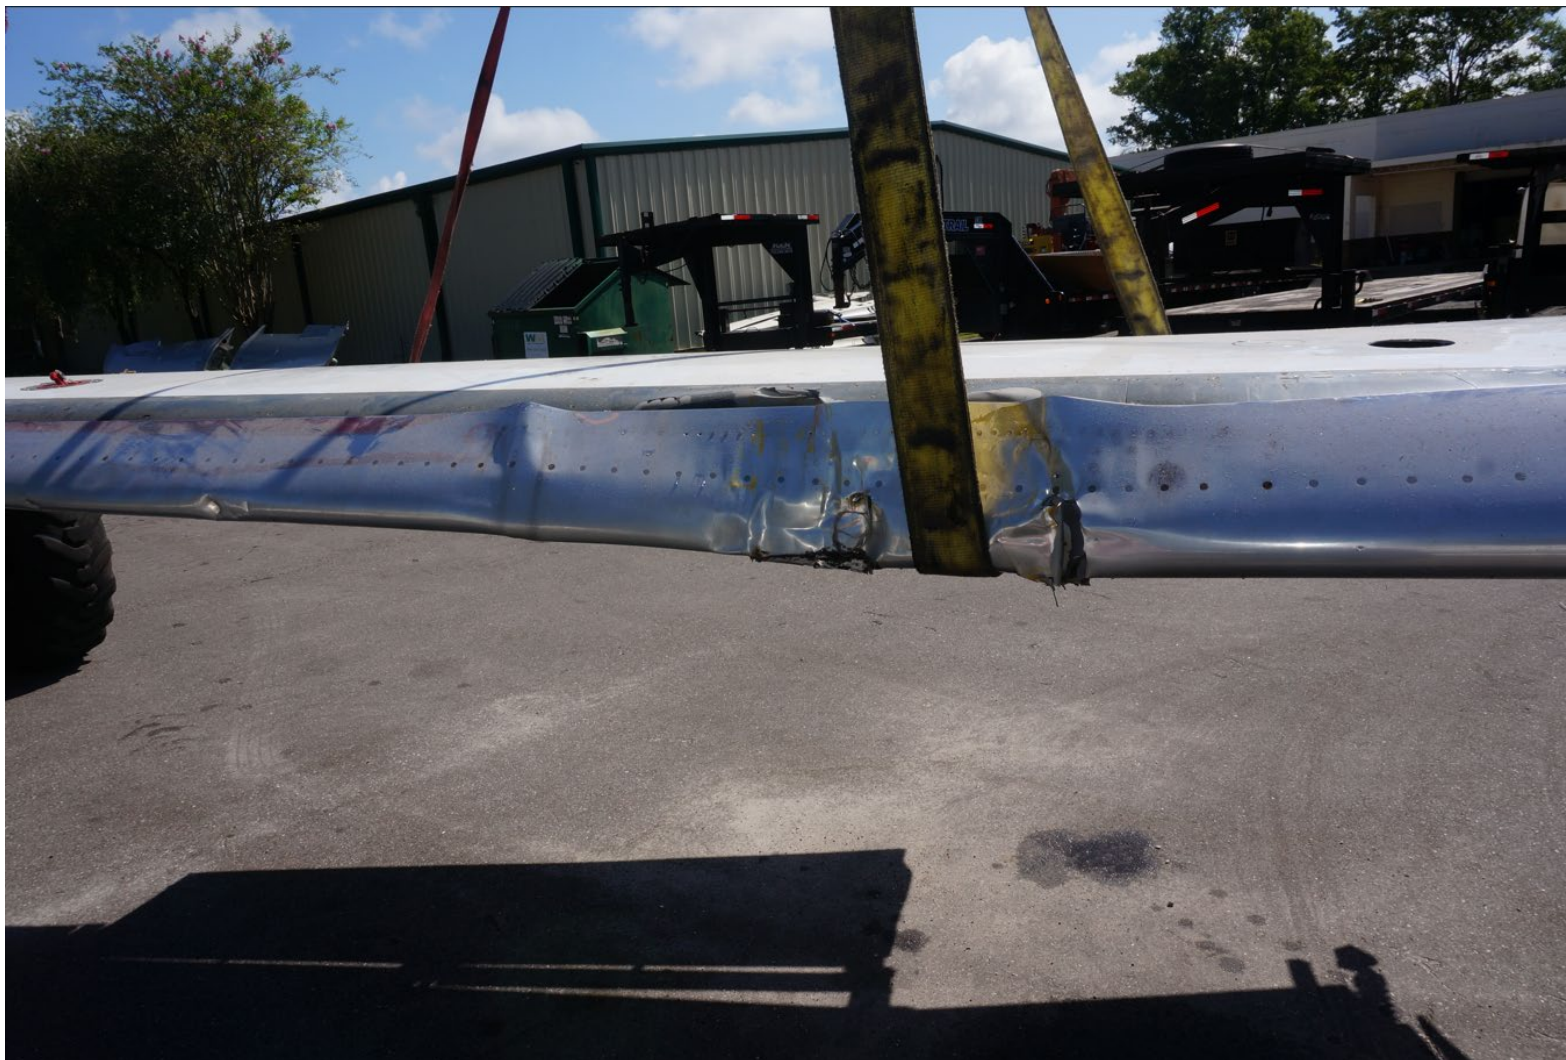
**Photograph 16 - Top Midspan Portion of Right Wing**

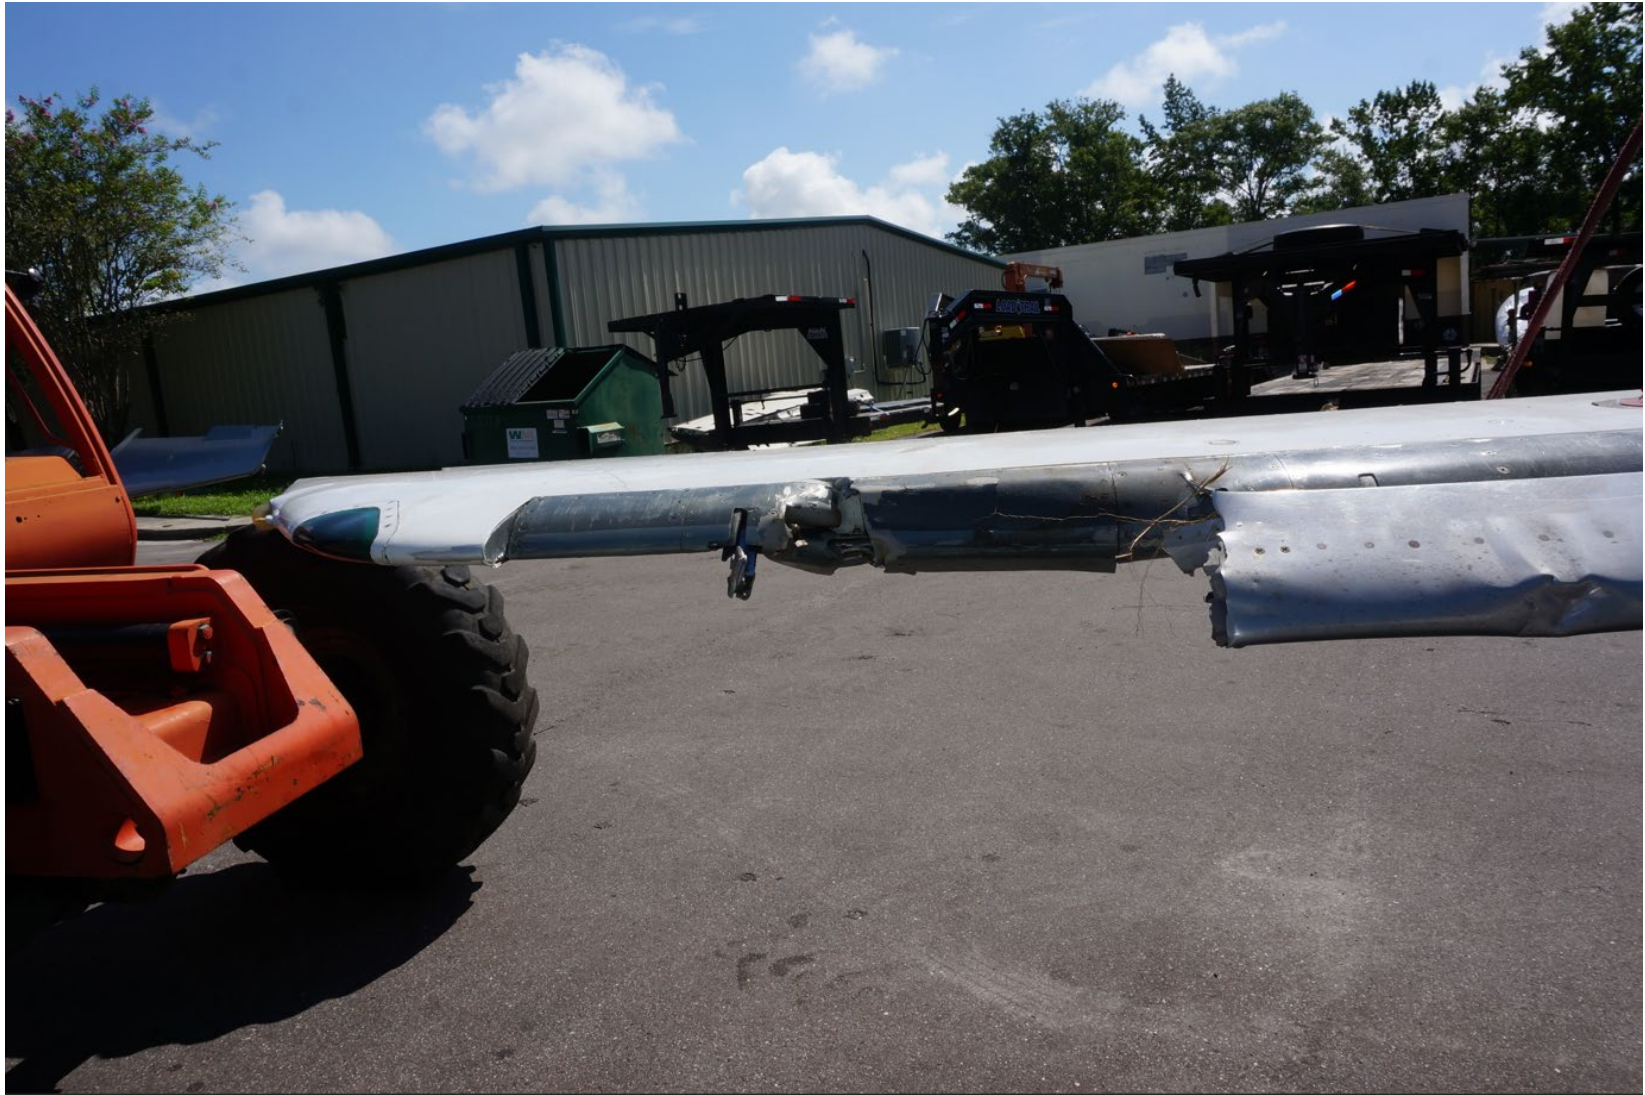
**Photograph 17 - Top Outboard Portion of Right Wing**

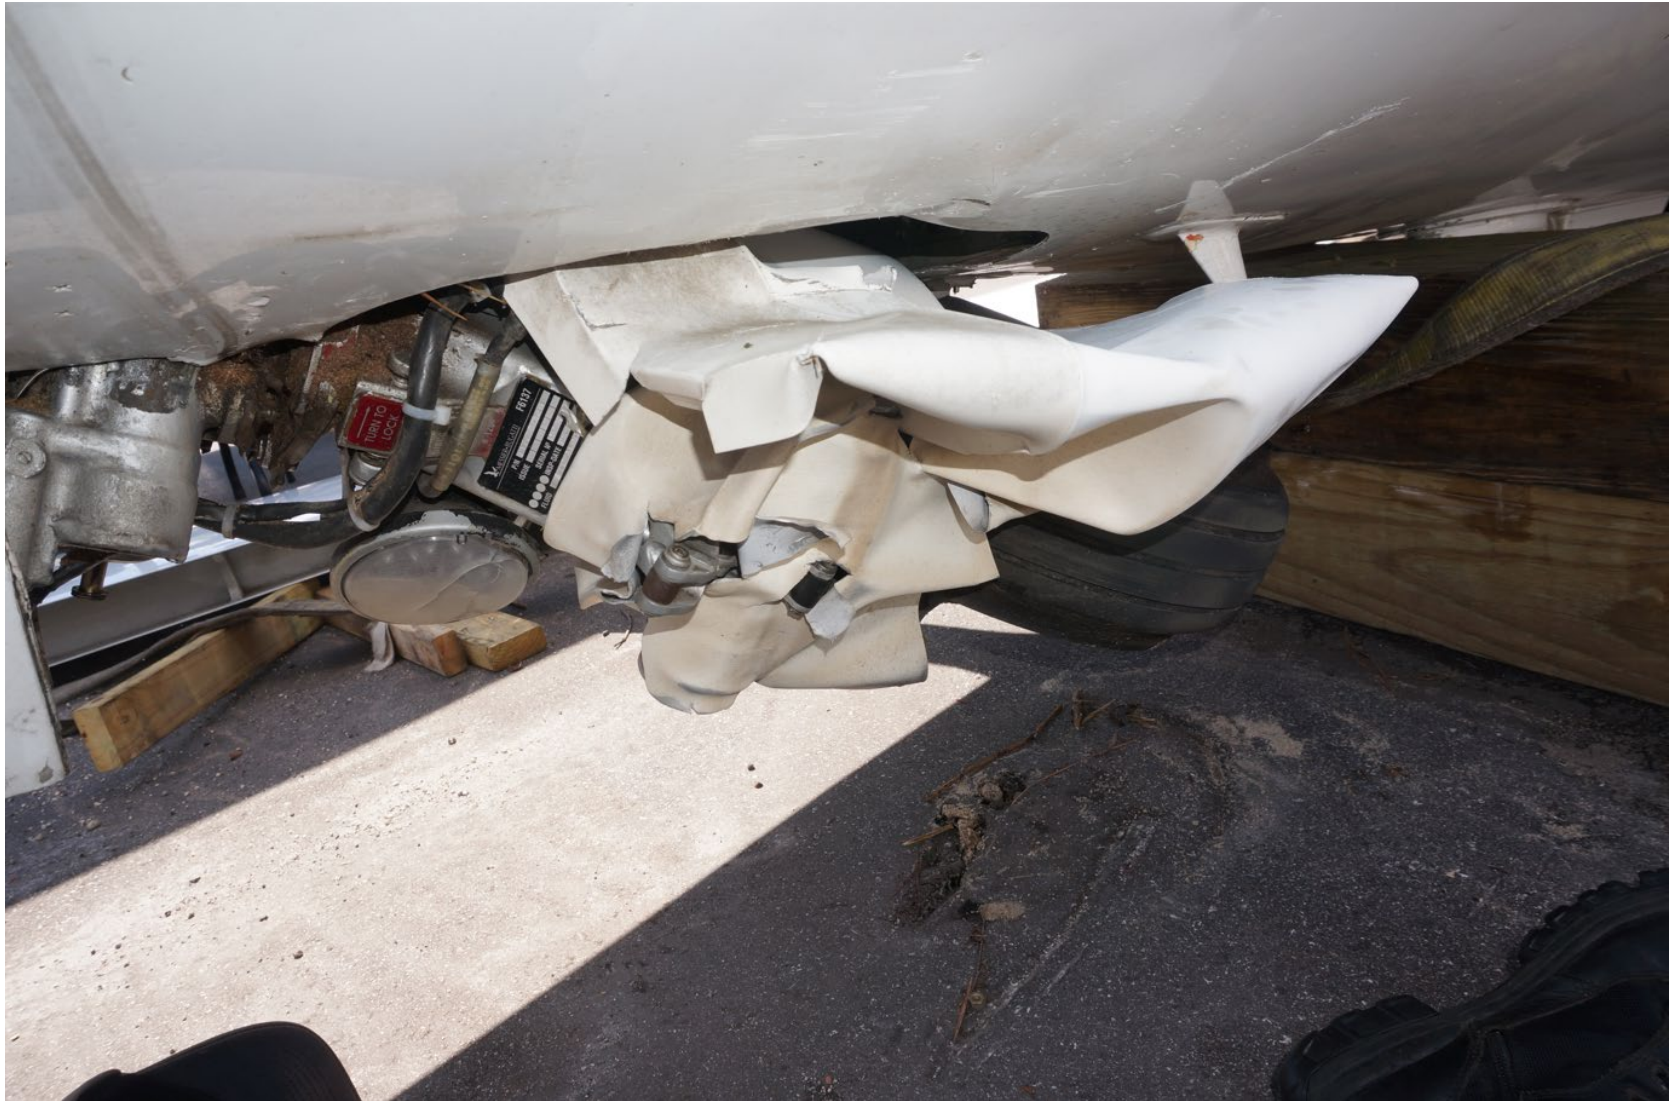
**Photograph 18 - Nose Landing Gear**
