ERA23LA261

## INVESTIGATION PHOTOGRAPHS

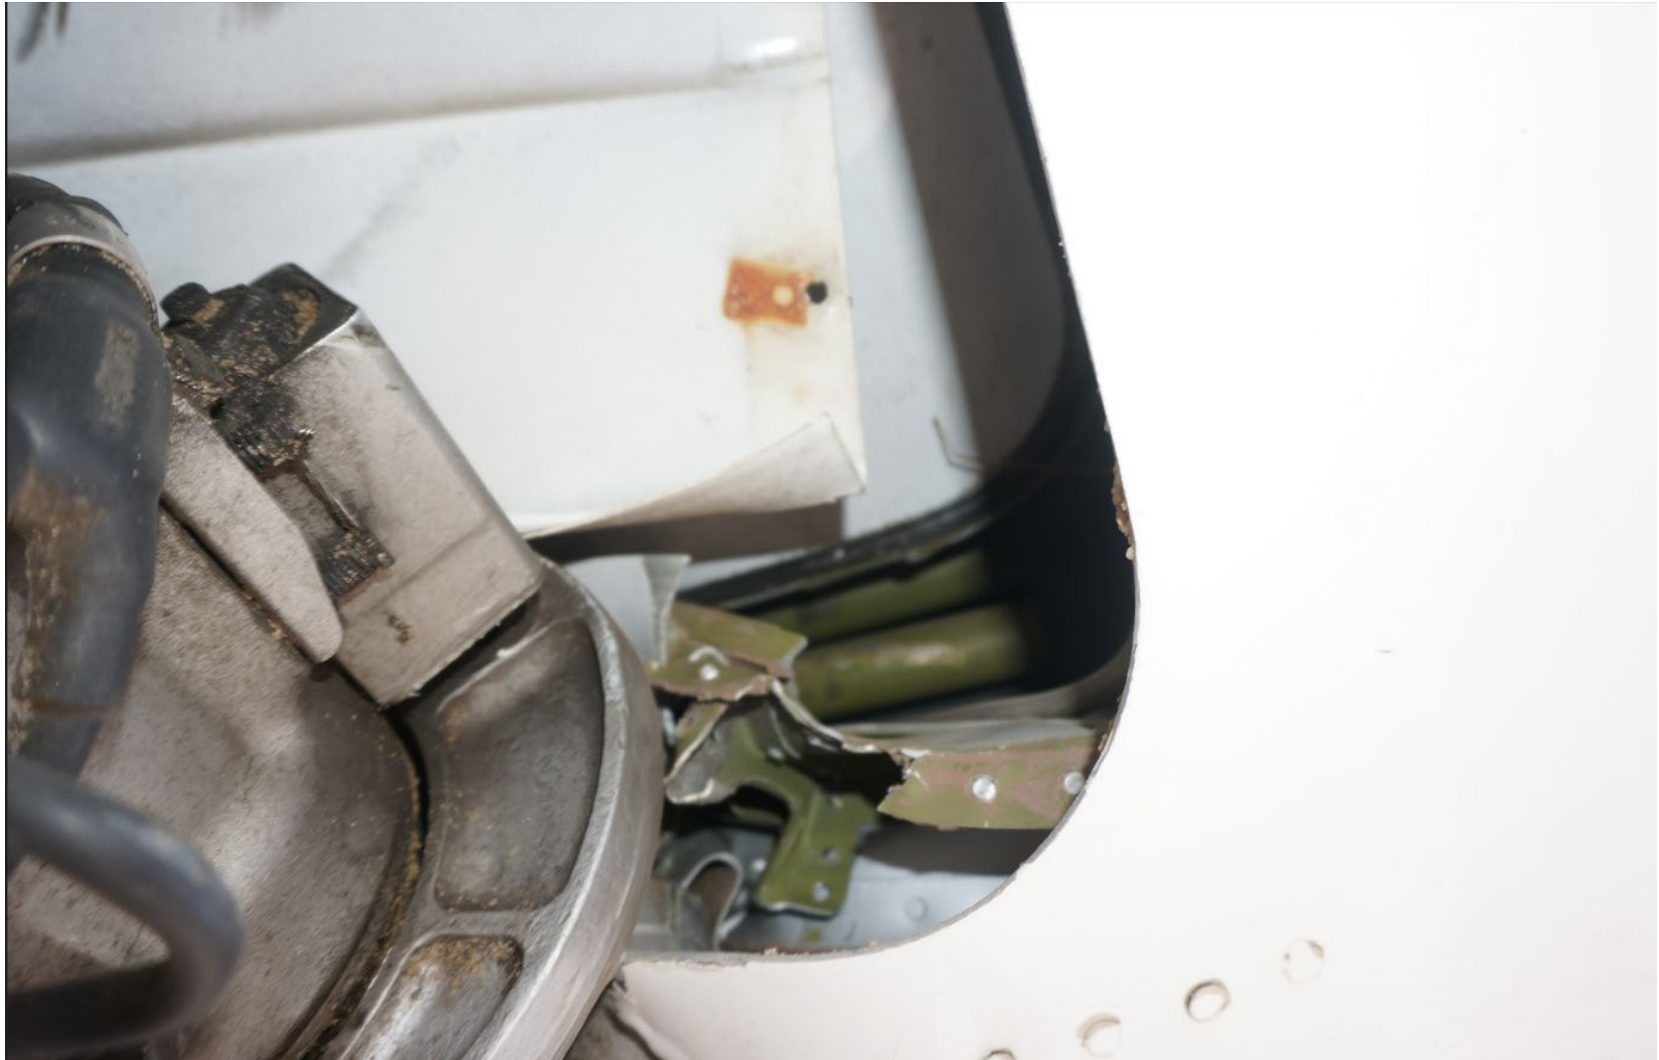
**Photograph 19 - Frame 0 (Forward Pressurization Bulkhead)**

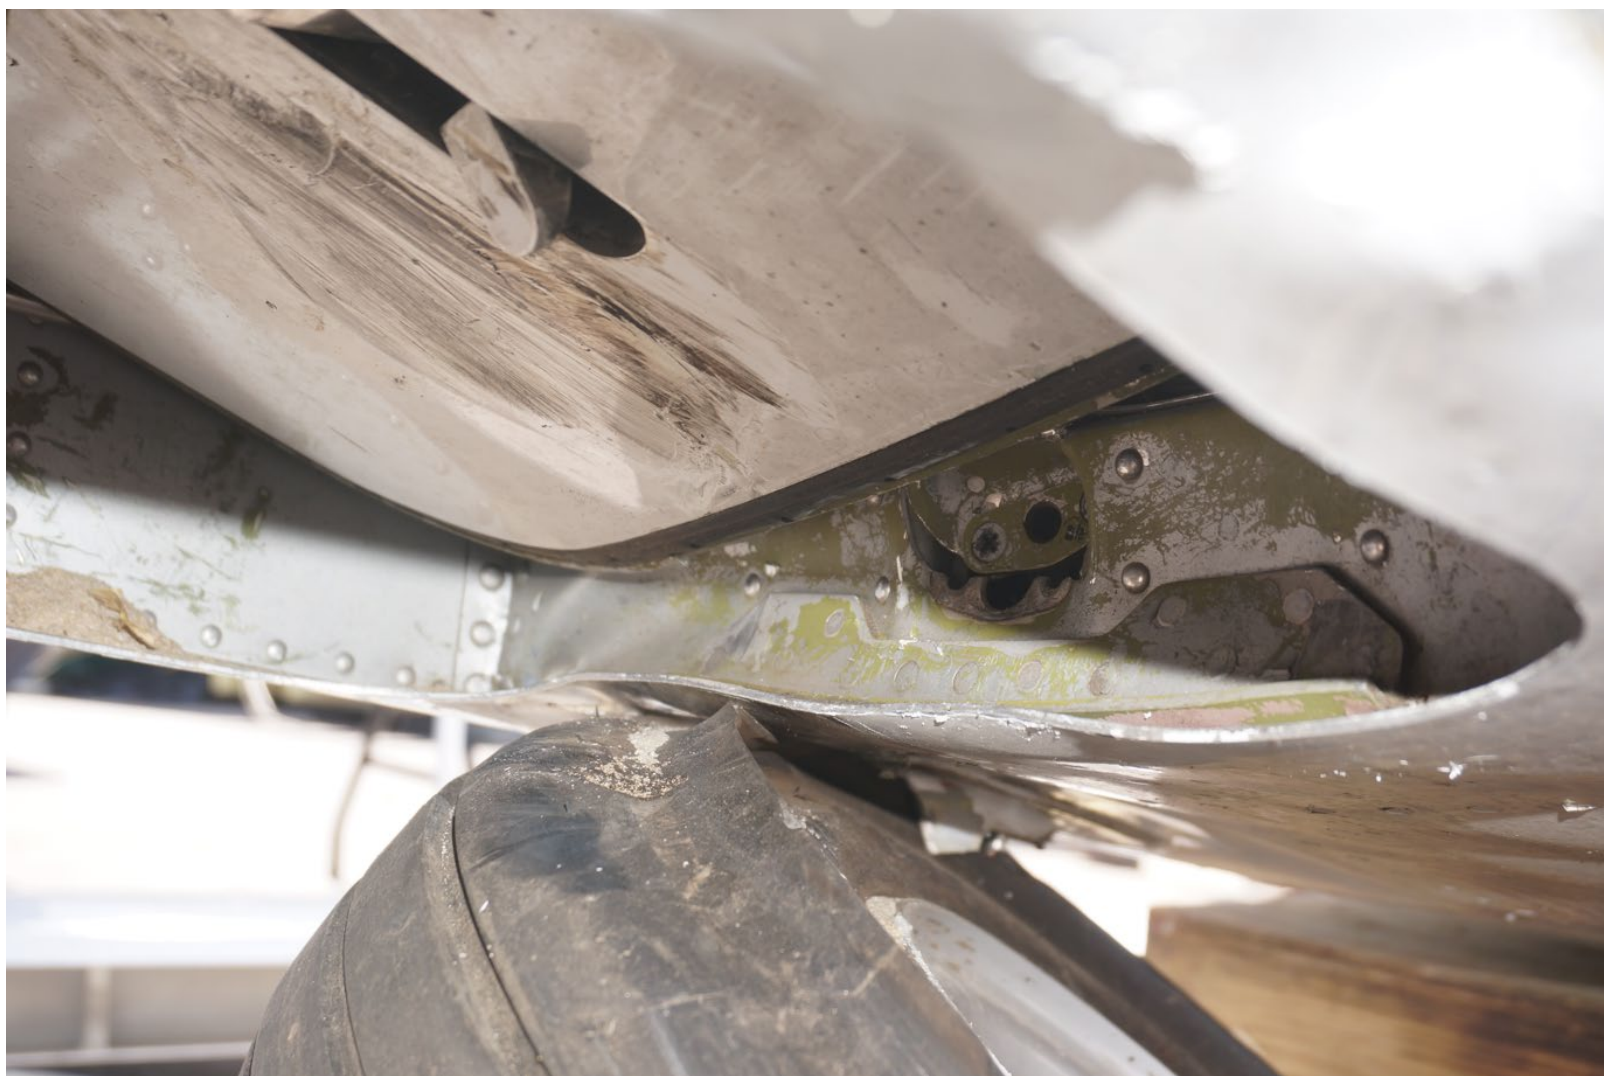
**Photograph 20 - 121AL Service Door (Pressurized)**

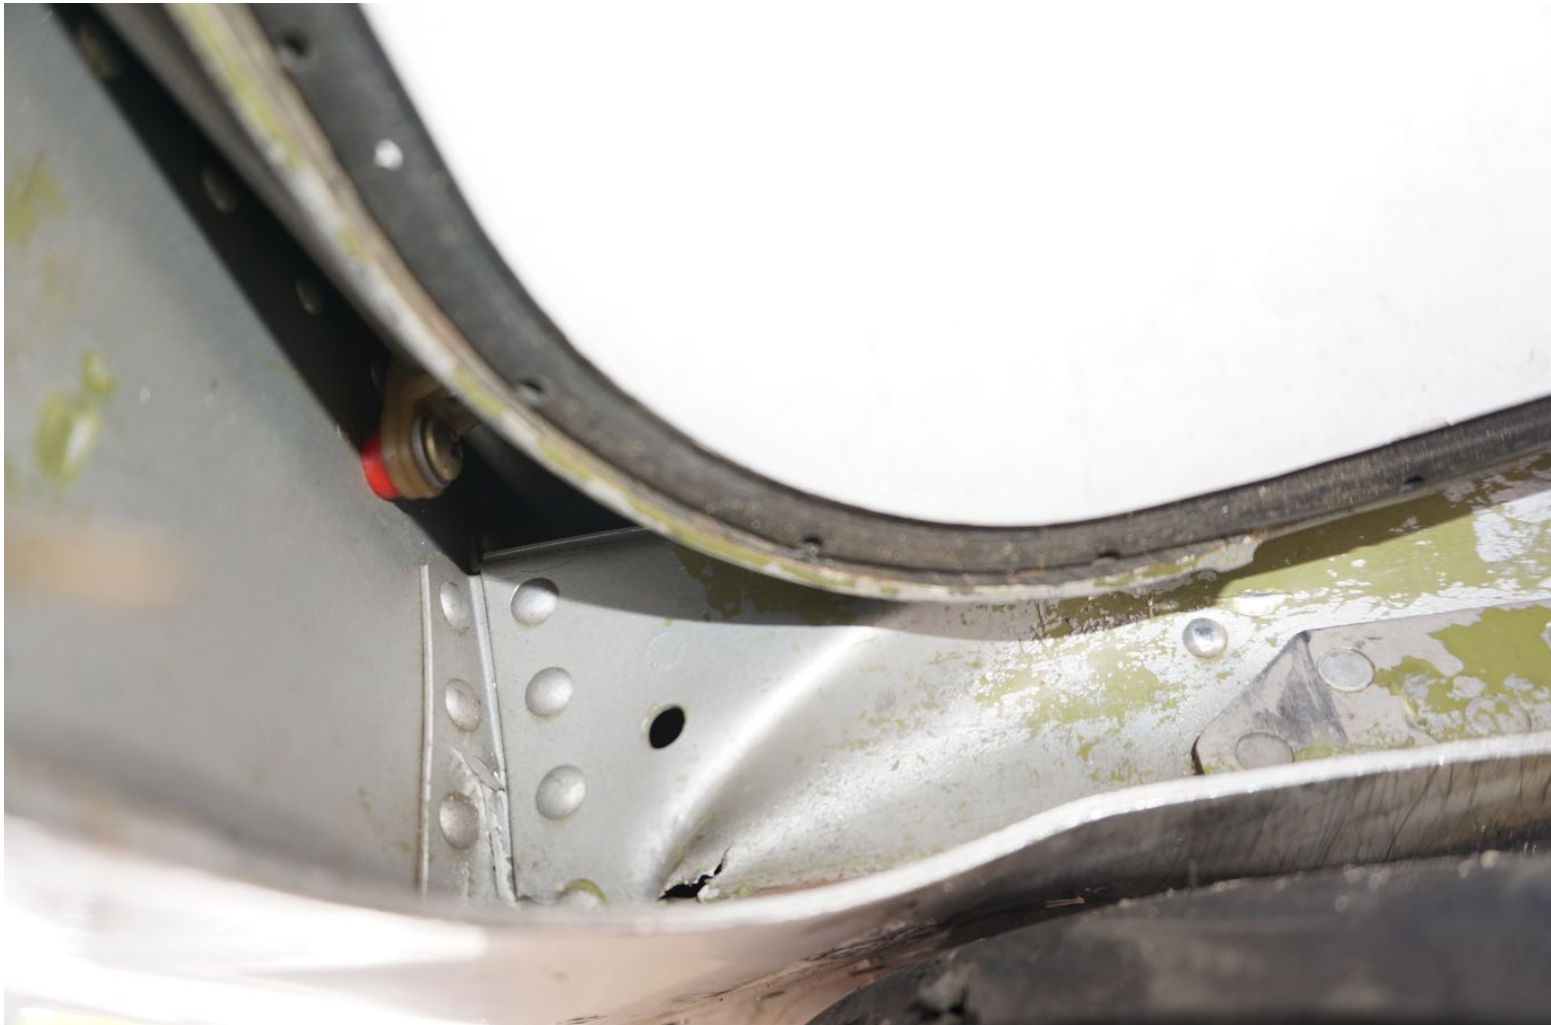
**Photograph 21 - Aft Right Corner of 121AL Service Door and Frame 1 (Pressurized)**

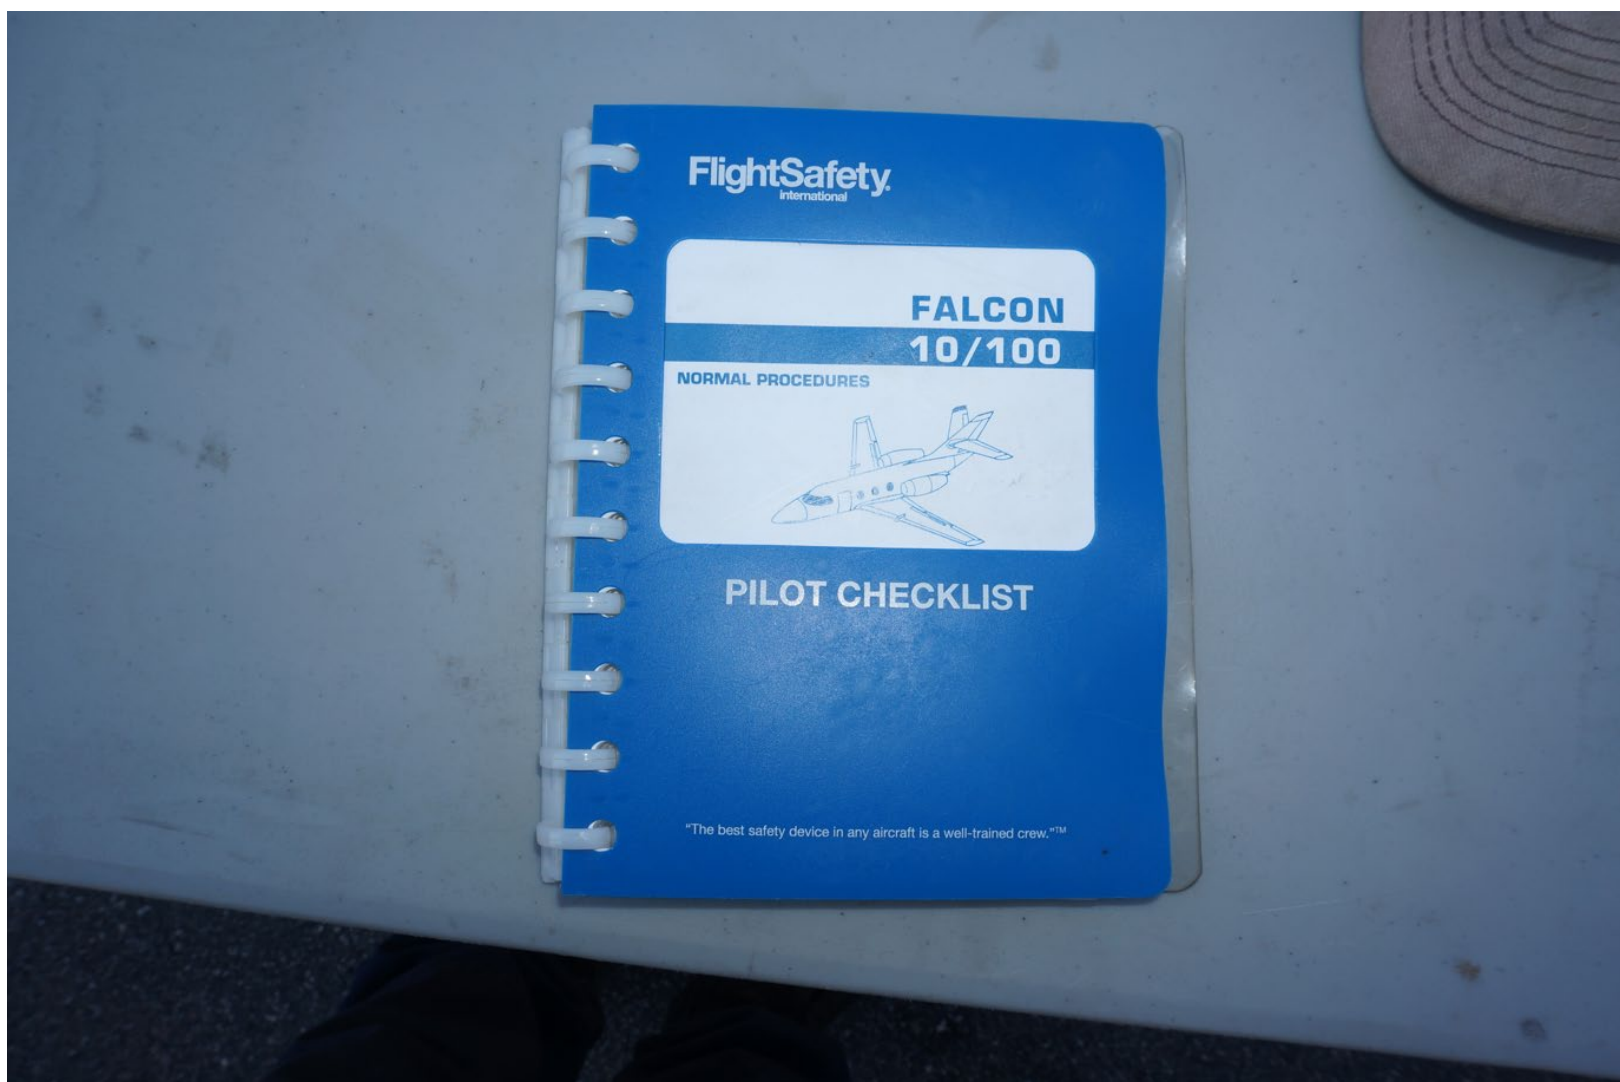
**Photograph 22 - Flight Safety Pilot Checklist**

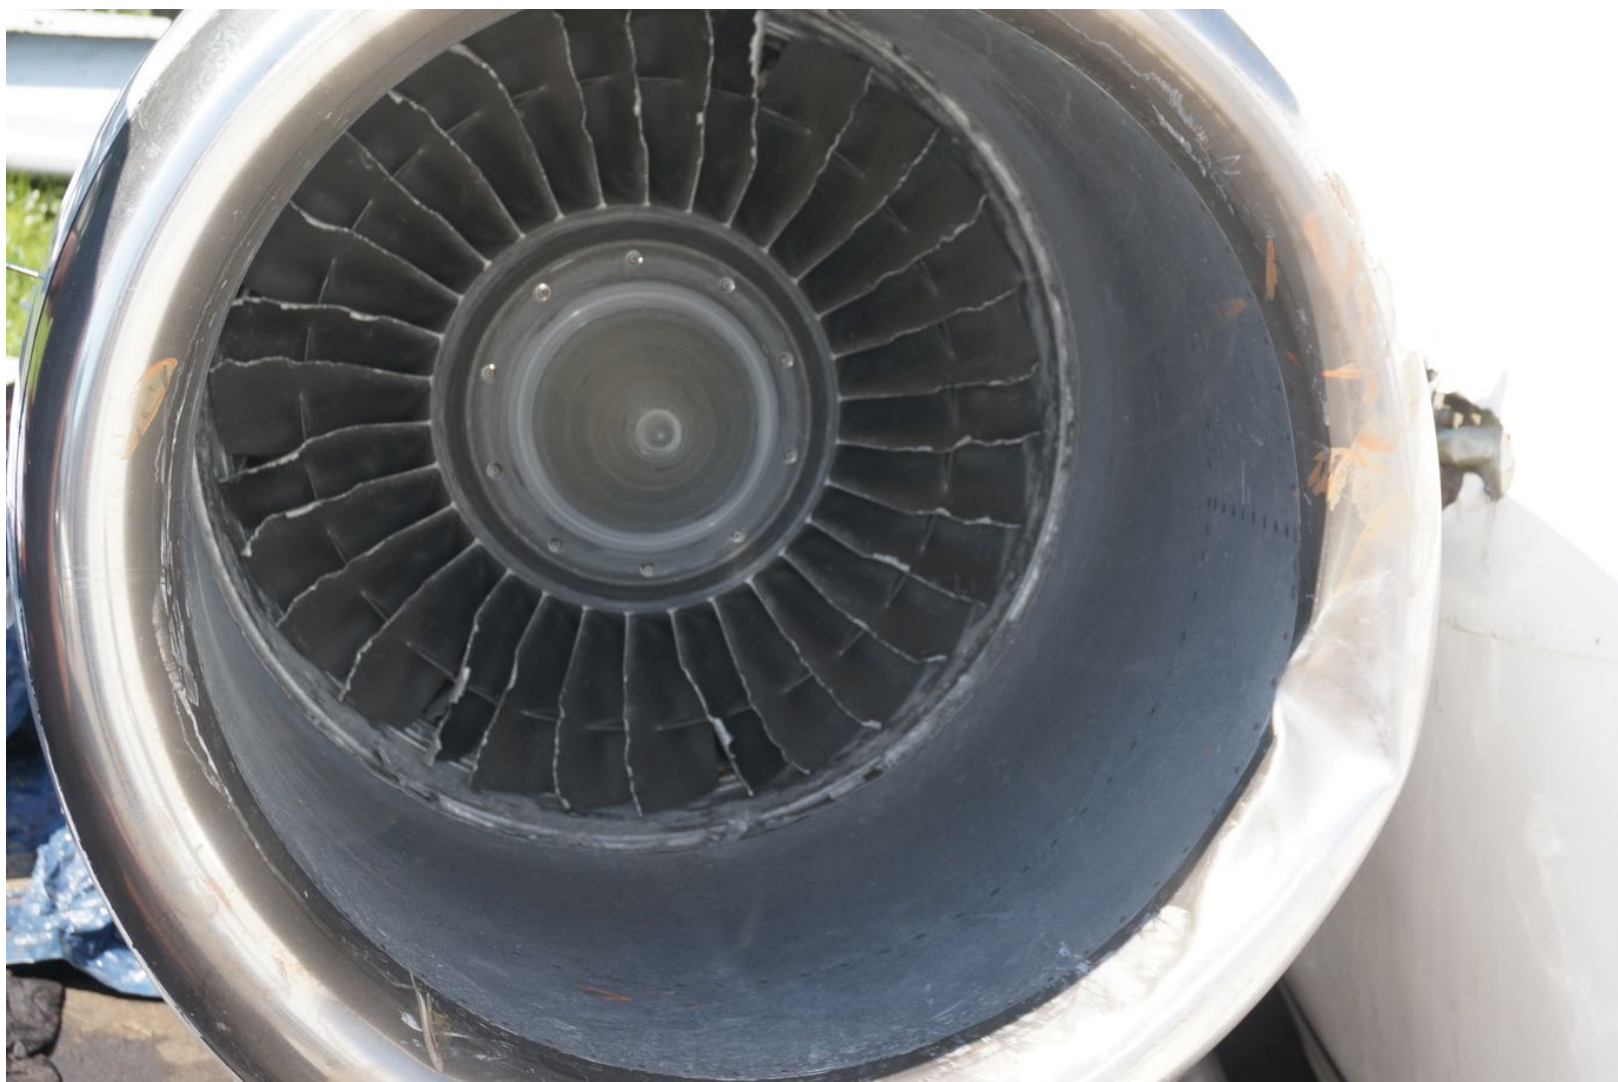
**Photograph 24 - Right Engine**

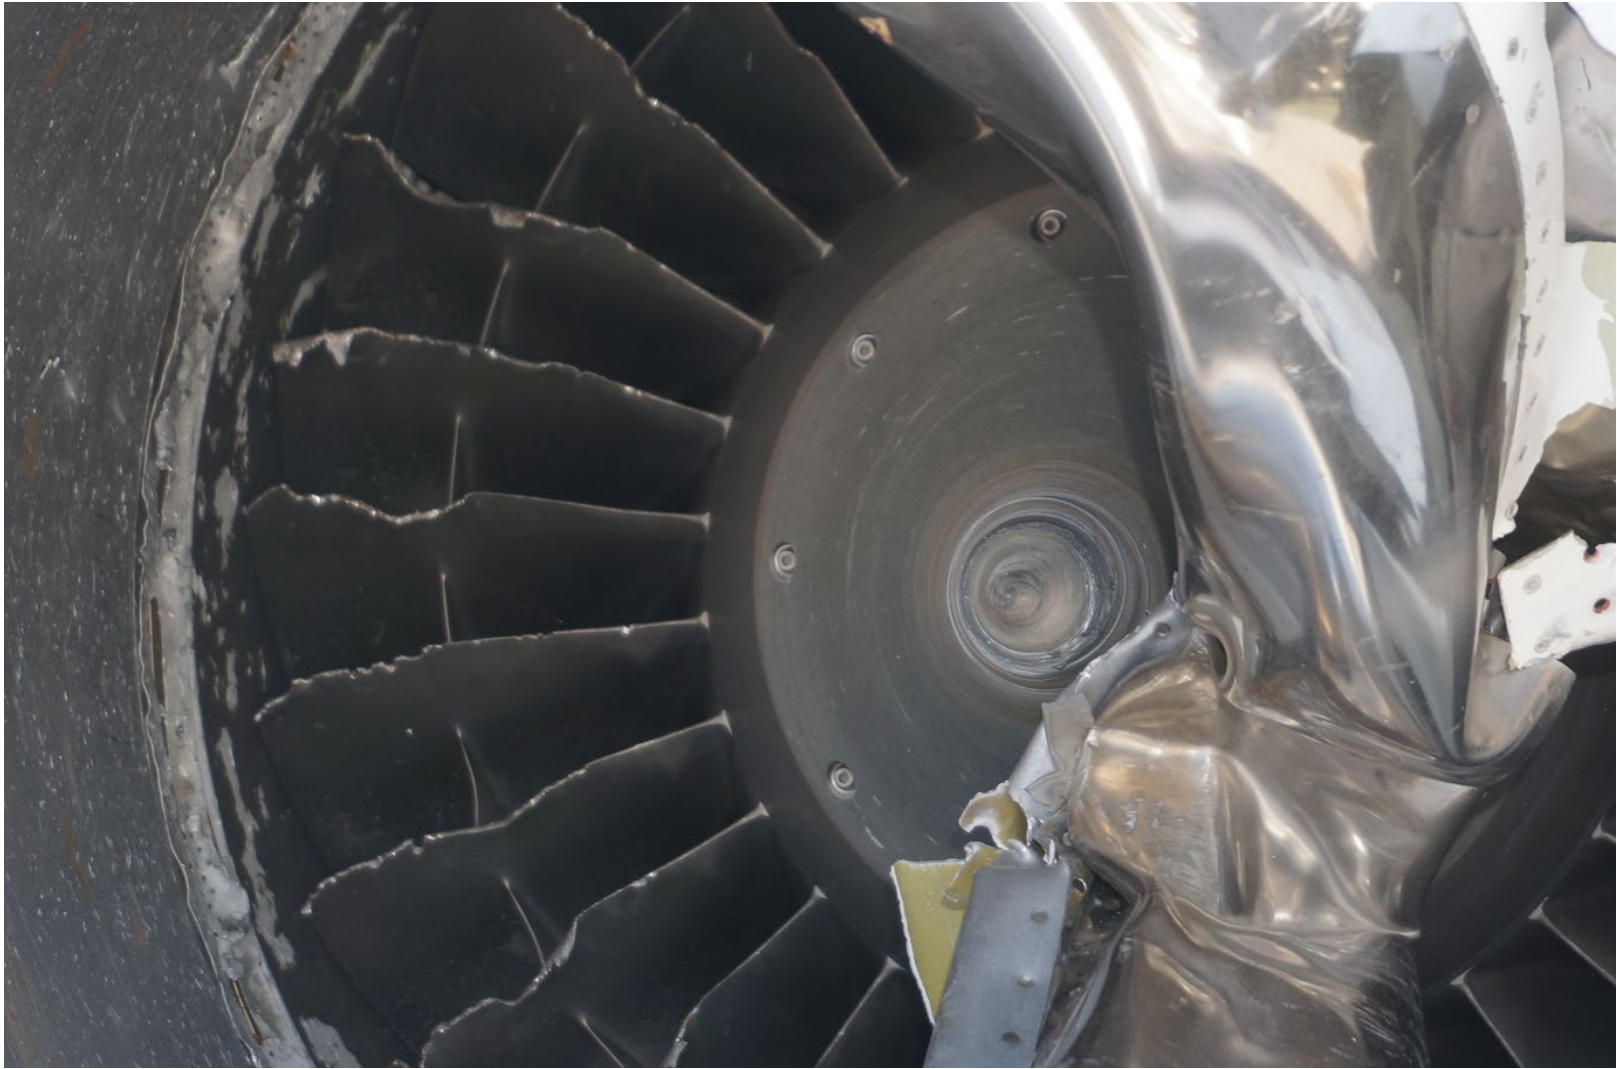
**Photograph 25 - Left Engine**
