# National Transportation Safety Board

ERA23LA264

## **MATERIALS LABORATORY**

Factual Report 24-029

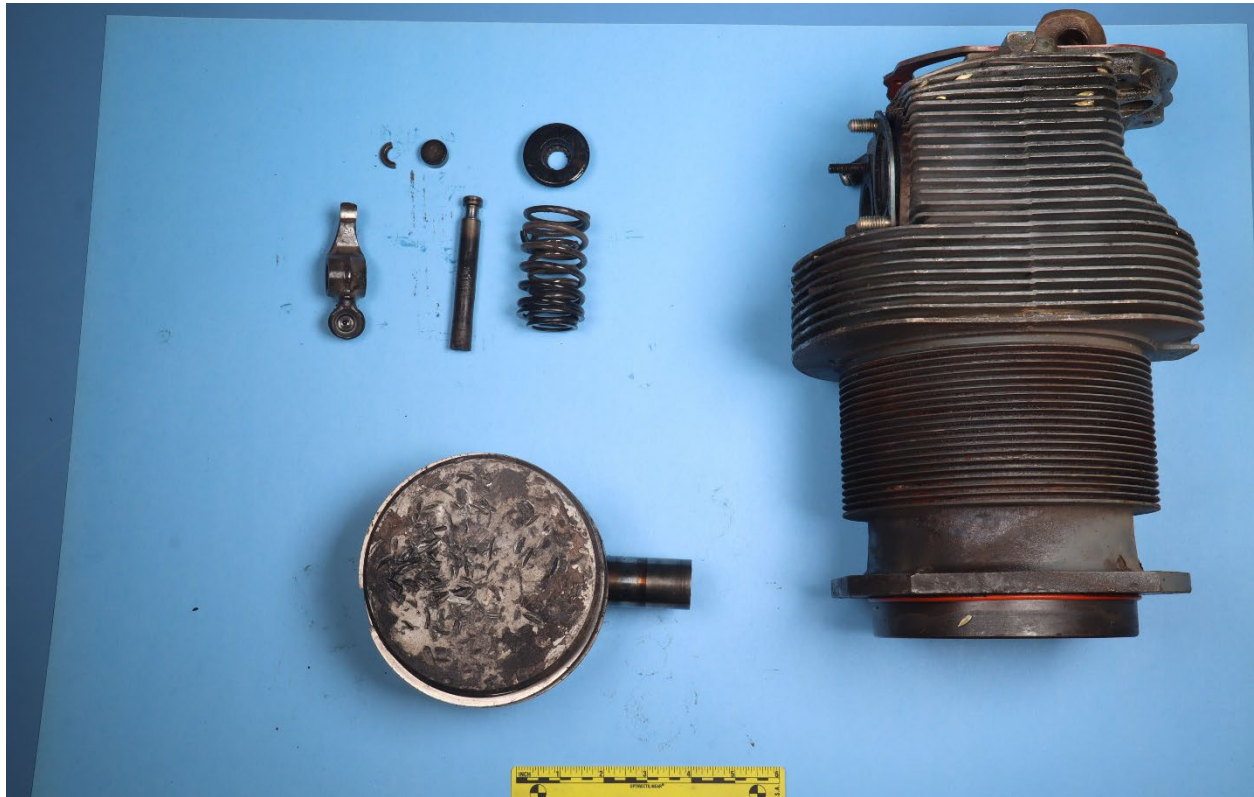
Figure 1 shows the received components from the #2 engine cylinder. The cylinder had been partially disassembled, with the springs, retainer, rocker arm, keepers, and valve stem remnant from the exhaust side removed. Figure 2 shows the side of the cylinder with the intake and exhaust ports. The exhaust port exhibited some flaky

Figure 1. The components from the engine, as received.

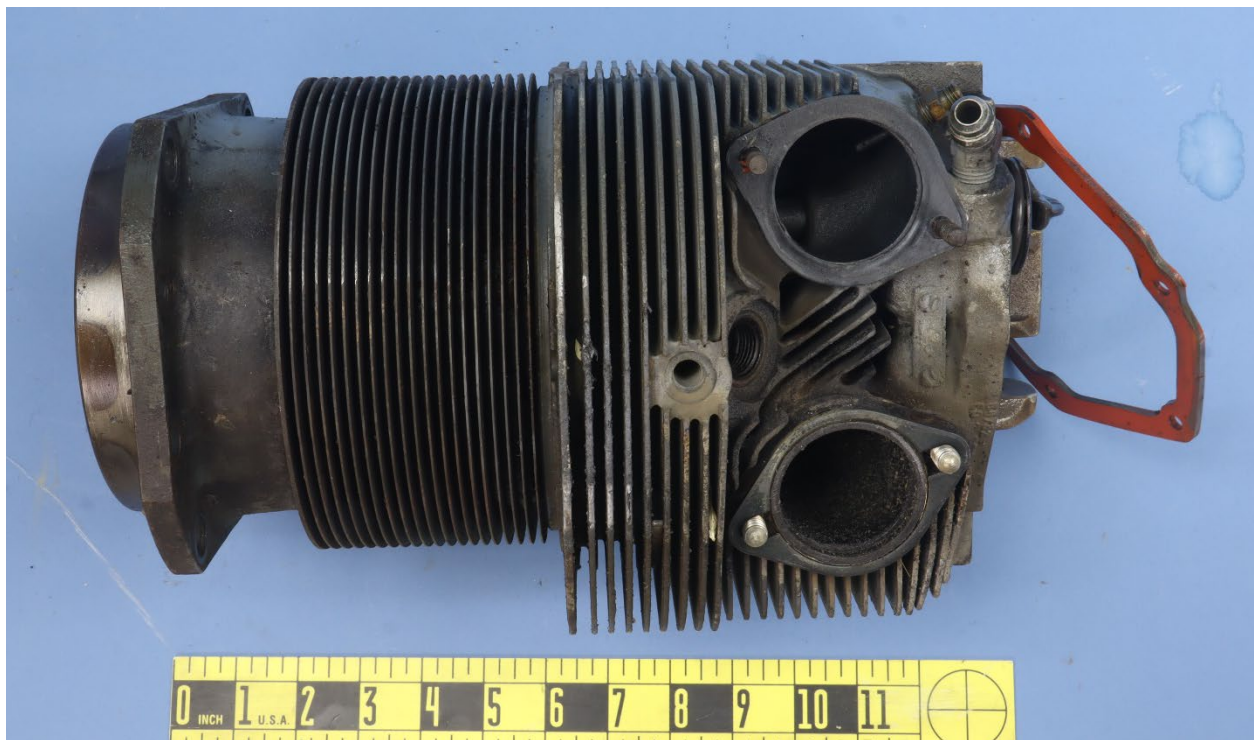
deposits along the interior. However, there were no indications of impact or mechanical damage to the exterior of the cylinder.

Figure 2. View of the cylinder from the side with the intake and exhaust ports.

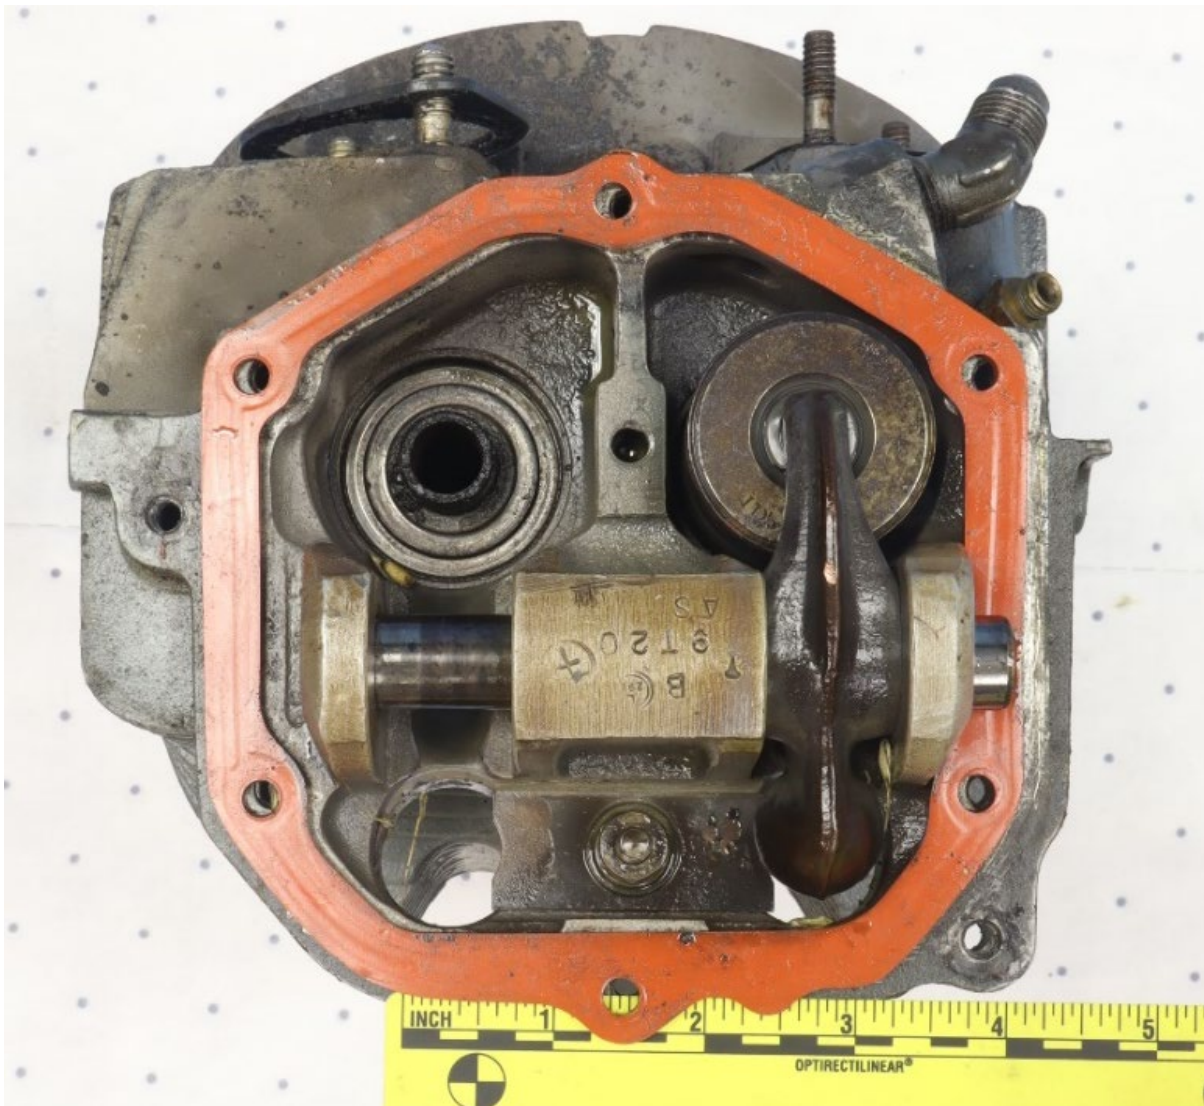
Figure 3 shows the upper portion of the cylinder assembly, as received. The housing and pushrods had been removed, along with the components from the exhaust side. The rocker and retainer from the intake side remained intact and exhibited few indications of wear or damage. Dark and flaky deposits were visible along the valve stem bore on the exhaust side (left in Figure 3).

Figure 3. View of the cylinder from the rocker and valve stem area with housing removed.

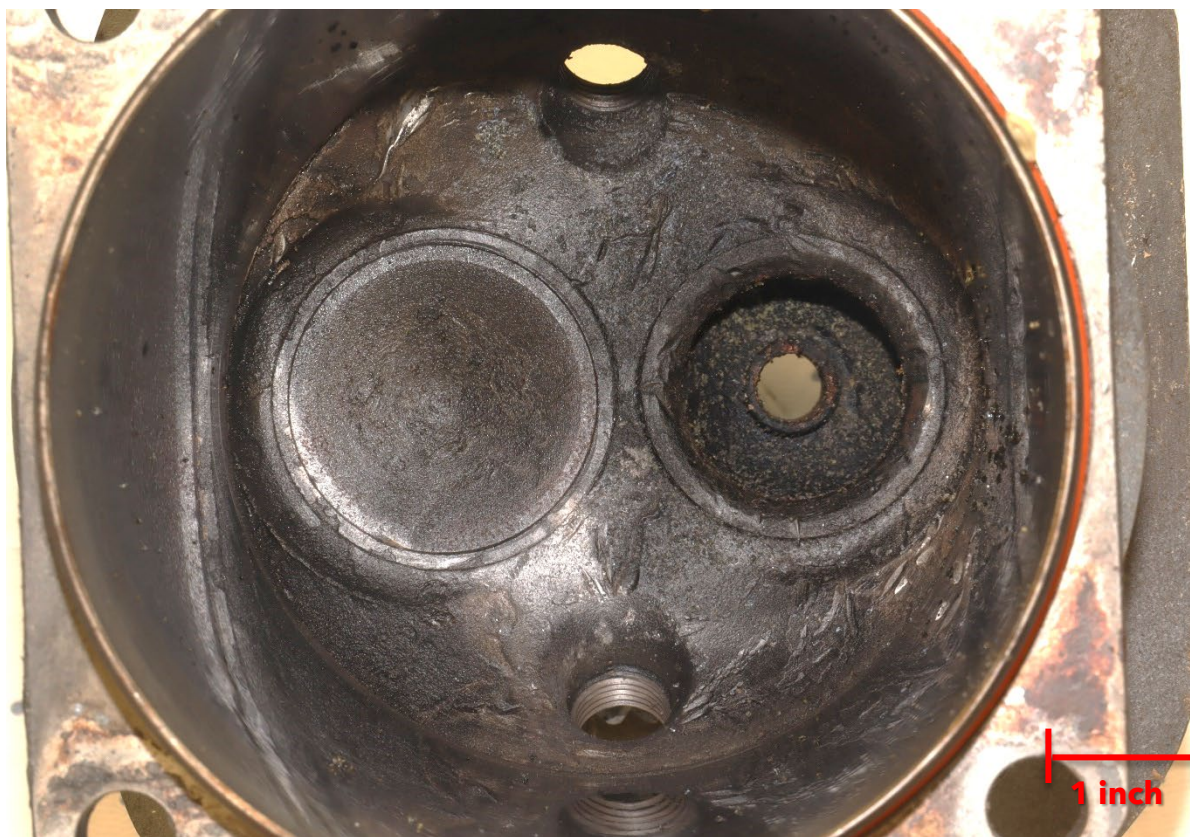
Figure 4 shows the interior of the cylinder, viewed from the crown side. The seat of the exhaust valve exhibited dark deposits built up along the interior surfaces, consistent with those seen on the exhaust side in Figure 3 and the fractured valve stem in Figure 1. The cylinder interior also exhibited elongated and randomly oriented impact marks. These marks were present throughout the cylinder crown and skirt interior surfaces.

Figure 4. Closer view of the interior of the cylinder, showing impact damage to the cylinder and valve seat surfaces.

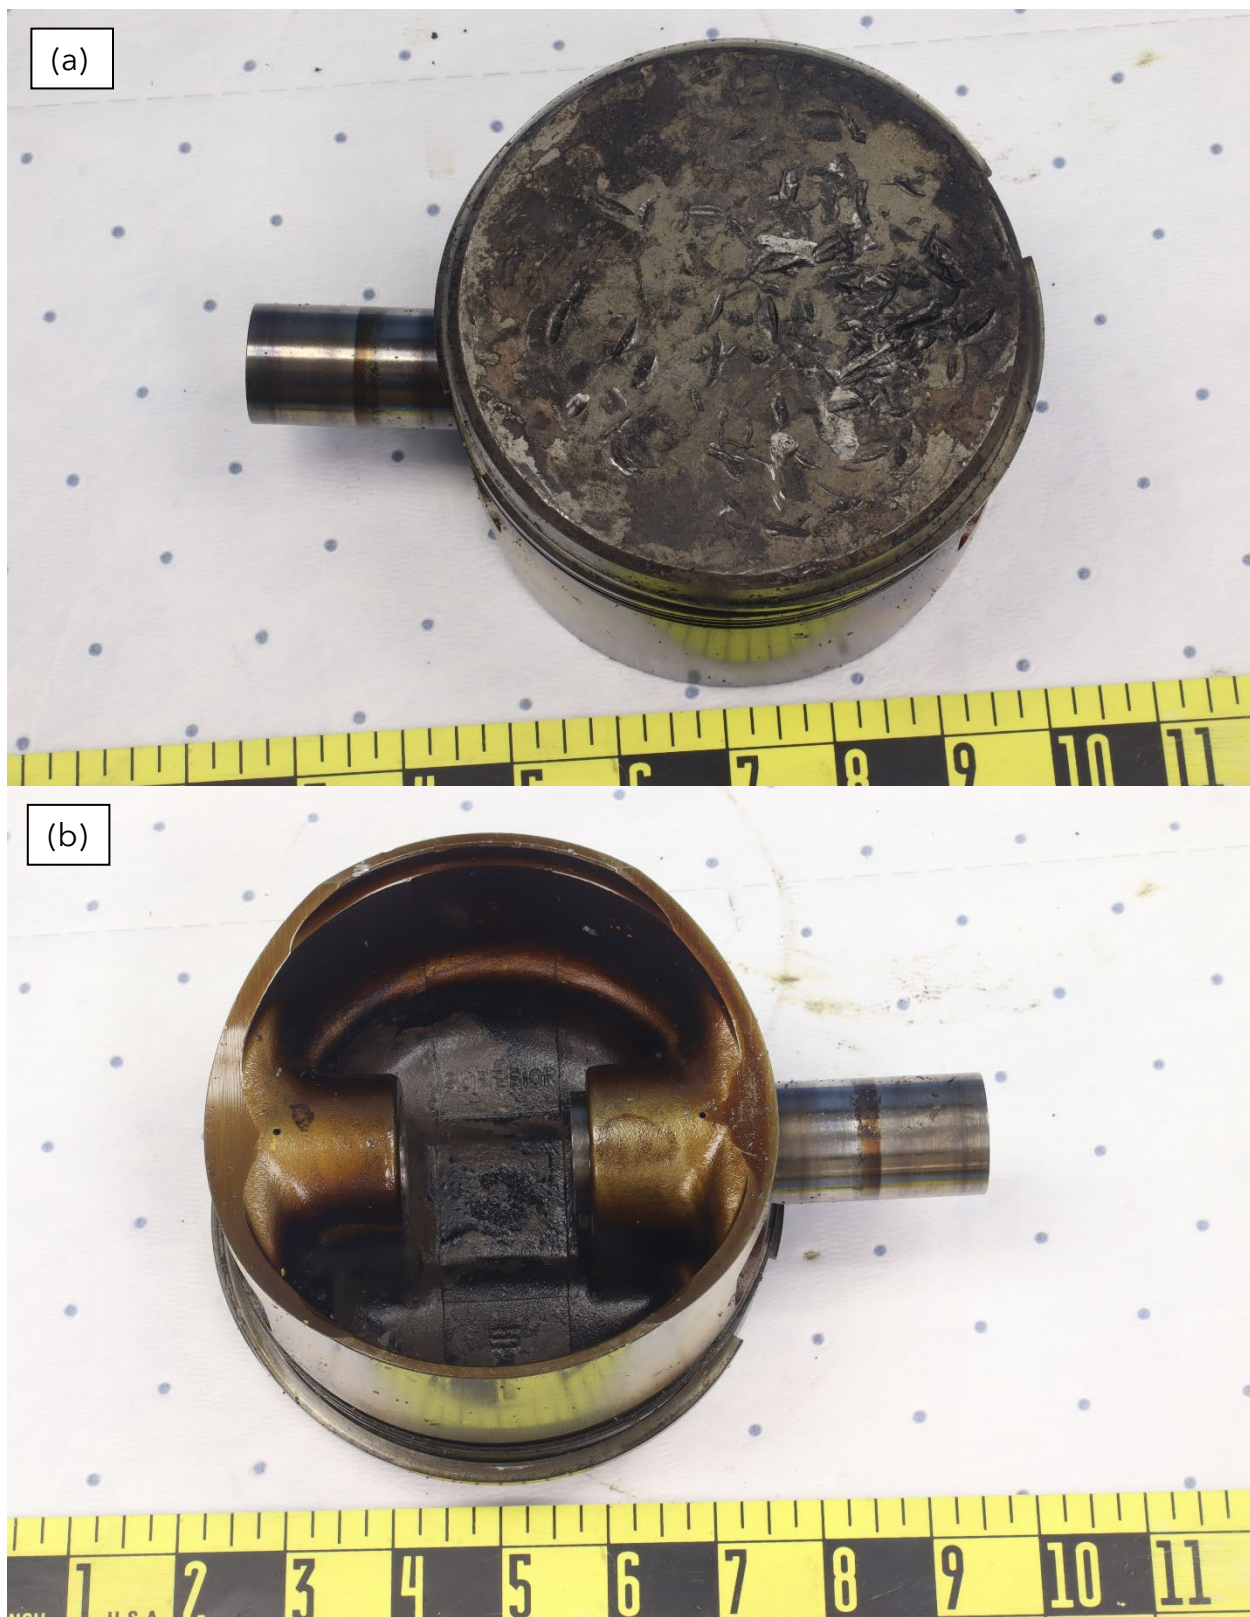
Figure 5 shows the mating piston from the crown and skirt sides. The piston pin was still partially inserted into the piston, as received. As illustrated in Figure 5a, the piston crown surface exhibited multiple linear impact marks surrounded by localized upward deformation features. These randomly oriented impact marks were consistent with those on the cylinder interior. The piston crown also exhibited tan and dark, flaky compounds along the surface.

Figure 5. Views of the piston and pin, as received, from (a) the crown and (b) the underside.

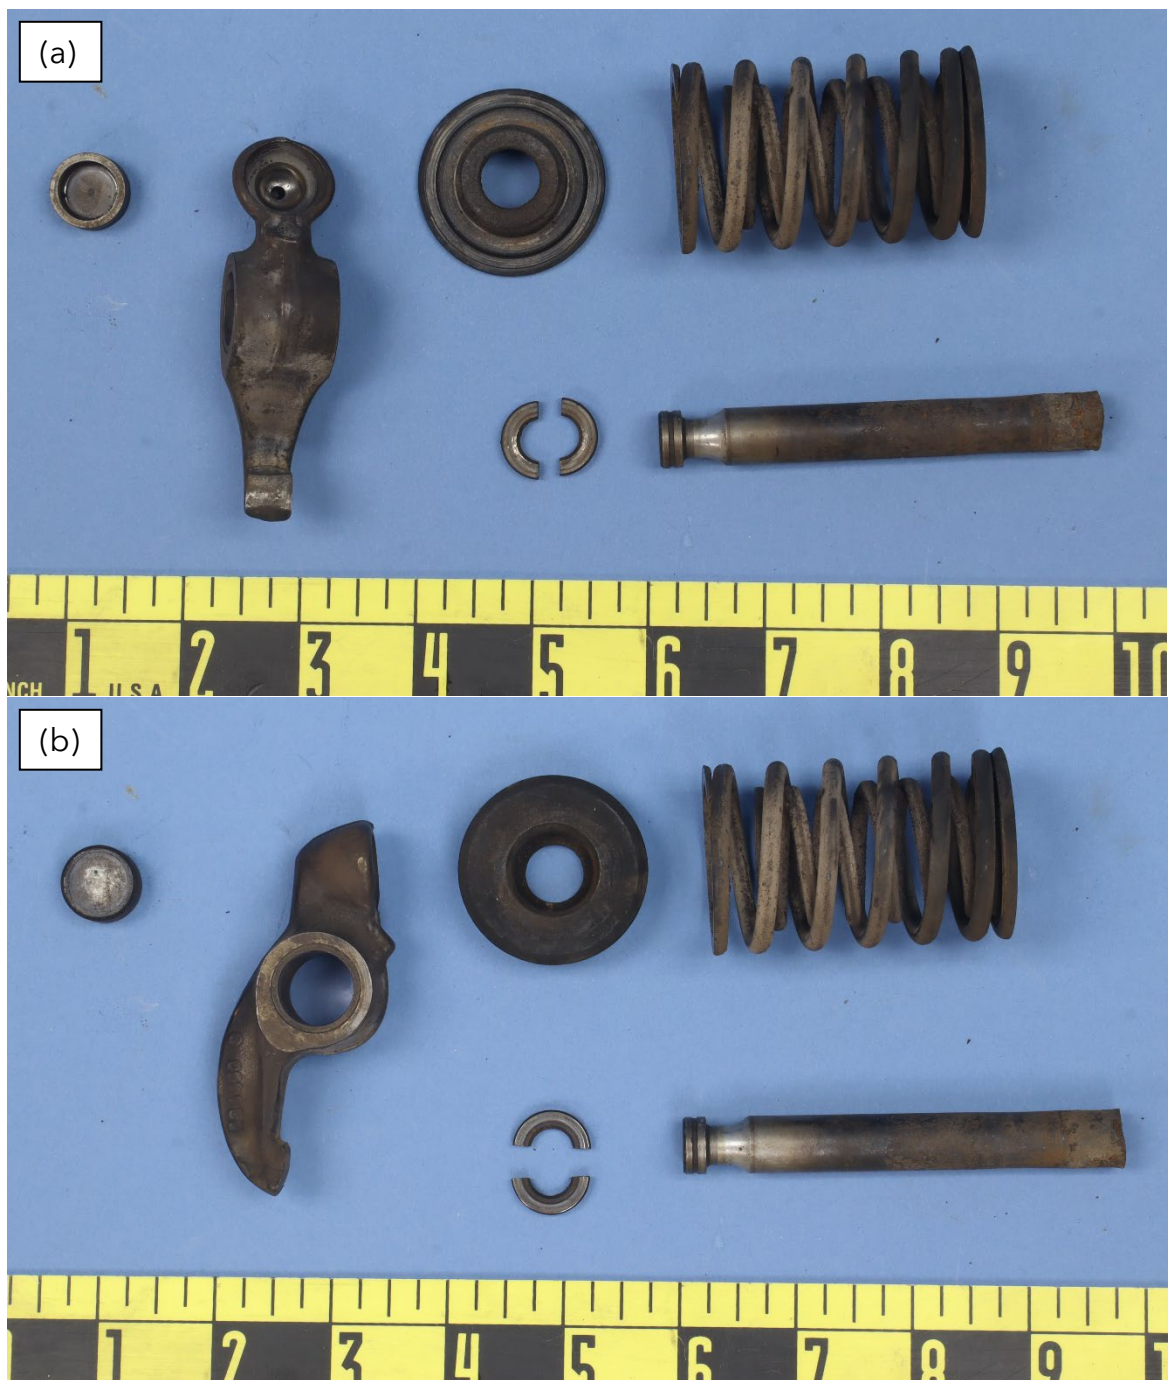
Figure 6 shows the components from the exhaust side of the cylinder assembly that had been removed before receipt. Except for the valve stem remnant, all other parts were intact. Many parts exhibited discoloration, indicating compounds deposited on their outer surfaces. These deposits were most prevalent on the left third of the springs in the figure, which showed white and tan flaky compounds, and the valve stem remnant, which exhibited progressively thicker deposits toward the fracture surface.

Figure 6. The disassembled rocker arm, retainer, keepers, springs, cap, and exhaust valve stem, from different sides.

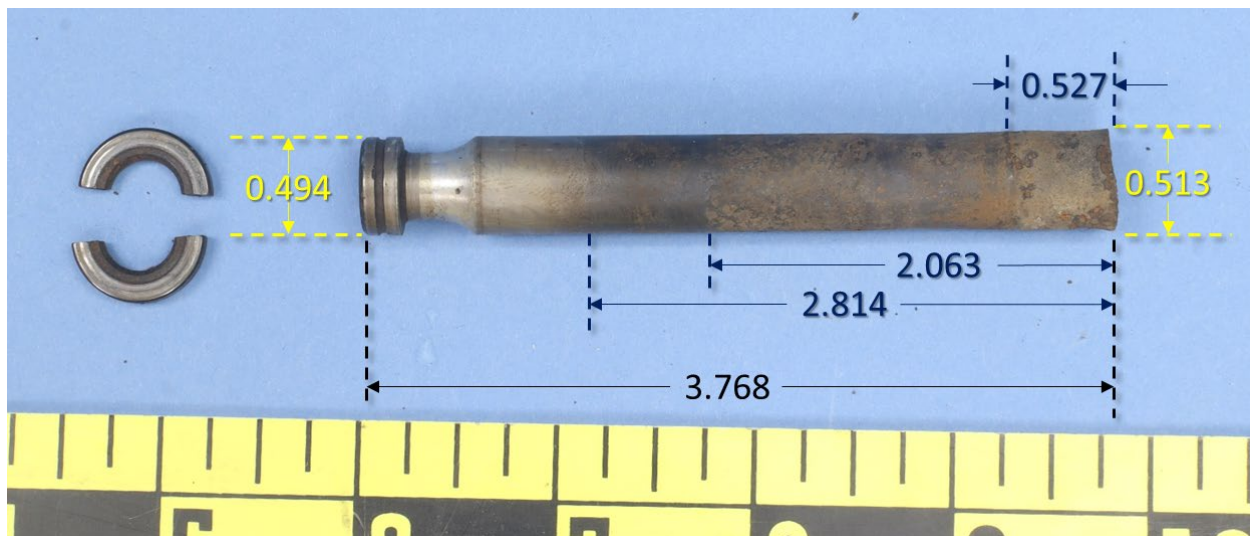
Figure 7 shows the remnant of the exhaust valve stem and the keepers. Figure 7 shows the dimensions of several regions along the stem. The total length of the remnant was 3.77 inches long, with 2.81 inches being the amount with combustion deposits. The region of thickest deposits was located in the nearest 0.53 inches of the stem remnant near the fracture surface. This was consistent with the diameter of the stem being thicker near the fracture surface than in areas away from it.

Figure 7. Closer view of the exhaust valve stem remnant and keepers.

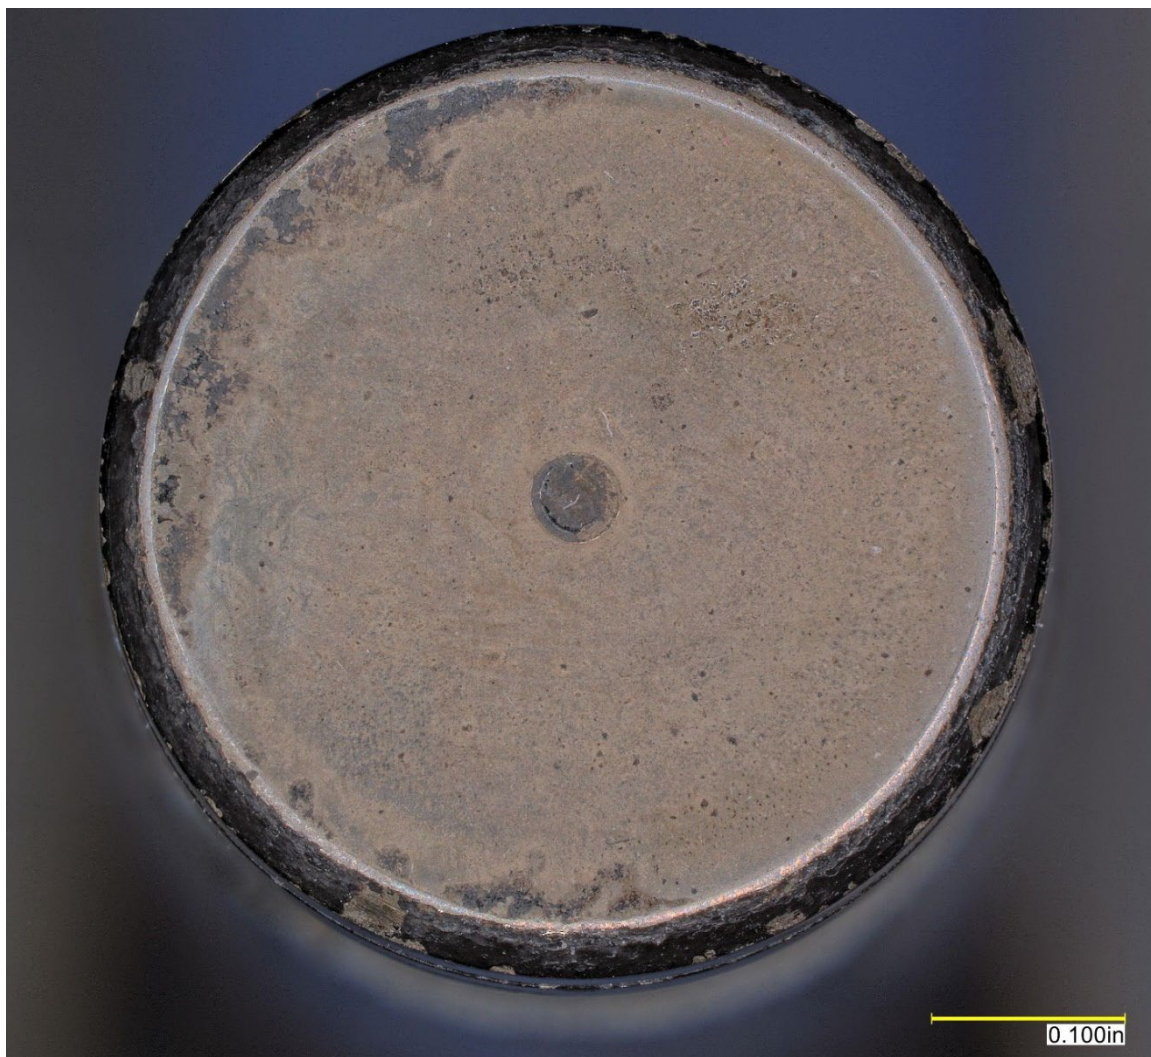
Figure 8 shows the face of the stem head. This face did not exhibit concentric or hourglass marks that would indicate uneven wear or contact with the rocker arm. No deformation or impact indications were observed on the upper part of the stem remnant.

Figure 8. The stem head face of the exhaust valve.

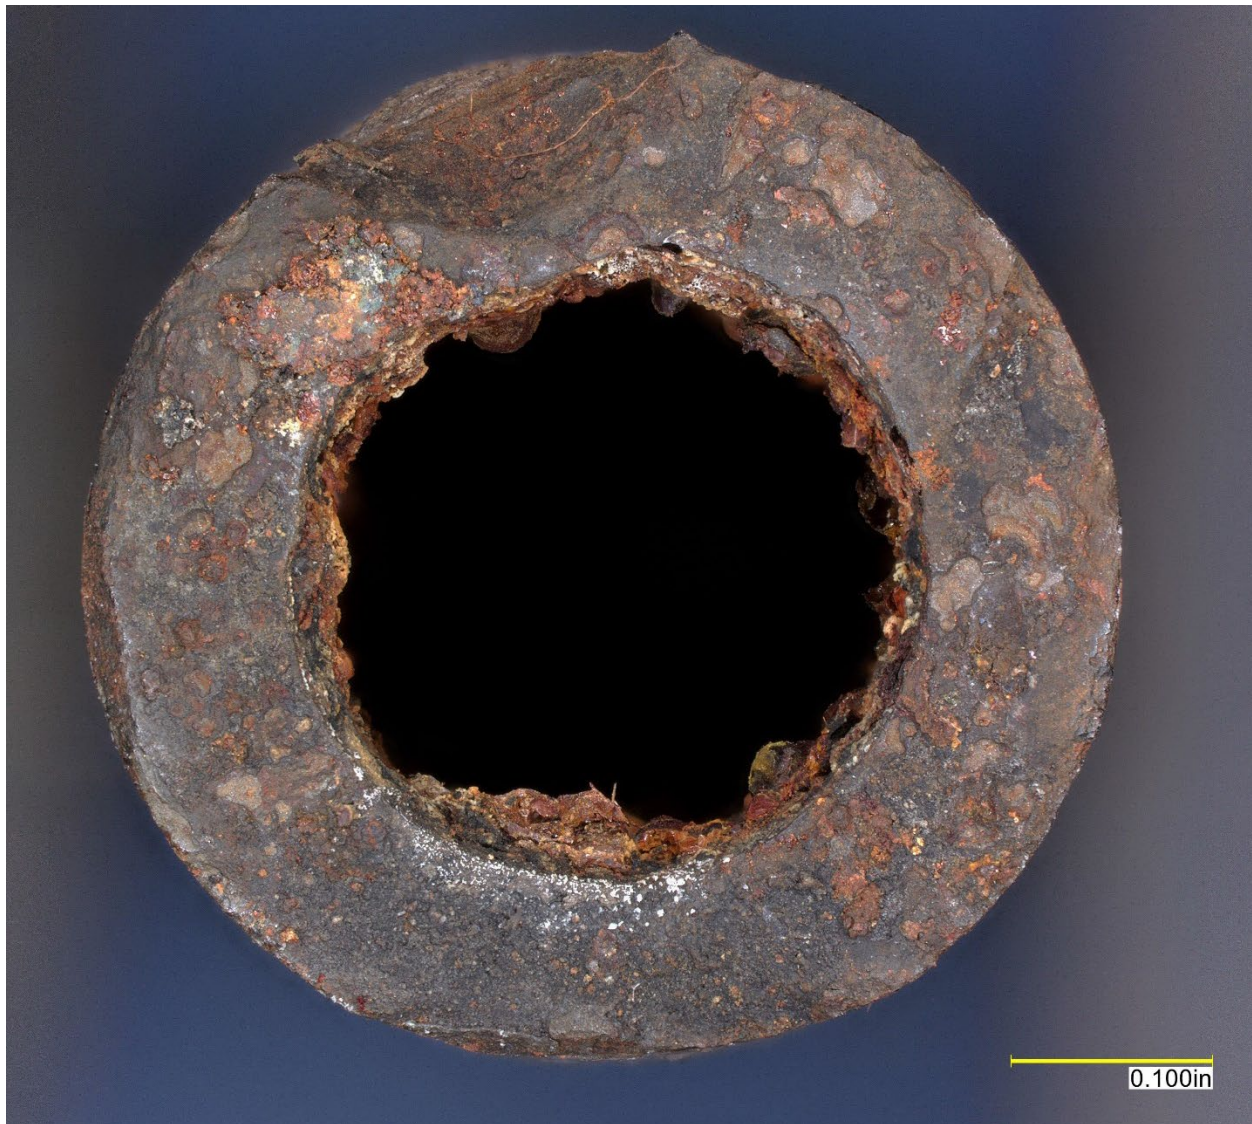
Figure 9 shows the fracture surface of the valve stem, as received. Corrosion compounds entirely obscured the surface, manifest as dark and rust-colored material in the figure. The valve stem was progressively cleaned in an ultrasonic bath of acetone, aqueous Alconox solution, and aqueous Evapo-Rust solutions to remove as much of the surface oxide without damaging the underlying metal morphology.<sup>2</sup> Figure 10 shows the fracture surface after the final cleaning.

Figure 9. The exhaust valve stem fracture surface, as received.

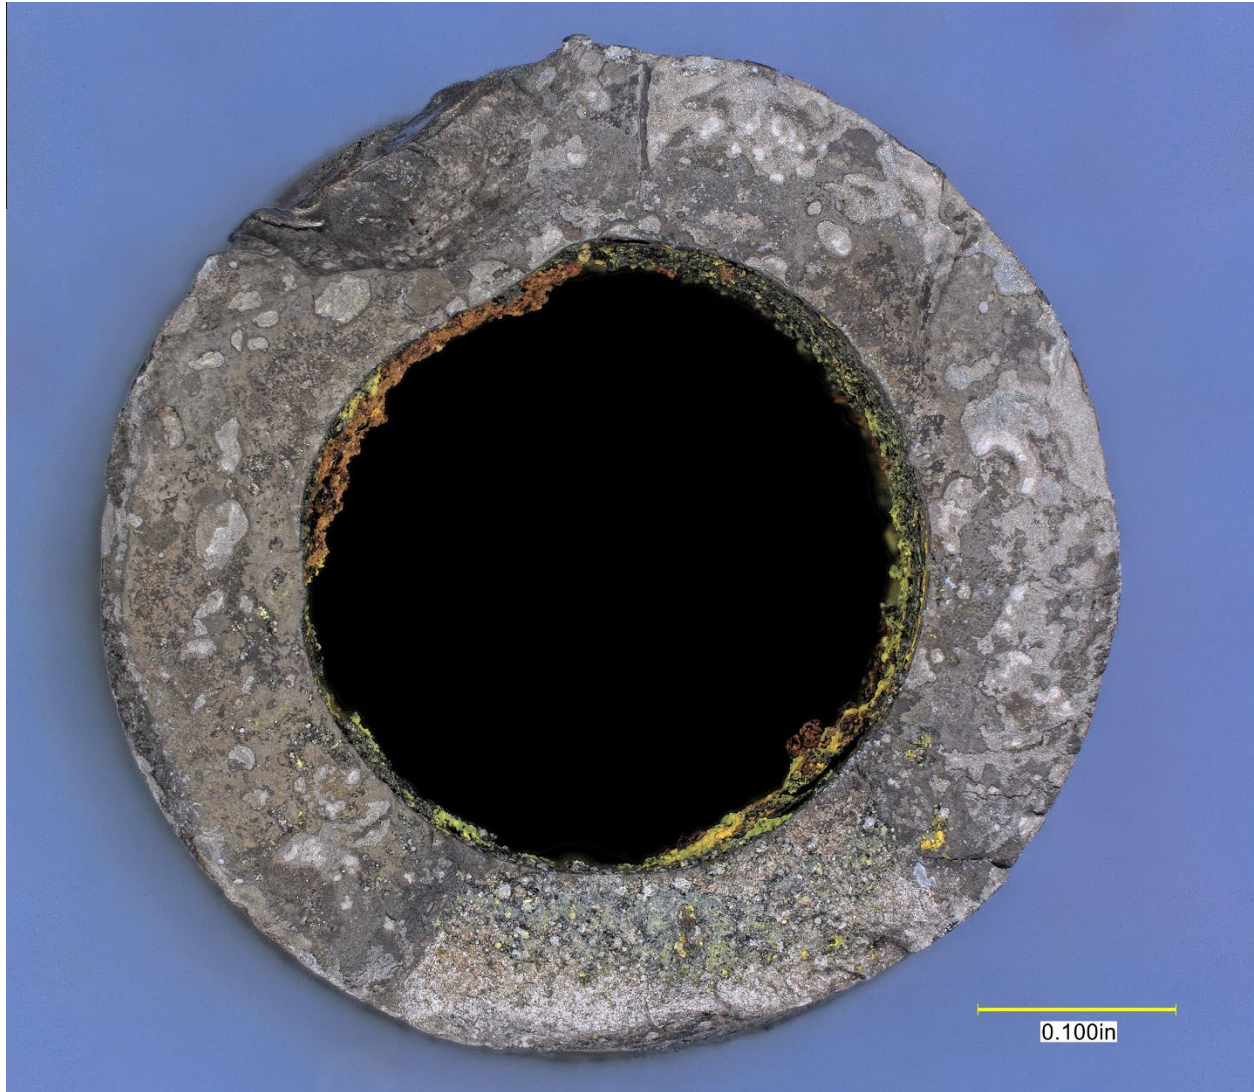
The upper left portion of the fracture surface exhibited an inward deformation at the edge, along with material deformed outward along the sides. This region was consistent with a post-fracture impact mark. Most of the rest of the fracture surface was relatively flat and oriented perpendicular to the stem direction. This portion of the fracture surface exhibited radial marks in the upper right, which only intersected with the external surface edge. A portion in the lower region exhibited a rougher surface morphology and appeared lighter than the rest of the darker areas of the fracture surface.

The exhaust valve fractured from fatigue cracking, which initiated at multiple locations along the stem exterior surface. Once the cracking progressed through most of the valve stem cross-section, the head liberated, and this loose fragment was repeatedly battered against the cylinder and piston surfaces. This sequence of events led to leading to a loss of engine power and proper timing in the #2 cylinder.

Figure 10. View of the exhaust valve stem fracture surface after multiple cleaning steps.

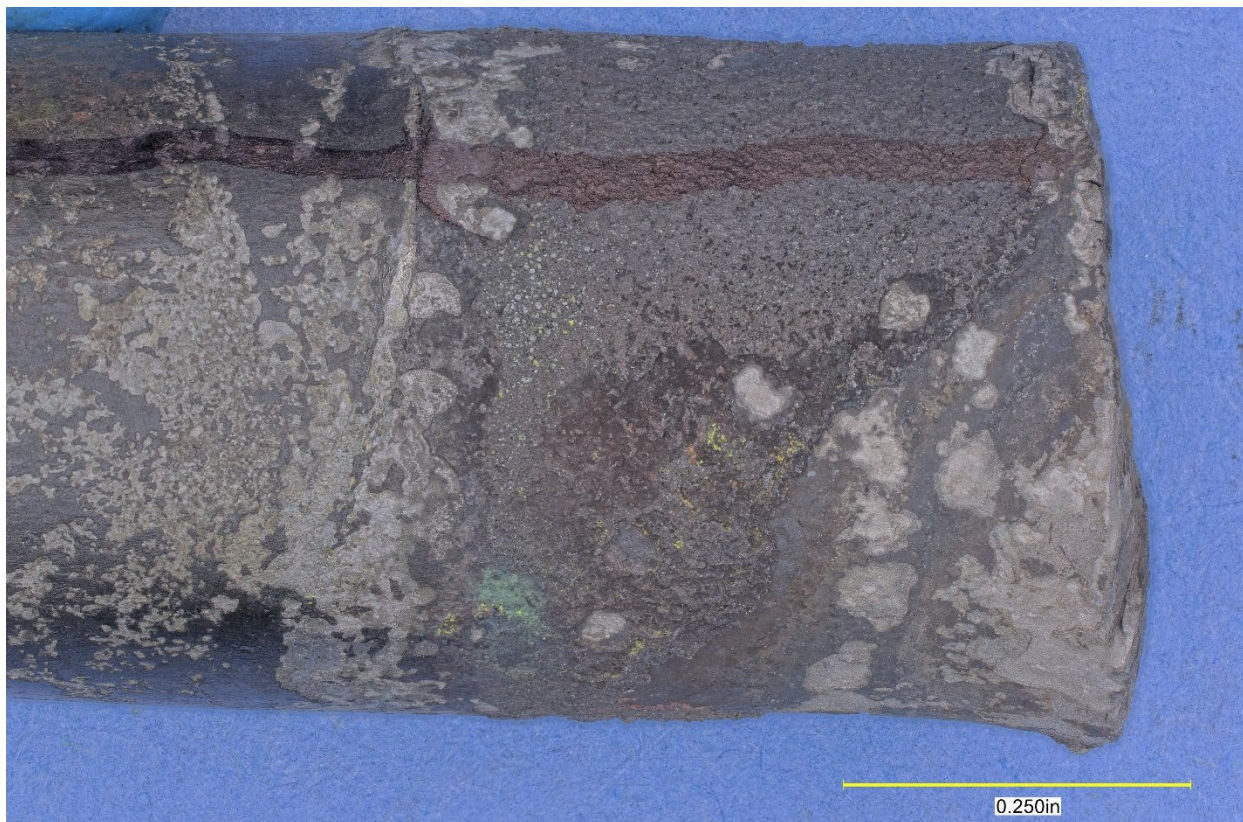
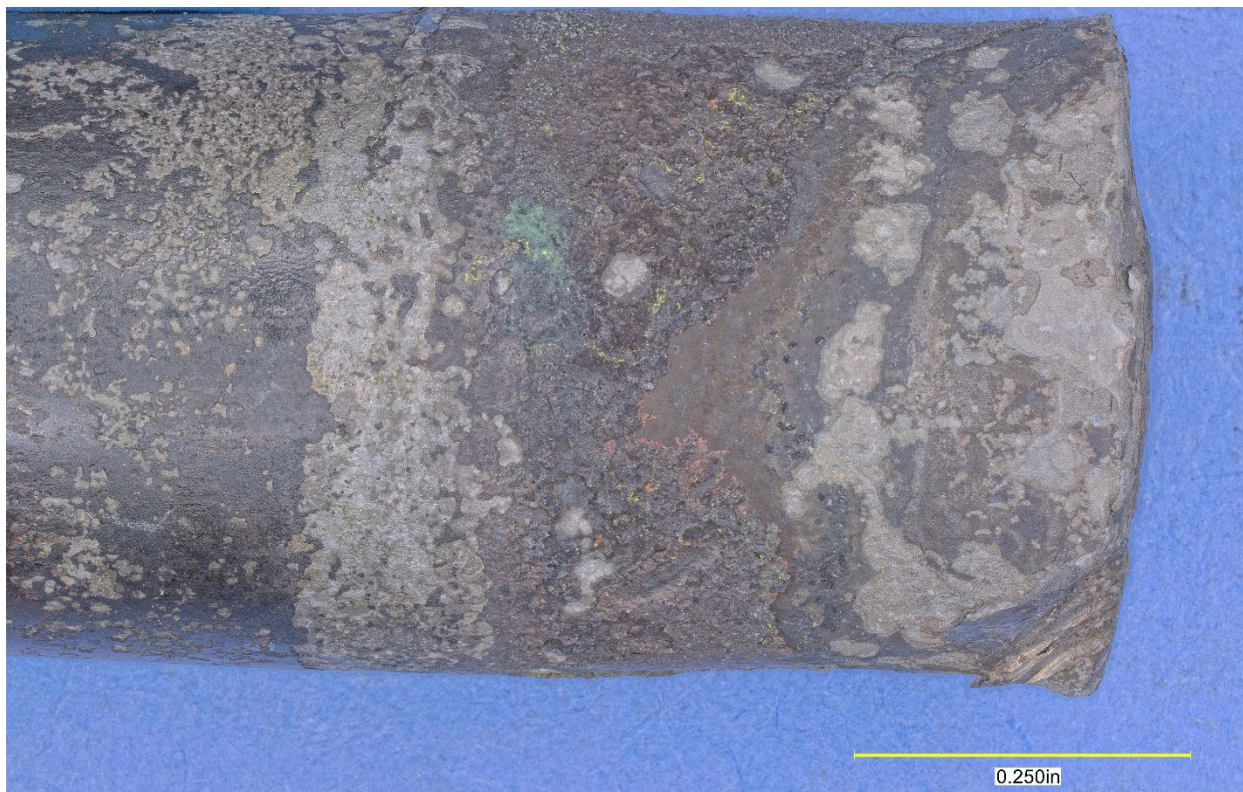
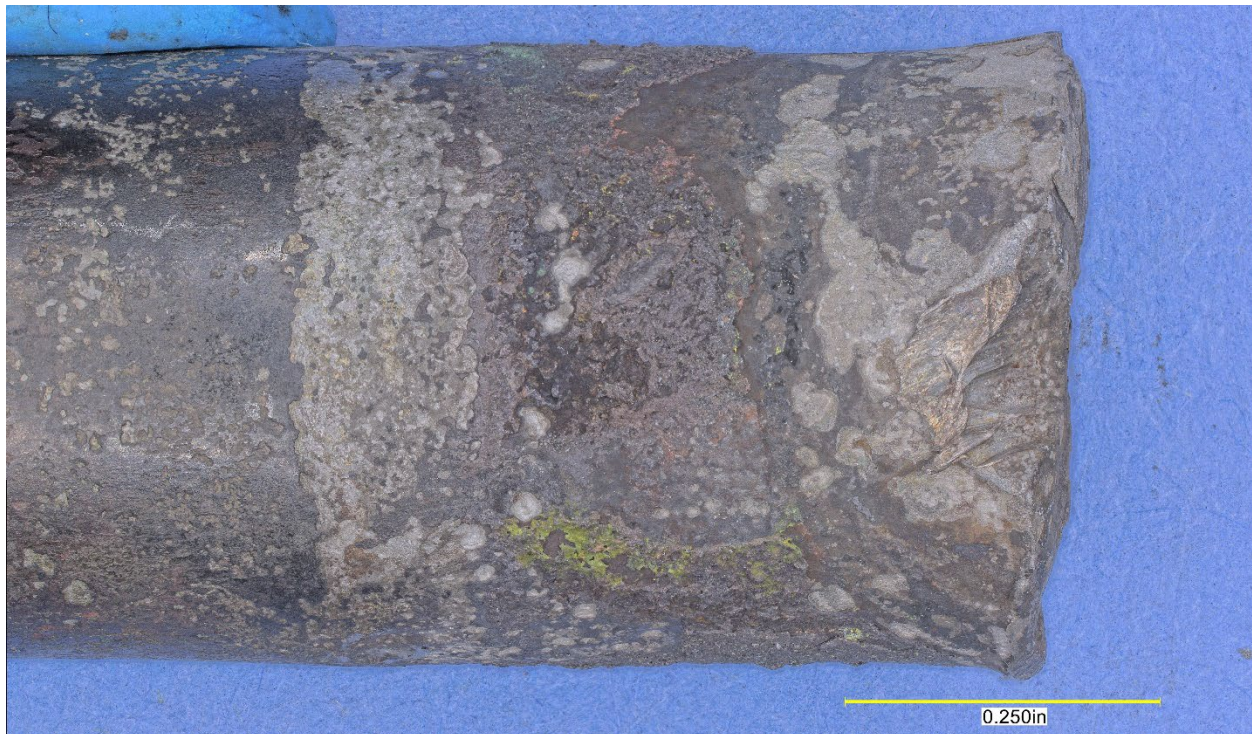
Figures 11 through 13 show side views of the stem near the fracture surface, with the rougher region at the bottom of Figure 10 being demarcated with a black permanent marker, as shown in Figure 11. The exterior of the stem near the fracture surface generally exhibited material loss and indications of impact region, particularly in Figure 13. This area corresponded to the impact in the upper left of Figure 10 on the fracture surface.

Figure 11. Side view of the valve fracture surface with the rougher region facing up.

Figure 12. Side view of the valve near the fracture, after cleaning, rotated 90° from Figure 11.

Figure 13. Side view of the valve near the fracture, after cleaning, rotated 90° from Figure 12.

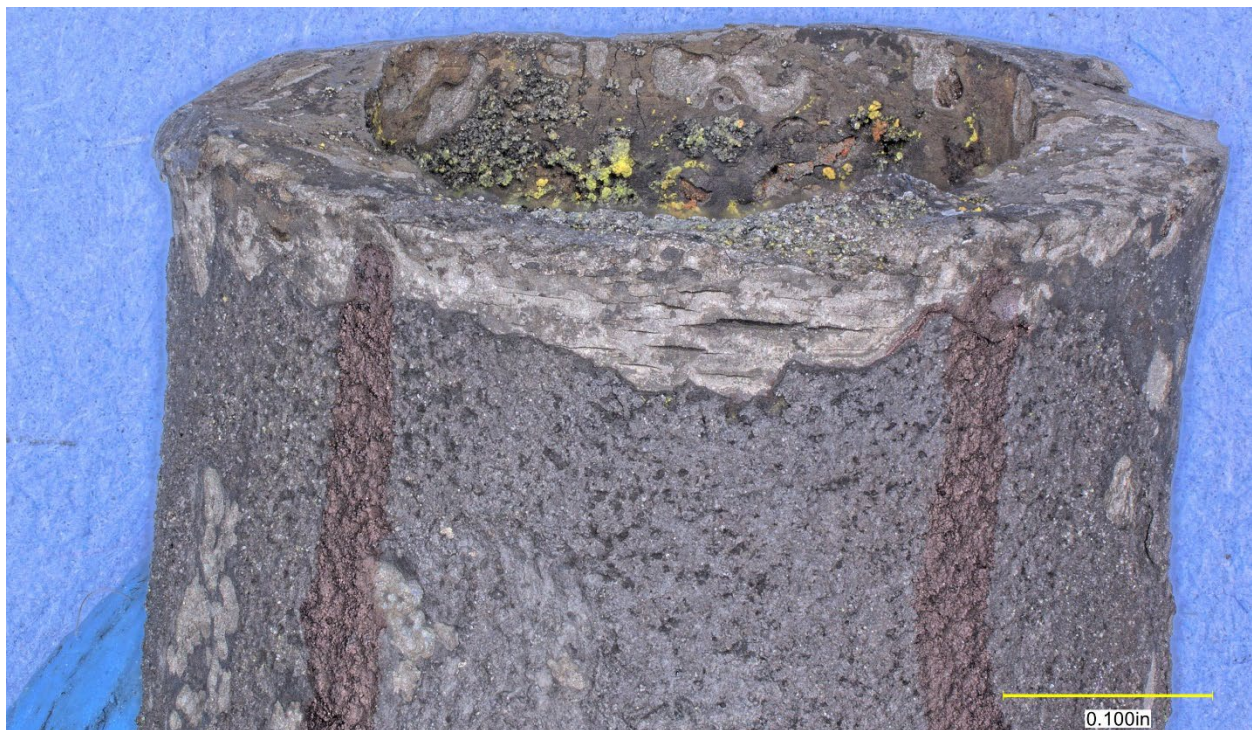
Figure 14 shows an angled view of the fracture surface along the area of rougher texture. Just below this region were parallel cracks, as demonstrated in Figure 15. Similar cracks were present on the opposite exterior surface, though smaller in size and quantity.

Figure 14. Angled view of the exhaust valve fracture surface, showing parallel cracks revealed after part cleaning.

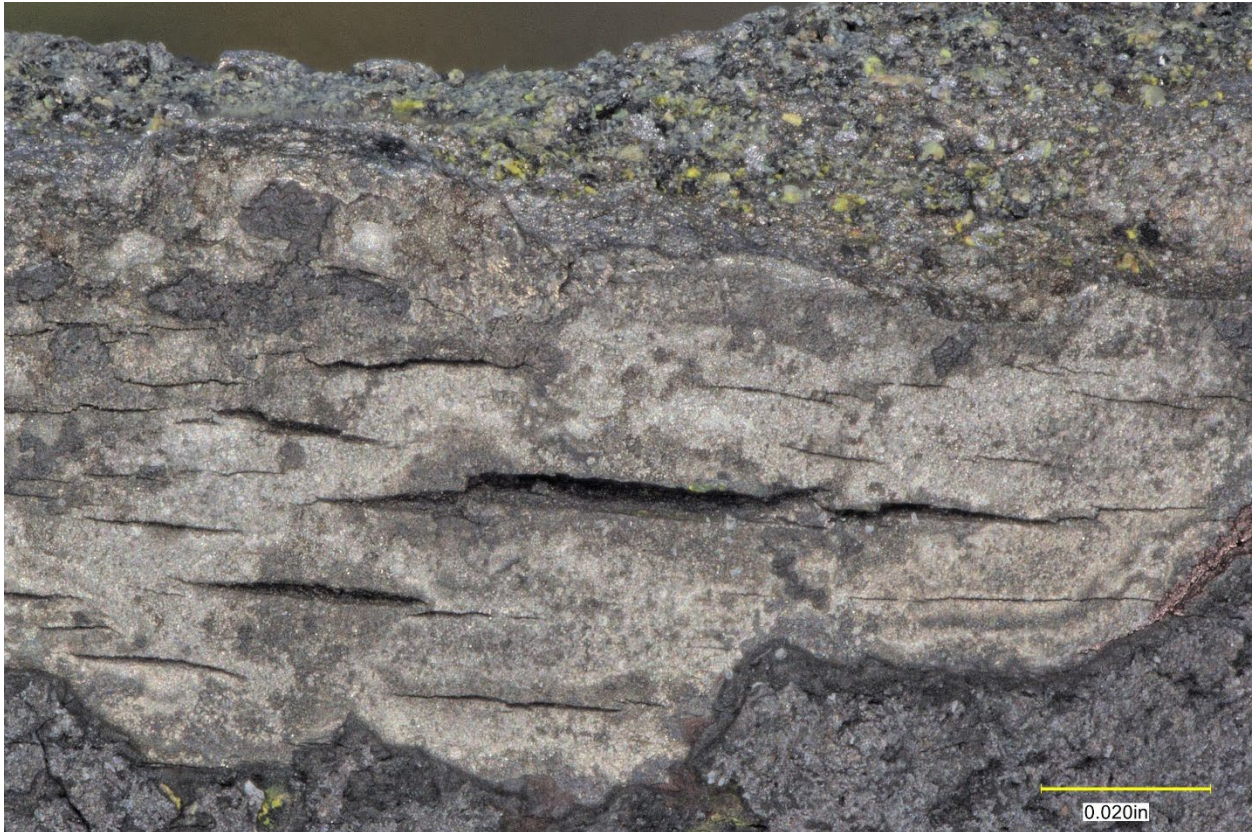
Figure 15. Closer view of the parallel cracks in Figure 14.

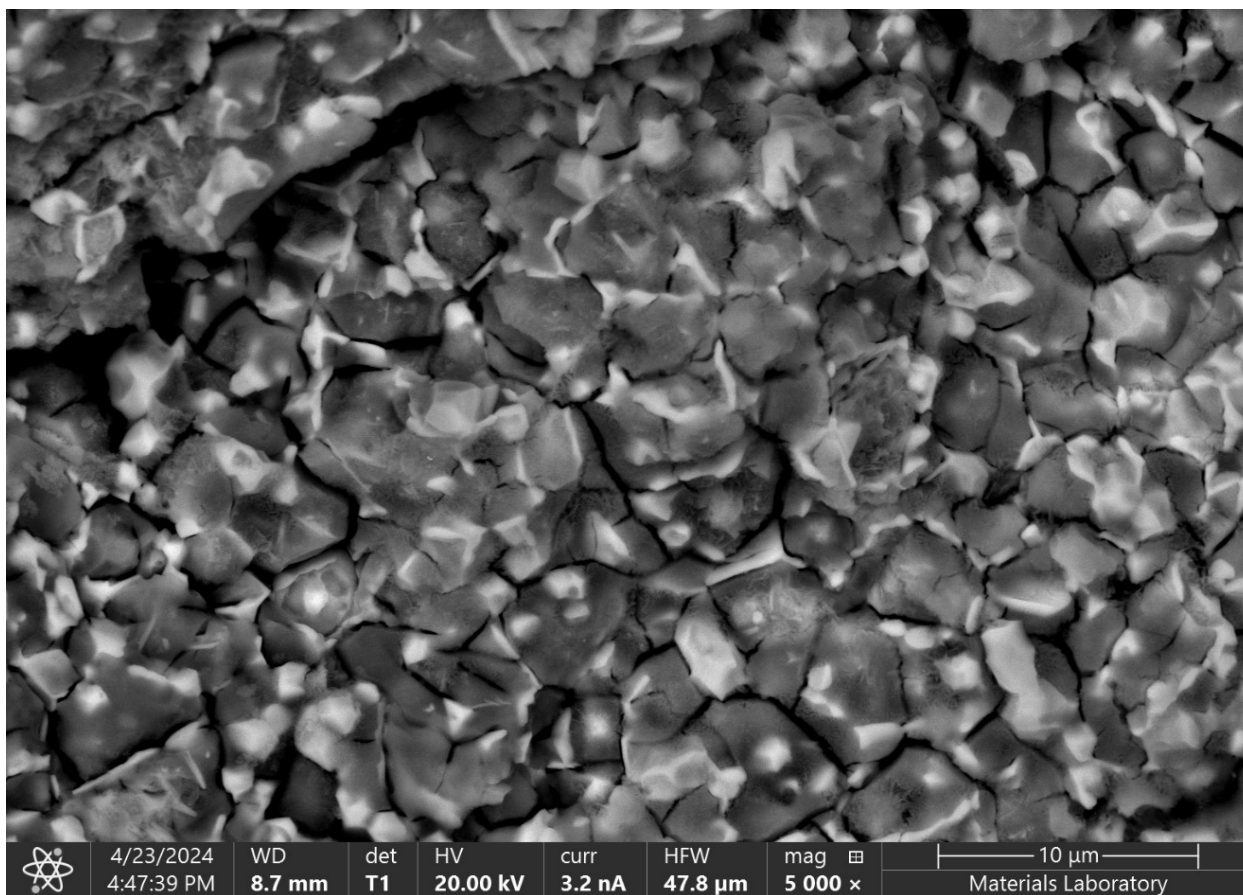
The fracture surface was examined using a field emission scanning electron microscope (SEM). Figure 16 shows a typical fracture surface area when examined at a magnification of 5000X. Even though the surface was cleaned of much of the oxide and corrosion product, a thick enough layer was still present over much of the surface, as typified in Figure 16. This figure shows a faceted surface texture with disparate material, as demonstrated by the contrast in backscattered electrons. This area was examined using energy dispersive x-ray spectroscopy (EDS), and was consistent with chromium and iron oxides (see Figure 17).

Figure 16. Backscattered electron (BE) micrograph of a typical area of oxide on the valve fracture surface.

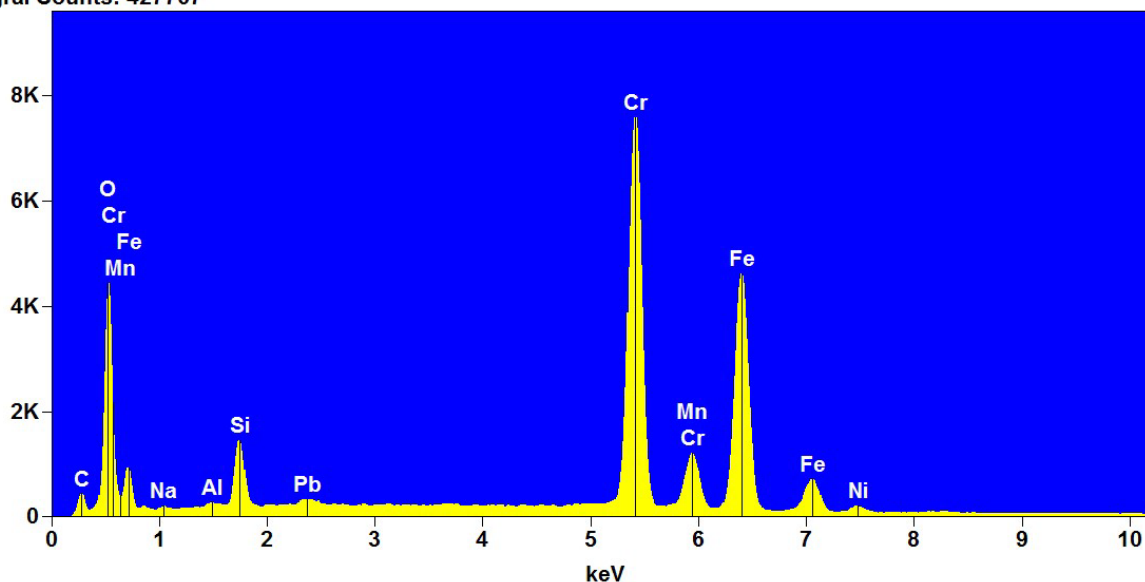
Figure 17. Typical EDS spectrum of the area in Figure 16, showing primarily Cr and Fe oxide.

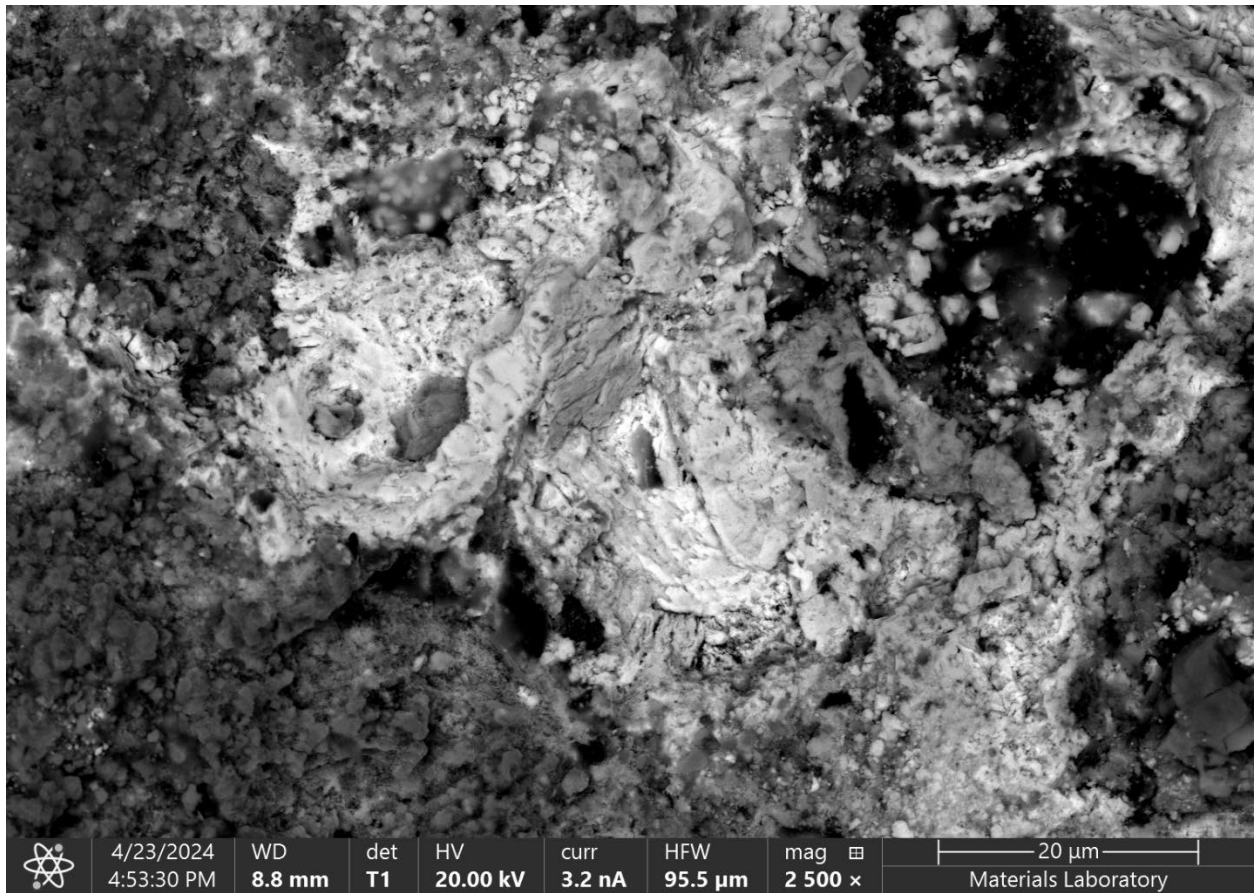
Some areas of the fracture surface exhibited bright contrast, as illustrated in Figure 18. When examined using EDS, the compounds exhibited high lead and bromine

Figure 18. BE micrograph of an area with high atomic number contrast (white) on the exhaust valve fracture surface.
