# National Transportation Safety Board

ERA23LA264

## **MATERIALS LABORATORY**

Factual Report 24-029

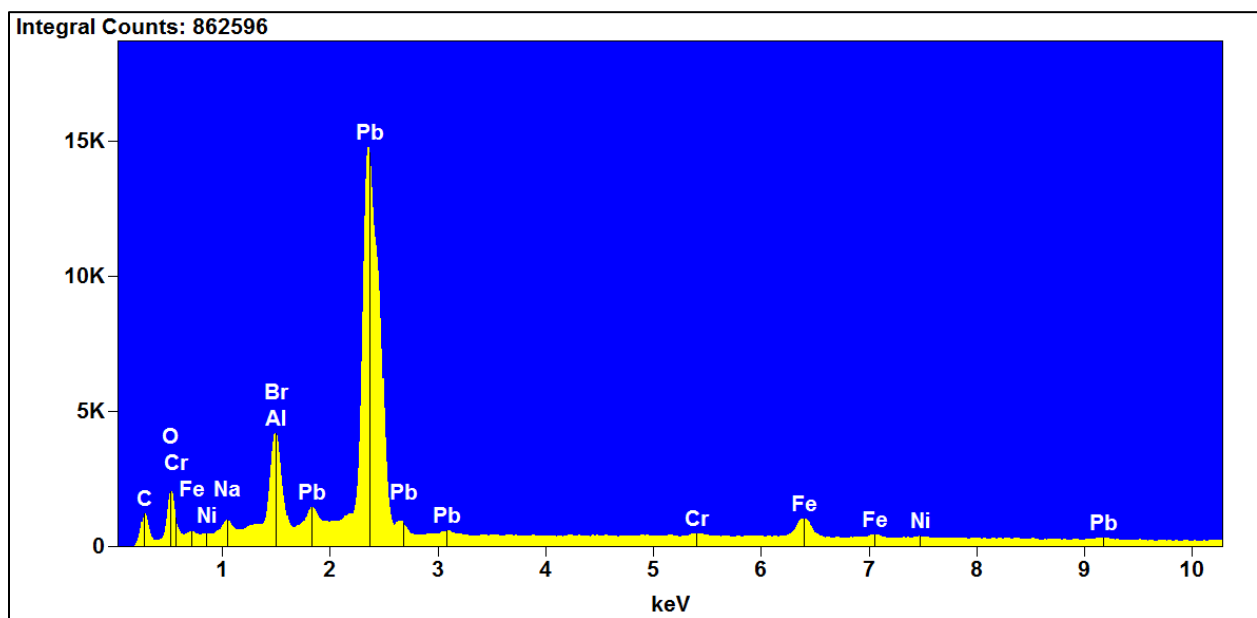
content, consistent with combustion deposits from tetraethyl lead additives in avgas fuel (see Figure 19).

The presence of thick lead oxide deposits, surface oxidation, and coarsened microstructure indicated elevated temperature exposure the valve experienced.

Figure 19. Typical EDS spectrum of the white area in Figure 18, showing compounds consistent with lead oxides.

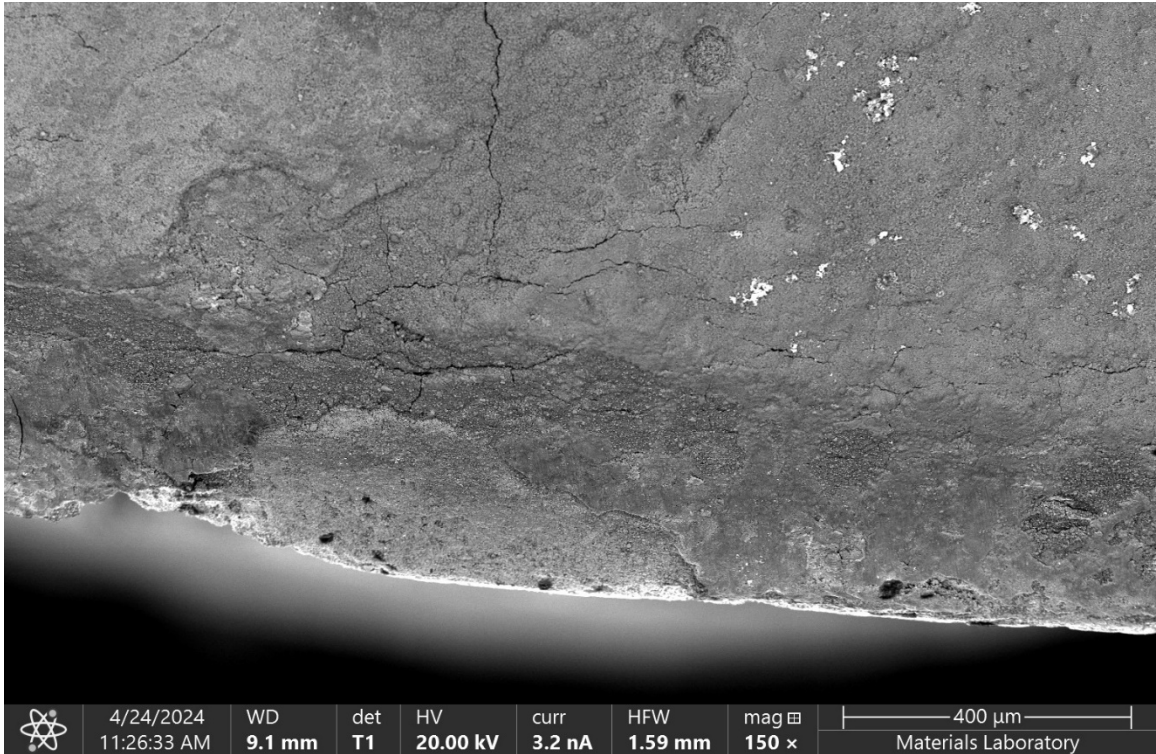
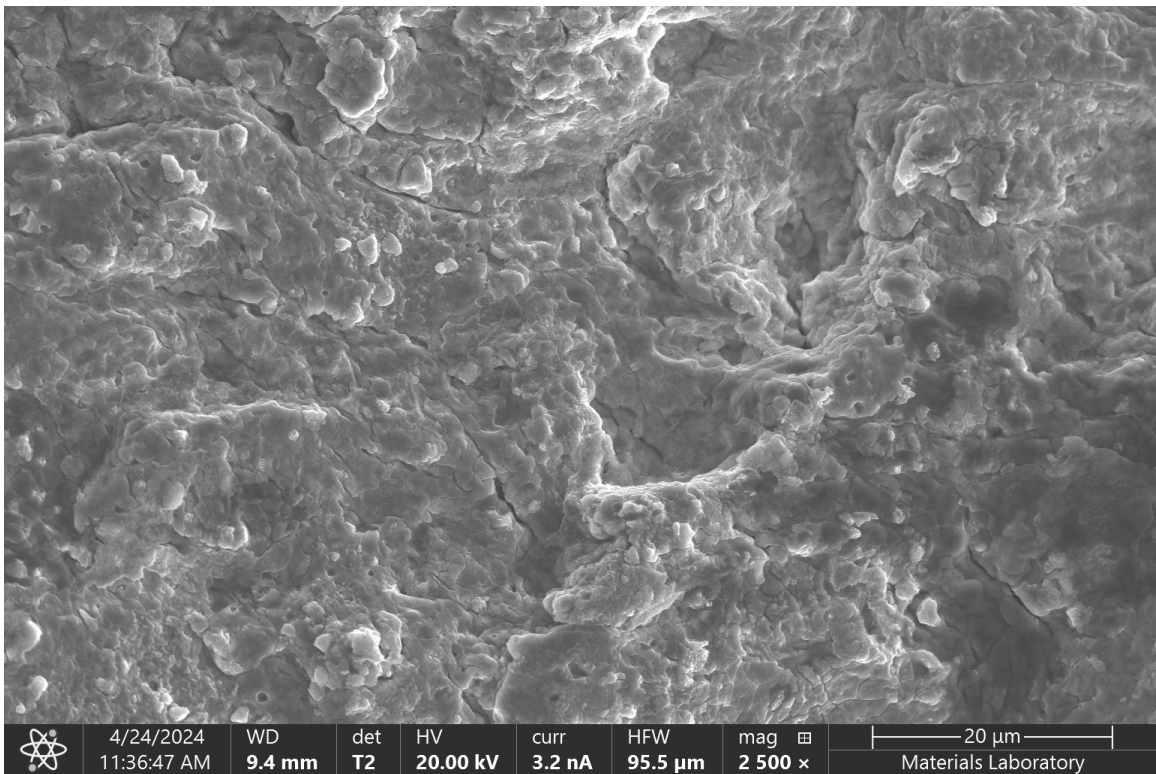
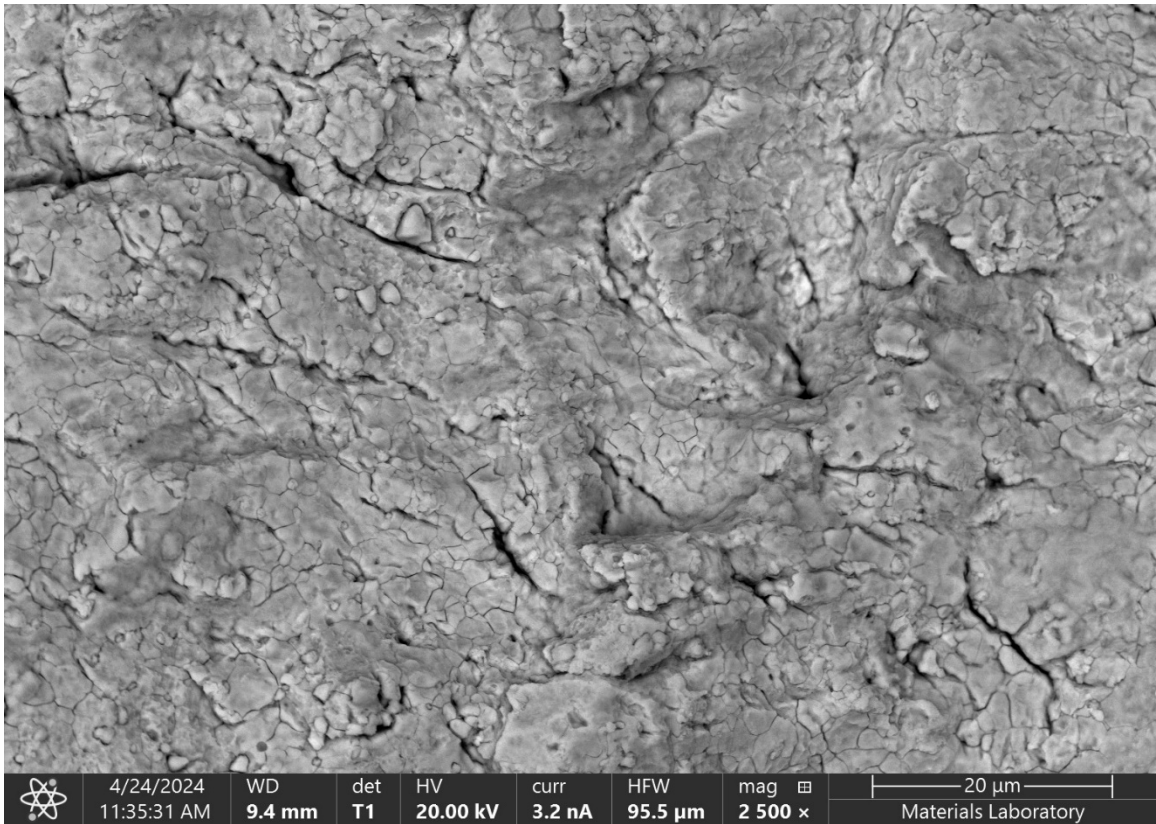
Selected areas of the fracture surface exhibited oxide layers that were thin enough to reveal the underlying features of the fracture surface. One area was present along the edge in Figure 20, between two of the radial marks in Figure 10. A closer view of this area revealed parallel linear features consistent with fatigue striations (see Figures 21 and 22). These striations were oriented parallel to the edge and were consistent with crack propagation from the exterior inward.

Figure 20. BE micrograph of an edge of the valve fracture surface.

Figure 21. SE micrograph of an area of the fracture surface after oxide removal, showing parallel striation-like features.

Figure 22. BE micrograph of the area in Figure 21, showing striation-like features.

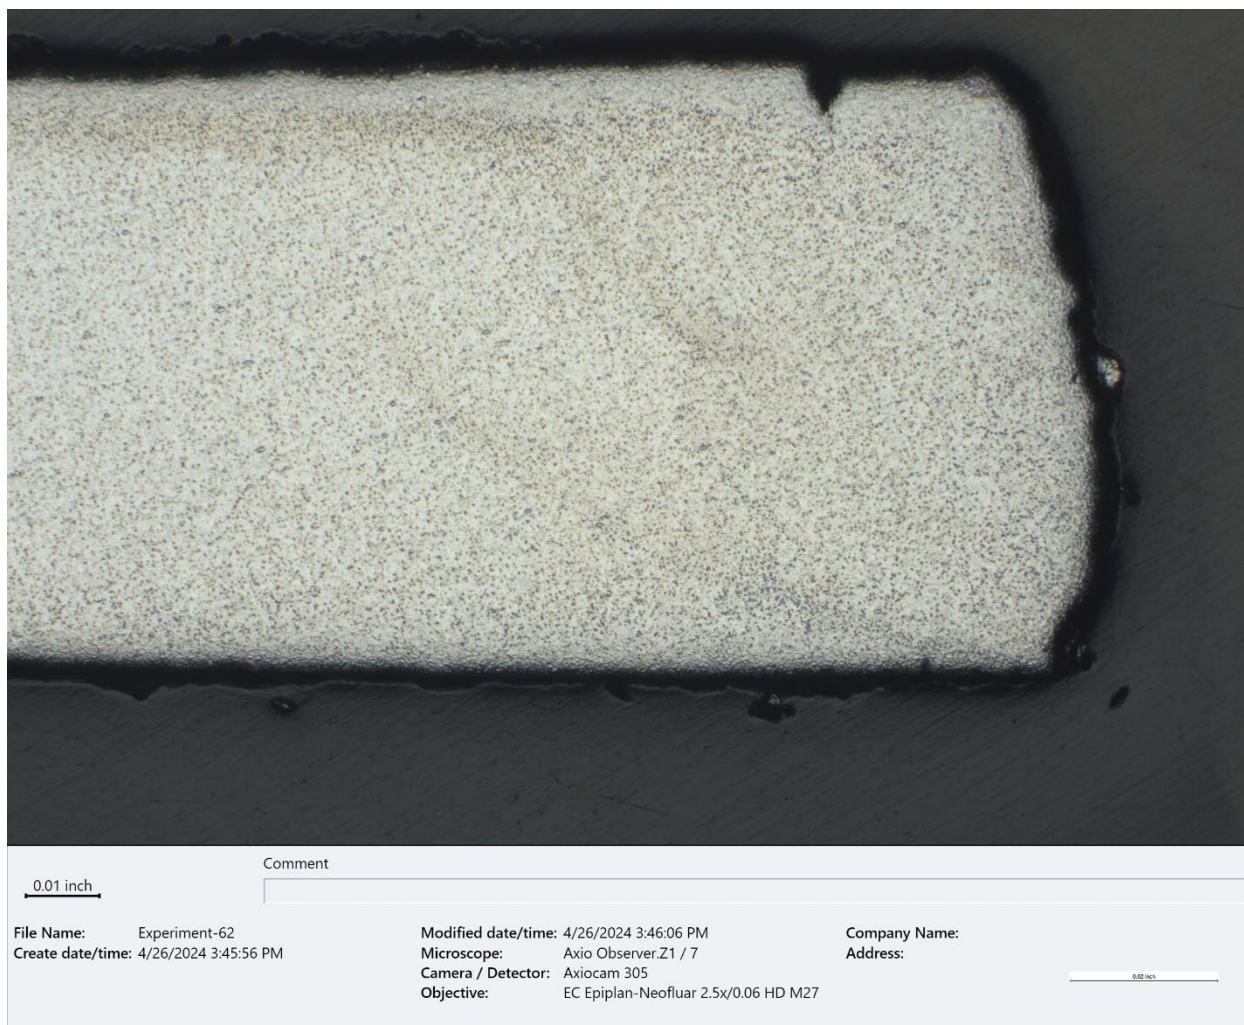
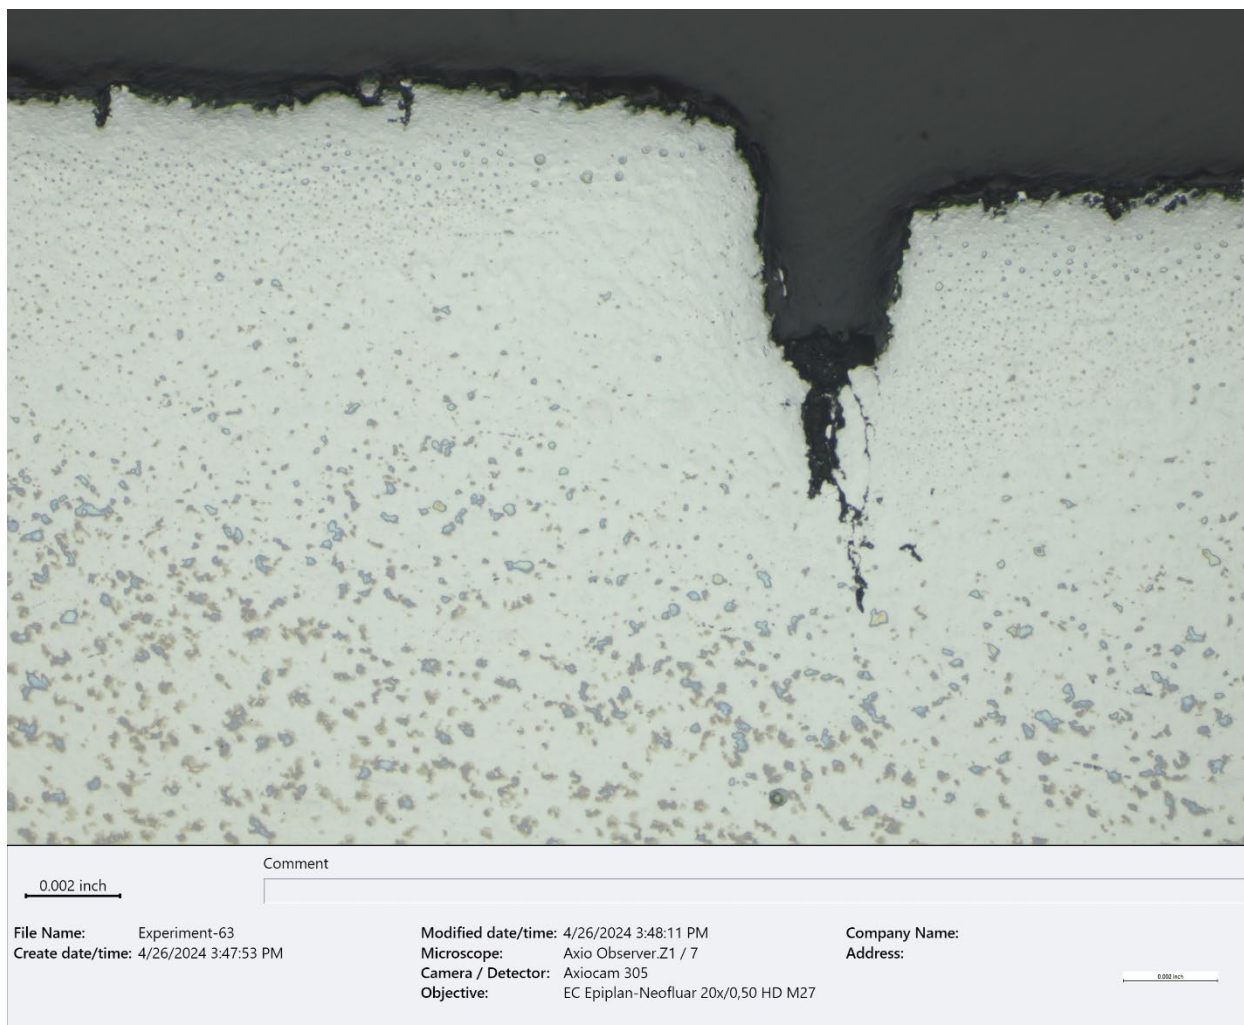
The fracture surface was cross-sectioned parallel to the stem's longitudinal direction through the secondary cracking area shown in Figure 14. Figure 23 shows a cross-section through the crack region, with the exterior facing upward in the figure and the fracture surface facing the right. This figure shows one of the larger cracks on the upper surface. Figure 24 shows a closer view, demonstrating the wide gap of the outer part of the crack, with the branched quality of the crack towards the tip. The surface differential of the opposite sides of the cracks also illustrates the material loss closer to the fracture surface.

Figure 23. Bright-field (BF) optical micrograph of a cross section through the area in Figure 14, showing cracking near the fracture surface, on the right in the figure (~25X, as-polished).

Figure 24. BF optical micrograph of a the surface crack in Figure 23 (~100X, as-polished).

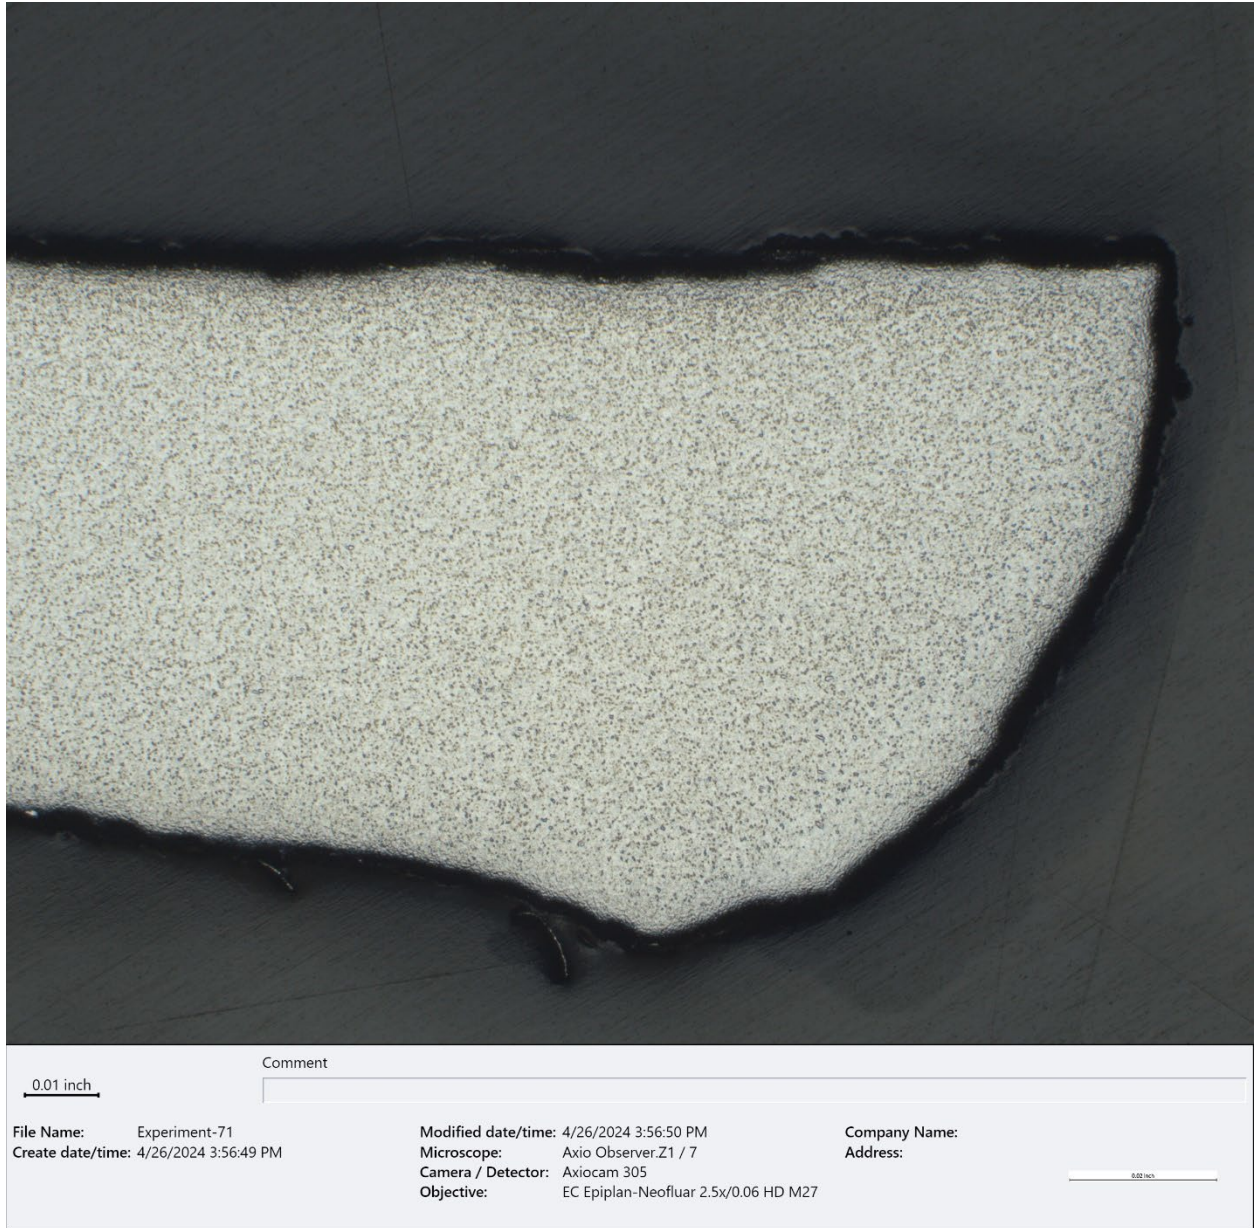
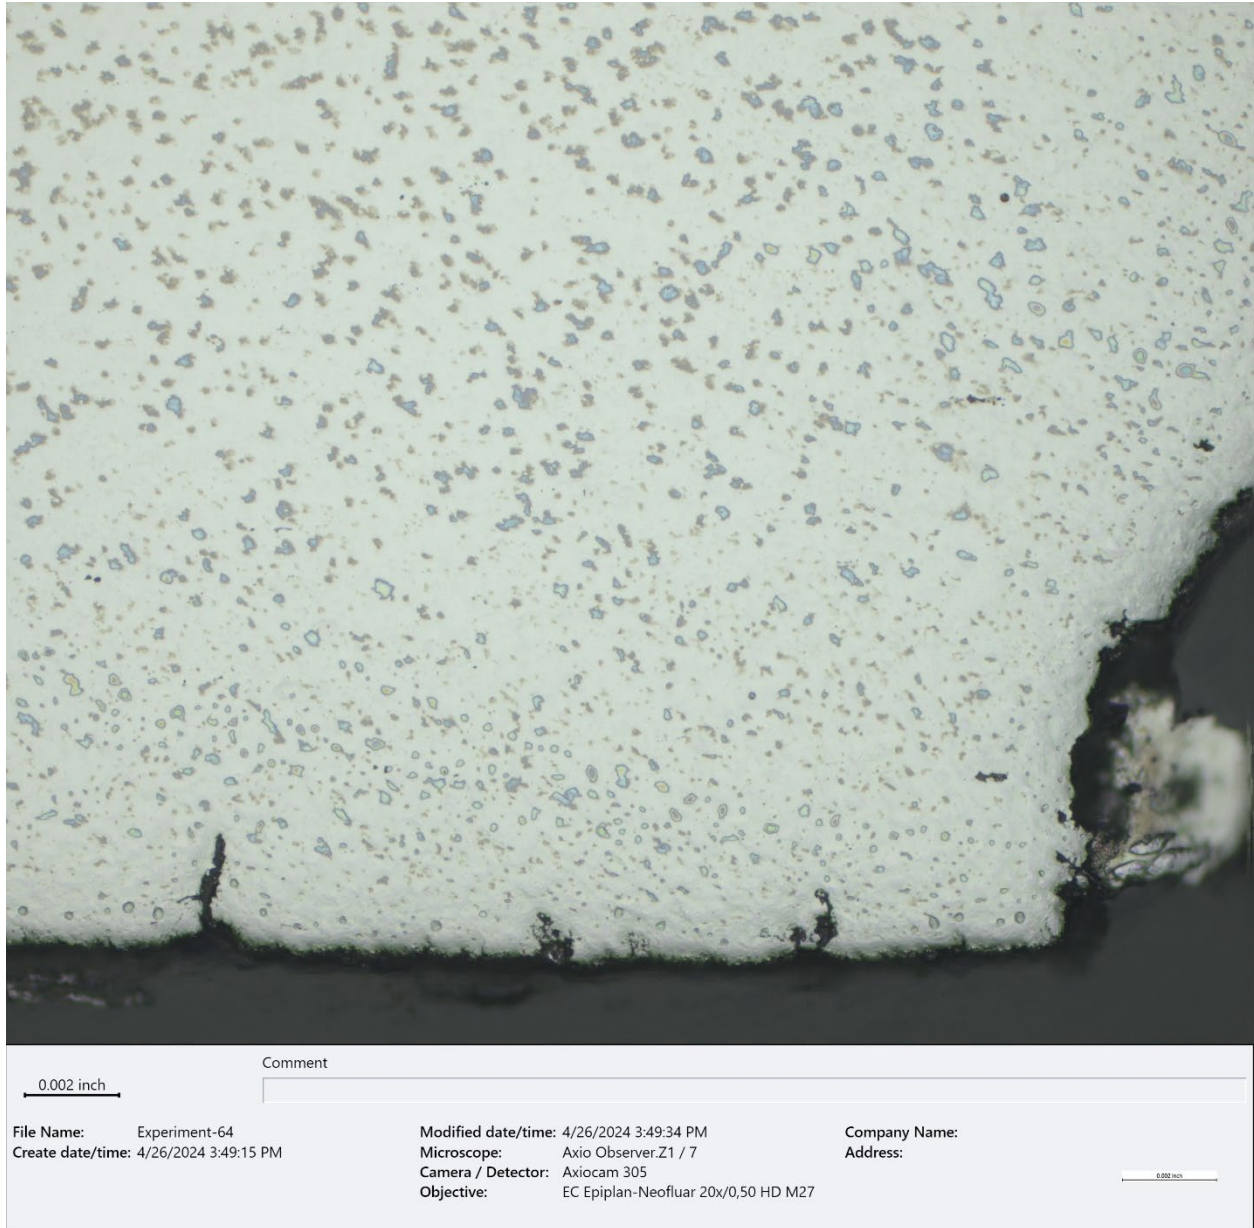
Figure 25 shows the opposite side of the stem cross-section across the hollow center cavity (in this figure, the exterior surface faces downward, and the fracture surface faces the right). Closer views of the edge near the fracture surface revealed shorter parallel cracks, consistent with having initiated at and propagated from the exterior surface (Figure 26).

Figure 25. BF optical micrograph of the opposite side of the valve, in cross-section (~25X, etched Fry's Reagent).

Figure 26. BF optical micrograph of a closer view of the exterior surface of the valve area in Figure 25, showing three surface cracks (~100X, etched Fry's Reagent)..

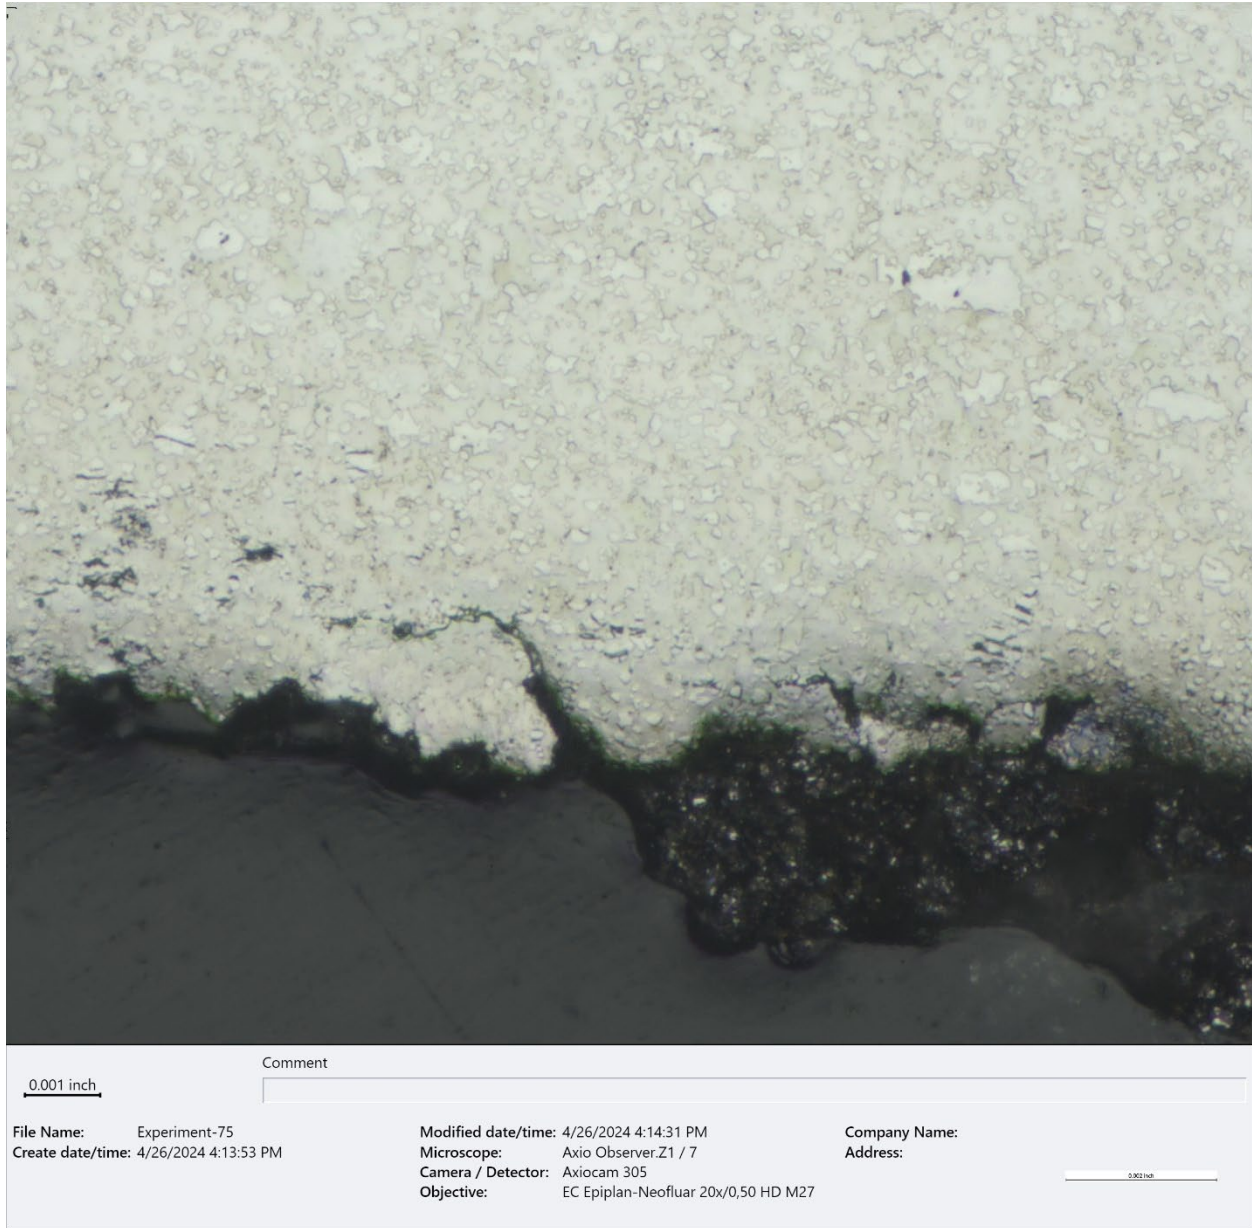
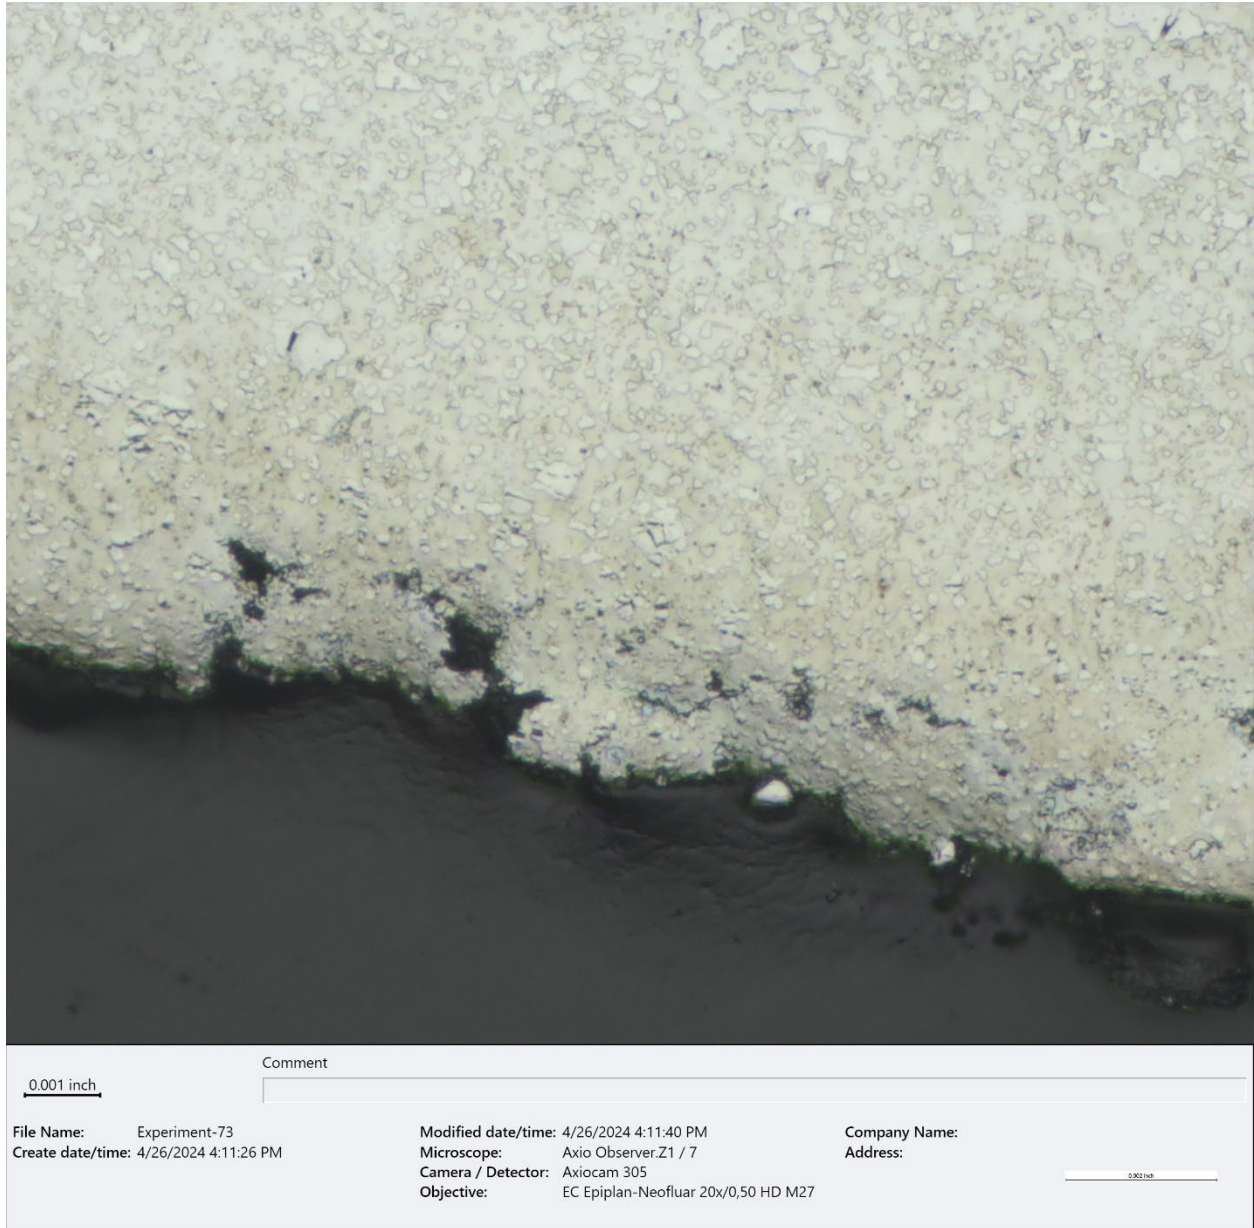
As typified in Figures 27 and 28, the exterior surface exhibited areas of cavity formation and localized cracking. Much of this cracking was oriented parallel to the exterior surface rather than perpendicular. In addition, there were areas of cracking within the second phase precipitates near the surface (Figure 27). In some regions, these cracks had coalesced below the surface.

Figure 27. BF optical micrograph of surface cracks and cracking within precipitates near the surface (~200X, etched Fry's Reagent).

Figure 28. BF optical micrograph of additional cracking parallel to the surface to the left of Figure 27 (~200X, etched Fry's Reagent).

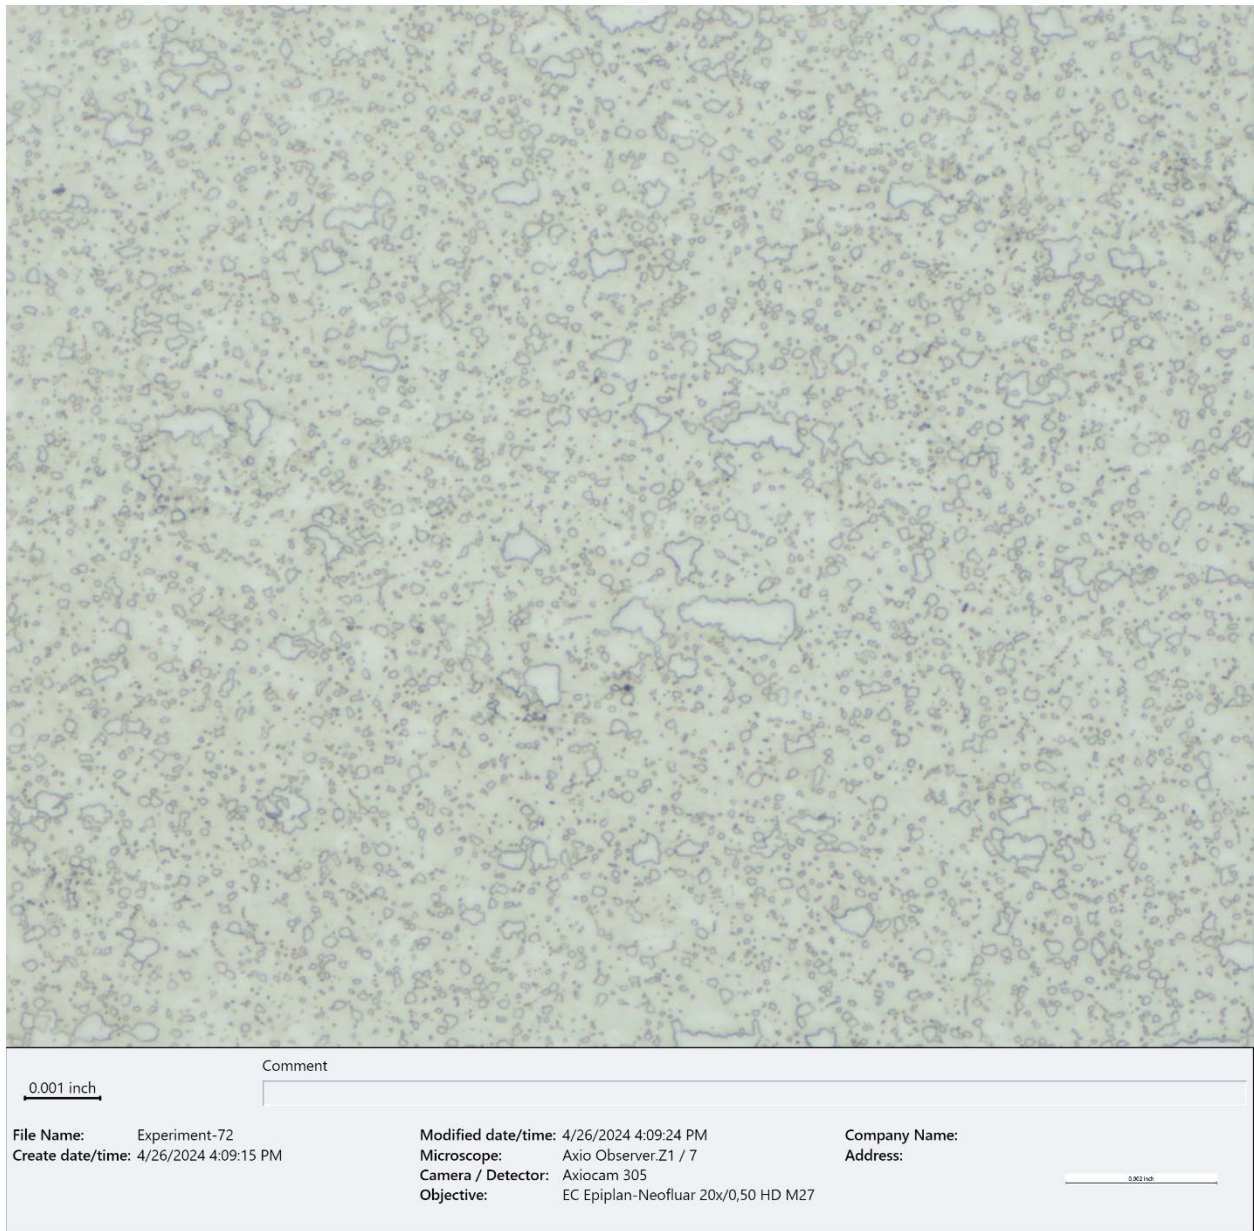
The core of the valve stem microstructure was examined after etching with Fry's Reagent. Figure 28 illustrates a typical view of the microstructure away from the surface. This microstructure showed multiple second phases consistent with chromium carbides typical of this composition.<sup>3</sup> The larger carbides exhibited rounding and coarsening throughout the microstructure, both near the surface and in the core. This microstructure was consistent with that near the surface shown in previous figures. These features were consistent with excessive temperature exposure, which changed the valve microstructure at this location.<sup>4</sup> The composition

was consistent with a martensitic or ferritic stainless steel, and the microstructure shown in these cross sections was inconsistent with typical as-manufactured conditions.<sup>5</sup>

Figure 29. BF optical micrograph of a typical area of the core microstructure of the exhaust valve cross section (~320X, etched Fry's Reagent).
