ERA23LA264

## INVESTIGATION PHOTOGRAPHS

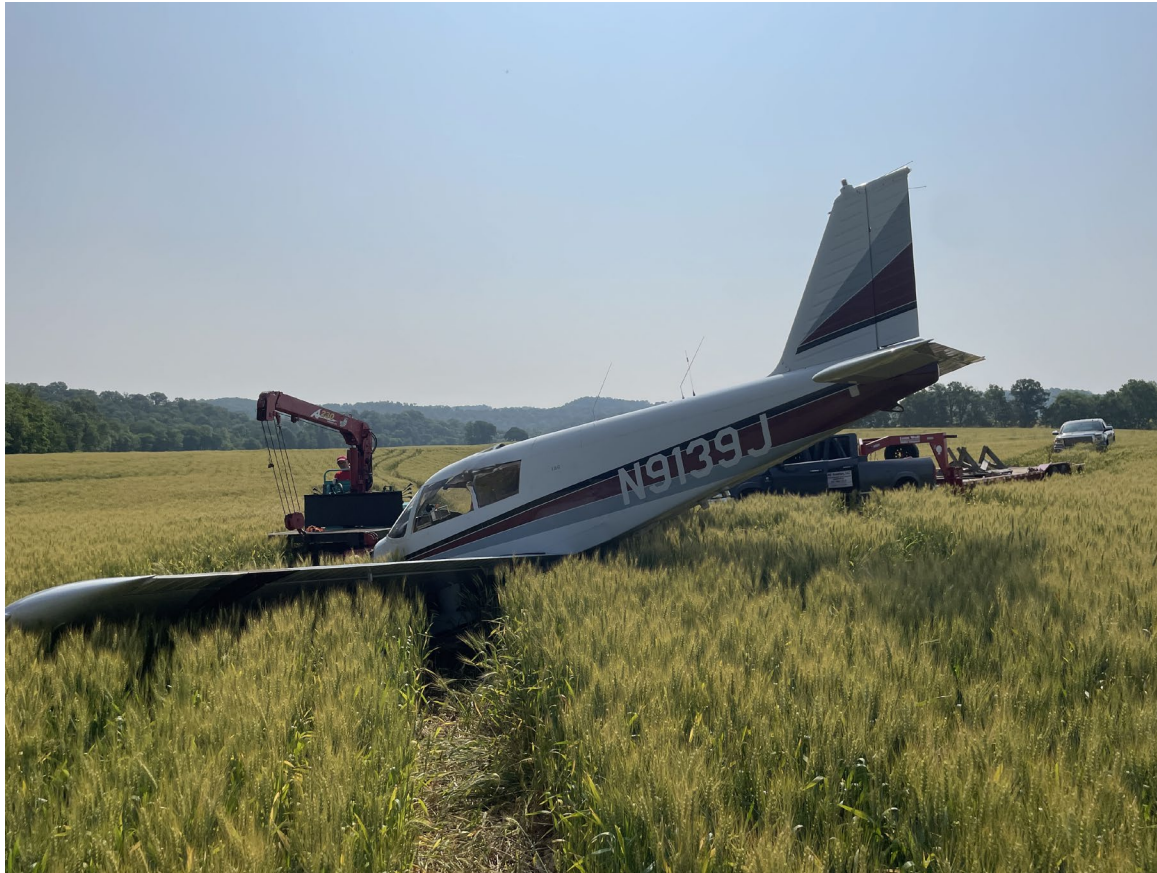
**Photograph 1 - Insurance Adjuster Digital Photograph Left Side View of the Airplane at the Accident Site**

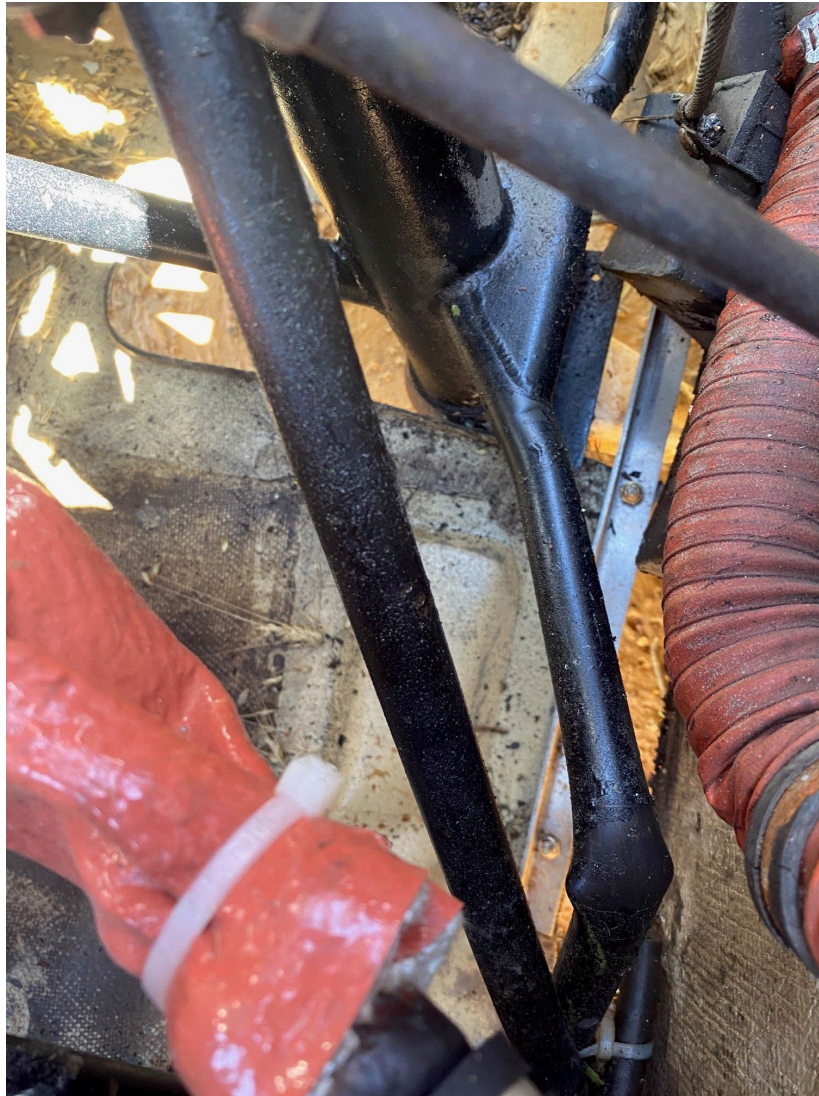
**Photograph 2 - Digital Photograph From Recovery Company View of the Damaged Engine Mount**
