# National Transportation Safety Board

ERA23LA268

## **WRECKAGE EXAMINATION**

Location: Louisville, Georgia  
Date: June 3, 2023  
Time: 1709 EDT  
2109 UTC  
Airplane: N828WD; Barden Jabiru J250

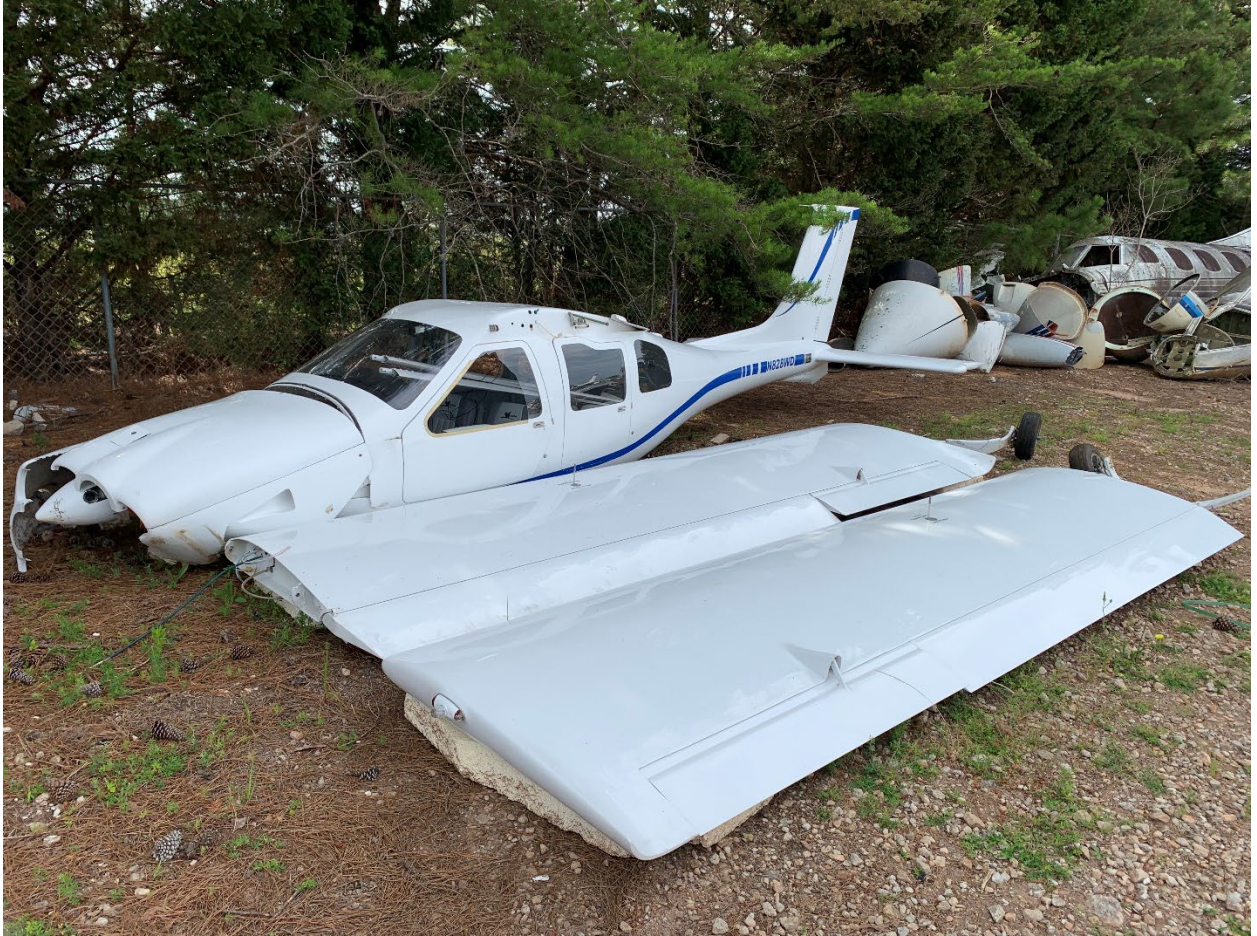
The wreckage was stored at the recovery facility in Griffin, Georgia and was in several sections consisting of the fuselage and empennage, both wings, both wing struts, and both main landing gear. There was no evidence of a fire.

**Photo 1: The wreckage laid out at the recovery facility.**

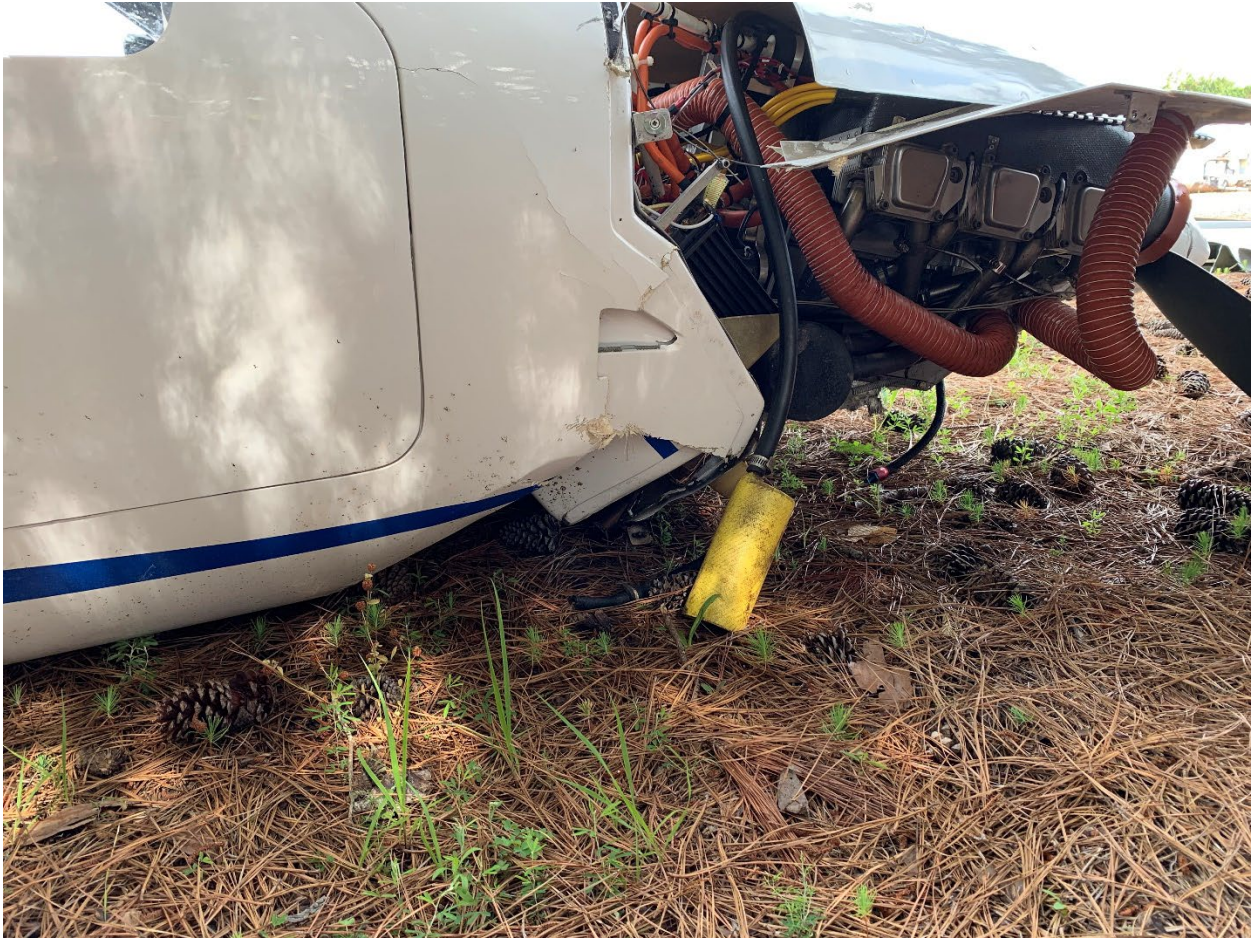
The fuselage remained intact with the cockpit and cabin doors still attached. The lower, forward fuselage (fiberglass construction) was crushed in an upward and aft direction, compromising and deforming the cockpit floor and impinging on the rudder controls.

**Photo 2: View of the forward fuselage crushed up and aft.**

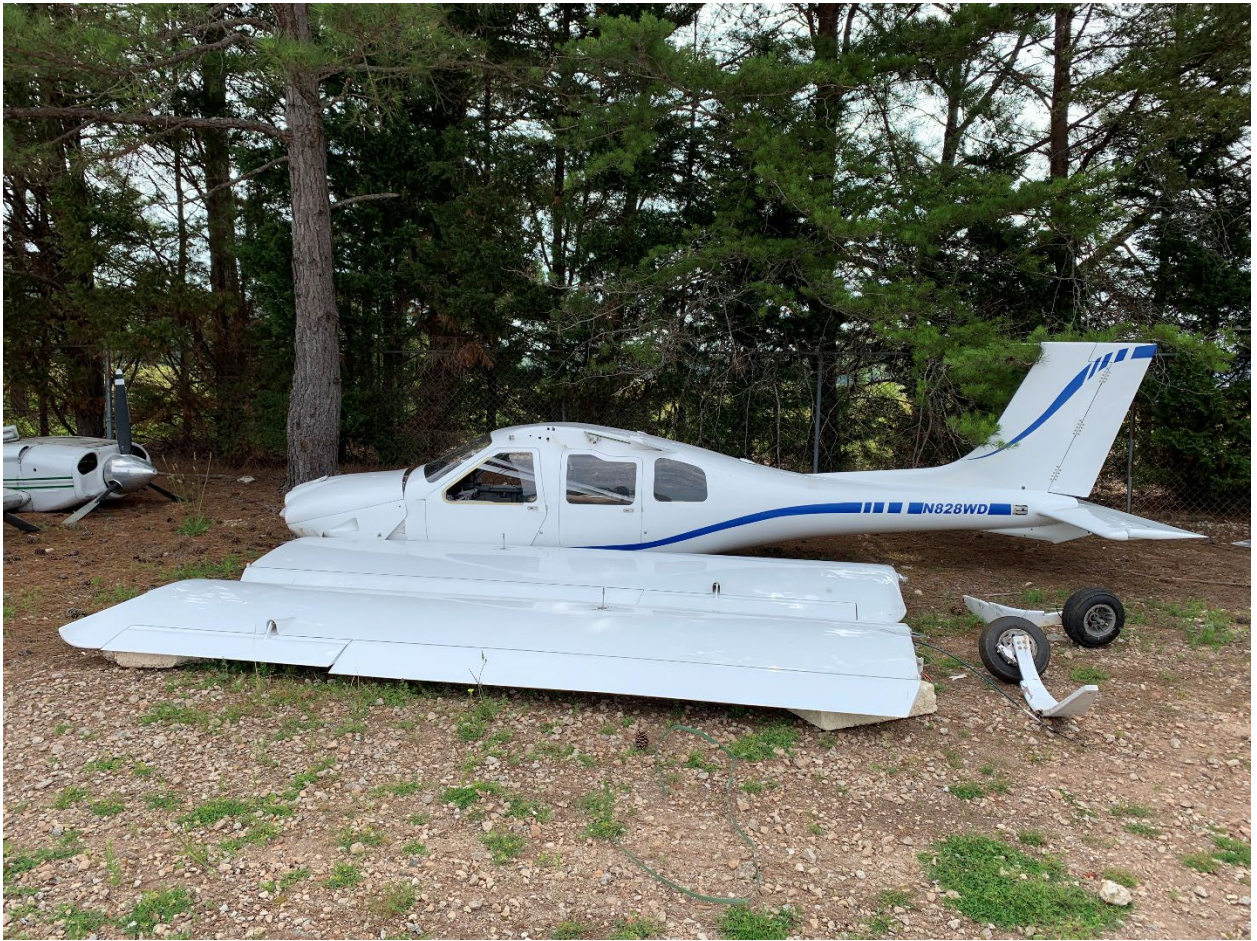
**Photo 3: View of the left side of the fuselage with main landing gear removed.**

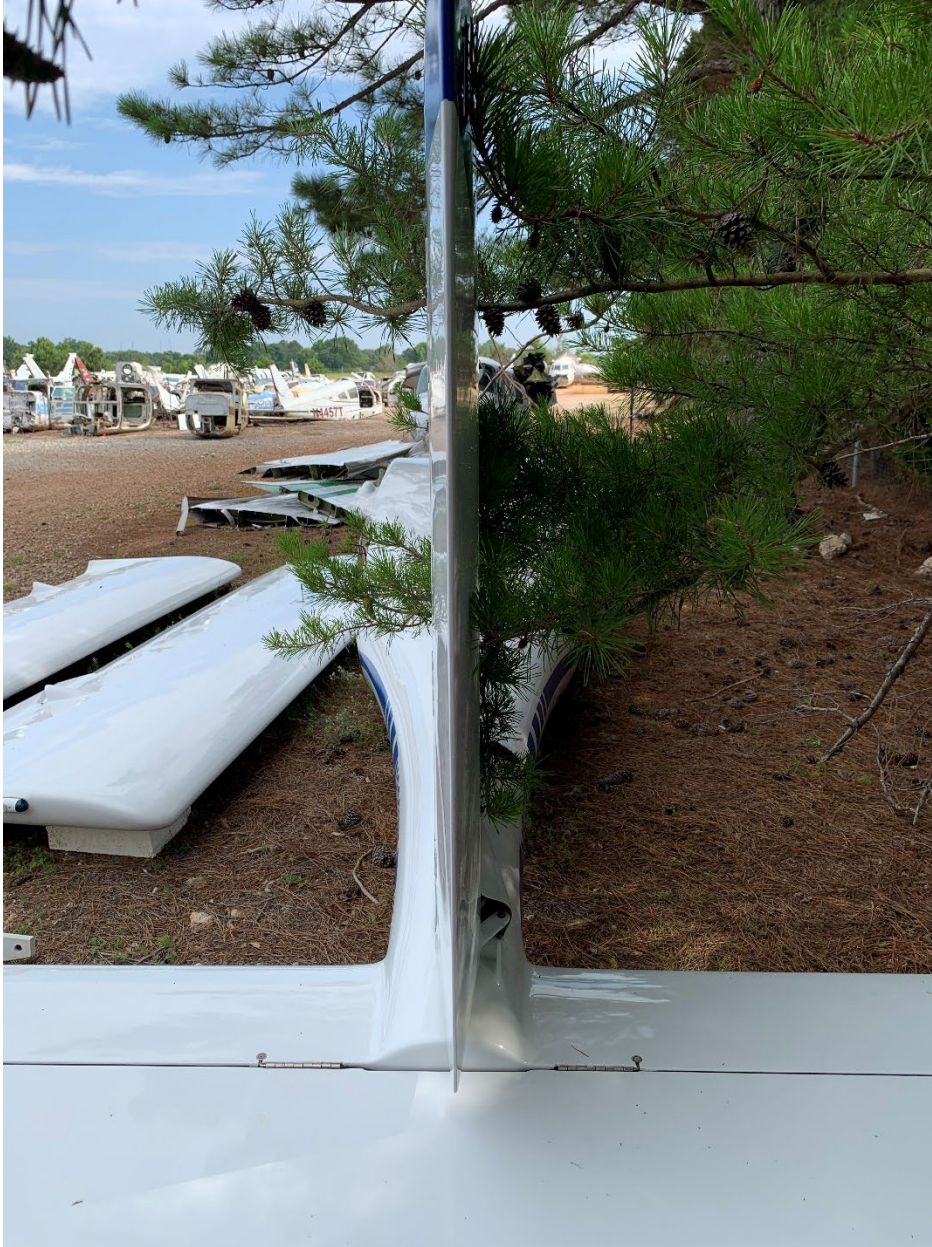
The empennage remained attached to the aft fuselage and was undamaged. The elevator remained attached and in position. Control continuity was established from the elevator to the center-mounted cockpit control (stick).

The rudder remained attached and in position. The control push/pull rod remained attached to the rudder. Control continuity was established from the rudder to both sets of rudder pedals in the cockpit. The pedals were manipulated by hand; the right rudder pedals were free to travel unrestricted to the hard stop. The left pedals were restricted by the postaccident deformation of the cockpit floor.

**Photo 4: View of the empennage, rudder in neutral position.**

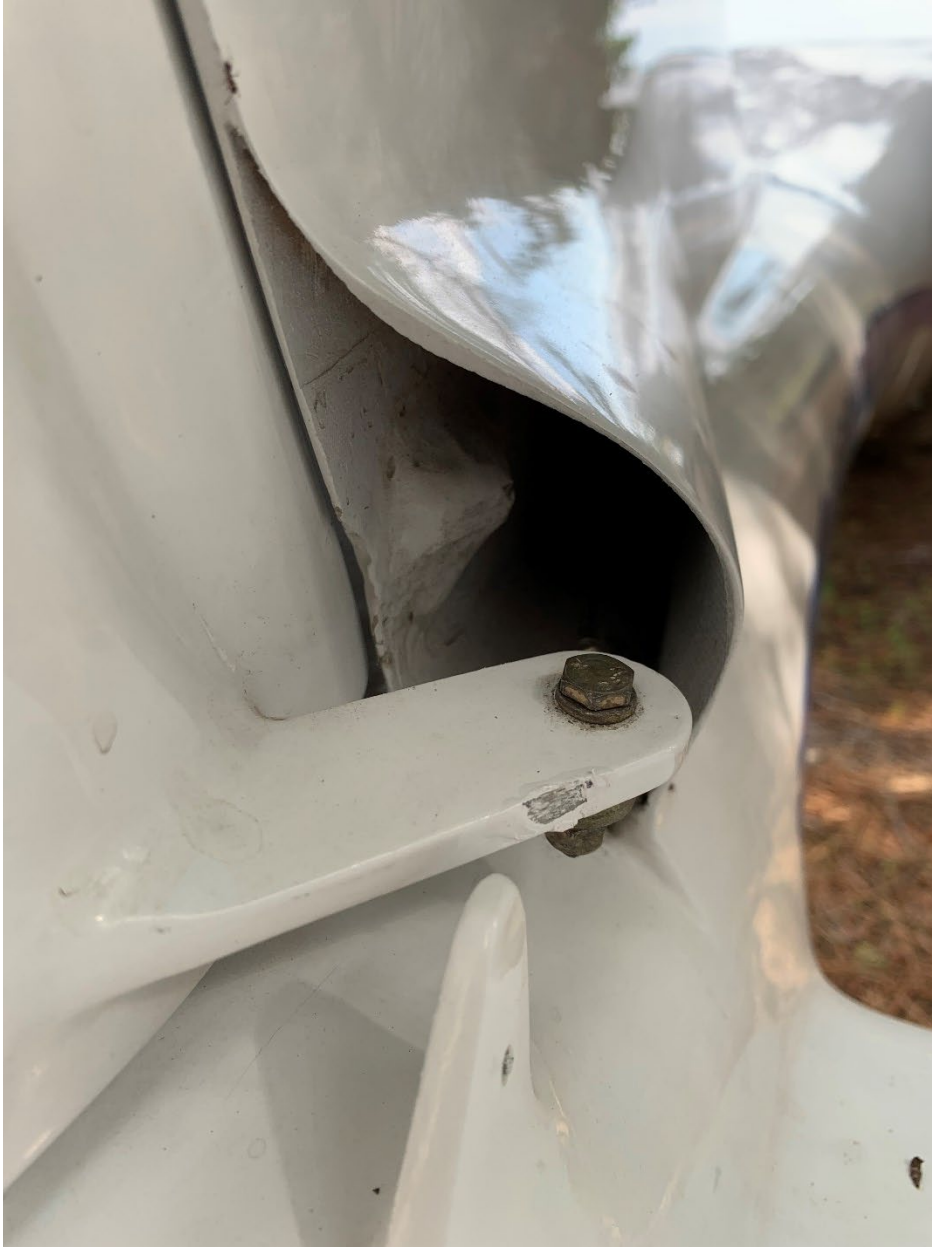
**Photo 5: View of the rudder attachment and hard stop.**

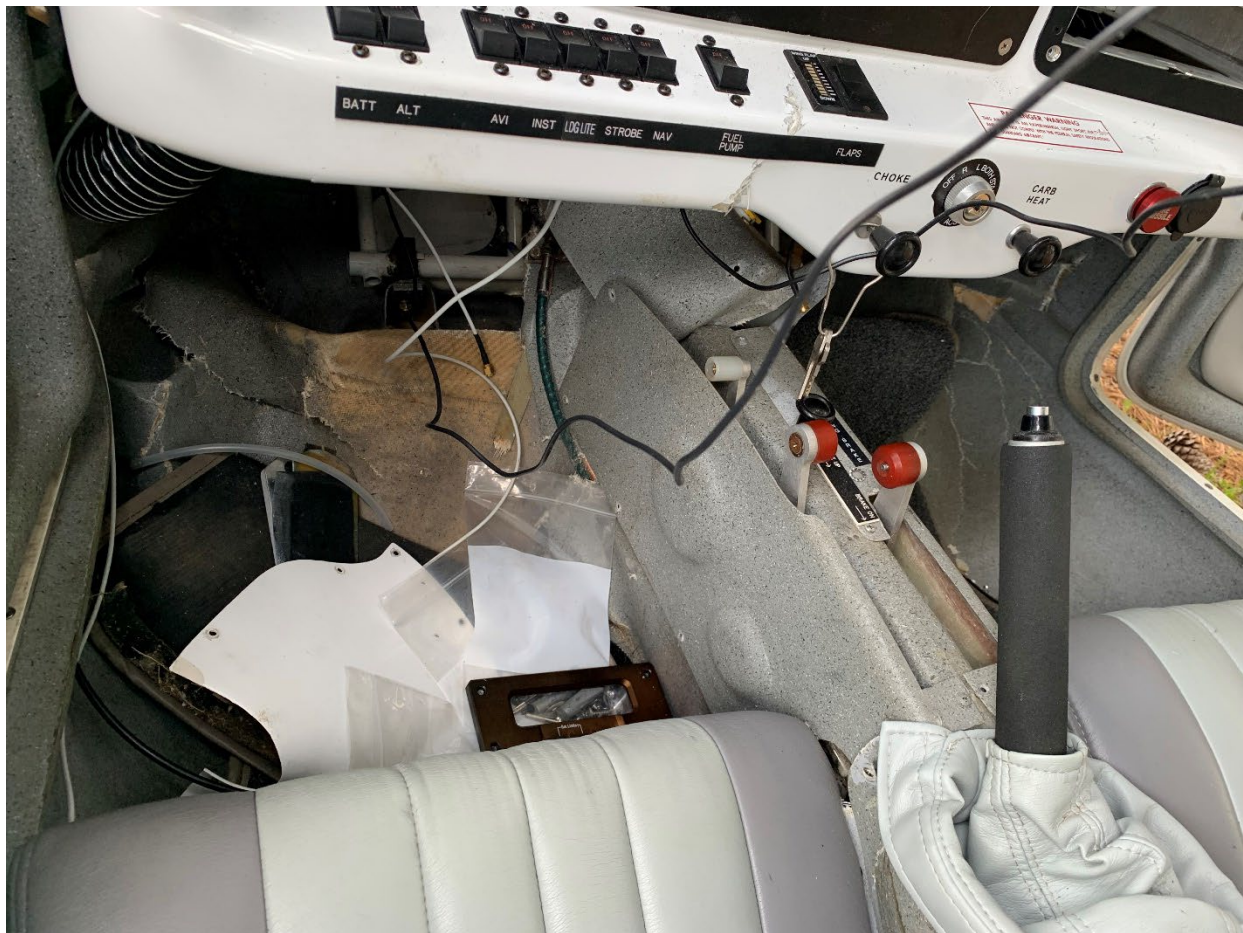
The cockpit was intact except for the previously mentioned floor deformation and the avionics were removed.

**Photo6: View of the cockpit, note deformation of cockpit floor.**
