# National Transportation Safety Board

ERA23LA272

## ENGINE EXAMINATION

A: Air Tractor AT802, N3096S

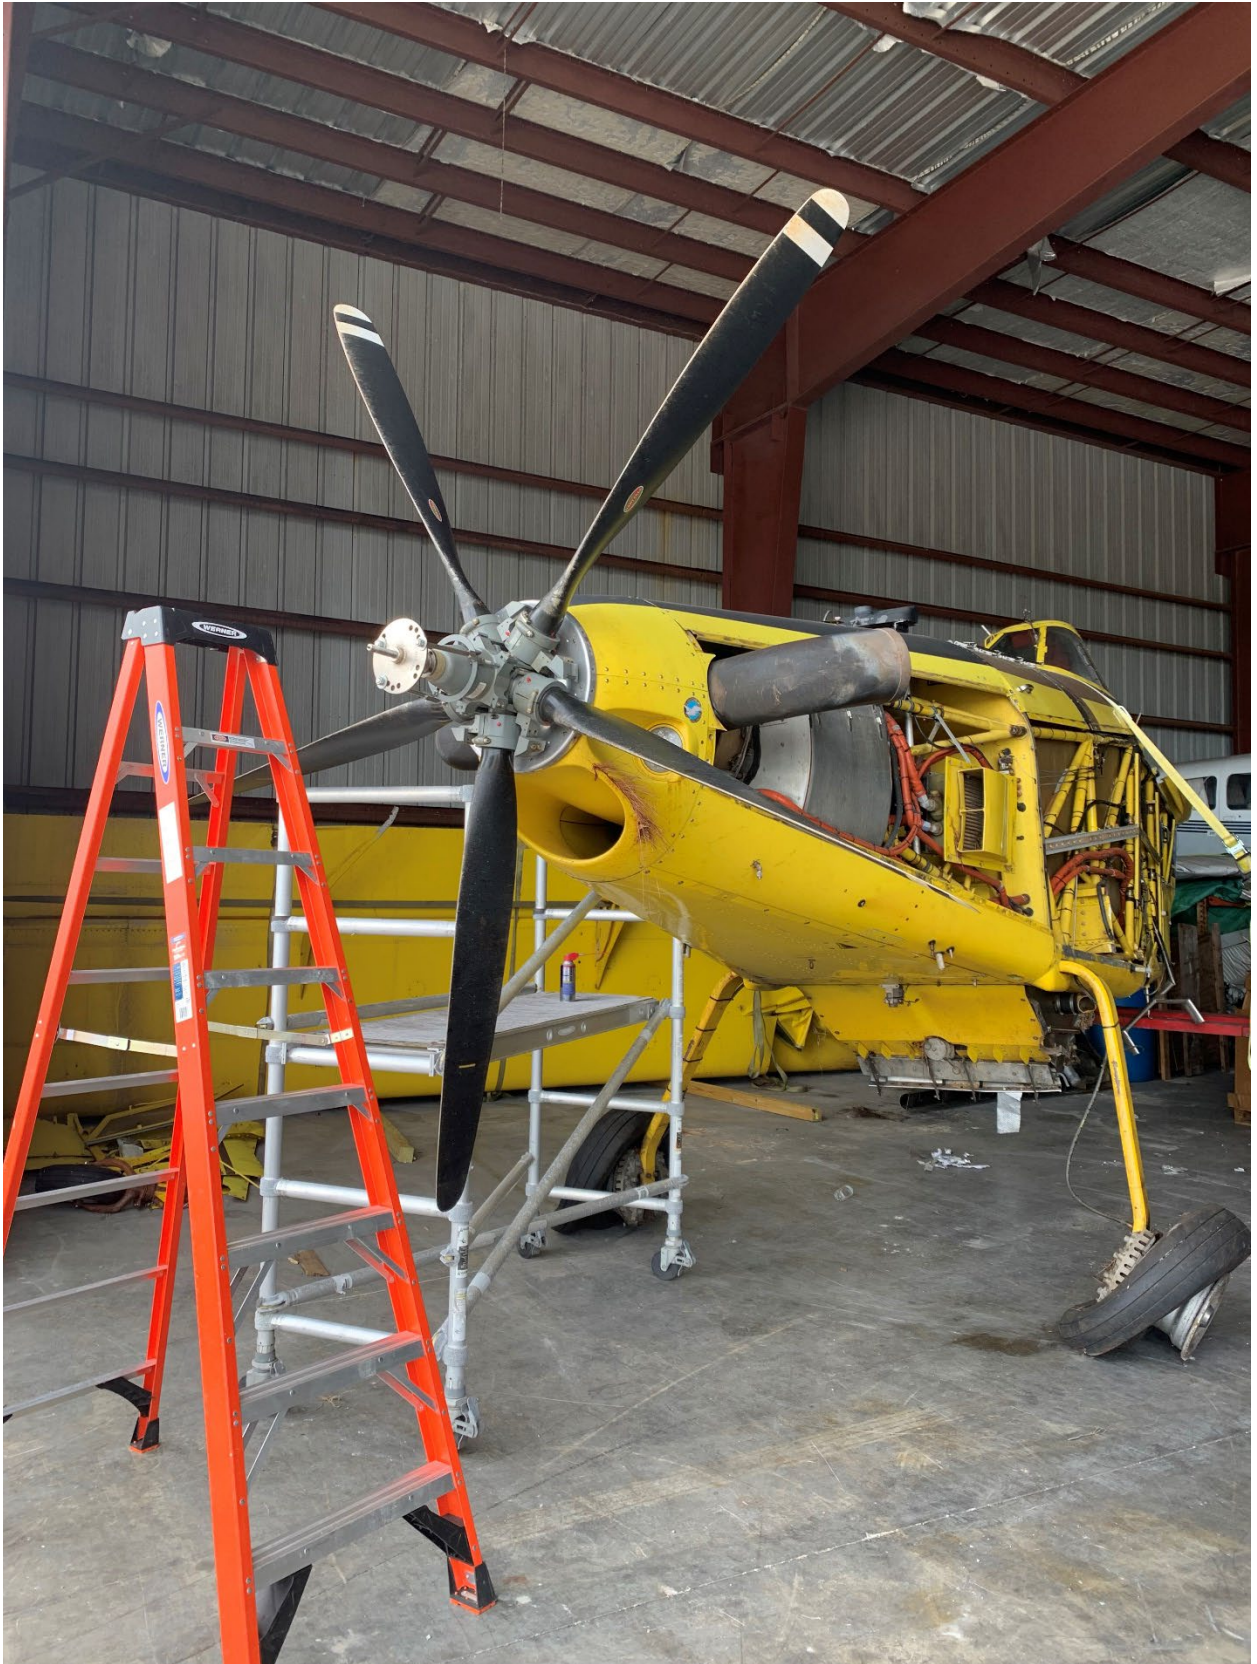
The propeller was visually examined and removed from the engine by a mechanic under the supervision of the NTSB on August 17, 2023. The 5-bladed metal propeller rotated freely, and no mechanical anomalies were noted with the propeller system (prop governor, etc.) or the installation of the propeller prior to removal. No damage (accept for operational nicks to the leading edges) were noted to all five blades.

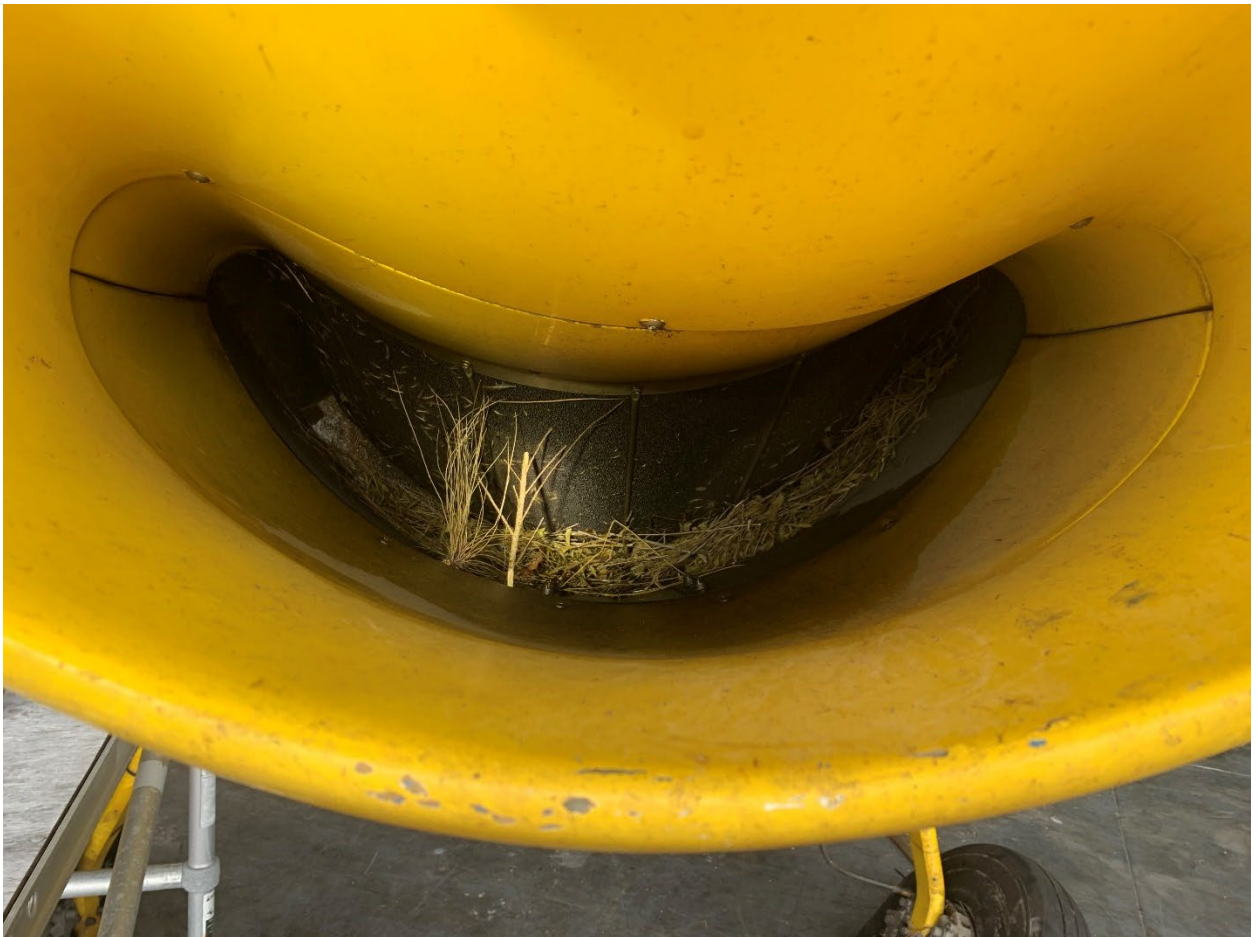
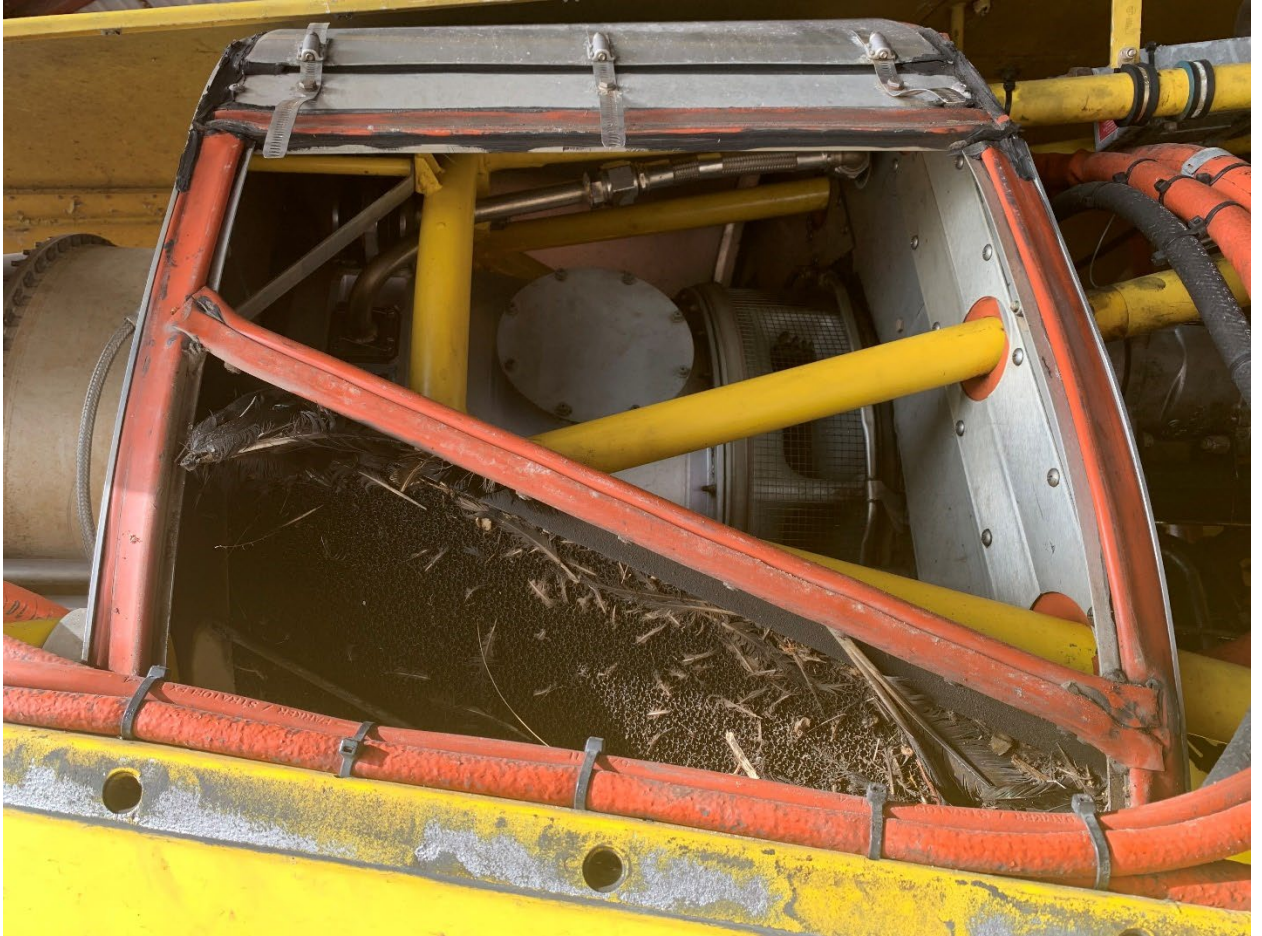
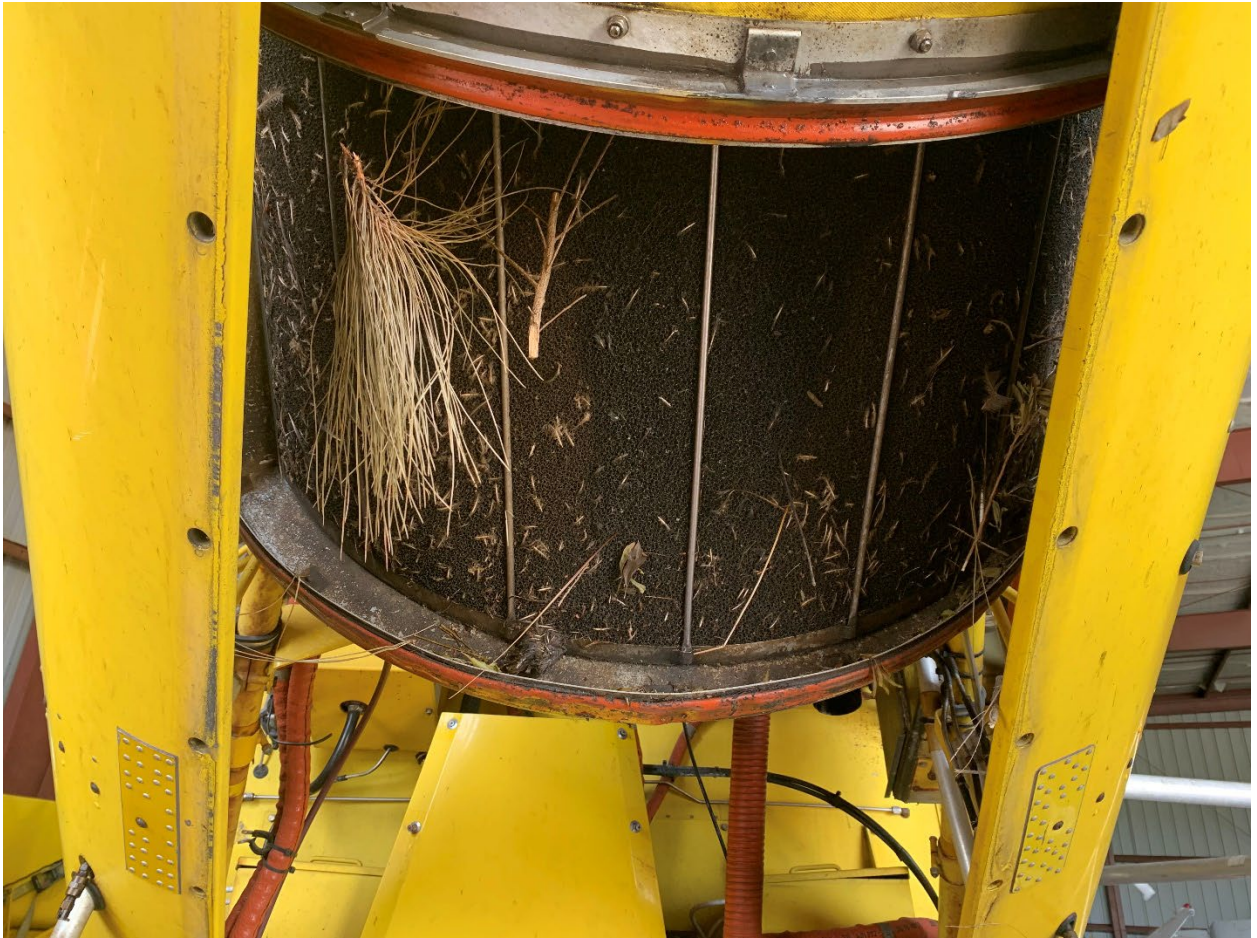
A cursory engine examination was conducted on August 22, 2023, under the supervision of the NTSB. The side cowlings had been removed prior to NTSB arrival. Visual examination of the engine revealed debris (pine needles and small sticks) jammed in the air intake. According to salvage personnel, the airplane impacted pine trees during the forced landing. Vegetation was also observed in the ram-air intake for the oil cooler. The lower engine cowling and air intake covers were removed to better view the engine air filter and the engine. The sponge-like air filter appeared dark and numerous small (1 to 2-inches long) bird feathers were observed embedded in the filter throughout. However, the feathers did not cover or block the entire air filter and were mainly scattered throughout. A small amount of bird carcass was noted on the bottom right-front of the air filter, and a section of bird wing (@ 9 x 4-inches) was observed on the left-side of the filter. A few larger feathers were also noted on the left side of the filter. The section of wing and one of the larger feathers was collected by the NTSB for further analysis. No feathers or bird remains were observed beyond the air filter or in the oil cooler ram-air inlet. The manual air filter bypass was closed. There was no evidence that the engine ingested any type of bird or debris. The engine inlet screen was absent of debris, and it was removed to observe the compressor section. The compressor rotated freely, and there was no evidence of FOD, or damage to the blades.

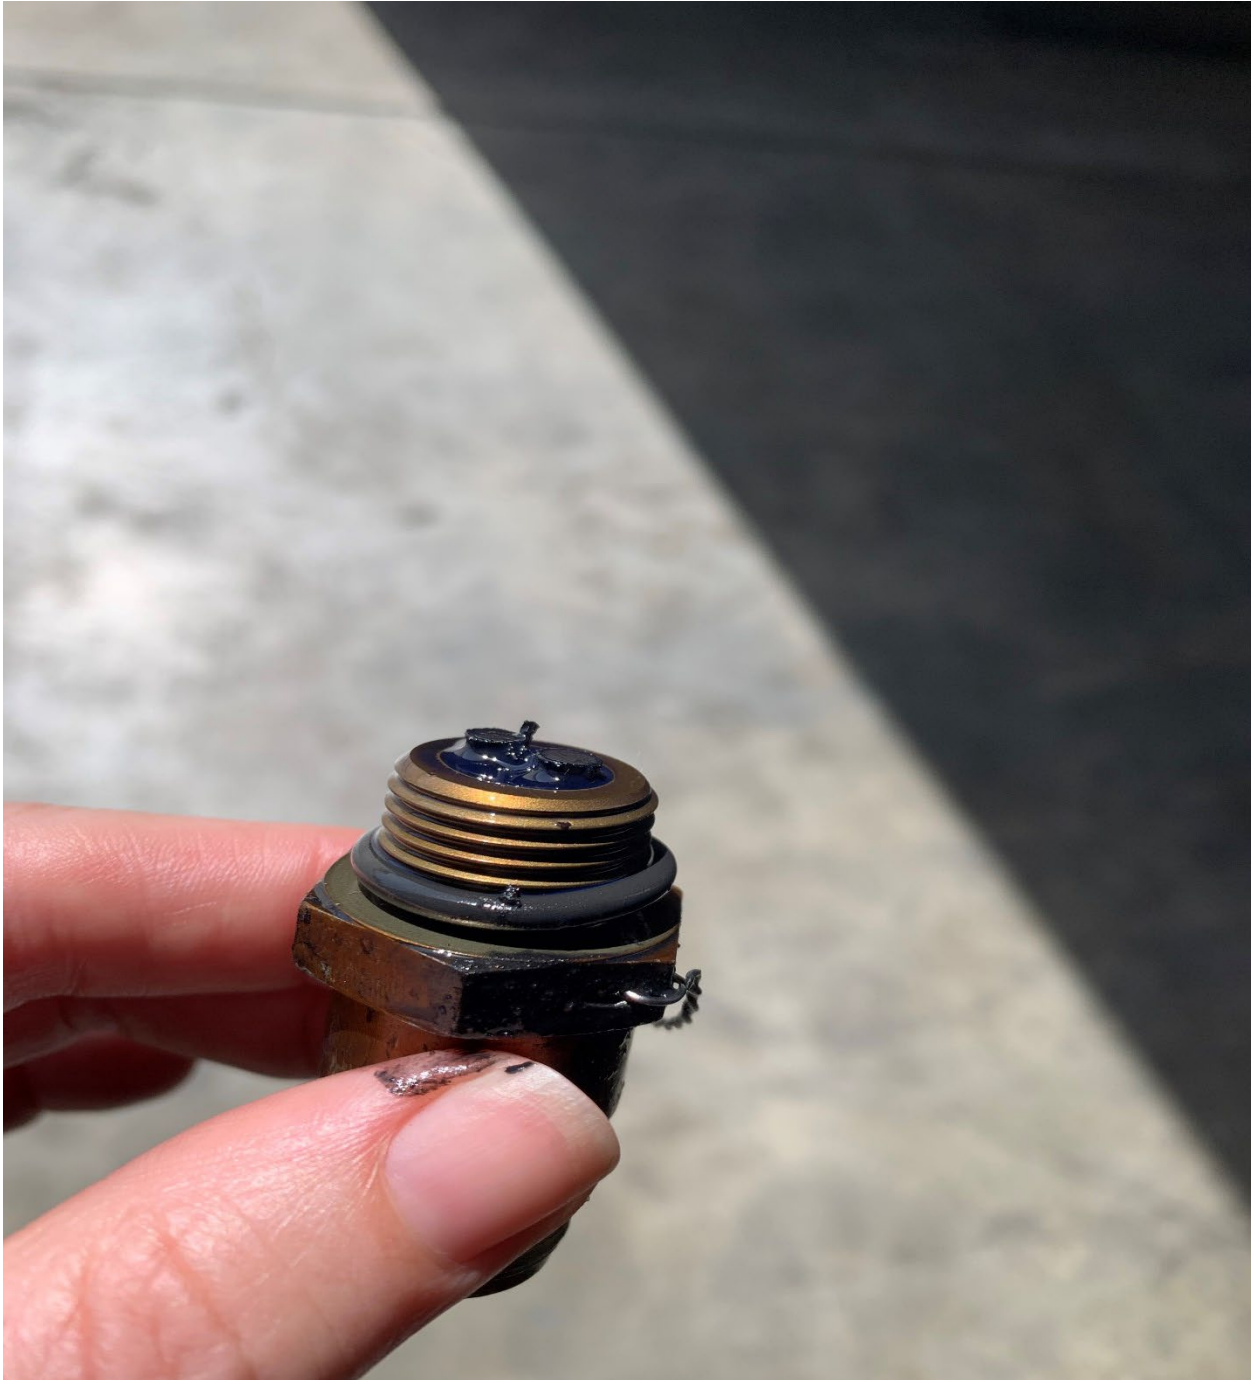
Accessory Gear-Box Chip Detector: Removed and about 5 quarts of oil drained from the engine. Some debris (possibly carbon deposits) were observed. The detector was placed back in the AGB for further exam at PWC.

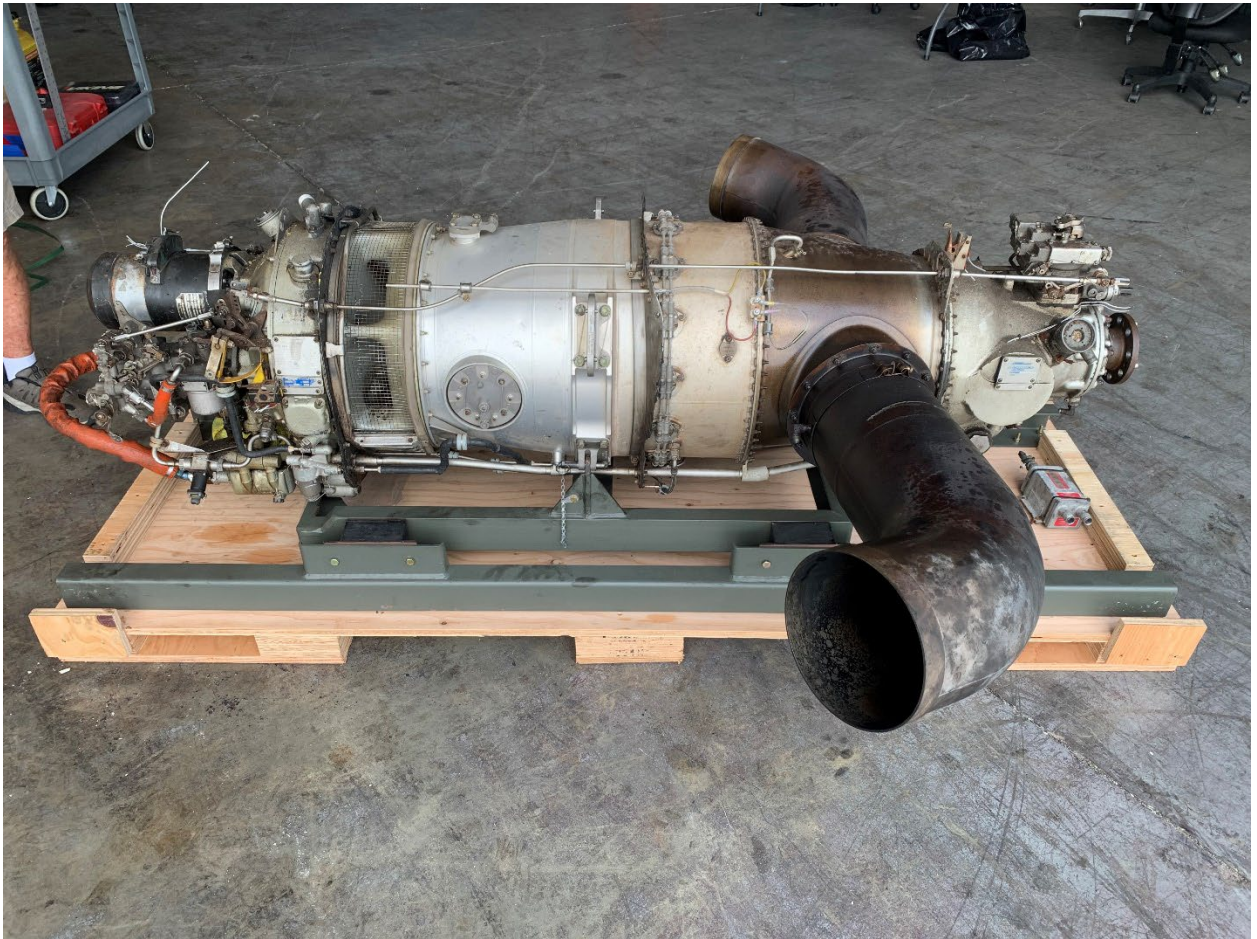
The engine was removed from the airframe on August 23, 2023, under the supervision of the NTSB. The engine was placed in a crate that had been shipped to Florida Air Recovery by PWC. The engine will be shipped back to PWC for further examination.
