# National Transportation Safety Board

ERA23LA272

## POWERPLANTS

Specialist's Factual Report

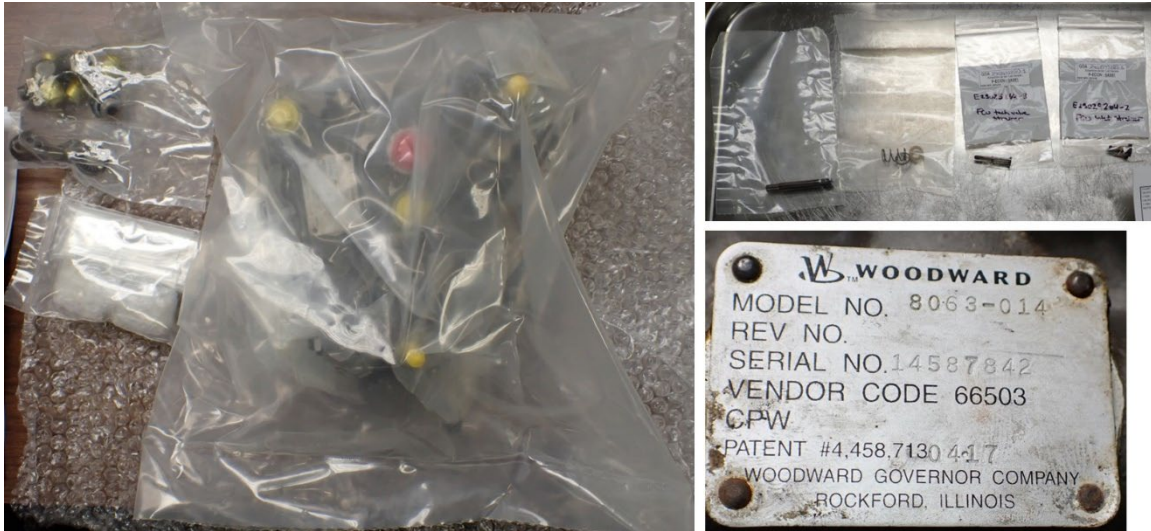
The shipping container was opened, the FCU and individual parts (FCU drive shaft, FCU inlet strainer and the FCU tachometer valve strainer) were found sealed within plastic bags. The FCU was removed from the plastic bag and the serial number verified on the data plate (Photo 1).

**Photo 1. Sealed FCU and Components**

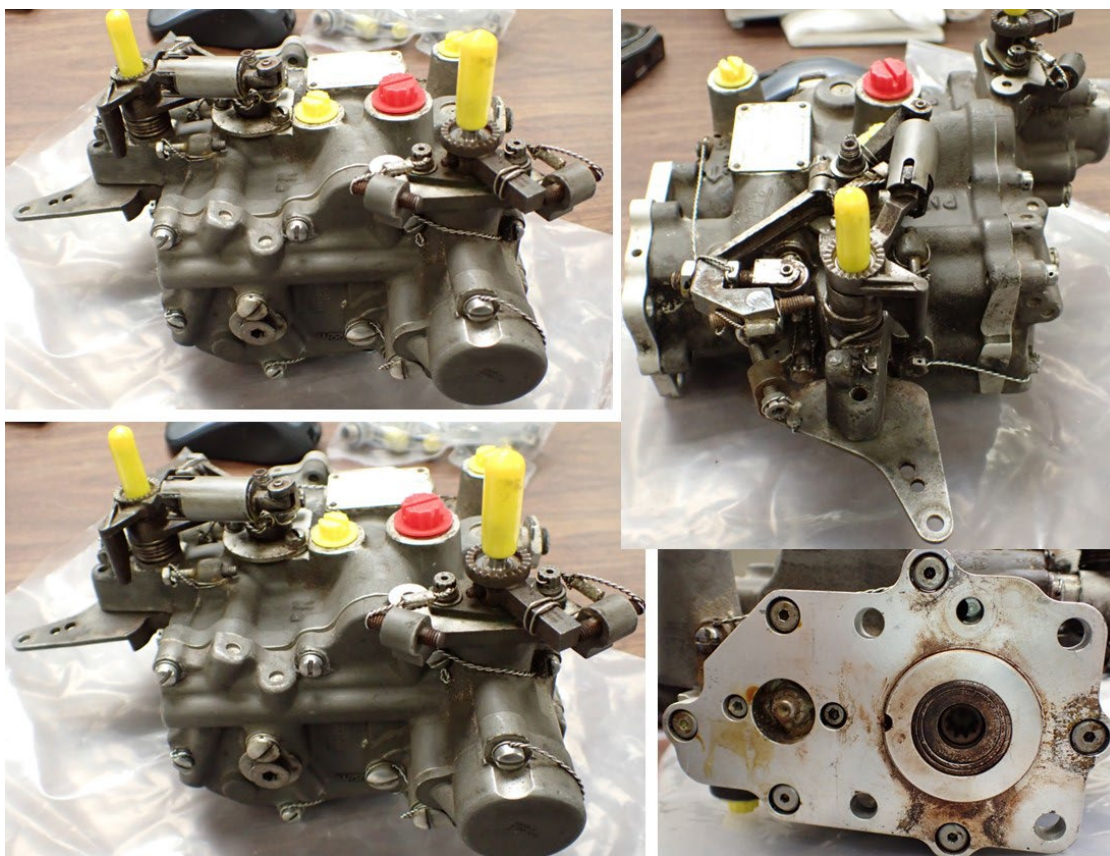
Initial visual as received inspection (Attachment 1) of the FCU was performed, the manual override screw was found wired in the closed position and no other anomalies were observed (Photo 2). The manual override screw being wired closed will not allow the pilot to manually control the fuel flow metering valve to allow engine power modulation in the event that P3 or PY air pressure is lost. The FCU drive shaft, previously found to be worn during the P&WC exam, was taken to Woodward's metallurgy laboratory for scanning electron microscope (SEM) analysis.

**Photo 2. As Received FCU**

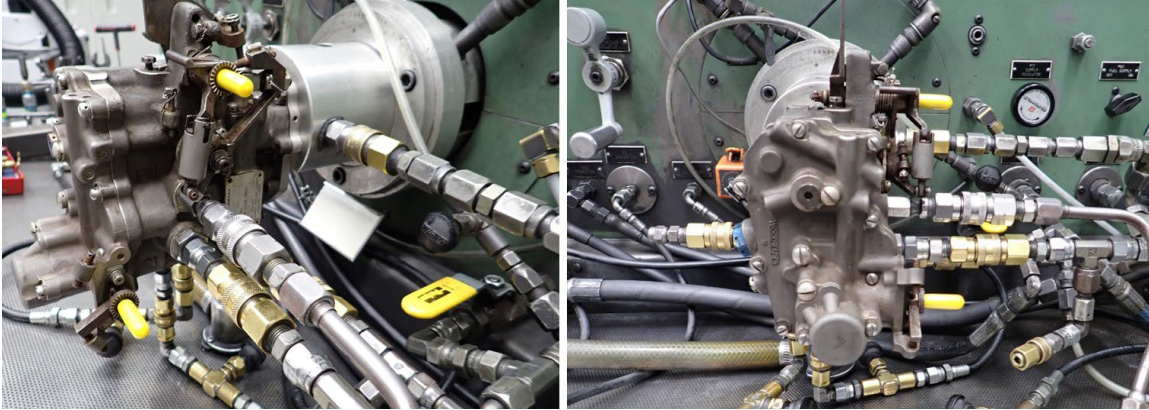
**Photo 3. FCU on the Test Bench**

The maximum forward power lever speed setting is a normal customer adjustment and was slightly higher than the acceptance test procedure (ATP) setting. The Woodward test stand had a separate fuel pump that was not coupled to the FCU drive such that inlet flow to the FCU can be controlled independent of the drive speed input to the FCU. The inlet flow was set at the maximum power lever condition and the drive speed was reduced to zero. The fuel flow initially increased to the maximum flow value as speed was reduced as expected based on the acceleration schedule. The final flow with zero speed was 416 pounds per hour (pph) with P3 set at 140 pounds per square inch differential (psid) per the maximum forward power lever test point. An indicator was installed on the speed setting cam of the tachometer assembly and the minimum speed stop was measured to be at 1460 revolutions per minute (rpm). See Attachment 2 for the bench test summary.

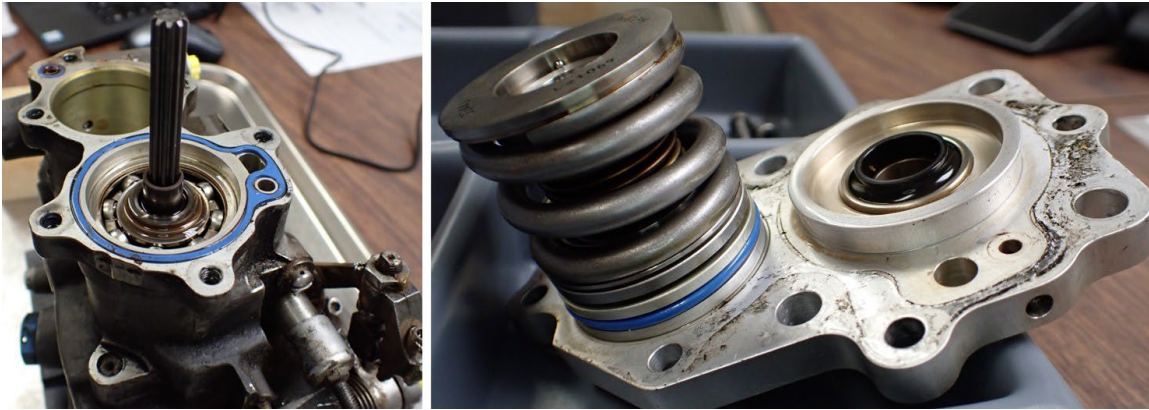
The FCU housing base cover was separated to facilitate further examination, the blue o-ring seal was found intact and undamaged, the bellows appeared undamaged and otherwise unremarkable (Photo 4). The ballhead bearings, spun with hand pressure, and had smooth and continuous rotation.

**Photo 4. FCU with Top Cover Removed**

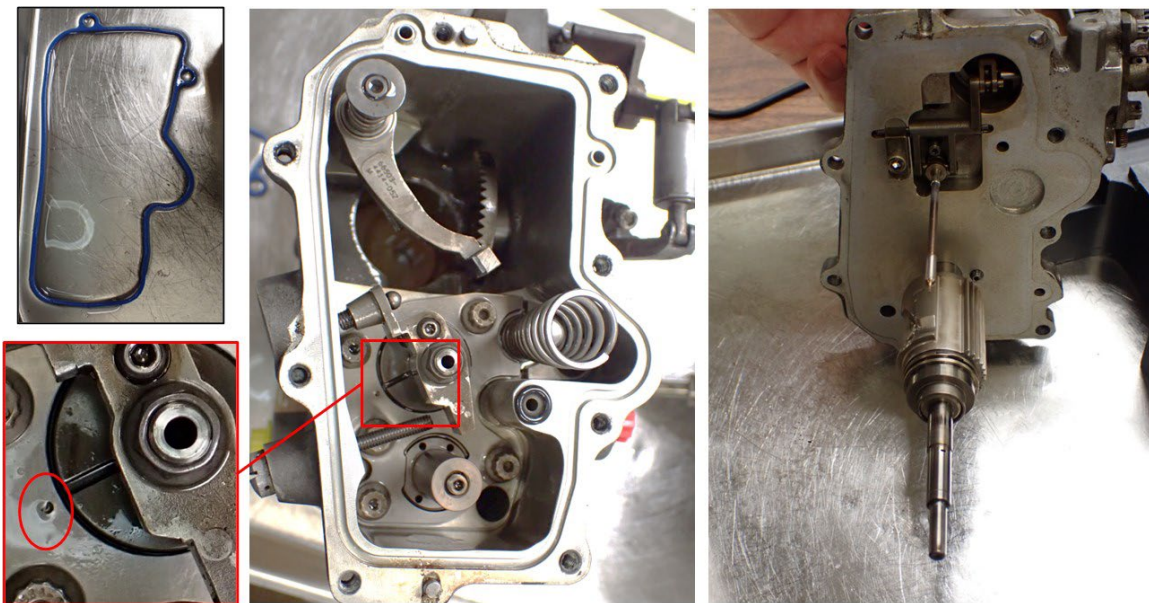
The FCU housing top cover was separated to facilitate further examination (Photo 5). The overboard drain port was found to be dirty and have debris within the port, which Woodward personnel reported as unusual. A dent or puncture next to fuel valve was found on the fuel valve plate.

**Photo 5. FCU with Bottom Cover Removed, Punctured Valve Plate**

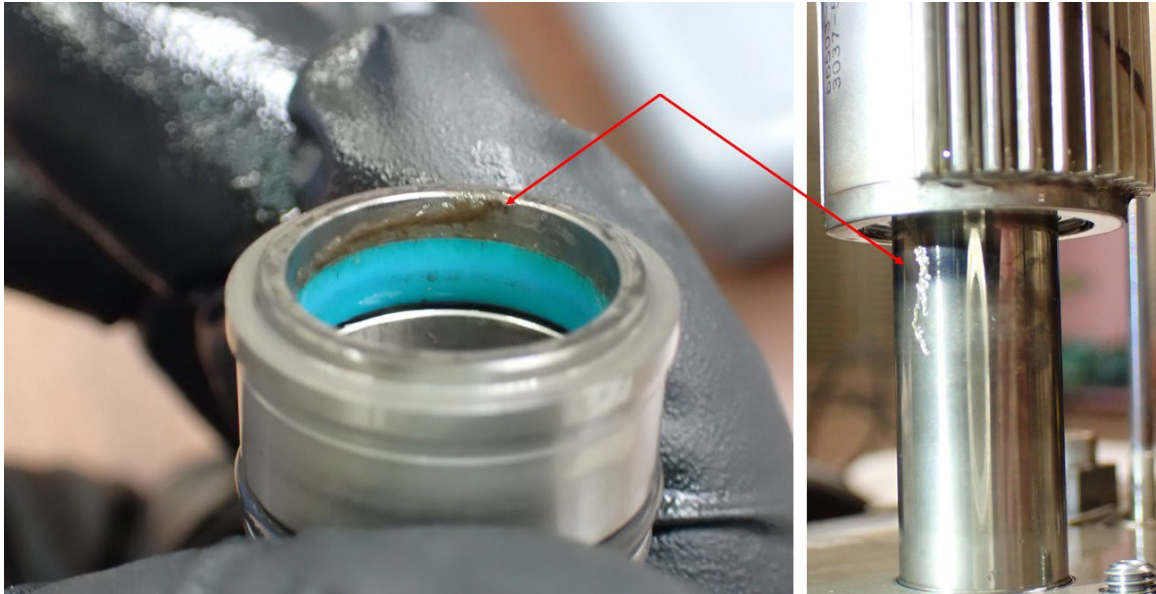
The three-dimensional (3D) cam and shaft assembly was removed from the FCU housing cover, and a nonmetallic substance was observed on the cam shaft (Photo 6). The 3D cam was separated from the cam shaft, the cam shaft Teflon seal was found partially extruded from its typical position. Teflon seal shedding/wear is a typical condition of used hardware according to Woodward personnel.

**Photo 6. Nonmetallic Substance on the Cam Shaft**

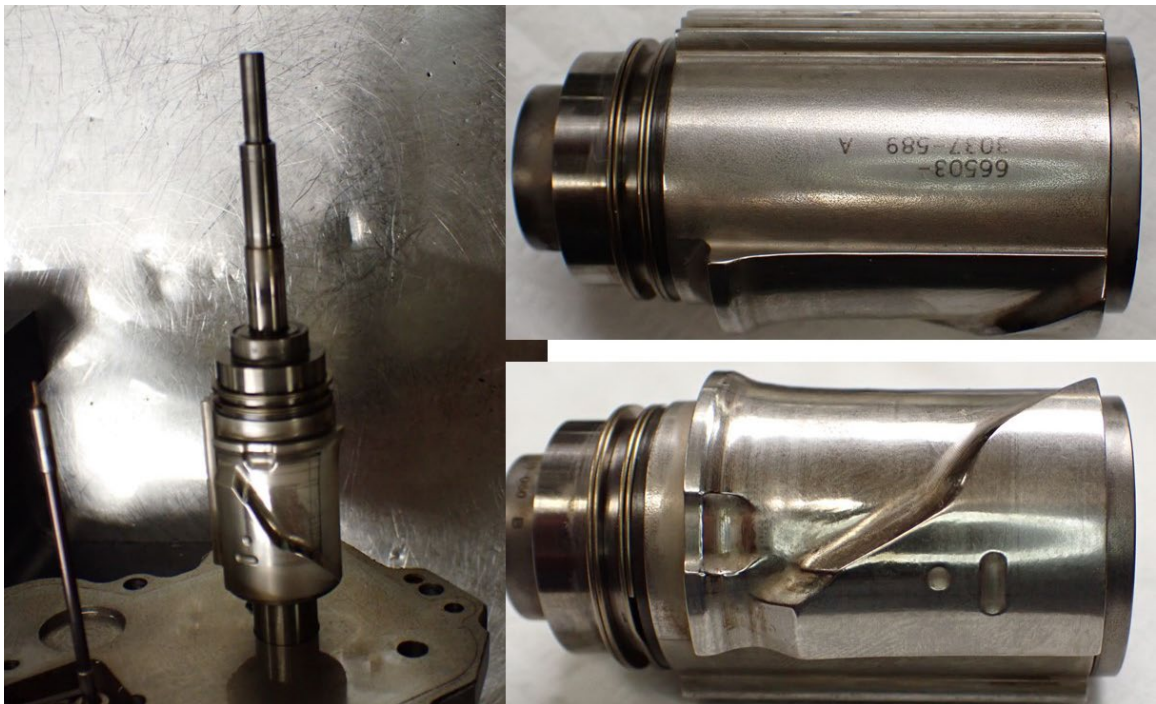
**Photo 7. 3D Cam**

The 3D cam was found to be undamaged and otherwise unremarkable (Photo 7), a small dent or area of wear was found on the cam shaft (Photo 8).

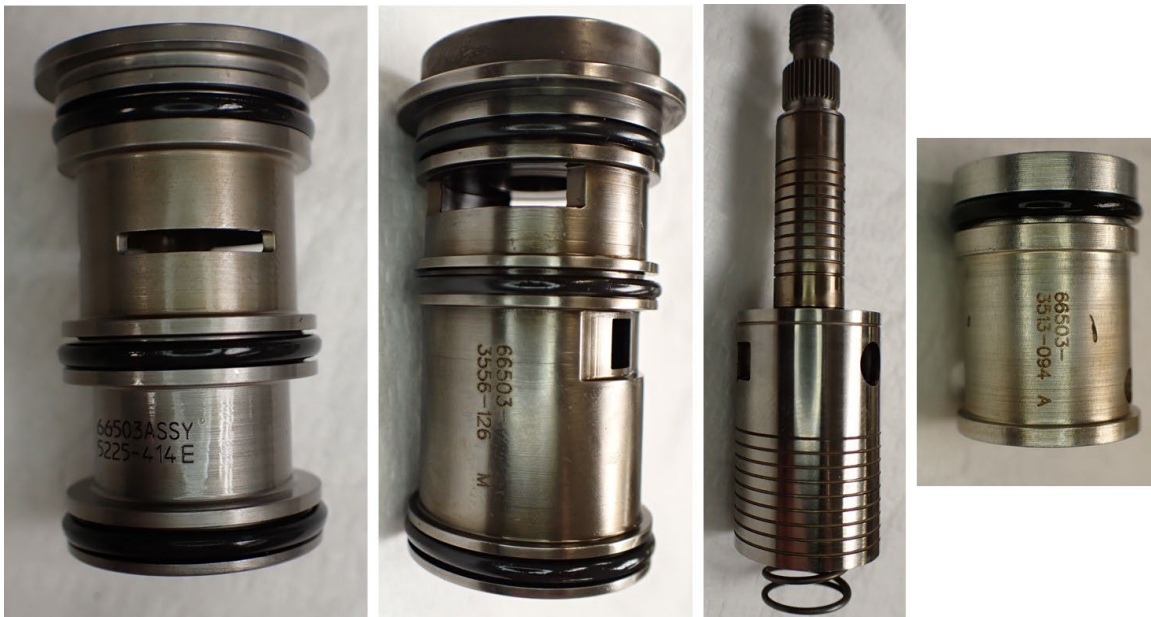
The fuel valve appeared undamaged and otherwise unremarkable. The fuel valve assembly, the piston and the sleeve, were correctly marked with matching serial numbers. The pressurizing valve appeared undamaged and otherwise unremarkable. The bypass valve appeared undamaged with some polishing and otherwise unremarkable. All the o-ring seals appeared intact and undamaged (Photo 9).

**Photo 9. Fuel Valve(L), Pressurizing Valve (C), Bypass Valve (R)**
