## Accident / Incident Report

Report No.: 23-093

Roma Air  
Air Tractor AT-802A, N3069S  
Wellington, Florida, USA  
20 June 2023  
PT6A-65AG, PN0077

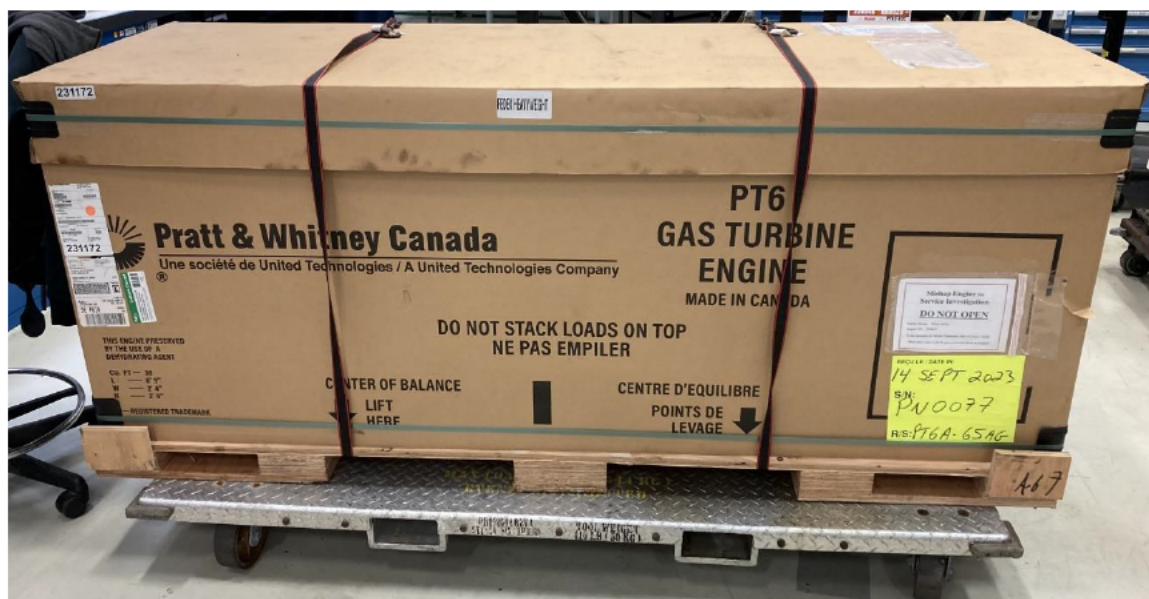
Photo No. 1, Shipping Box as Received

The as received engine shipping container showed no external signs of any damage, Photo No. 1. Opening of the container showed that the engine was mounted on a standard P&WC engine shipping cradle with the rear side covered in a black plastic bag, Photo No. 2. A cardboard box, in which the engine exciter was shipped in, was found to the left side of the reduction gear box, red arrows, Photo No. 2 & 3. The engine data plate, Photo No. 4, confirmed the engine model to be a PT6A-65AG with serial no.: PN0077.

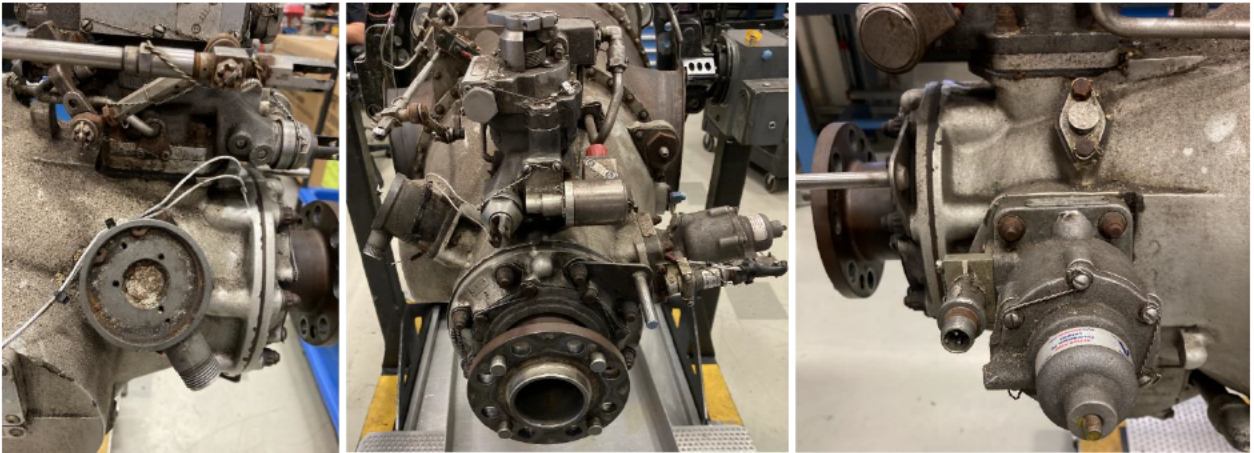
**Photo No. 5, Reduction Gear Box**

**Reduction Gearbox (RGB):** Visual examination of the RGB housing and attached accessories exhibited a normal in-service condition, Photo No. 5. The propeller shaft rotated freely by hand with no abnormal sound or feel.

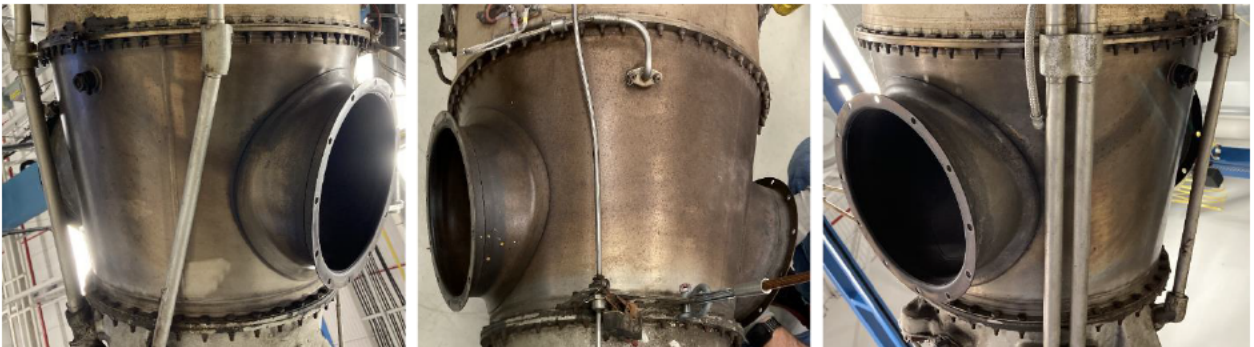
**Photo No. 6, Exhaust Duct**

**Exhaust Duct:** The exhaust duct external surfaces exhibited a normal in-service condition, Photo No. 6. Visual examination through the exhaust ports showed dark and oil wetted surfaces including the power turbine (PT) blades, Photo No. 7.

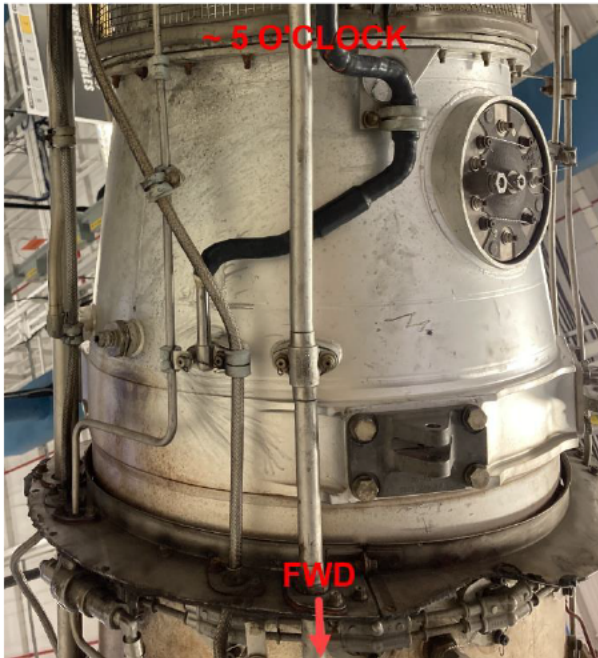
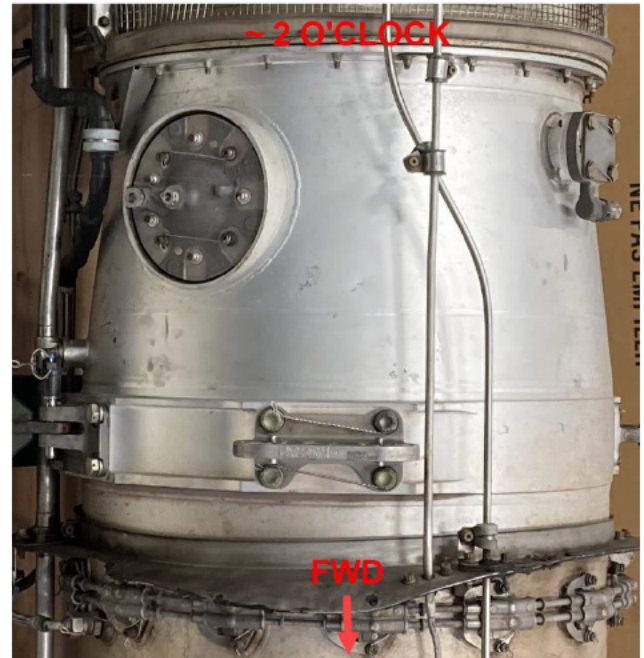
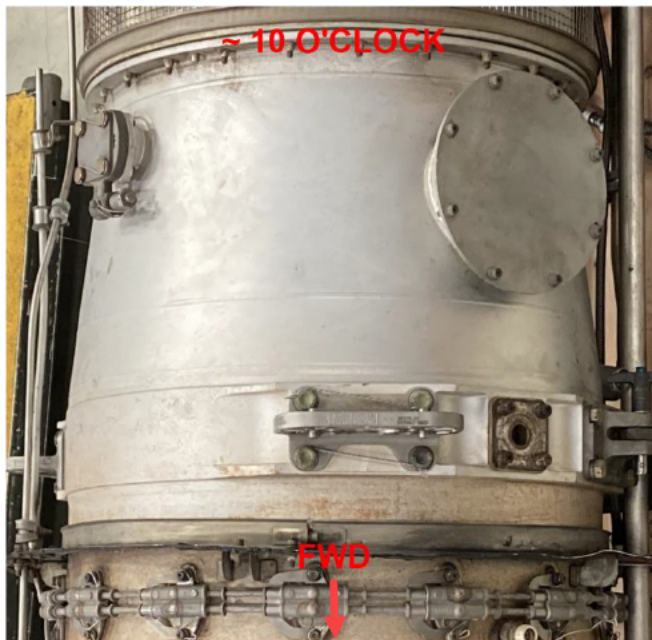
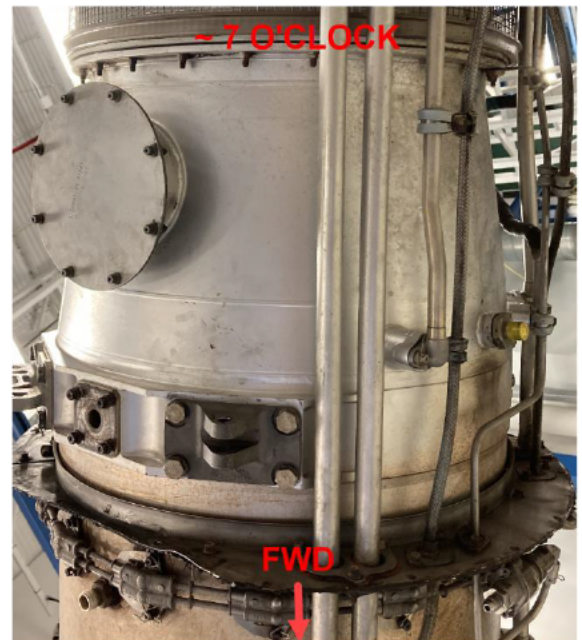
Photo No. 8, Gas Generator Case

**Gas Generator Case (GGC):** The external surfaces of the GGC visually exhibited a normal in-service condition, Photo No. 8.

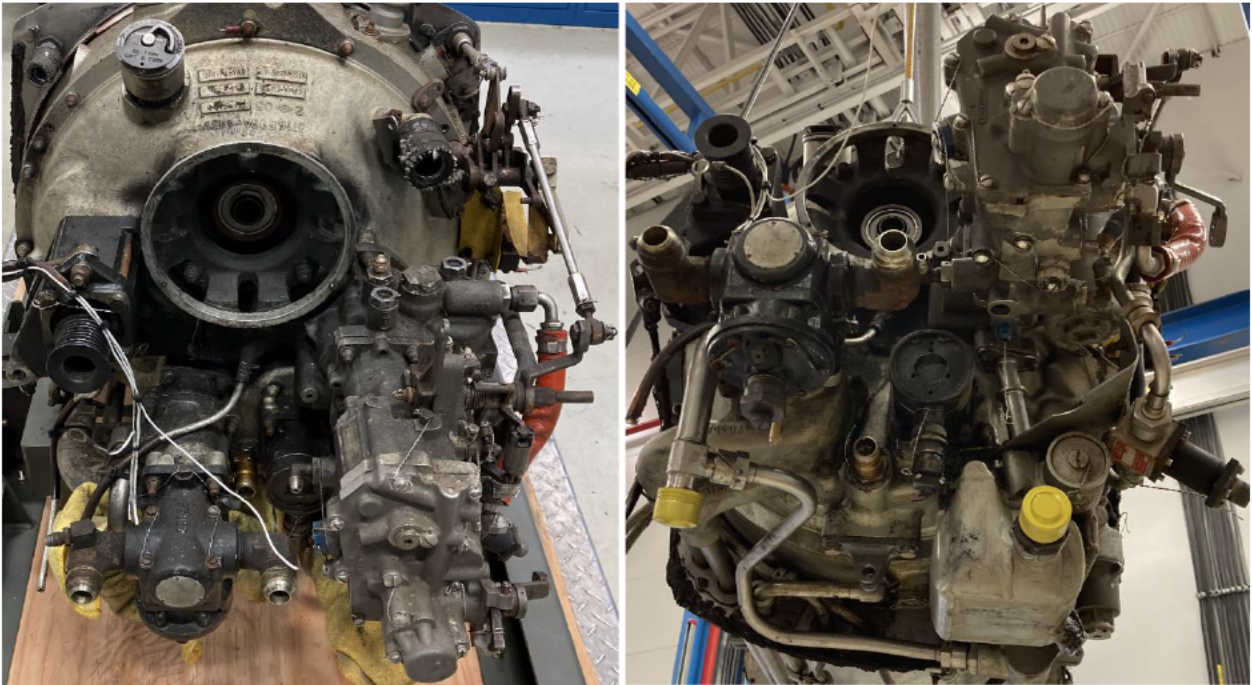
Photo No. 9, Accessory Gear Box

**Accessory Gearbox (AGB) and Inlet Case:** The AGB external surfaces visually exhibited a normal in-service condition, Photo No. 9.

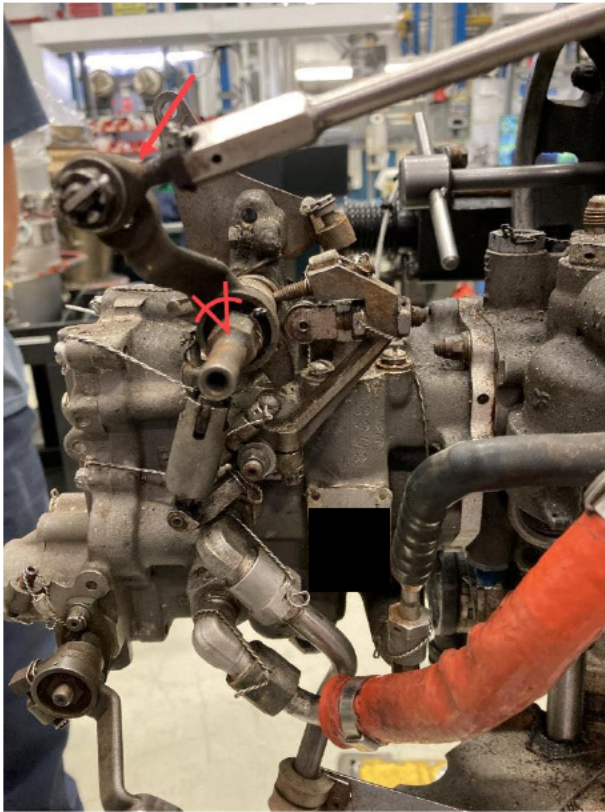
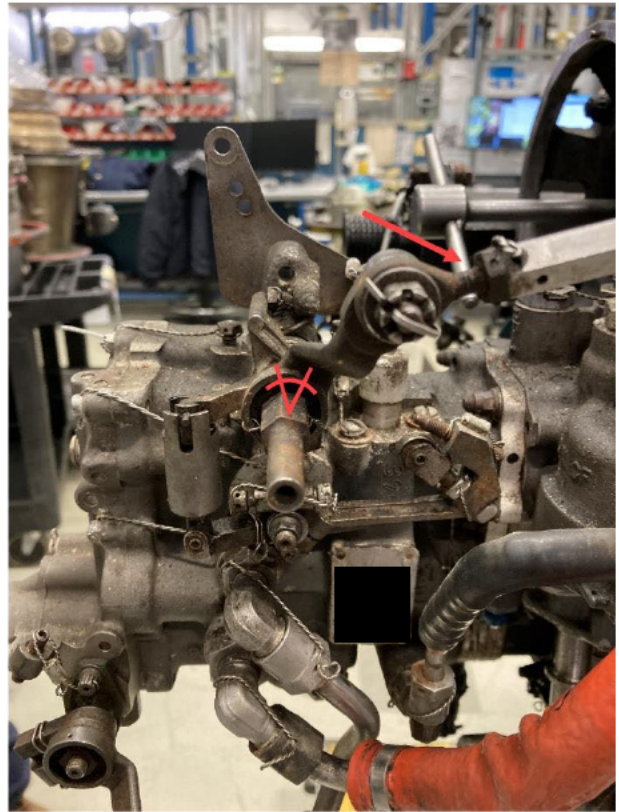
**Photo No. 10, Power Control and Reversing Linkages**

The FCU power control and reversing linkages were covered in environmental debris but visually did not show any damage. Continuity check of the linkages and connecting rod confirmed a continuous movement through the entire range of travel, red arrow, Photo No. 10.

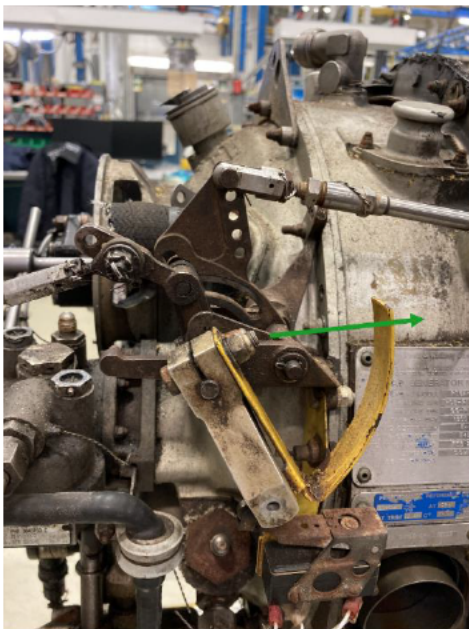
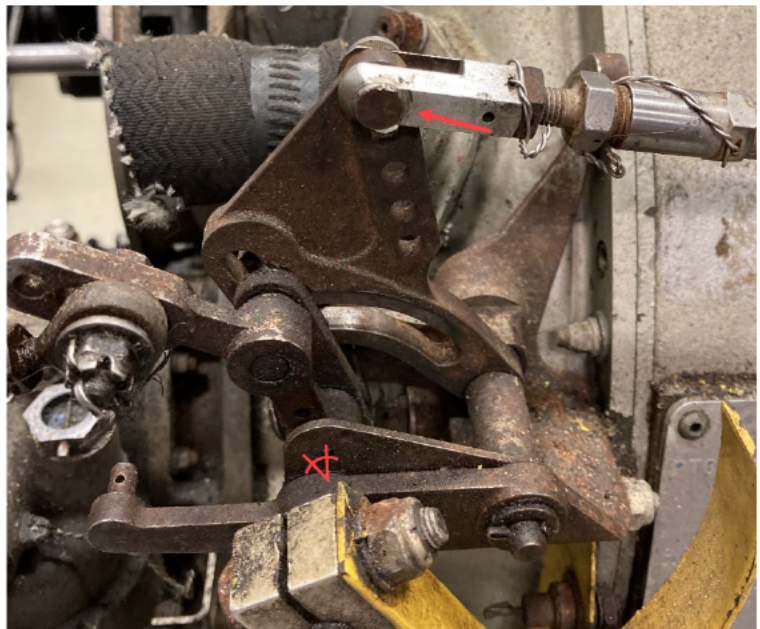
**Photo No. 11, CAM Box Linkages**

The CAM box linkages and propeller governor were also covered in environmental debris and exhibited no damage, red arrow, Photo No. 11. The linkages exhibited a continuous movement through the entire range of travel. As the Beta valve lever was not received, movement of the Beta valve was verified to be unimpeded by hand, which showed a normal in-service condition, green arrow, Photo No. 12. The Beta pin was straight with no visual damage, red arrow, Photo No. 12.

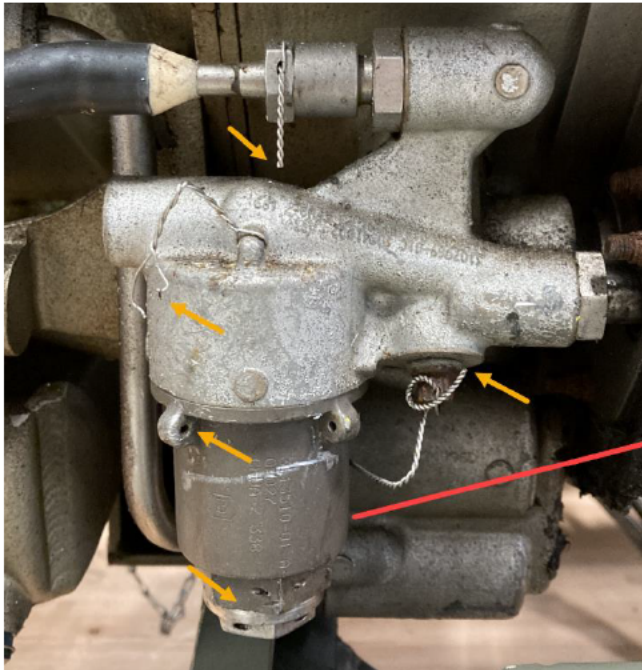
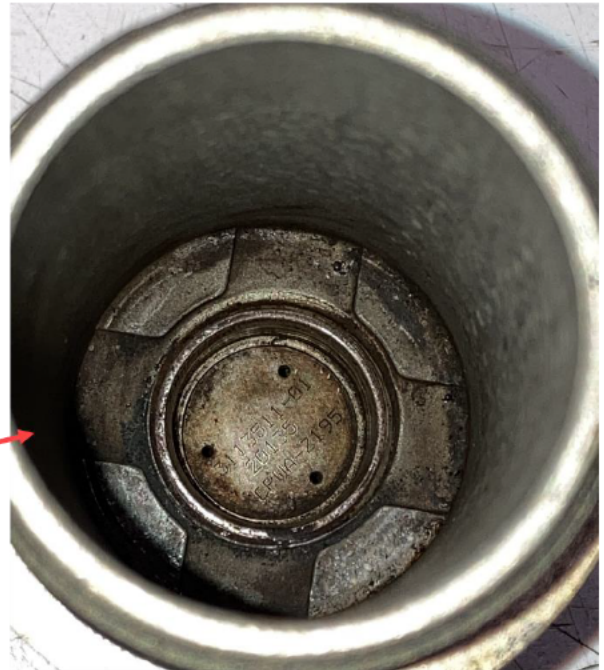
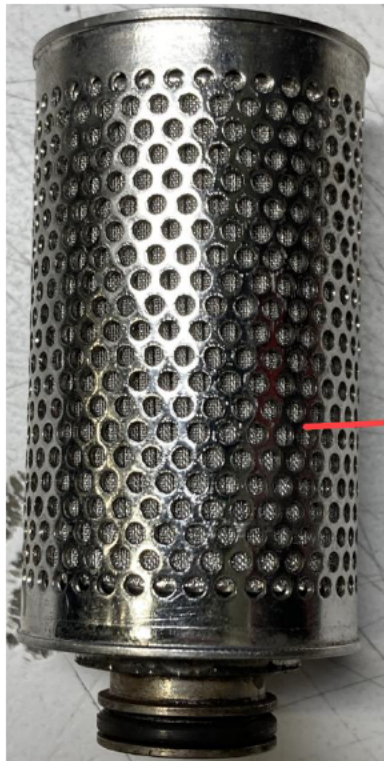
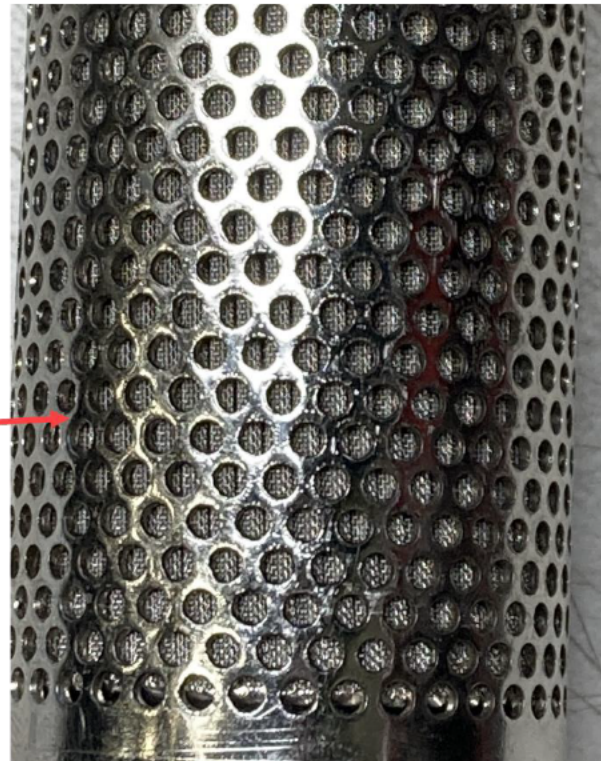
**Compressor Discharge Air (P3) and P3 Filter:** It was observed that the P3 filter bowl safety lockwire was cut, yellow arrows, Photo No. 13. The bottom of the filter bowl exhibited dark staining, right view, Photo No. 13. The air filter was clean with no visible debris, Photo No. 14. The filter bowl interface top surface exhibited a black sticky powder like substance, bottom view, Photo No. 15. The B-nuts on the P3 line between the GGC and the FCU were tight and secured with lockwire. A leak test of the P3 line was not performed.

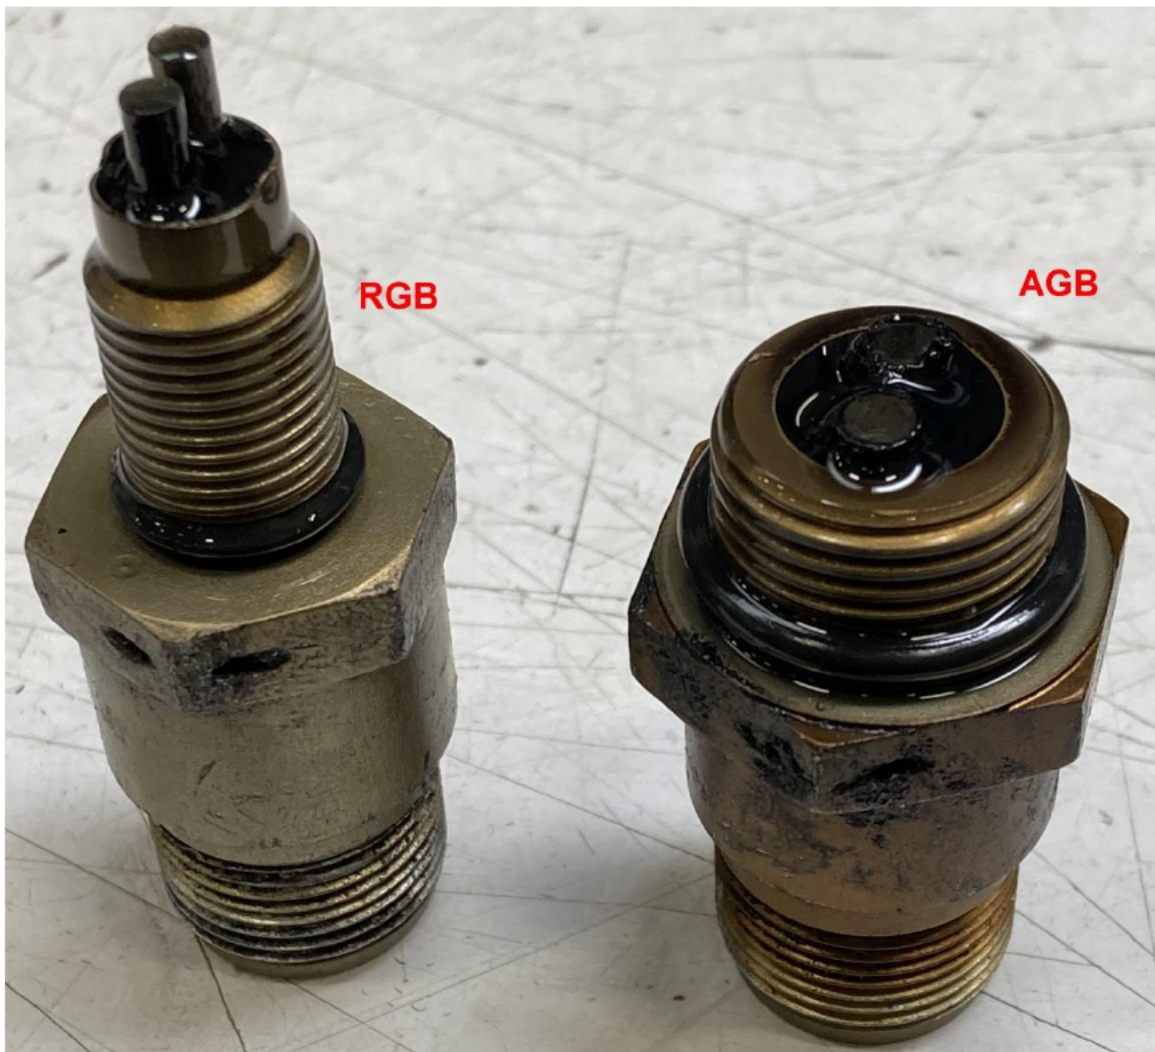
Photo No. 16, RGB & AGB Magnetic Chip Detectors

**Chip Detectors:** The AGB and RGB magnetic chip detectors (MCD) exhibited a normal in-service condition, Photo No. 16.

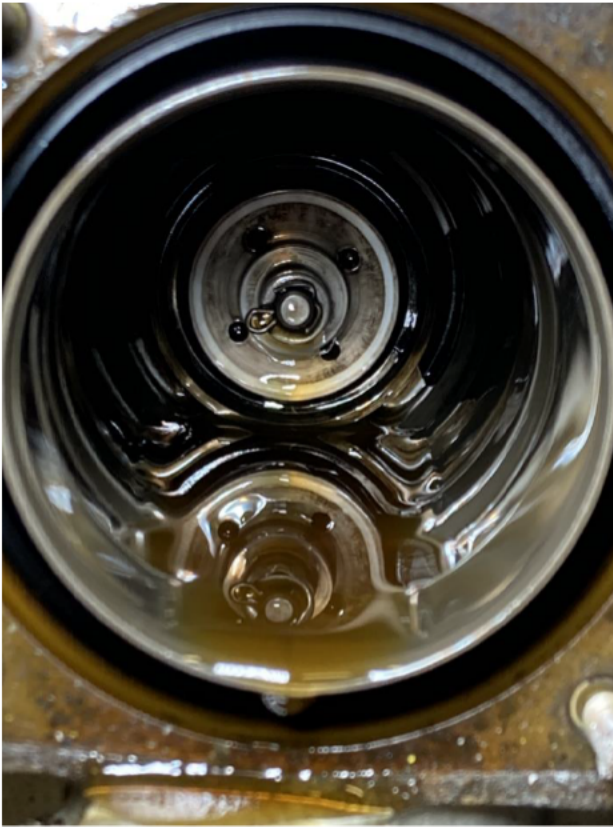
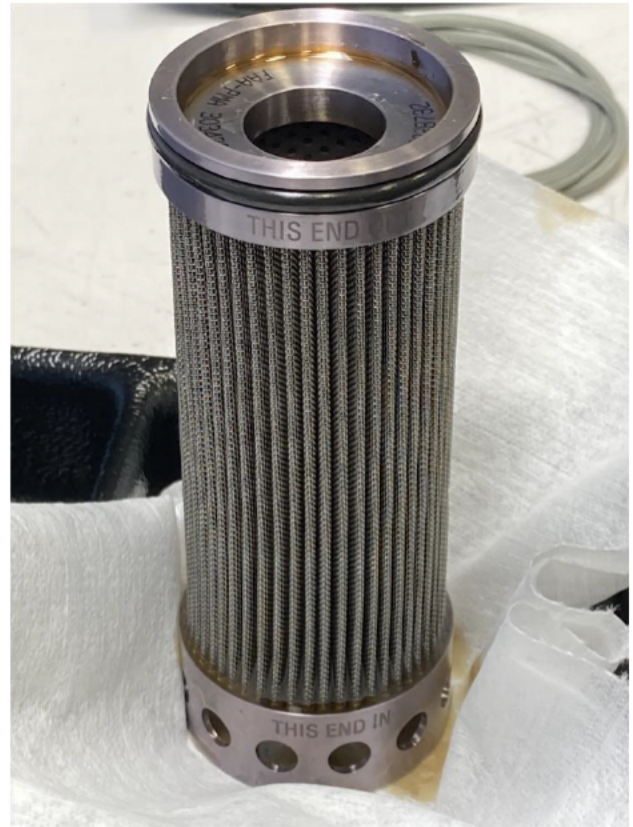
Photo No. 17, Oil Filter & Housing

**Oil Filter:** The oil filter housing and filter were wet with oil and visually free of debris, Photo No. 17.

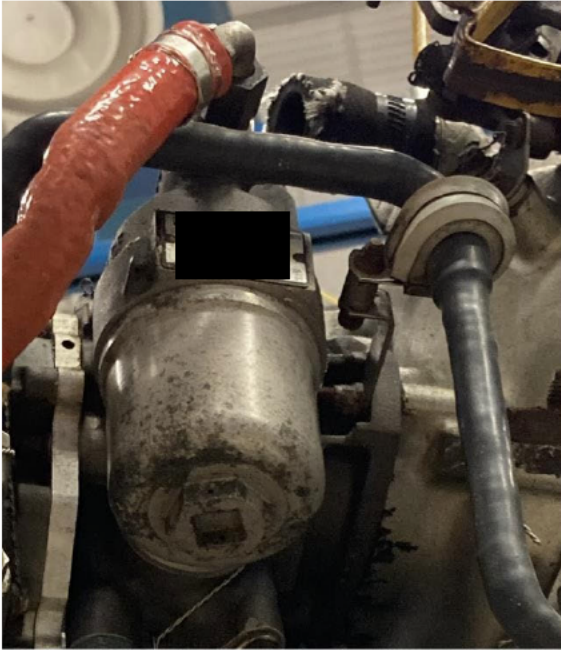
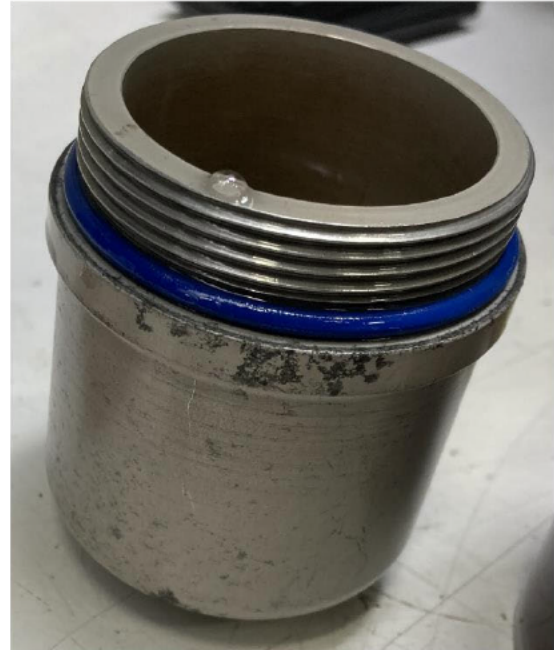
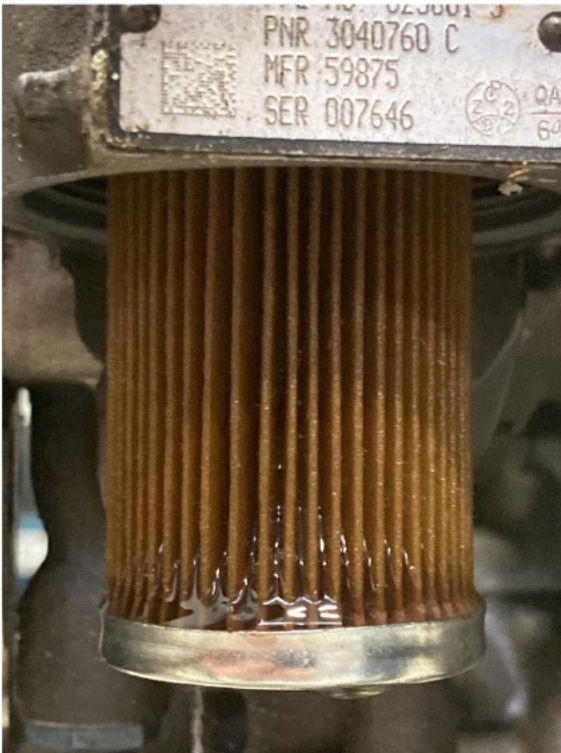
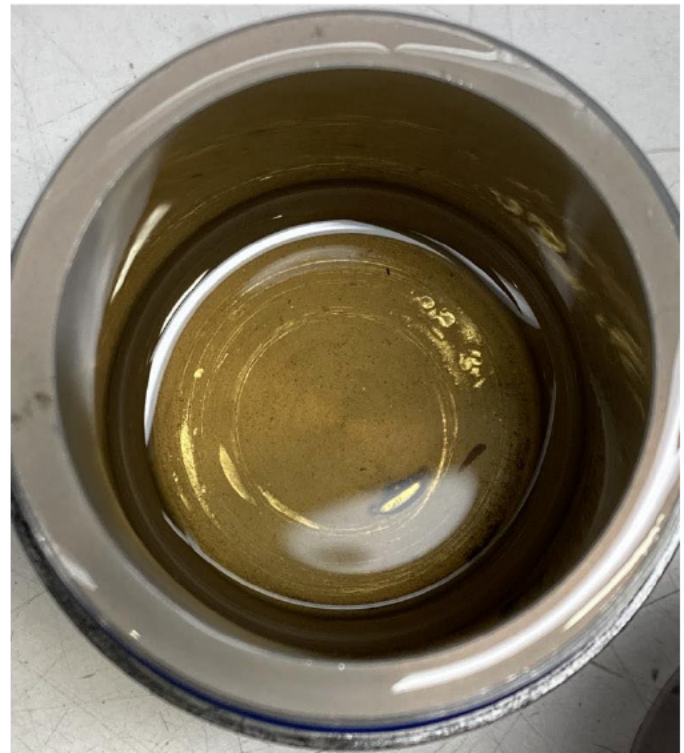
Photo No. 18, Fuel Filter and Bowl

**Fuel Filter:** The fuel filter element and filter bowl were wet with fuel and visually free of debris, Photo No. 18. The fuel filter screen was clean and free of debris, Photo No. 19.

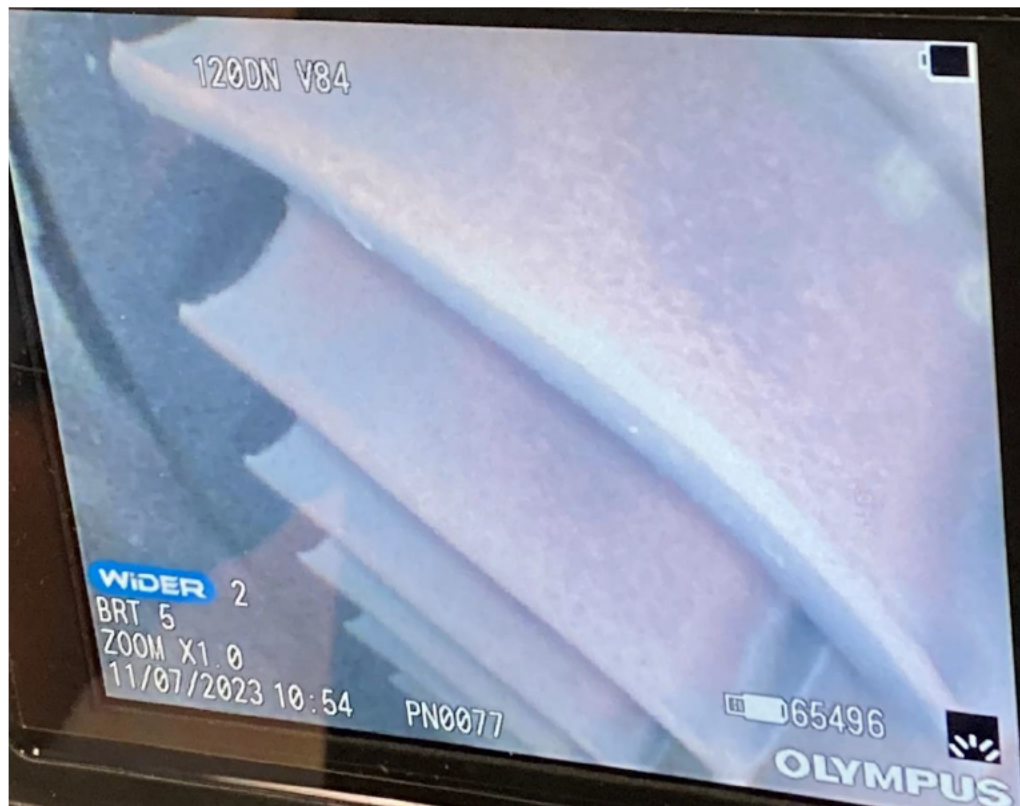
Photo No. 20, Compressor Turbine Borescope Inspection

Borescope inspection (BSI) of the compressor turbine blades showed a slight erosion on the pressure side blade tips but no indications of any anomalies that would affect normal engine operation, Photo No. 20.

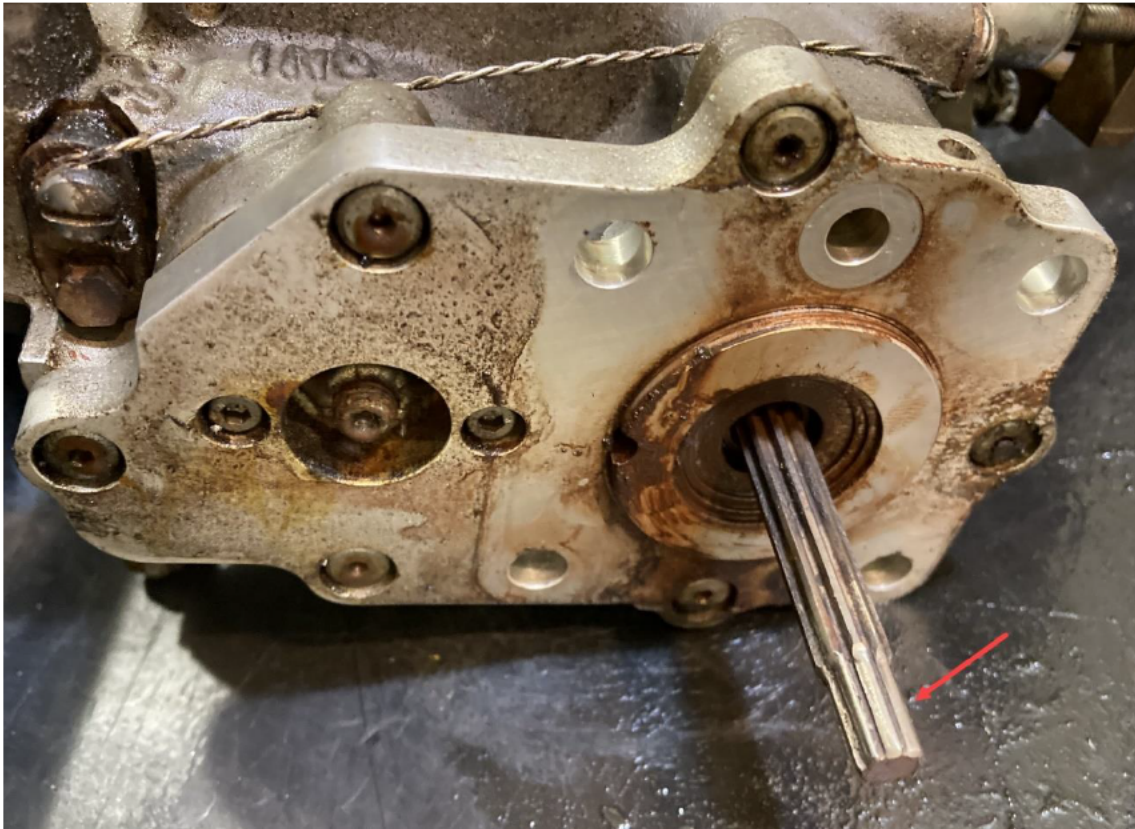
Photo No. 24, FCU Drive Shaft Wear

- 2.2 Closer observation of the removed FCU drive shaft and fuel pump interface found worn external and internal mating splines coated with a brownish iron oxide residue. As a result, the significant wear on the splined connection contributed to the disengagement of the Ng input to the FCU which, resulted in a commanded minimum fuel flow condition.

- 3.1 The reported loss of power was determined to be due to the decoupling that occurred between the worn FCU drive shaft splines and the worn fuel pump drive gear splines. The decoupling between the FCU and fuel pump resulted in the FCU to command minimum fuel flow and prevent normal engine operation. The wear mechanism of the splines in the absence of any original material anomaly could not be determined conclusively.

During the 4<sup>th</sup> troubleshooting iteration it was observed upon removal of the original FCU that the drive shaft splines were worn, red arrow, Photo No. 24. The mating internal splines of the fuel pump were wet with a brown residue and exhibited wear as observed on the drive shaft splines, Photo No. 25. Removal of the fuel pump from the AGB revealed a similar brown residue on the AGB interface and drive shaft, Photo No. 26. The FCU and fuel pump were packed in separate boxes and submitted to the P&WC Engine Controls Accessories Technical Support (ECATS) for investigation.

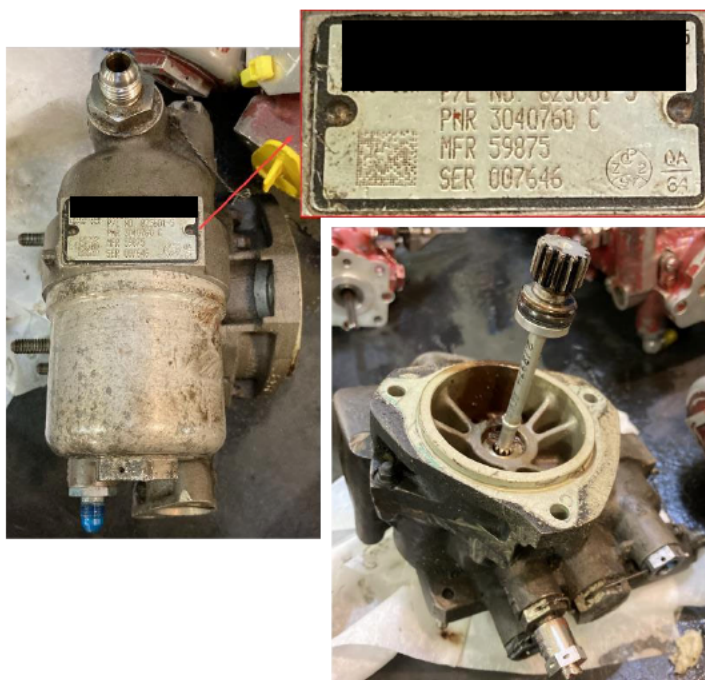
Photo No. 27, Fuel Pump Data Plate and Drive Shaft

**Fuel Pump** [PN:3040760 SN:007646]: Rotational resistance of the drive shaft was noted to be normal, Photo No. 27. The fuel pump was tested to the Component Maintenance Manual (CMM) criteria, and the fuel flows were below the minimum limits, most likely caused by worn pump gears. The wear of the pump gears could be associated with low fuel lubricity. These fuel flow deviations would not have been contributory to the event, as the fuel pump delivers more fuel than required by the engine. The fuel pump investigation is detailed in the P&WC ECATS Accessories Investigation Report (Reference A)

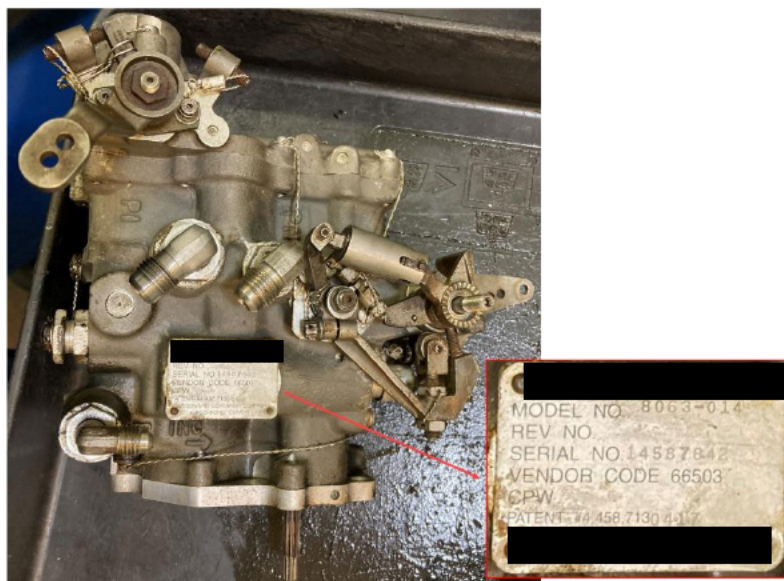
Photo No. 28, Fuel Control Unit Data Plate

**Fuel Control Unit** [PN:8063-014 SN:14587842]: The FCU drive shaft running torque was 2–3 inch pounds, which was only slightly higher than typical units returned from service and was not found excessive. The FCU plate was removed to examine the tach valve and governor components for signs of possible shaft rotation restrictions. There were no visual anomalies observed. The FCU data plate did not show the PWC part number. This indicates that maintenance was performed on the unit at some point in the life of the FCU, where the ID plate was changed, Photo No. 28.

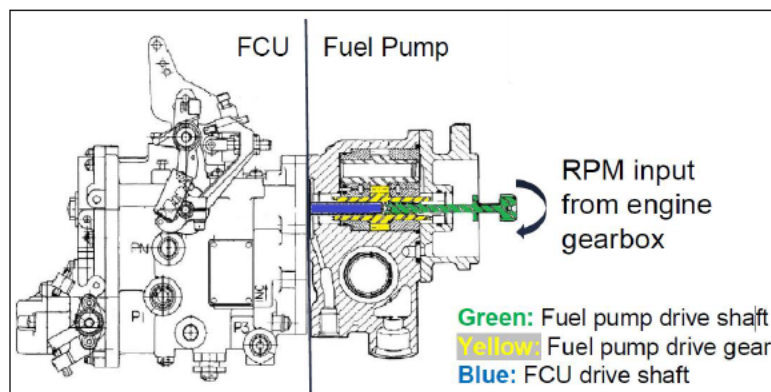
Figure 1

The FCU receives the engine gas generator rotational speed ( $N_g$ ) signal via the drive shaft of the fuel pump (Figure 1). This allows fuel modulation in relation to the engine gas generator RPM ( $N_g$ ), among other inputs.

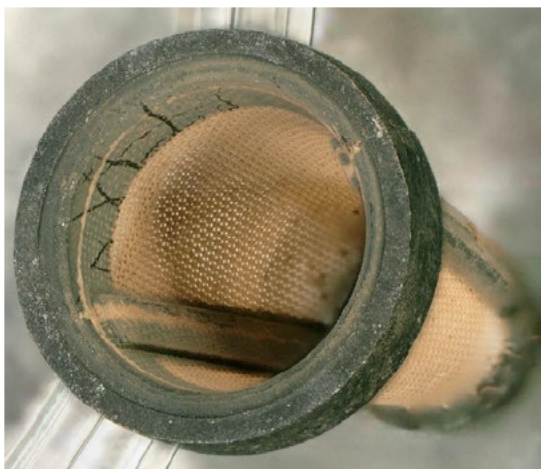
Figure 11

The fuel inlet strainer (Figure 11) and the tachometer valve strainer (Figure 12) showed a brownish-red deposit. The deposit was identified as a mixture of iron-sodium-sulfur-zinc rich particles as well as silicon rich particles (Figure 13).

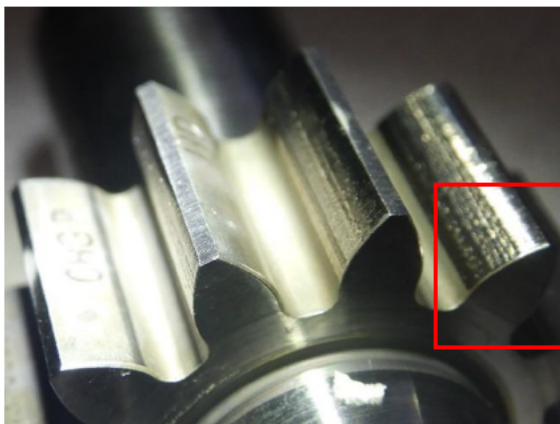
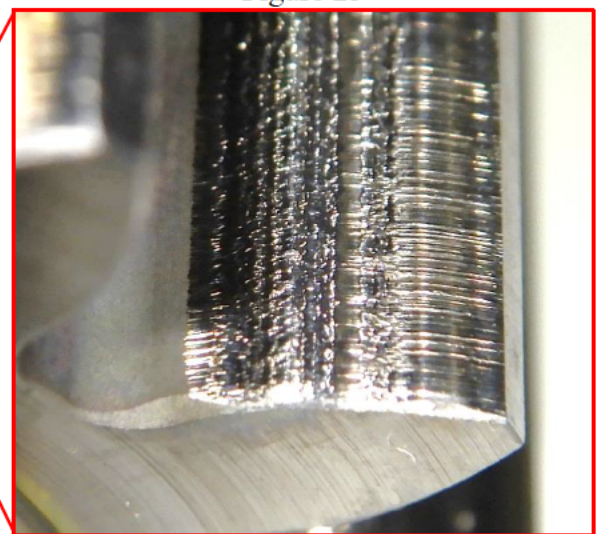
The fuel pump cover, with the AGB side carbon seal, and the fixed bearings were removed and found unremarkable. The drain cavity in the housing had a brownish coloration. A step wear on both gears face mating to the pressurized bearings could be felt with a scribe. The two floating bearing packings had displaced rubber and the base material of the bushing above the packing was scored (Figure 20 and Figure 21). The fixed bearings had pitting on the dams (Figure 22). There was one small debris on the face of the FCU side carbon seal, with corresponding scoring of the drive gear sealing face (Figure 23). The gearset showed wear on the teeth face working flank (Figure 24, Figure 25) as well as corrosion on the gear journal

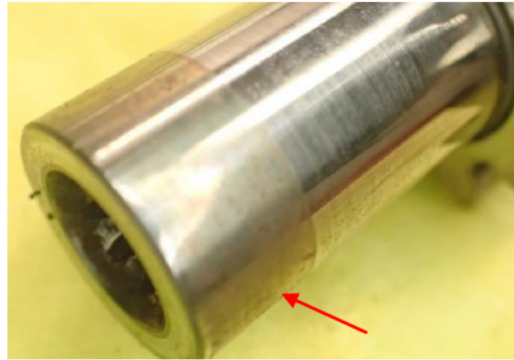
Figure 26

(Figure 26). The housing gear pockets showed some cavitation pitting (Figure 27, Figure 28) and the gear wipe was typical of an in-service fuel pump.

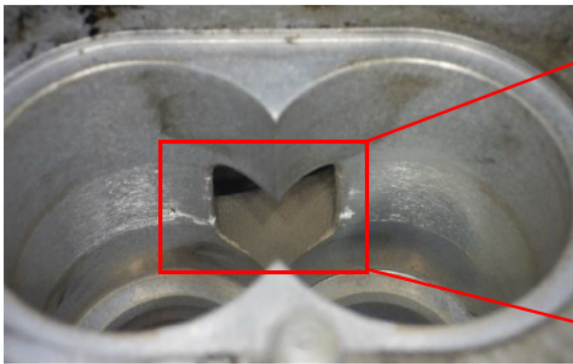
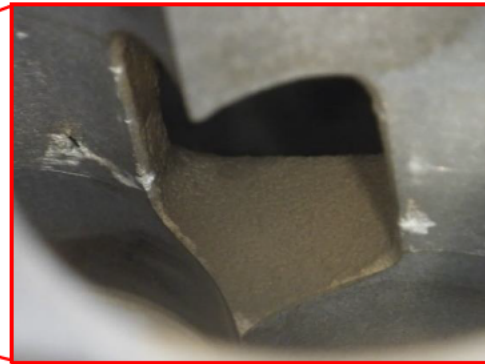
Disassembly of the fuel pump showed pitting on the fixed bearing dams and on the housing gear bore inlet surfaces, both evidence of exposure to prolonged cavitation. The drive gear journals exhibited surface corrosion. The drive and driven gear teeth showed a high level of wear on the working flanks of the teeth.

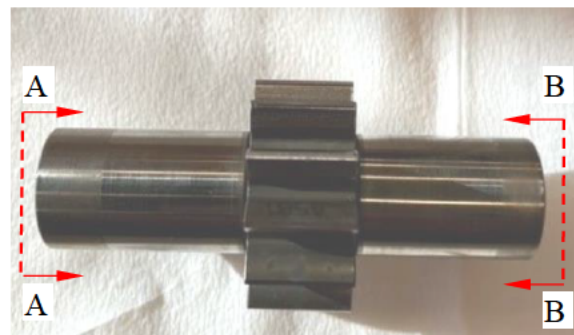
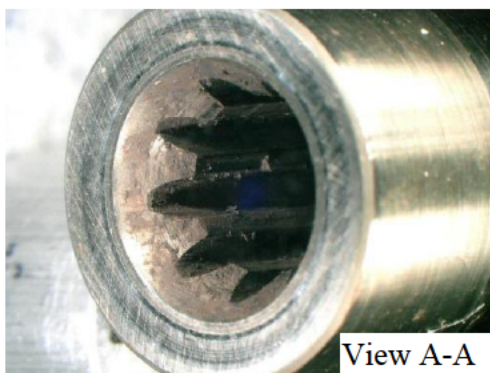
SEM-EDX analysis of the residue from the AGB side of the fuel pump drive gear (Figure 31, Figure 32) displayed iron, fluorine, oxygen, some carbon, and traces of chromium, aluminum, and sodium. FTIR displayed an organic material suggesting a perfluorinated grease. The residue is possibly a mixture of an iron-oxide material with a grease. The residue present in the FCU drive side (Figure 31, Figure 33) was rich in iron, oxygen, and traces of chromium suggesting an iron-oxide material.

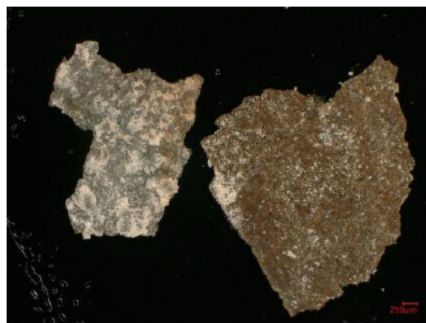
Figure 34

The debris observed on the AGB mounting face of the fuel pump was composed of a viscous fluid and of a flaky material (Figure 34)

The flaky material contained two distinctive surfaces. One side of the surface was composed of magnesium with some oxygen and traces of zinc and aluminum. The other side was composed of carbon, some oxygen, magnesium, and traces of chromium, phosphorus, sodium, sulfur, and aluminum. FTIR displayed a hydroxide compound as well as an enamel compound. This may have suggested a magnesium hydroxide compound in the presence of an enamel coating.

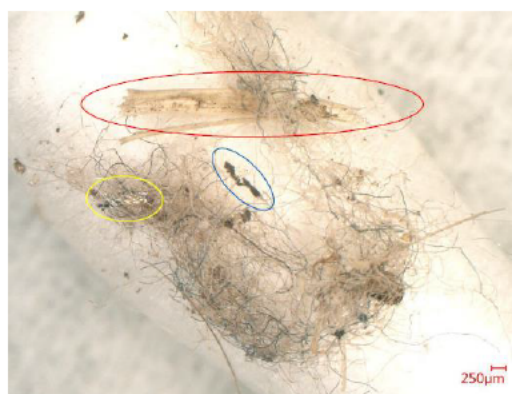
Figure 35

The debris found in the fuel inlet strainer (Figure 35) contained various particles. A flat brown coloured particle suggested wood fibers (circled in red). A fluorine rich particle with some carbon suggested a fluorocarbon material. A leaded bronze (circled in yellow) material was observed. Particles rich in calcium, sulfur, and oxygen suggested a calcium sulfate material. Calcium rich particles with traces of silicon suggested environmental particles. Aluminum-based particles and fibrous particles composed of carbon, some sulfur and oxygen were detected. A particle suggesting an acrylic compound (circled in blue) was detected.
