## N9543E ASI Inspection Report

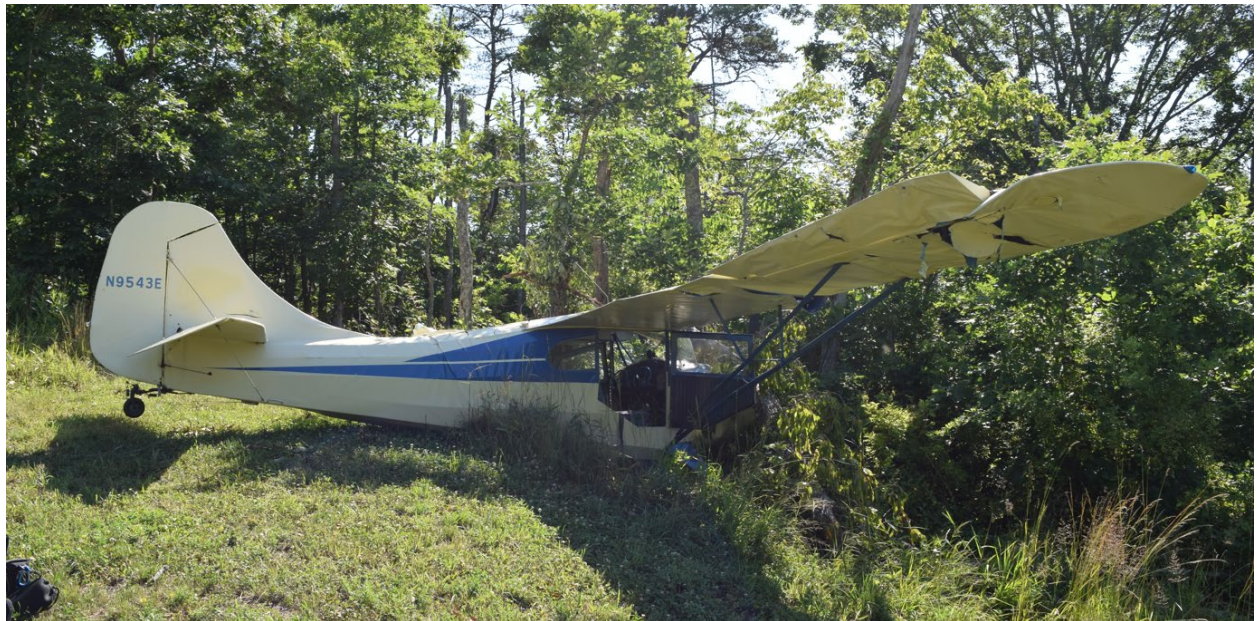
- Rear tail wheel assembly broken fork to left side
  - Fuselage appears to be bent direction of front up, center down and back up. Aircraft appears to have lost forward momentum mostly landed mostly flat after collision with trees.

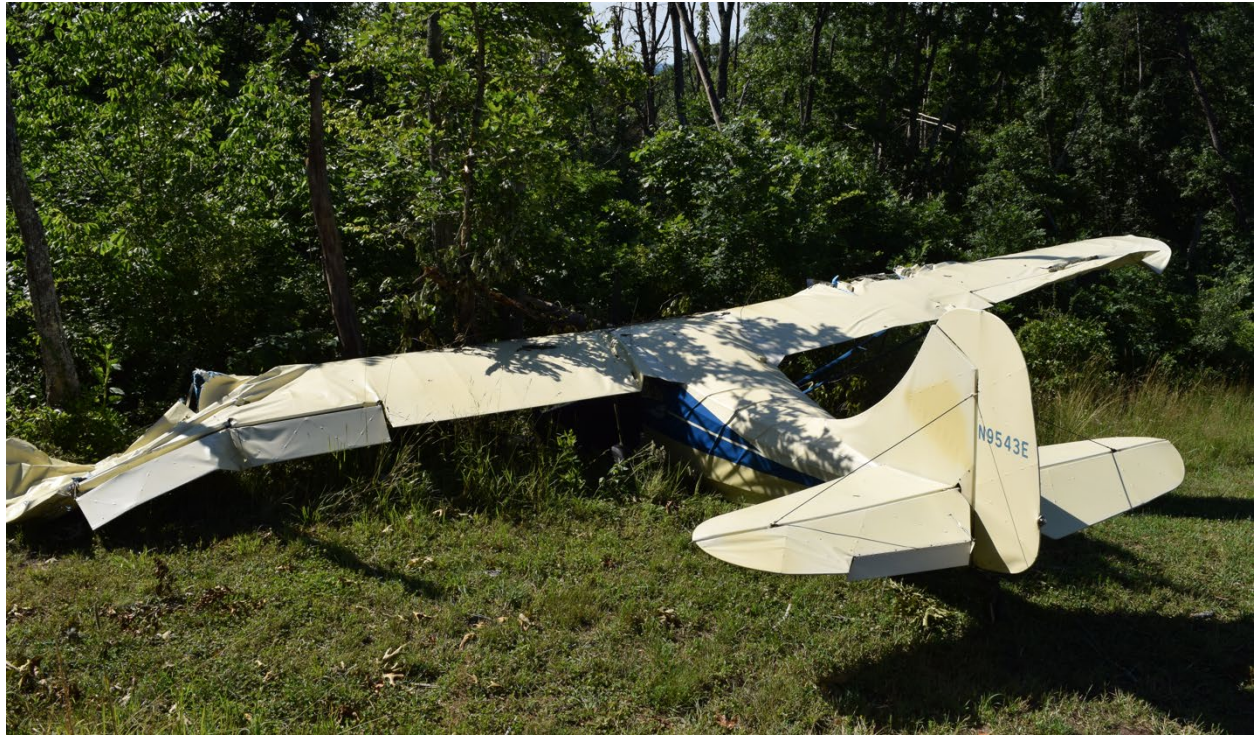
- Bent spinner and cowling
  - ELT missing (Pilot stated removing)
  - Carb heat in "Off" position pilot said he pushed it back to off
  - Fuel Off position , pilot stated turning off

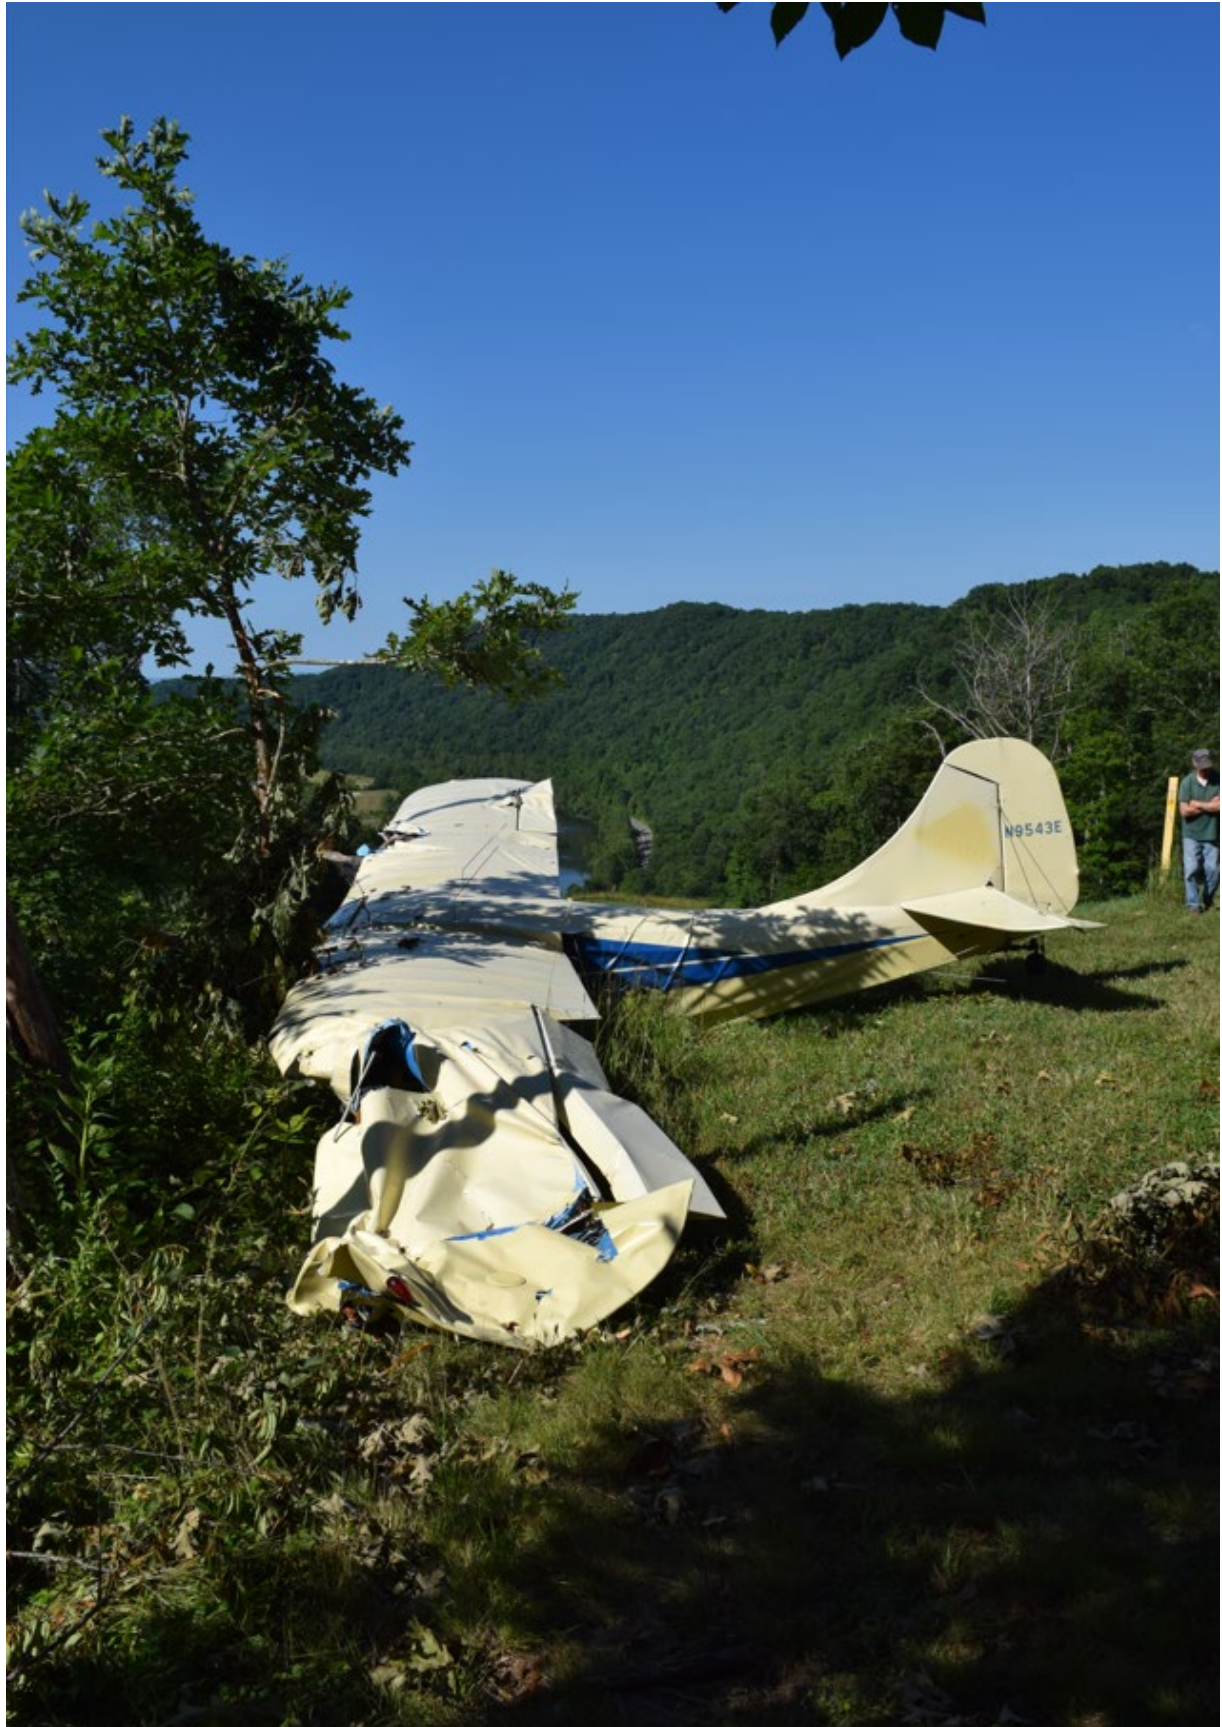
- Rear left exhaust gasket partially blown out
    - Carb heat tubing not fully attached to carb intake box
    - Use of STC auto gas noted (added marvel mystery oil used ) noted by residue found in carburetor intake plenum and verified by pilot)
