ERA23LA277

## INVESTIGATION PHOTOGRAPHS

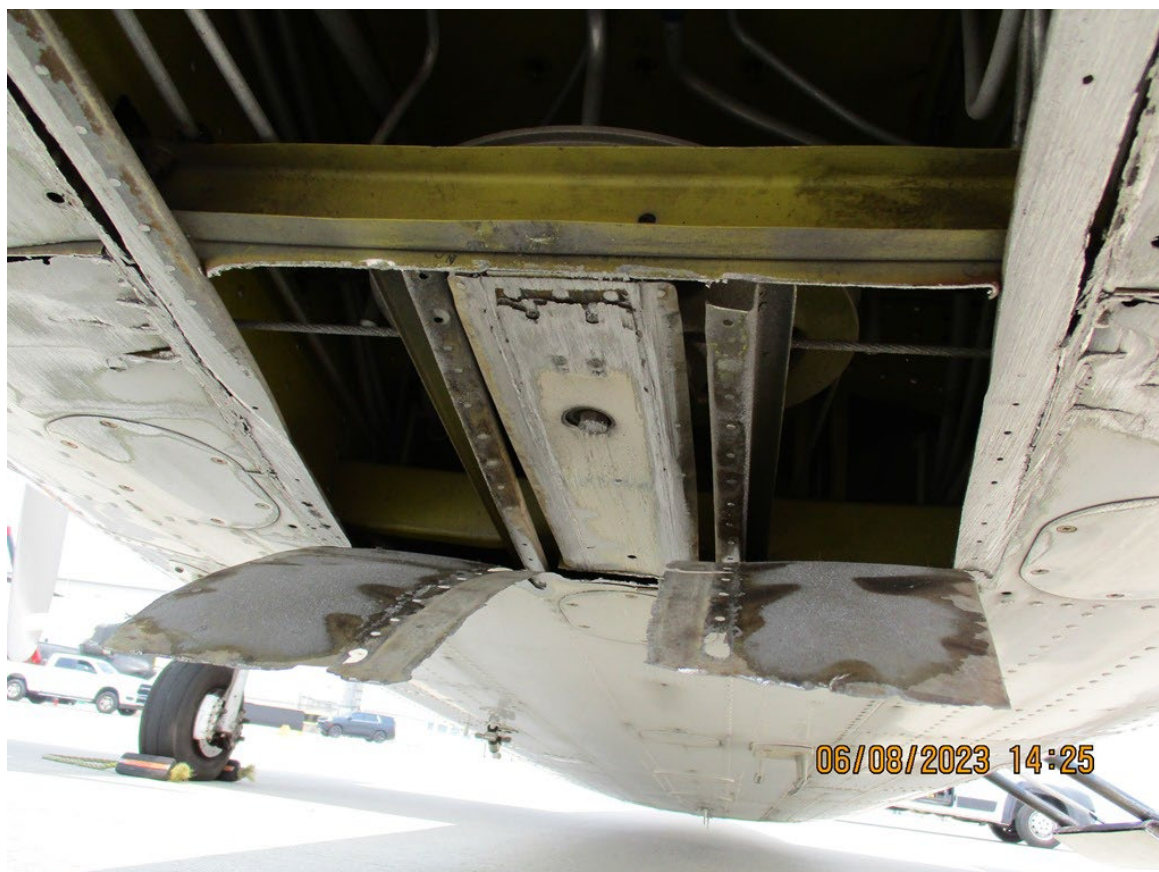
**Photograph 1 - Damage aft of nose gear landing well (Courtesy FAA)**

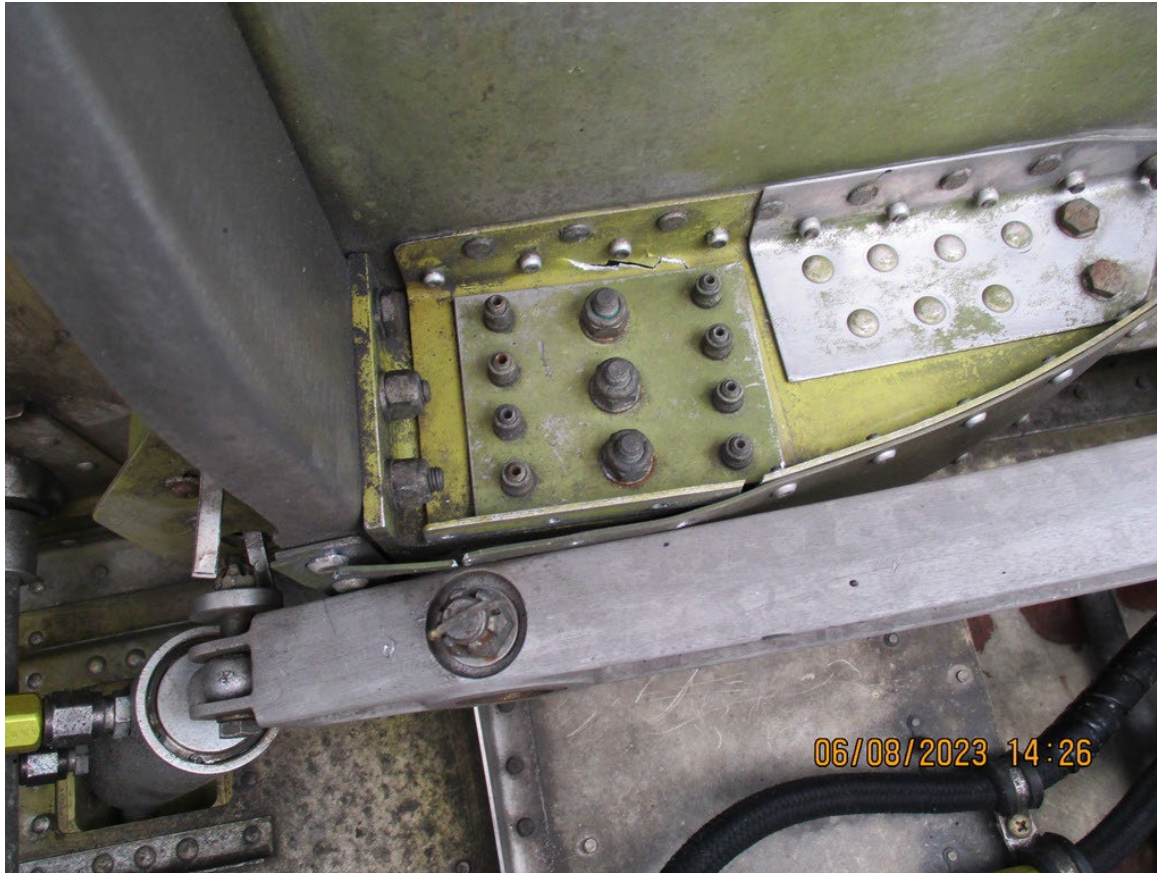
**Photograph 2 - Nose Landing Gear Actuator Mount Structure (Courtesy of FAA)**
