Ref. T-2307 (19 pgs)  
(Addendum A , 24 pgs)

Subject: No Technical Objection to Ferry Flight of N515AM with Temporary Repair.

Twin Commander, LLC has No Technical Objection (NTO) to permitting a Ferry Flight of aircraft FAA Reg # N515AM, Model 695, Serial Number 95008, from Philadelphia PA (PHL) to Youngstown OH (YNG) to enable proper repairs to be undertaken, provided the limitations stated below are complied with;

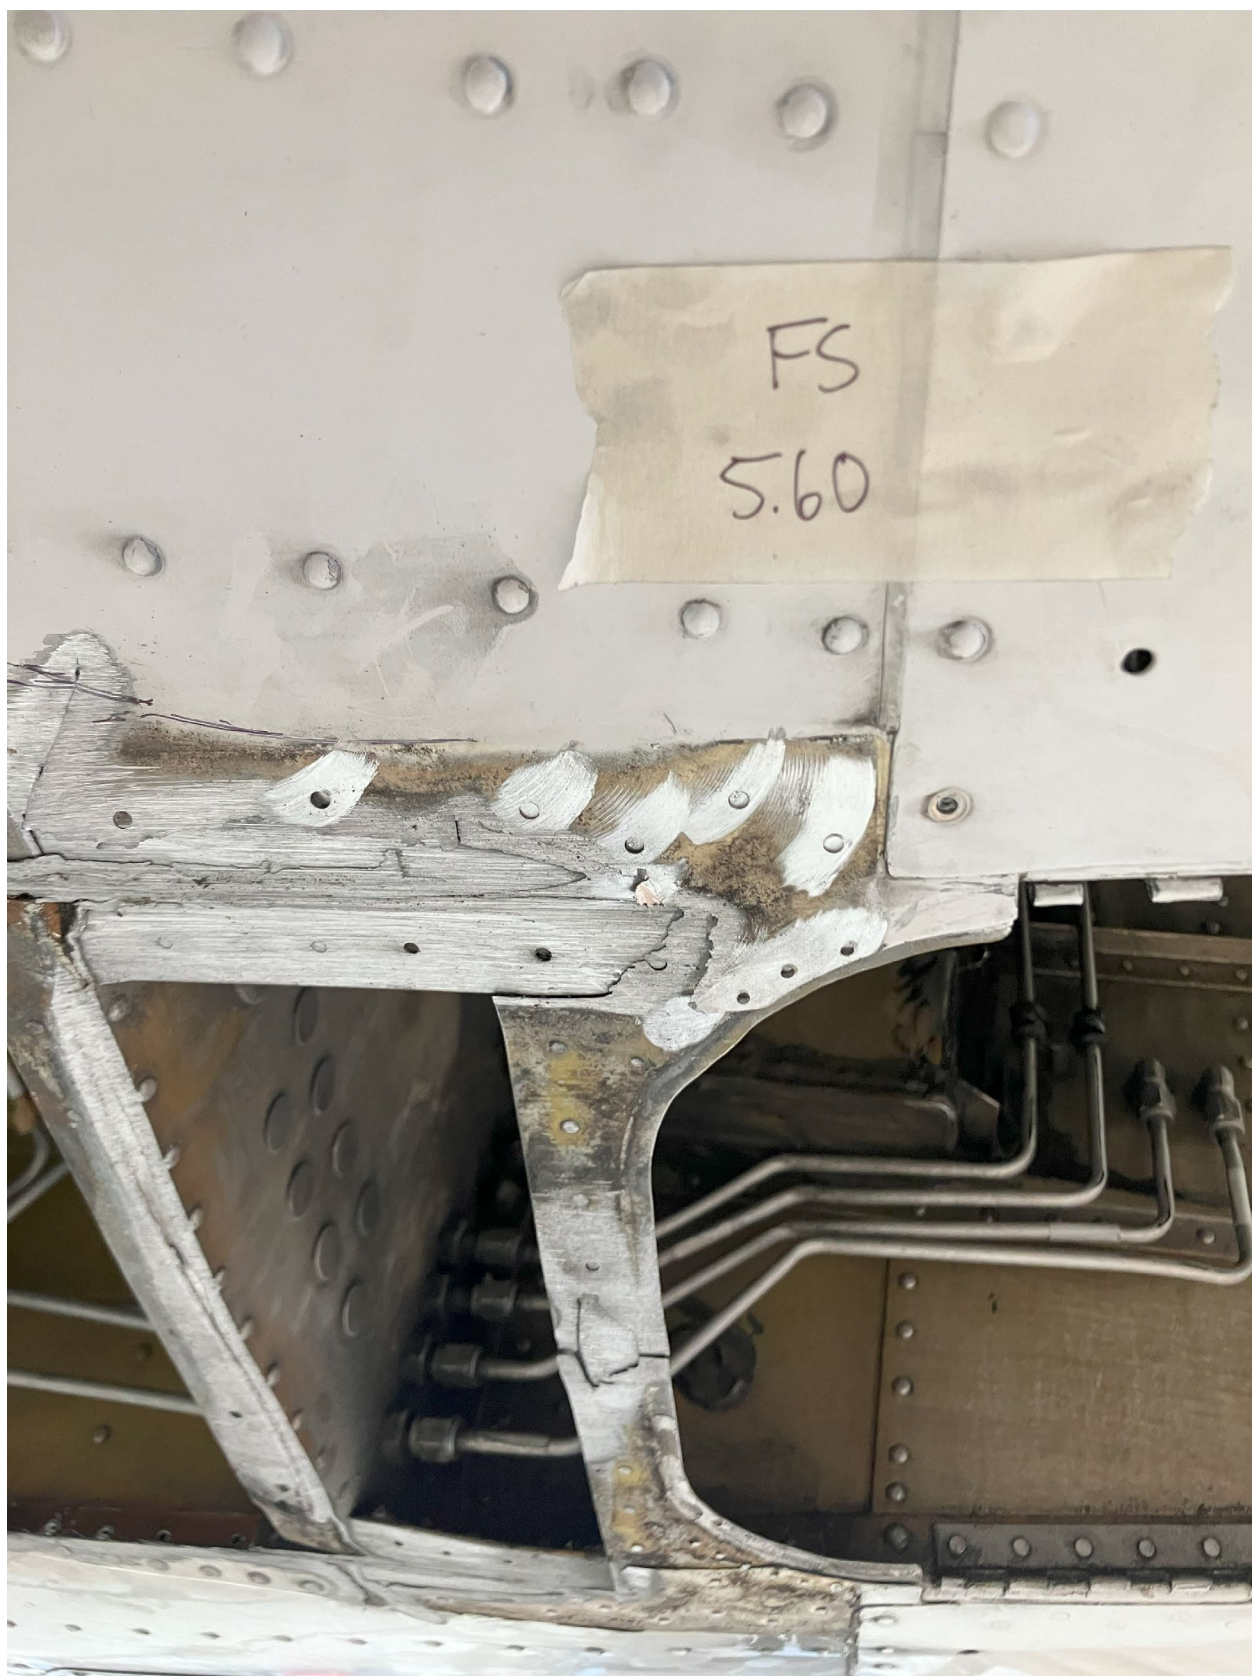
The lower angle of the frame, which also acts as the fwd pressure bulkhead, was worn thru, and this was re-fabricated with formed sheet of one gage thicker 2024-T3 material. The pressure vessel is actually at the floor height, which is above this angle. Replacement of this angle has no impact on the pressure vessel.

Figure 1: View looking up, FS5.5 and 12.5 (pressure bulkhead) Damaged flanges with skin removed

The fwd lateral angle supporting the Aileron Drum support hat channel was reinforced as the original angle flange was worn away. The lateral angle at FS12.5 was also damaged. Replacement parts were fabricated from formed sheet alclad 2024-T3, 0.040" thick. The original angles were 0.020" thick of the same material. They are attached using the same number of rivets at the same locations. The skin at FS5.5 was just trimmed out as it was mostly gone from chafing. The skin doubler will restore the skin material.

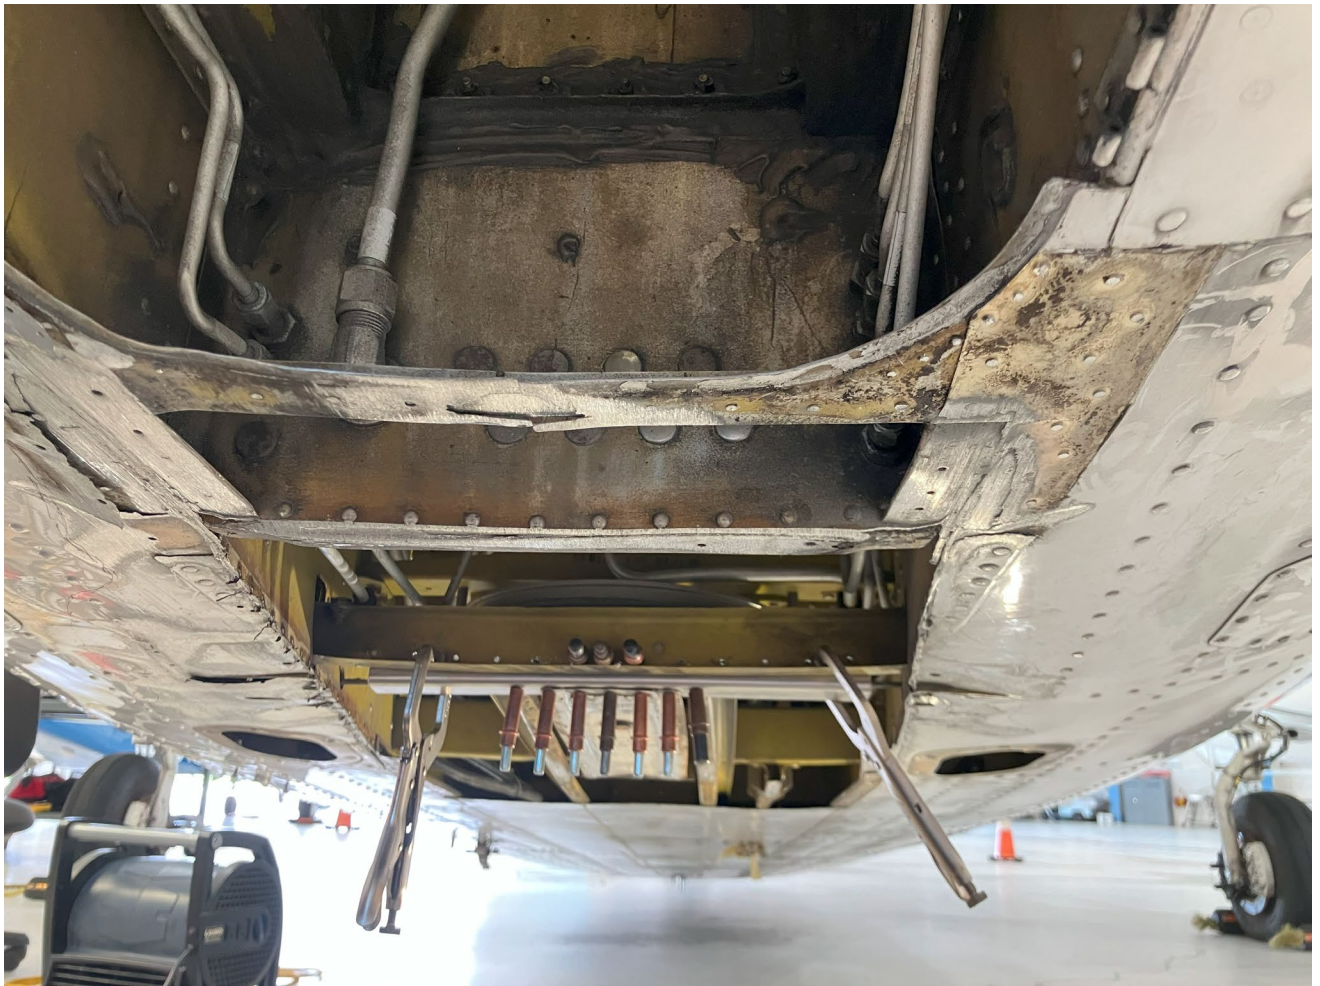
Figure 2: View looking up/aft, Repair angle at FS23.5 (fwd end of aileron drum hat channel) being worked.

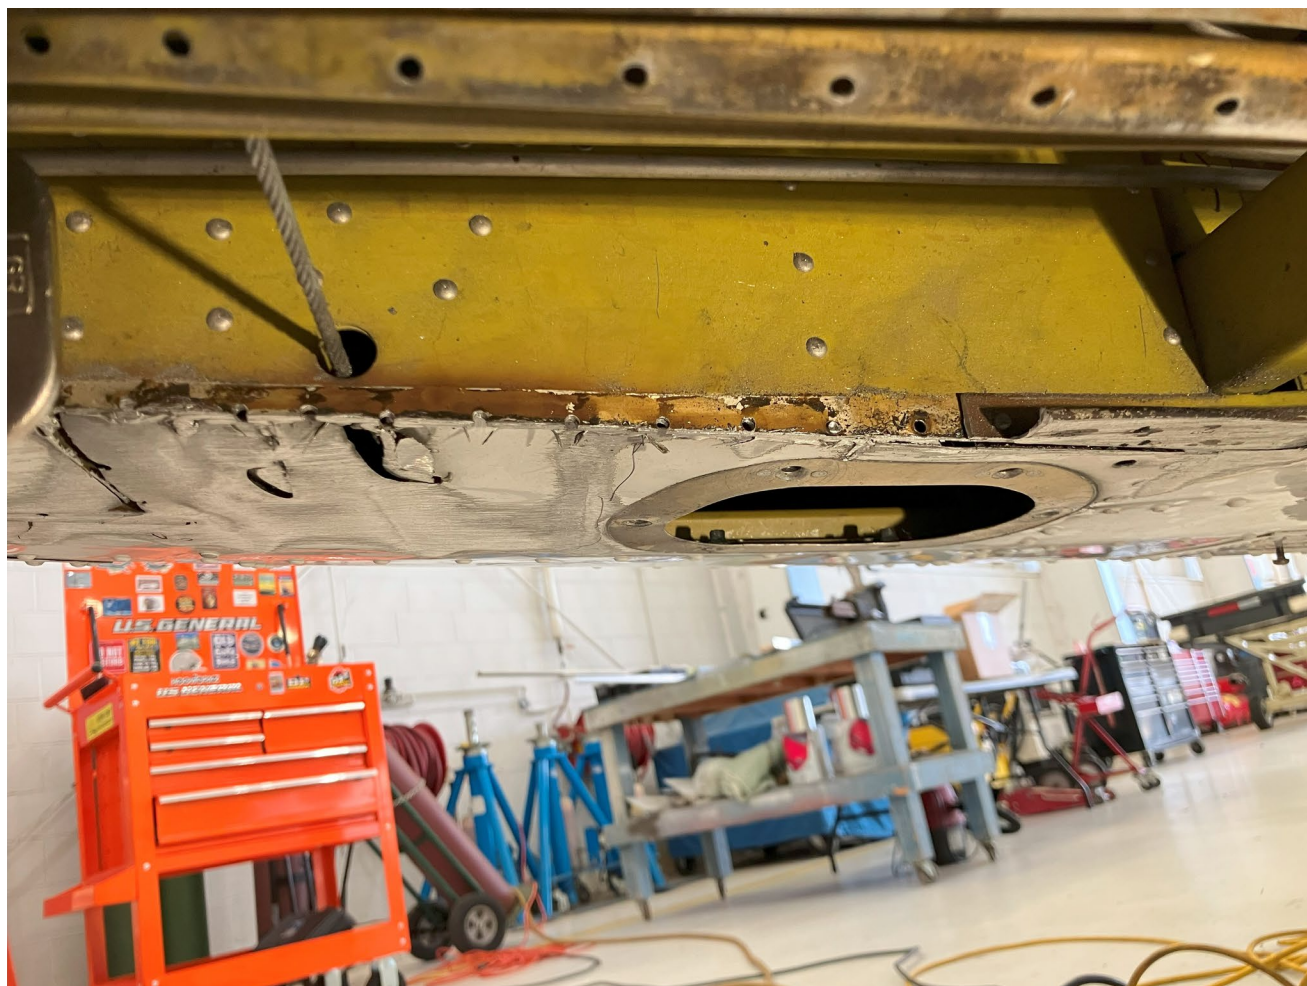
Figure 3 Chafed skin been trimmed out LH Side aft of FS23.5

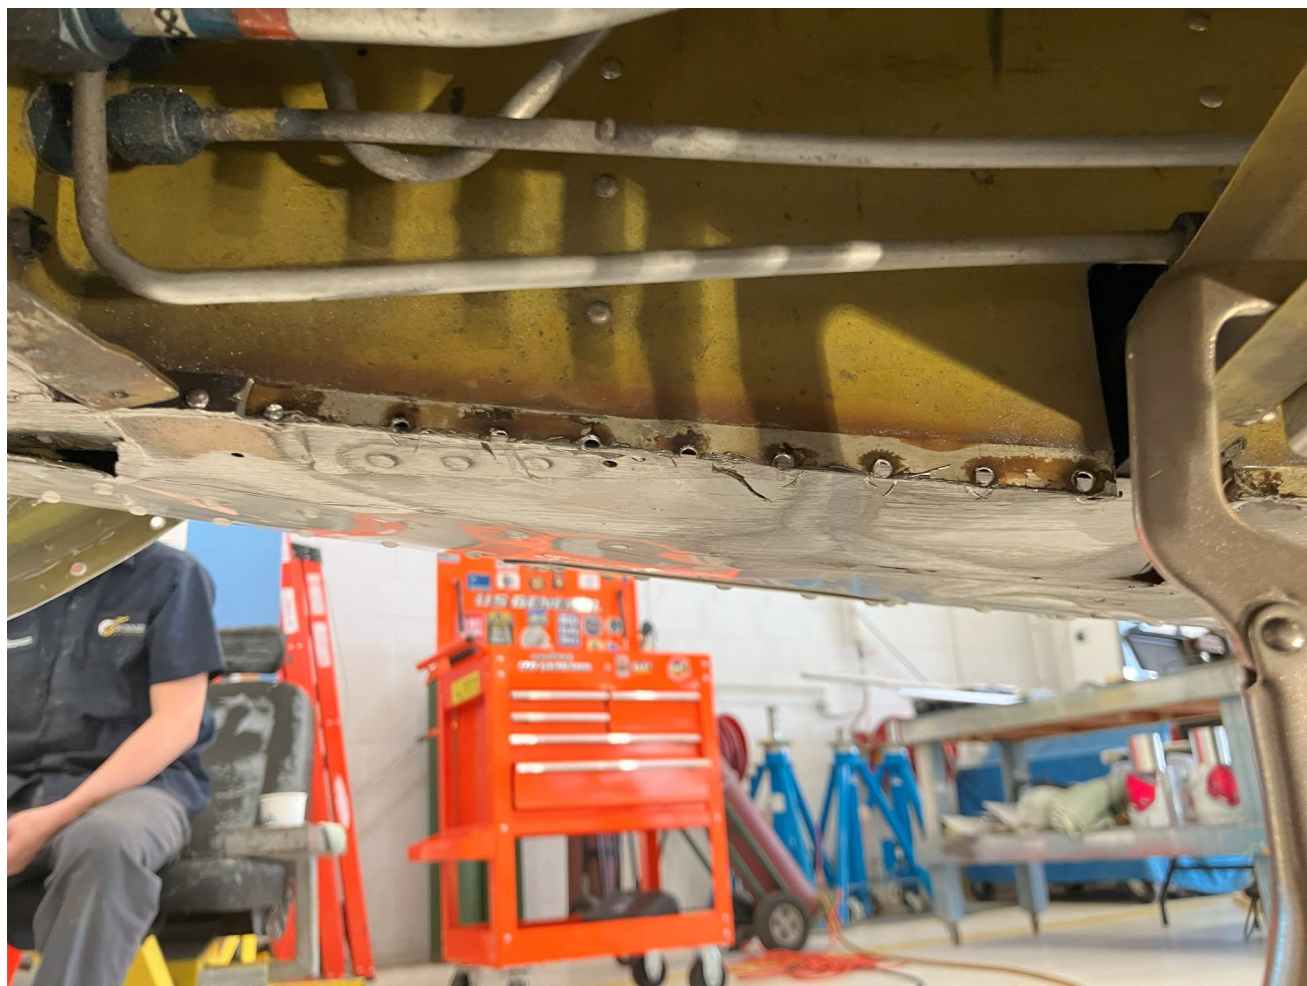
Figure 4 Chafed skin been trimmed out LH Side just fwd of FS23.5

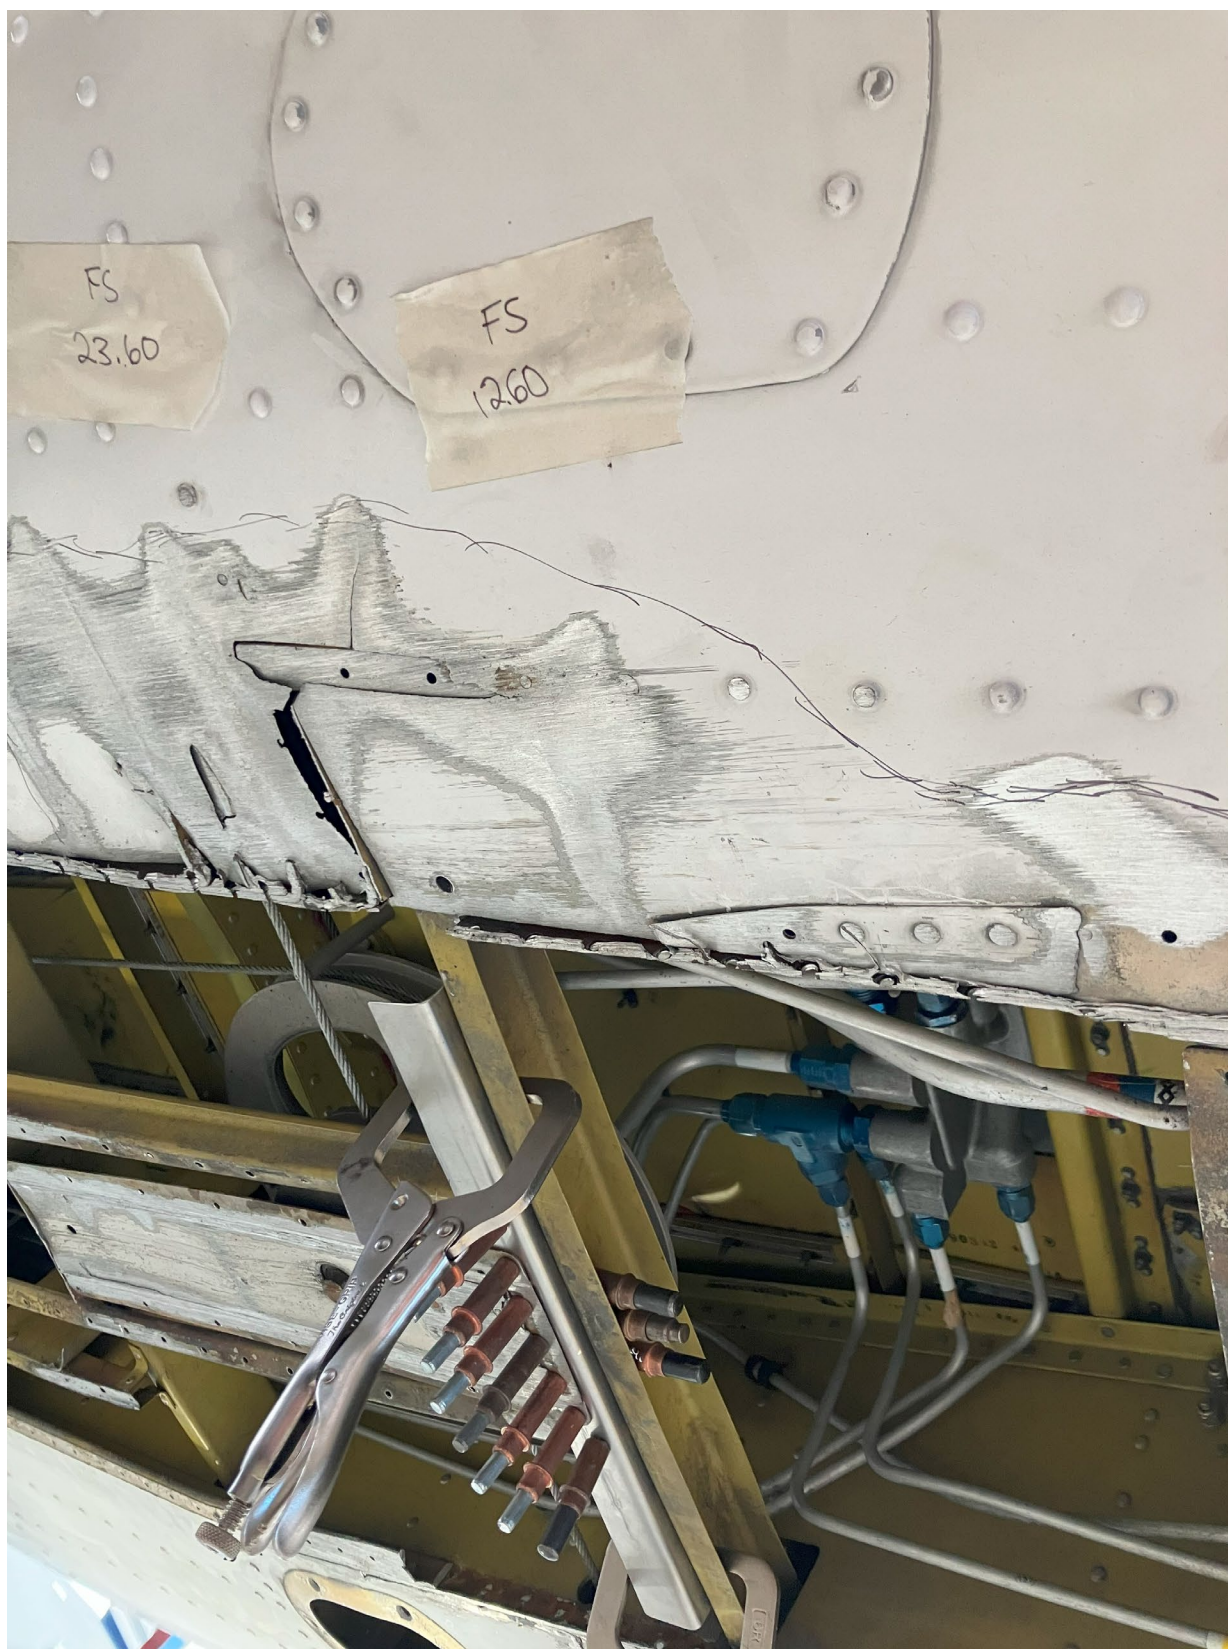
Figure 5 Repair angle at FS23.5, and chafed skin RH Side

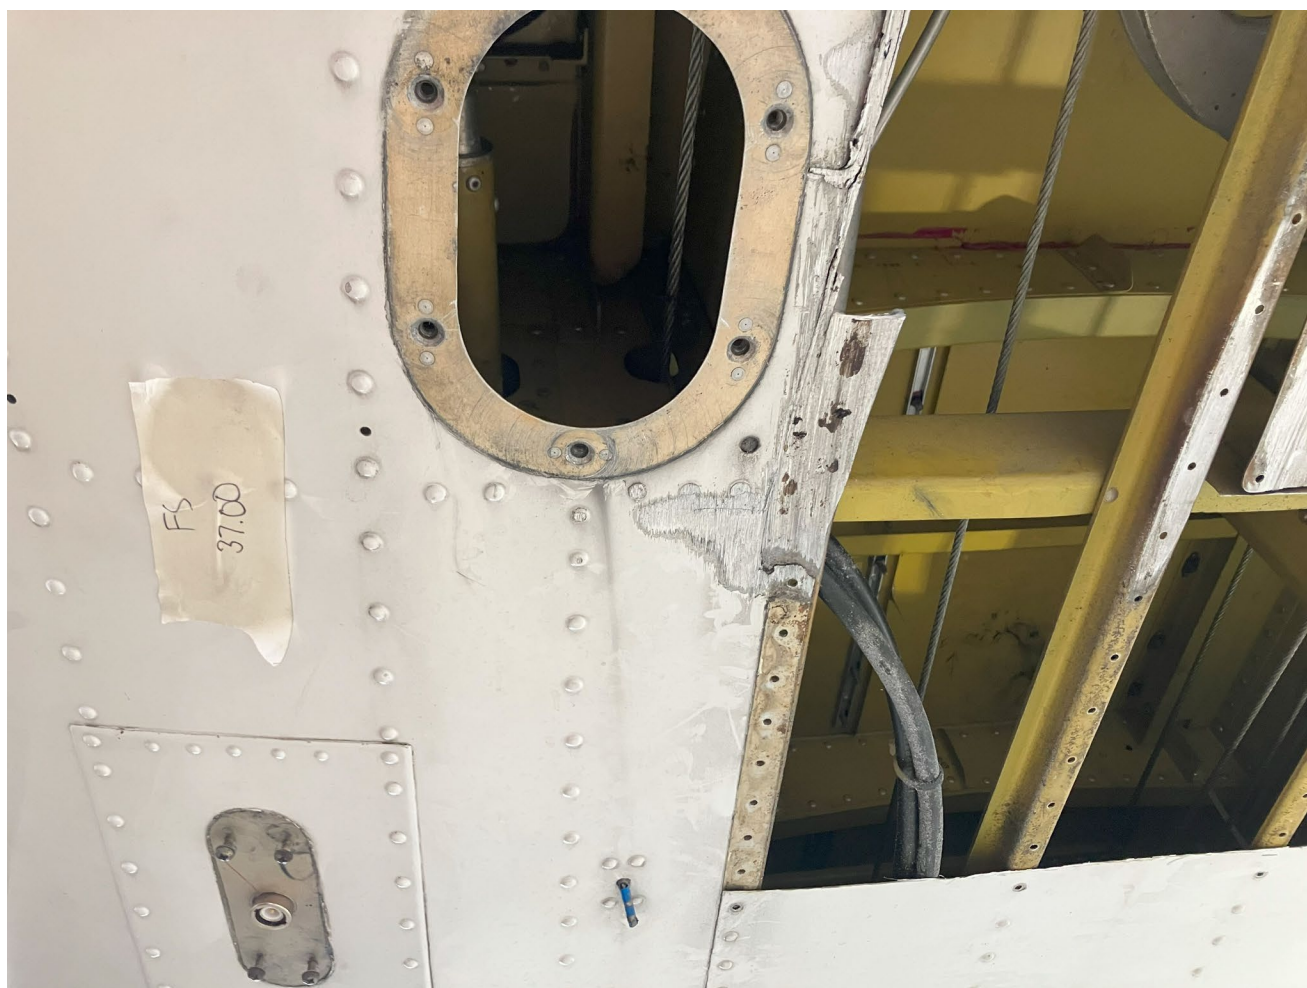
Figure 6 View looking up at FS37.0 – chafed skin cut out.

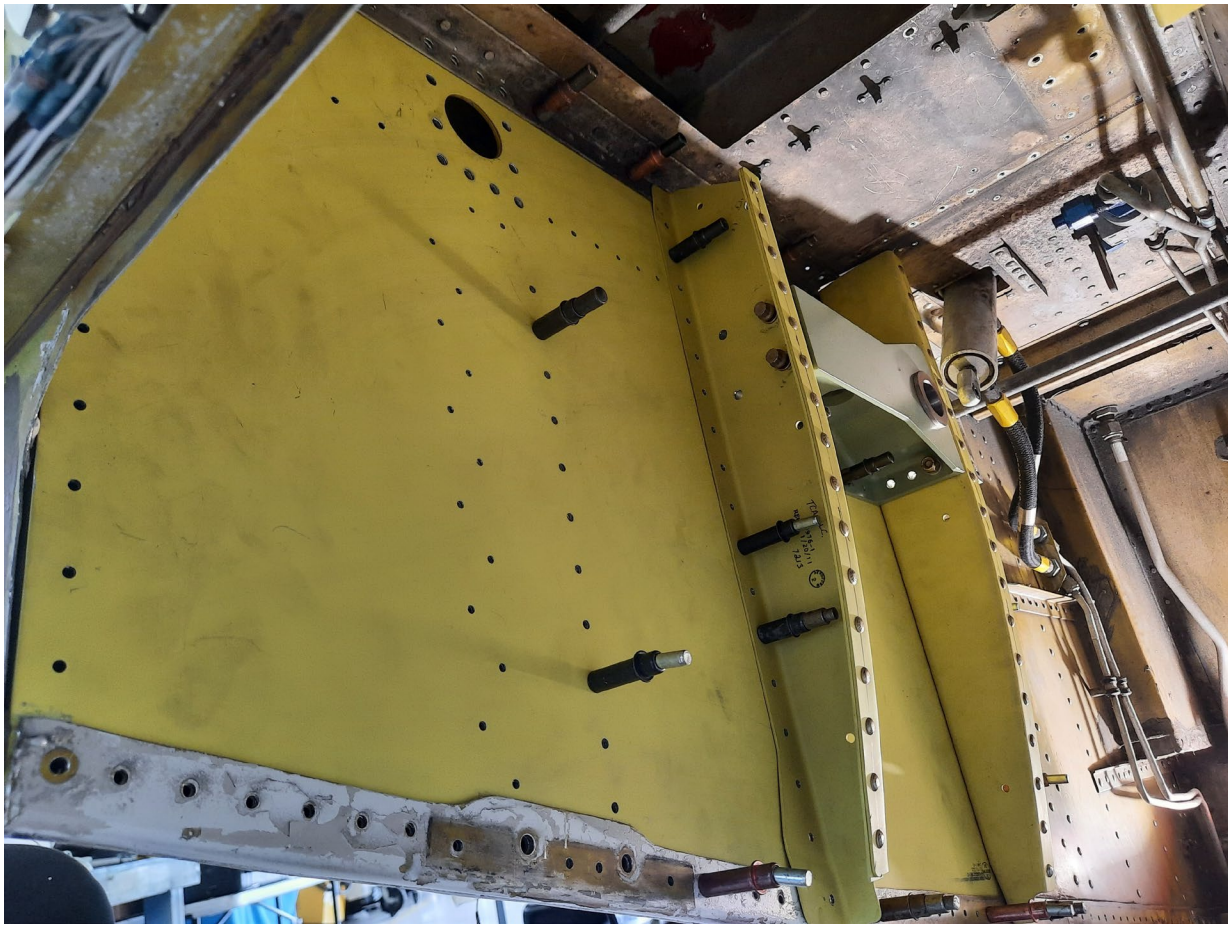
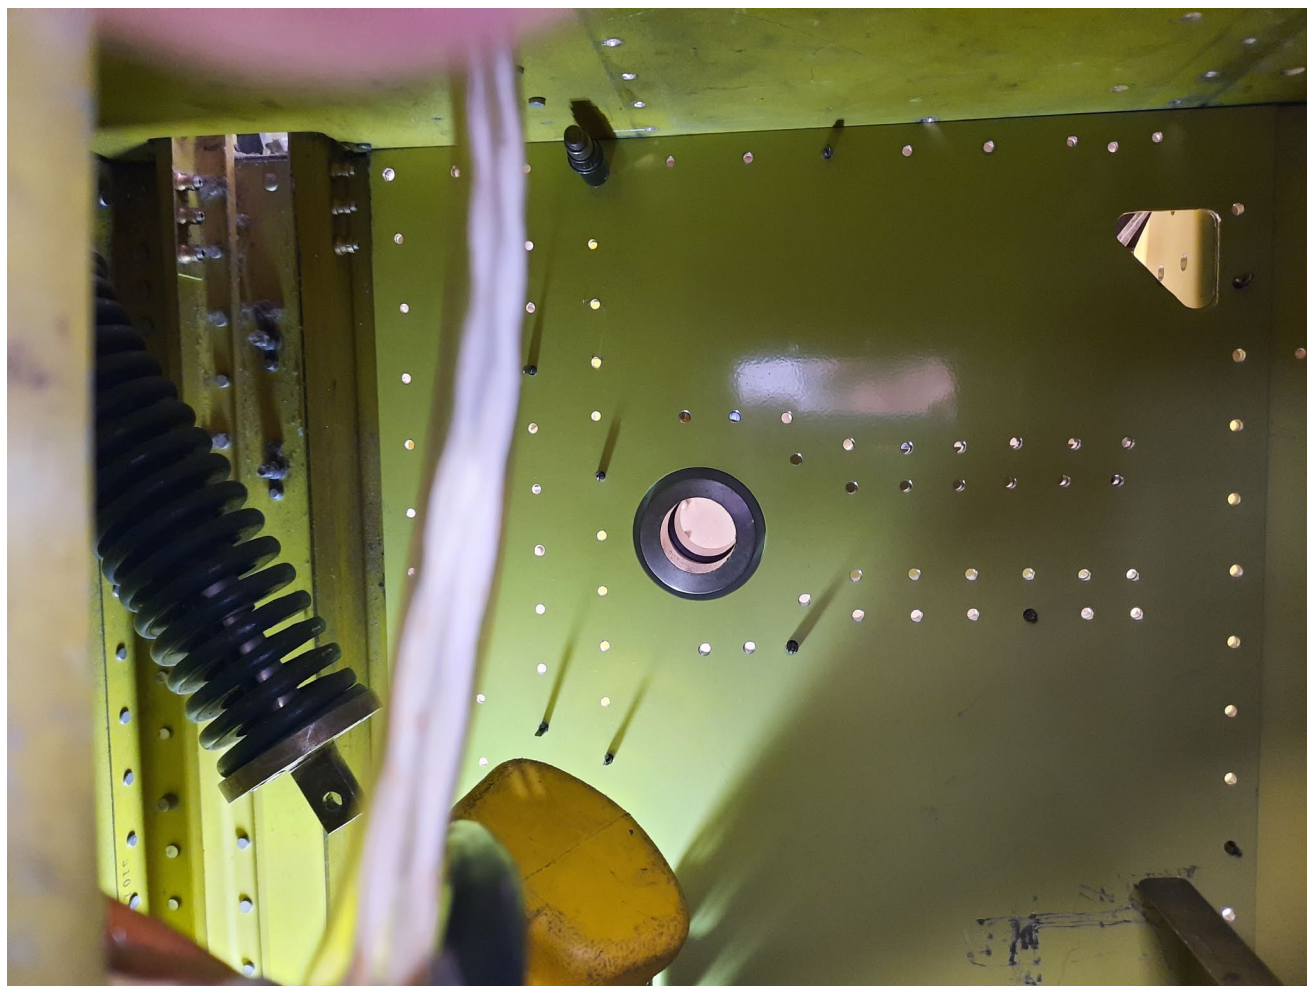
Figure 7 RH CK 159-1 being installed in Keelson web.

Figure 9 RH CK 159-1 being installed in Keelson web.

Twin Commander kits CK159-1 and CK159-2 have been completely installed. The CK159-1 kit removes all of the cracked and damaged structure at the aft upper drag brace attachment.

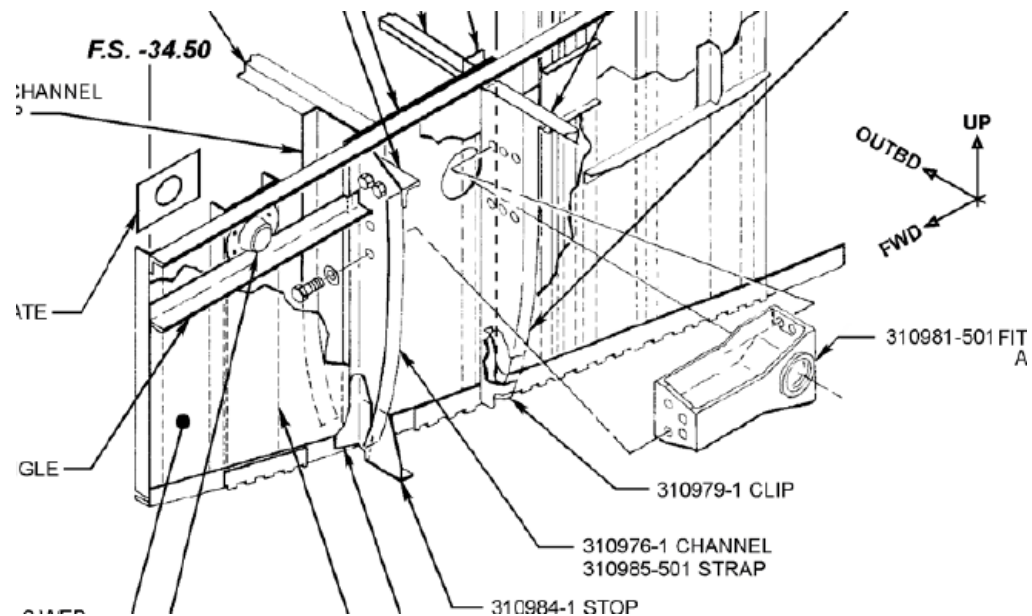
Figure 8: Figure from CK 159-1 showing instln.

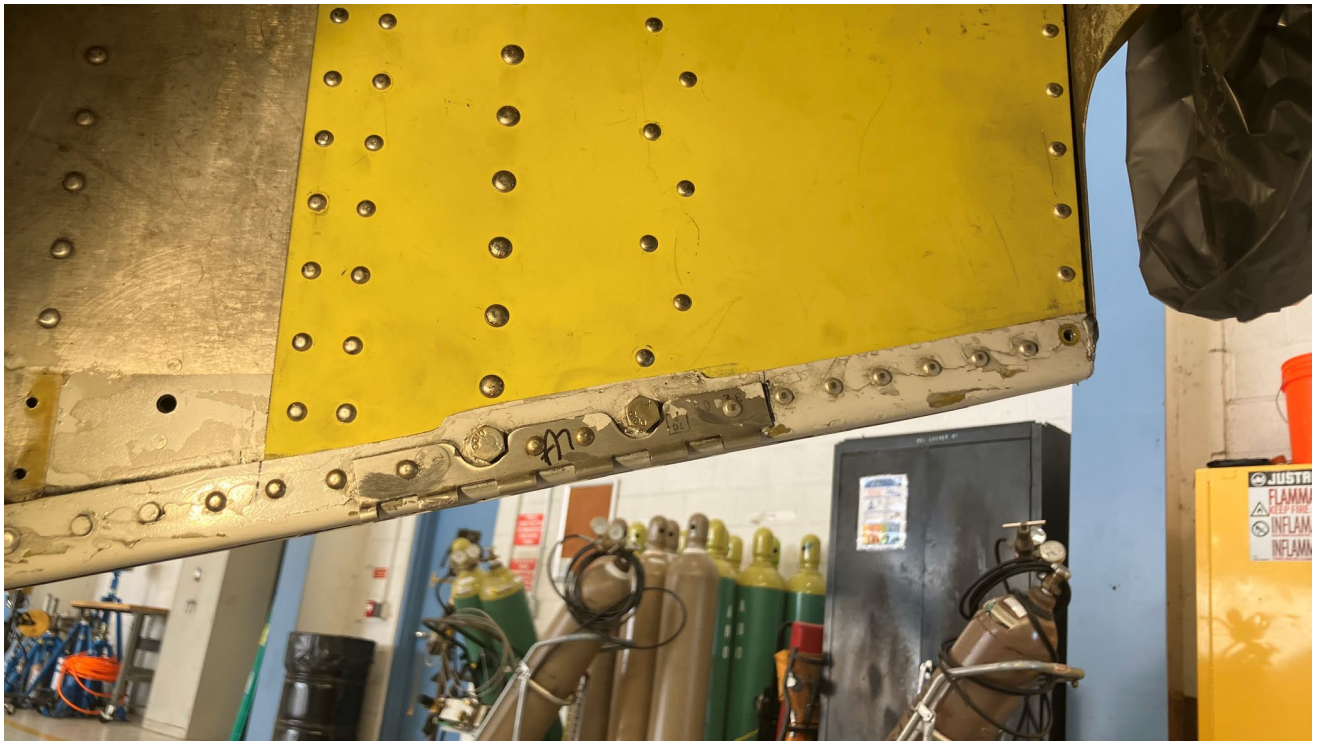
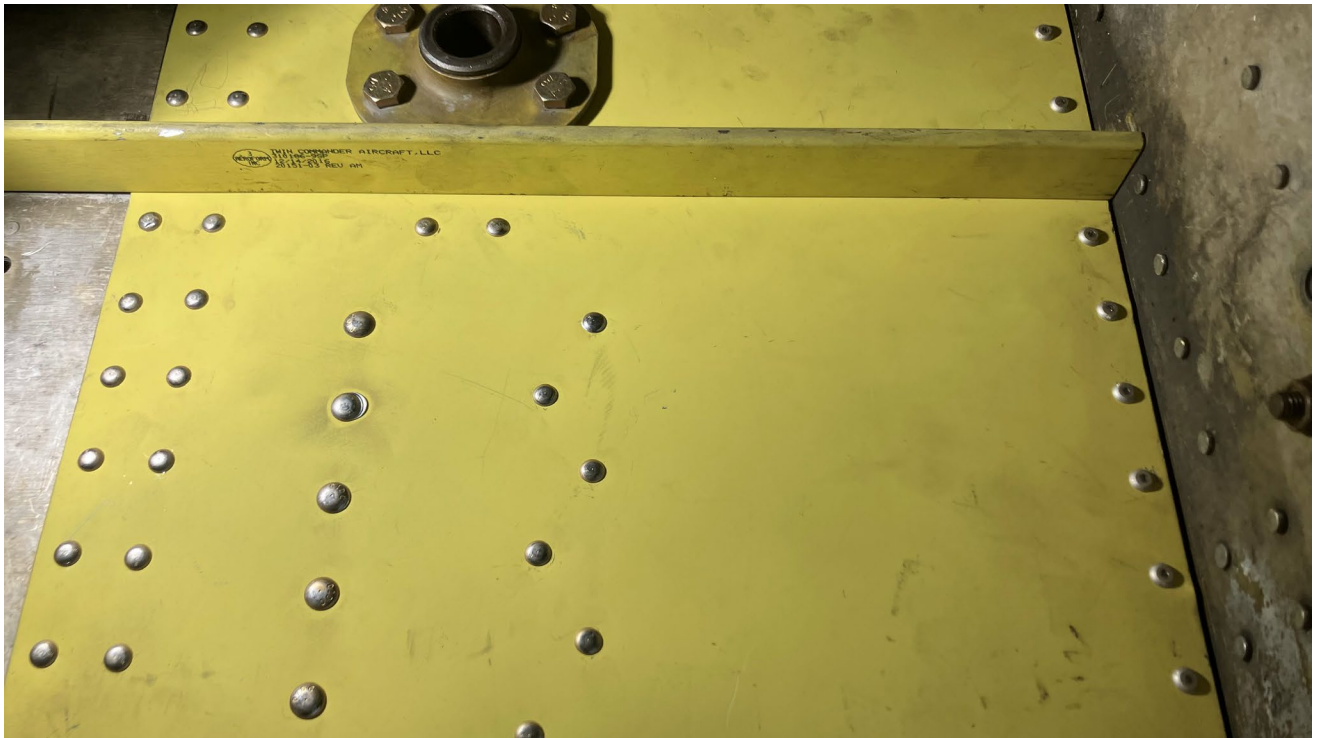
Figure 10 LH CK 159-2 being installed to keelson

Figure 11 LH CK 159-2 being installed to keelson

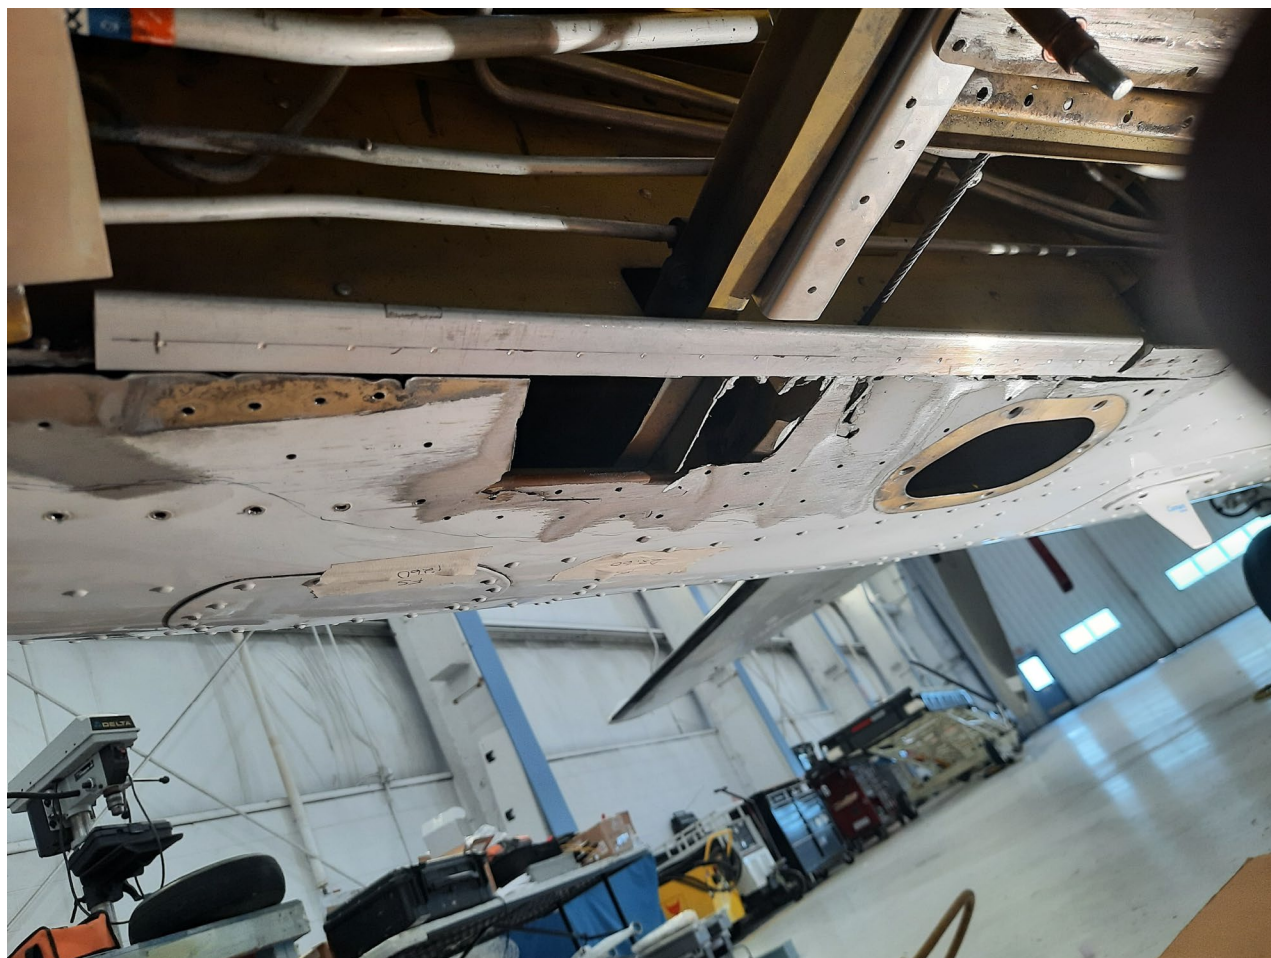
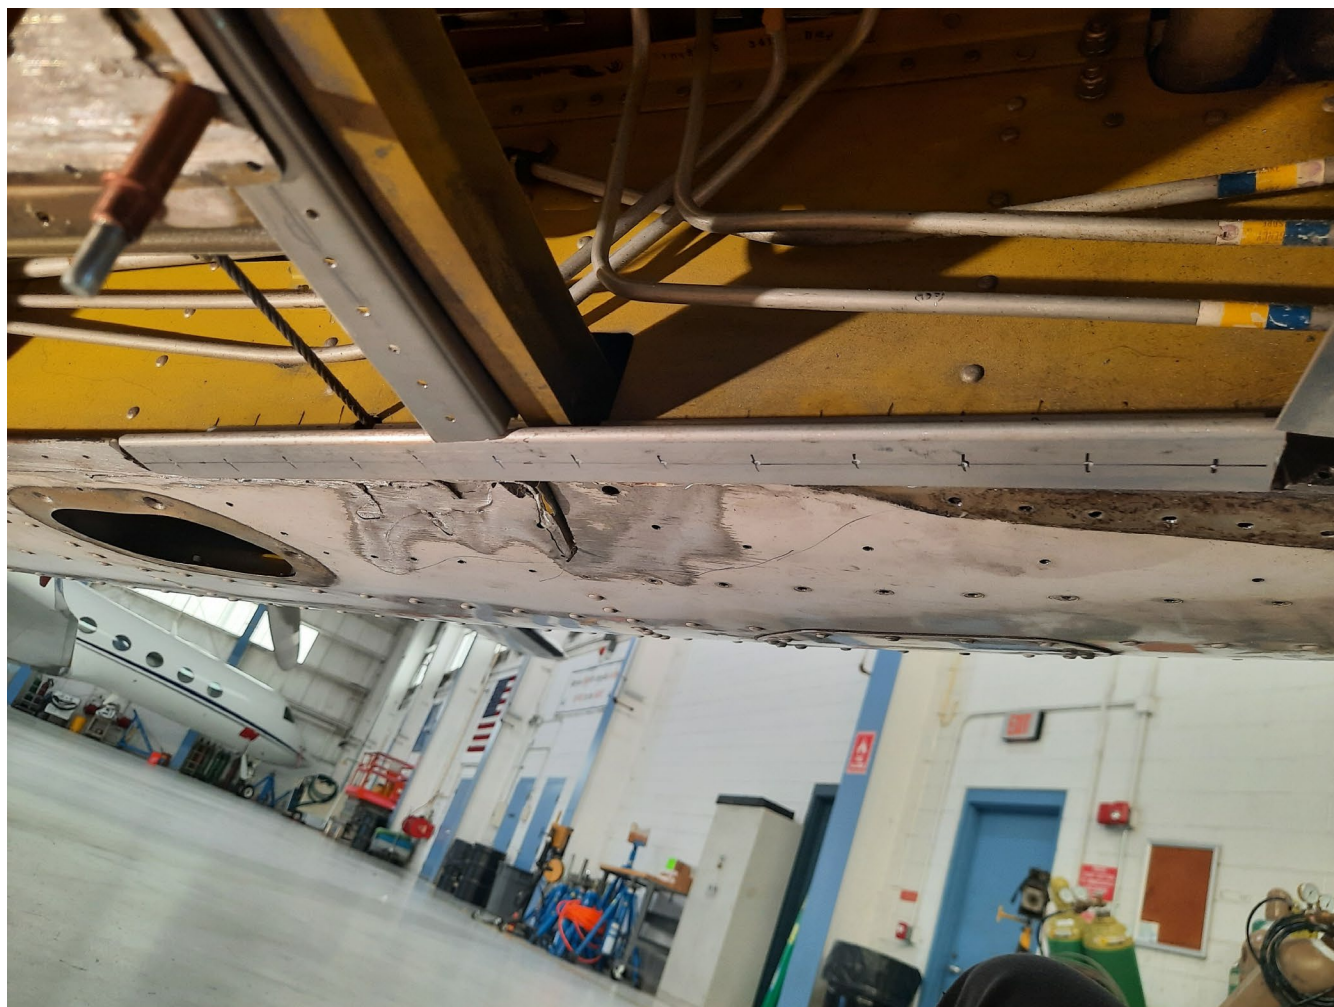
Figure 12 keelson web lower intercostals being repaired

Figure 13 keelson web lower intercostals being repaired

Where the fwd/aft intercostals, acting as lower keelson web beams were worn away, replacement angles of 2024-T3511 extrusion per AND10135-1005 were used, picking up on the same number of fasteners, attaching to the large skin doubler, and the keelson web. This AND section is a little thicker and has longer flanges than the original B/P angles. In the keelson web, the original BJ4 rivets were drilled out, and new rivets were installed a little higher ensuring enough material into the keelson web, restoring the shear connection.

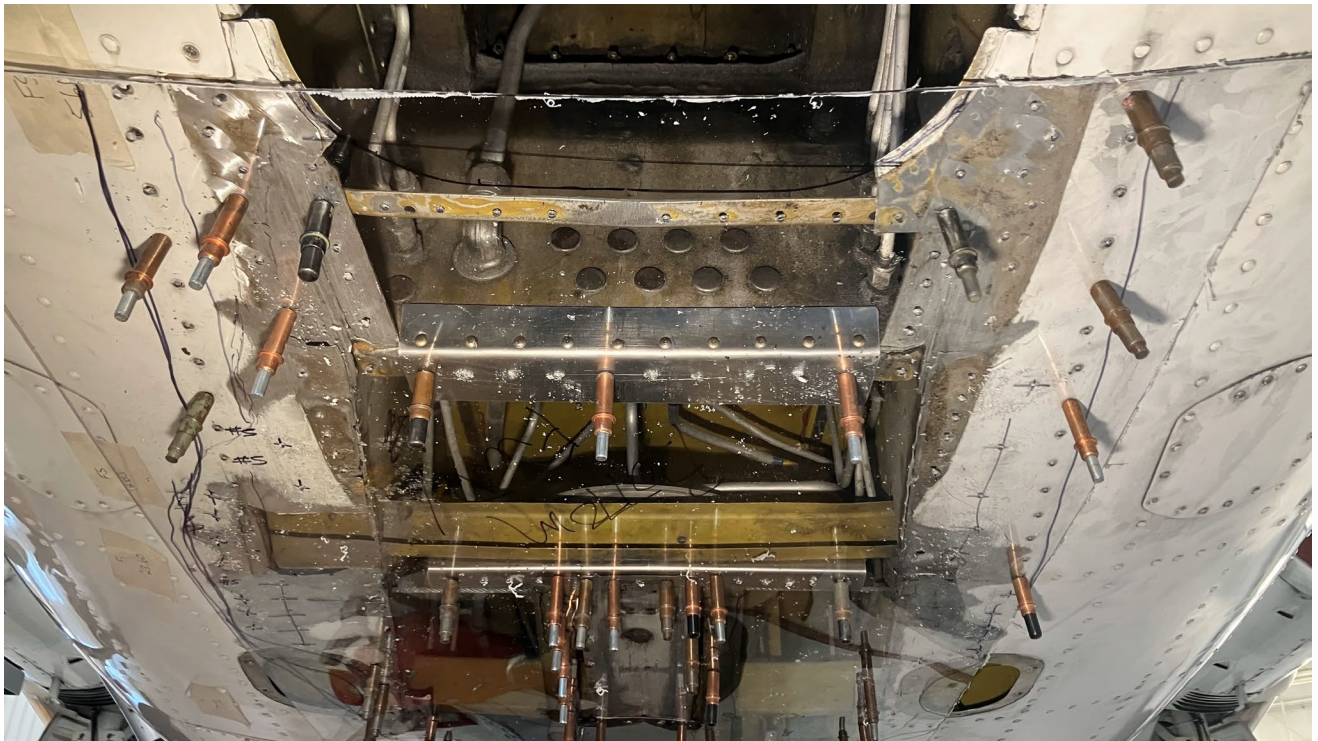
Figure 14 View looking up/aft Mylar being used to transfer holes to skin doubler.

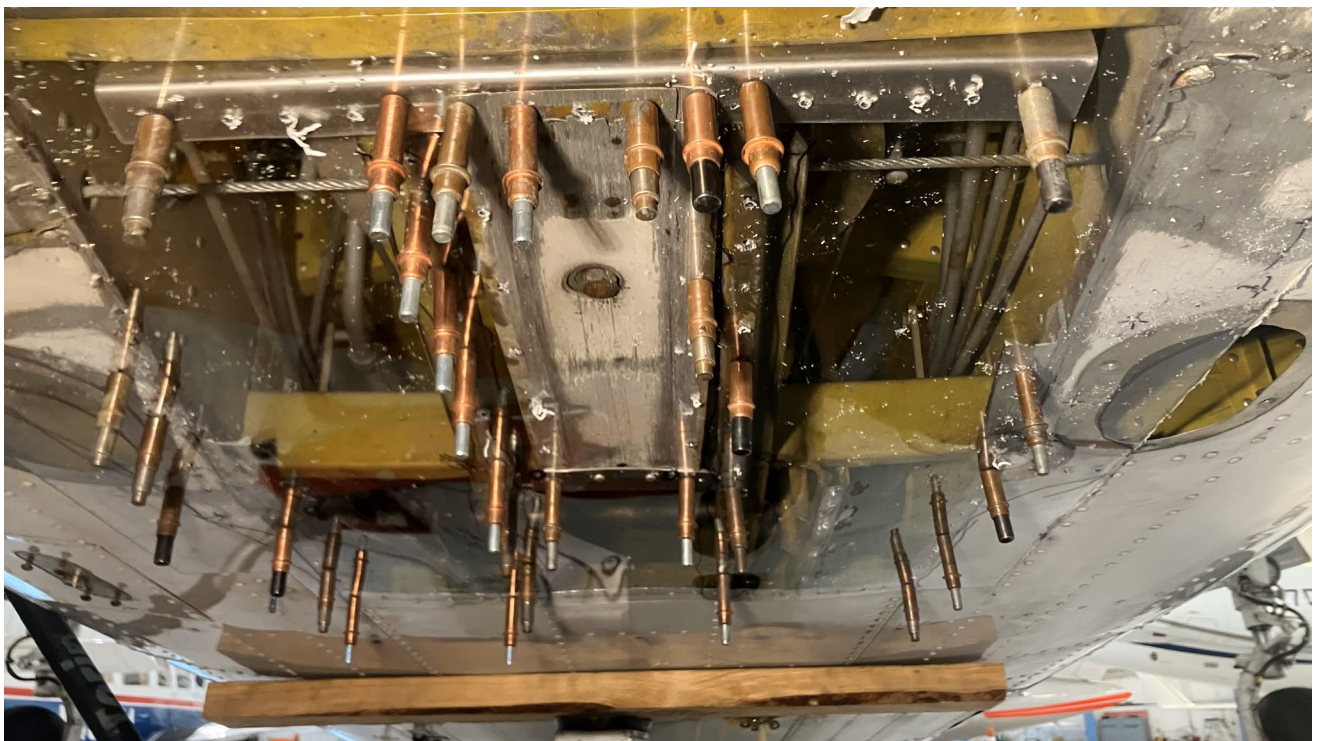
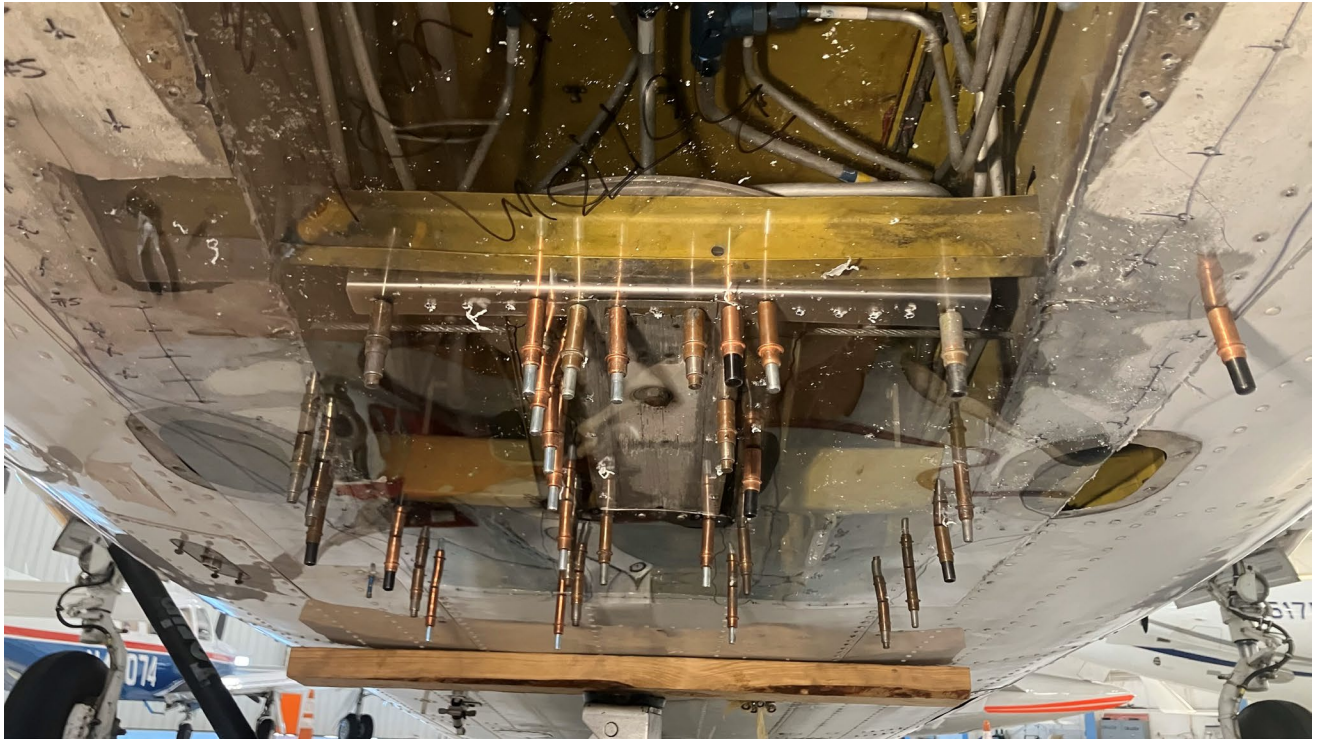
Figure 15 View looking up/aft, fasteners holes being drilled in mylar to transfer to skin doubler.

Figure 16 View looking up/aft, fasteners holes being drilled in mylar to transfer to skin doubler.

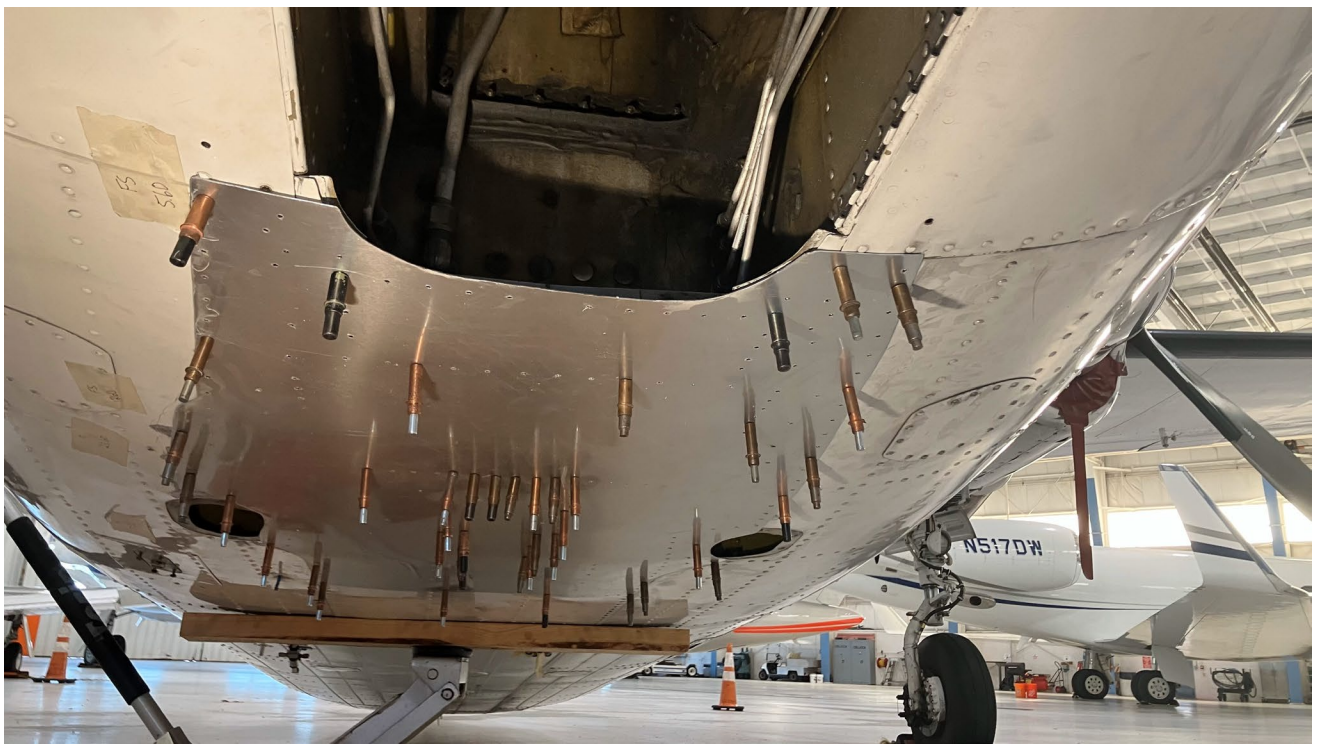
Figure 17 Skin doubler taking shape.

The repair doubler is fabricated from 0.032" thick alclad 2024-T3 material, which is the same as or thicker than the mating skins (0.025" or 0.032").
