Ref. T-2307 (19 pgs)  
(Addendum A , 24 pgs)

Subject: No Technical Objection to Ferry Flight of N515AM with Temporary Repair.

Twin Commander, LLC has No Technical Objection (NTO) to permitting a Ferry Flight of aircraft FAA Reg # N515AM, Model 695, Serial Number 95008, from Philadelphia PA (PHL) to Youngstown OH (YNG) to enable proper repairs to be undertaken, provided the limitations stated below are complied with;

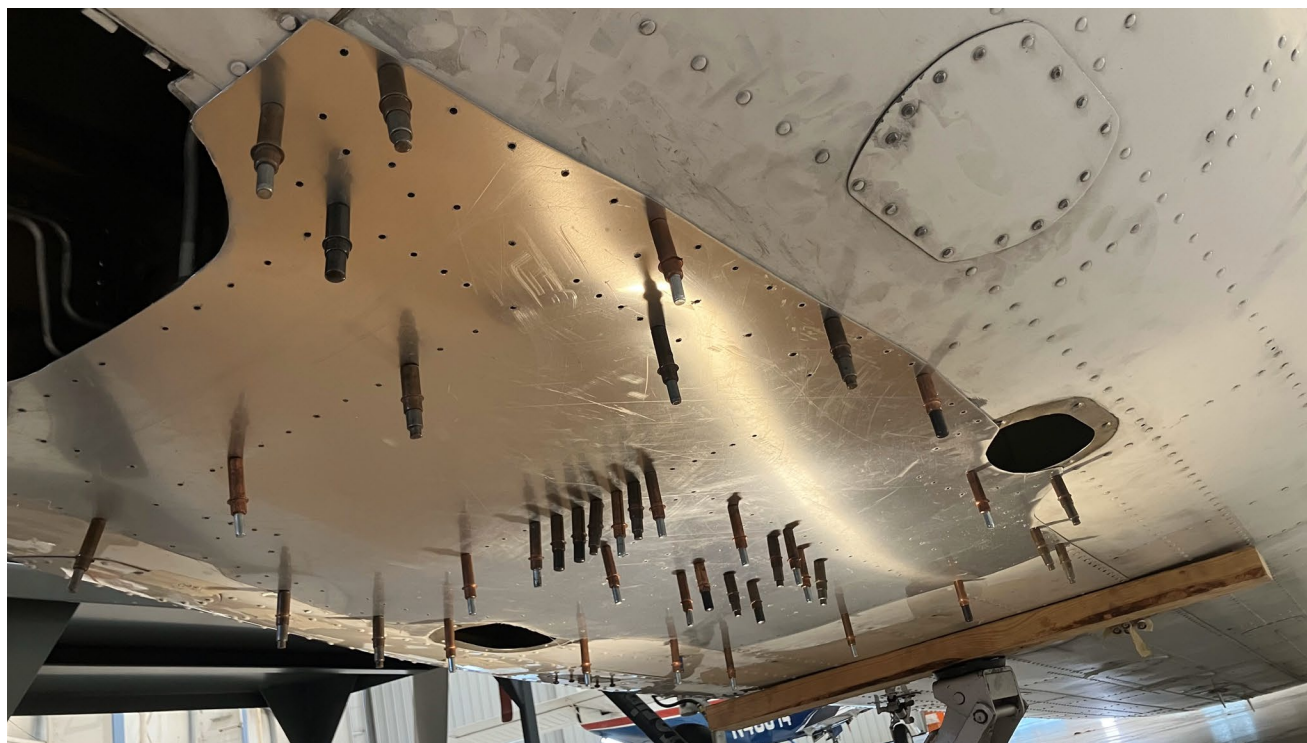
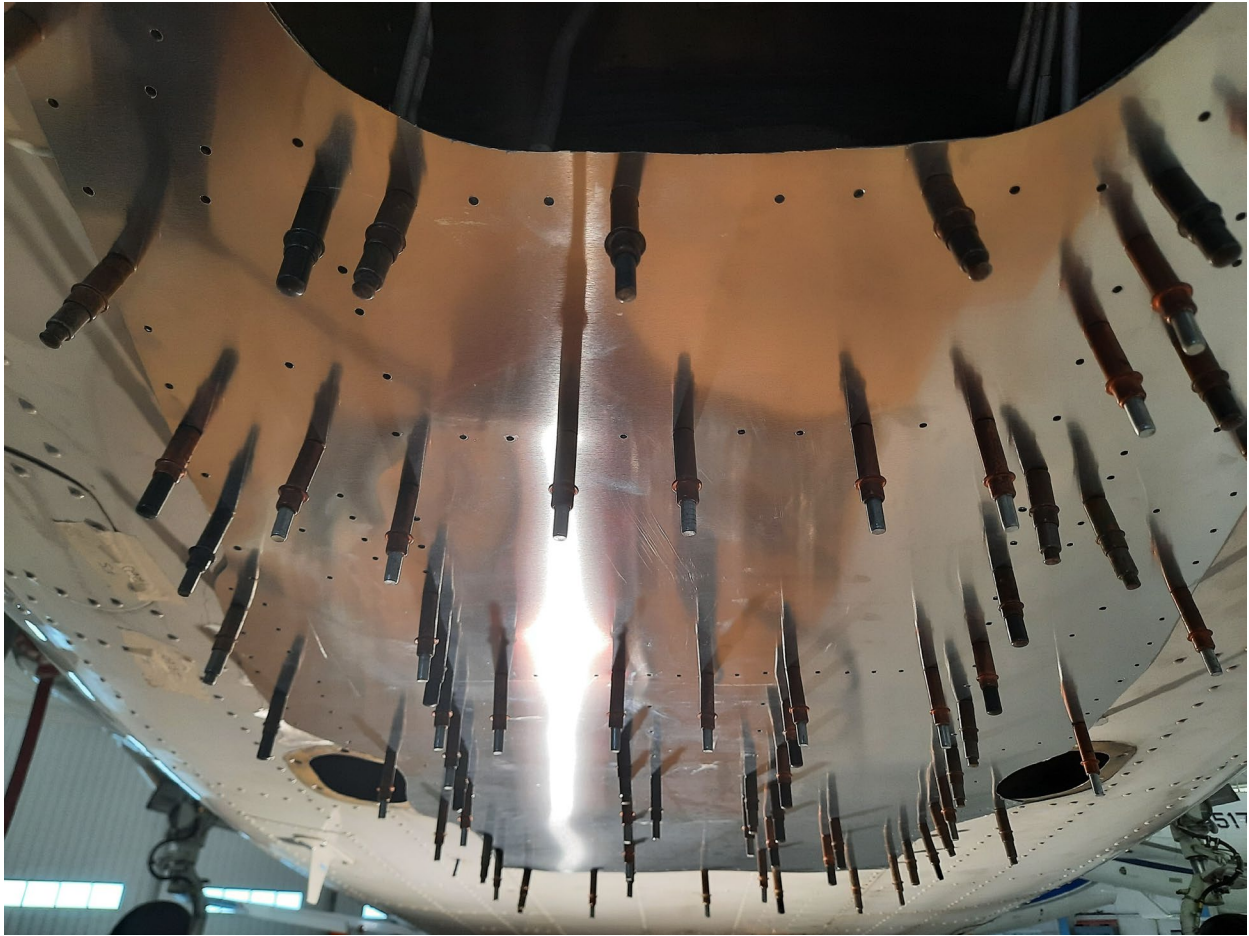
Figure 18 Skin doubler attach holes being located and picked up.

Figure 19 Skin doubler attach holes being located and picked up.

The skin doubler picks up on all frames, stringers and keelson intercostal structure effectively restoring the longitudinal and lateral load paths. A review of the 680T SRM (as there is no SRM for this model), shows typical external doublers in non pressurized areas, only requiring a single peripheral row of fasteners to the original skin. Over the various Twin Commander models this design element has not changed in the area of the forward fuselage unpressurized section.
