ERA23LA281

## INVESTIGATION PHOTOGRAPHS

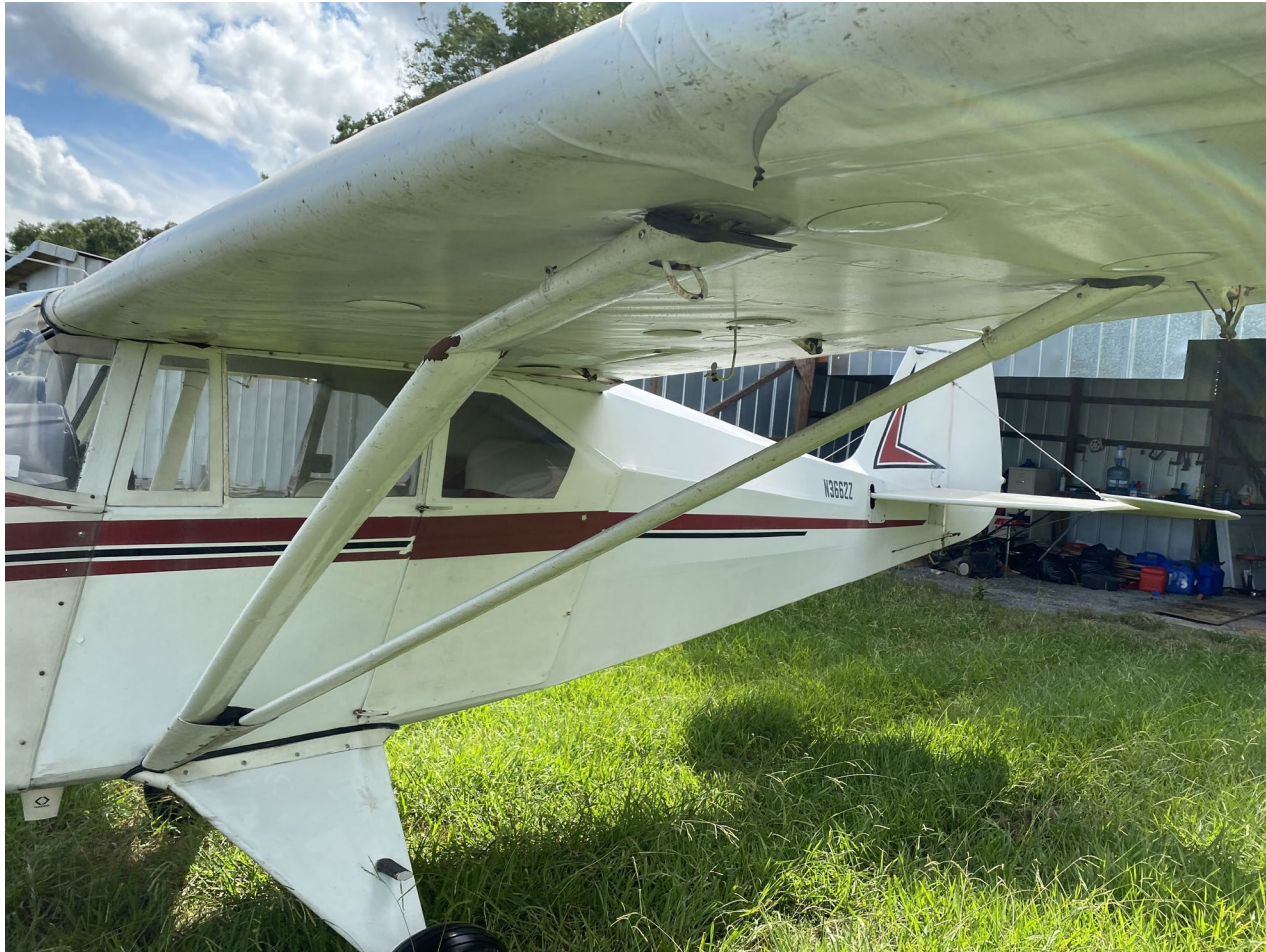
**Photograph 1 - Damaged left wing strut. (Courtesy of FAA)**

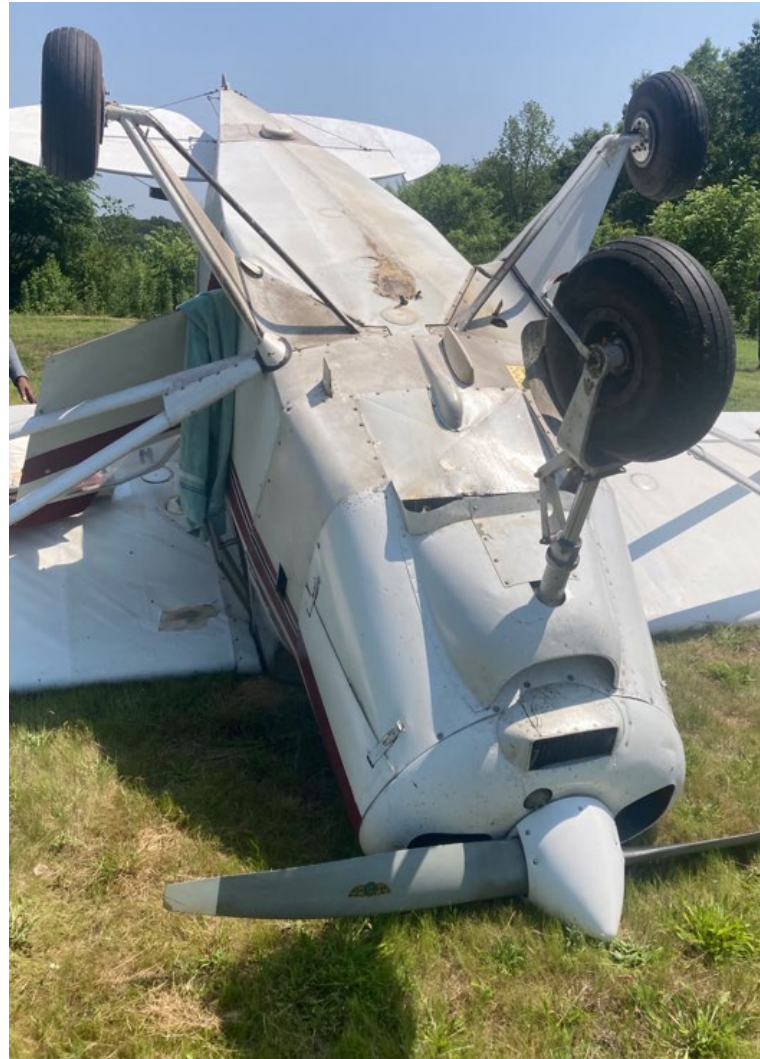
**Photograph 2 - View of airplane damage at accident site before recovery. (Courtesy of FAA)**

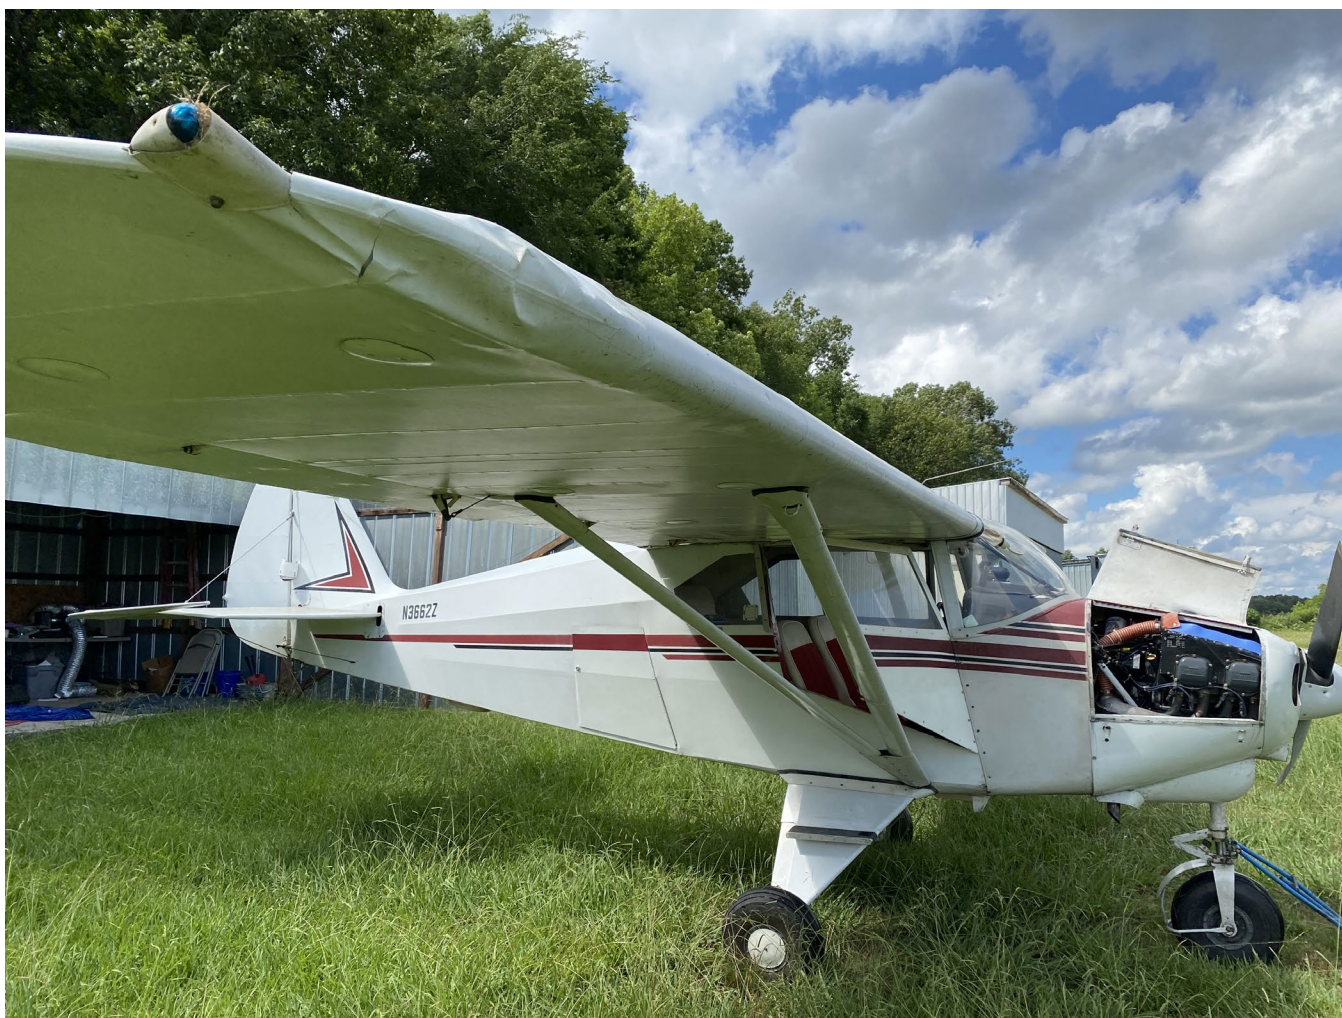
**Photograph 3 - Right wing damage (Courtesy of FAA)**
