ERA23LA283

## INVESTIGATION PHOTOGRAPHS

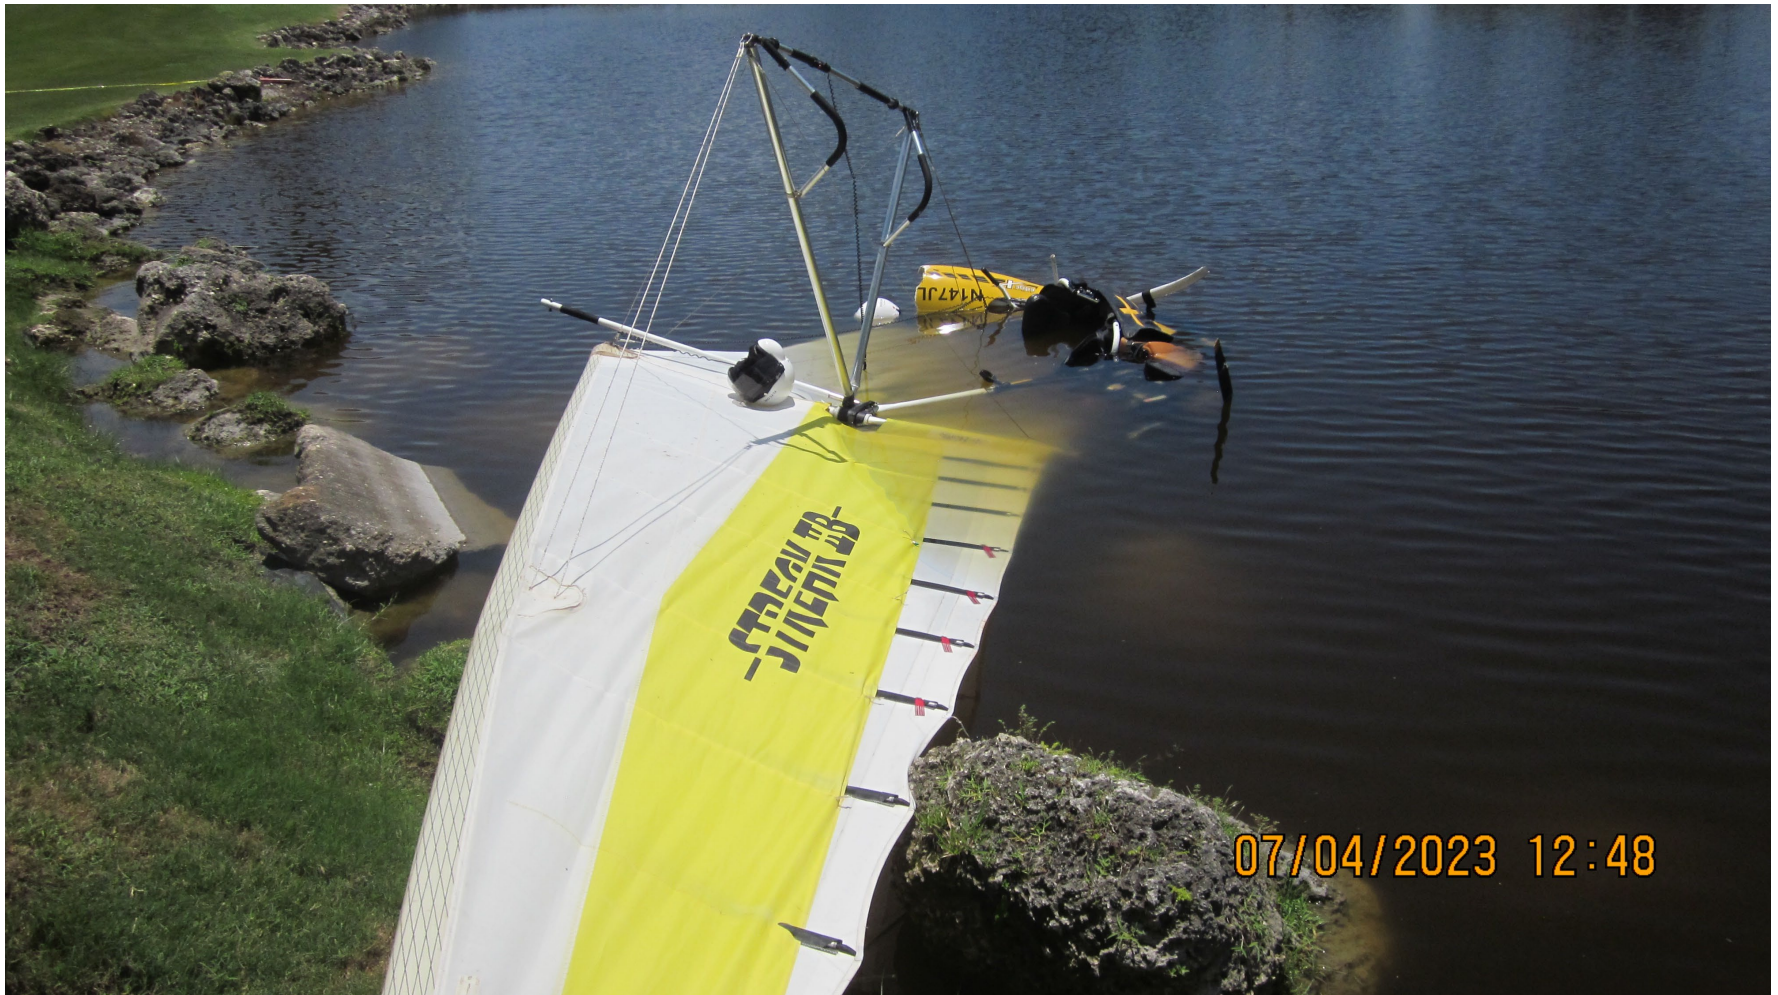
**Photograph 1 - View of aircraft at rest (Courtesy of FAA Inspector)**

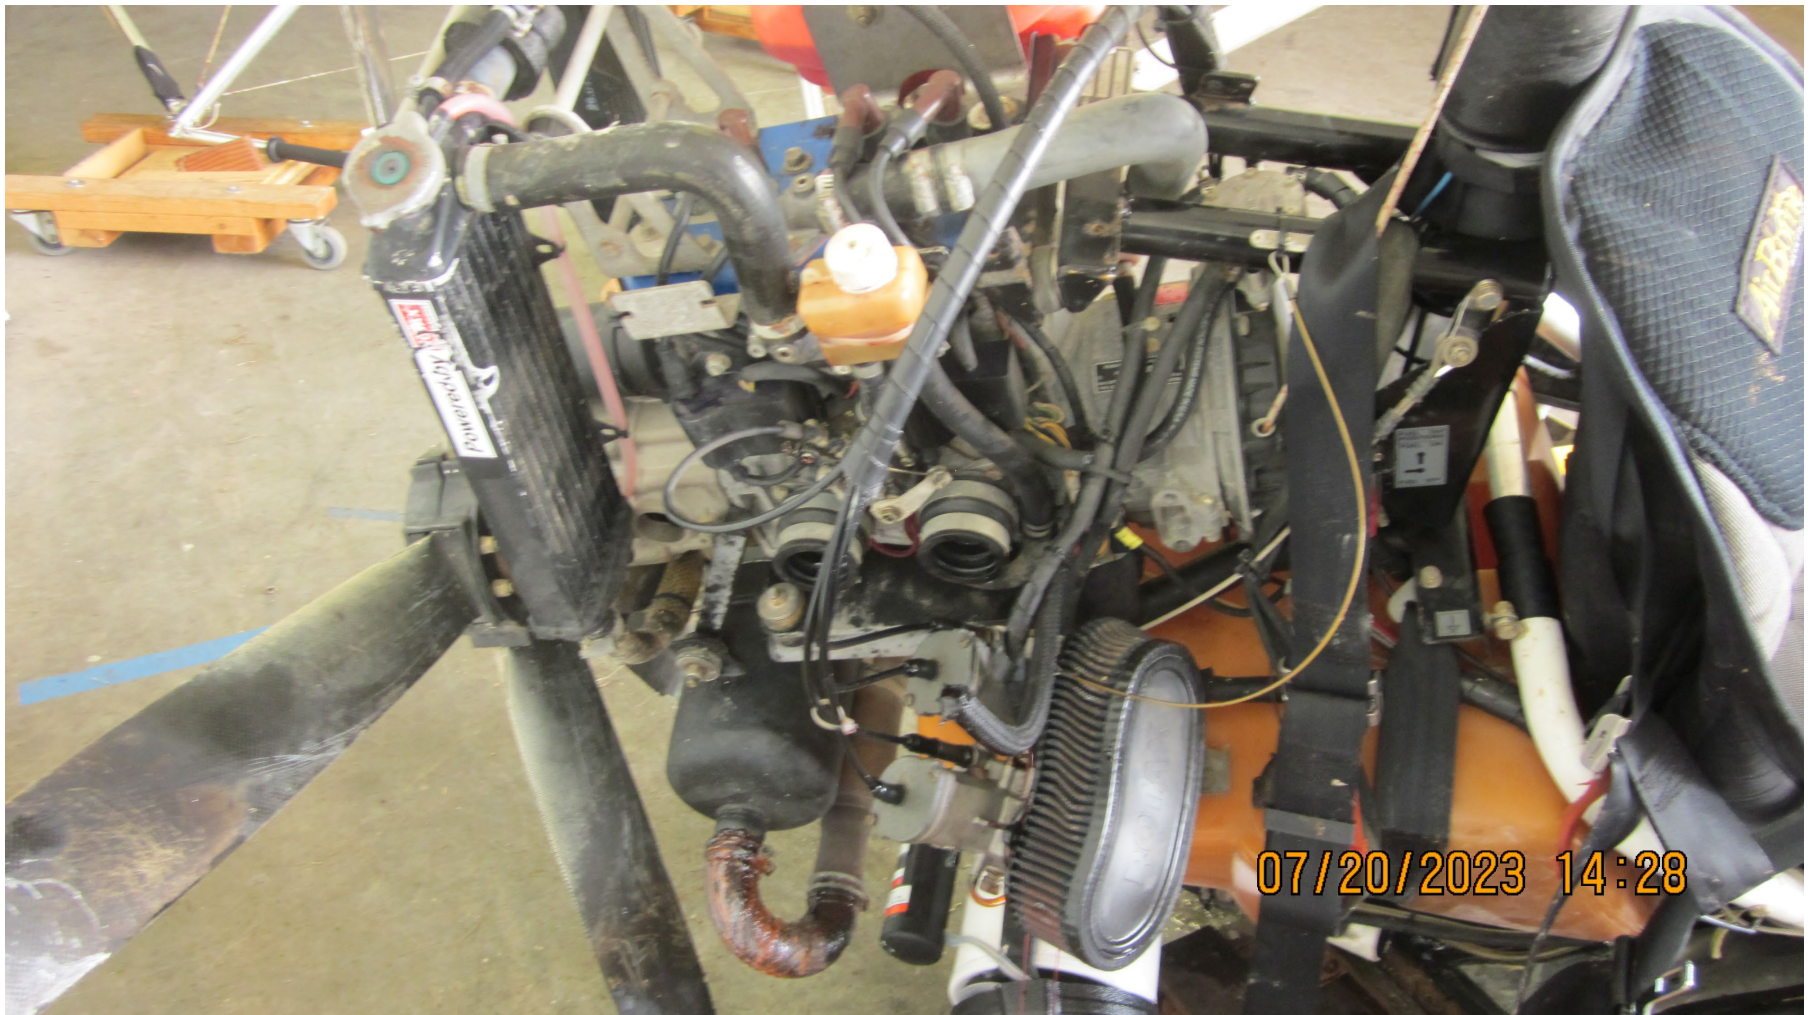
**Photograph 2 - View of Engine (Courtesy of FAA Inspector)**

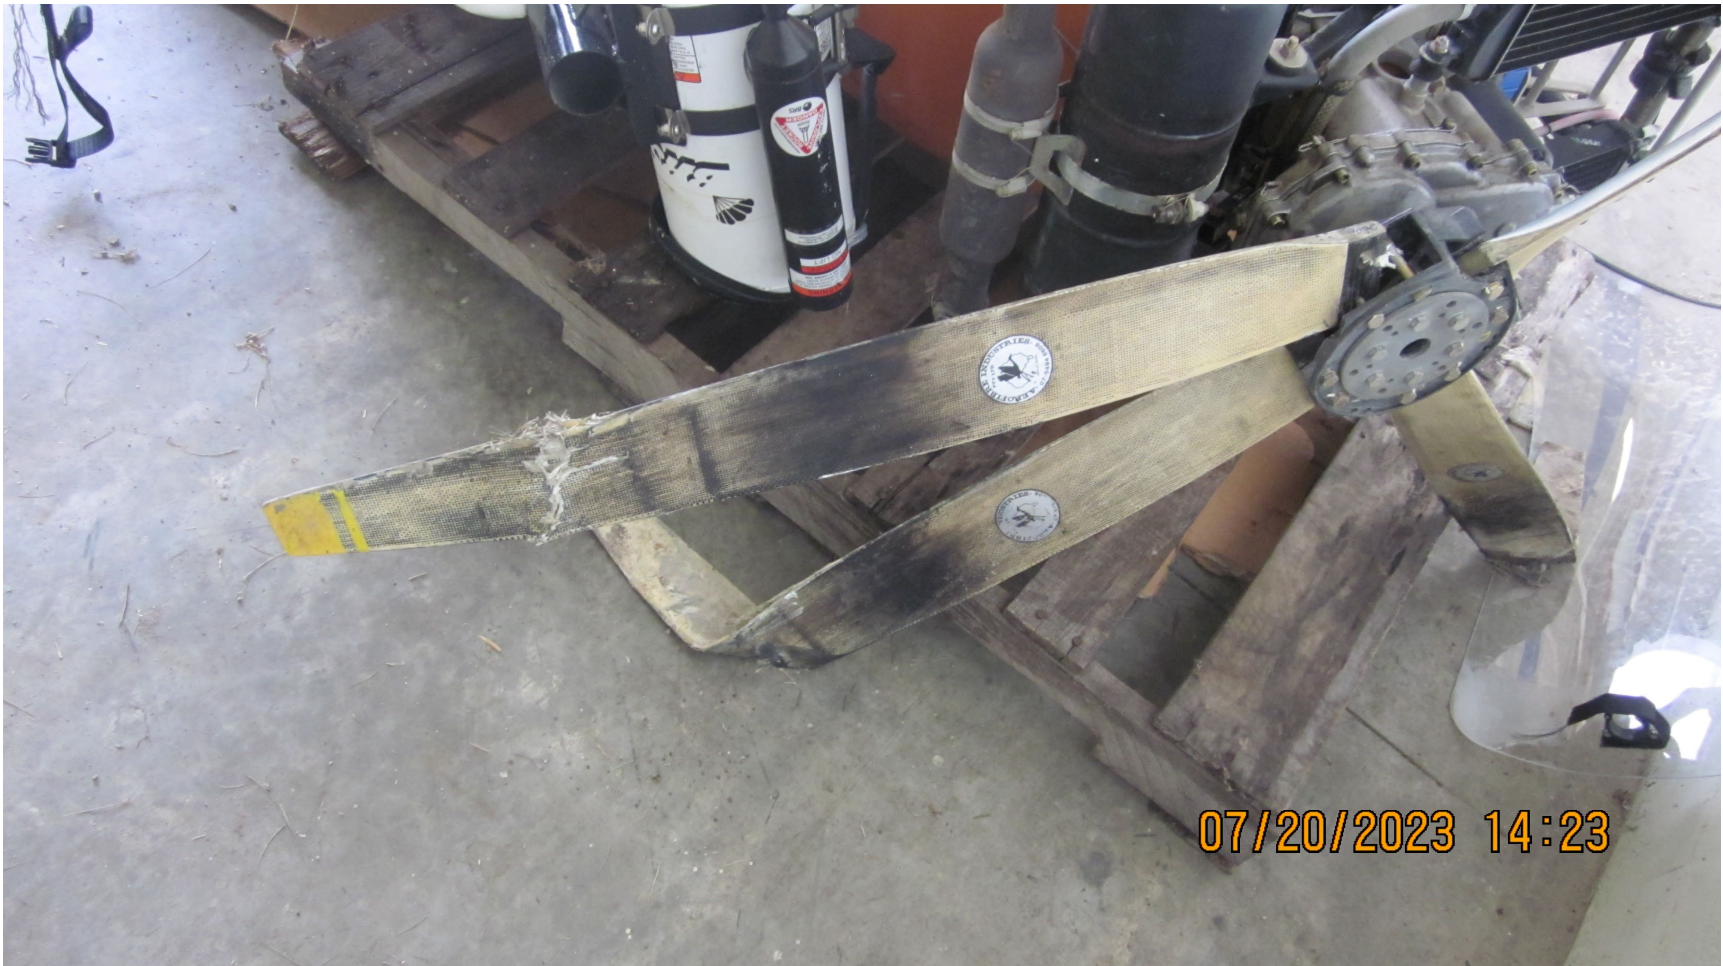
**Photograph 3 - View of propeller blades (Courtesy of FAA Inspector)**
