# National Transportation Safety Board

ERA23LA285

## **MATERIALS LABORATORY**

Factual Report 23-104

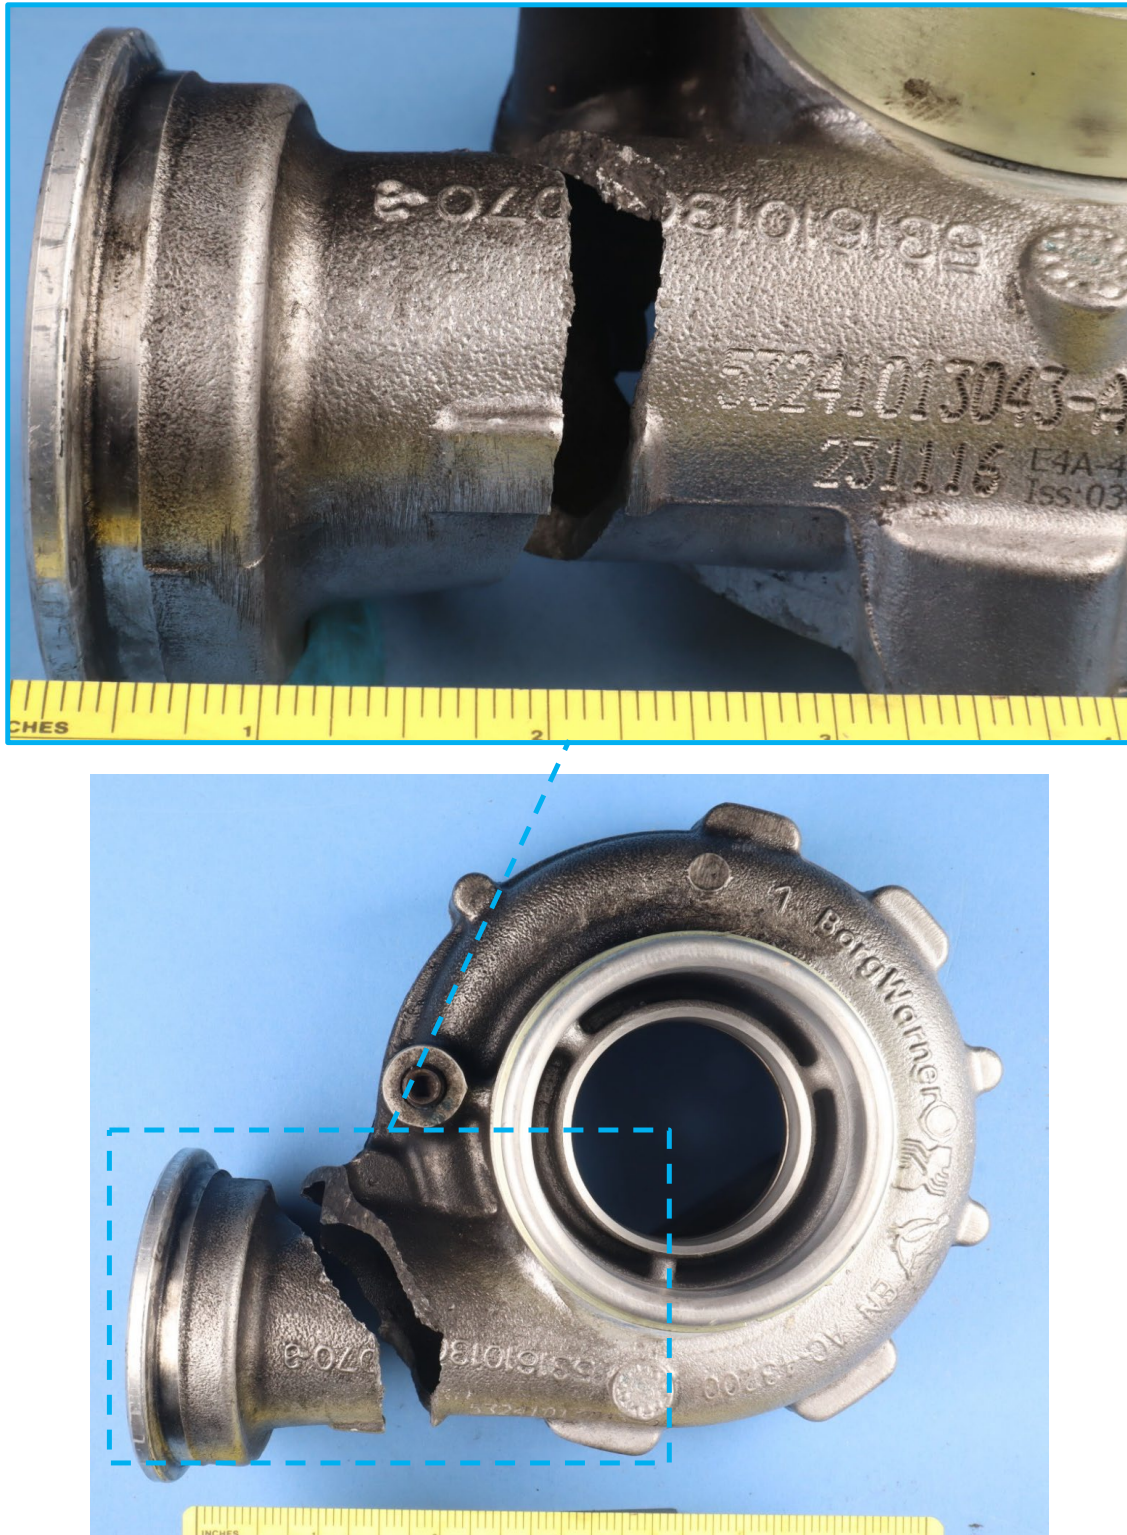
The air outlet flange had separated from the housing, as shown in Figure 1. The fracture was relatively straight on the outboard side, before proceeding at an angle following the curve of the housing outer diameter. The mating fracture surfaces are shown in Figure 2 with the straight portions indicated by white brackets.

**Figure 1.** Overall (bottom) and close-up (top) photos of the separated air outlet flange on the submitted turbo charger induction housing.

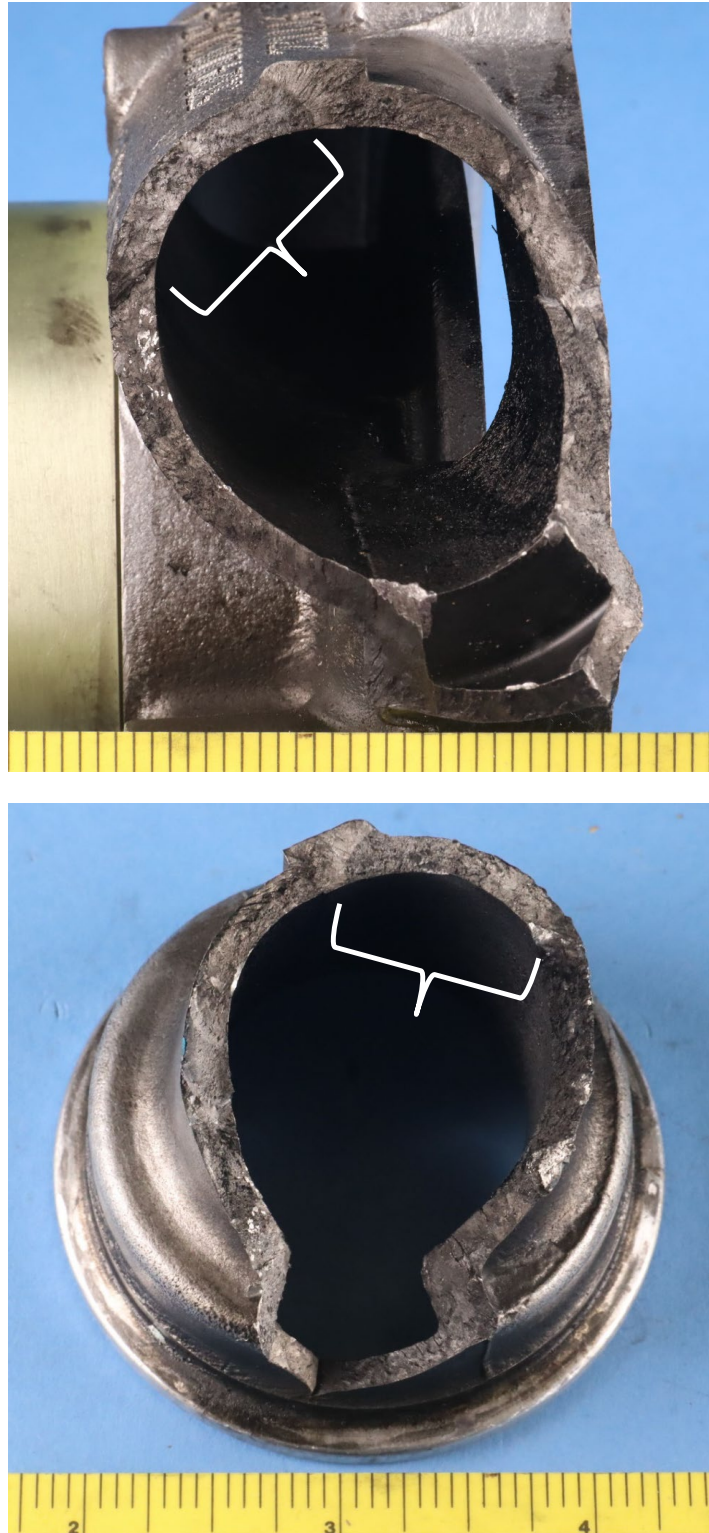
**Figure 2.** Close-up photos of the mating housing fracture surfaces with the straight portions indicated by white brackets.

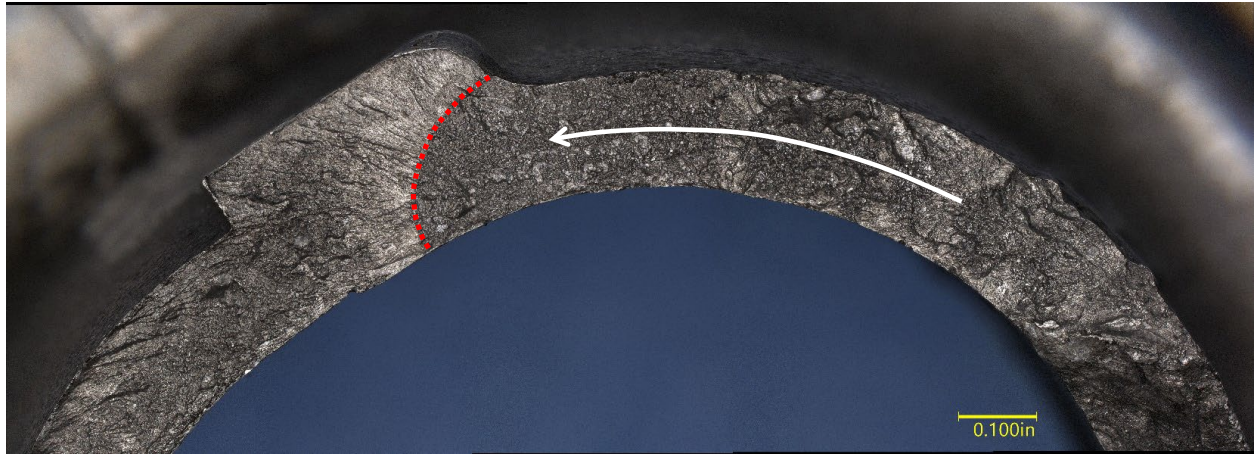
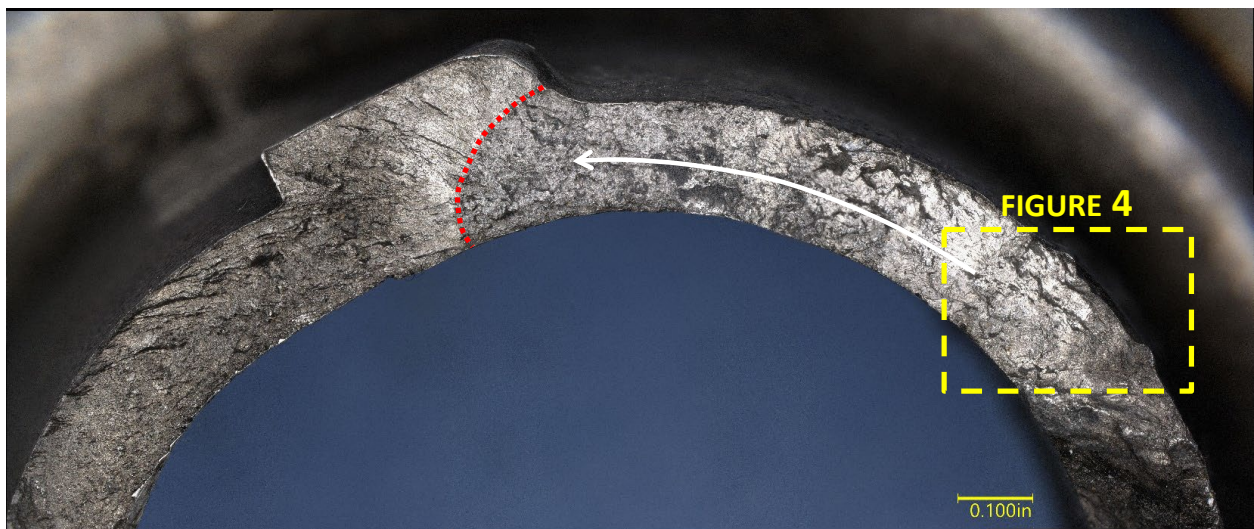
Digital microscope images of the fracture surface on the separated flange piece are shown in Figures 3 and 4. The top image in Figure 3 shows the appearance of the fracture surface as-received, while the bottom image shows the appearance after cleaning with mild detergent and then immersed in an ultrasonic methanol bath. The macro features of the straight portion of fracture surface were consistent with fatigue cracking. The fatigue cracking emanated from the outer surface of the housing and proceeded circumferentially until the red dotted line. Steps on the fracture surface (yellow arrows, Figure 4) indicate fatigue cracking on multiple planes had coalesced into one main fatigue crack. The remainder of the fracture surface had macro features consistent with overstress.

**Figure 3.** Digital microscope images of the fracture surface on the flange piece before (top) and after (bottom) cleaning. The white arrows and red dotted lines indicate the direction and end of fatigue crack propagation, respectively.

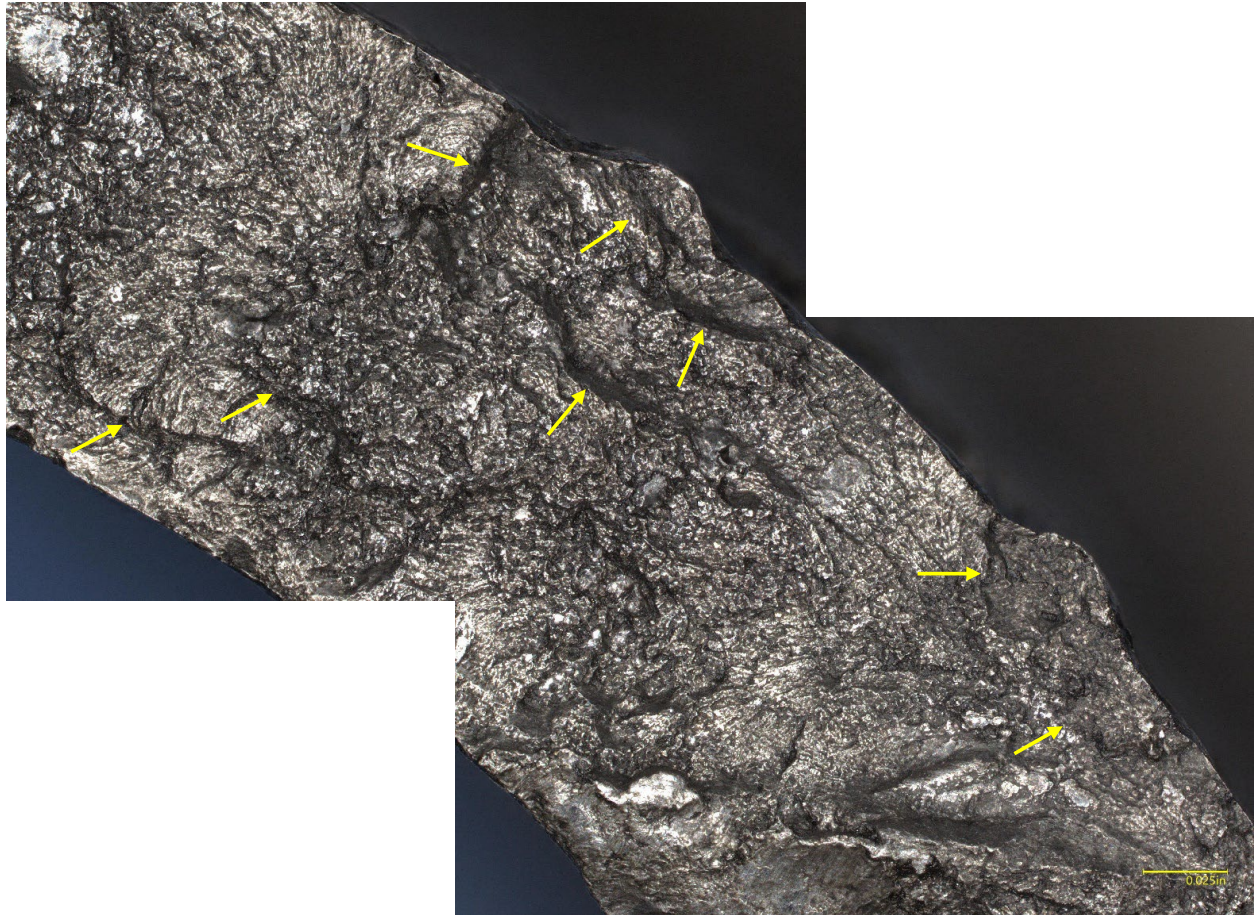
**Figure 4.** Digital microscope image of the fracture surface on the flange piece with yellow arrows pointing to steps on the fracture surface.

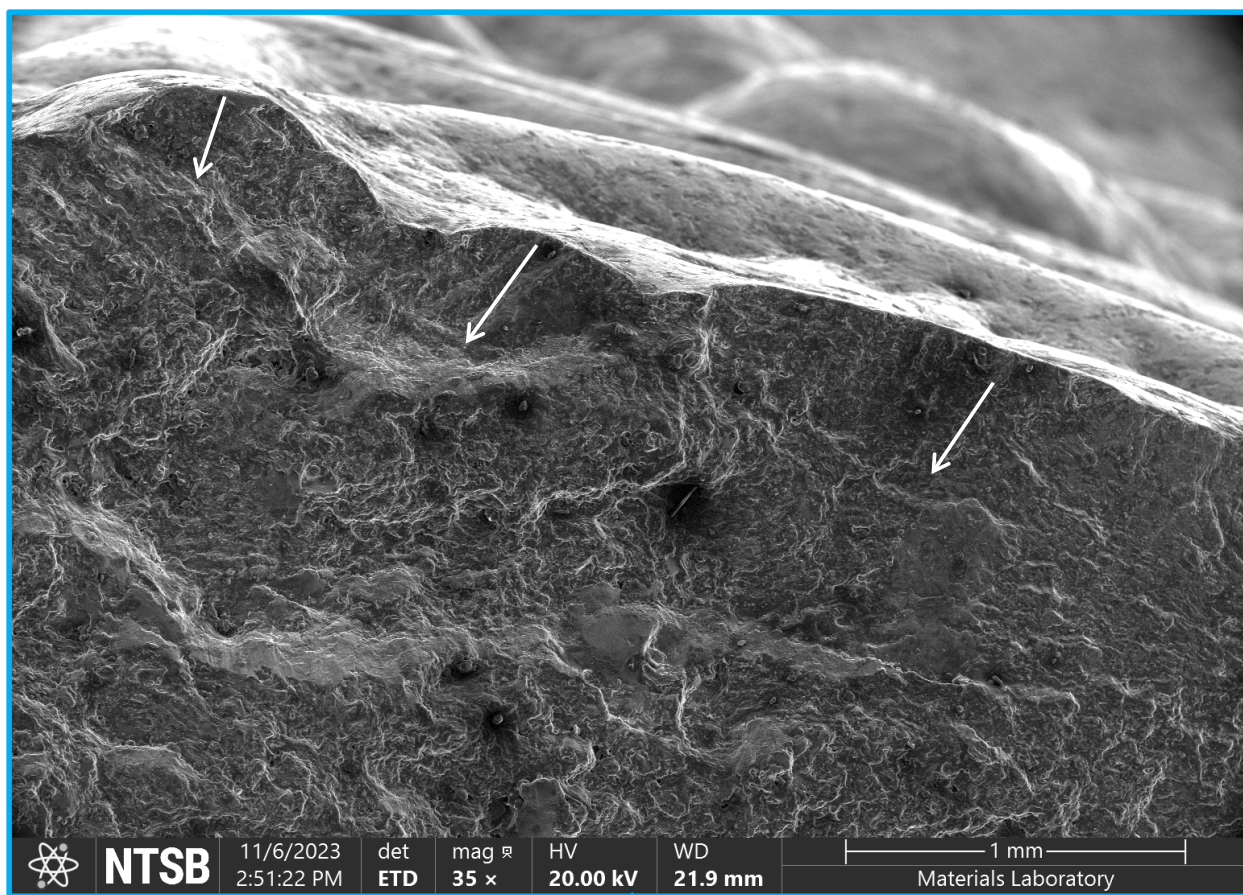
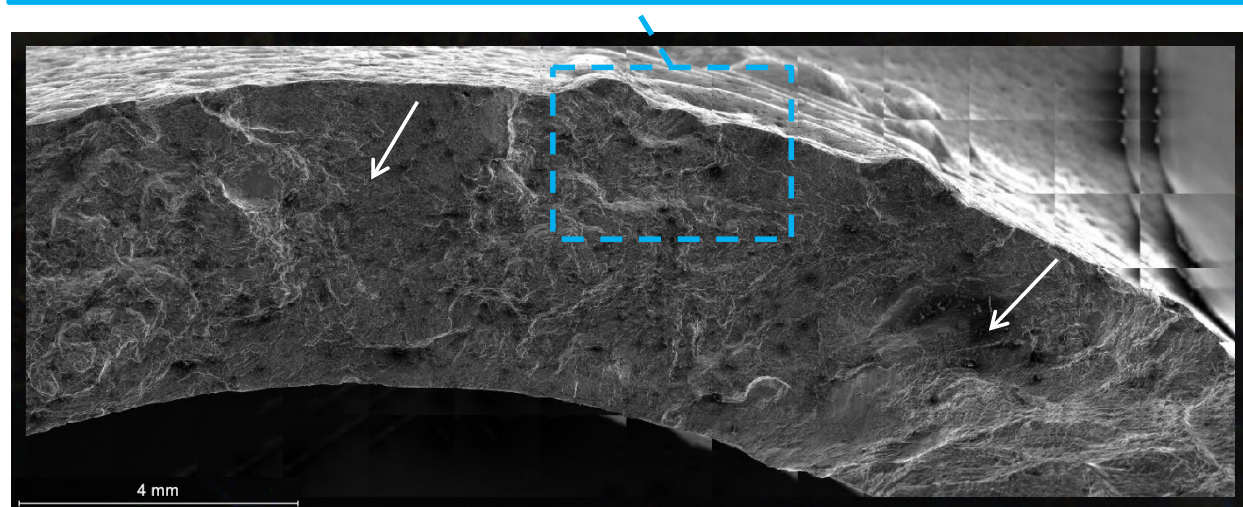
The cleaned flange piece fracture surface was examined using a Thermo Scientific Apreo 2 field emission scanning electron microscope (SEM). SEM images of the fracture surface are shown in Figures 5 and 6. Progressive crack arrest marks consistent with fatigue were observe in the straight area on the fracture surface. The

crack arrest marks emanated from the outer surface of the housing in multiple locations. The white arrows indicate the direction of propagation of several of the cracks emanating from the outer surface. The remainder of the fracture surface had ductile dimple features consistent with overstress.

**Figure 5.** Secondary electron SEM images of the fracture surface on the flange piece with white arrows indicating the direction of crack propagation from multiple fatigue crack initiations.

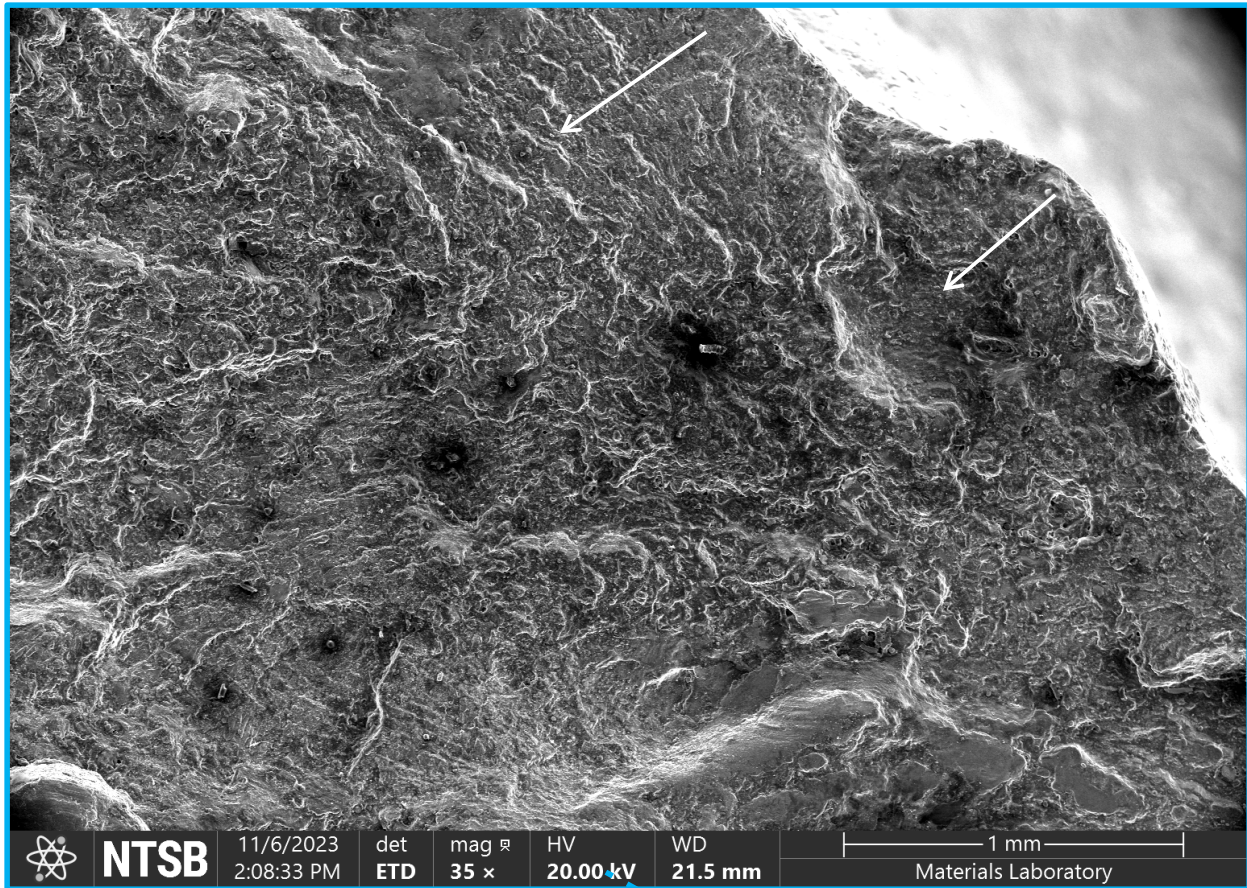
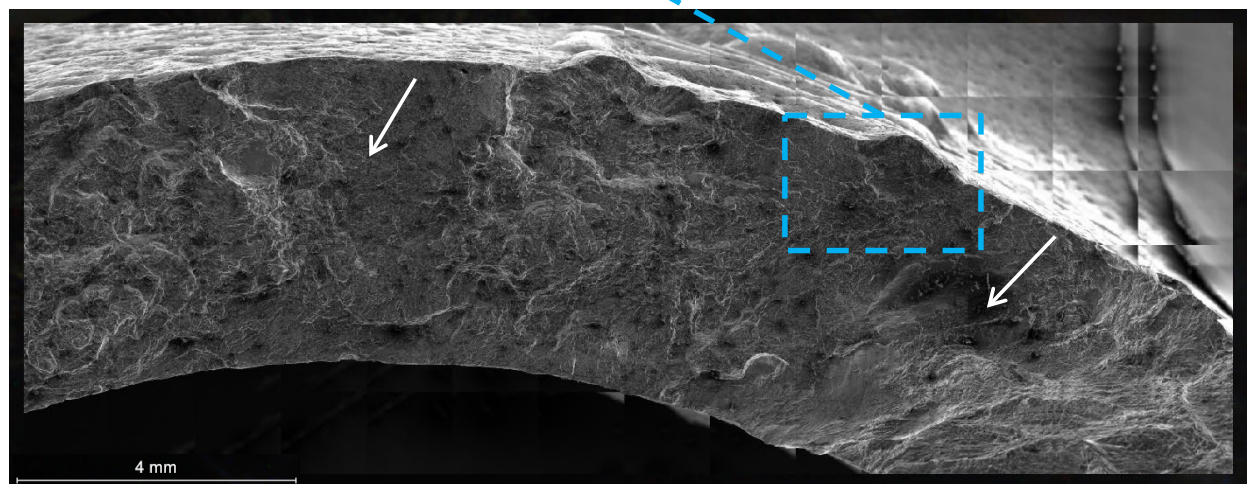
**Figure 6.** Secondary electron SEM images of the fracture surface on the flange piece with white arrows indicating the direction of crack propagation from multiple fatigue crack initiations.

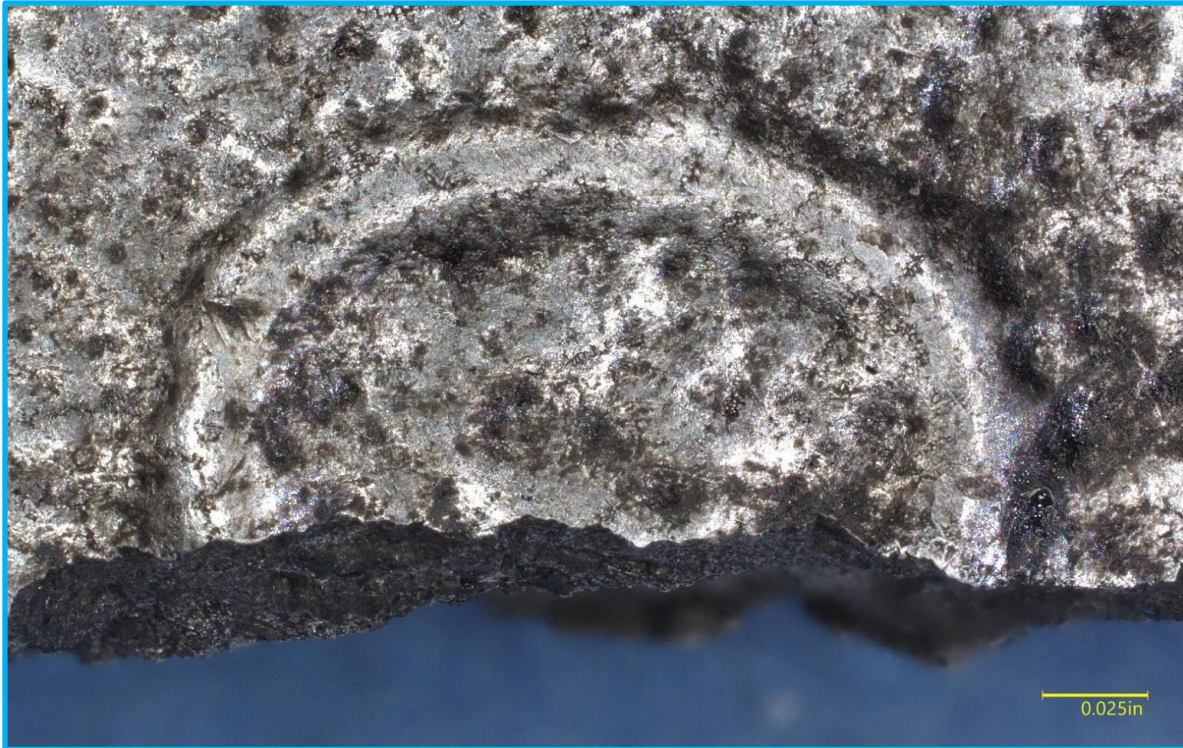
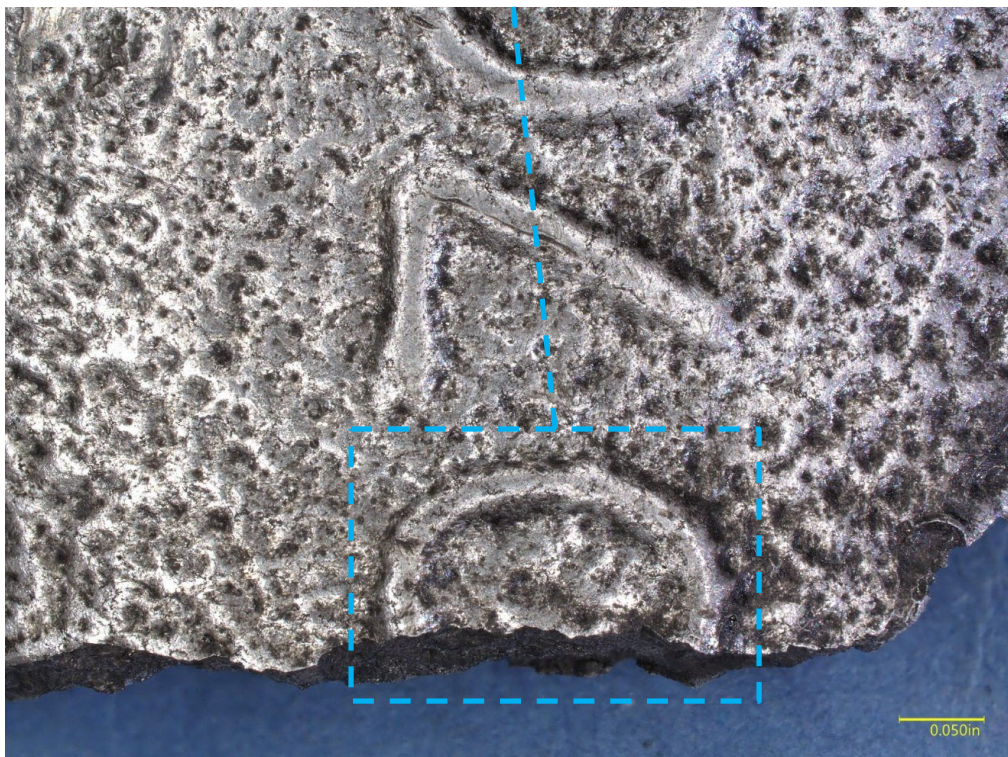
Figure 7 shows digital microscope images of the outer surface on the housing adjacent to the fracture surface. The outer surface had a rough appearance consistent with an as-cast surface. The straight fracture proceeded through the approximate center of a zero digit in the part number that was embossed on the outer surface of the housing casting. Figure 8 shows a comparison of digital microscope images of the housing outer surface and the straight fracture surface. The red dashed lines align the digit features on the two surfaces. Some of the fatigue cracking emanated from the digit features, as well as areas next to the digit. The embossed digit and other raised areas on the rough outer surface of the housing likely acted as stress risers for fatigue crack initiation.

**Figure 7.** Digital microscope images of the outer surface on the housing adjacent to the fracture surface.

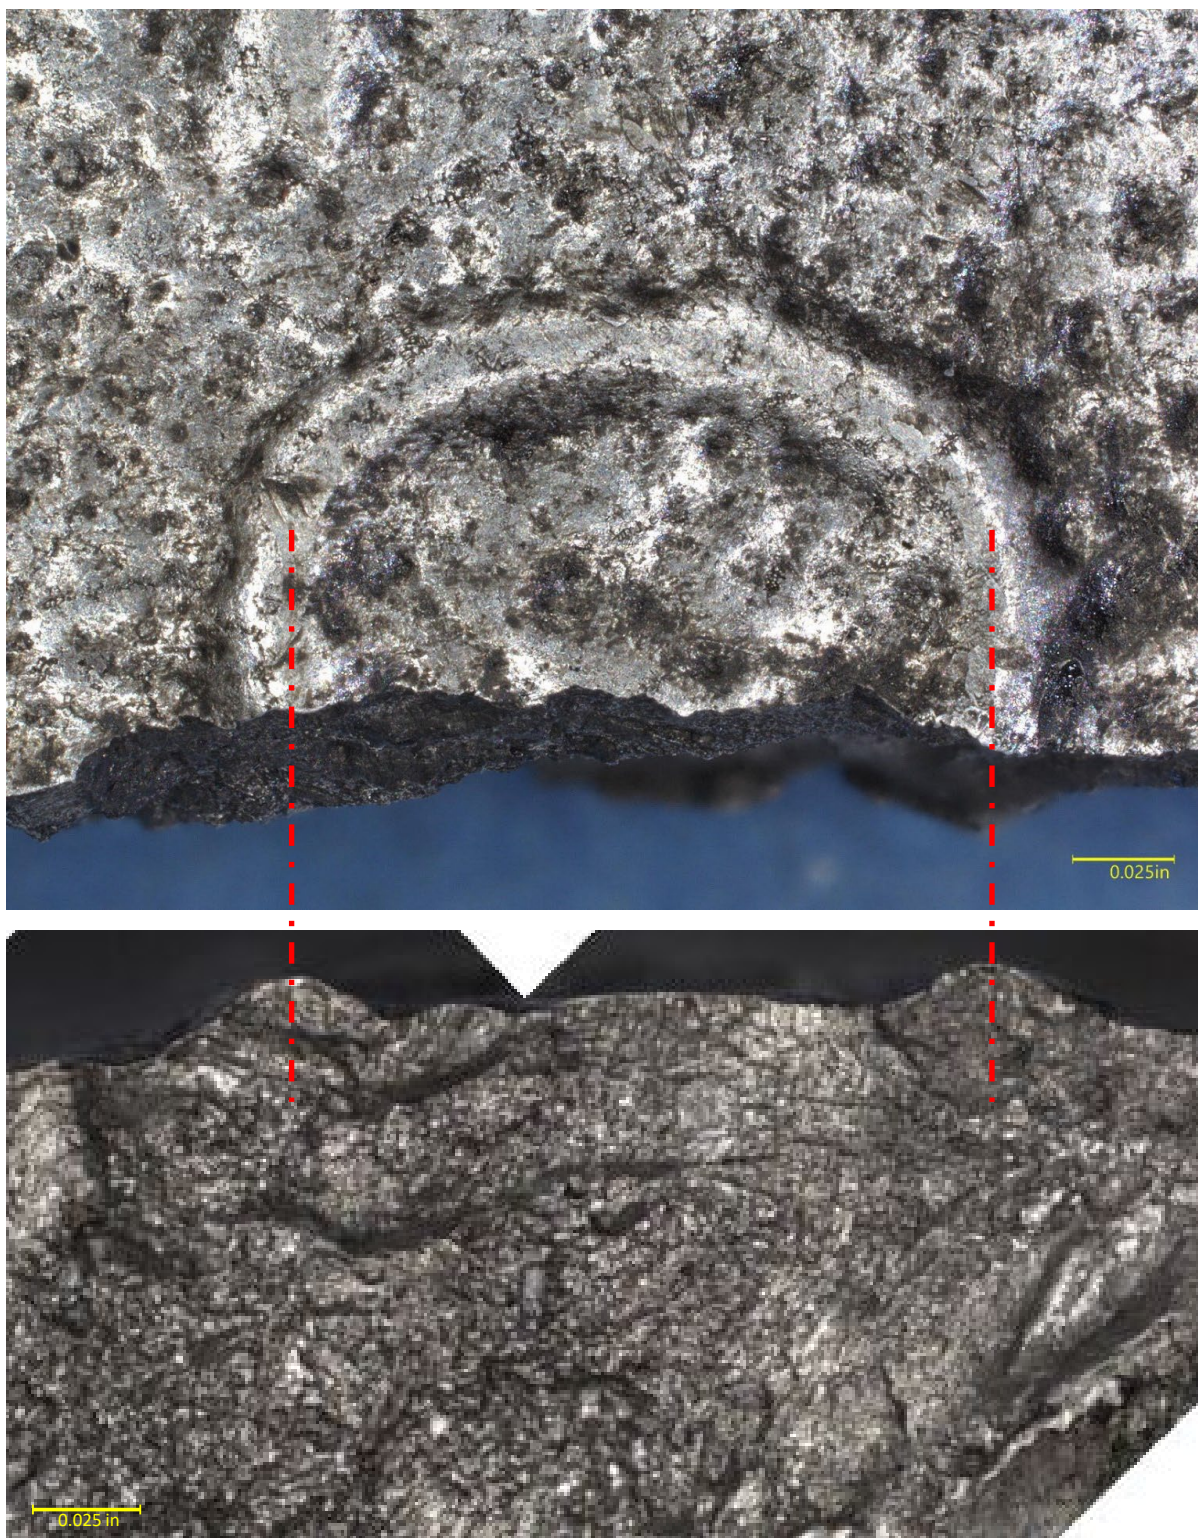
**Figure 8.** Comparison of digital microscope images of the outer surface on the housing adjacent to the fracture surface and the fracture surface. The red dashed lines align the features of the embossed zero digit on the housing surface.
