# National Transportation Safety Board

ERA23LA285

## **WRECKAGE EXAMINATION SUMMARY**

Location: Yorktown Heights, NY  
Date: July 29, 2023  
Time: 1222 EDT  
<Enter HHMM coordinated universal time (UTC)>  
Airplane: Diamond DA40

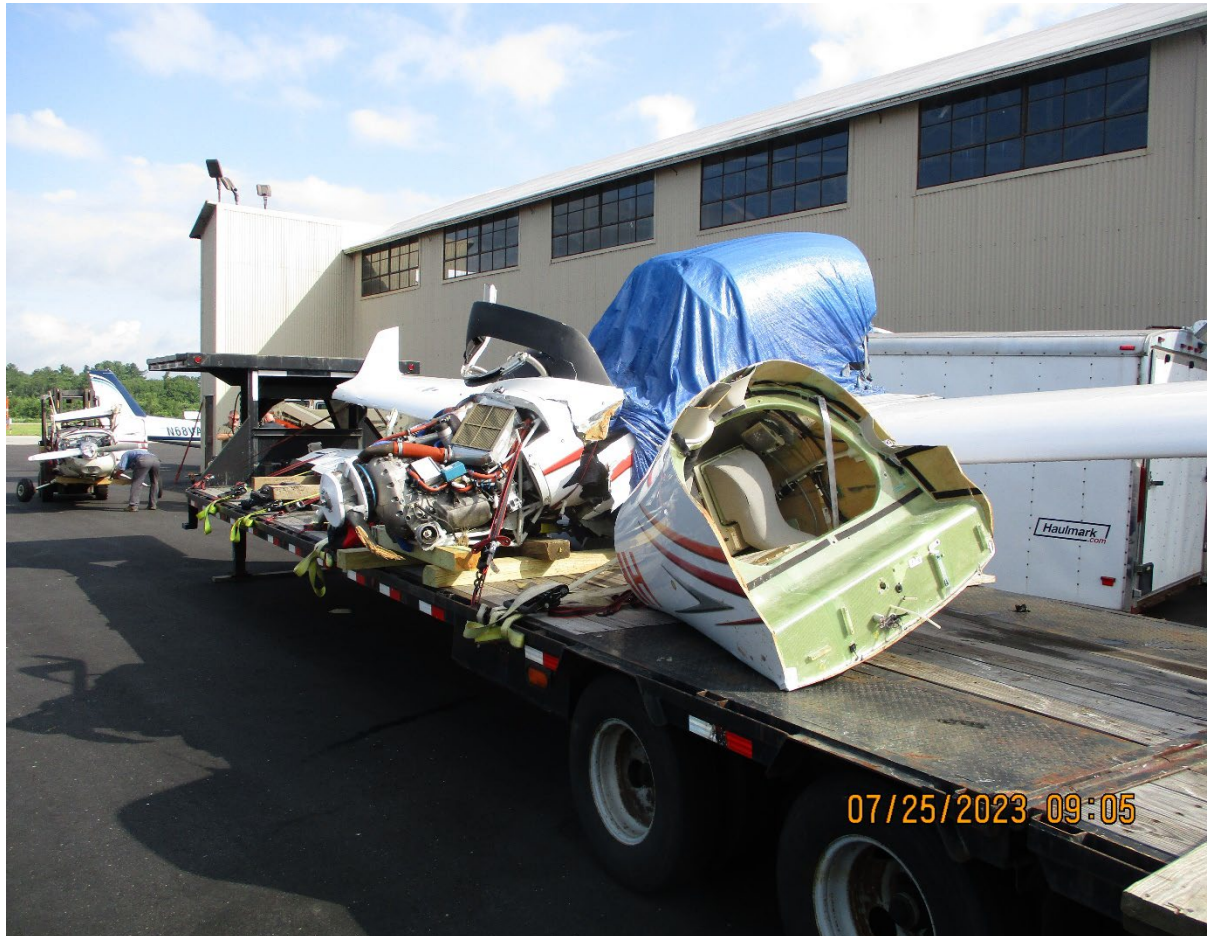
The recovery company cut the tail of the airplane off for transportation. All four corners of the airplane were present on the trailer.

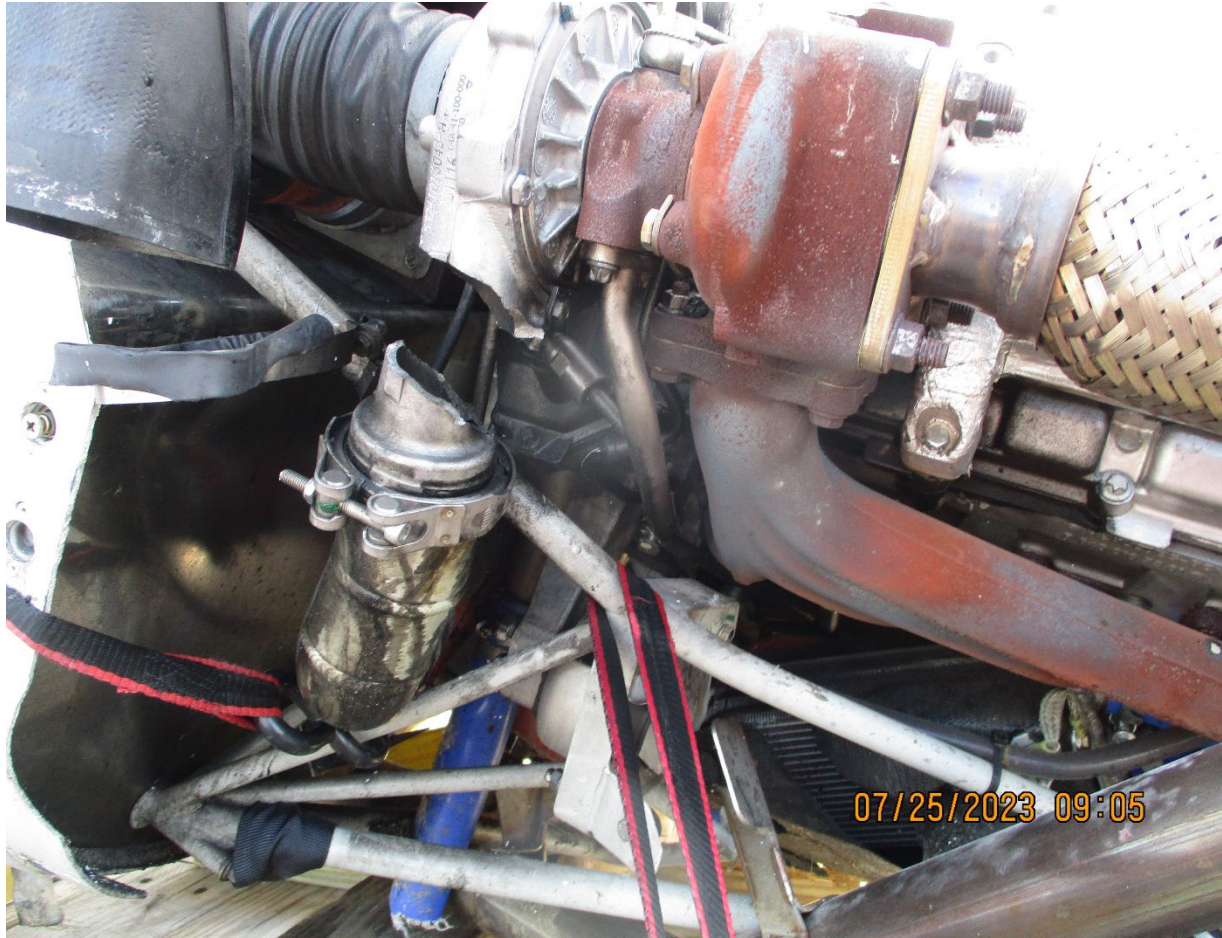
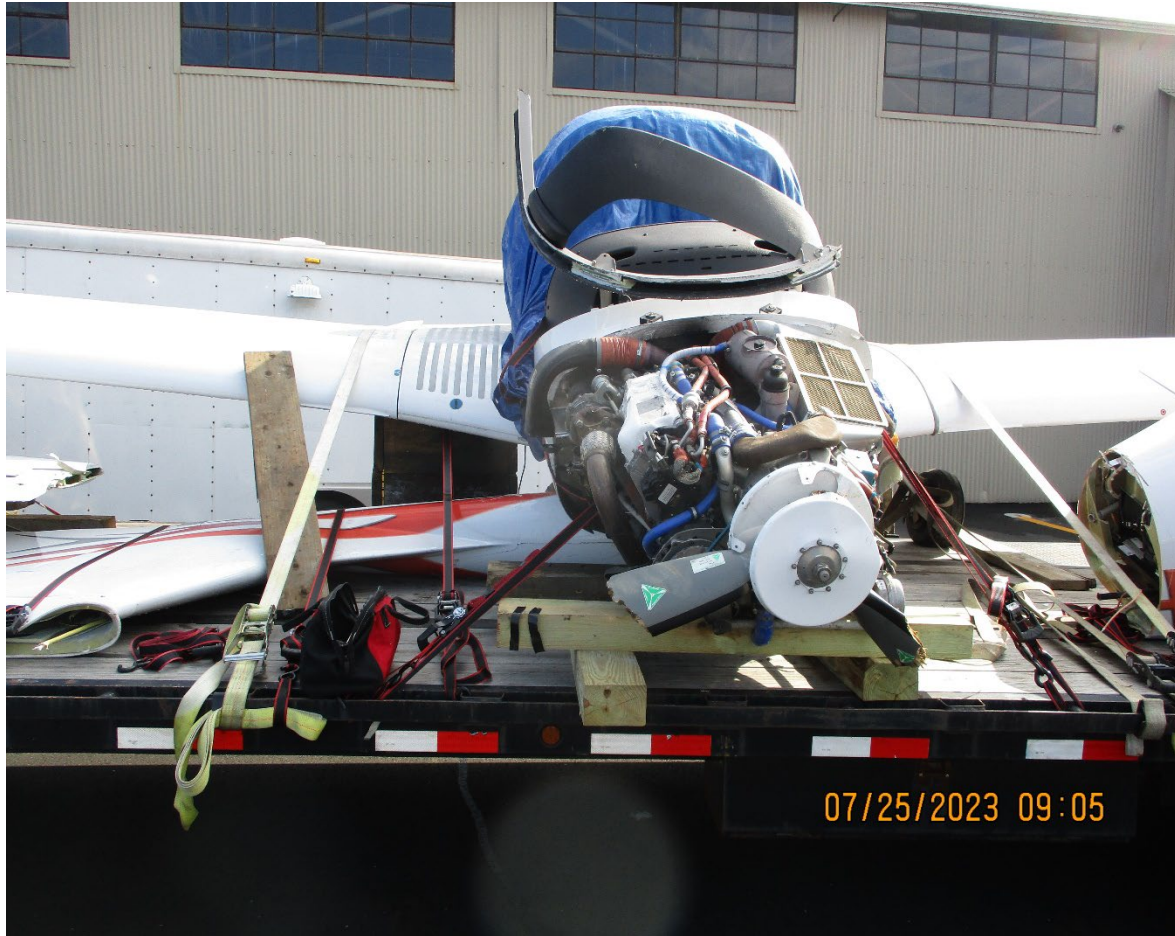
The engine turbo charger induction housing was fractured and showed signs of an existing fracture surface. The turbo charger housing was removed and sent to NTSB materials lab. The propeller blades were all fractured near the hub. The glow plugs were removed and the propeller was rotated by hand, compression could be heard out of the glow plug holes. The engine rotated smoothly and did not reveal any preimpact anomalies.
