ERA23LA285

## INVESTIGATIVE PHOTOS

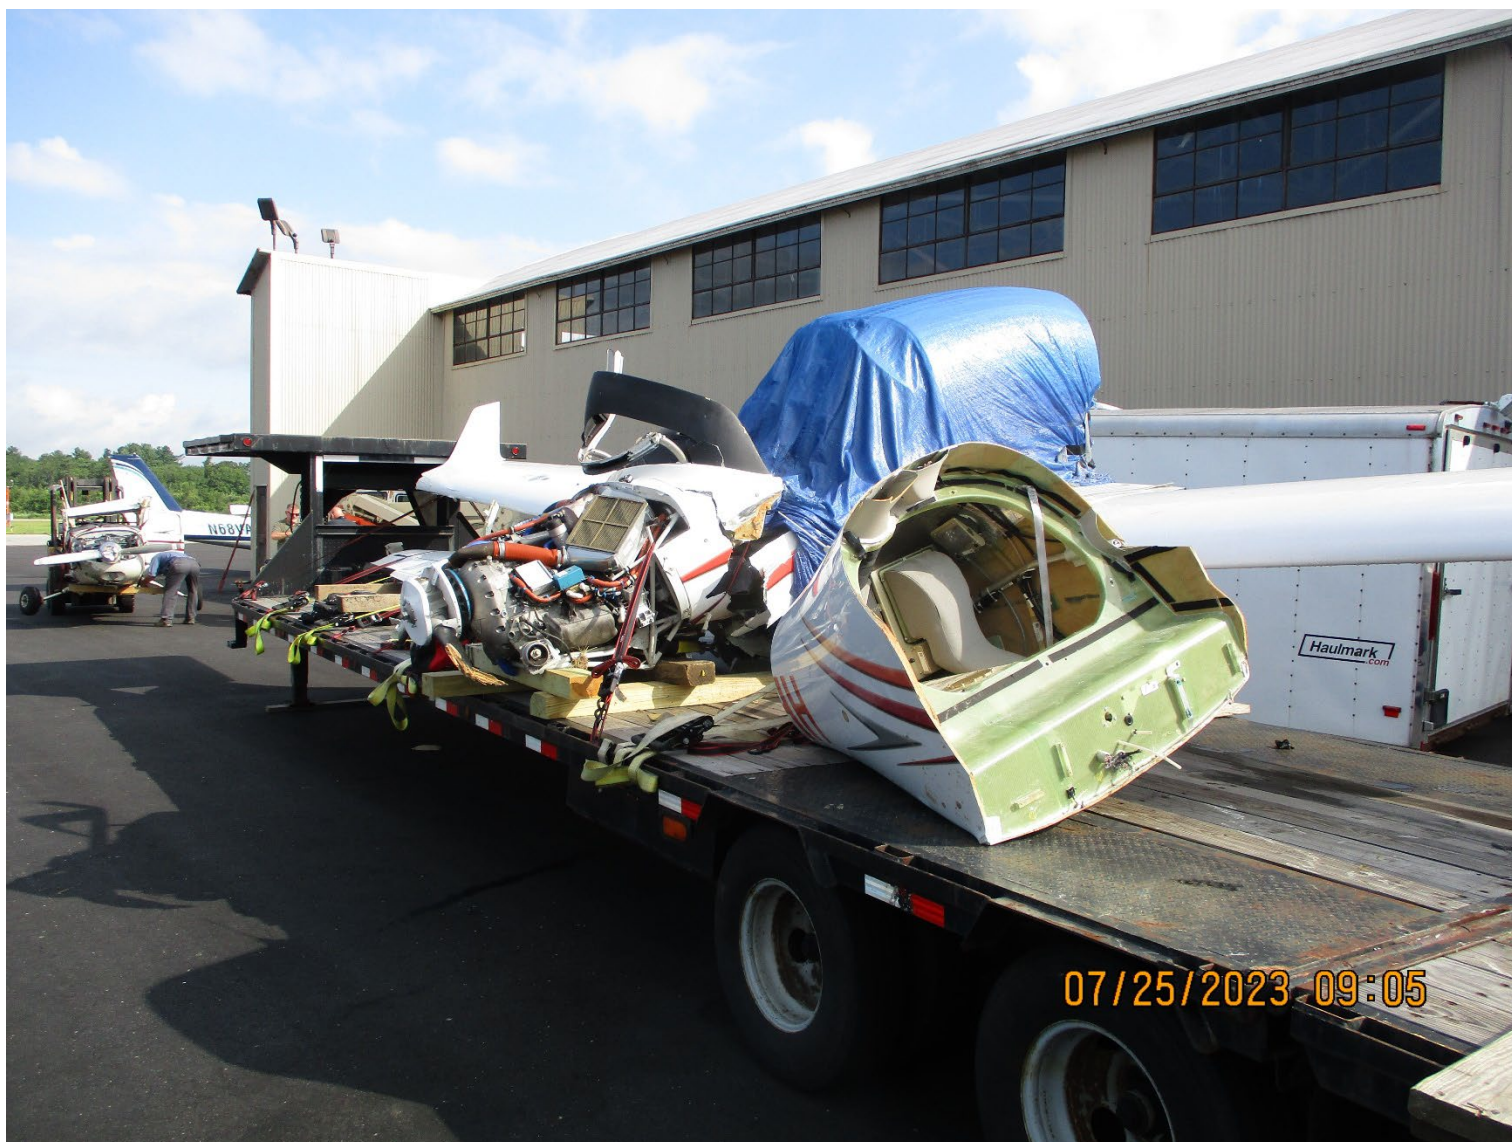
**Photograph 1 - main wreckage on trailer**

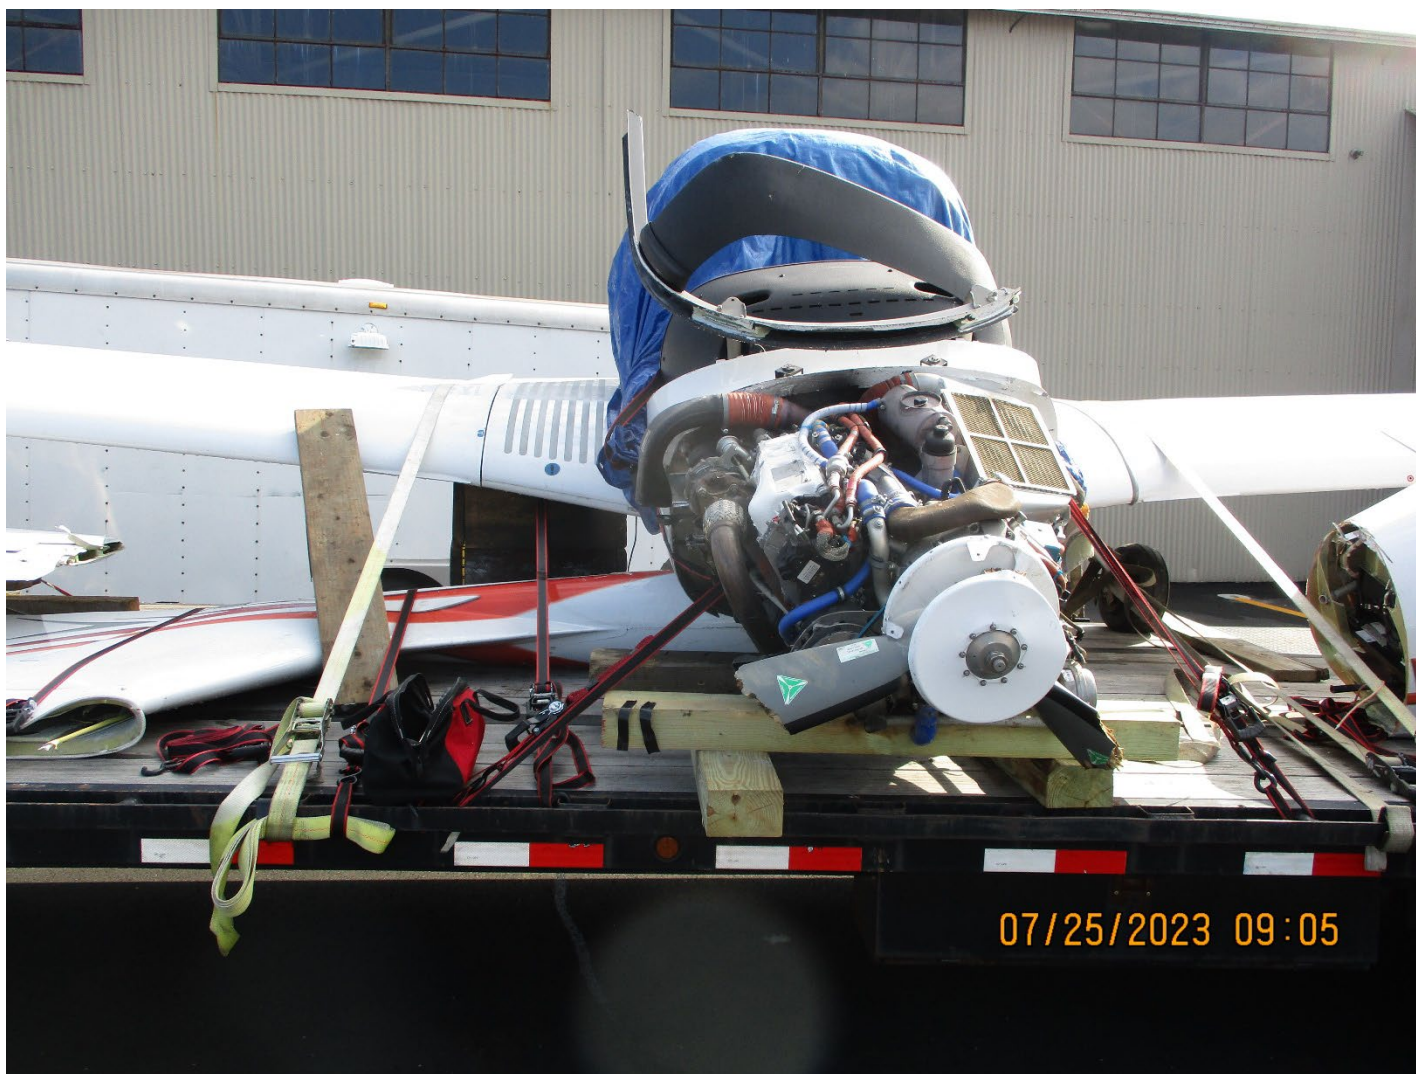
**Photograph 2 - airplane on trailer by recovery company**

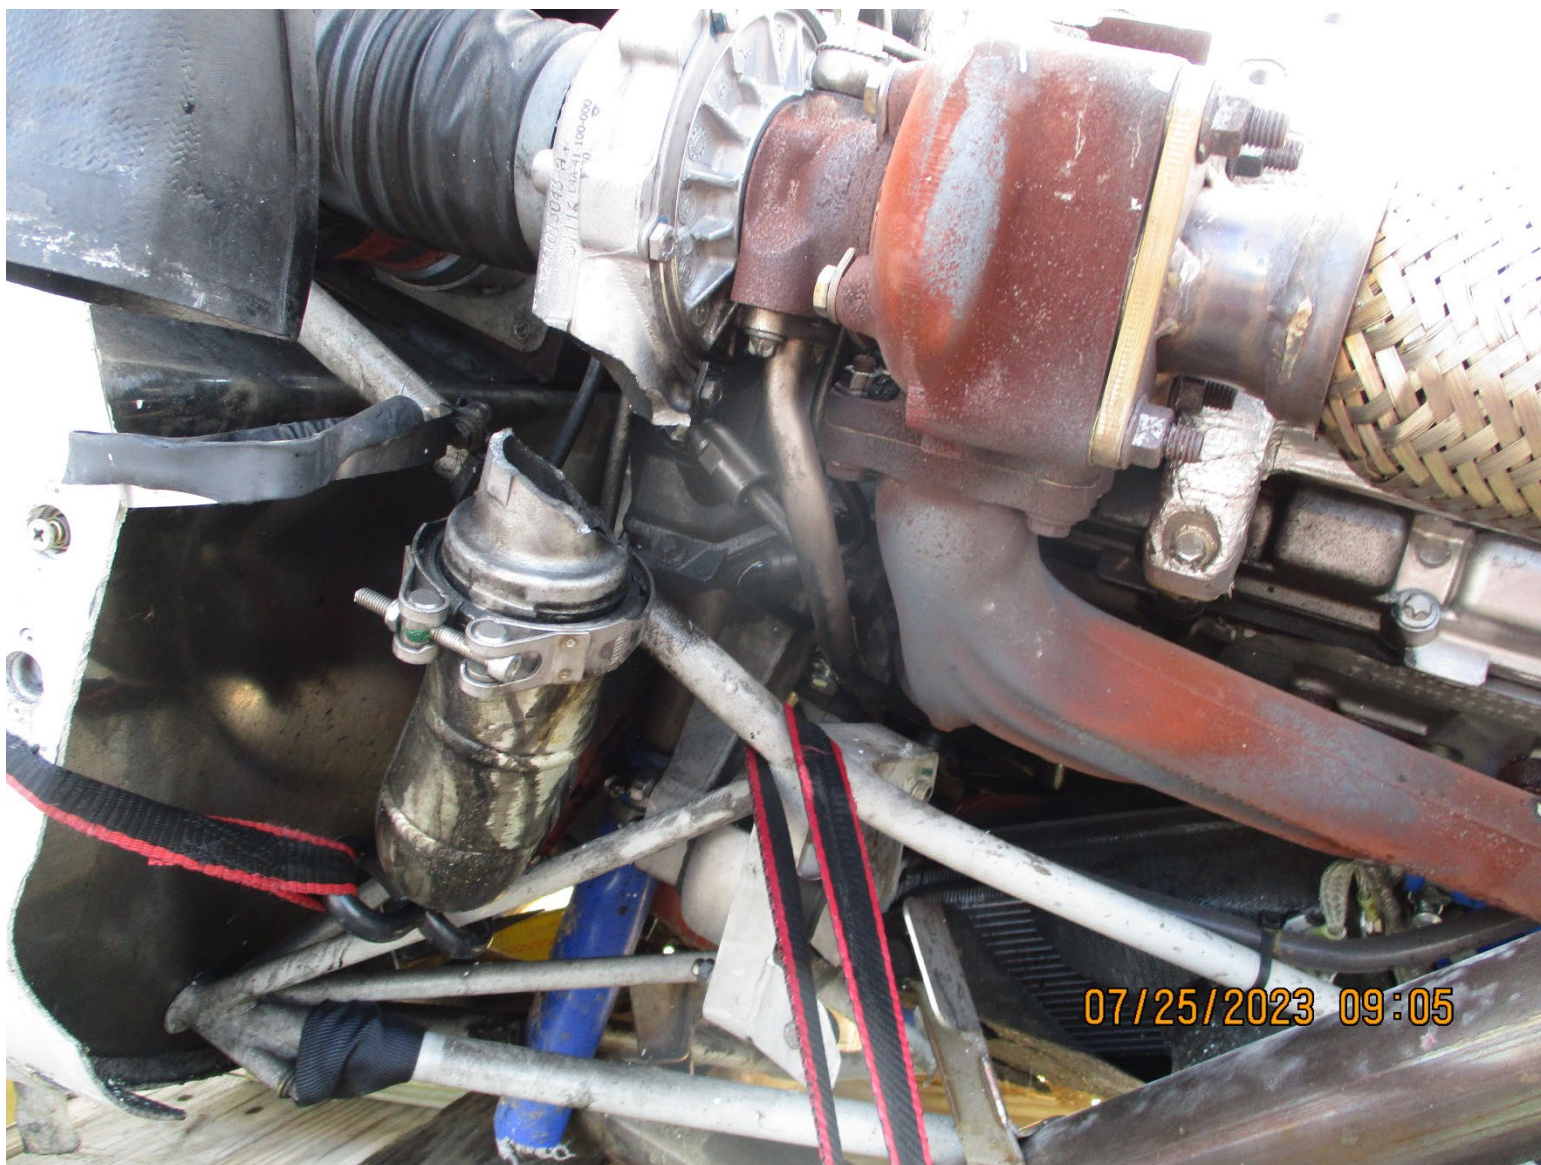
**Photograph 3 - Turbo charger fractured.**
