**Subject:** ERA23LA286, Record of Conversation/Interview

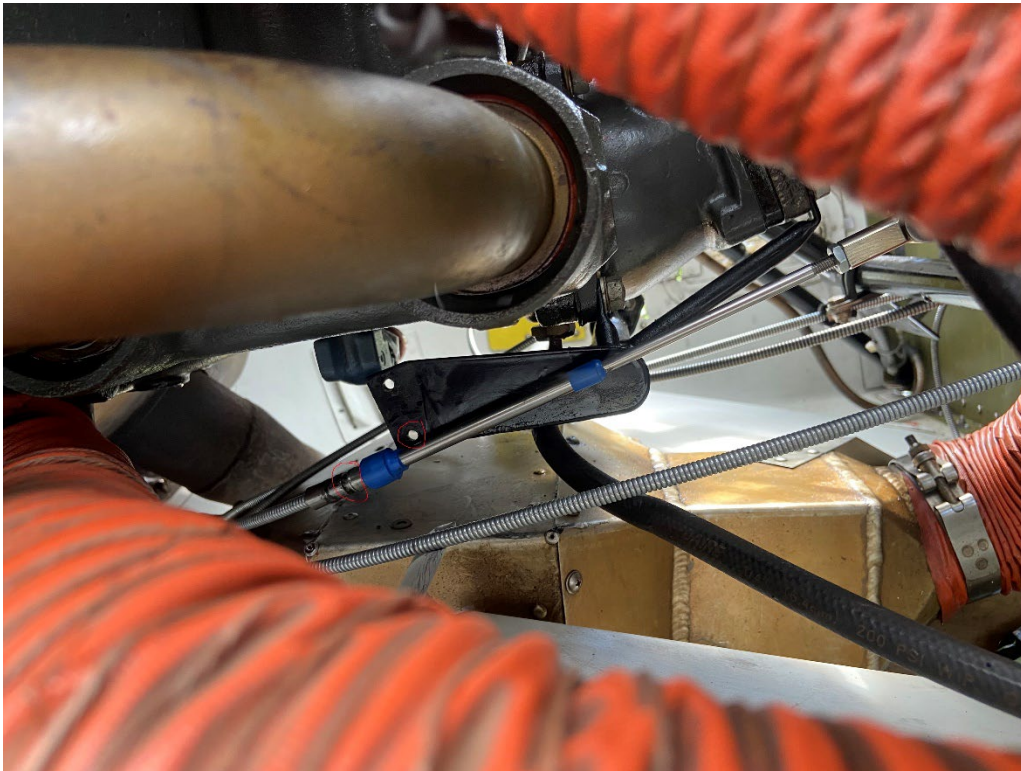
Inspector Hudgins reported that during his inspection of the engine compartment of N26387, he found the throttle cable outer housing unsecured in the engine compartment (Figure 1) which allowed the entire cable assembly to “shift fore and aft.” Movement of the throttle control in the cockpit did not result in movement of the throttle control lever at the fuel servo which rendered throttle control “ineffective.” The clamp was not located during the inspection.

Figure 1: FAA Annotated Digital Photograph. View of the engine compartment showing the unsecured throttle control cable outer housing. The red circles denote where the cable outer housing is required to be clamped.

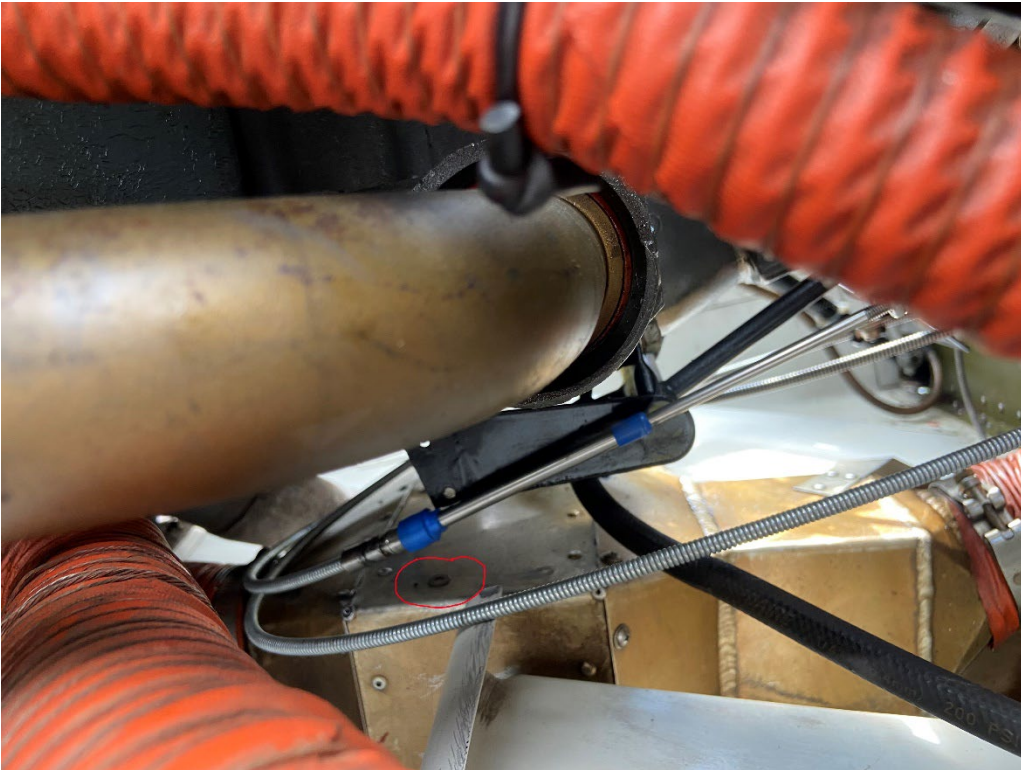
He noted that the airplane Illustrated Parts Catalog (IPC) specified that the throttle cable outer housing was specified to be clamped to a “shim” part number (P/N) MT-969 near the carburetor by a stamped steel design “clamp” P/N 160-A2, and secured by two (2) MS35207-264 screws (Attachment 1). The inspector did note one loose washer on top of the airbox (Figure 2).

Figure 2: FAA Annotated Digital Photograph. View of the engine compartment showing the unsecured throttle control cable outer housing. The red circle denote the recovered single flat washer.
