**NTSB ERA23LA291**

PR-ZVL, Volato 400

Photo Array

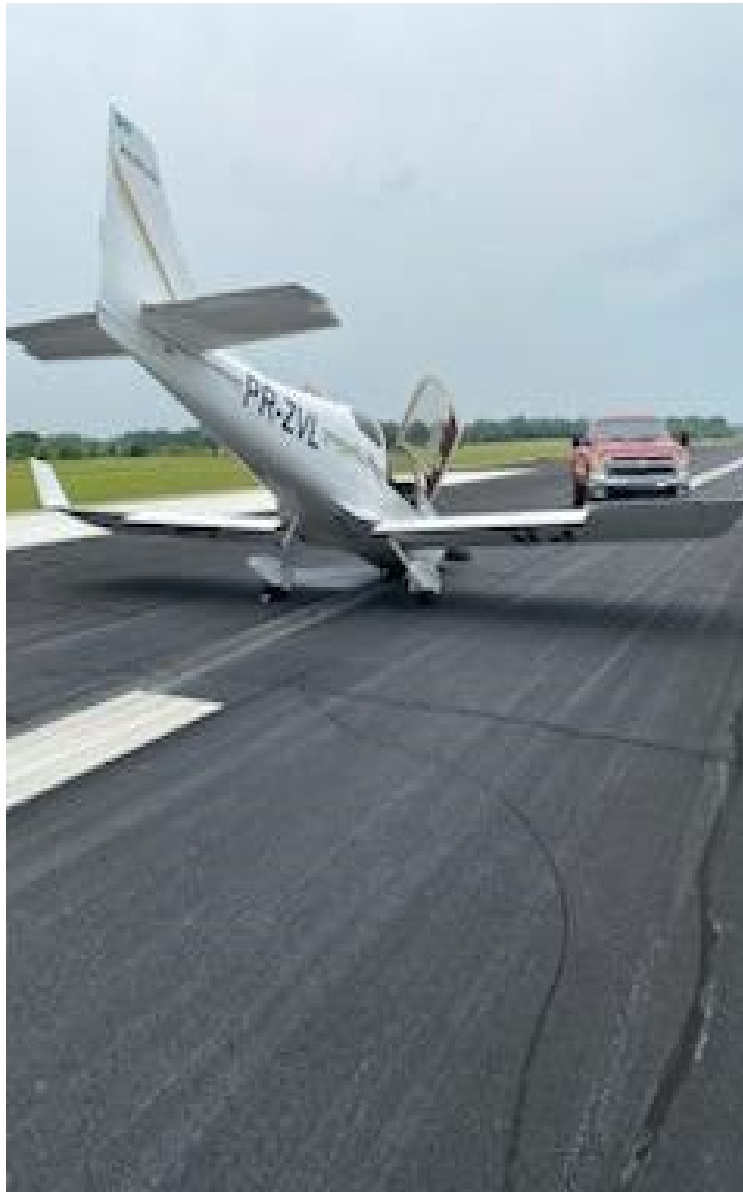
Photo 1: Overview of the airplane at the accident site. (Photo Courtesy of FAA)

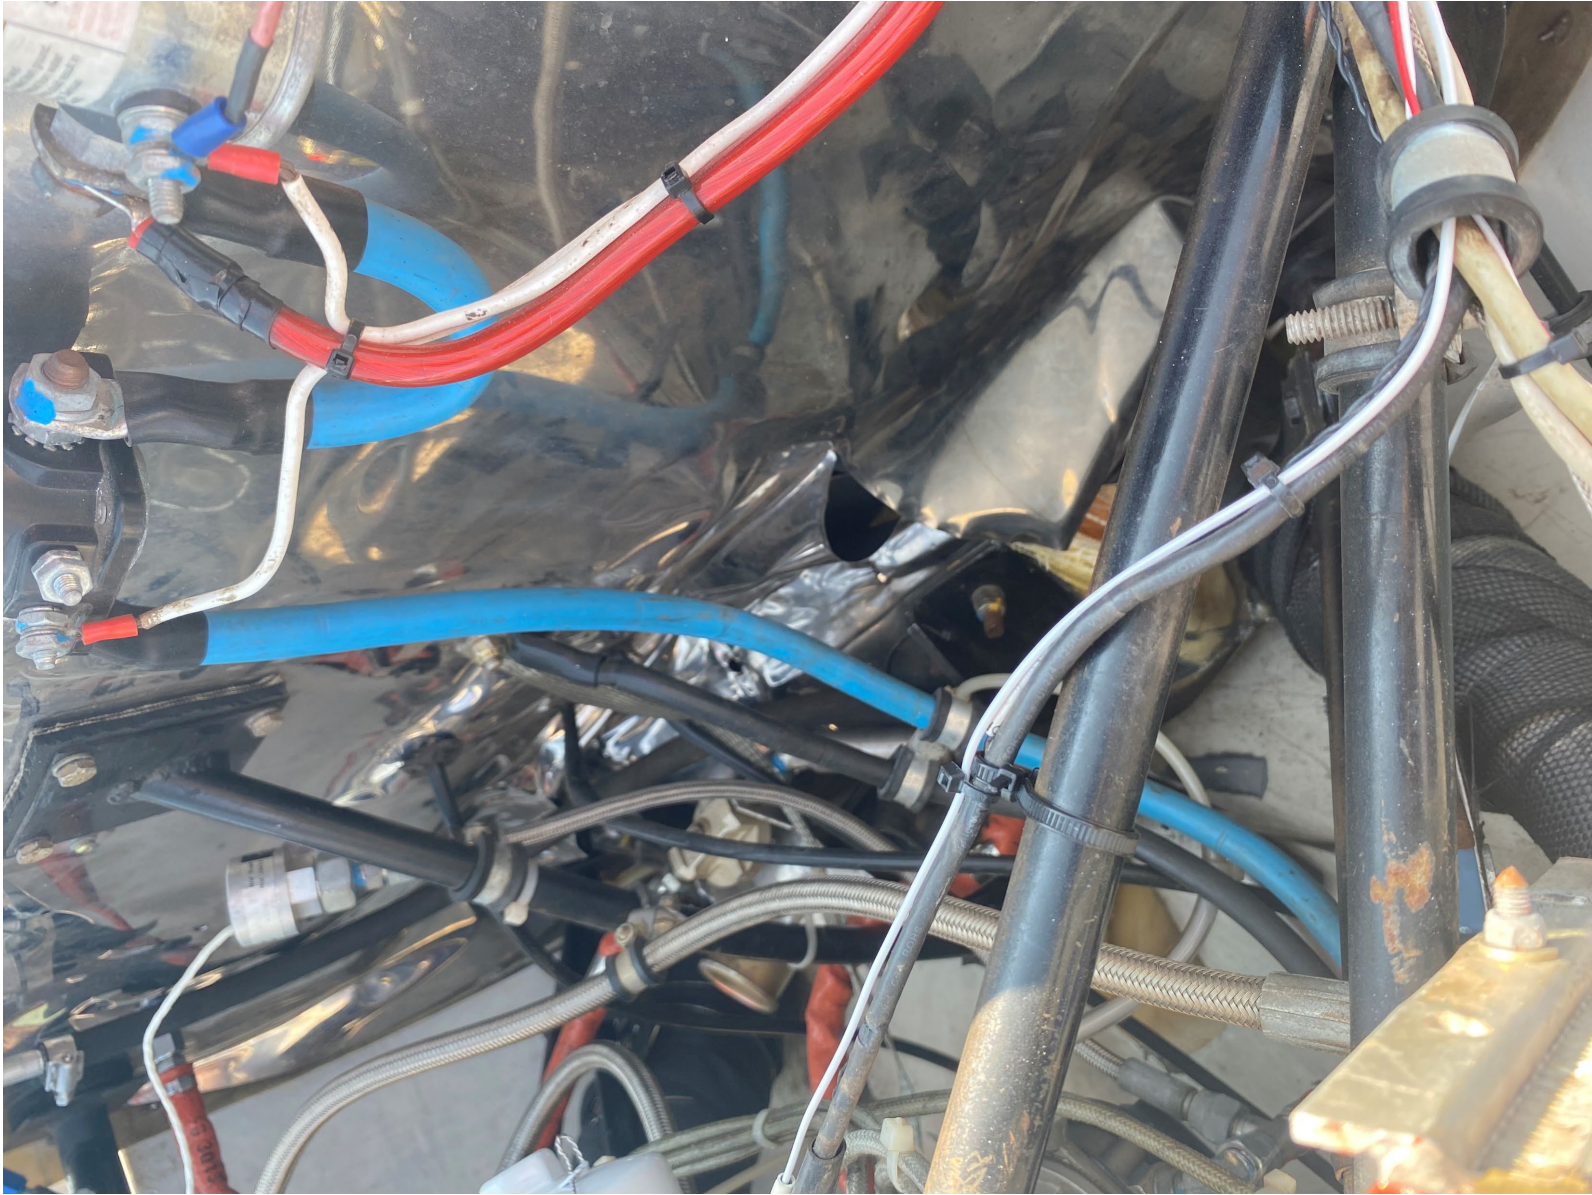
Photo 2: View of the damage to the firewall. (Photo Courtesy of FAA)

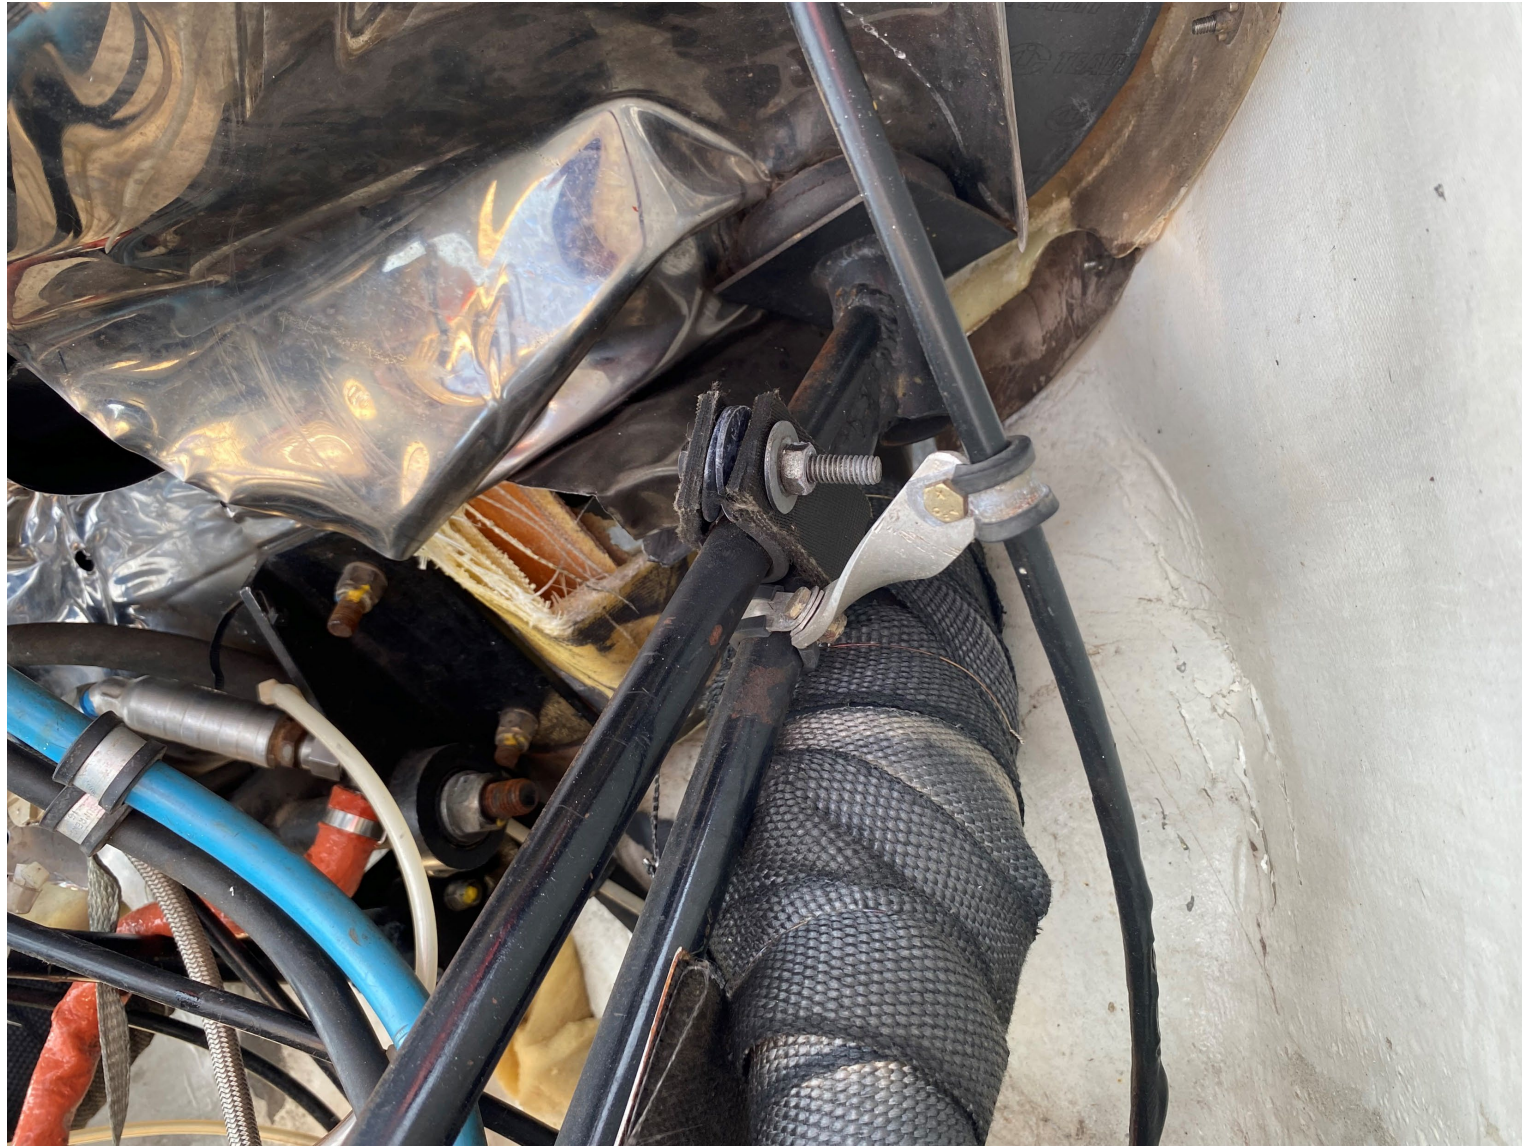
Photo 3: View of the damage to the firewall. (Photo Courtesy of FAA)

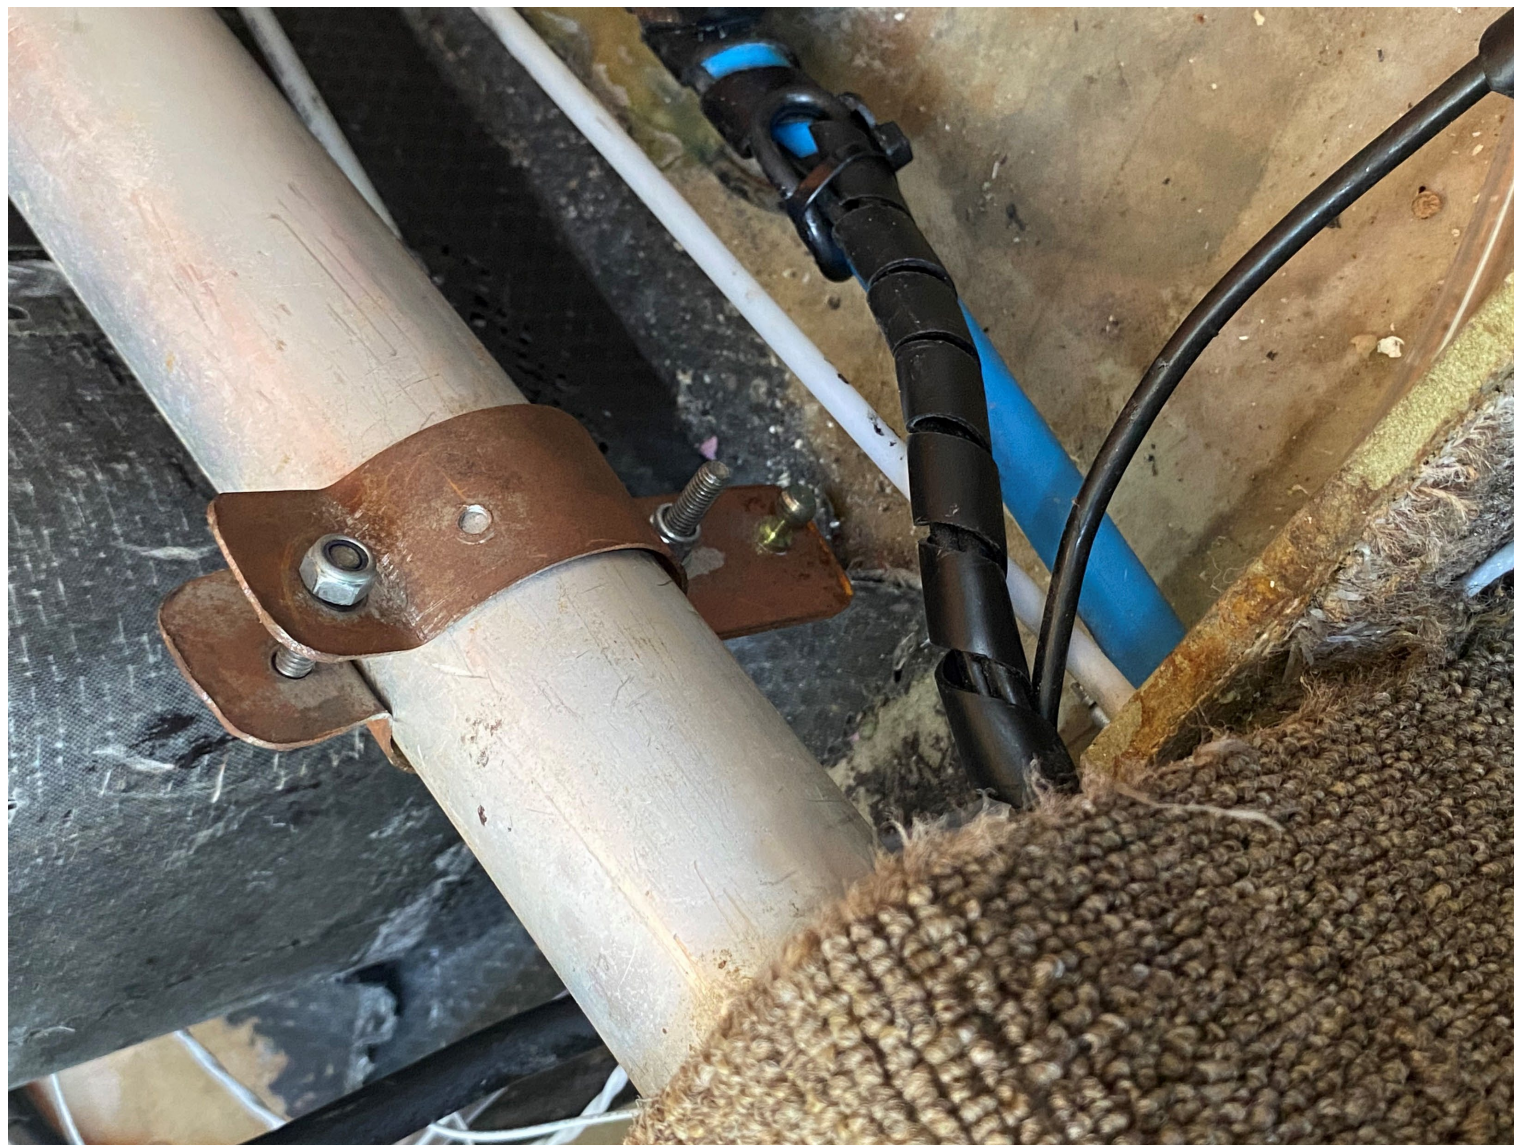
Photo 4: View of the autopilot servo bracket on the elevator control tube. (Photo Courtesy of FAA)
