**NATIONAL TRANSPORTATION SAFETY BOARD**

**Investigative Photographs**

**ERA23LA292**

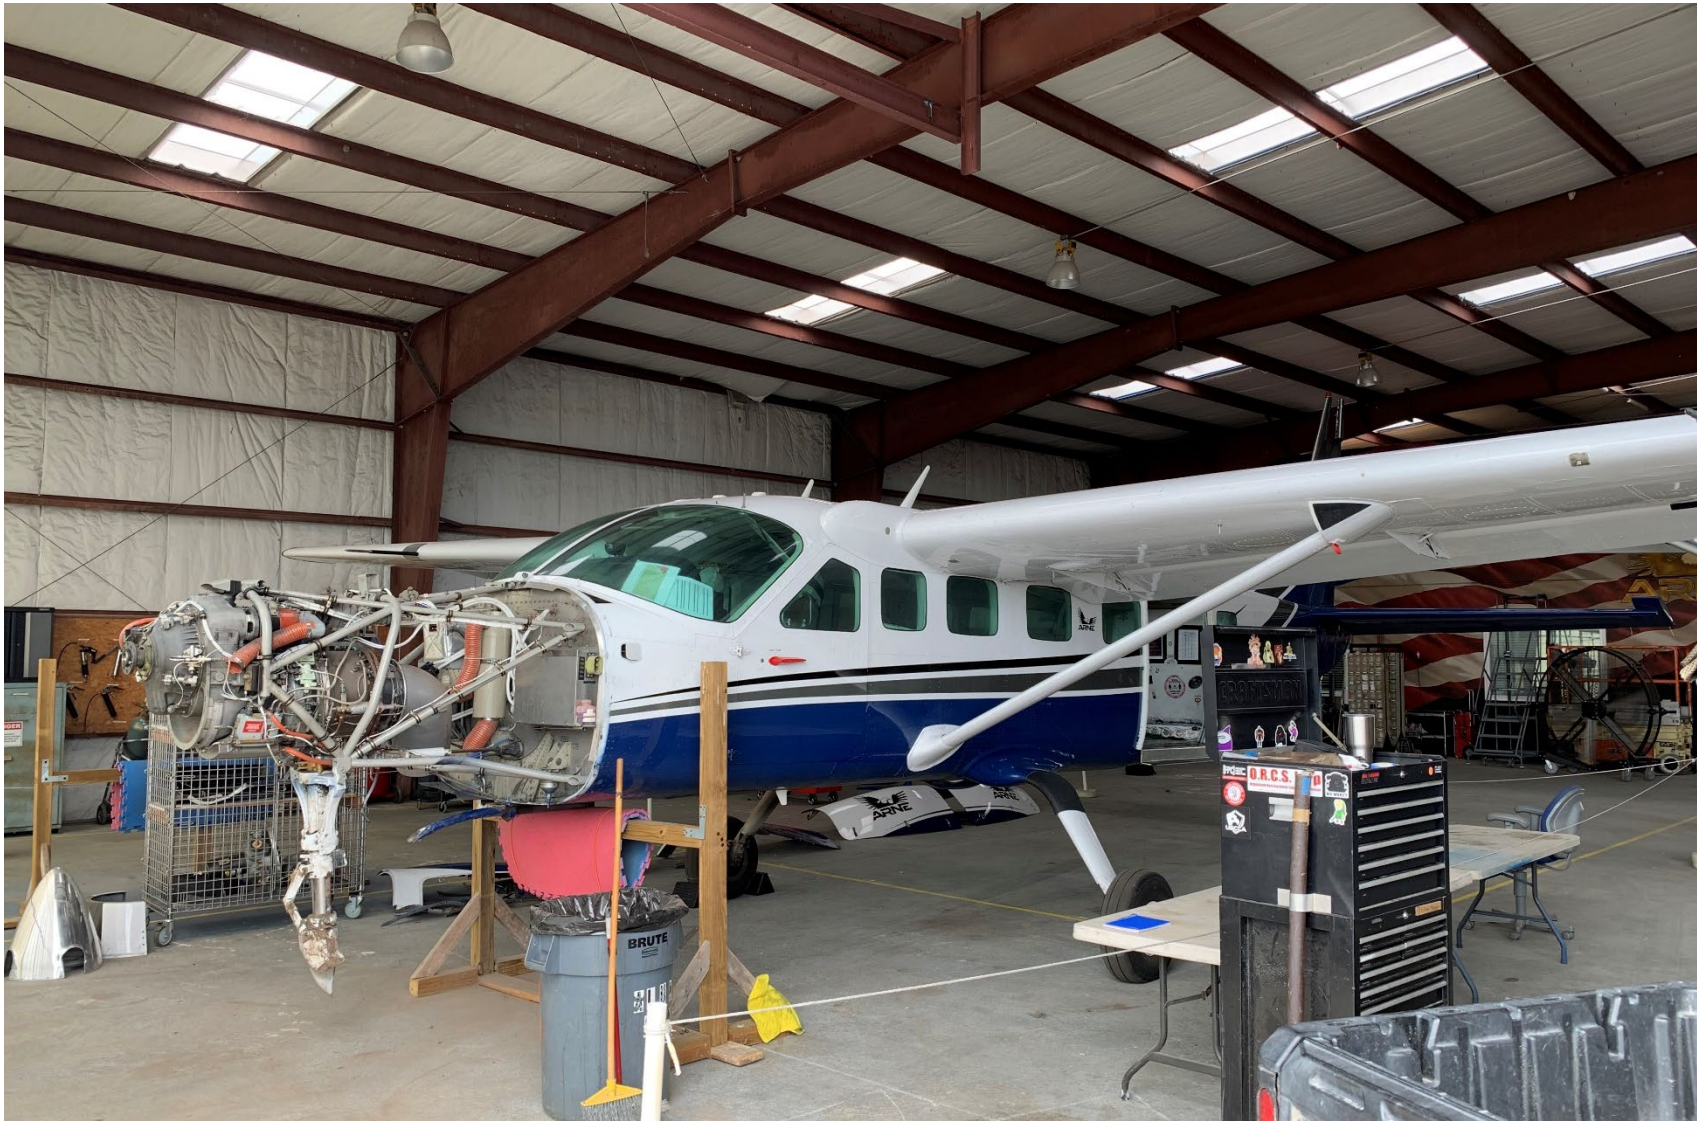
**Photo 1 – View of Accident Airplane (Courtesy of FAA)**

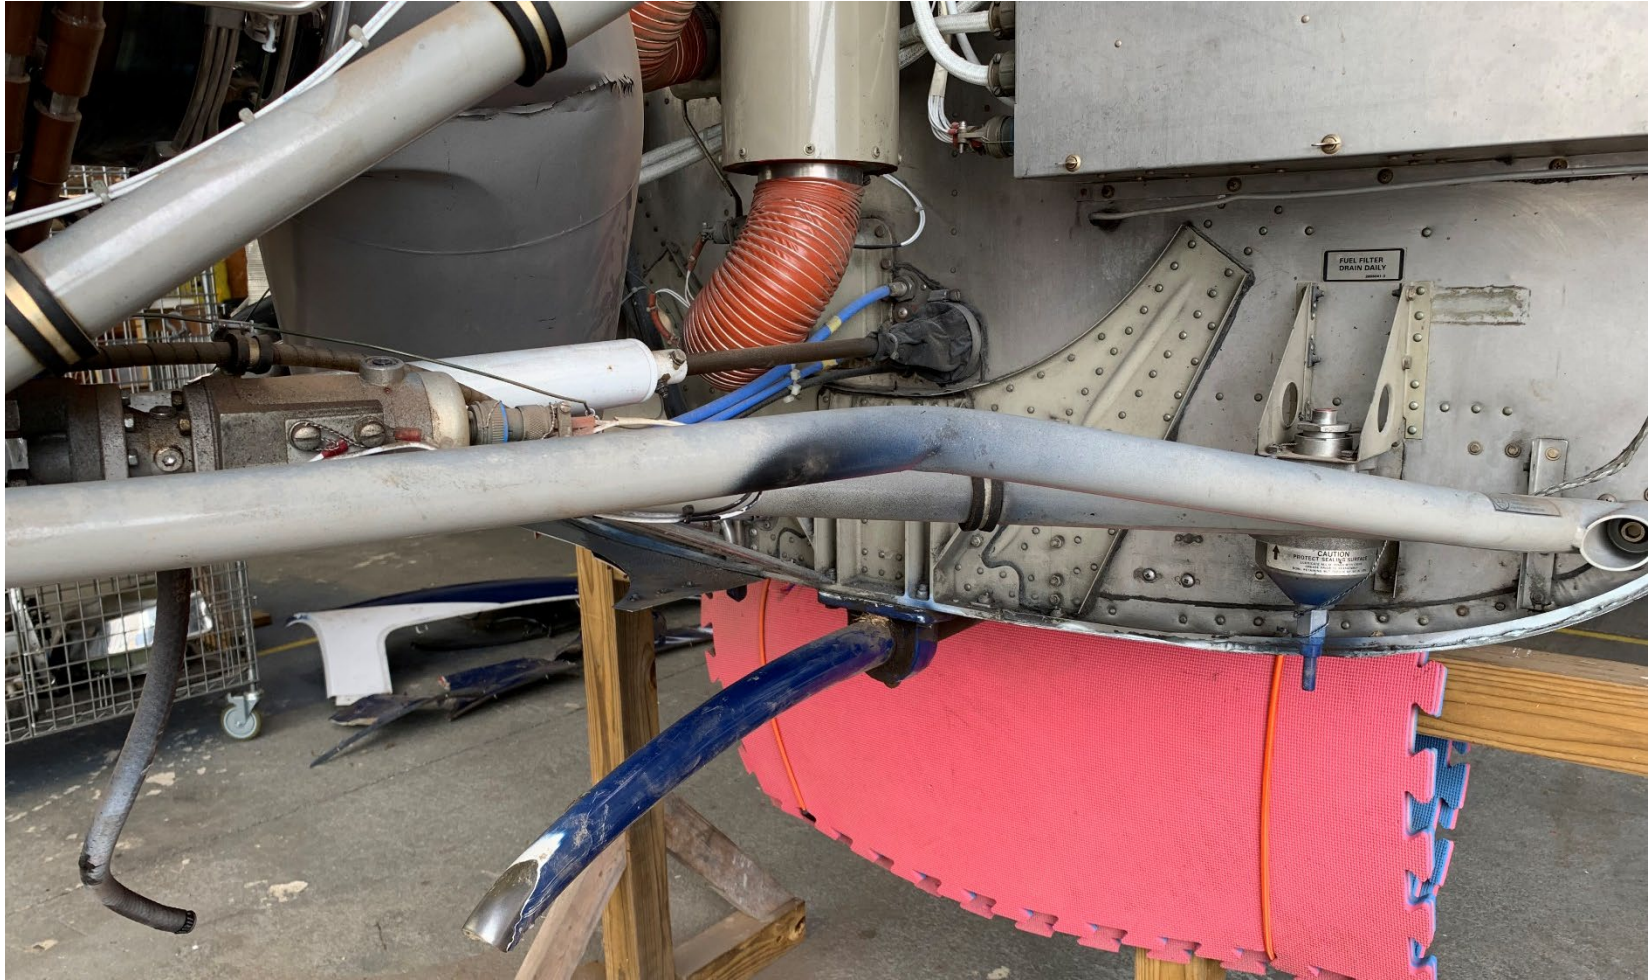
**Photo 2 – View of Engine Mount Damage (Courtesy of FAA)**
