# National Transportation Safety Board

## **MATERIALS LABORATORY**

Factual Report 24-030

Location: Waldorf, Maryland  
Date: July 9, 2023  
Vehicle: Hughes 369D, N5027P  
Investigator: Chihoon Shin, AS-40

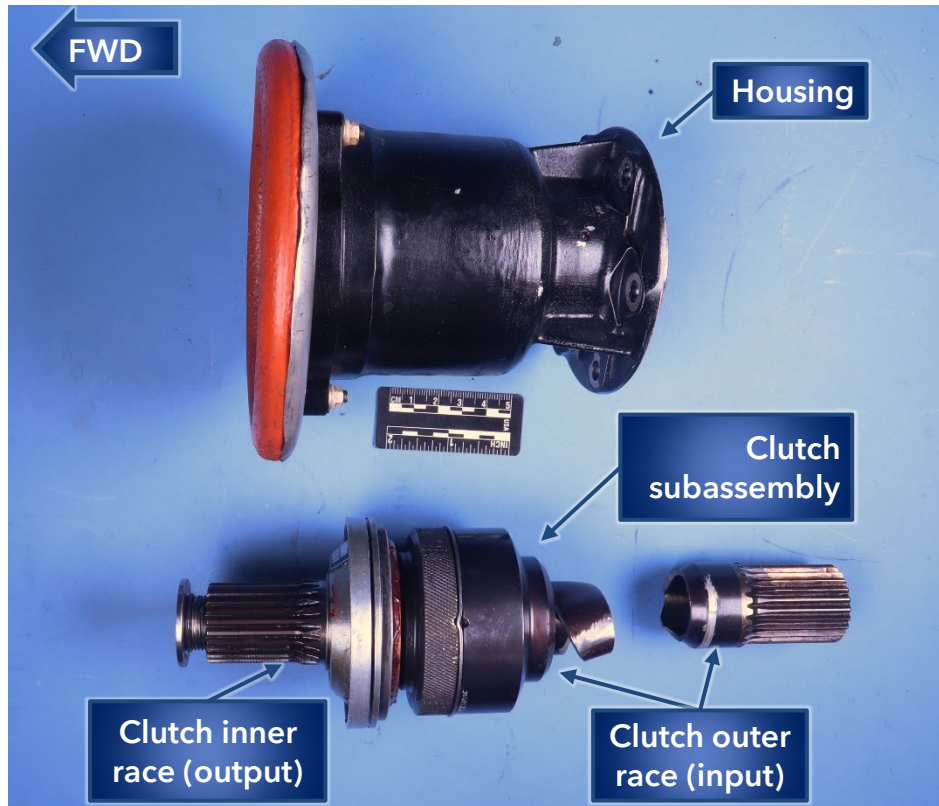
An overall view of the submitted overrunning clutch subassembly and housing are shown in figure 1. The clutch outer race was fractured near the forward end of the hollow shaft portion of the outer race, and the splined input end of the shaft was separated from the rest of the clutch subassembly. The clutch inner race was intact at the output end of the clutch subassembly. The nut appeared tight against the outer race, and crimps in the lock washer were in place in the respective grooves in the nut and outer race.

**Figure 1.** Overall view of the submitted overrunning clutch assembly as received.

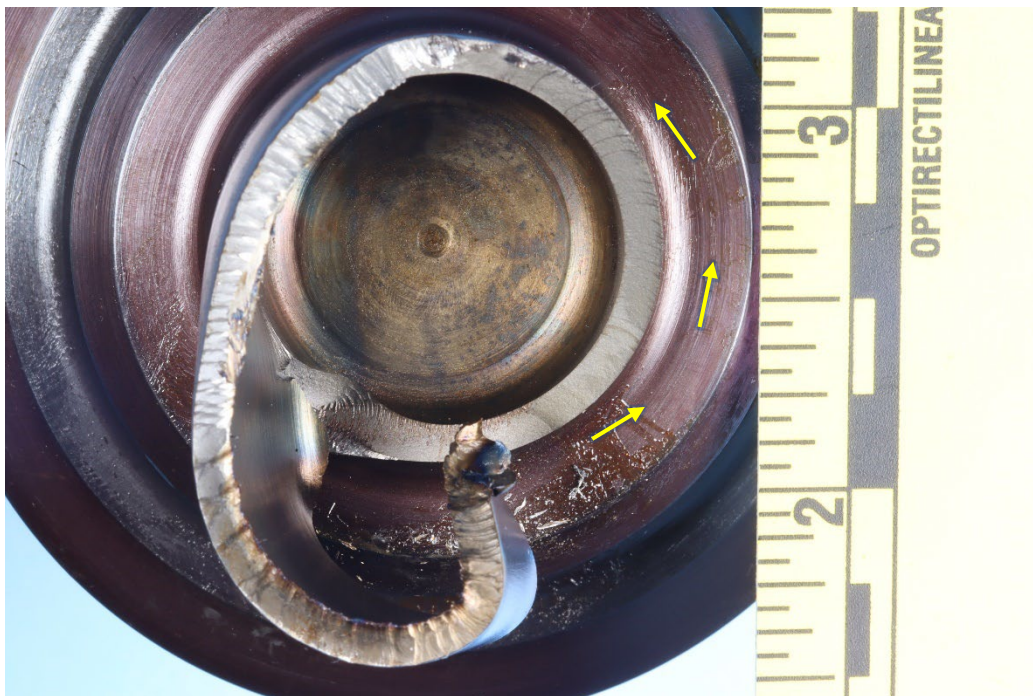
An overall view of the forward side of the clutch outer race fracture is shown in figure 2. A portion of the fracture surface had relatively smooth fracture features with curving crack arrest lines, features consistent with fatigue fracture. Unlabeled arrows in figure 2 indicate the overall direction of the fatigue crack growth counterclockwise (as viewed looking forward unless otherwise specified) around the shaft wall. Fatigue fracture features emanated from the fillet area where the forward end of the shaft transitioned to a shoulder on the larger-diameter portion of the outer race. The fatigue features showed propagation through the thickness at the forward end of the exposed fracture surface as shown in figure 3 and propagated aft as the crack propagated counterclockwise, forming a spiral orientation to the fracture consistent with fatigue fracture under torsion loading. At the aft end of the spiral, the fracture transitioned to a nearly circumferential fracture with rubbing damage and twisting deformation consistent with ductile overstress fracture of the remaining ligament under torsion loading.

**Figure 2.** Visible portion of the forward side of the fracture surface in the clutch outer race. Unlabeled arrows next to the fracture surface indicate the direction of fatigue propagation on the spiral portion of the fracture.

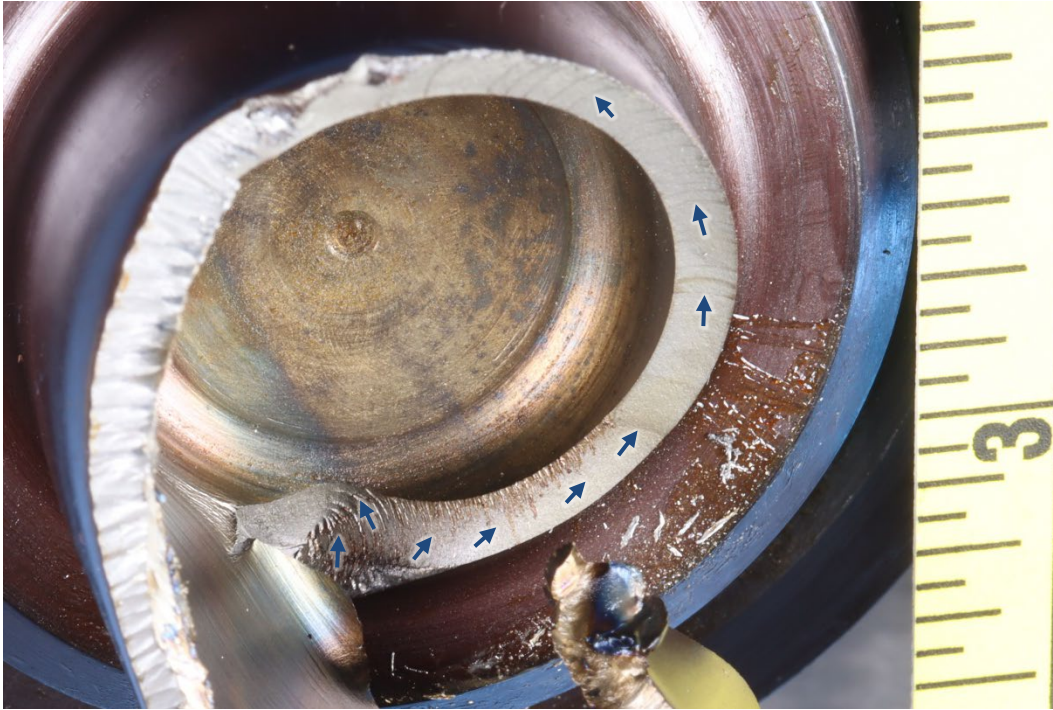
**Figure 3.** Another view of the visible portion of the fracture in the clutch outer race. Unlabeled arrows indicate local fatigue propagation directions.

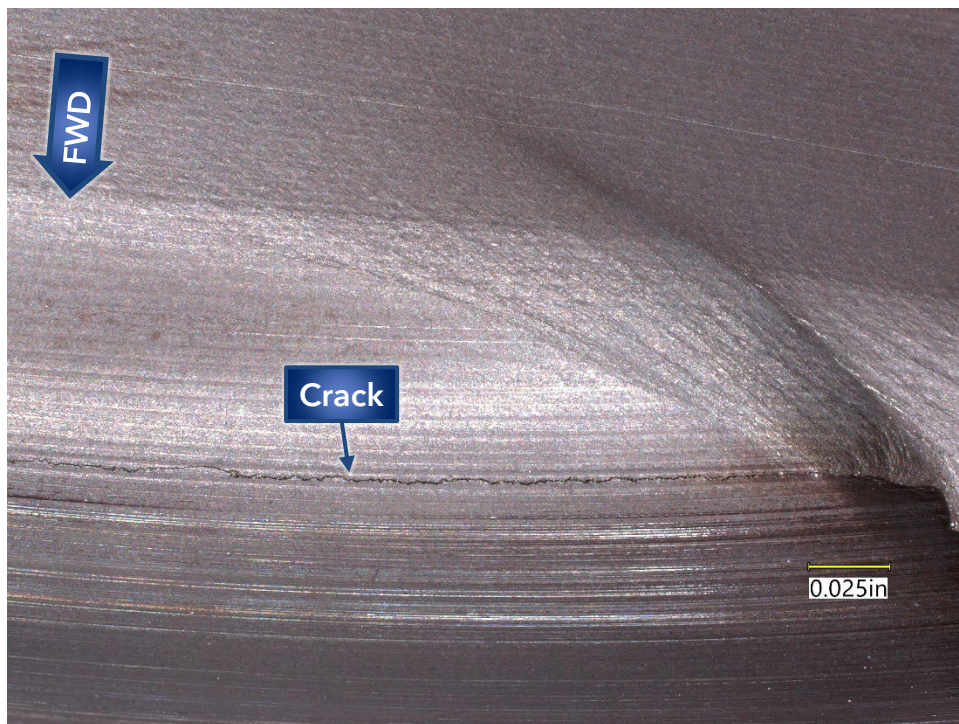
A circumferential crack was observed in the fillet radius as shown in figure 4 extending clockwise around approximately 40 percent of the circumference from the exposed fracture surface. The fillet radius forward of the spiral portion of the fracture is shown in figure 5. The surface had an etched appearance with circumferential

**Figure 4.** Crack in the fillet radius between the clutch outer race shaft and adjacent shoulder. The crack intersects the visible portion of the fracture at the right side of the image.

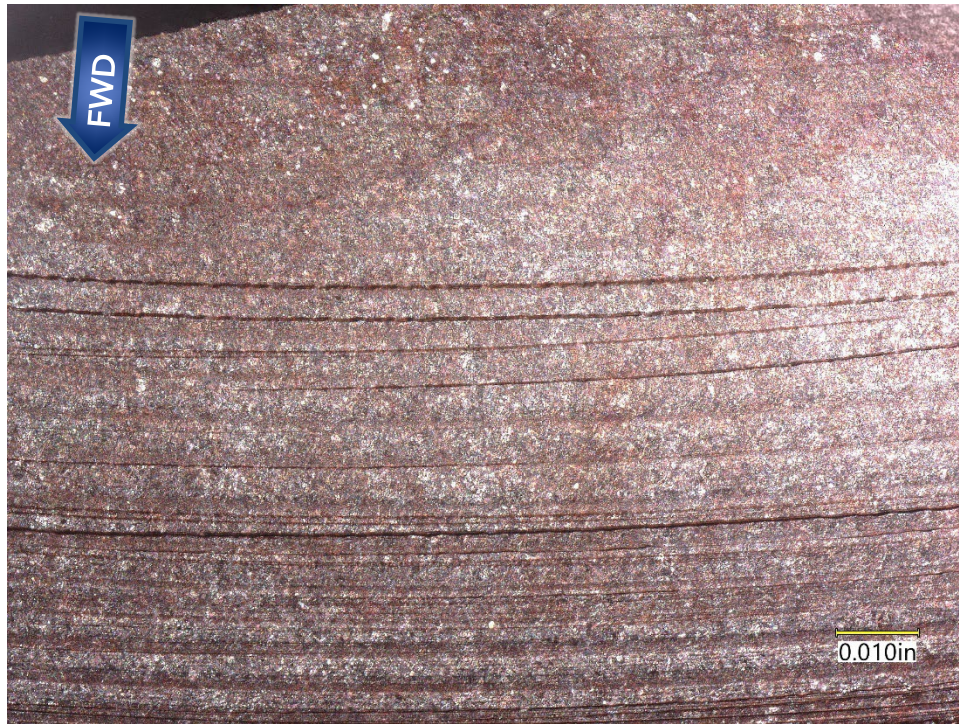
scratches that disturbed the surface finish. However, the circumferential crack to the clockwise side of the spiral fracture was not associated with the observed scratches. A backlit image of the intact portion of the fillet radius is shown in figure 6 showing a smooth radius of curvature.

**Figure 5.** Intact fillet radius between the input shaft and adjacent shoulder on the clutch outer race forward of the spiral portion of the fracture.

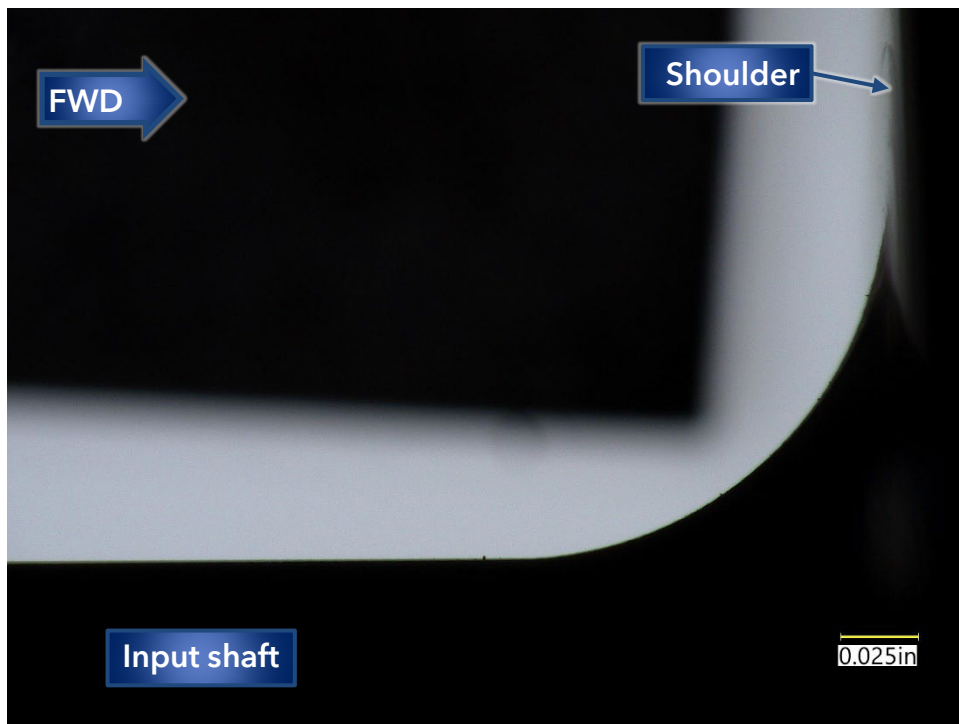
**Figure 6.** Backlit image of the clutch outer race showing the fillet radius between the input shaft and the adjacent shoulder.

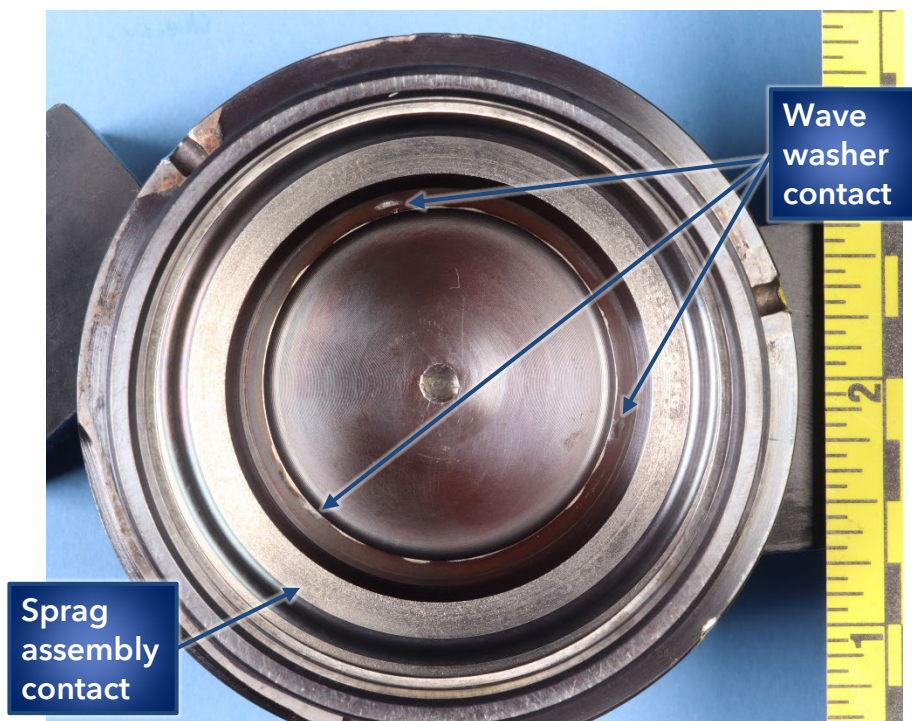
**Figure 8.** Forward side of the clutch outer race showing wave washer contact areas and marks from contact with the aft face of the sprag assembly.

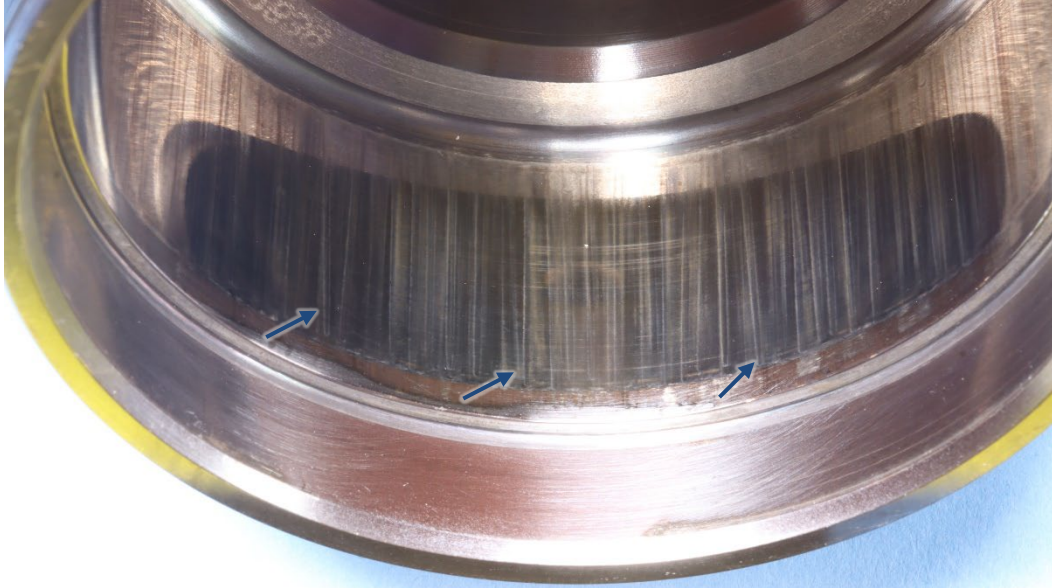
Sprag element contact marks were observed on the sprag raceway on the clutch outer race as shown in figure 9. The ends of the sprag element contact marks varied in axial position. Additionally, some marks were observed angled relative to the longitudinal axis. Unlabeled arrows in figure 9 indicate several sprag contact marks that were angled relative to the longitudinal axis.

**Figure 9.** Sprag element contact marks on the clutch outer race. Unlabeled arrows point to several off-axis sprag element contact marks.

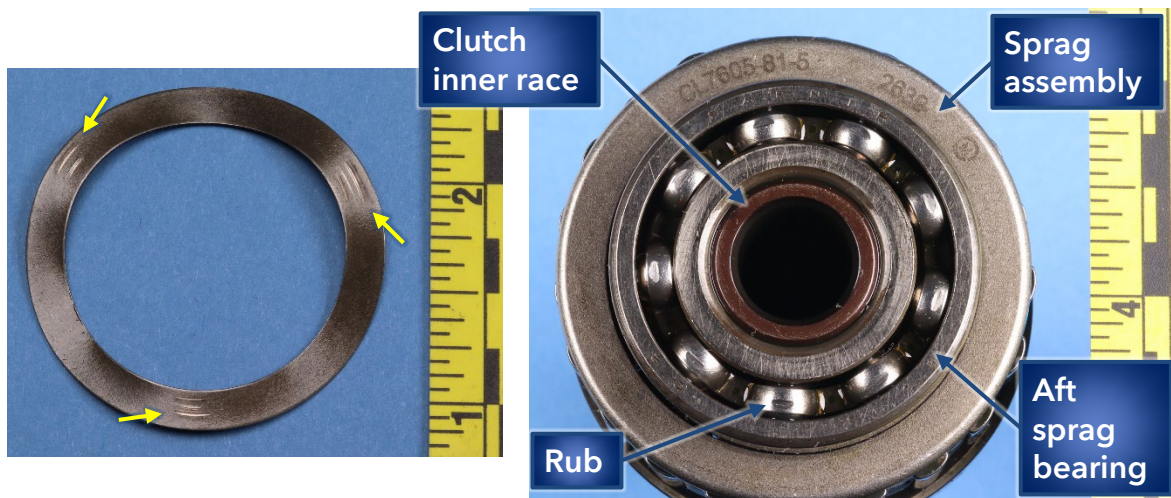
The wave washer had markings at the wave peaks corresponding to contact with the clutch outer race on the aft side of the washer and with the aft sprag bearing on the forward side of the washer. On the forward side of the washer shown in figure 10, multiple distinct contact marks were observed at each contact location corresponding to contact with the inside diameter edge of the aft sprag bearing outer race.

The aft end of the clutch inner race with attached aft sprag bearing and sprag assembly is shown at the right in figure 10. The aft sprag bearing outer race had markings that read "FAFNIR MS8K C2" on the aft face and "369A5363B" on the outside diameter. The sprag assembly cage was marked "CL7605-81-5 2639" followed by a circled M symbol on the aft side and "369D25351-E FORMSPRAG USA CL42315 S/N 9870" with an arrow between the E and F pointing toward the F on the forward side. Rub marks corresponding to contact with the inside diameter edge of the wave washer were observed on the aft sprag bearing cage as indicated in the right image in figure 10.

**Figure 10.** Forward face of the wave washer (left image) and aft end of the clutch inner race with attached sprag assembly and aft sprag bearing (right image). Unlabeled arrows in the left image point to circumferential contact marks corresponding to contact with the aft sprag bearing outer race.

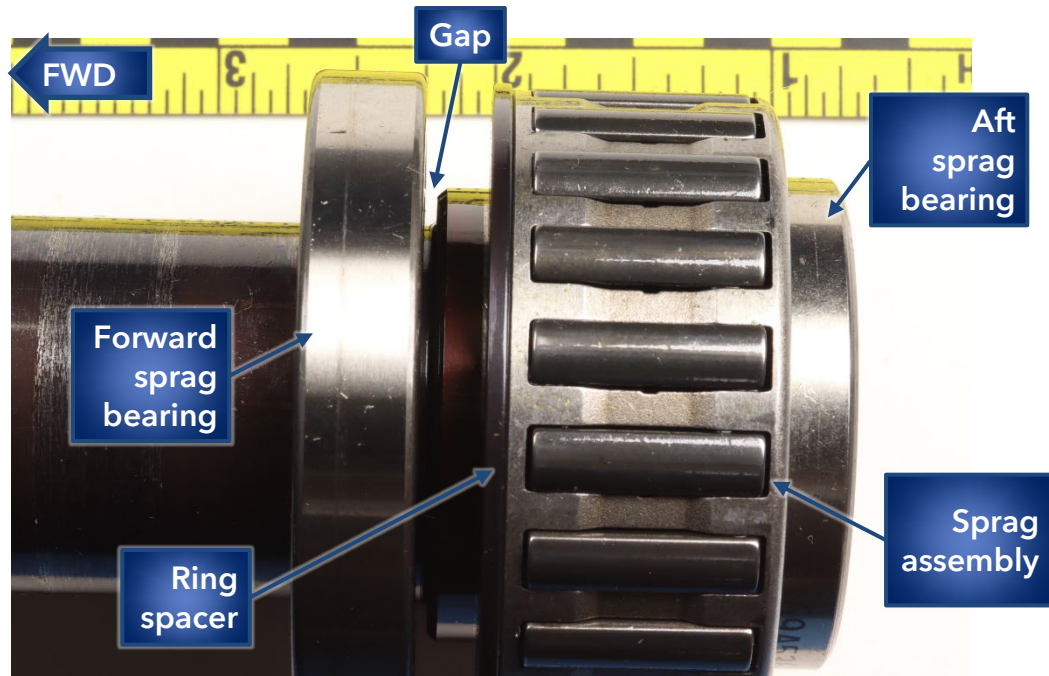
The forward sprag bearing was marked "2770 MRC R20 Japan" on the aft side of the outer race. As installed on the inner race, a gap was observed between the aft side of the forward bearing and the adjacent shoulder on the inner race as shown in figure 11. The gap measured approximately 0.040 inch.

**Figure 11.** Side view of the clutch inner race, sprag assembly, and sprag bearings showing a gap between the forward sprag bearing and adjacent shoulder for the sprag inner race.

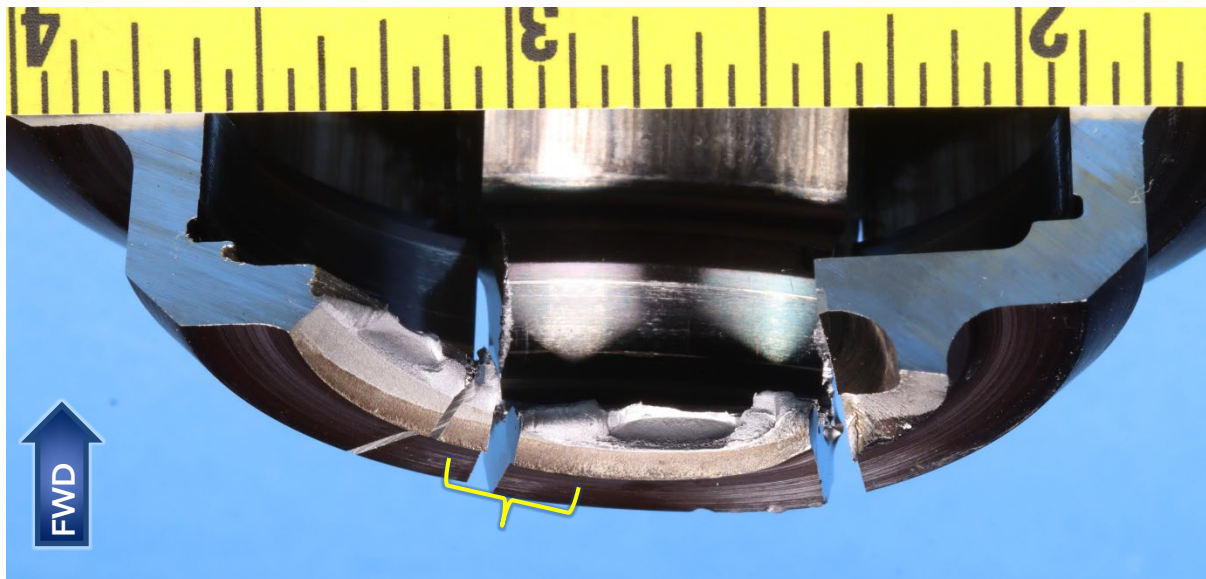
An overall view of the circumferential crack that was opened by lab-induced fractures is shown in figure 14. A portion of the crack had relatively dark features emanating from a broad origin area near the middle of the circumferential crack region. An unlabeled bracket in figure 14 indicates the approximate origin area. The fatigue features in the spiral fracture portion of the fracture shown in figures 2 and 3 emanated directly from the counterclockwise end of the exposed circumferential crack.

**Figure 14.** Overall view of the fatigue origin area after lab fracture of the circumferential crack. A bracket indicates the approximate fatigue origin area.

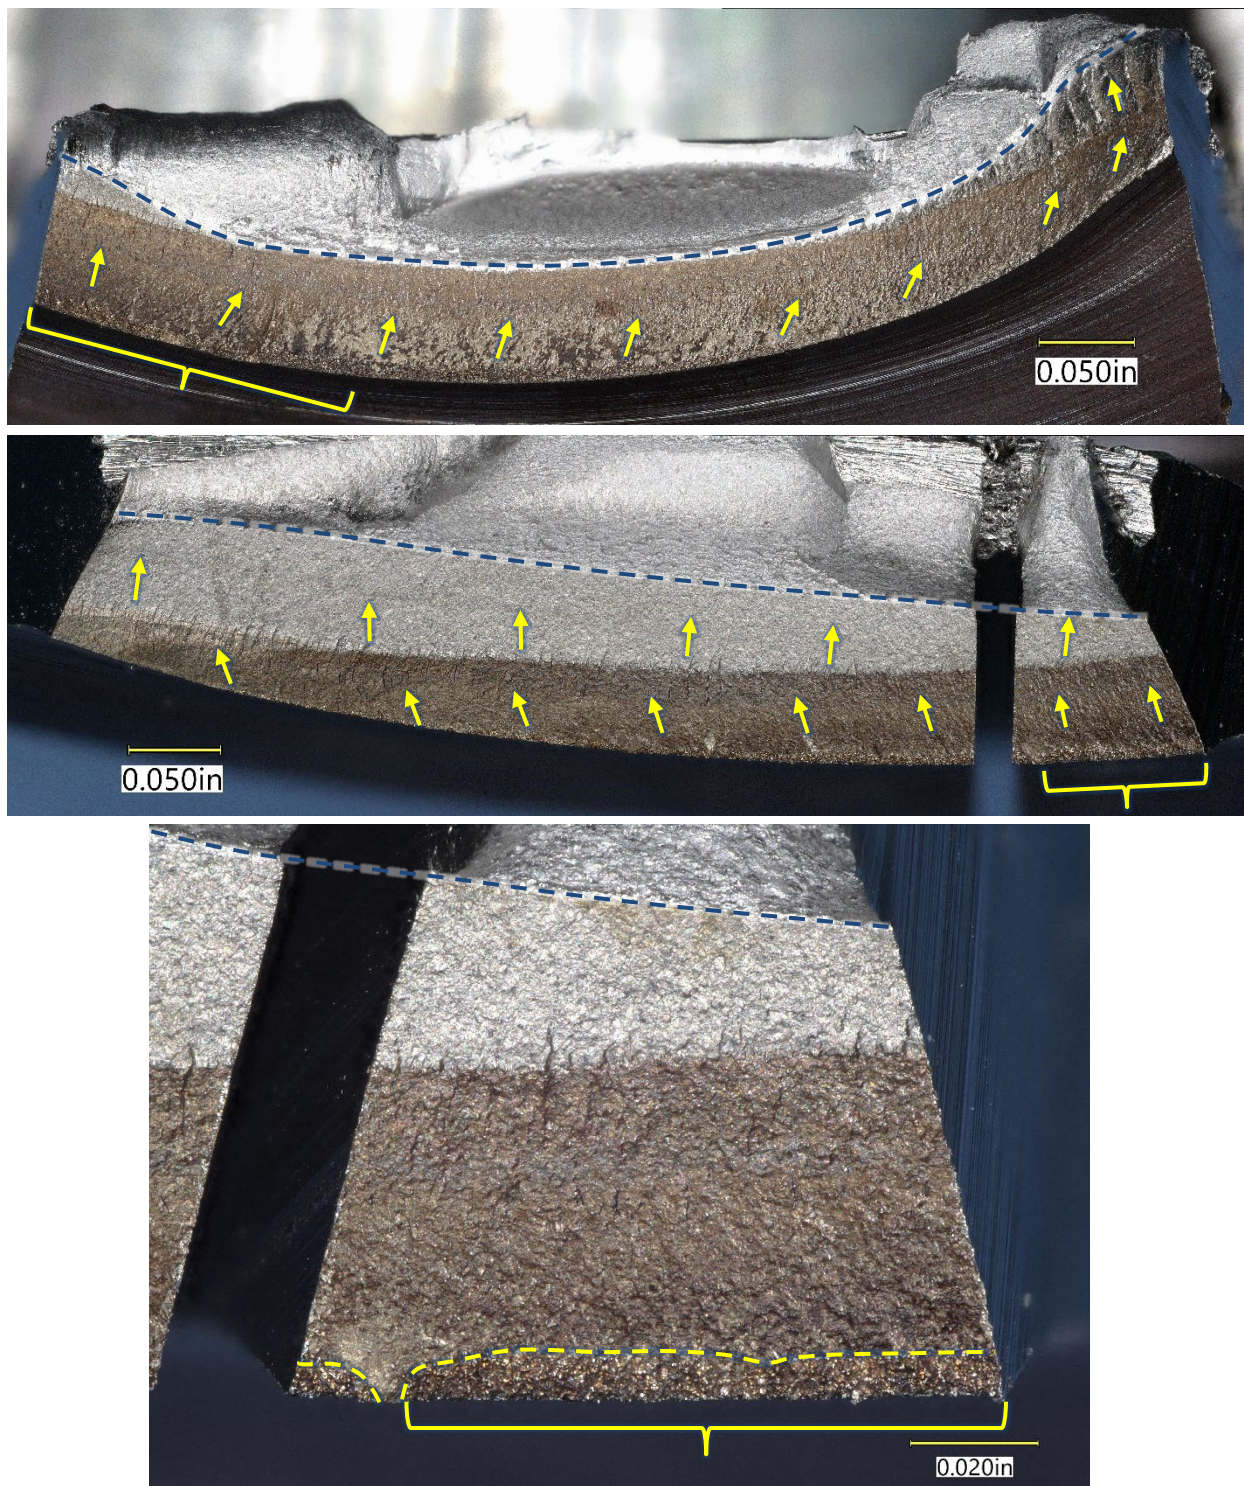
Closer views of the circumferential crack features are shown in figure 15. The fracture surface had a flat region oriented perpendicular to the fillet surface extending into the outer race to the boundary indicated with a dashed blue line. The fracture surface showed signs of progressive fracture consistent with fatigue. A portion of the fracture was relatively dark covering most of the fatigue region in the upper image and a lesser portion of the fatigue region toward the clockwise end of the crack. Unlabeled arrows in figure 15 indicate local fatigue crack propagation directions, which emanated from a broad origin area as indicated with unlabeled brackets on either side of a longitudinal cut made to facilitate the lab-induced fractures.

A closer view of crack fracture features at the clockwise end of the fatigue origin area is shown in the lower image in figure 15. Adjacent to the external surface, the fracture surface had a rock candy appearance consistent with intergranular fracture features. Yellow dashed lines in figure 15 indicate the extent of the observed intergranular fracture features.

**Figure 15.** Optical images of the circumferential crack after opening (upper and middle images) with a closer view of the fatigue region near the origin area at the left side of the middle image. Blue dashed lines indicate the fatigue boundary, yellow dashed lines indicate the transition from intergranular to transgranular fracture. Unlabeled arrows indicate local fracture propagation directions, and brackets indicate approximate fatigue origin areas.

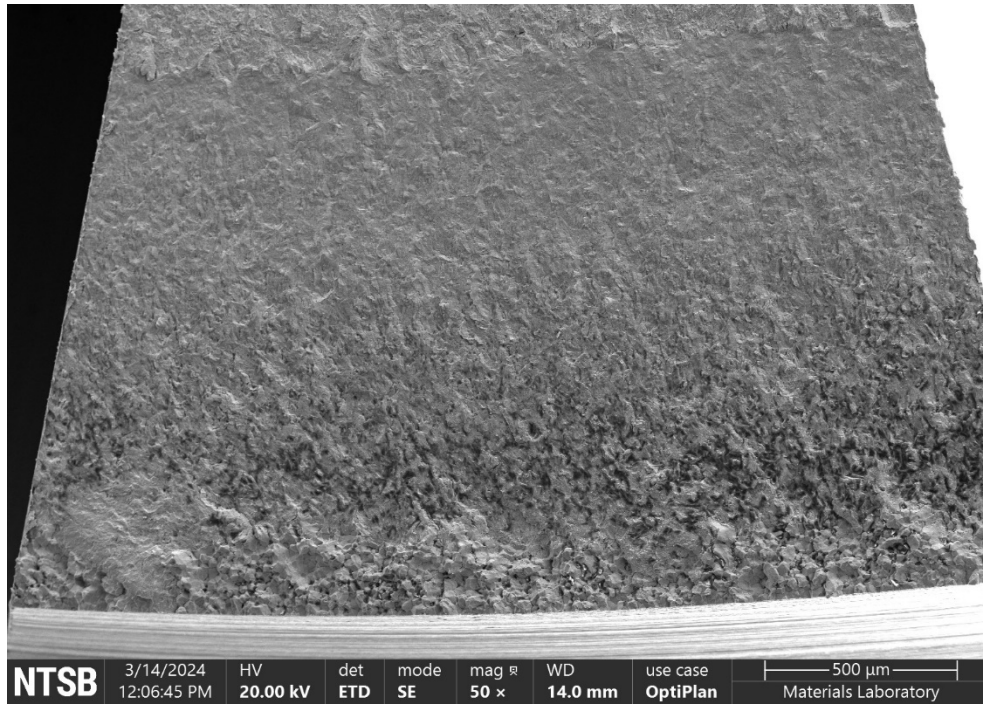
The fracture surface shown in the middle image in figure 15 was cleaned using an ultrasonic cleaner while submerged in acetone. The fracture surface was then examined using a scanning electron microscope (SEM). An SEM image of the fracture surface at the clockwise end of the origin area is shown in figure 16. Intergranular fracture features were observed adjacent to the exterior surface as shown in figure 17 extending up to 0.00921 inch (234 micrometers) deep. The fracture then transitioned to a flat transgranular fracture with feathery features typical of high-cycle fatigue in steel.

**Figure 16.** SEM image of the fatigue region shown in the lower image in the previous figure.

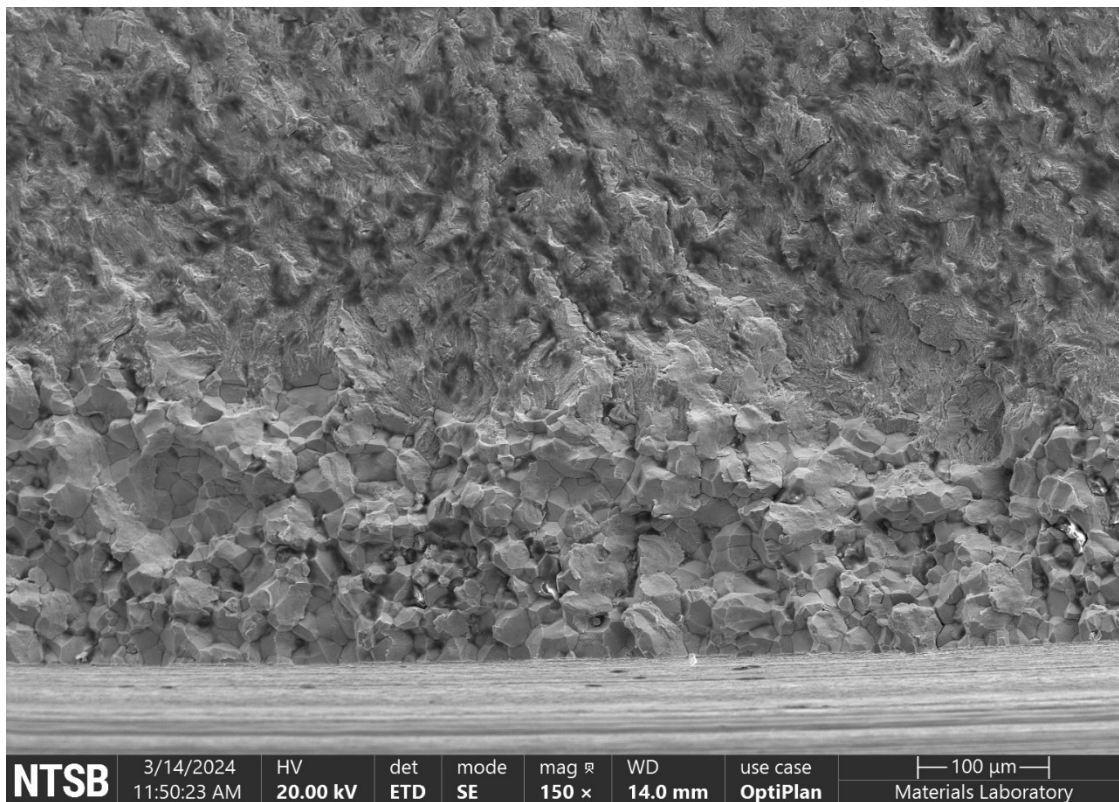
**Figure 17.** SEM image of the intergranular fracture region near the exterior surface in the fatigue origin area.

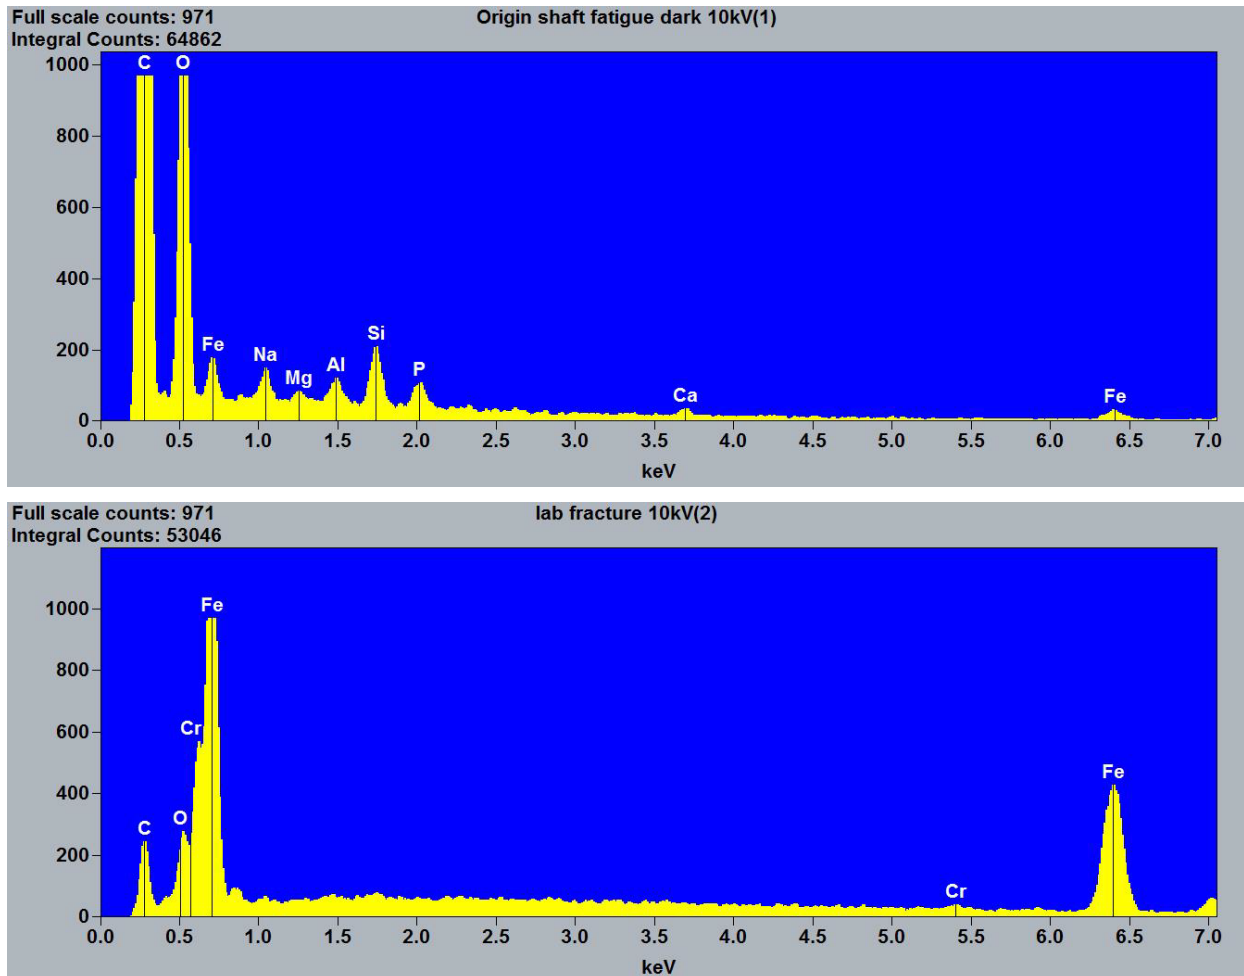
beam energy set at 10 kV. The upper image in figure 18 shows a typical EDS spectrum for the dark deposits showing high peaks of carbon and oxygen with smaller peaks of elements commonly associated with additives used in grease. For comparison, an EDS spectrum obtained in the lab-induced overstress region of the fracture surface is shown in the lower image in figure 18.

**Figure 18.** EDS spectra of dark non-conductive deposits on the fracture surface (upper spectrum) and of fracture features in the lab-induced overstress fracture region (lower spectrum) obtained with a 10 kV electron beam energy setting.

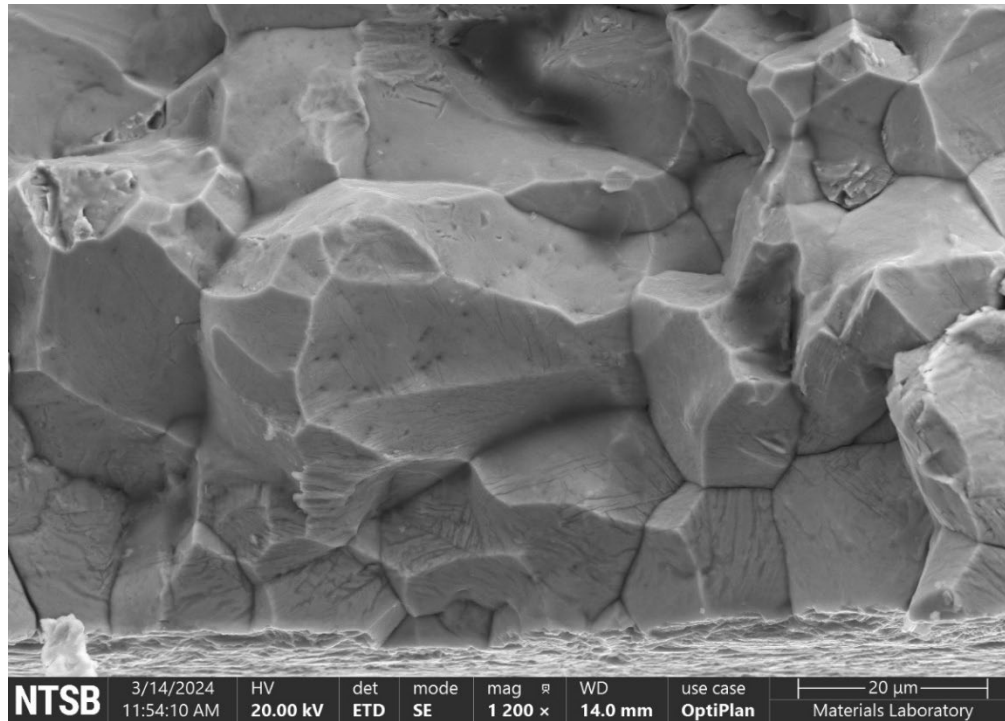
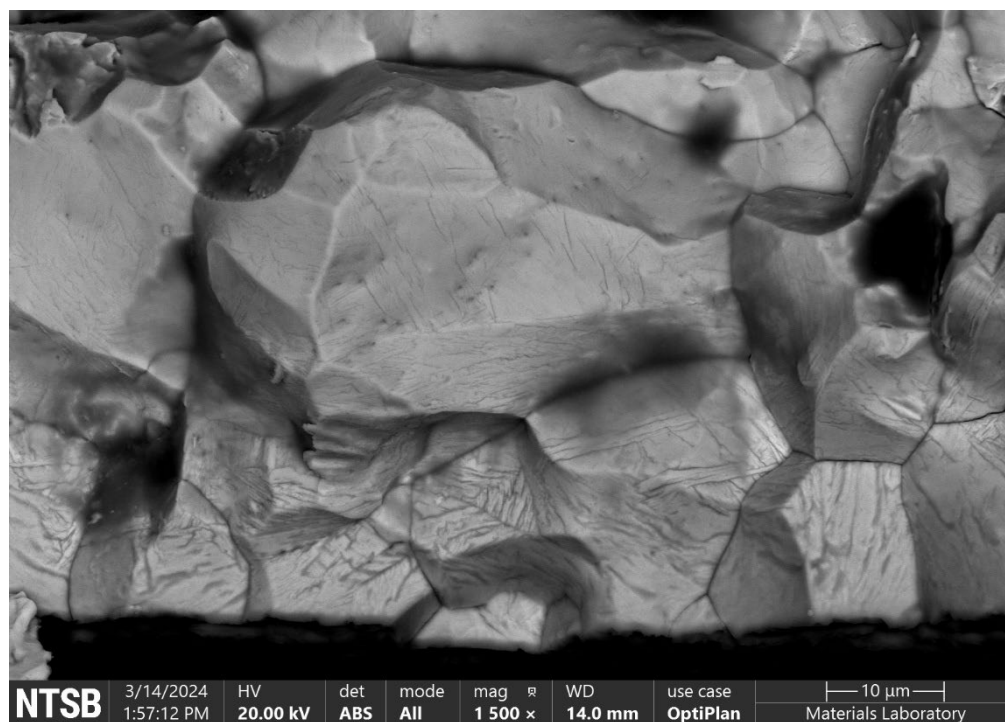
Typical intergranular fracture features in the origin area of the circumferential crack adjacent to the exterior surface are shown in figure 19. Within 2 to 3 grains of the surface, the microstructural features of the individual grains were revealed on the fracture surface. While visible using the secondary electron detector that primarily reveals fracture topography (upper image in figure 19), the microstructural features became more visible when viewed using the backscatter detector in composition mode (lower image in figure 19). When imaging with the backscatter detector in composition mode, materials with lower atomic weight appear darker than materials with higher atomic weight. As shown in figure 19, the microstructural features revealed on the grain surface were most evident on grains adjacent to the surface and were mostly absent from grains more than approximately 3 grains deep.

**Figure 19.** SEM images of typical intergranular fracture features adjacent to the exterior surface as viewed using the secondary electron detector (upper image) and the backscattered electron detector in composition mode (lower image).

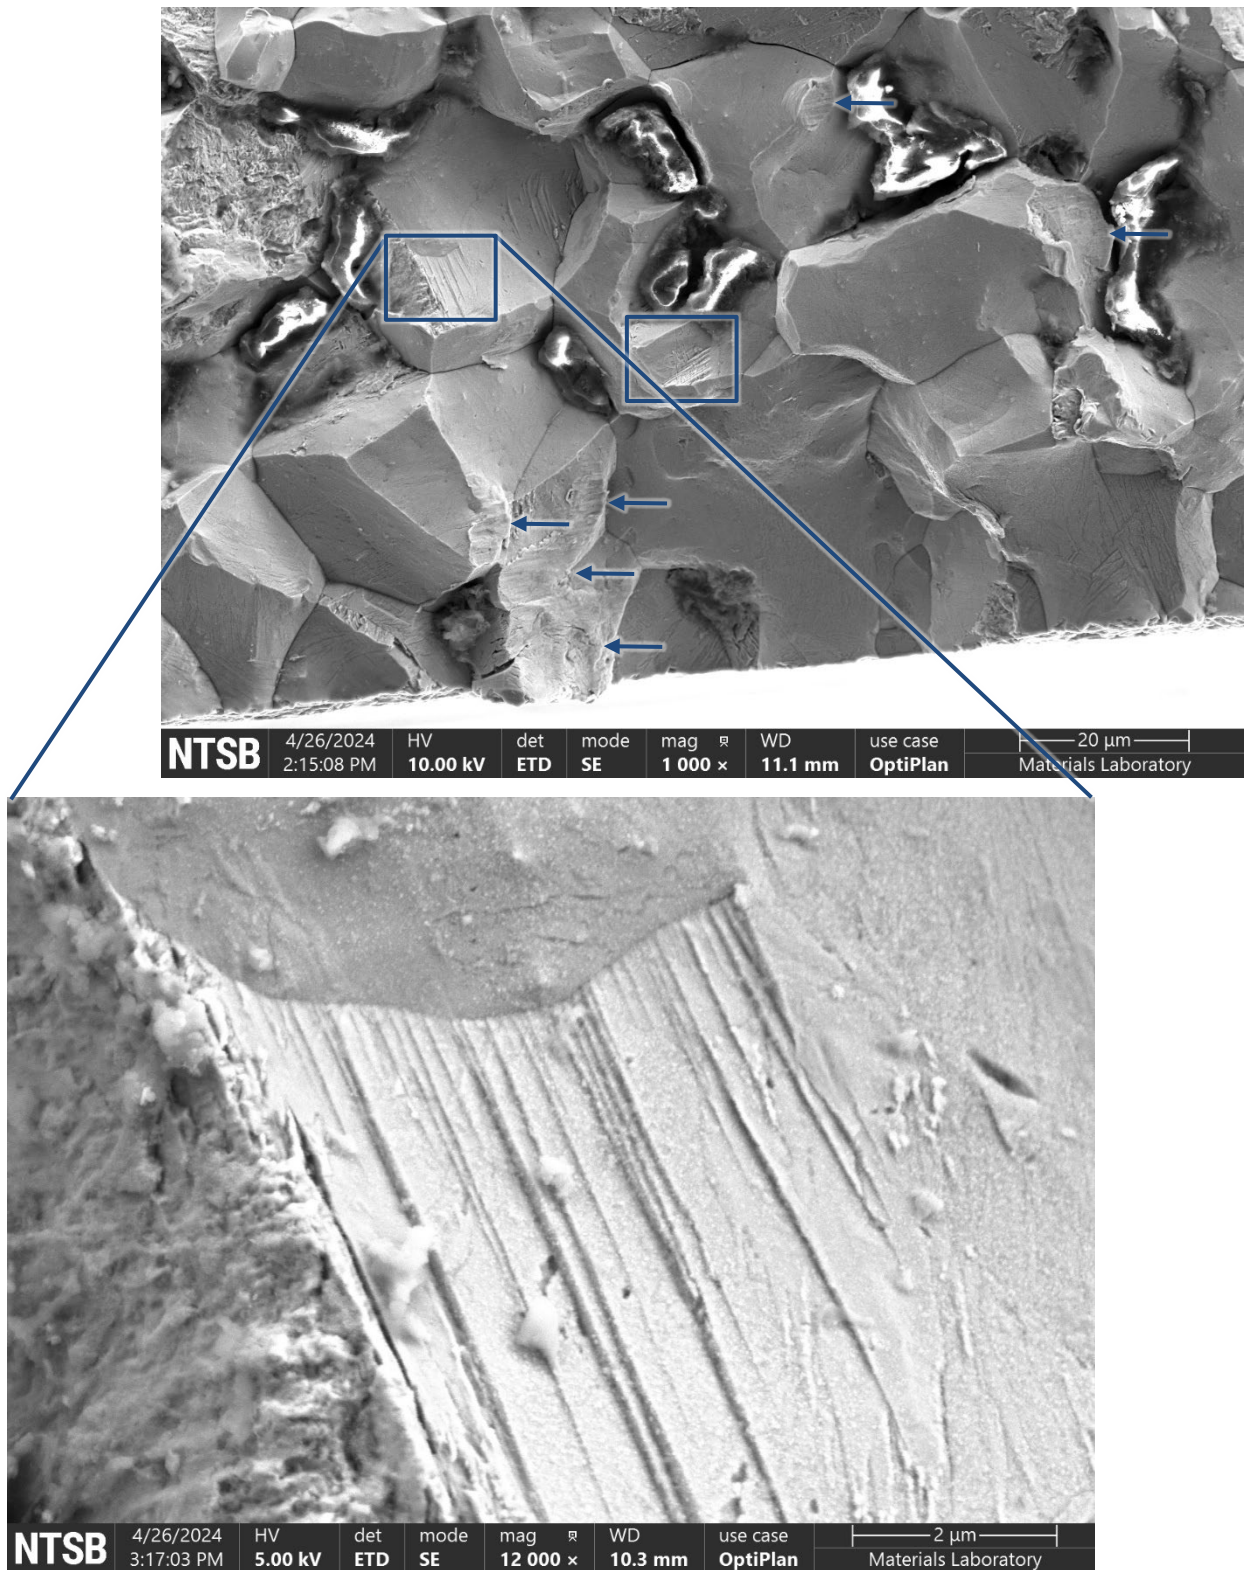
Another SEM image of the circumferential crack origin area showing intergranular fracture features adjacent to the exterior surface is shown in figure 20. Step features were observed on some of the exposed intergranular surfaces highlighted with rectangles in the upper image in figure 20 and shown at higher magnification in figures 20 and figure 21. Grain surfaces with similar step features were observed on intergranular fracture surfaces in other isolated areas scattered throughout the origin area.

Post-fracture contact damage consistent with relative motion associated with torsion loading was observed throughout the circumferential crack fracture surfaces. Sliding contact marks on several grains are indicated with unlabeled arrows in the upper image in figure 20, consistent with the mating aft side of the fracture moving clockwise relative to the forward side shown in figure 20.

**Figure 20.** Intergranular fracture surface adjacent to the exterior surface (upper image) showing areas with crystallographic step features magnified in the lower image of this figure and in the next figure. Unlabeled arrows in the upper image point to sliding contact damage from the mating fracture surface.

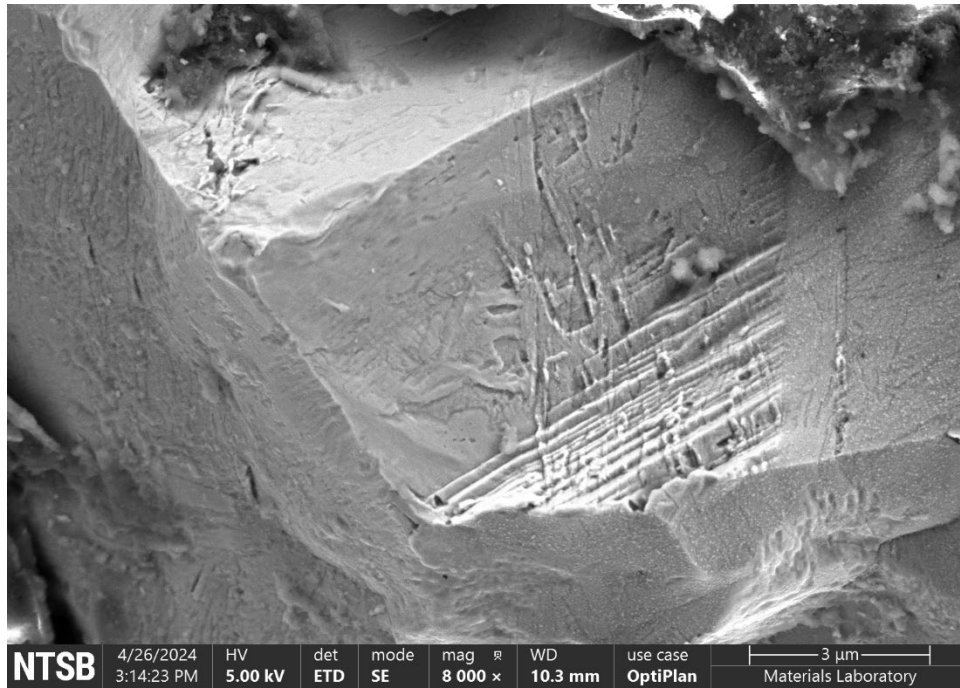
**Figure 21.** Crystallographic step features on the intergranular fracture surface in the area indicated in the previous image.

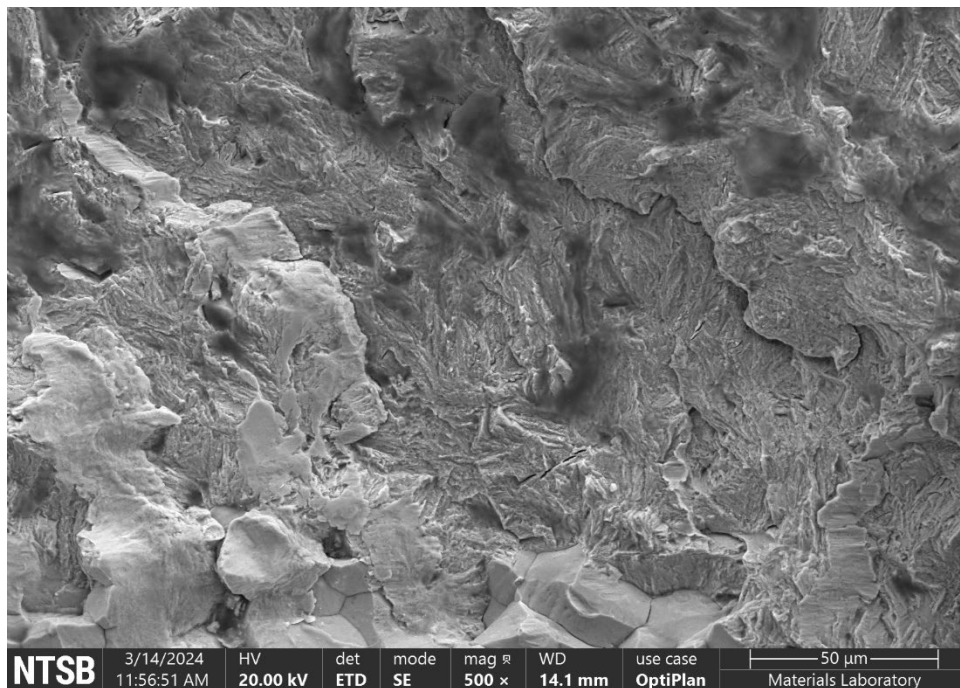
A view of typical circumferential crack fracture features where the intergranular fracture transitioned to transgranular fracture is shown in figure 22. Another view of typical fracture features in the transgranular portion of the crack is shown in figure 23. The transgranular fracture features had feathery features with limited secondary crack openings consistent with high cycle fatigue. In the lab-induced overstress region, ductile dimple features were observed as shown in figure 24.

**Figure 22.** SEM image of typical fracture features at the transition from intergranular to transgranular fracture.

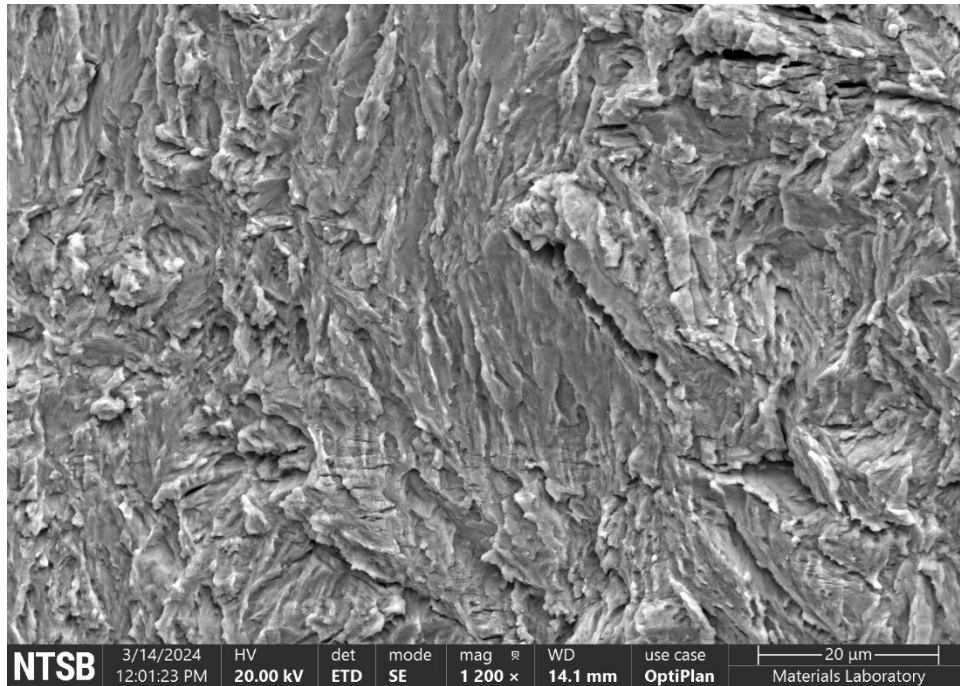
**Figure 23.** Typical transgranular fatigue fracture features through the thickness of the clutch outer race input shaft.

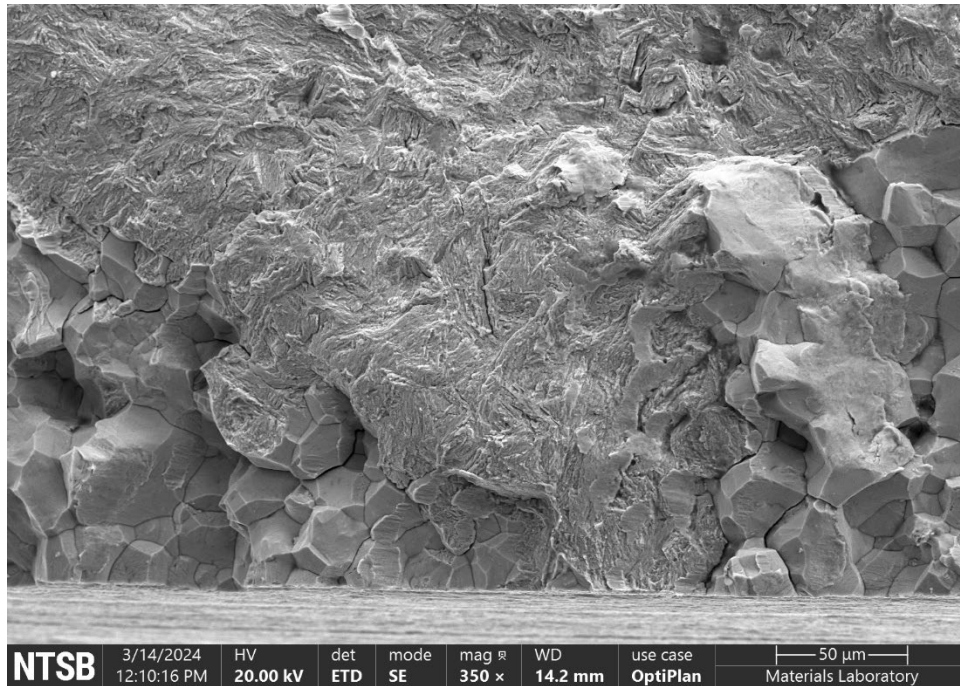
The intergranular features associated with the circumferential crack varied in depth and were discontinuous at the exterior surface. An SEM image of the fracture features adjacent to the exterior surface at the clockwise end of the origin area is shown in figure 25. Transgranular fatigue features emanating from the intergranular features at the right side of the image intersect the exterior surface and an adjacent region of intergranular fracture shown at the left side of the image. Further from the

**Figure 25.** End of the fatigue origin area where transgranular fatigue features were observed intersecting the exterior surface between two regions of intergranular fracture features.

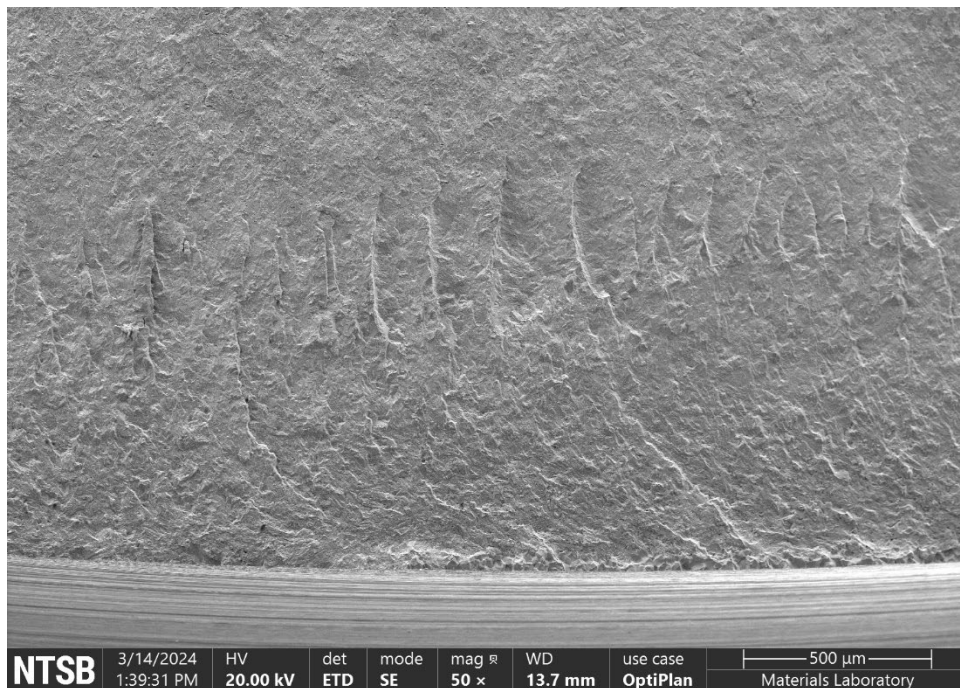
origin near the clockwise end of the circumferential crack, the intergranular fracture features were limited to several grains deep or less (up to 0.0024 inch or 60 microns deep) as shown in figure 26. The image in figure 26 shows the clockwise end of the intergranular fracture features where fatigue fracture propagation extending clockwise from the intergranular region had transgranular fatigue fracture features intersecting the exterior surface.

**Figure 26.** Overall view of the fracture features adjacent to the surface near the clockwise end of the circumferential crack showing a reduced extent of intergranular fracture at the origin area.
