# National Transportation Safety Board

## **MATERIALS LABORATORY**

Factual Report 24-030

Location: Waldorf, Maryland  
Date: July 9, 2023  
Vehicle: Hughes 369D, N5027P  
Investigator: Chihoon Shin, AS-40

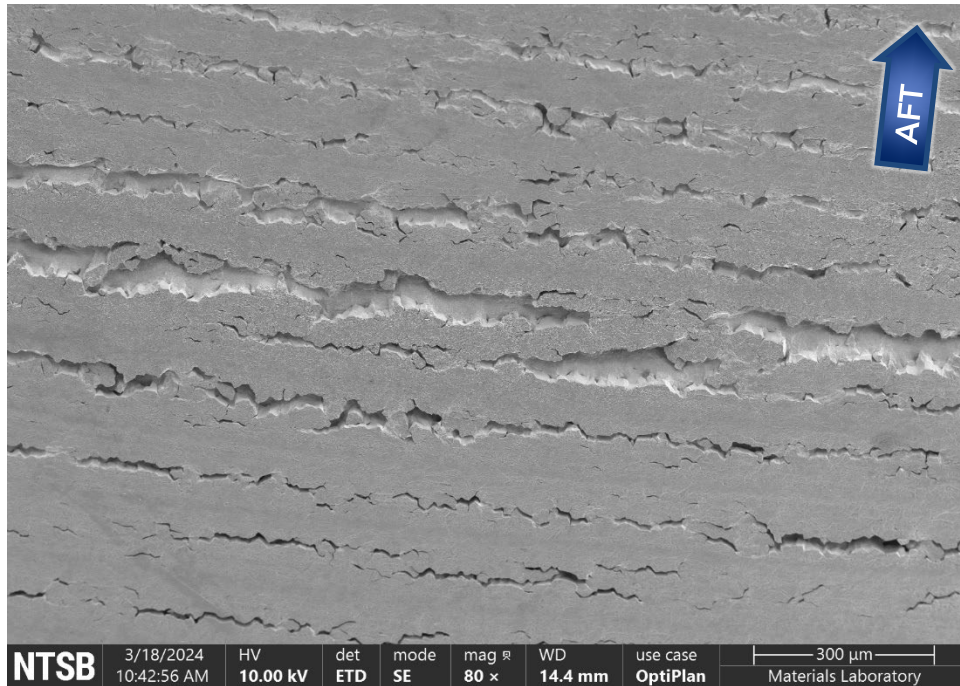
In the process of opening the portion of the circumferential crack shown in the upper image in figure 15, the input shaft wall aft of the crack was bent to a curved shape. As the input shaft wall was bent, a series of parallel secondary cracks and microcracks opened on the exterior surface. The bent piece was cleaned with acetone, and the secondary cracks and microcracks were examined using the SEM. A series of secondary microcracks on the external surface of the bent input shaft piece at the forward end near the fillet are shown in figure 27. The microcracks had intergranular fracture paths along the surface. Some of the microcracks were gaped open, showing ductile deformation at the tip of the intergranular fracture features. A closer view of one of these opened microcracks is shown in figure 28. As shown in figure 28, the intergranular features typically extended 1 to 2 grains deep near the forward end of the shaft adjacent to the fillet. Cracks in the fillet area appeared to extend deeper, but the cracks were also not opened as wide to view the extent of cracking. Further aft on the shaft surface, the external surface had a more rippled appearance consistent with plastic deformation with intermittent areas of shallow intergranular microcracks.

**Figure 27.** Secondary cracks on the shaft segment aft of the fillet radius that opened from lab-induced plastic deformation produced when exposing the circumferential crack.

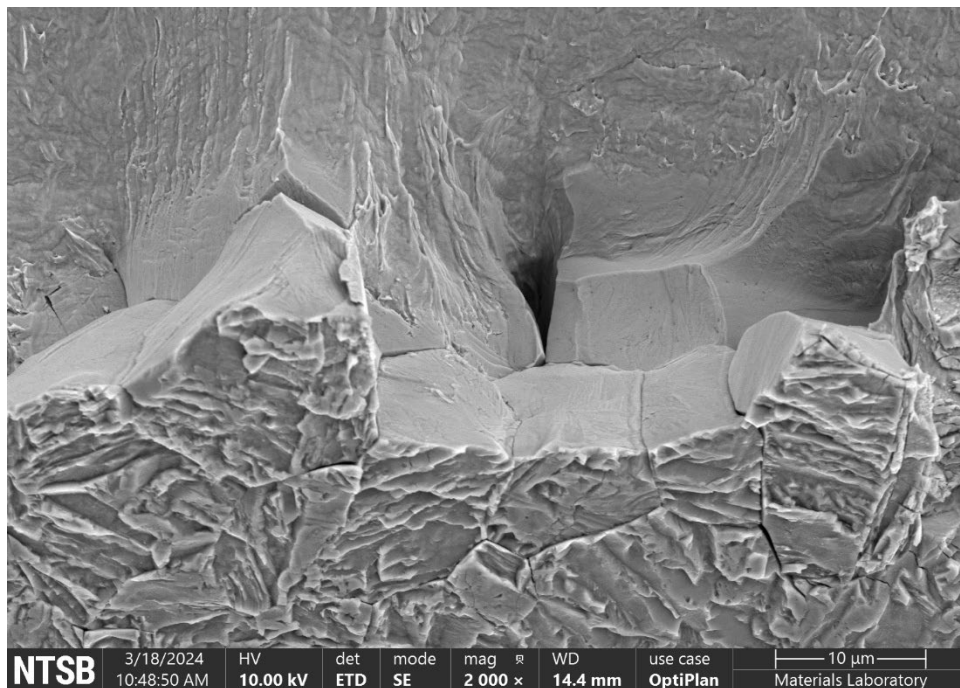
**Figure 28.** Intergranular fracture features across 1 to 2 grains typical of the opened secondary cracks shown in the previous figure.

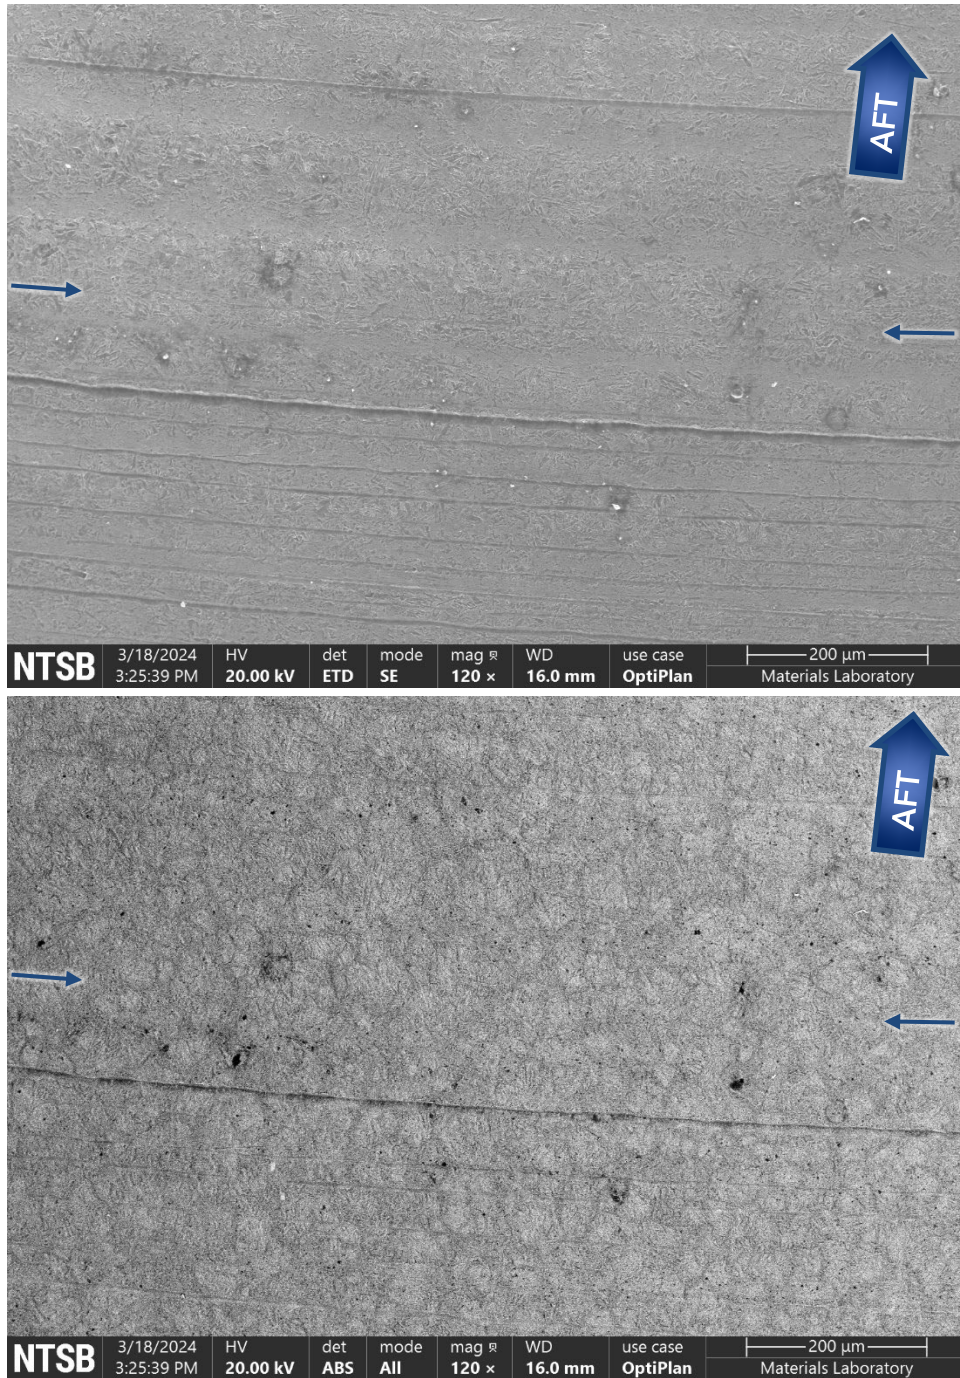
The intact fillet radius on the clutch outer race forward of the spiral portion of the fracture was examined using the SEM. The fillet radius surface is shown in figure 29 as viewed using the secondary electron detector (upper image) and the backscattered electron detector in composition mode (lower image). Unlabeled arrows in figure 29 indicate the approximate circumferential plane associated with the circumferential crack on the opposite side of the clutch outer race. In the upper image, circumferential scratch marks are shown interrupting the surface texture, indicating they occurred after the overrunning clutch had been etched during the manufacturing process. The lower image shows slight variations in contrast appearing as a cell-like network of compositional difference likely associated with the black oxide treatment applied at manufacture. At higher magnification, a network of possible intergranular microcracks were observed on the surface as indicated with unlabeled arrows in figure 30. These possible microcrack features were observed to be most concentrated near the middle of the fillet radius.

**Figure 29.** SEM images of the surface of the fillet radius in the intact side forward of the spiral fracture surface as viewed using the secondary electron detector (upper image) and the backscattered electron detector in composition mode (lower image). Arrows indicate the approximate location where the fillet was cracked on the opposite side of the clutch outer race.

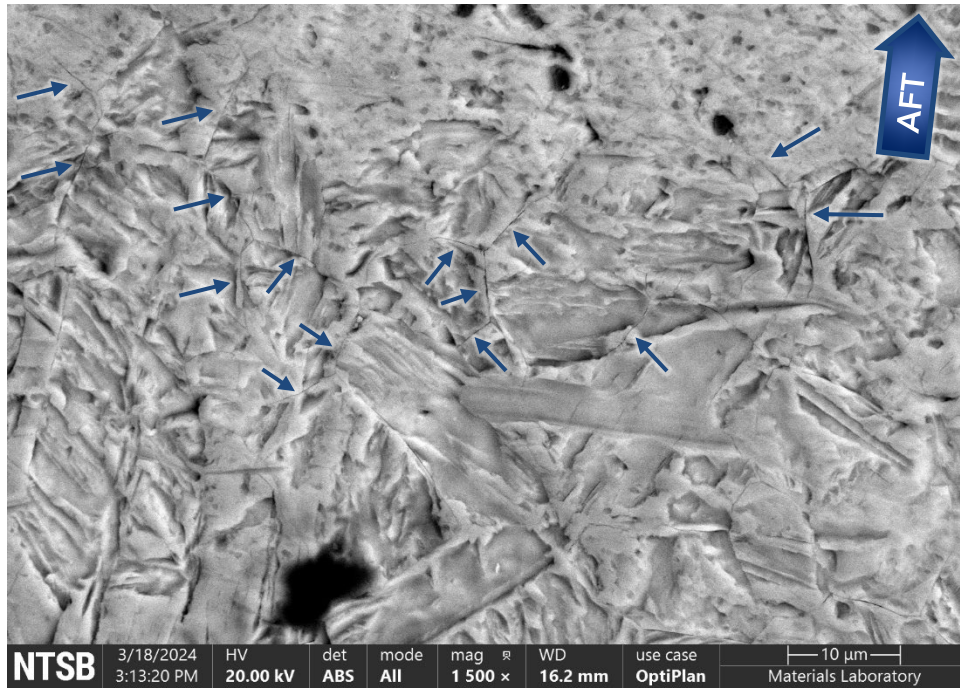
**Figure 30.** SEM image using the backscattered electron detector in composition mode showing intergranular crack features (indicated with unlabeled arrows) on the surface shown in the previous figure.

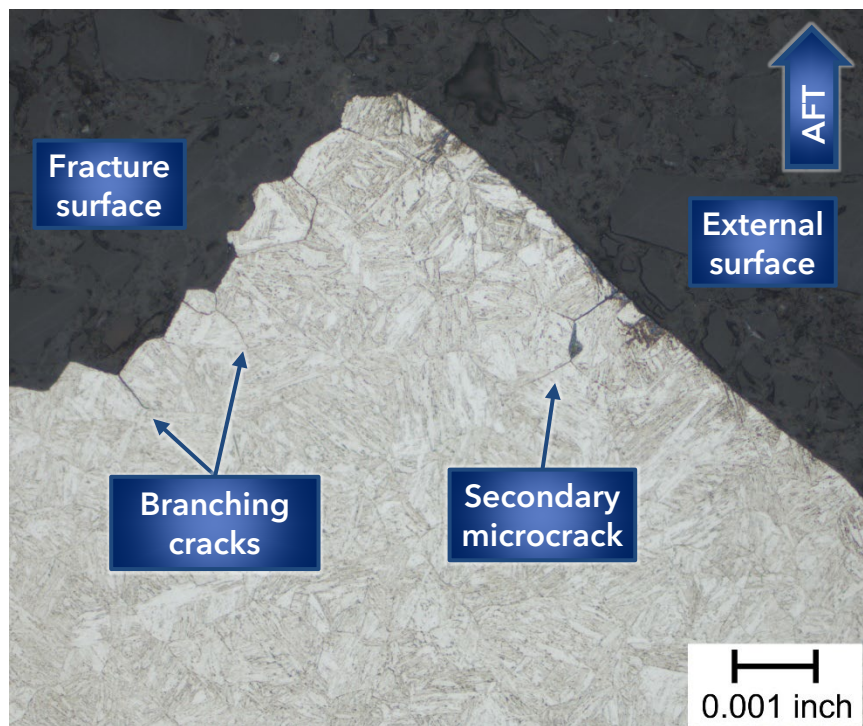
appearance adjacent to the external surface (figure 31) as in the core away from the surface (figure 32). The opened circumferential crack showed an intergranular fracture path extending from the external surface that appeared to follow the prior austenite grain boundaries. Some crack branching was observed as indicated, but the branching cracks were generally limited less than 2 grains from the main crack path. A secondary microcrack with limited branching and an intergranular fracture path extending approximately 2 grains deep in the polished plane was observed emanating from the external surface in the fillet area adjacent to the primary crack as shown in figure 31.

**Figure 31.** Optical micrograph of the polished and etched cross-section of the circumferential crack in the clutch outer race at the origin area. (Etchant: 2% nital)

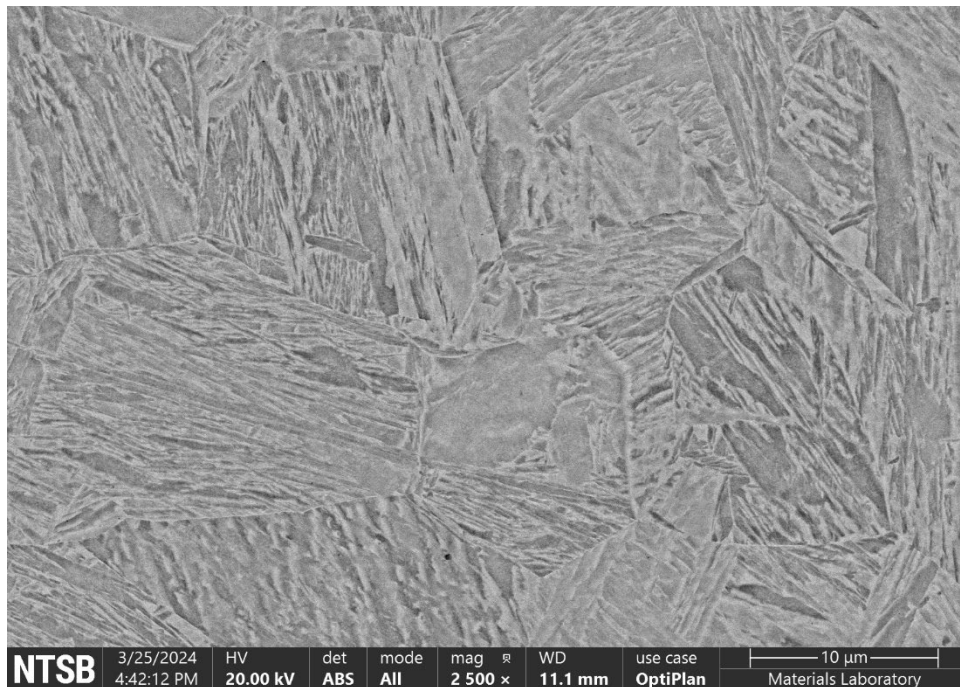
The metallographic sample shown in figure 31 was further examined using the SEM. Images of the typical etched microstructure are shown in figures 33 through 35 as imaged using the backscattered electron detector in composition mode. The microstructure adjacent to the exterior surface in the fillet region is shown in figure 33, and the microstructure adjacent to the surface further forward on the shoulder for the clutch outer race is shown in figure 34. Both areas had similar microstructural features, and both were similar to the microstructure deeper into the wall thickness adjacent to the circumferential crack surface where the crack had a transgranular fracture path as shown in figure 35.

**Figure 35.** SEM image of typical etched microstructural features adjacent to the circumferential crack where the crack had a transgranular fracture path viewed using the backscattered electron detector in composition mode. (Etchant: 2% nital)

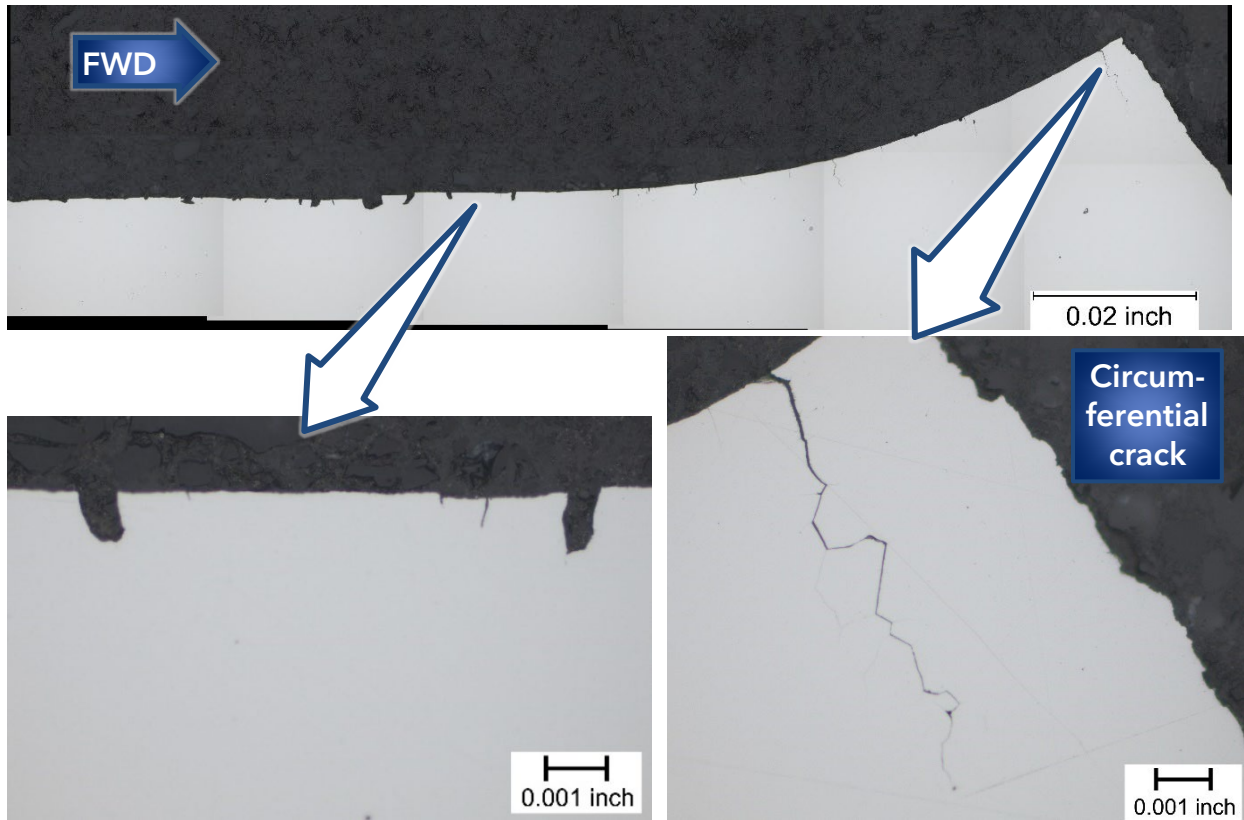
A piece of the bent shaft wall that had the series of opened secondary cracks shown in figures 27 and 28 along with the aft side of the opened circumferential crack was mounted and polished for metallographic examination of the cross-section. A montage of optical images stitched to show an overall view of the surface aft of the opened circumferential crack is shown in the upper image in figure 36. As shown in the stitched image, a series of secondary cracks with intergranular fracture paths were observed at the exterior surface that generally extended deeper in the fillet radius and generally became shallower further aft on the shaft. As shown in the lower right image in figure 36, a secondary crack was observed extending up to 0.0083 inch deep adjacent to the opened circumferential crack. The secondary crack had a jagged fracture path consistent with intergranular fracture and showed crack branching that was generally limited to one grain away from the main crack path.

The lower left image in figure 36 shows secondary microcracks in the shaft portion of the clutch outer race just aft of the fillet radius. The microcracks were shallower (0.002 inch deep or less), appearing to extend approximately 1 to 2 grains deep, and many of the cracks were gaped open with blunt crack tips.

**Figure 36.** Polished cross-section through the clutch outer race shaft after opening the circumferential crack. The upper image is a montage of optical images stitched to show an overall view of the surface aft of the opened circumferential crack. The lower images show secondary microcracks with blunted crack tips approximately 1 to 2 grains deep on the shaft (lower left image) and a deeper intergranular secondary crack in the fillet radius near the opened circumferential crack (lower right image).

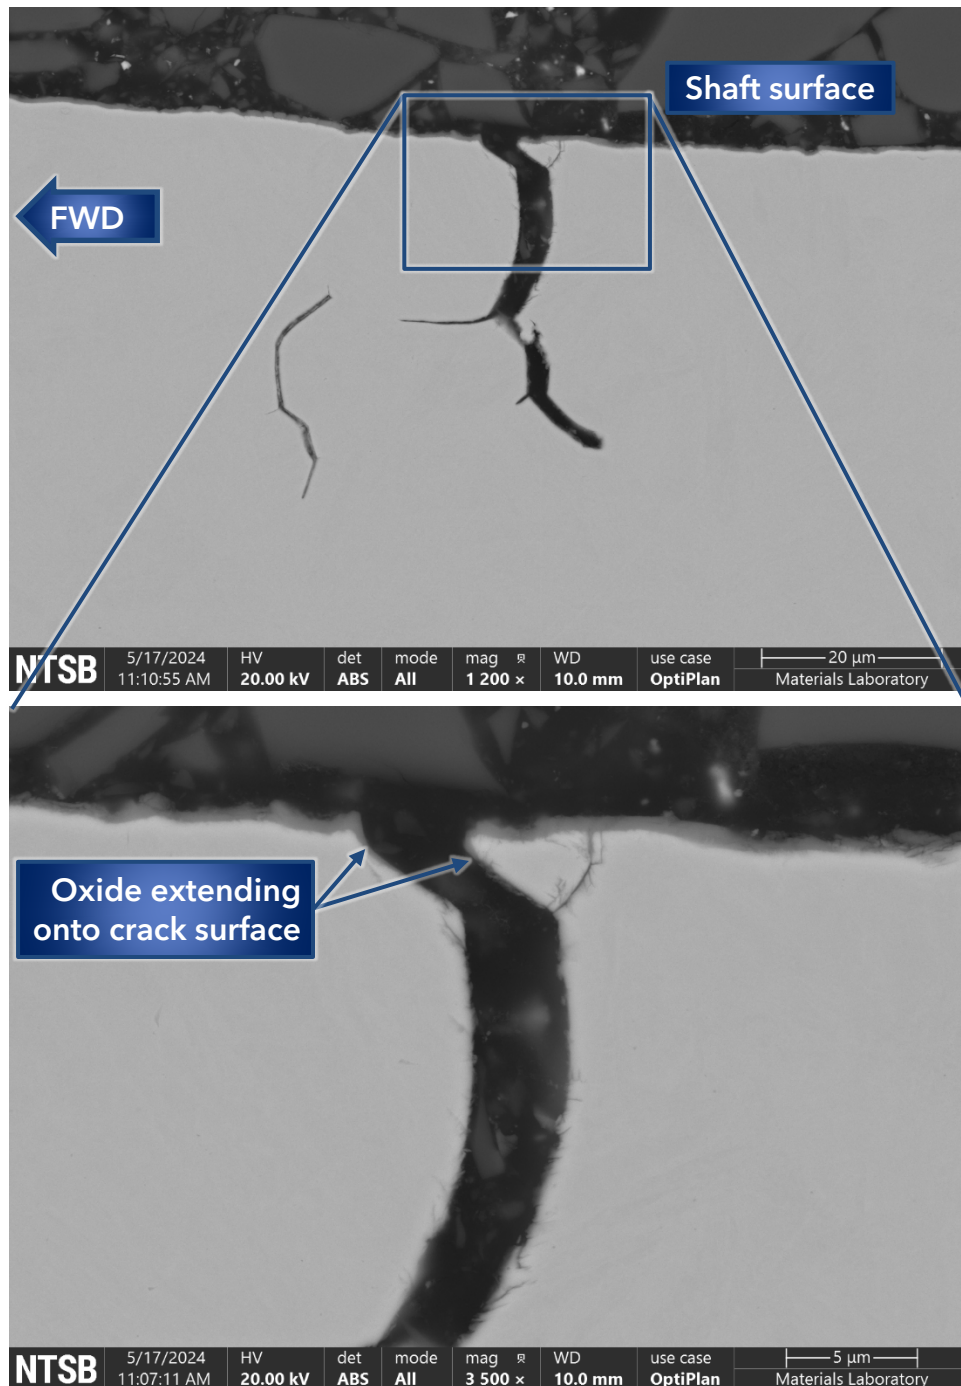
detector in composition mode. The cracks had apparent intergranular fracture paths. At the surface, a thin coating with a relatively darker shade of gray was observed consistent with the black oxide layer applied during manufacturing of the clutch outer race. As indicated in the lower images in figures 37 and 38, the darker gray layer appeared to extend onto the crack surface with tapering thickness along the apparent grain boundary for the first grain. In many of the microcracks, dark microcrack-like features extended from the grain boundary into the grains in the first two grains from the surface. These dark branching microcrack-like features appeared to correspond to the dark microstructural features observed on the grain surfaces as shown in figure 19. When analyzed using EDS in spot mode, the dark branching microcrack-like features had a relatively high peak of oxygen when compared to the adjacent areas of the grain cross-section.

**Figure 37.** SEM images of a secondary microcrack in the as-polished metallurgical sample from the shaft portion of the clutch outer race after the lab-induced fracture of the circumferential crack.

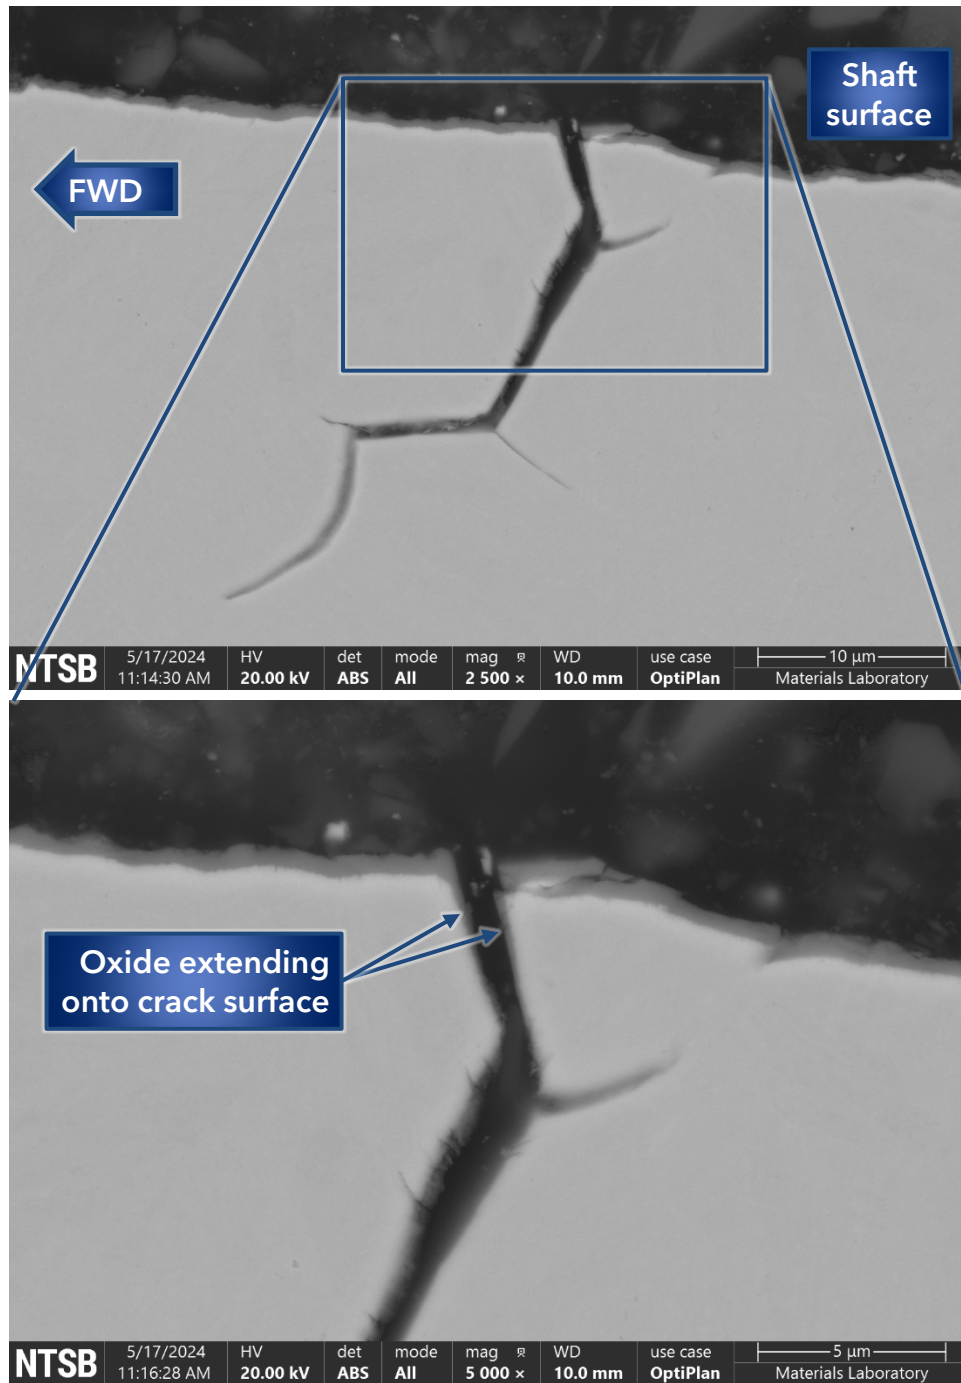
**Figure 38.** SEM images of a secondary microcrack in the as-polished metallurgical sample from the shaft portion of the clutch outer race after the lab-induced fracture of the circumferential crack.

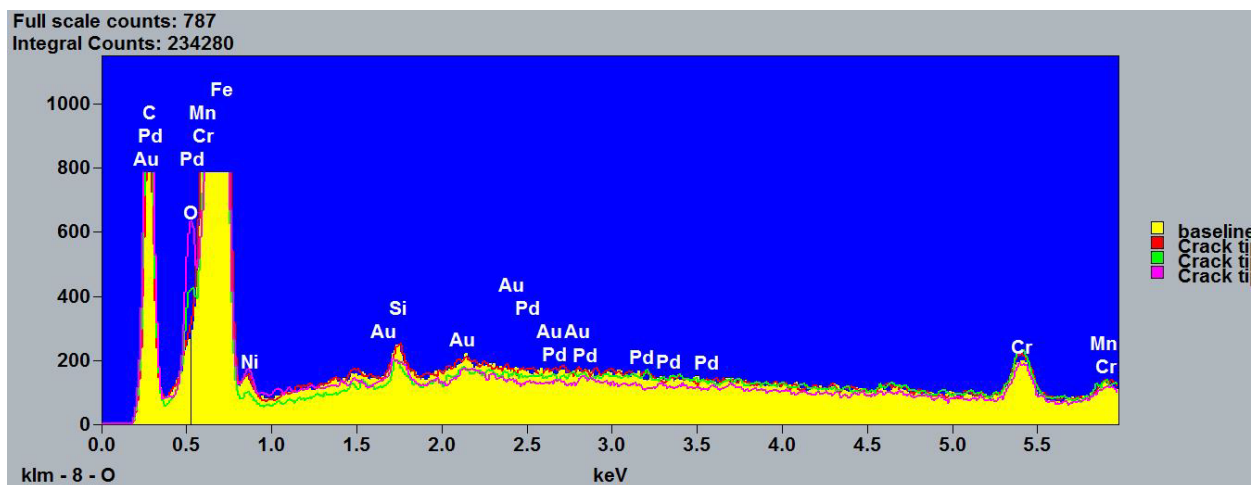
Several EDS spectra were obtained from areas at the tip of one of the microcracks. When acquiring the EDS spectra, the SEM beam was set to spot mode with the spot aimed in the microcrack near the crack tip. The resulting spectra were compared to a baseline spectrum obtained deeper in the cross-section away from the surface. A comparison of the EDS spectra is shown in figure 39. The EDS spectra obtained in the microcrack showed elevated peaks of oxygen compared to the baseline spectrum. Peaks for the remaining elements were similar to the baseline spectrum.

**Figure 39.** Baseline EDS spectrum (shown in yellow) of the clutch outer race material obtained from the gold/palladium coated metallurgical sample shown in figure 36 with overlaid spectra displayed as red, green, and magenta lines obtained in spot mode aimed in an intergranular crack near the crack tip.
