# National Transportation Safety Board

ERA23LA293

Specialist's Factual Report

Location: Waldorf, Maryland  
Date: July 9, 2023  
Time: 1027 eastern daylight time  
Helicopter: MD Helicopters 369D, registration N5027P

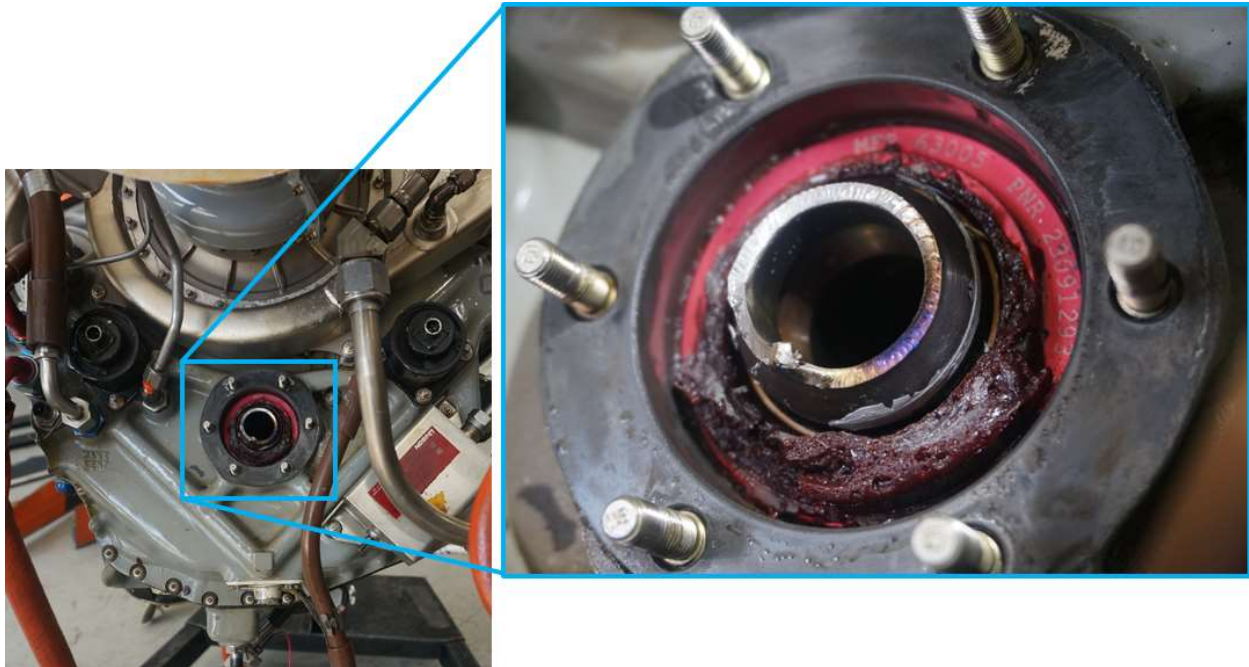
**Figure 1.** The fractured outer race splined shaft of the overrunning clutch, still installed in the engine gearbox.

The overrunning clutch assembly was examined by the NTSB Materials Laboratory in Washington, DC. Examination of the fracture surface showed signatures consistent with fatigue. Other notable findings included evidence of a gap between the forward-most bearing's inner race and the clutch inner race shoulder, off-axis sprag contact marks around the circumference of the outer race, and asymmetric contact marks on the wave washer. Additionally, secondary microcracks were observed on the shaft portion of the clutch outer race. For additional details of the clutch assembly examination, see NTSB Materials Laboratory Report No. 24-030 in the docket for this investigation.

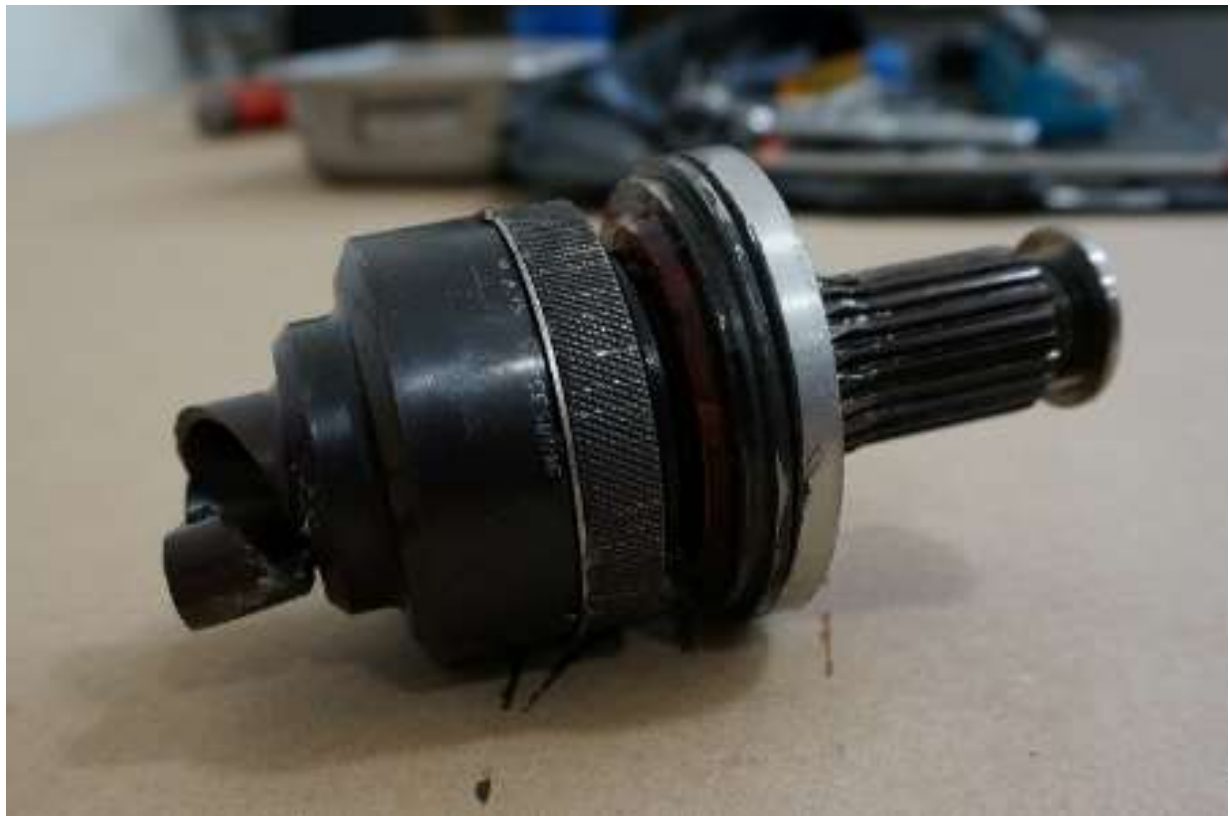
**Figure 2.** The accident overrunning clutch subassembly.

The accident helicopter, serial number (S/N) 611002D, was manufactured in 1981. At the time of the accident, the helicopter had an aircraft total time (ATT) of 24,821.4 hours and a Hobbs time of 709.7 hours. According to the operator's maintenance records, the accident overrunning clutch subassembly was P/N 369A5350-51 and S/N 6968, which were confirmed during examination of the component.
