# National Transportation Safety Board

ERA23LA293

## **MATERIALS LABORATORY**

Factual Report 24-039

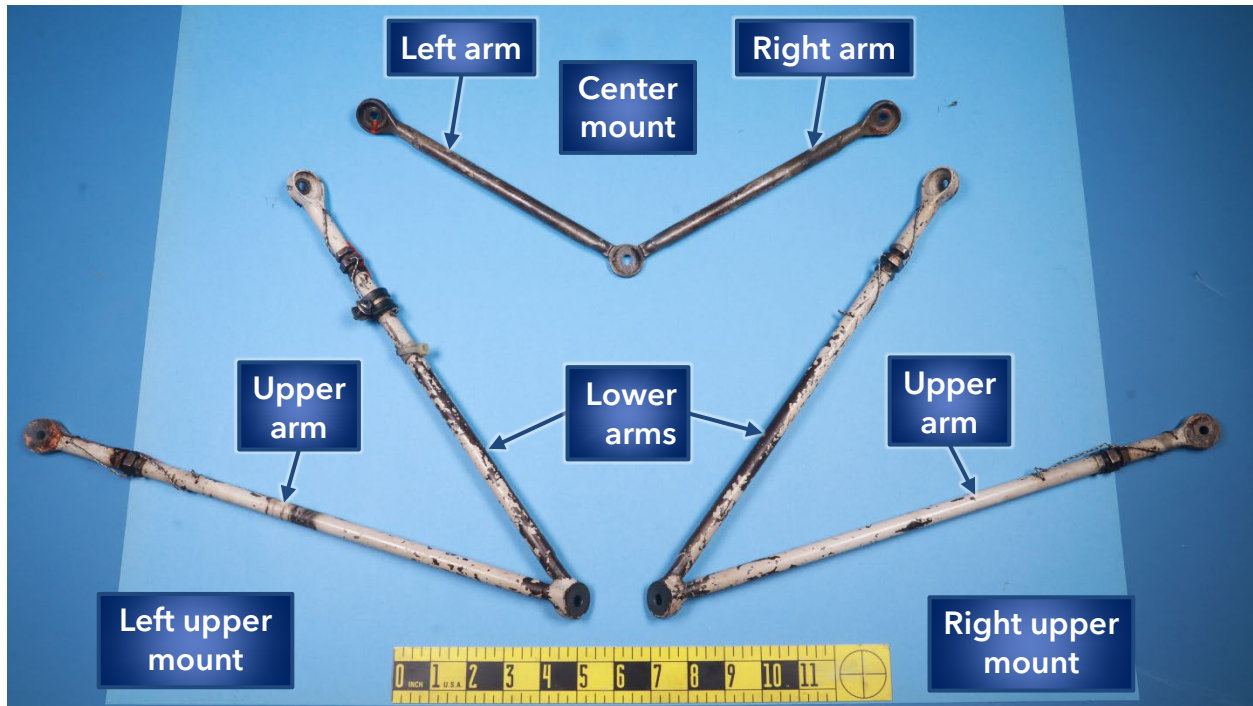
An overall view of the submitted engine mounts as received is shown in figure 1. The engine mounts were intact as shown, and the arms appeared to be straight. Welded areas attaching the arm tubes to the fittings at the inboard ends of the upper mounts and at the center and outboard ends of the center mount were examined at up to approximately 50x magnification using a stereo microscope, and no evidence of cracks were observed.

**Figure 1.** Overall view of the submitted engine mounts.
