ERA23LA297

## INVESTIGATION PHOTOGRAPHS

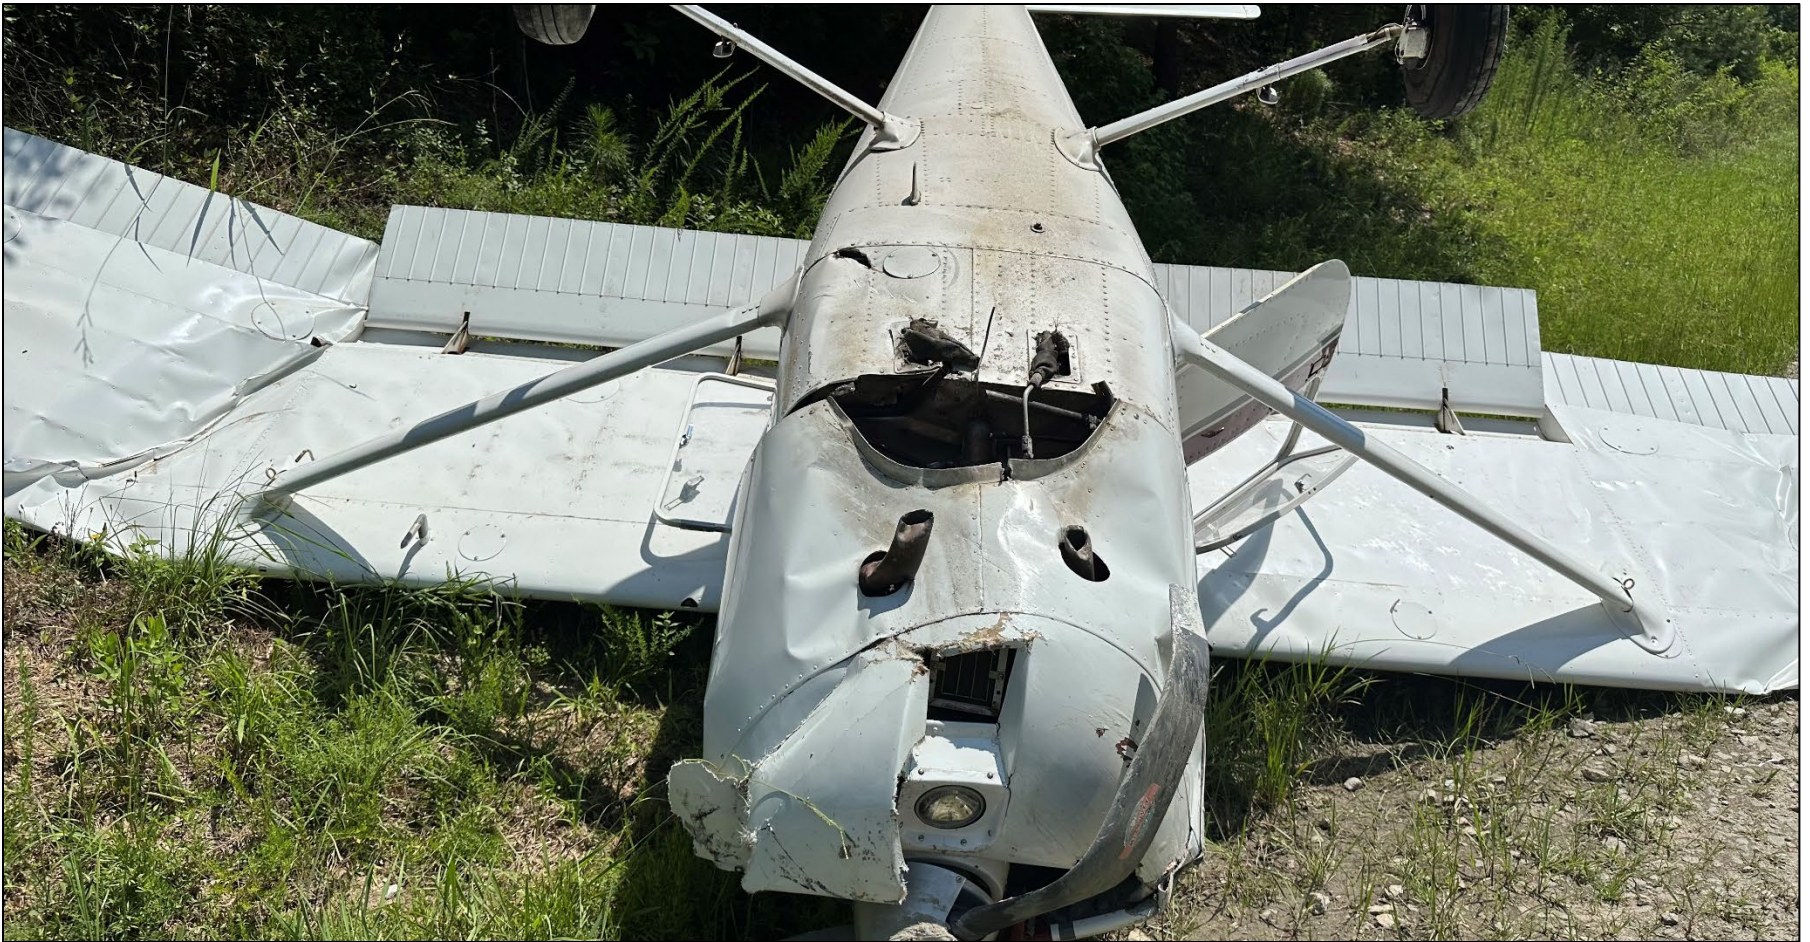
**Photo 1: View of the airplane at the accident site nosed over (Photo Courtesy of FAA)**

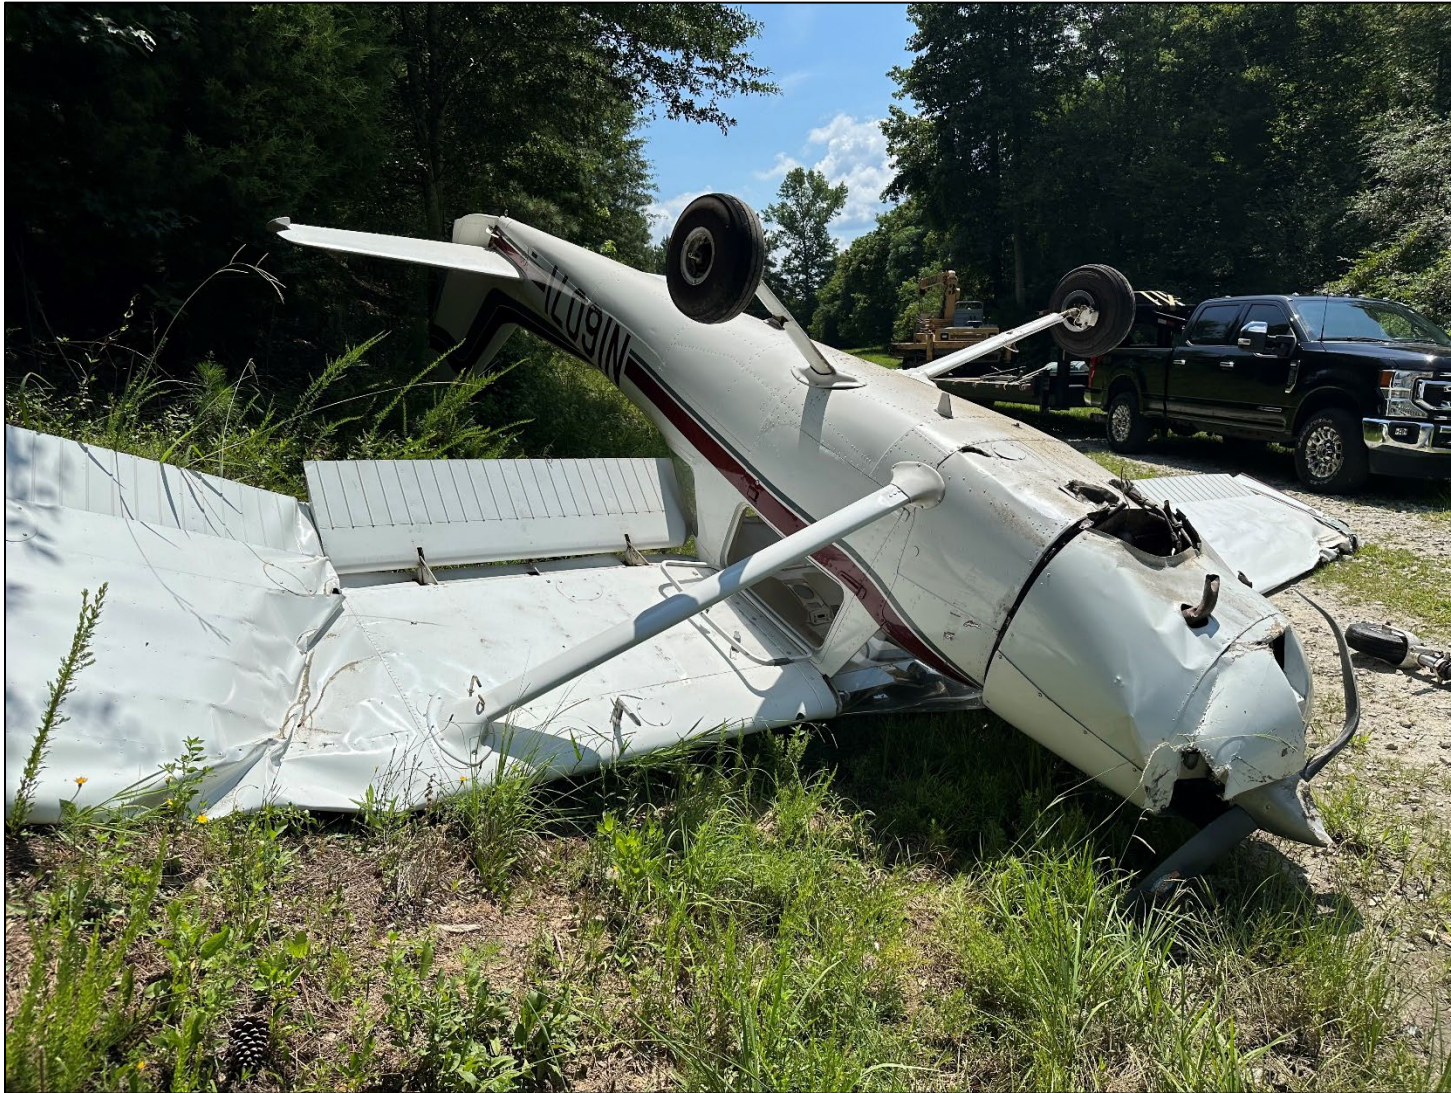
**Photo 2: View of the airplane at the accident site nosed over (Photo Courtesy of FAA)**

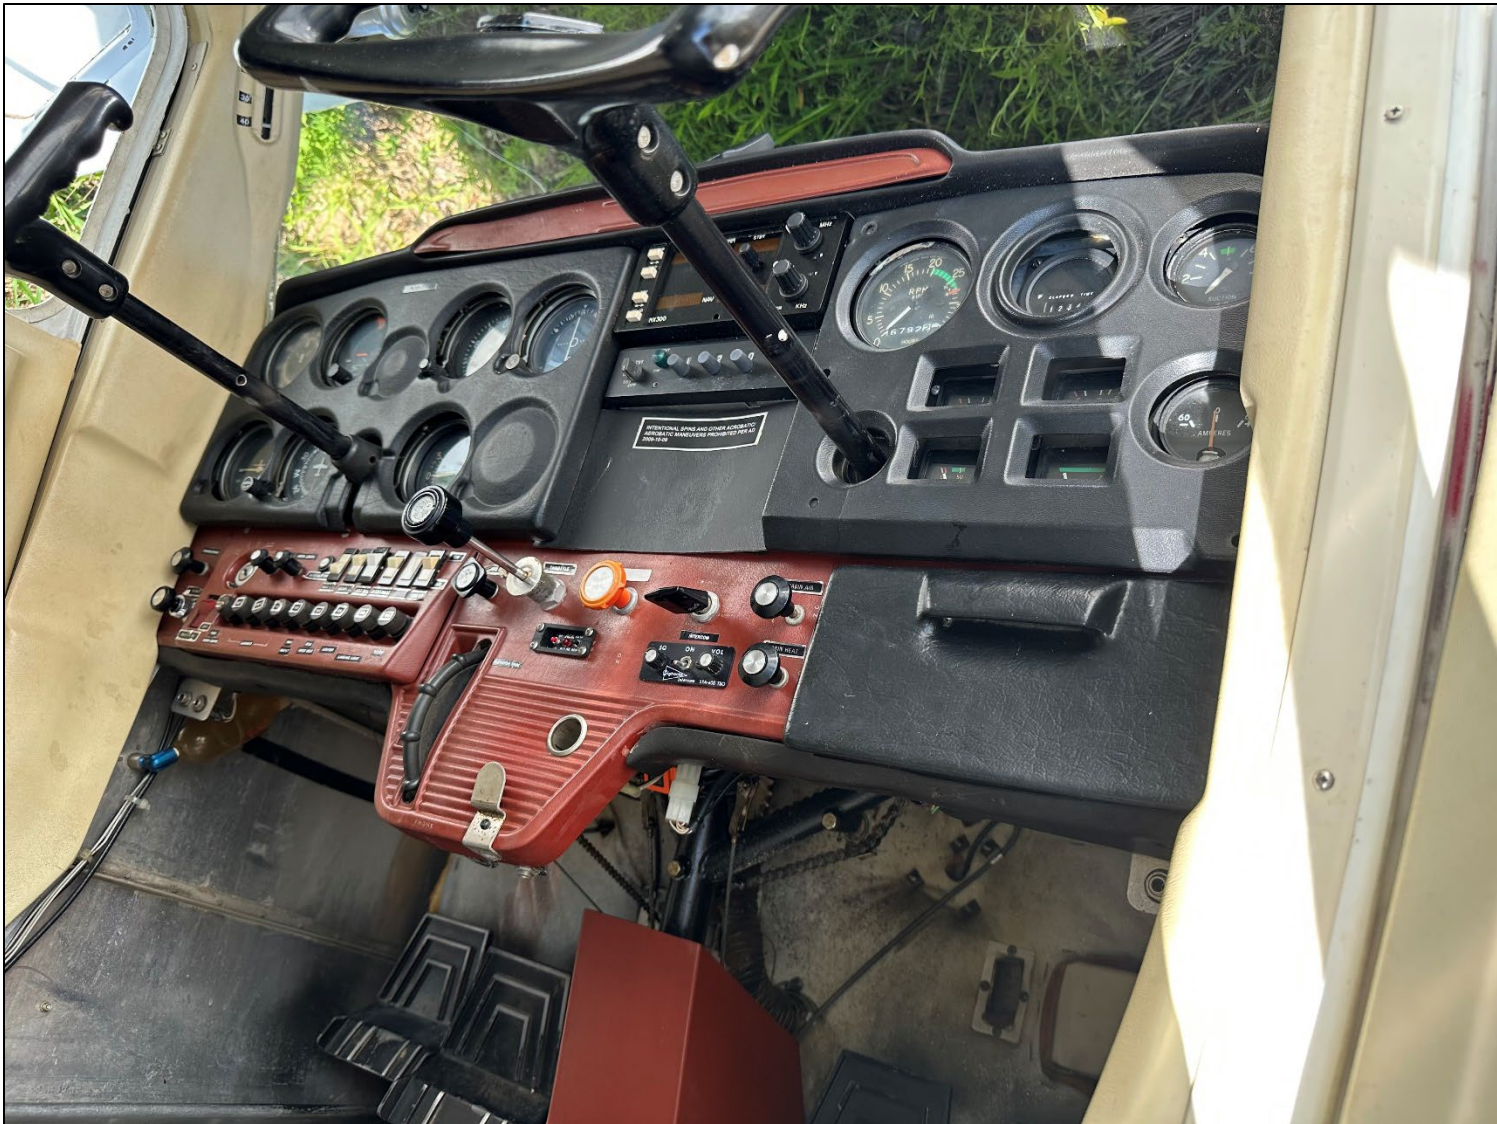
**Photo 3: View of the cockpit at the accident site (Photo Courtesy of FAA)**

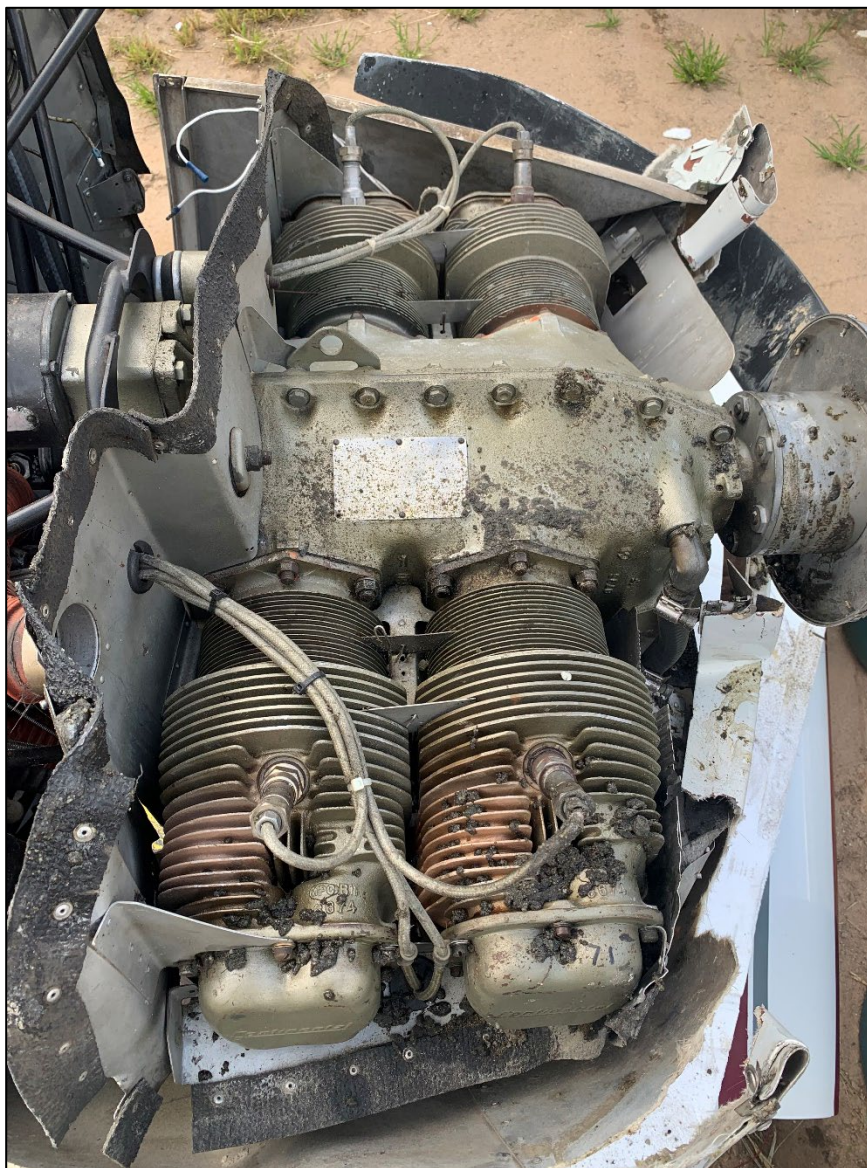
**Photo 4: View of the engine at the accident site (Photo Courtesy of FAA)**

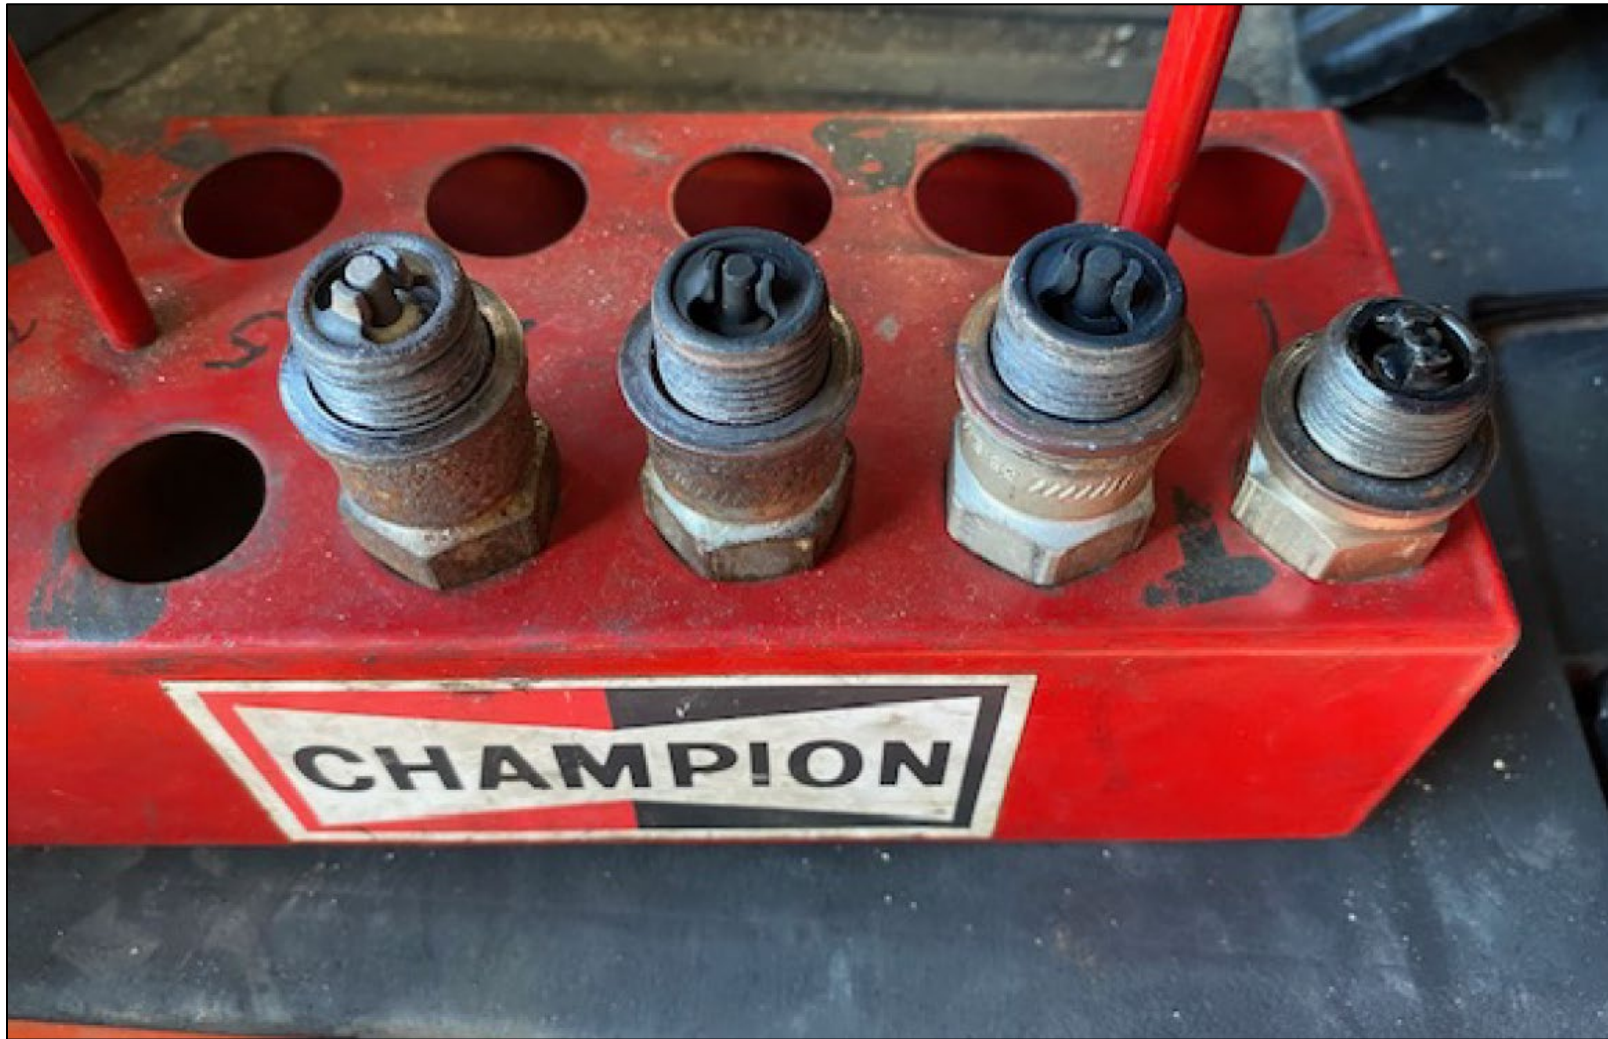
**Photo 5: View of the top spark plugs (Photo Courtesy of FAA)**

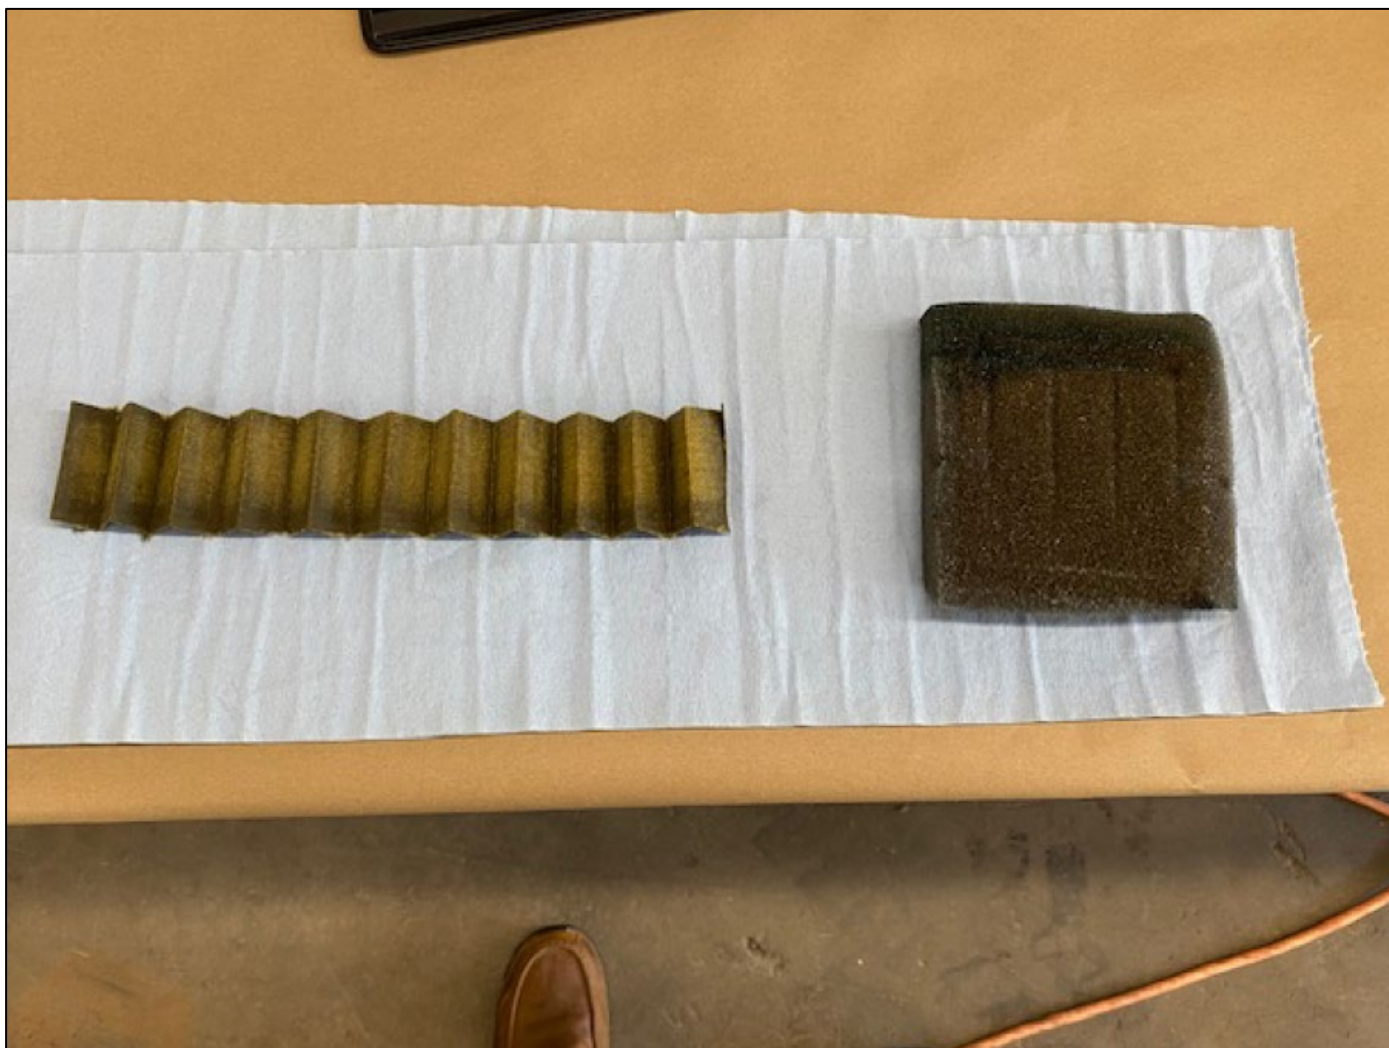
**Photo 6: View of the engine filters (Photo Courtesy of FAA)**

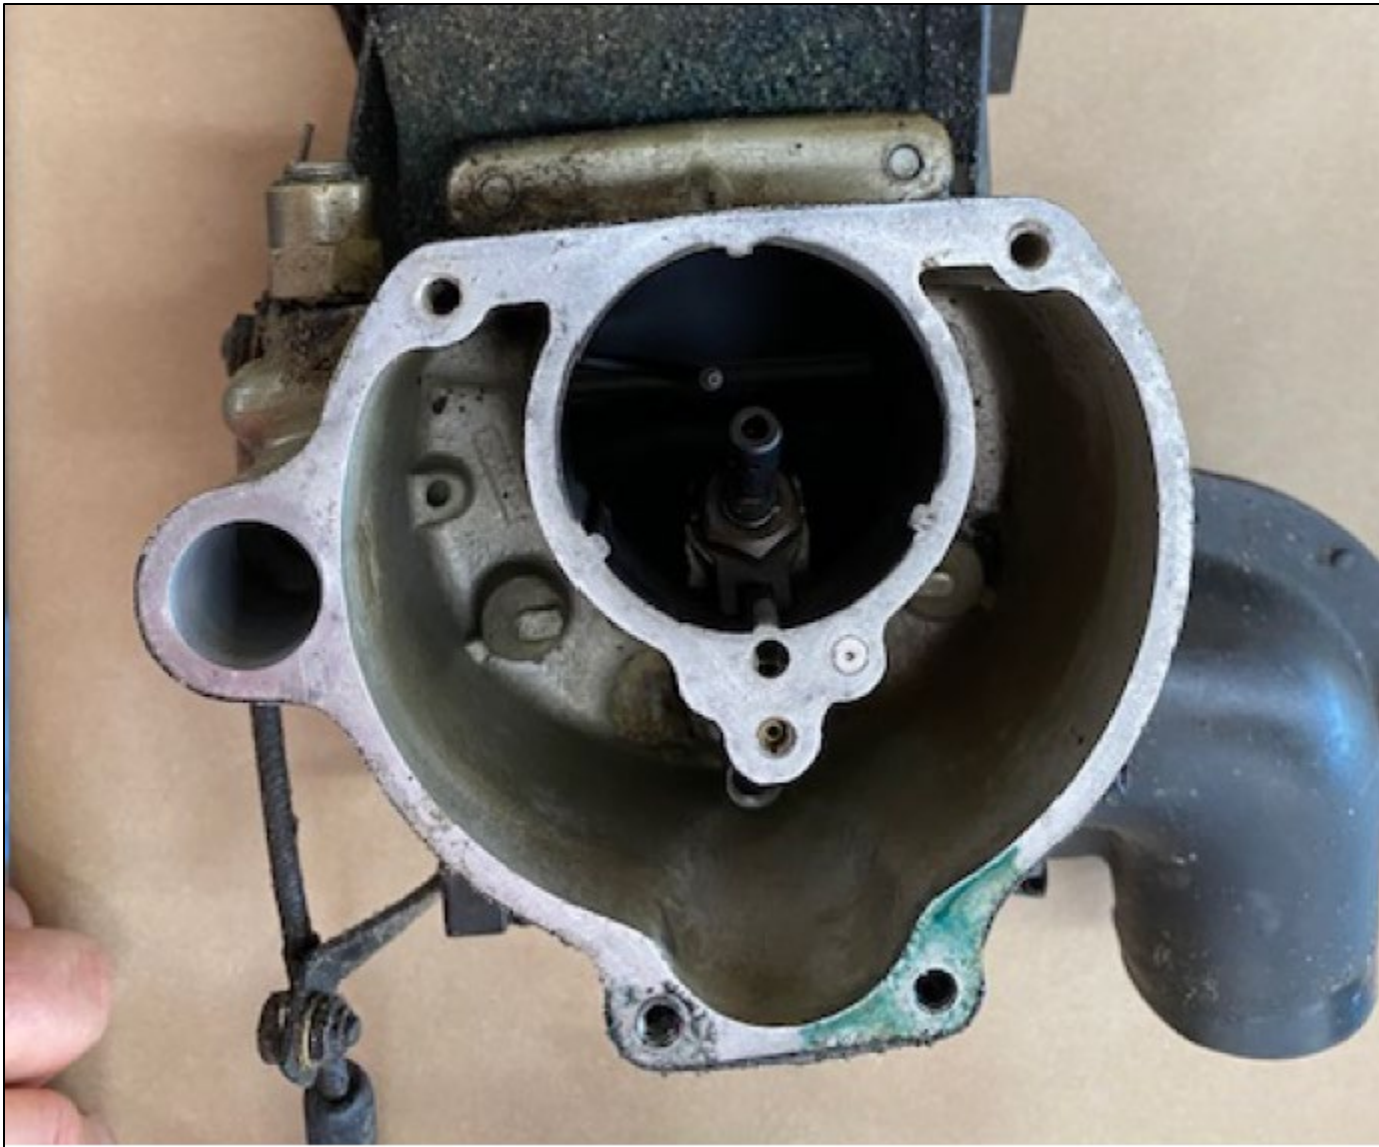
**Photo 7: View of the partially disassembled carburetor (Photo Courtesy of FAA)**
