A-4K, T/N N143EM, 12 July 2023

**DRAKEN INTERNATIONAL**  
**AIRCRAFT ACCIDENT INVESTIGATION**  
**RELEASABLE PRELIMINARY REPORT**

**A-4K, T/N N143EM  
MARINE CORPS AIR STATION, CHERRY POINT, NORTH CAROLINA  
12 JULY 2023**

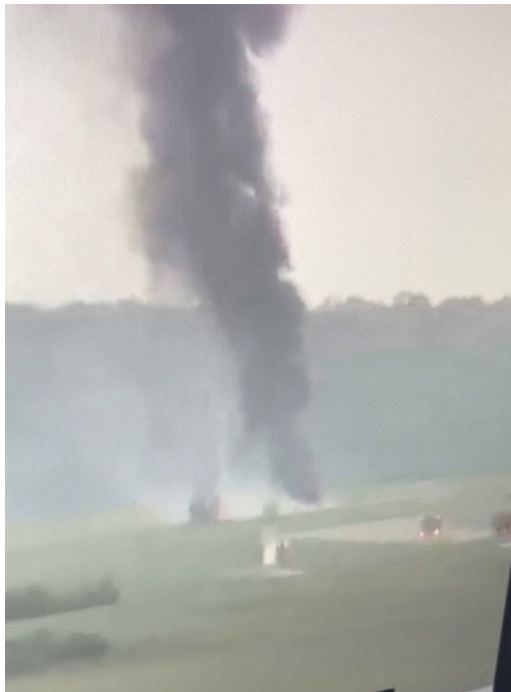
**MCAS Cherry Point security footage of N143EM accident**

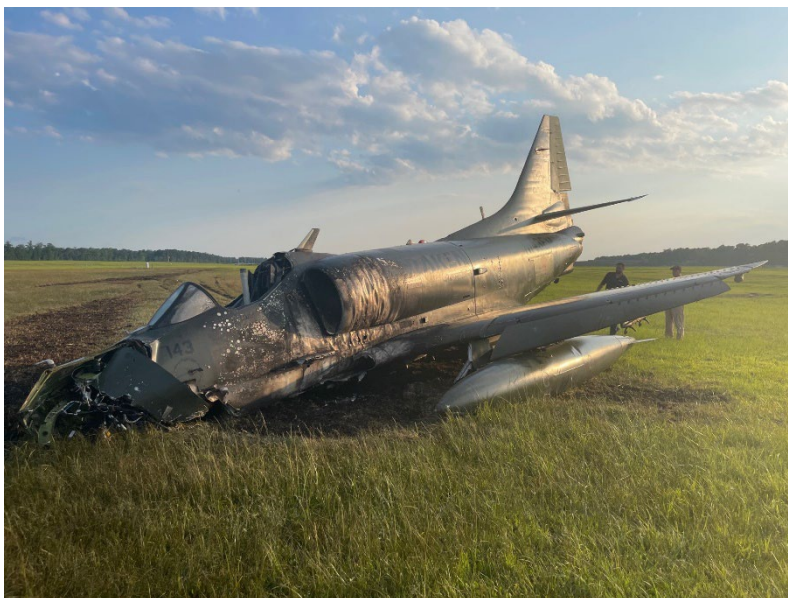
After ejection, the MA traveled for approximately 3,000 feet off the departure end of Runway 5L. One external fuel tank departed the aircraft, causing a fire which destroyed the external fuel tank and a majority of the fuselage, wings, and landing gear sections of the MA. The resulting impact and fire destroyed the MA.

**Aircraft N143EM at departure end of RWY 5L**

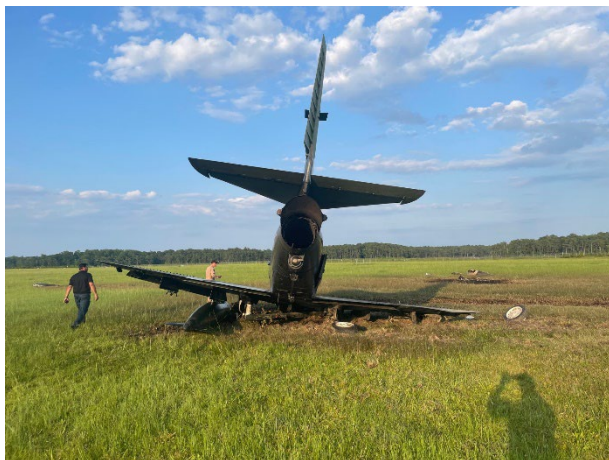
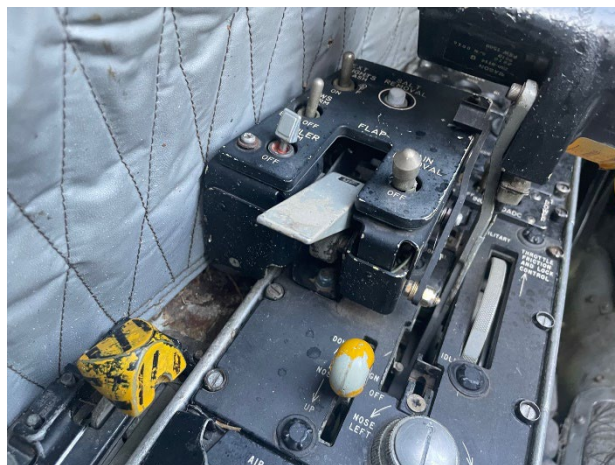
Regarding the flaps UP abnormality, there are several possible reasons this could have occurred. It is possible, however not probable, that the MP left the flaps in the UP position by mistake. This is not probable due to multiple witness statements saying the flaps were set appropriately to the takeoff position before the MA started its taxi. It is most probable that the flaps and flap lever were forced into the UP position during the ejection sequence or during the aircraft's violent departure from the runway.

**Flaps and Flap Switch discovered in the UP position**

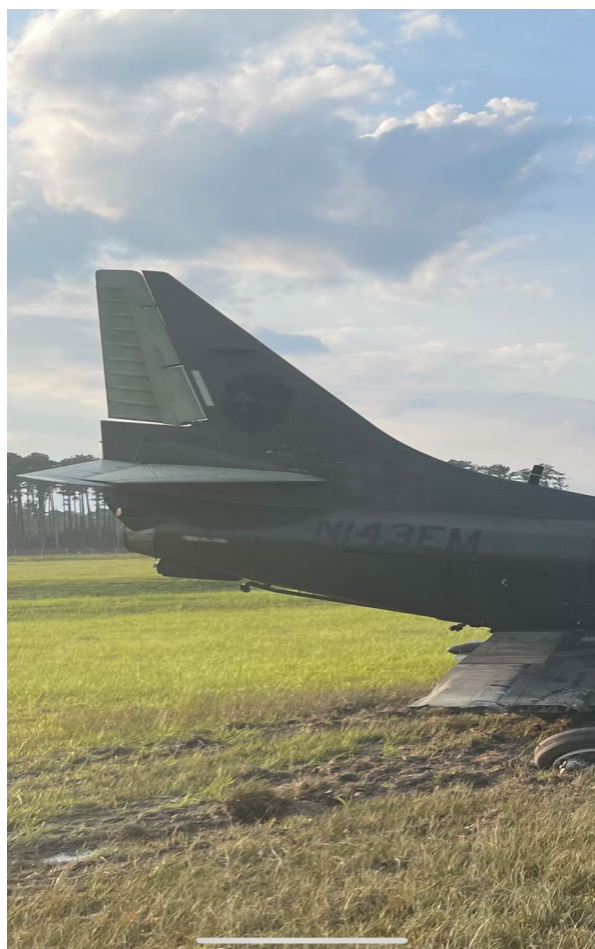
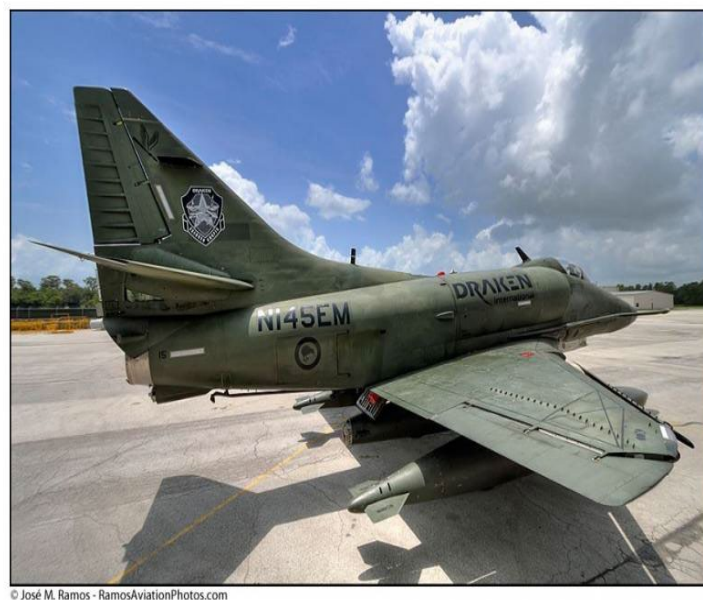
During recovery the horizontal stab was found at the zero degrees. Normal setting for takeoff is between 6 and 8 degrees, and this was checked by all ground maintenance personnel, the Mishap Flight Lead prior to takeoff, and by the Mishap Pilot internally prior to takeoff. This anomaly would be investigated by the safety team during the analysis phase of the investigation.

Regarding the stab position, during analysis the safety team verified the Horizontal Stabilizer Actuator Limit Switches and wiring read correctly. There were no shorts, opens, or anomalies to this system. Using the Horizontal Stabilizer Trim Test Box, the team verified that horizontal stabilizer trim traveled correctly when directed, both nose up and nose down directions. All indications of the stab trim system were of normal operation, meaning the trim switch and manual override stab switches were verified electrically neutral and not stuck in the up or down position. It is a possibility that the aircraft suffered a runaway nose down trim during the takeoff roll, which is a known anomaly in the A-4 Skyhawk, and has happened several times in the US Navy and US Marine Corps fleet history. This runaway nose down trim could have been either mechanical or electrical in nature.

From the beginning of the takeoff roll to the MP attempted rotation, the stabilator trim setting moved from 8 degrees to 0 degrees. The 0 degrees stabilator position prevented the aircraft from becoming airborne when rotation was attempted by the pilot. The exact cause of the trim change from 8 degrees to 0 degrees during the takeoff roll could not be determined. However, the following possibilities could not be ruled out as potential causal factors; the MP unintentionally moved the trim switch forward on the control stick while holding the stick full forward during the takeoff roll (holding the stick full forward on takeoff roll is normal procedure in the A-4) or the trim was moved by an input (runaway trim forward) not commanded by the MP. Either of the two scenarios are just as likely to have occurred.

**Stab position discovered in the 0 position (Left) / Normal 8 position (Right)**

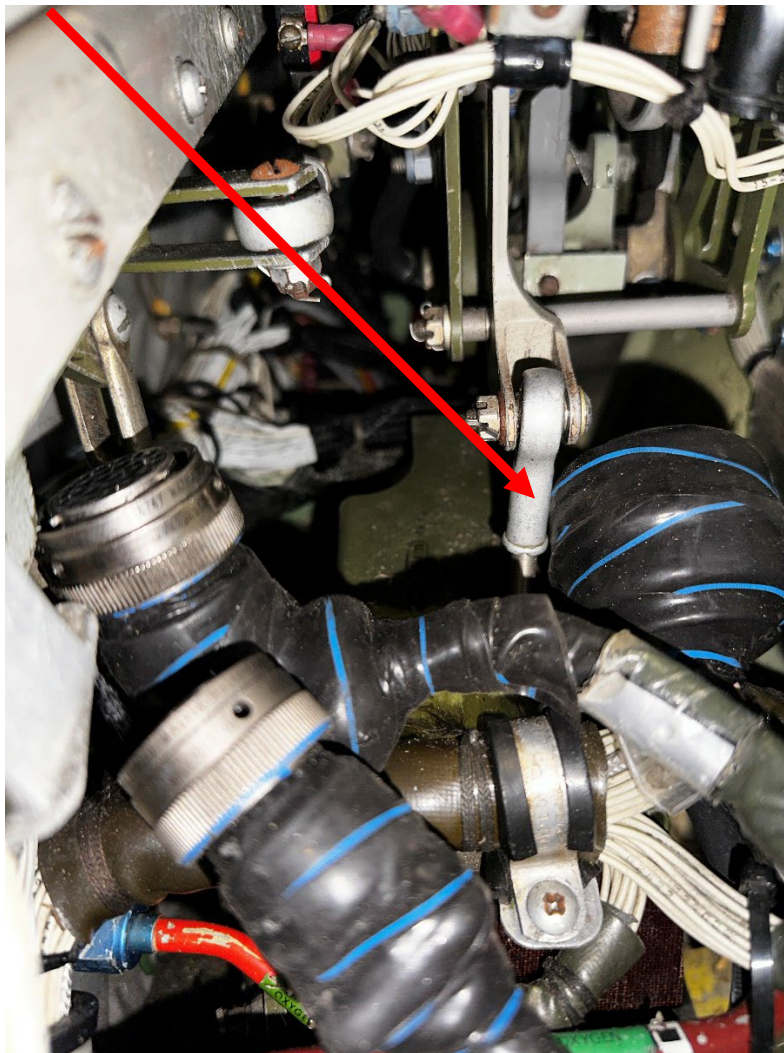
During further analysis, it was discovered in the front left throttle quadrant that the Air-to-Air Refueling Store Control Head Cannon Plug was loose. The Cannon Plug was resting against the Horizontal Stab Manual Override Push-Pull Rod End in such a manner that it may have impeded the normal operation of the Manual Override Switch. Although not conclusive, the possibility does exist that it may have interfered with the normal operation of the Trim Override Switch. The Cannon Plug also showed evidence of severe chafing which could have caused an abnormality in the pitch trim system when the Manual Override Switch is used.

- The Air-to-Air Refueling Store Control Head Cannon Plug was resting against the Horizontal Stab Manual Override Push-Pull Rod End in such a manner that it may have impeded the normal operation of the Manual Override Switch
  - This is not conclusive; however, the possibility does exist that it may have interfered with the normal operation of the Override Switch
- The Buddy Store Control Head Cannon Plug showed evidence of severe chafing

Original location of cannon plug

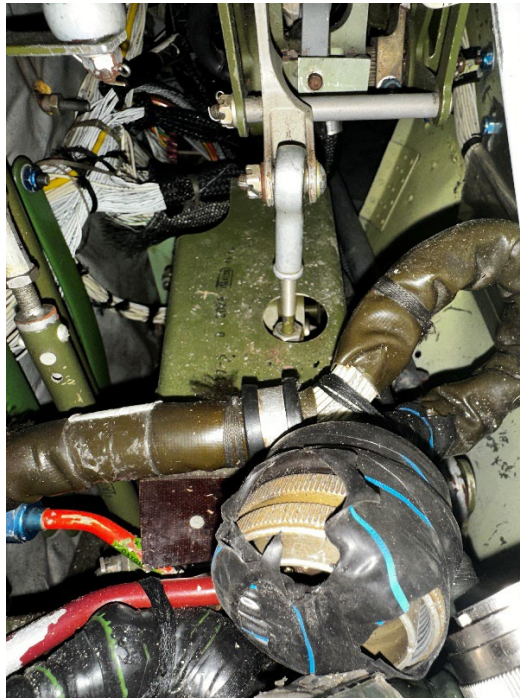
Cannon plug moved for clarity

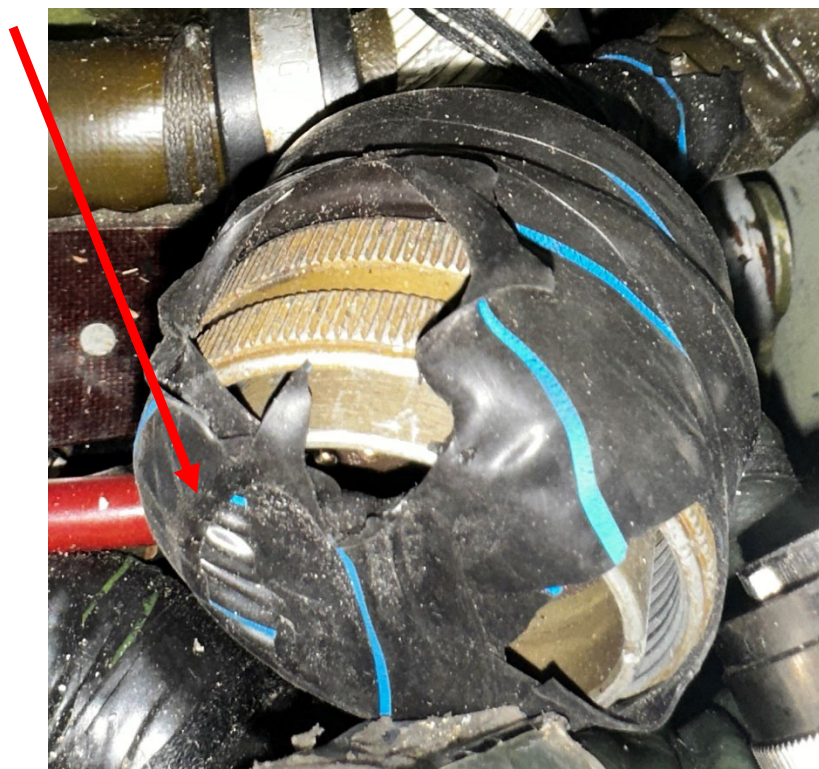
Chafing of cannon plug
