ERA23LA300

## INVESTIGATION PHOTOGRAPHS

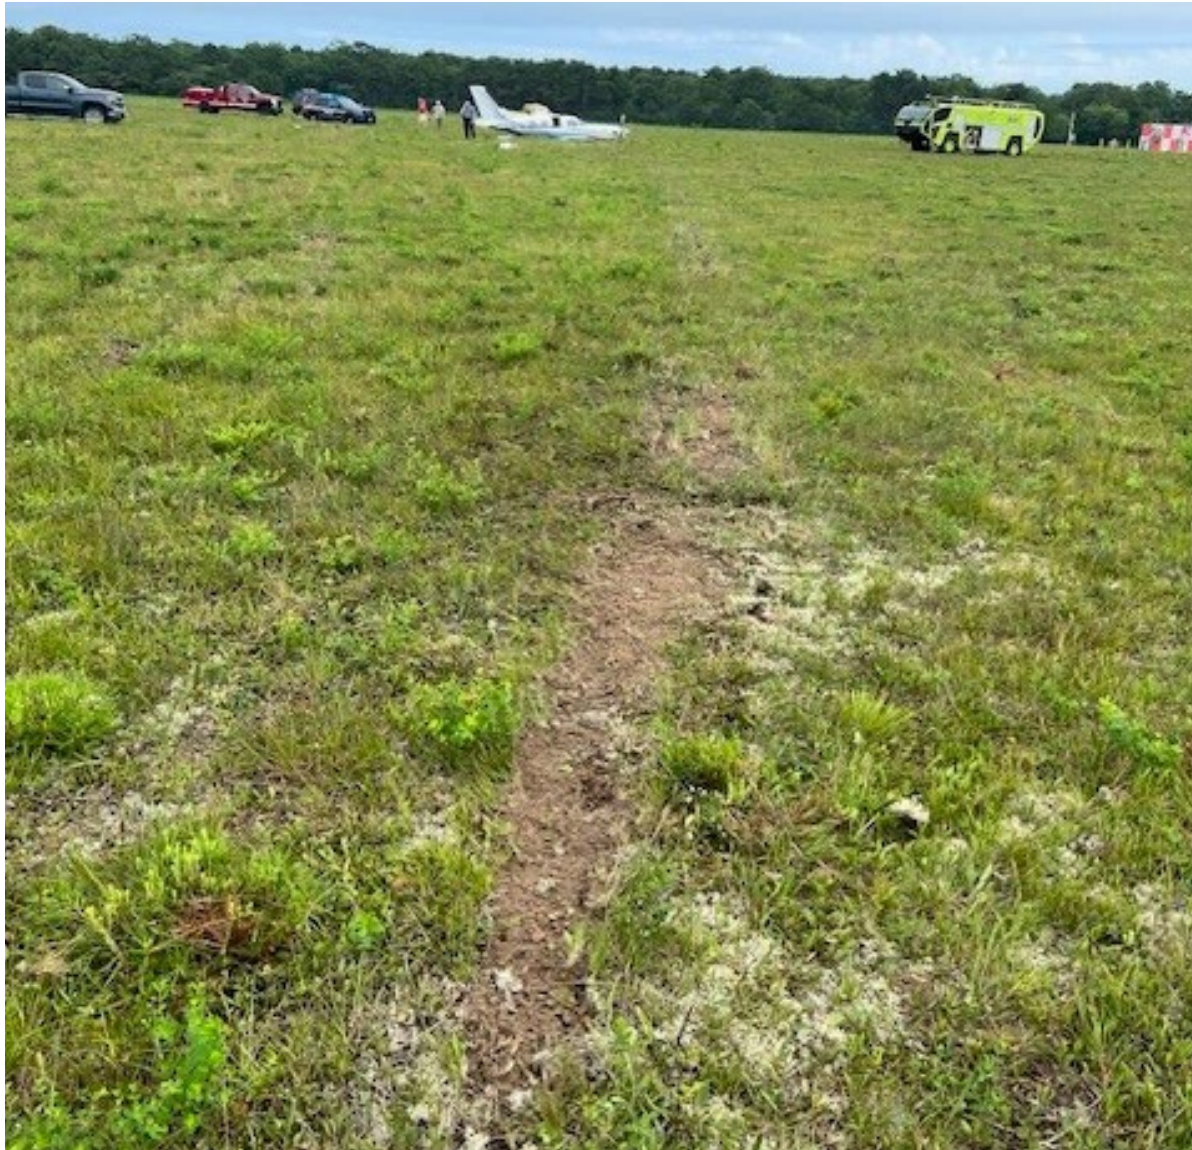
**Photograph 1 - Ground scar leading up to airplane (Courtesy of MVY Airport Manager)**

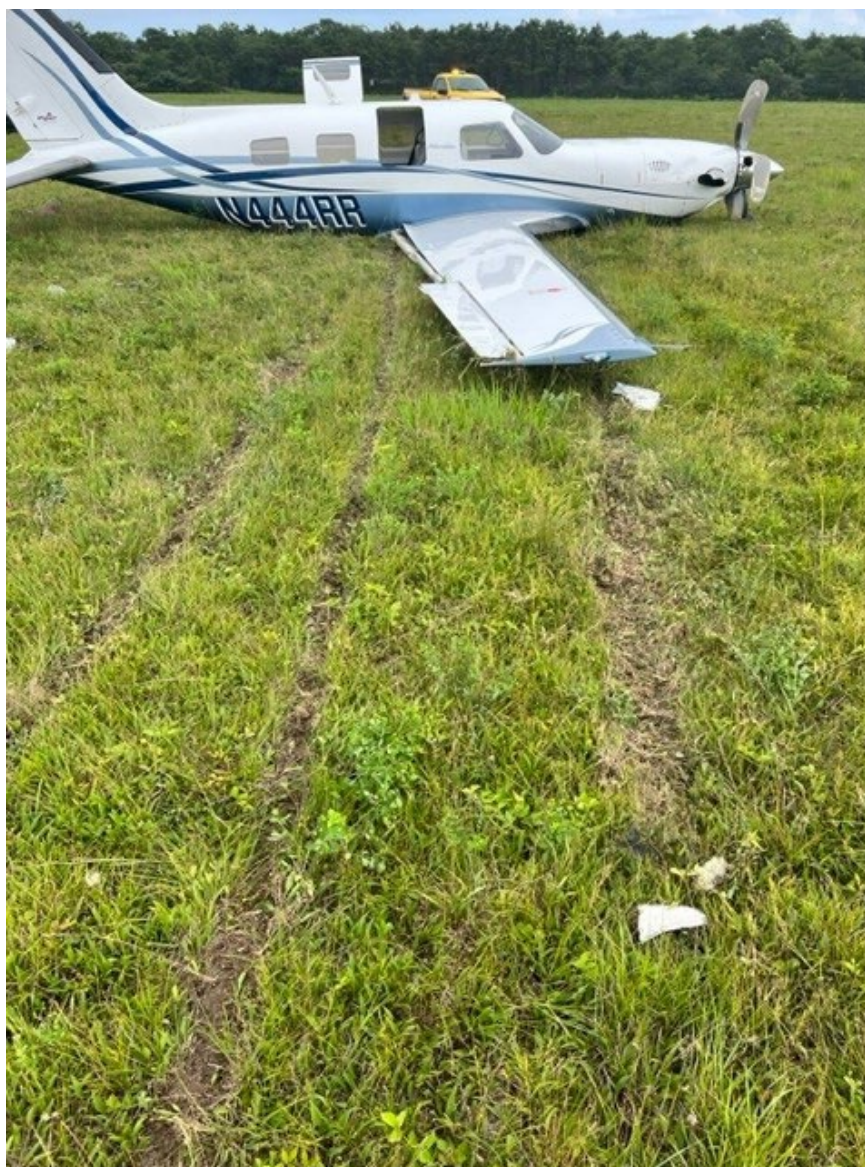
**Photograph 2 - View of airplane from right wing (Courtesy of MVY Airport Manager)**

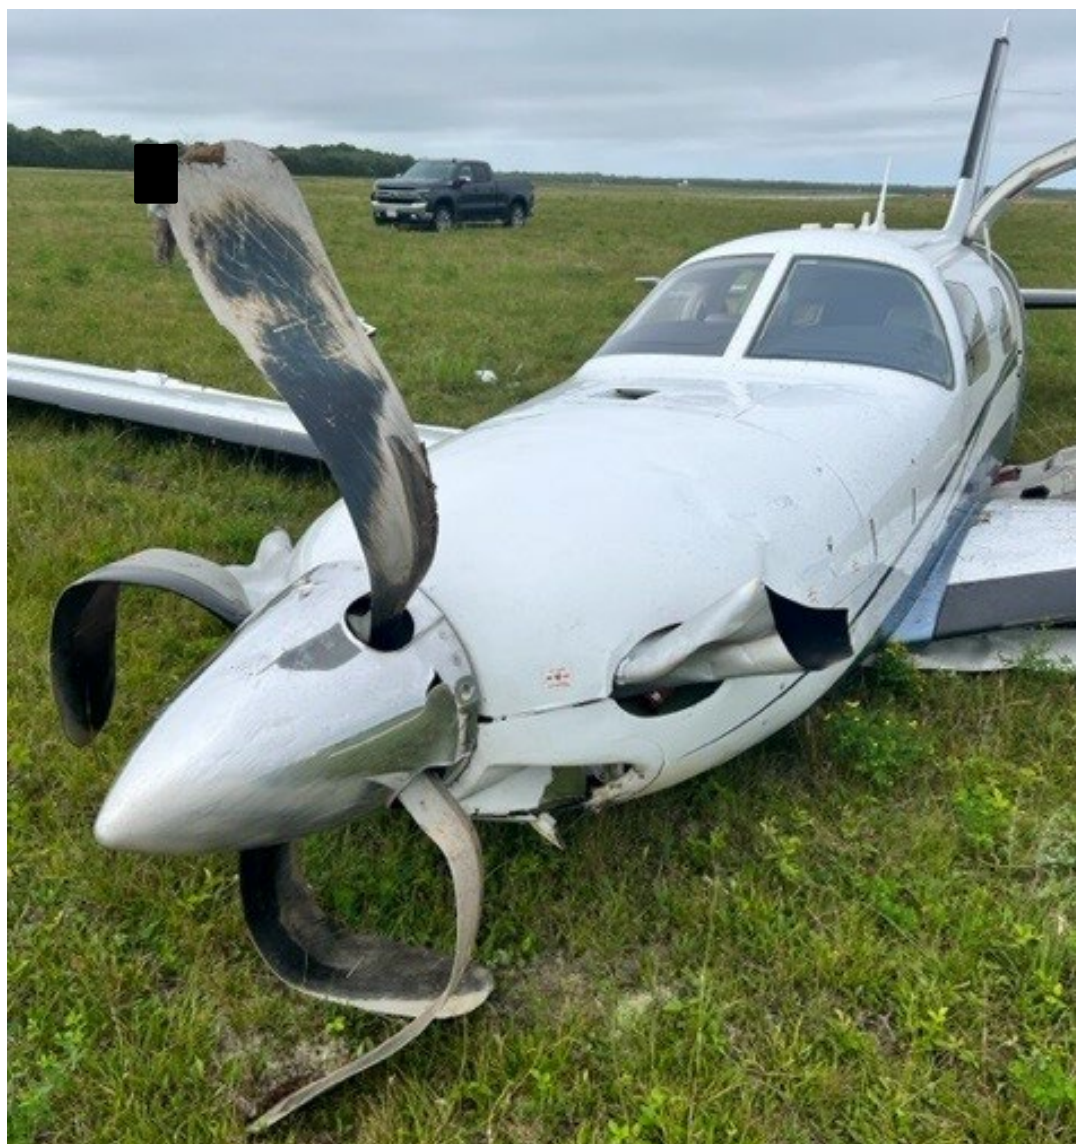
**Photograph 3 - View of airplane from front (Courtesy of MVY Airport Manager)**

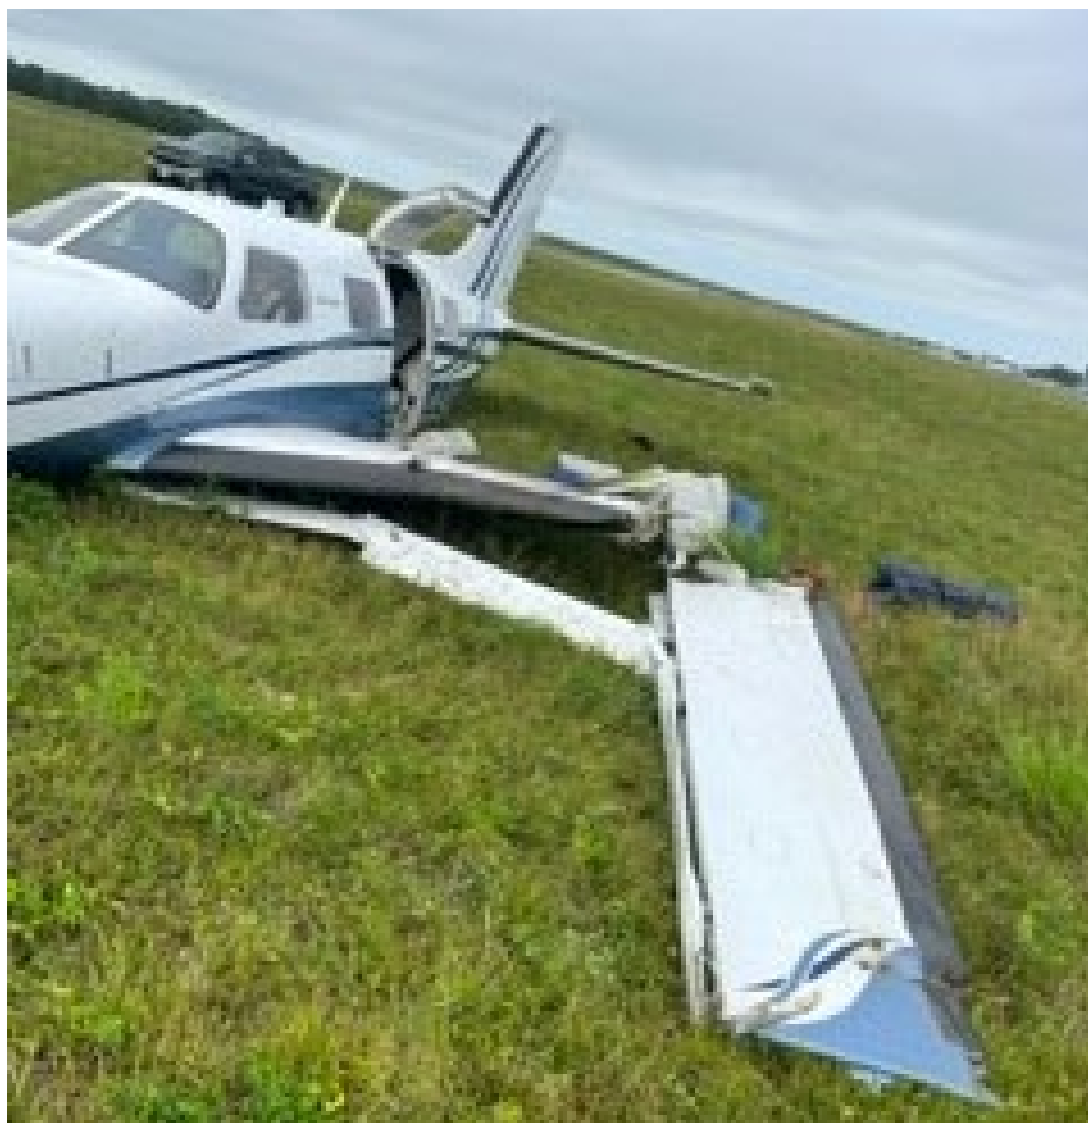
**Photograph 4 - View of fractured left wing (Courtesy of MVY Airport Manager)**
