# National Transportation Safety Board

ERA23LA309

## **AIRWORTHINESS FACTUAL REPORT**

Location: Caldwell, Ohio  
Date: July 23, 2023  
Time: 1420 Eastern Daylight Time (EDT)  
1920 Coordinated Universal Time (UTC)  
Aircraft: Bell Helicopter 206-L4, N482TJ

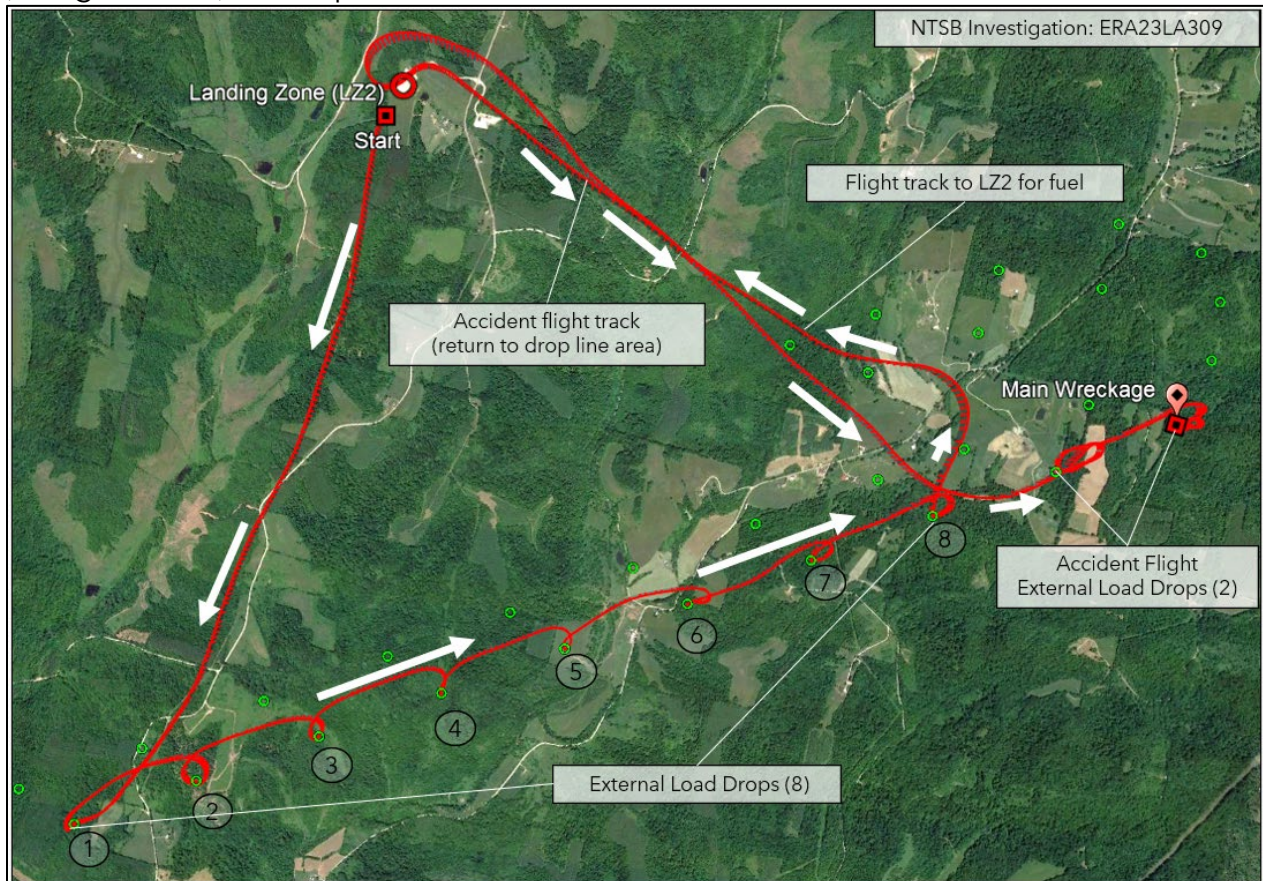
After departing the landing zone, the flight track data indicated that the pilot maneuvered southeast towards one drop zone and then proceeded to maneuver to drop another bag. The flight track showed the helicopter circled the area over the accident site before the helicopter descended through the trees in near vertical path (straight-down) and impacted terrain.

**Figure 1: Overview of the Foreflight Sentry flight track (red line) with drop zones (green dots) and accident site denoted.**

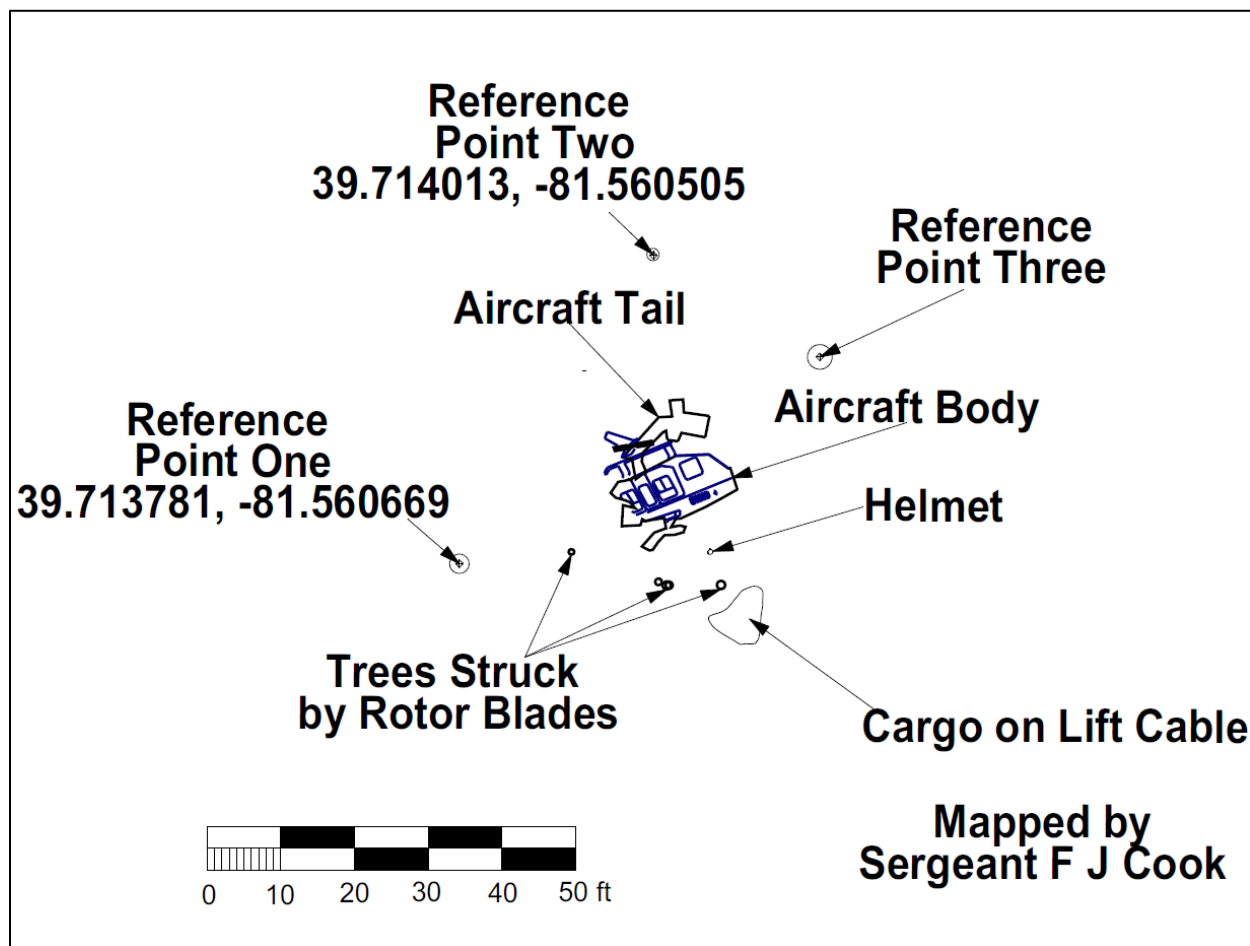
Photographs of the accident site provided by Federal Aviation Administration inspectors depicted that the helicopter sustained substantial damage. The tail boom had separated from the fuselage and was found a few feet from the fuselage. Both main rotor blades had fractured from the main rotor mast. The long line was found partially wound around the main rotor mast and the cargo hook remained closed.

The long line was found entangled with the trees surrounding the main wreckage. The external load was found about 20-30 ft from the main wreckage. The below figure outlining the wreckage orientation was provided by the Ohio State Highway Patrol.

**Figure 2: Wreckage diagram provided by the Ohio State Highway Patrol.**

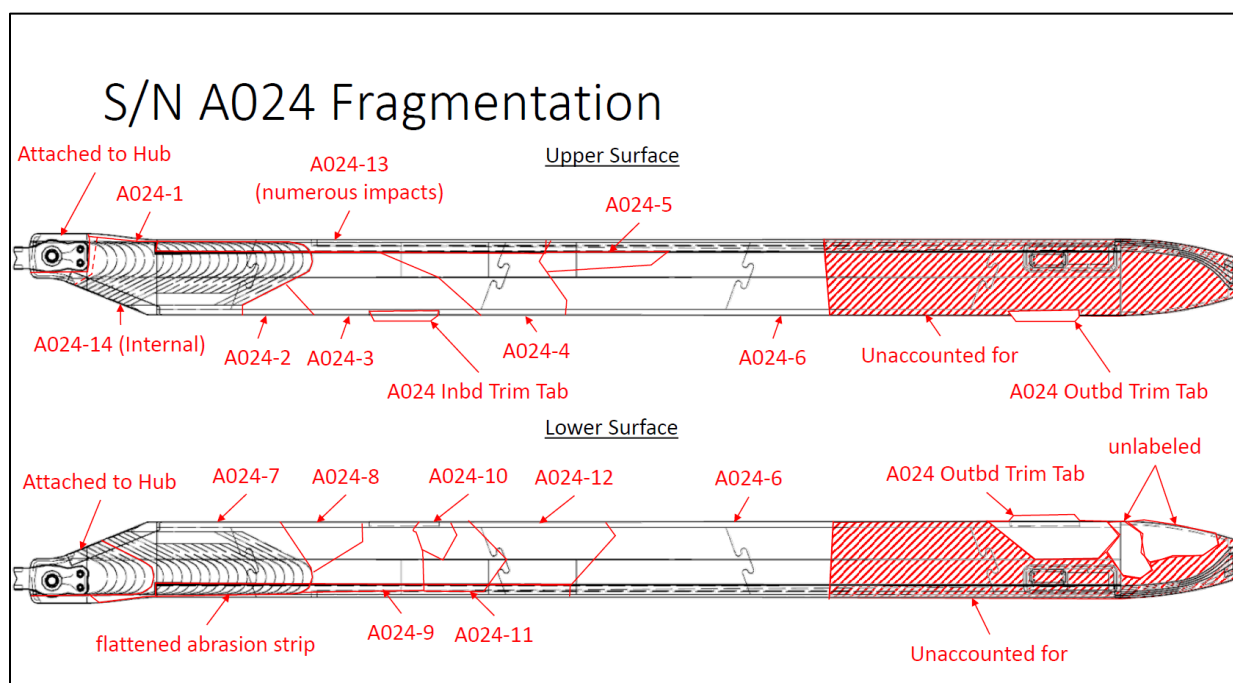
Both blades exhibited multiple indications of leading edge impact related damage. The trailing edge was split open down the entire length of the recovered blades. Respective to blade A024, about 150 inches of blade fragments were pieced together, and of A025, about 180 inches were pieced together. The total length should be about 208 inches. Multiple fragments from the outboard portion of the blades including one tip closeout (PN 20633313-1) piece were located, however which blade they came from could not be determined. In addition, all four trim tabs were located in the debris. The figures below provide an overview of fragments located for both main rotor blades.

**Figure 3: Main rotor blade A024 fragments.**

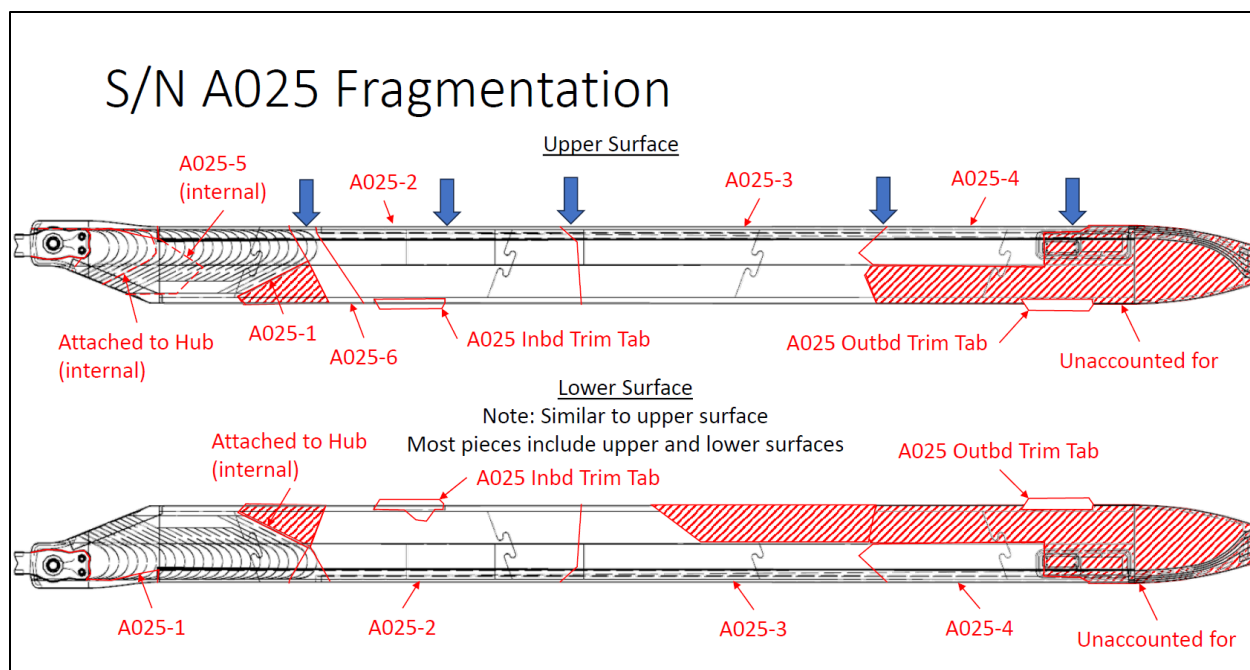
**Figure 4: Main rotor blade A025 fragments.**

The balance weight receptacles (PN 20633311-1) were not located in the recovered wreckage, nor did they remain installed. On blade A025 a portion of the weight pocket cut out was located where the weight normally would have been installed. Leading edge impact damage was observed immediately forward of that location.

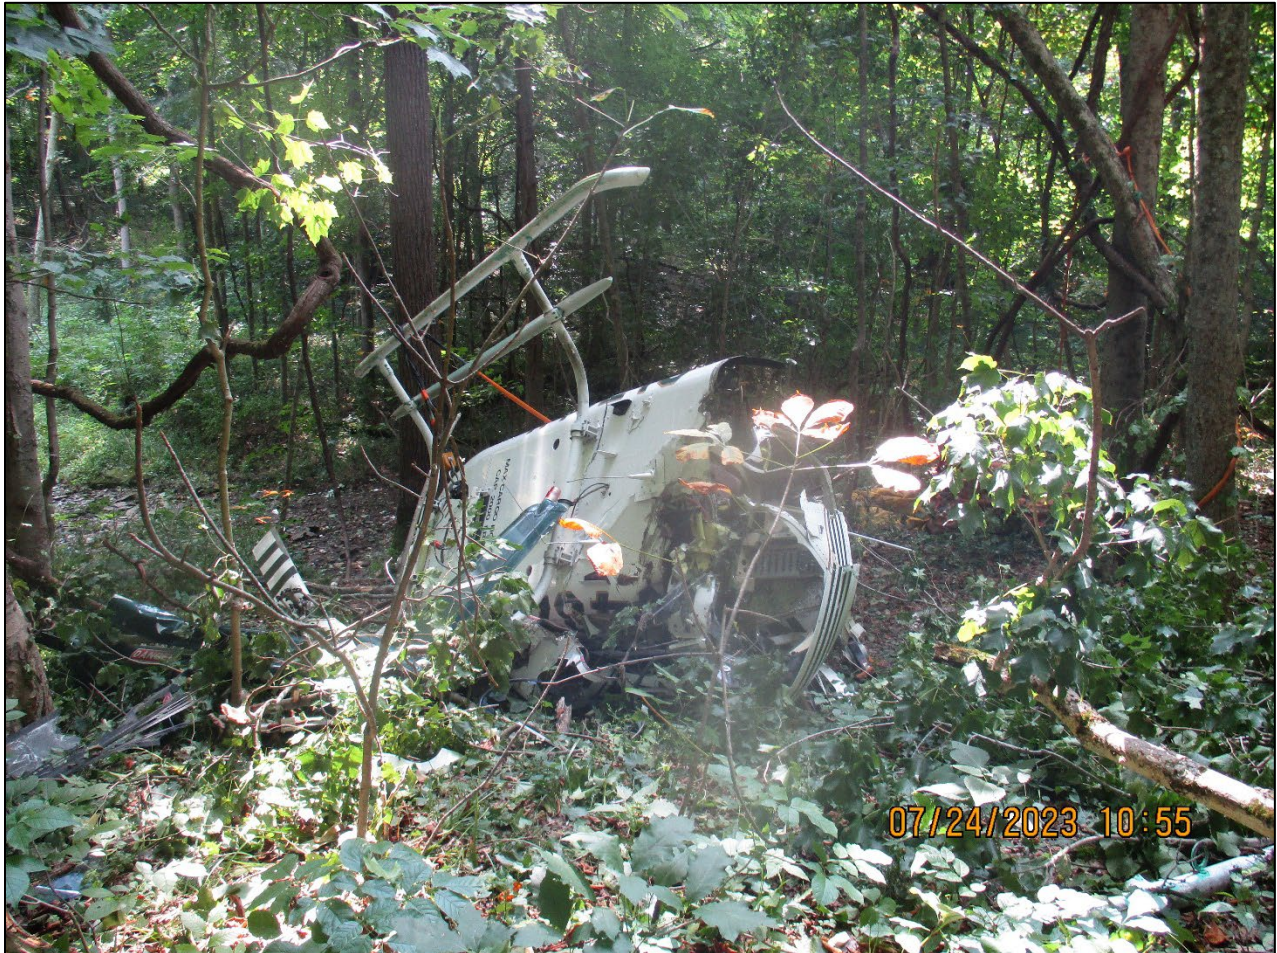
**Figure 5: View of the helicopter and accident site area.**

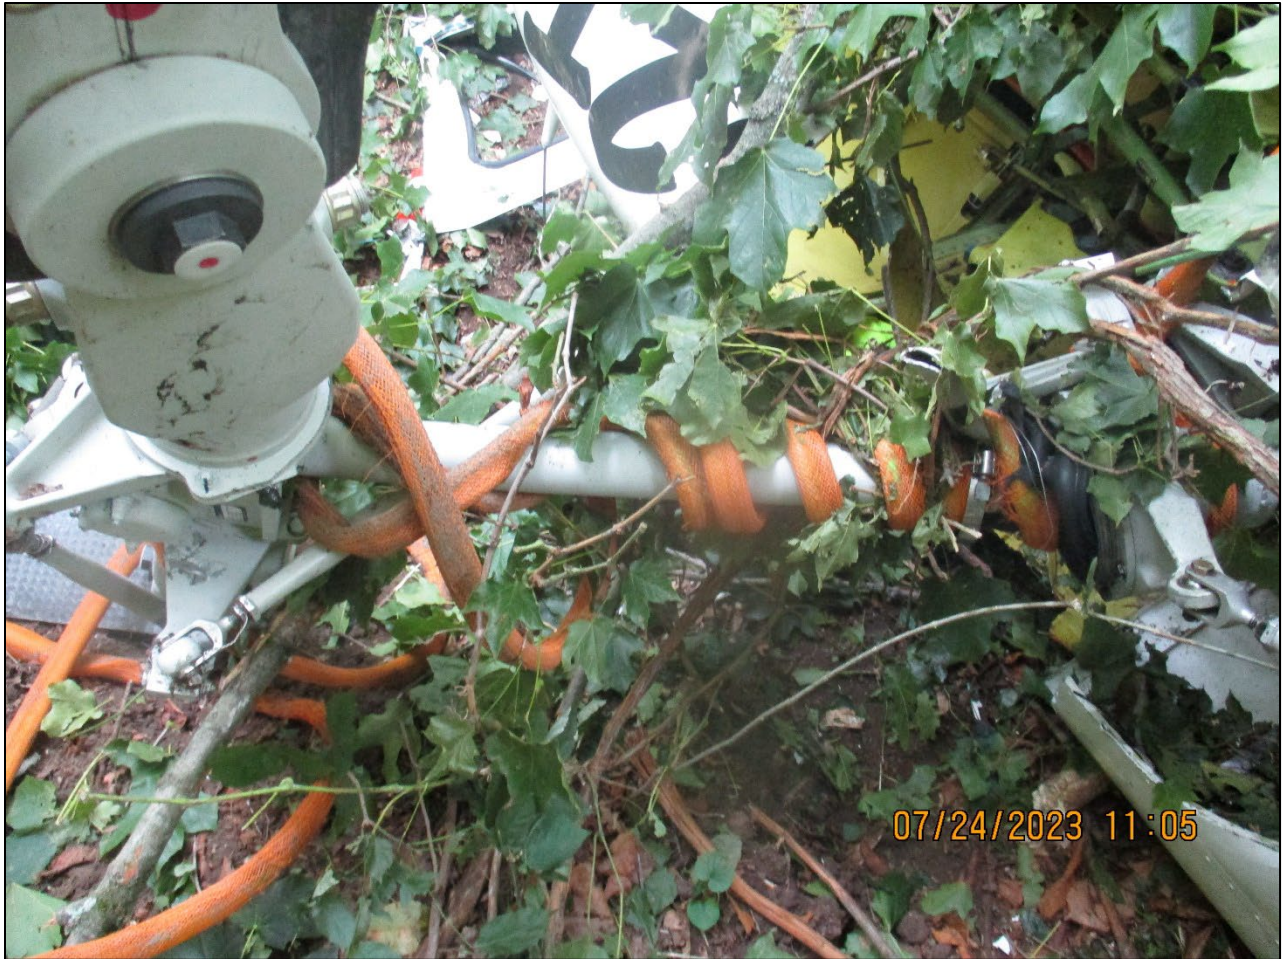
**Figure 6: View of the helicopter and accident site area. Note the long line found wrapped around the main rotor drive shaft.**

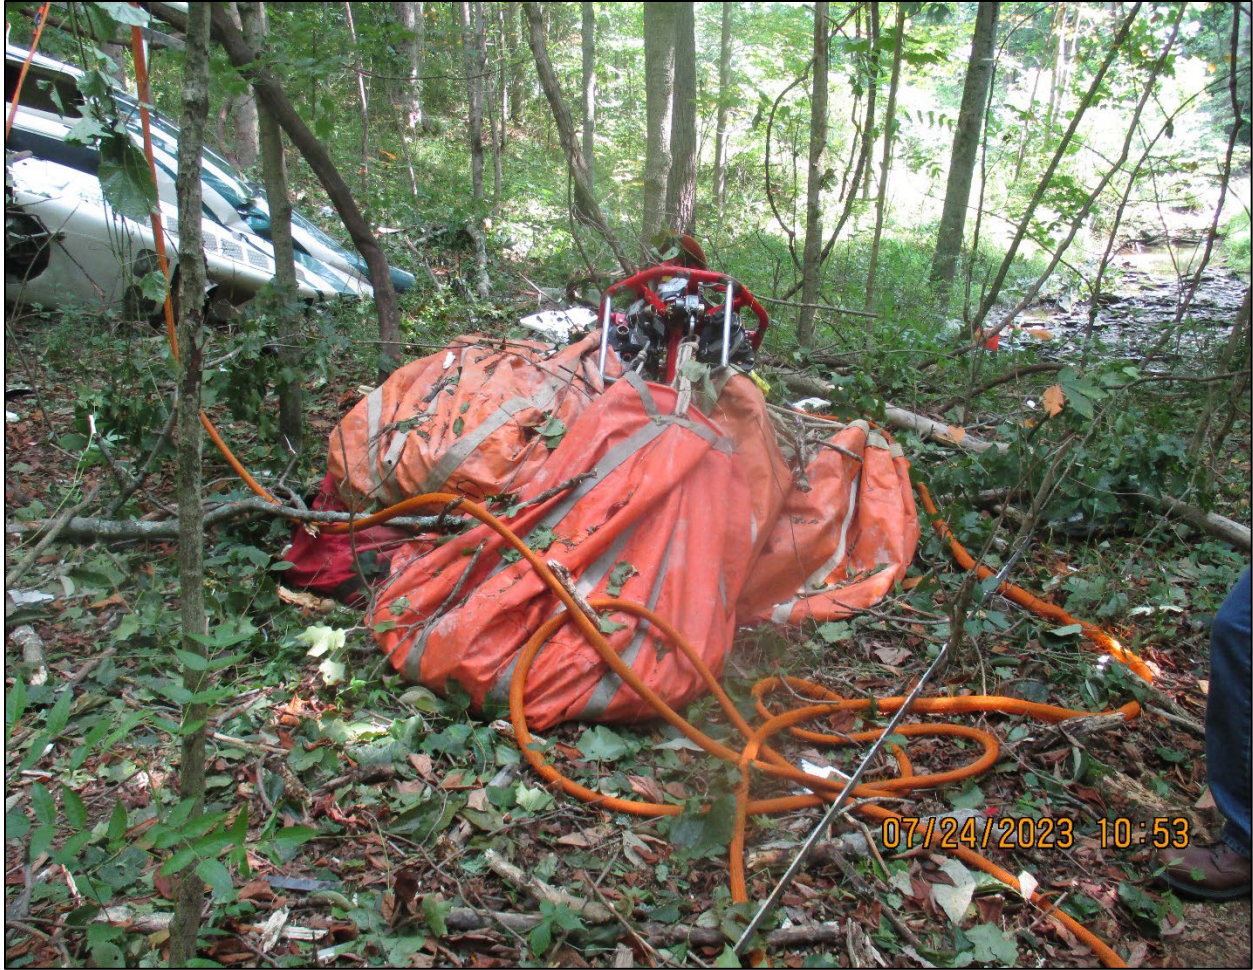
**Figure 7: View of the external load as found next to the helicopter.**

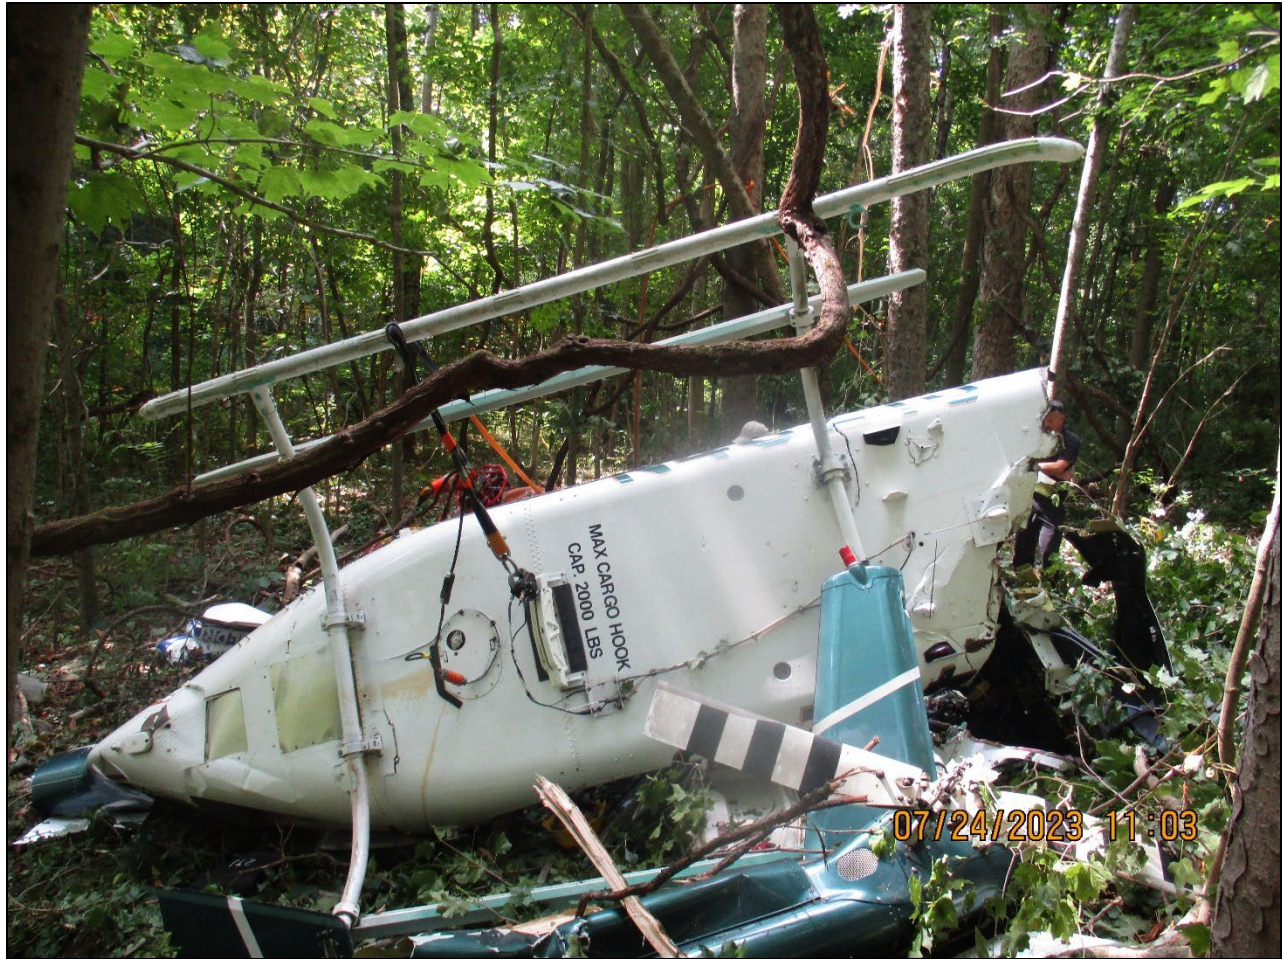
**External Cargo System:** The cargo hook attached to the underside of the fuselage was found closed with the long line hook still attached. There was no evidence of pulling damage or deformation to the hook system. The emergency hook release was found closed. When actuated, the cargo hook opened, and the long line hook separated from the helicopter. The long line was found twisted around the main rotor mast. Extending downward from the long line hook, about 14 ft in length, the line exhibited evidence of tearing and abrasions where it had wrapped around the main rotor mast. The total length of long line was measured to be 122 ft.

**Figure 8: View of the helicopter and accident site area. Note the cargo hook remained closed/secured.**

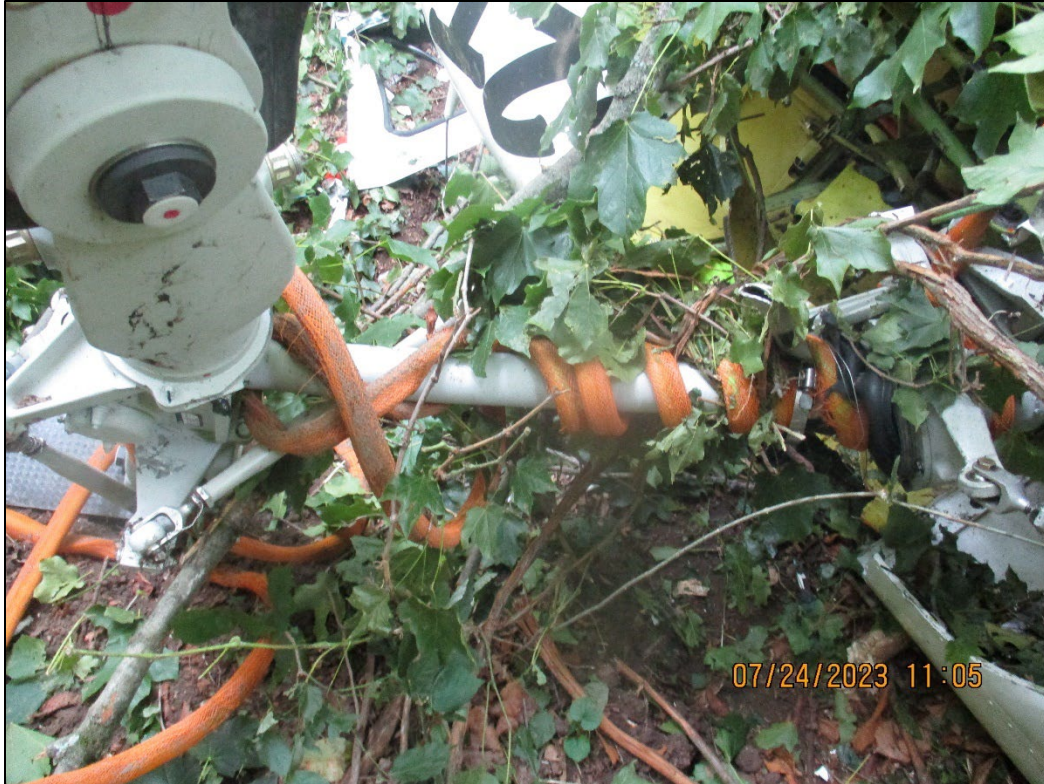
**Figure 9: Additional view of the long line wrapped around the main rotor drive shaft.**

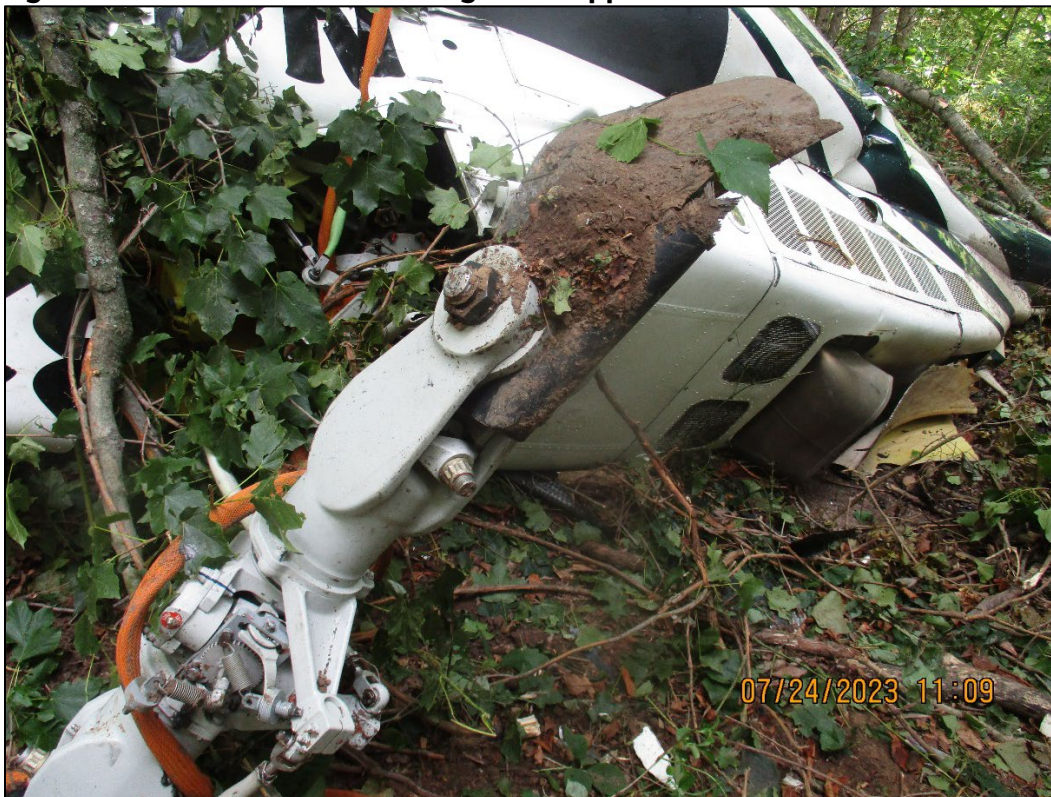
The main rotor blades were Van Horn Aviation blades (PN20633000-101, SN A024, SN A025). Both blades exhibited significant fragmentation. The root ends remained attached to the hub with fractures immediately outboard of the main rotor grip plates.

**Figure 10: View of a main rotor blade with impact related dirt and debris affixed to its fracture area.**

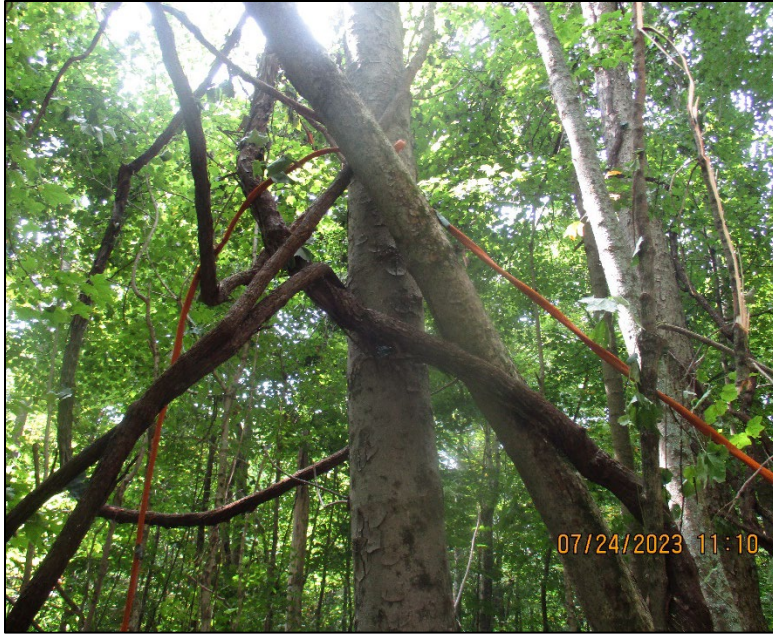
**Figure 11: View of the long line tangled with trees.**

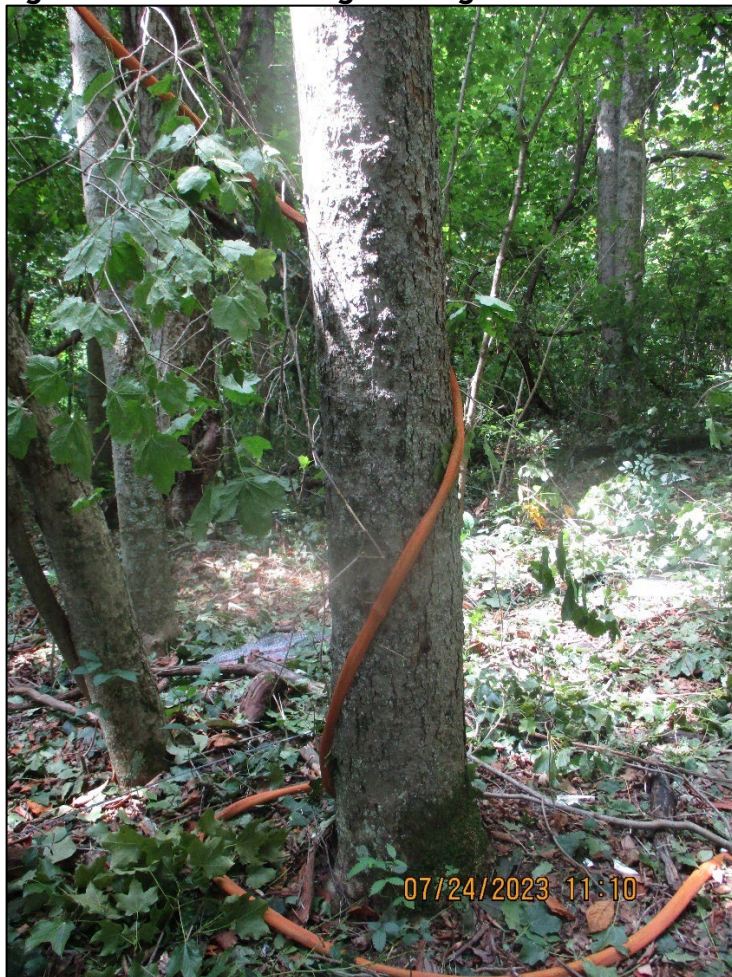
**Figure 12: View of the long line tangled with trees.**

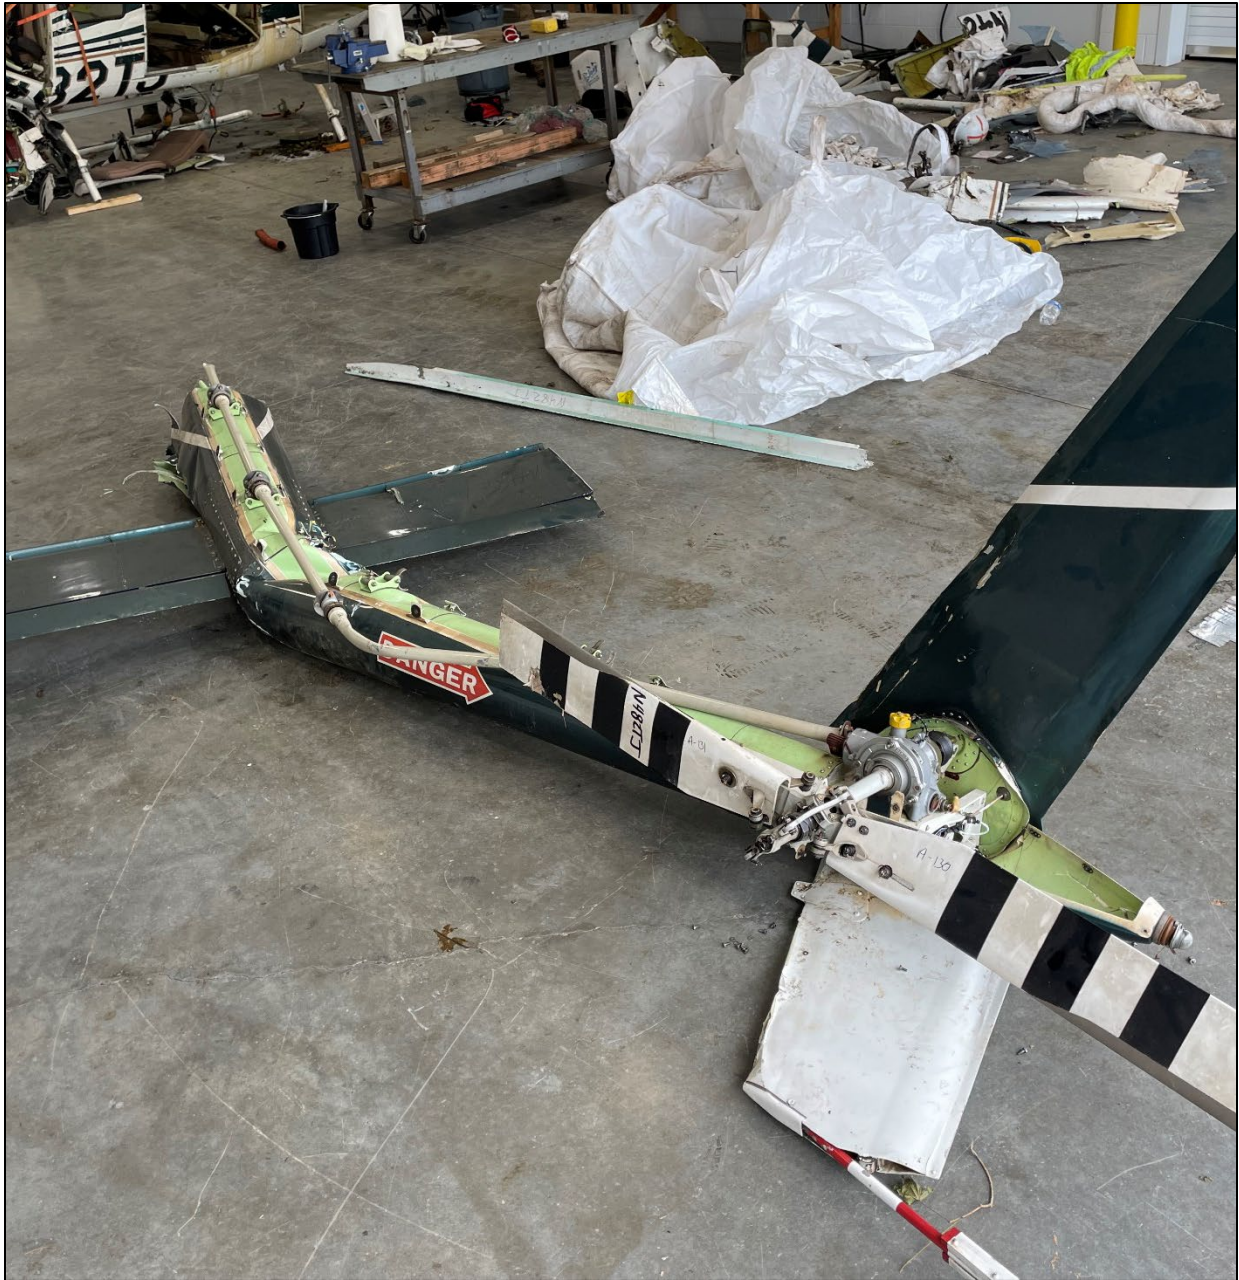
**Airframe:** The components of the forward airframe (cockpit area) was substantially damaged by impact forces. The tail boom separated just aft of the intercoastal support. Both horizontal stabilizers remained attached to the tailboom. The right finlet had separated but the left finlet remained attached.

**Figure 14: View of the tail rotor and tail boom.**

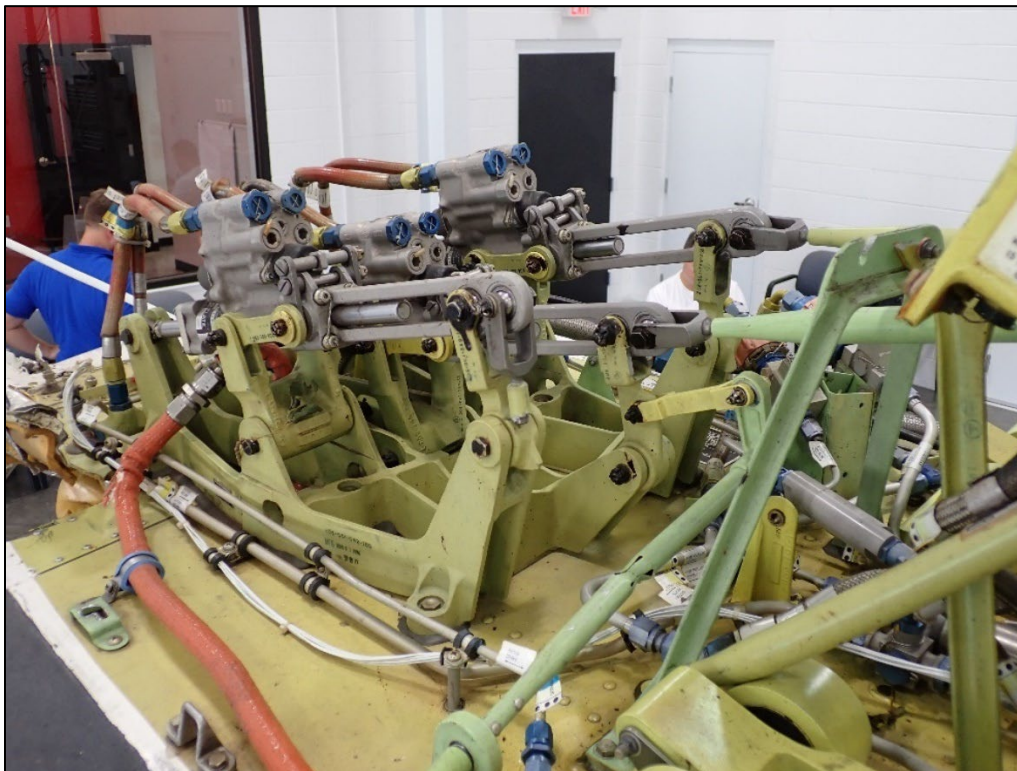
**Flight controls:** The cyclic and collective had been removed from the left side of the cockpit prior to the flight. The pilot cyclic was fractured at the base, however, when the base of the cyclic was moved, there was corresponding movement of the control tubes to the right servo actuator. Lateral movement of the cyclic controls was not possible due to damage caused by impact. Control tube continuity was observed to all three servo actuators. The left seat collective was fractured at the base but moving the collective base on the right side showed corresponding movement to the center servo actuator. Additionally, there was a fracture of the cyclic yoke underneath the seats. The left side anti-torque pedals were recovered. Directional control continuity was observed from the fractured control tube in the tailboom to the fractured control tube under the cockpit. Additional continuity was observed from the fracture control tube (in the separated tail boom) to the tail rotor blades. All three main rotor servos remained attached to the support and hardware was present.

**Figure 17: View of the servo actuators.**

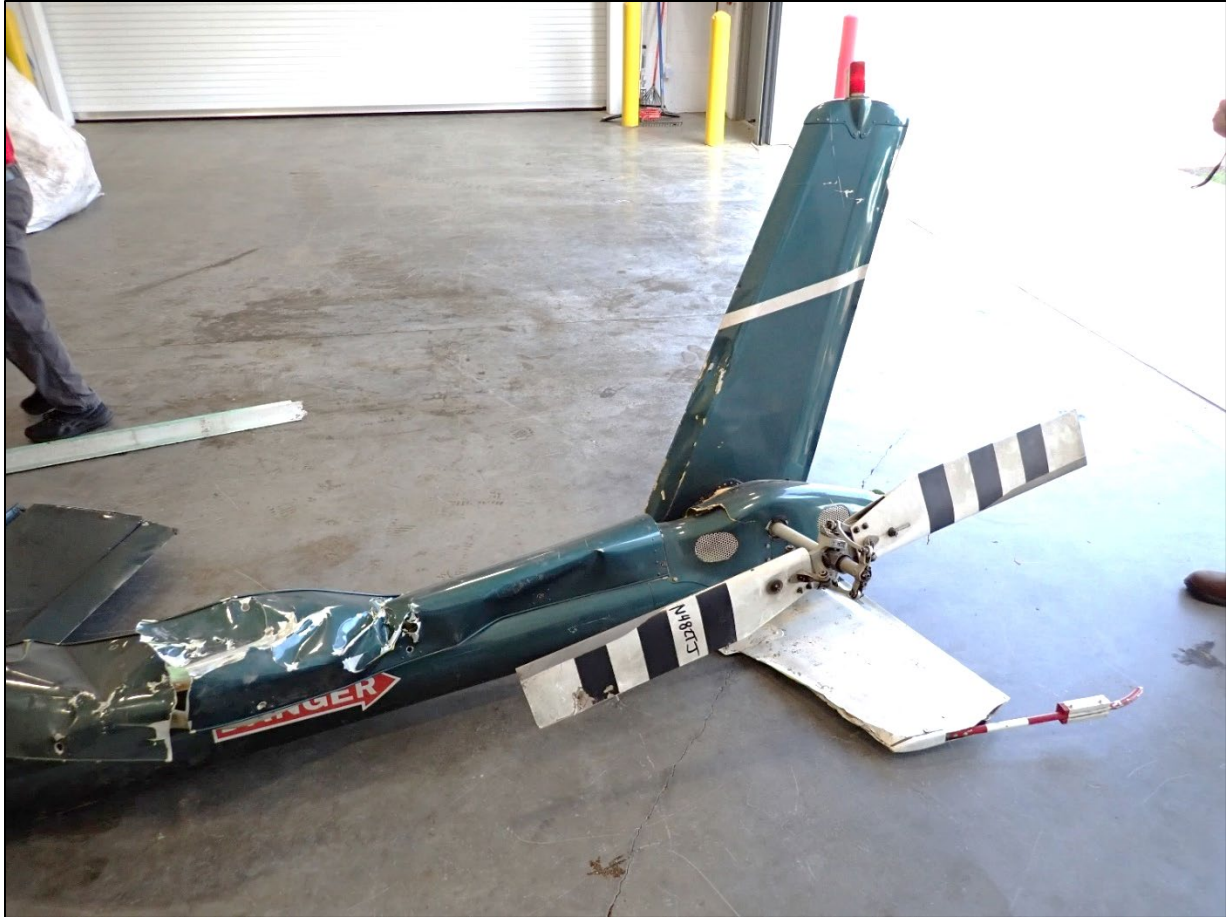
**Tail Rotor:** The two tail rotor blades remained installed and did not exhibit significant deformation or fragmentation. The tail rotor flap stops exhibited evidence of contact with the yoke. The tail rotor pitch change links remained installed and did not exhibit fractures or deformation. The pitch of the tail rotor blades was manipulated by hand with appropriate control movement forward to the aft end of the fractured control tube.

**Figure 18: View of the tail rotor.**

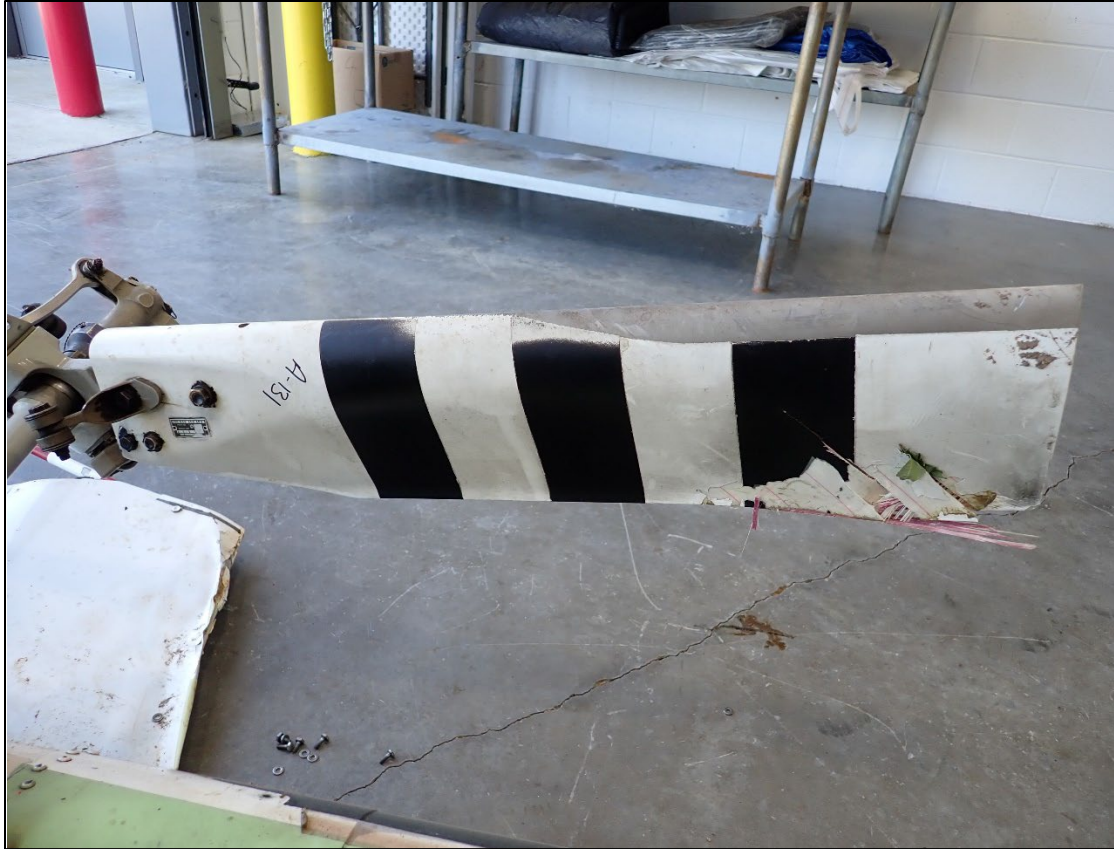
**Figure 19: View of the tail rotor.**

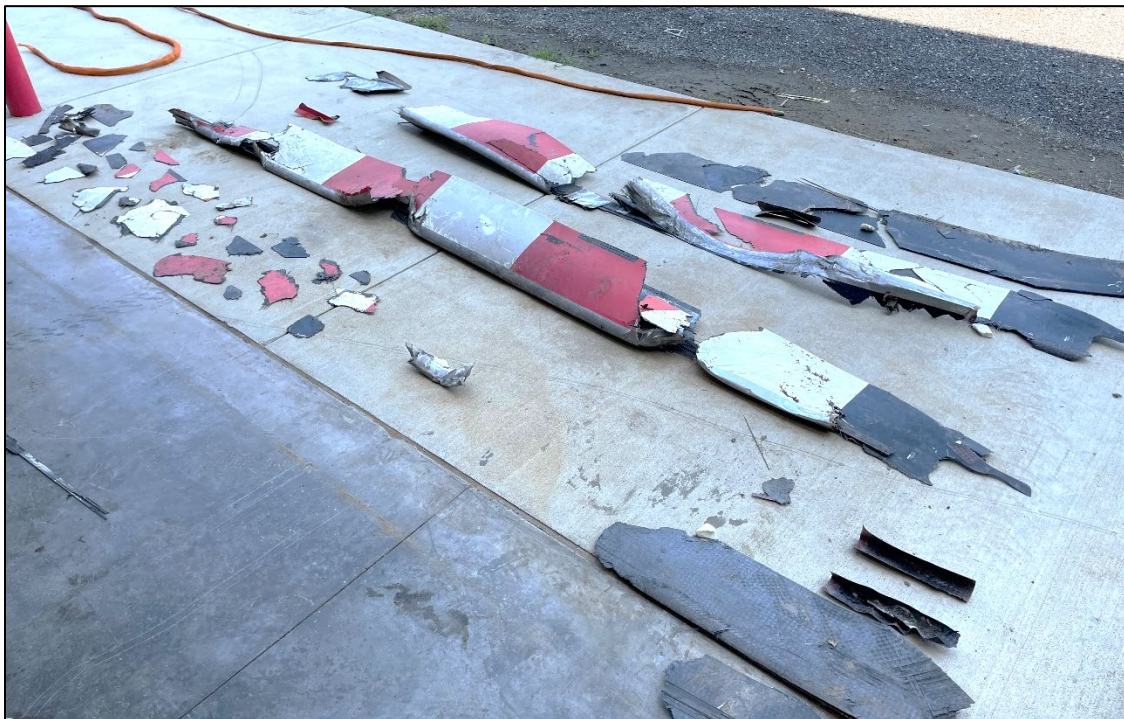
The leading edge abrasion strip was fractured at multiple locations including large sections that had entirely separated and were deformed and flattened. The foam core was found heavily fragmented, and the majority of the foam core had evacuated from the interior of the blades. There were multiple foam core remnants internal to the blade fragments.

**Figure 20: View of the main rotor blade recovered fragments.**

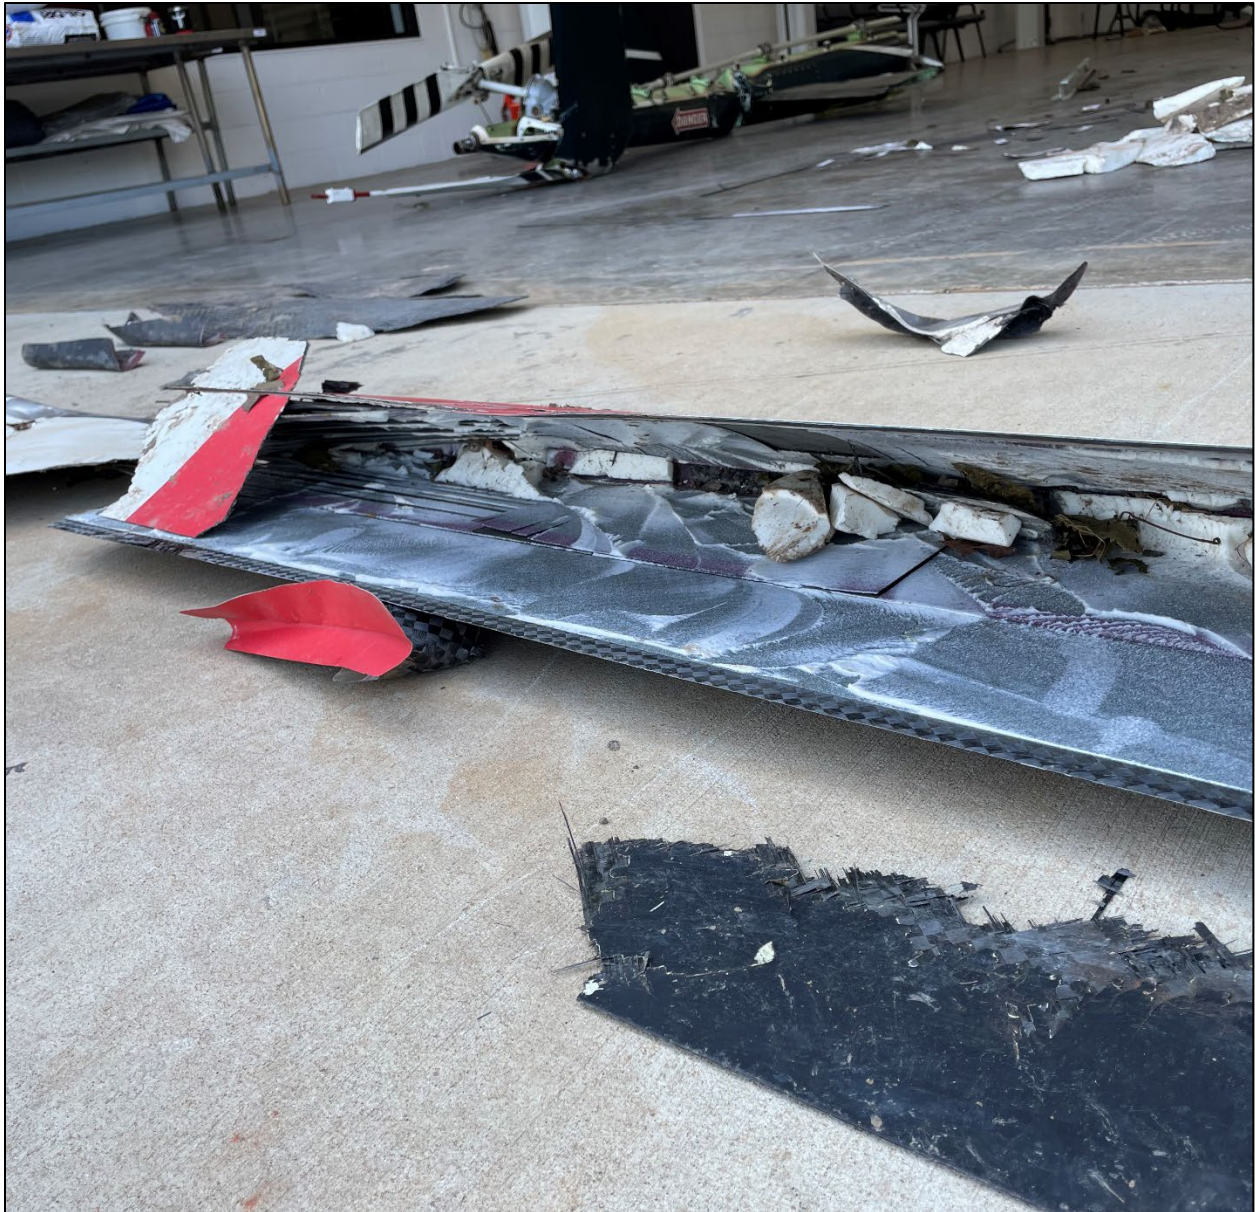
**Figure 21: View of the main rotor blade recovered fragments.**

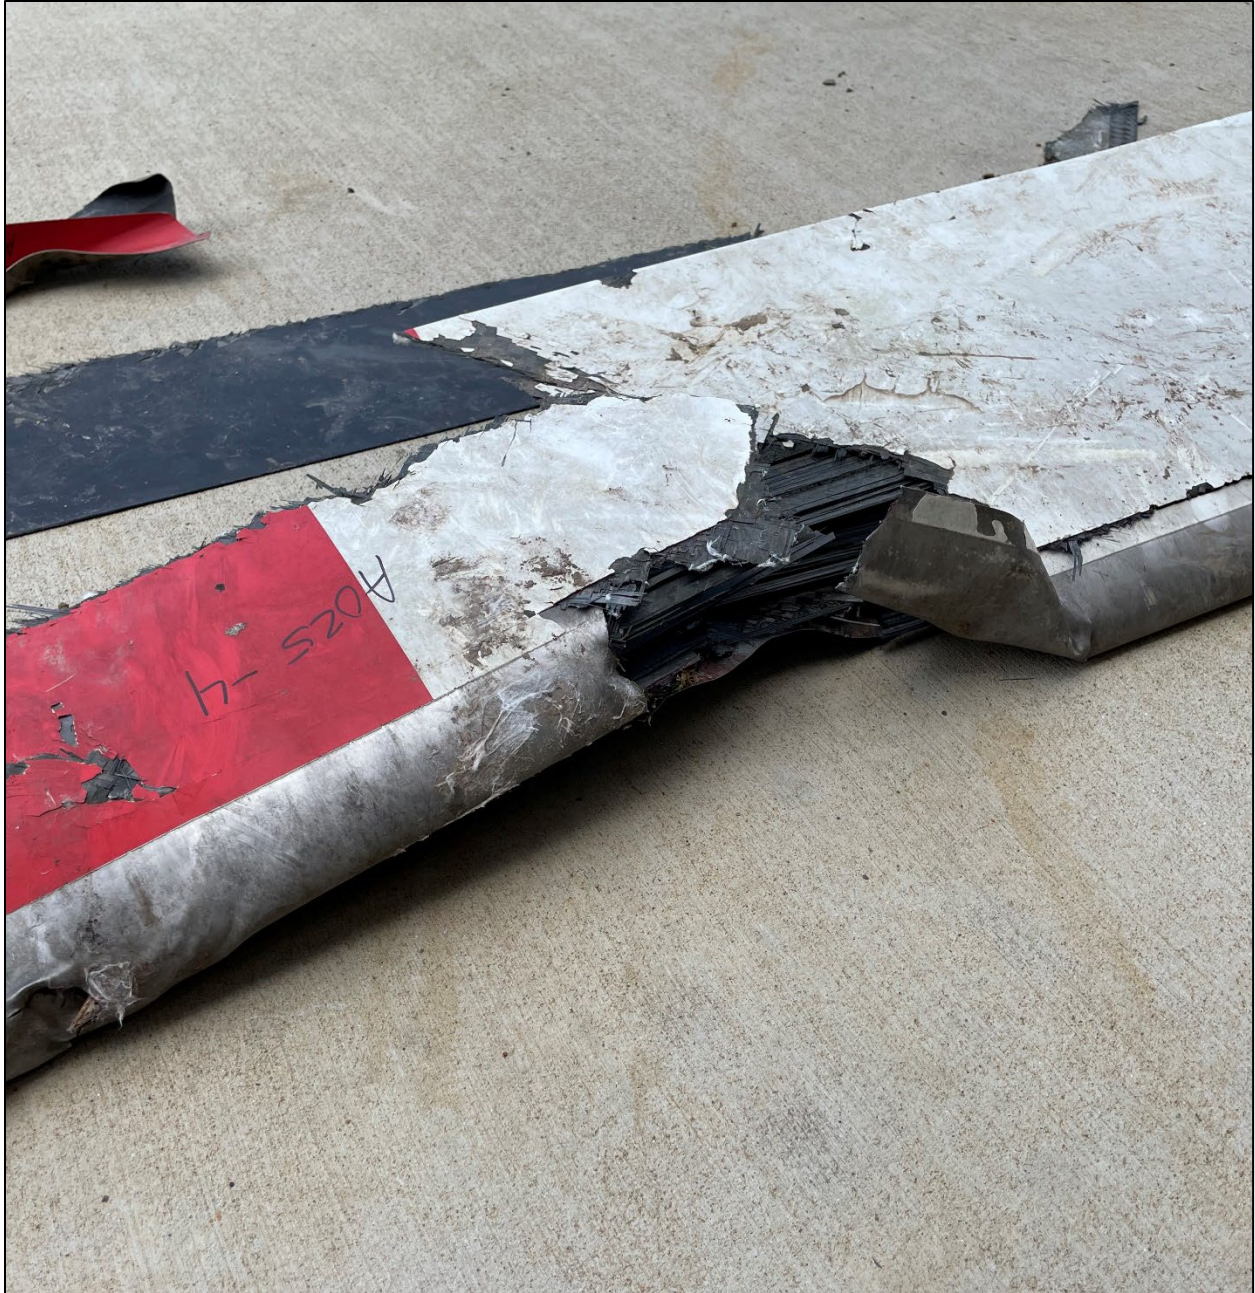
**Figure 22: View of leading edge damage to A025 main rotor blade.**

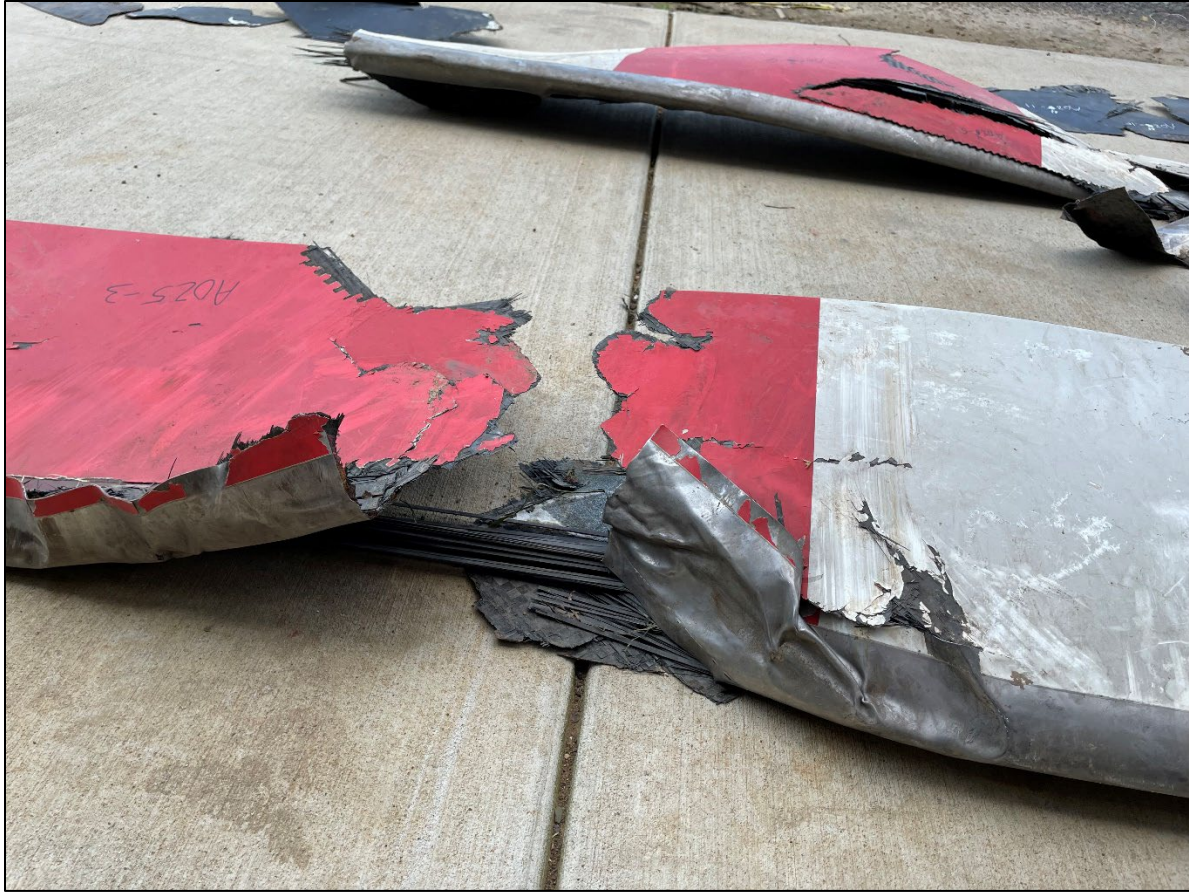
**Figure 23: View of leading edge damage to A025 main rotor blade.**
