# National Transportation Safety Board

ERA23LA309

## **AIRWORTHINESS FACTUAL REPORT**

Location: Caldwell, Ohio  
Date: July 23, 2023  
Time: 1420 Eastern Daylight Time (EDT)  
1920 Coordinated Universal Time (UTC)  
Aircraft: Bell Helicopter 206-L4, N482TJ

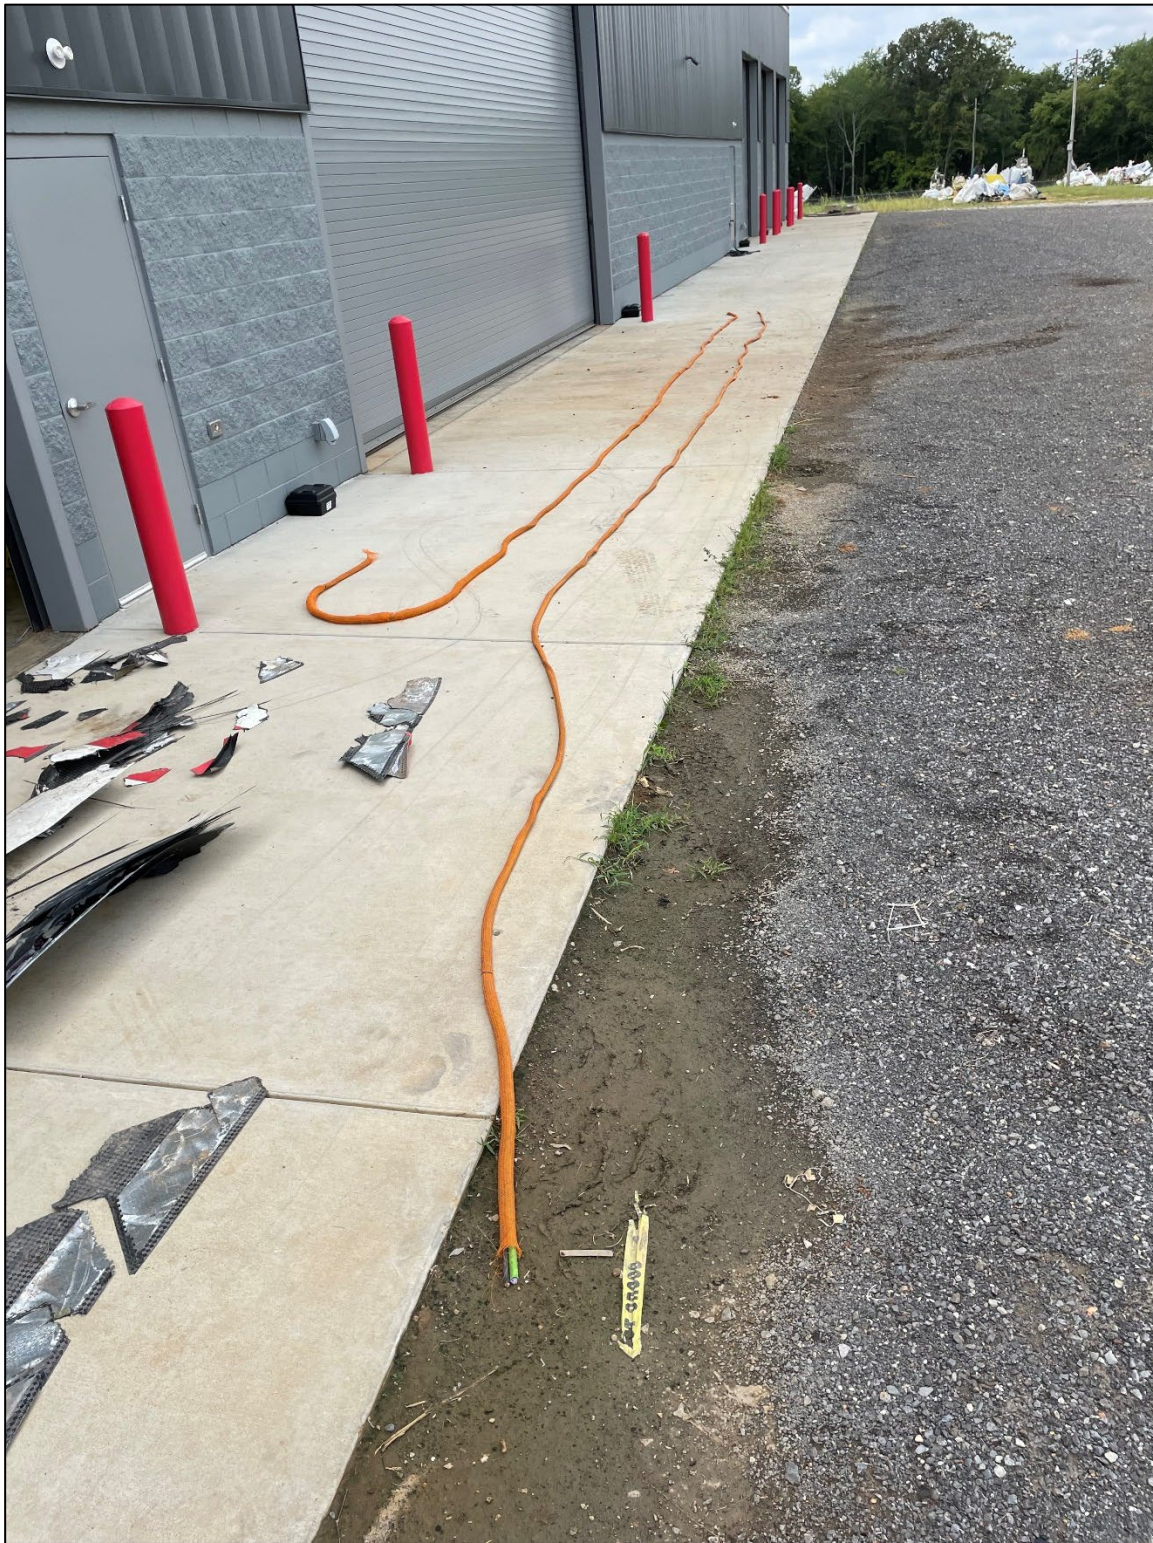
**External Cargo System:** The cargo hook attached to the underside of the fuselage was found closed with the long line hook still attached. There was no evidence of pulling damage or deformation to the hook system. The emergency hook release was found closed. When actuated, the cargo hook opened, and the long line hook separated from the helicopter. The long line was found twisted around the main rotor mast. Extending downward from the long line hook, about 14 ft in length, the line exhibited evidence of tearing and abrasions where it had wrapped around the main rotor mast. The total length of long line was measured to be 122 ft.

**Figure 24: View of the long line.**

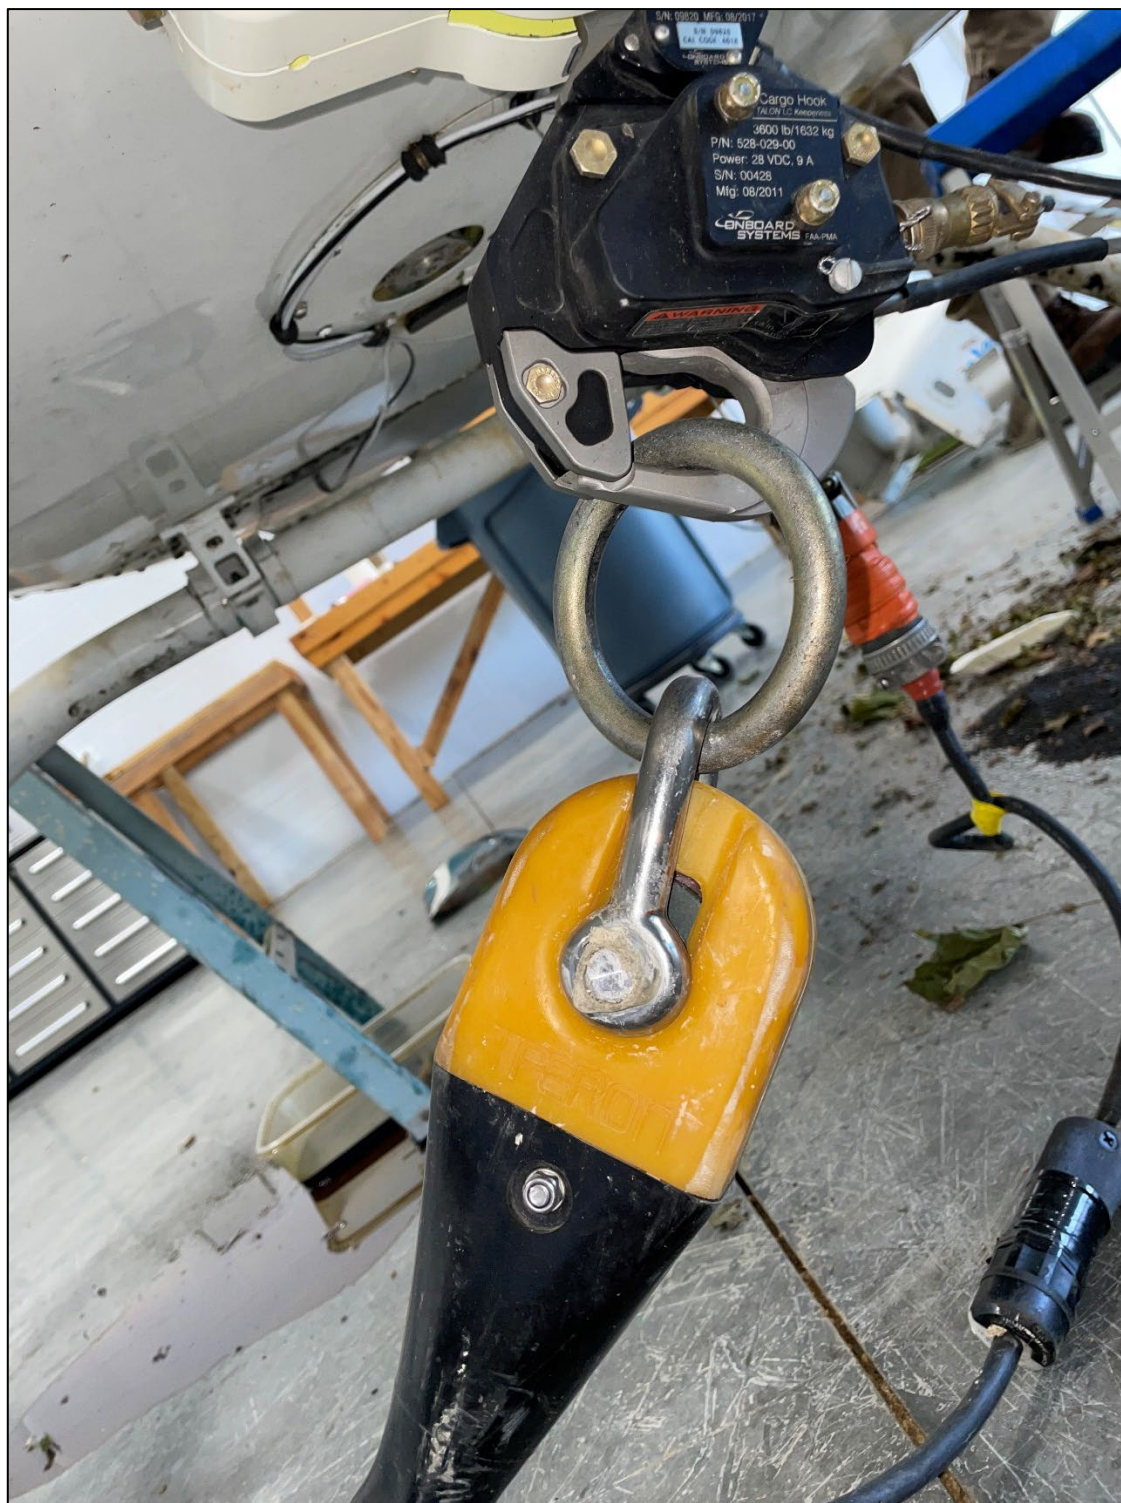
**Figure 25: View of the cargo hook.**

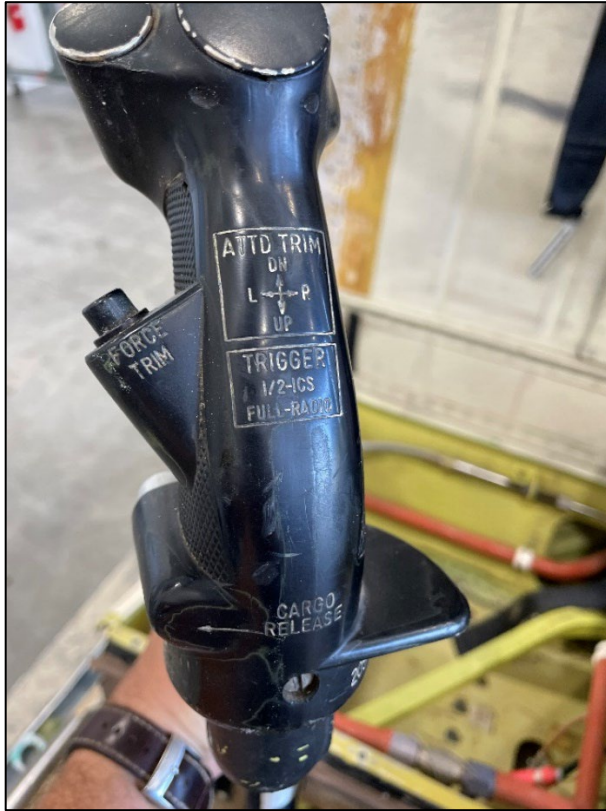
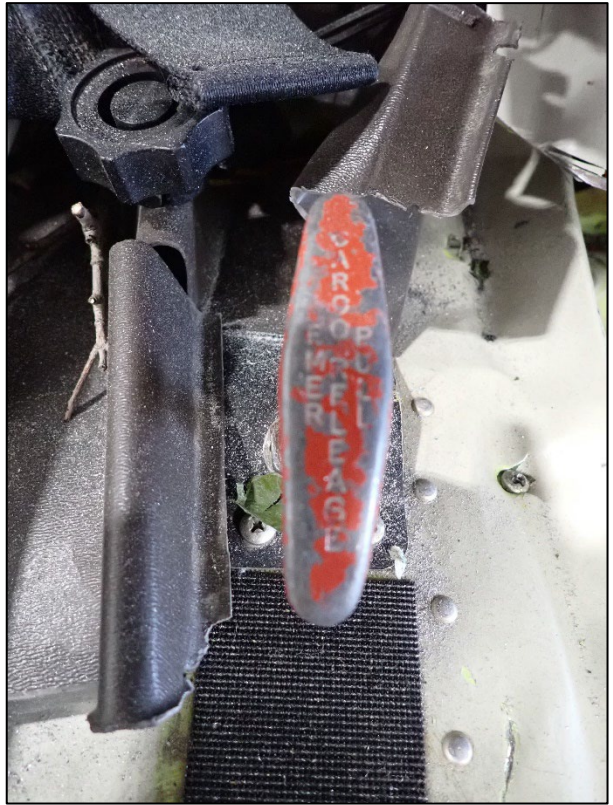
**Figure 26: View of the control stick cyclic denoting the "Cargo Release." Right Side: Red handle, emergency cargo release (found closed - not released).**

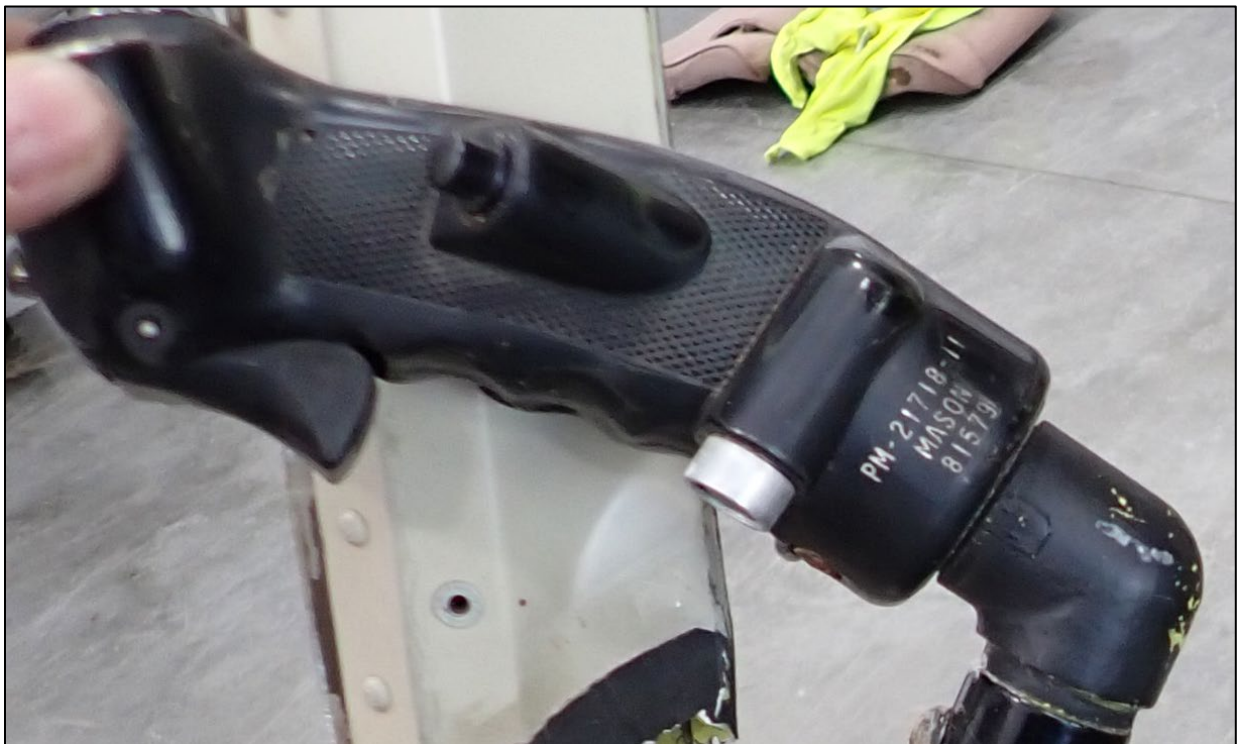
**Figure 27: Additional view of "Cargo Release" on the cyclic.**

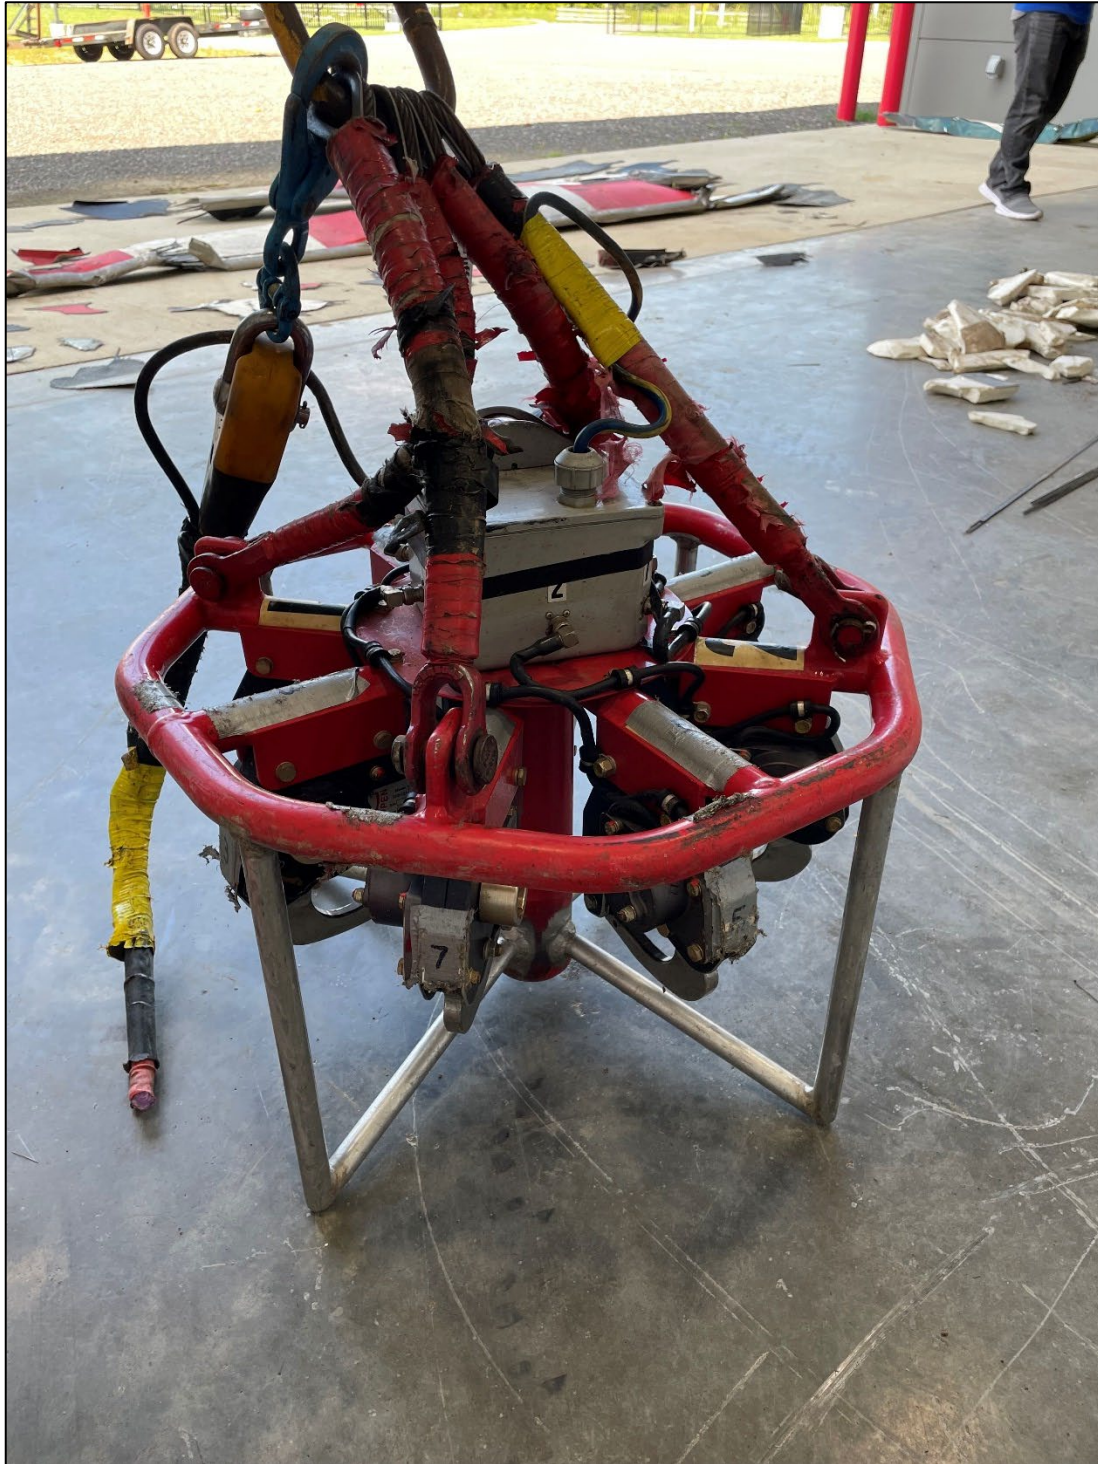
A carousel cargo hook device was located in the debris. It contained a total of 8 hooks, which were found closed.

**Figure 28: External load carrier with 8 separate release hooks.**
