# National Transportation Safety Board

ERA23LA310

## EXAMINATION REPORT

Location: Stanly County Airport (VUJ), Albemarle, North Carolina.  
Date: July 24, 2023  
Time: 1630  
2030 UTC  
Airplane: Piper PA-28-140, N98134

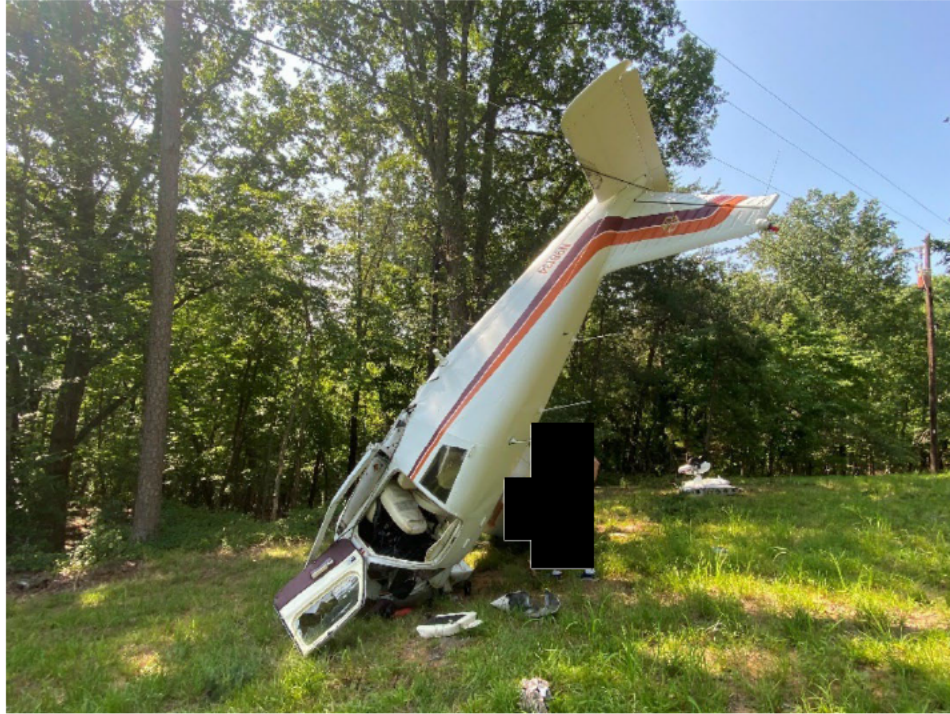
The right wing had separated during impact and the fuel tanks were breached. The fuselage was crushed forward from the engine compartment into the cockpit. The airplane was resting on its nose in an inverted attitude with the engine and propeller rested on the ground and were canted upwards and aft into the cockpit instrument panel. The entire aircraft was being suspended by electrical transmission wires that were wrapped around the stabilator.

**Figure 1 Airplane wreckage as it was discovered.**

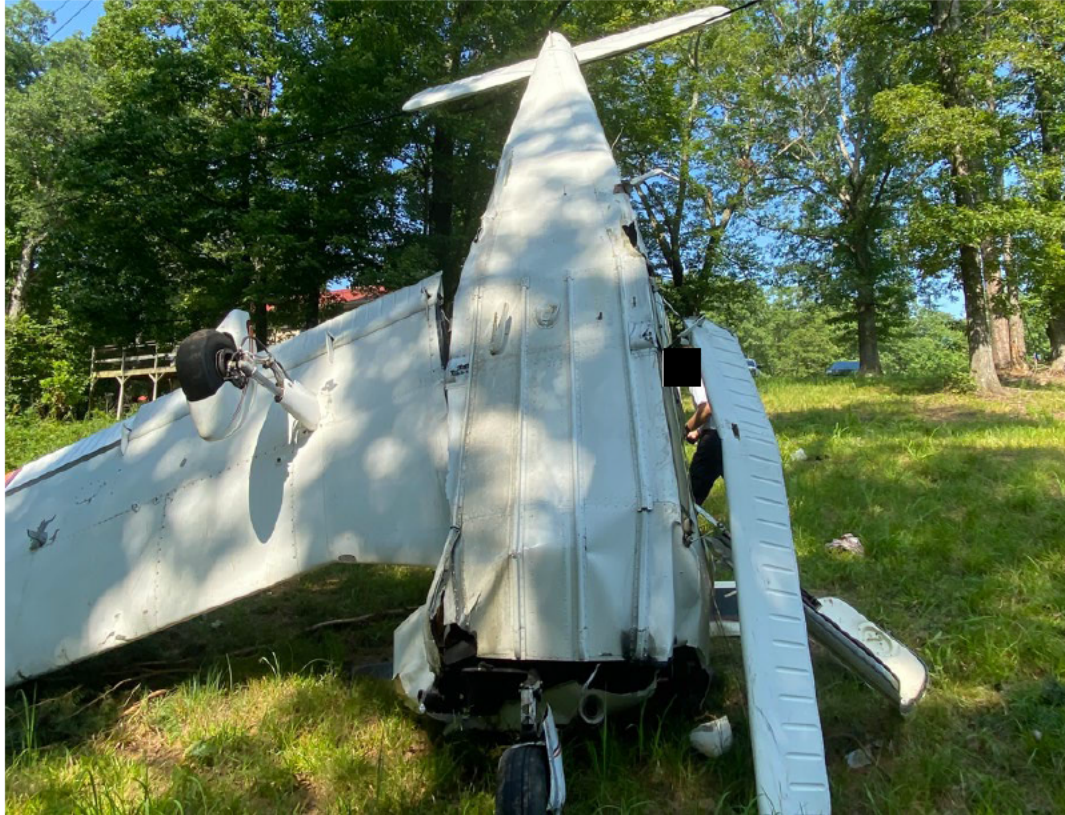
Right wing was separated. Left wing partially separated near the wing root.

**Figure 2 Airplane wreckage from bottom of aircraft showing wing separation.**

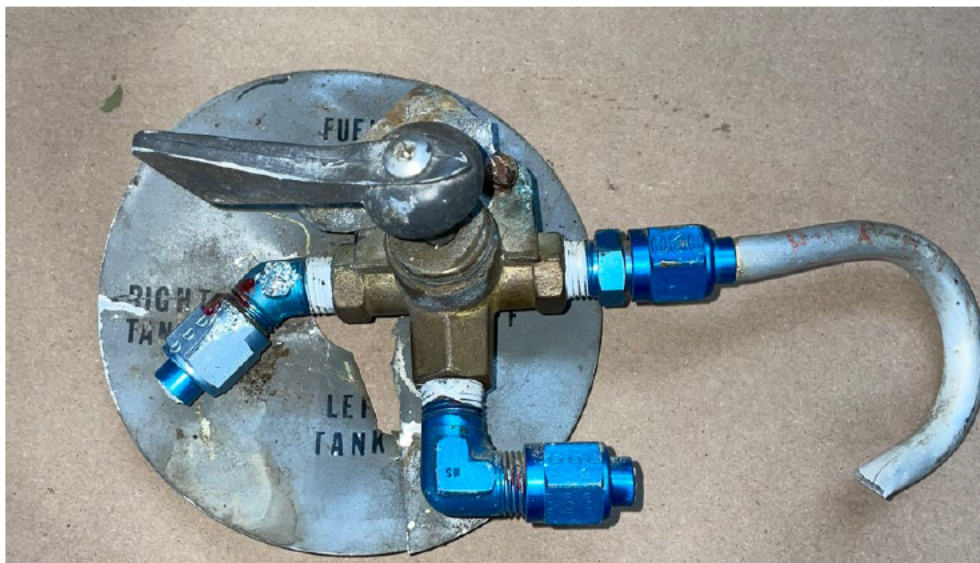
The fuel system was damaged by impact and the fuel tanks were compromised. The fuel selector and fuel lines in the wings leading up to the gascolator were free of debris/blockages.

**Figure 3 Fuel selector valve.**

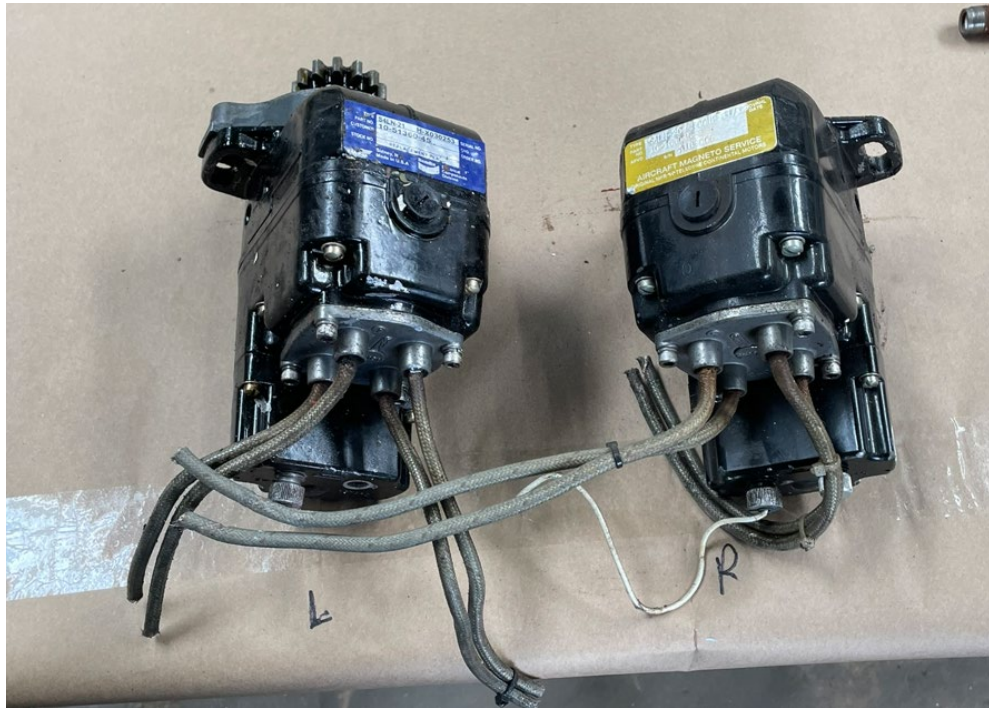
Left and Right Magnetos and all associated leads and terminals were not damaged, and an electric drill was used to manipulate the magnetos. On both left and right mag produced healthy blue/purple spark.

**Figure 4 Magnetos.**

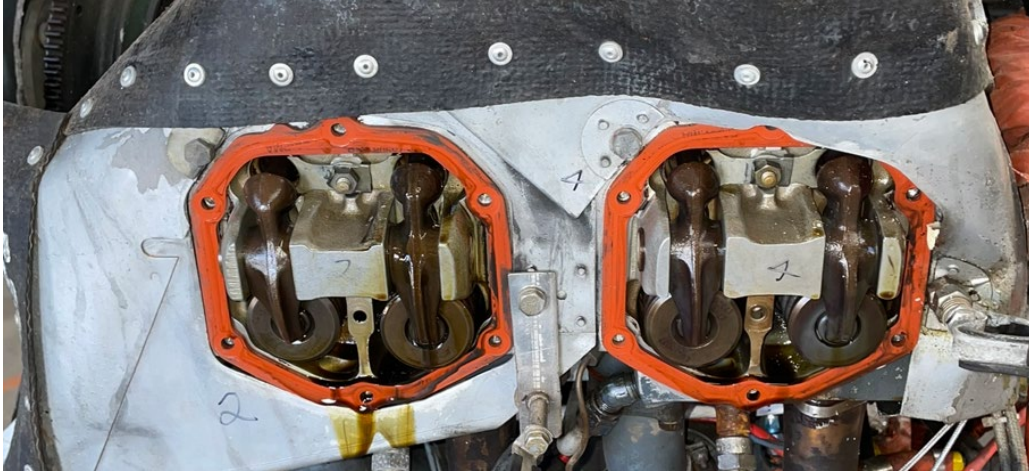
Engine examination continuity check, compression was obtained on cylinder Nos. 1,2, 3; no compression was obtained on No. 4. The No. 4 cylinder exhaust valve was stuck in the open position but became unstuck during manual manipulation; light taps with a rubber mallet. Unable to reproduce the stuck valve after.

**Figure 5 The number 2 and 4 cylinder assembly. No 4 had stuck valve.**

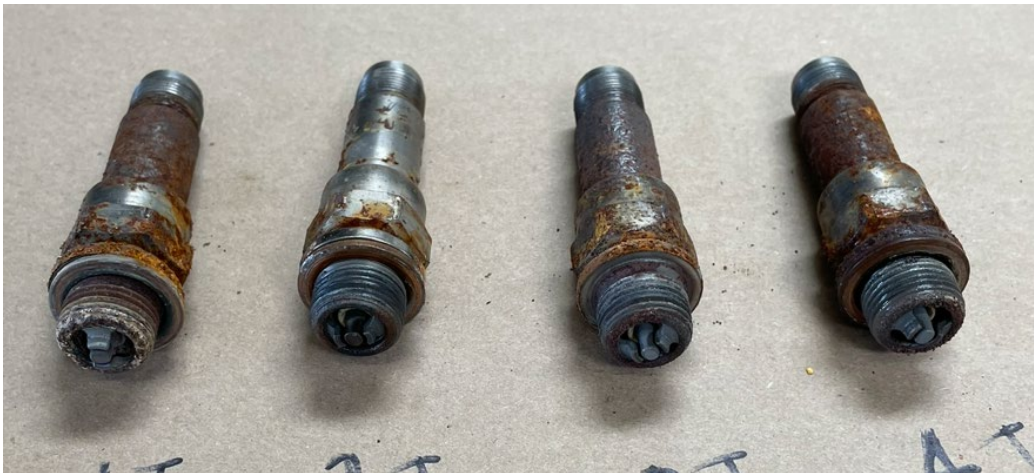
The Nos. 3 and 4 spark plugs contained minor carbon build up on the electrodes, the rest had normal coloration as compared to the Champion Aerospace AV-27 Check-A-Plug chart.

**Figure 6 Top spark plugs.**
